1.0 Ambrosia Lake, New Mexico, Disposal Site

1.1 Compliance Summary

The Ambrosia Lake, New Mexico, Uranium Mill Tailings Radiation Control Act (UMTRCA) Title I Disposal Site was inspected on August 19, 2015. The disposal cell was in excellent condition. Inspectors identified no maintenance needs or cause for a follow-up or contingency inspection.

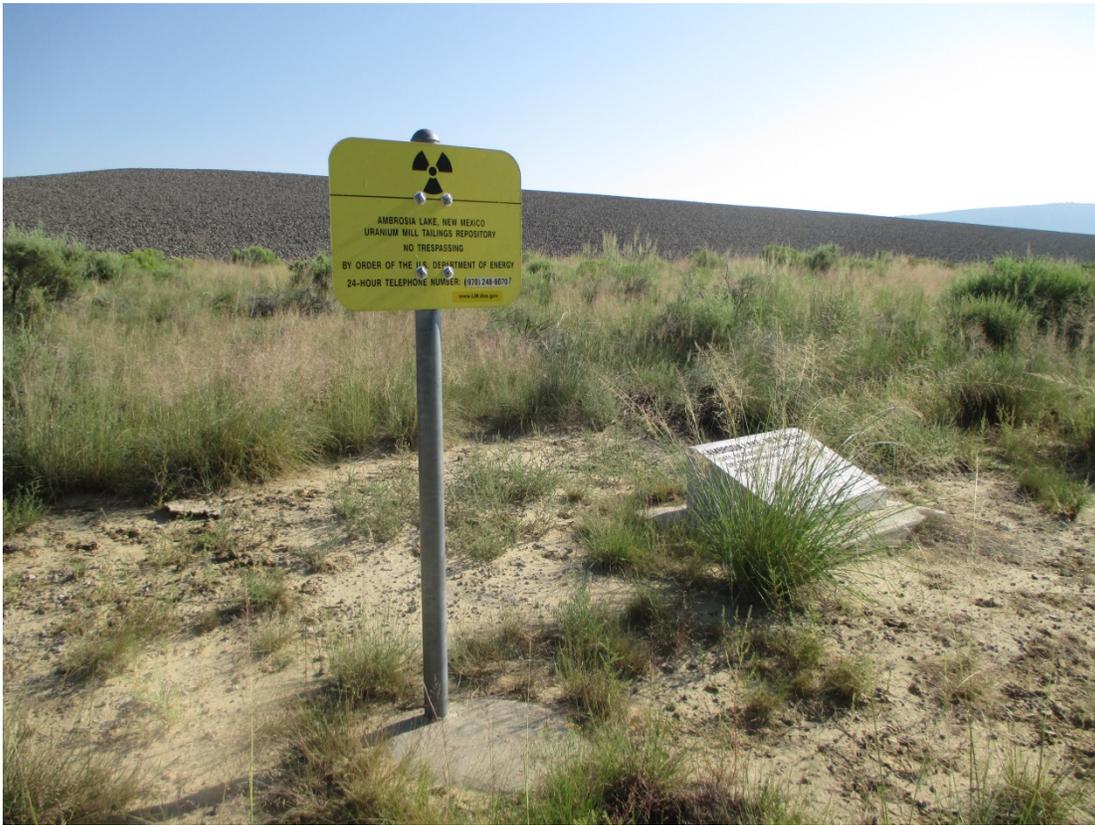
The entrance sign was in good condition (PL-1).

AMB 8/2015. PL-1. Entrance sign and site marker SMK-1.

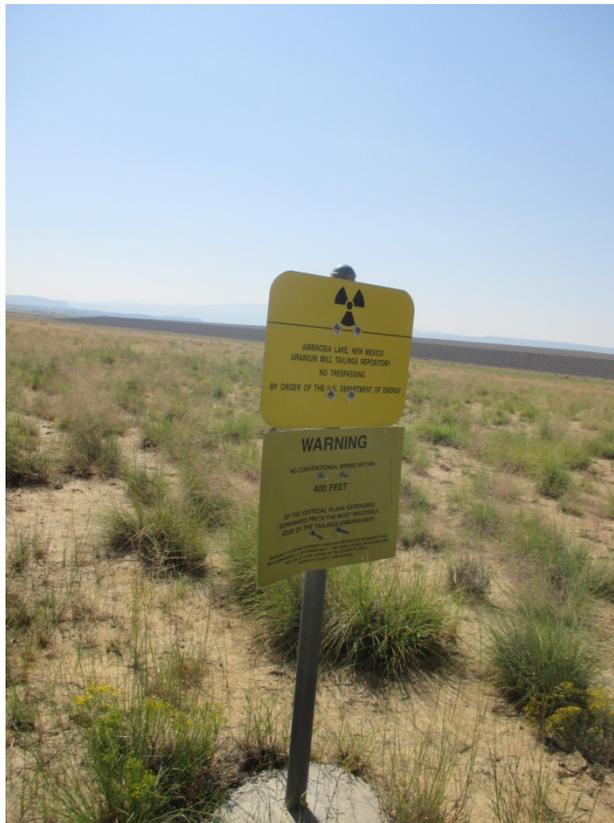
The site is not fenced. Seventy perimeter signs, positioned on the site boundary, were in good condition. Posts for perimeter signs P1 through P15 include mining-restriction-area warning signs. Cattle have rubbed against and bent the mining restriction signs but the signs were otherwise in good condition (PL-2).

AMB 8/2015. PL-2. Perimeter sign P14.

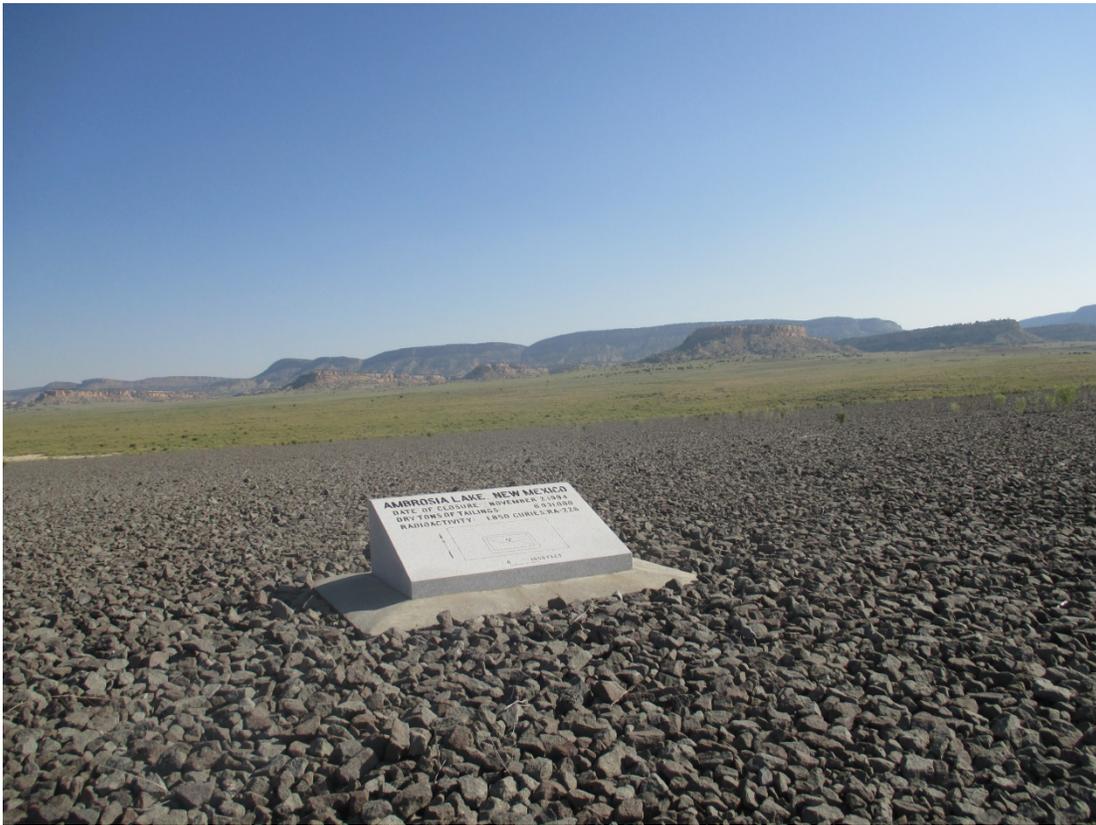
Granite site markers are located near the site entrance and on top of the disposal cell (PL-3). Both site markers were in excellent condition.

AMB 8/2015. PL-3. Site marker SMK-2.

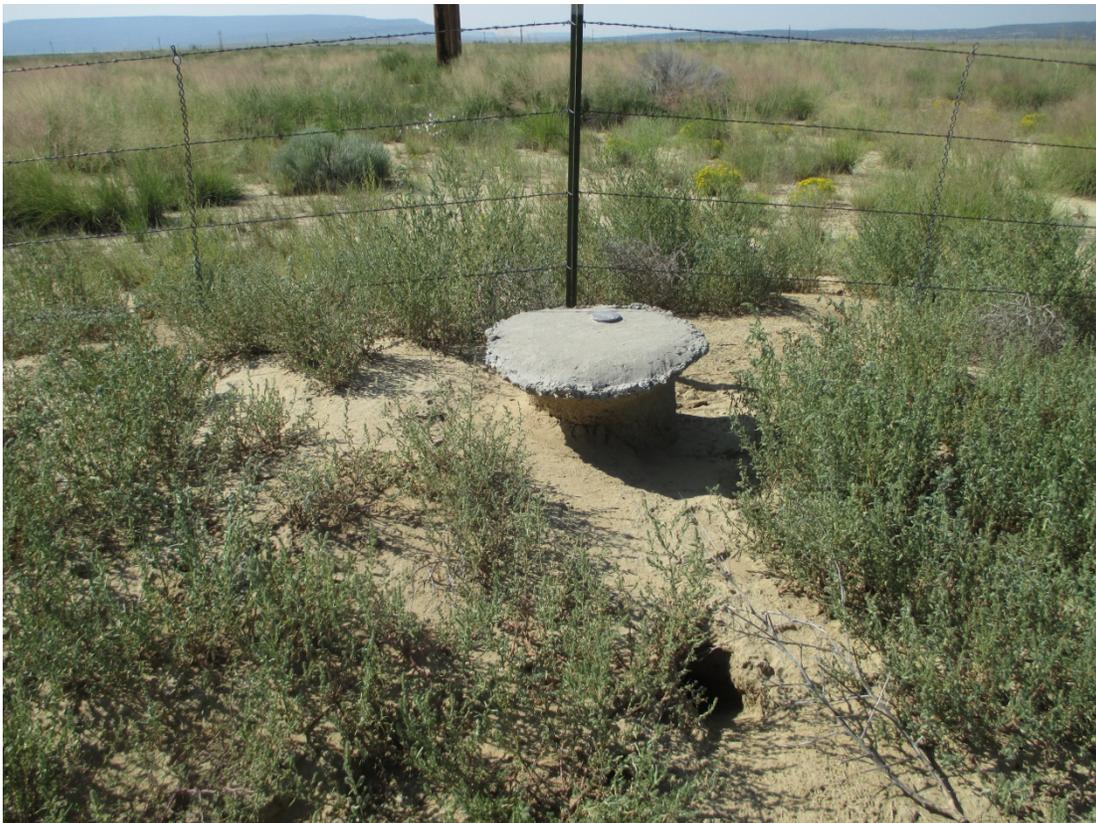
Three combined survey and boundary monuments and five additional boundary monuments identify the property corners and boundary. Boundary monument BM-3 was not found and was apparently covered with soil. All of the other monuments were undisturbed and in good condition. Wind erosion has exposed the concrete base of boundary monument BM-8, but the monument is stable (PL-4).

AMB 8/2015. PL-4. Boundary monument BM-8.

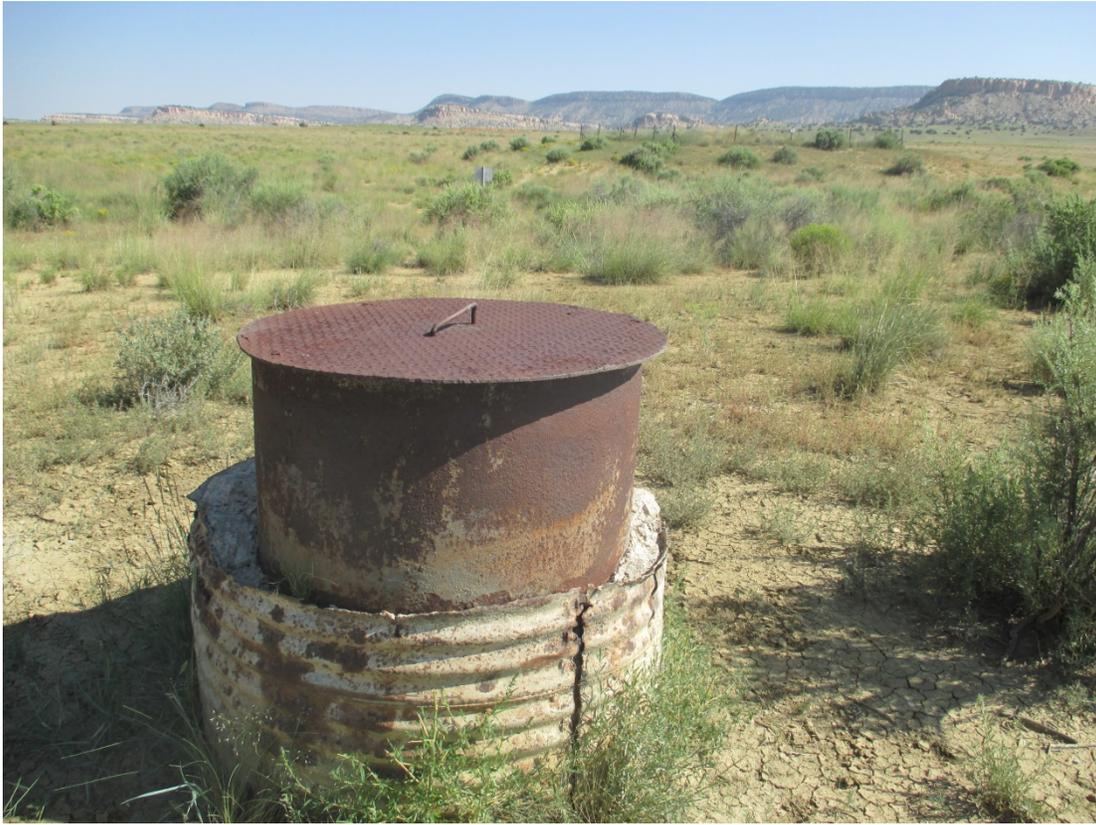
A mine vent shaft, associated with an abandoned underground mine, is within the site boundary in the northern portion of the site. The vent has a casing, which rises approximately 3 feet above the ground, and a spot-welded cover. The vent was secure at the time of the inspection (PL-5). Inspectors will continue to monitor the condition of the vent to ensure that the closure remains secure.

AMB 8/2015. PL-5. Vent south of Ann Lee mine shaft.

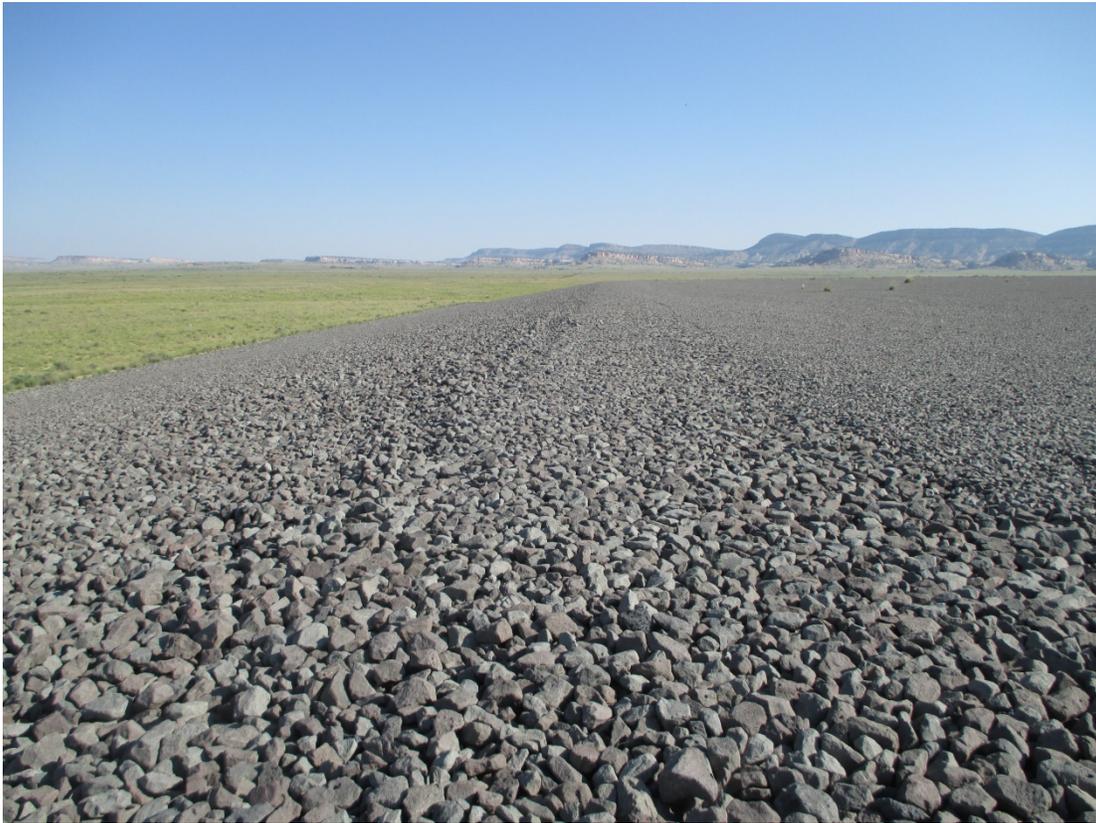
The 91-acre disposal cell was completed in 1994. The basalt riprap-covered top slope of the disposal cell was in excellent condition (PL-6). There was no evidence of cracking, slumping, or erosion, and there was no indication of riprap degradation.

AMB 8/2015. PL-6. West edge of disposal cell top slope.

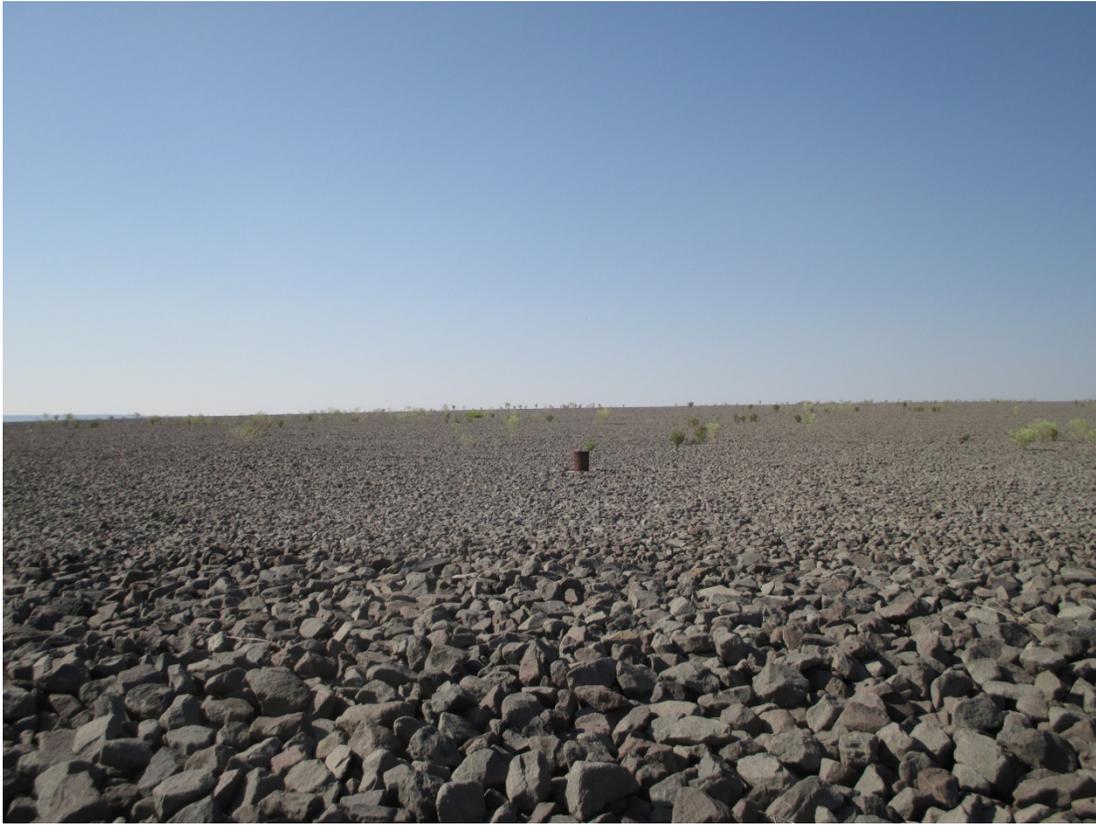
A shallow depression around settlement plate SP-4, near the northeast corner of the disposal cell cover, was first noted during the 1997 inspection and continued to grow in depth and area in subsequent years. The depression was repaired in August 2005. Visual observations during the 2015 inspection indicate that very minor settlement may have occurred since the depression was repaired (PL-7).

AMB 8/2015. PL-7. Settlement plate SP-4.

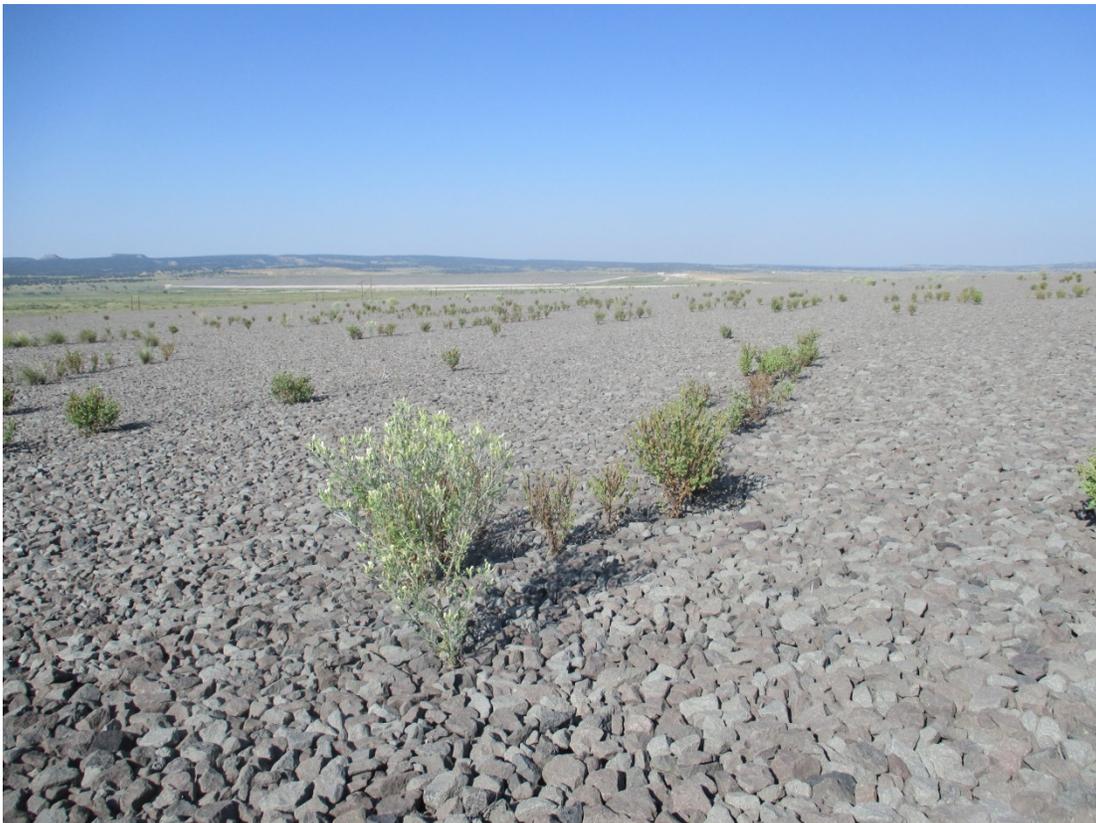
Scattered annual weeds and perennial grasses and forbs are growing on the disposal cell top slope (PL-8). In accordance with the LTSP, deep-rooted shrubs are to be removed from the cell cover. No deep-rooted shrubs were noted during the inspection.

AMB 8/2015. PL-8. Vegetation on southeast portion of top slope.

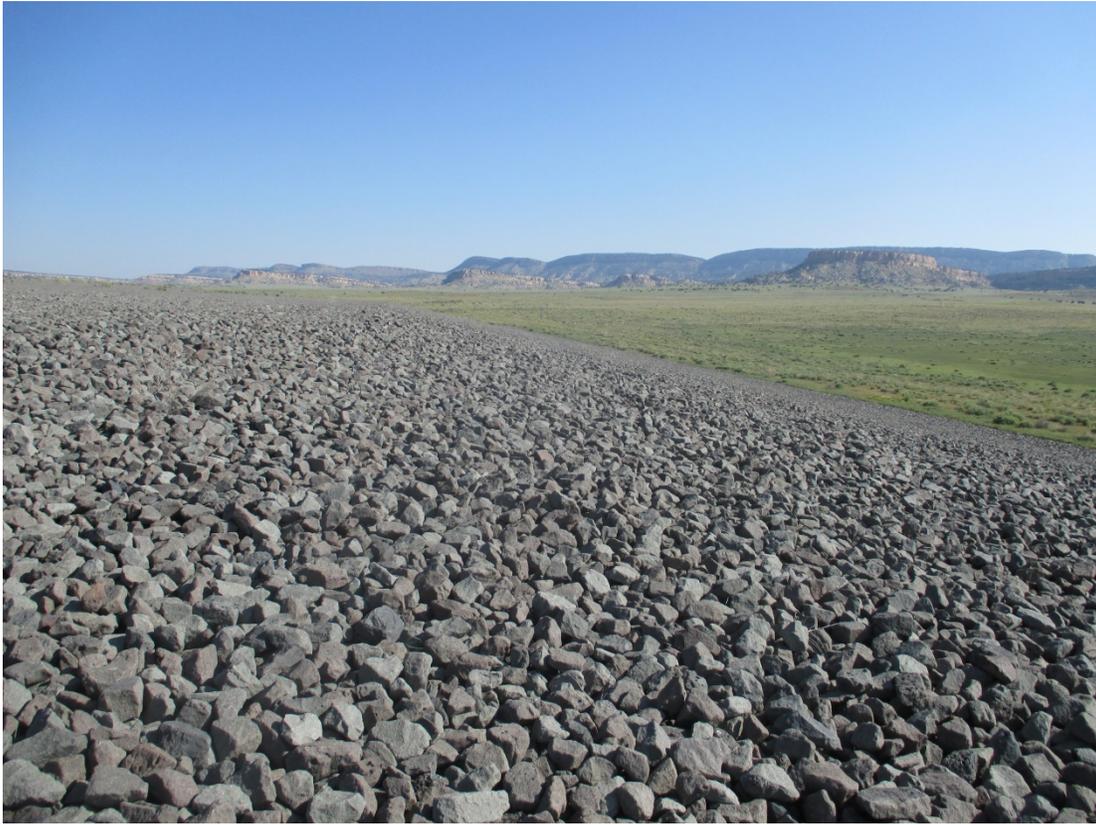
The basalt riprap-covered side slopes and apron were in excellent condition and showed no evidence of cracking, settling, slumping, or erosion (PL-9). Standing water was present in a portion of the south apron (PL-10). This location is the topographic low spot along the base of the disposal cell and rainfall runoff collects in this area.

AMB 8/2015. PL-9. East side slope.

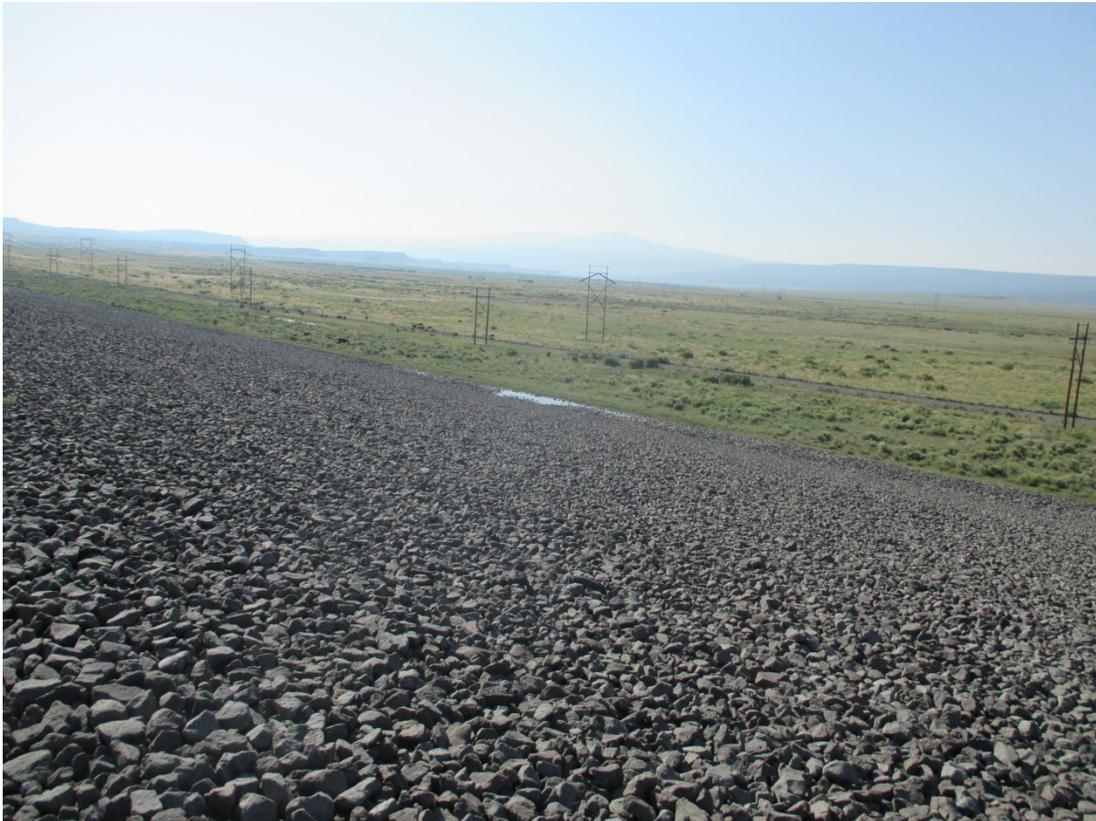
AMB 8/2015. PL-10. South side slope and standing water in apron.

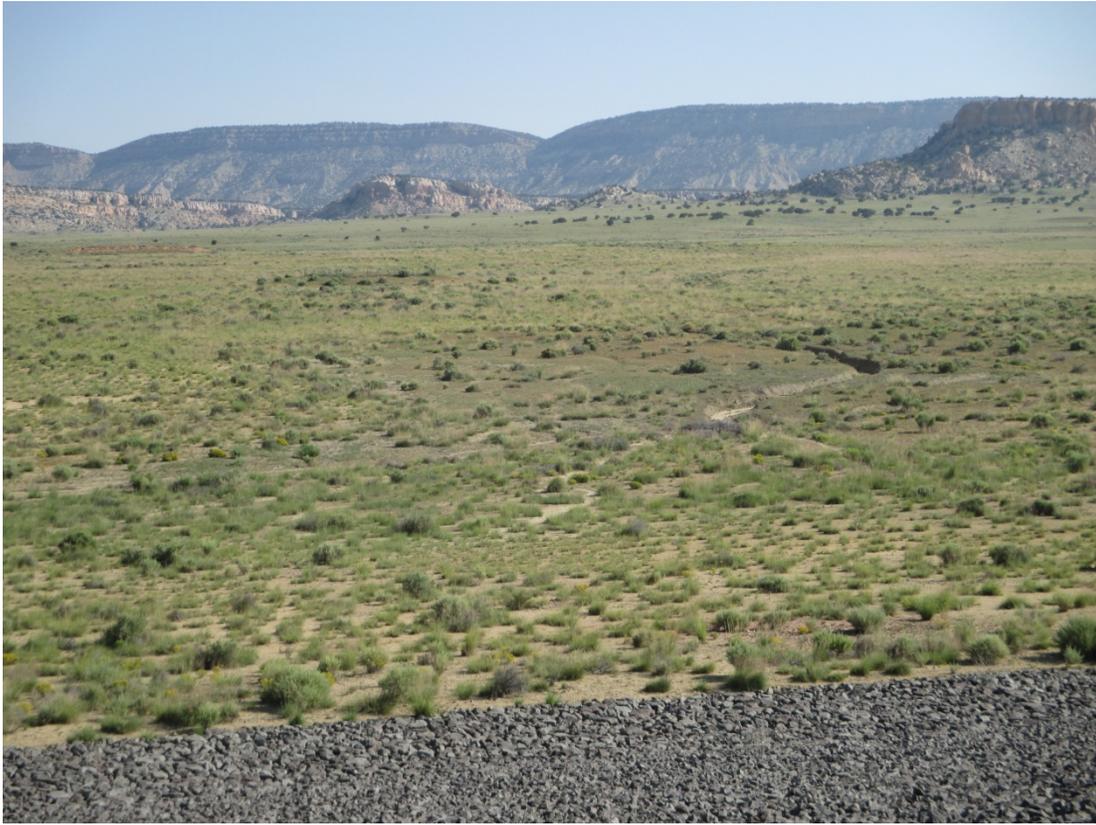
Rills and gullies within the DOE property north and east of the disposal cell have been monitored for several years (PL-11). These erosional features do not threaten the disposal cell’s performance or integrity because headward erosion is progressing away from the cell, and there is no significant sedimentation near the cell.

AMB 8/2015. PL-11. Erosion north of disposal cell.
