SITE SCREENING MEMORANDUM
PHASE II REMEDIAL INVESTIGATION
FORMER AMCHITKA ARMY AIR BASE
AMCHITKA ISLAND, ALASKA

February 1996

Submitted To:
Department of the Army
Alaska District, Corps of Engineers

By:
Shannon & Wilson, Inc.
2055 Hill Road
Fairbanks, Alaska 99709-5244

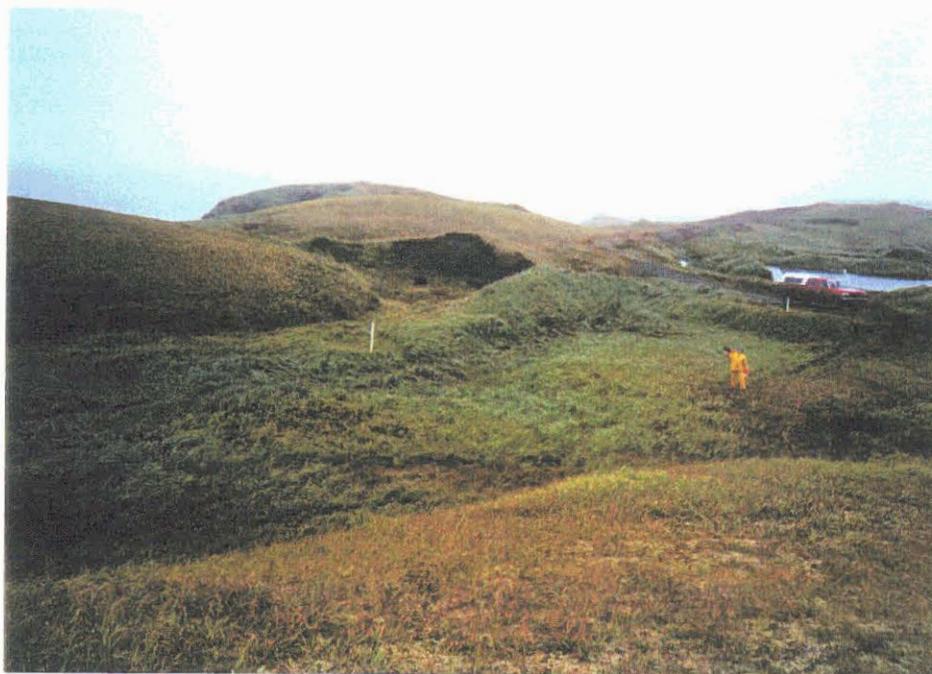
Photo 1: Tanks 11 and 12 site, standing near Tank 10 facing northeast. Tank 12 setting and wetland at center, Lake Grace at center right.

Based on the 1998 investigation, it is concluded that: (1) no primary or extensive secondary source remains for continuing contaminant release, (2) contaminated soil does not appear to extend beyond the area immediately downslope of the tanks, and (3) there is no visible or supporting chemical evidence of significant levels of hydrocarbons migrating to the marine environment. No further action is recommended at this site.

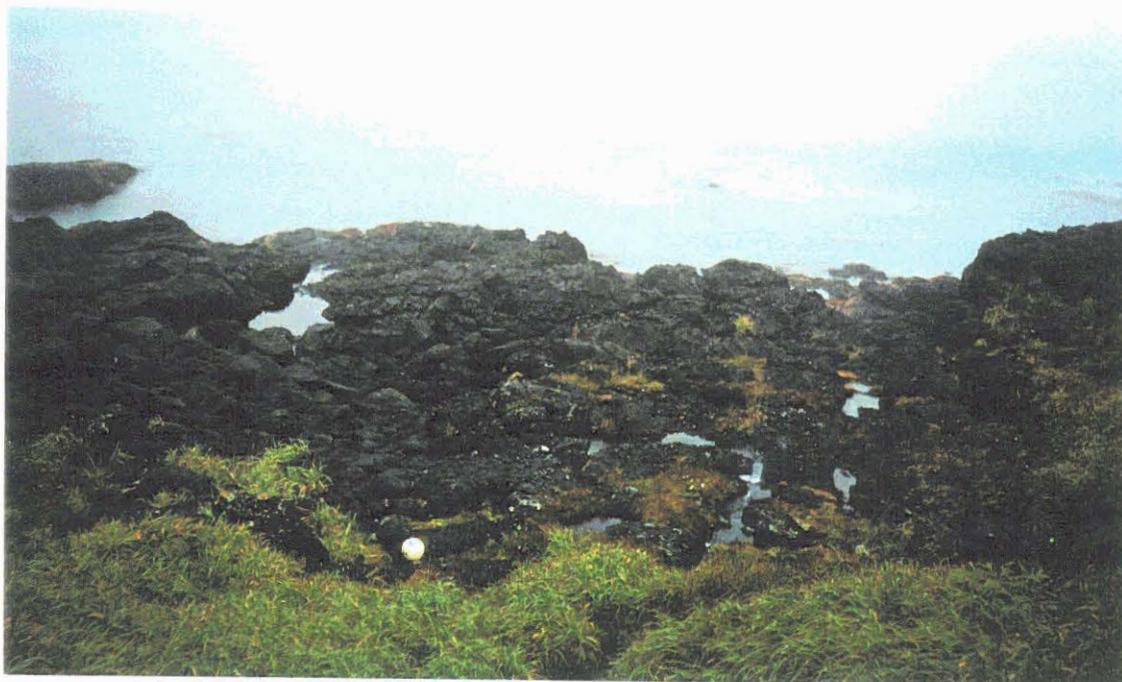
water samples collected from the stream and tide pools had DRO concentrations ranging from 149 to 177 ug/L. The sediment sample collected from the stream had a DRO concentration of 41 mg/kg. None of these samples contained detectable levels of PAHs. These concentrations may reflect at least some contribution by biogenic hydrocarbons in the DRO range, because they are consistent with levels of DRO found in surface waters from elsewhere on the island at uncontaminated background sites. Similar low levels of diesel-range hydrocarbons were found in the soil and groundwater from the monitoring wells, with the exception of higher concentrations that were detected in the well immediately adjacent to the 1997 stream sample location.

Photo 2: Tanks 11 and 12 site, beach at stream mouth, surface water samples collected from pools in intertidal area.

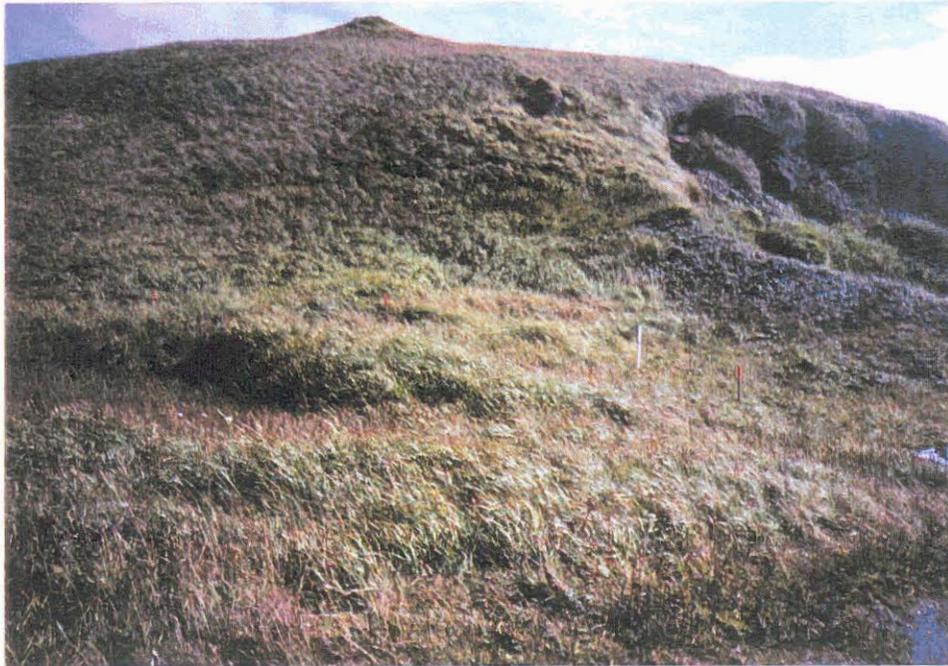
Tanks 16 and 19 are also located in the diesel portion of the Kirilof Peninsula Tank Farm, east of, and also unrelated to, the Kirilof Point Seeps. Evidence of hydrocarbon contamination observed in 1997 included stained soil with a strong hydrocarbon odor at the toe of a roadside bench downslope from the two tanks that may have been a roadside turnout or fill stand for fuel oil trucks. Water that was seeping from the slope near the stained soil was flowing directly into a small north-flowing stream that drains to the Bering Sea. Samples collected in 1997 from this stream and from a tributary stream that drains the vicinity of Tank 19 contained maximum DRO concentrations of 37,500 mg/kg and 445 ug/L, respectively, in sediment and surface water. Other contaminants detected in the sediment samples included low concentrations of PAHs and alkylated benzenes.

Photo 3: Tanks 16 and 19 site, north side of Tank 19 where three soil borings were drilled.

No primary source remains for continuing contaminant release, and the impacted stream water and sediment do not appear either extensive or continuous to the marine environment. No further action is recommended at this site.

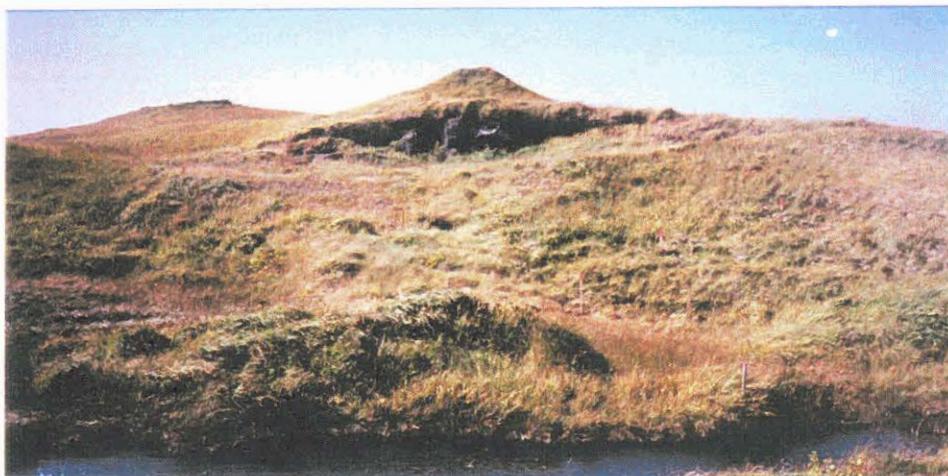
It is concluded that the contamination at the bench may have resulted from a fill stand or a short-term leak in the nearby pipeline. The contaminated areas in the streams may have resulted from contaminants originating upgradient that are migrating through the bedrock on the water table, and coming to the surface as seeps along the streams (and possibly at the toe of the bench as well). Such a migration pathway was hypothesized in the 1997 Phase I RI to explain the seemingly random distribution of DRO contamination at the adjoining Kirilof Point Seeps.

Photo 4: Tanks 16 and 19 site, facing northwest toward Tank 16 setting. Location where five soil borings were drilled, pipeline trench full of standing water in foreground

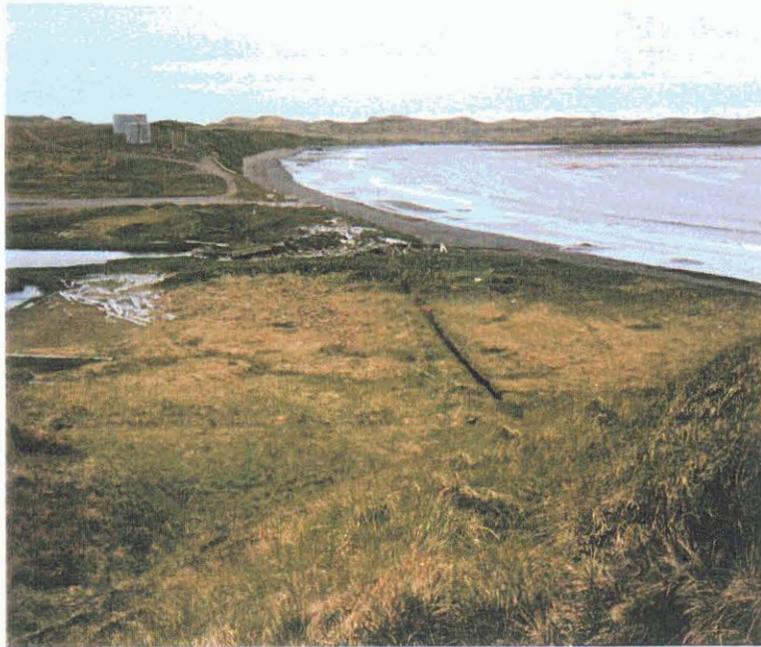
This POL pipeline site is located along the gasoline pipeline between the former White Ship Dock and the aviation gasoline facilities near Baker and Charlie Runways. During the Phase I RI, a thin film of what appeared to be petroleum was found on groundwater in a shallow test hole excavated in a 3-foot by 3-foot, 4-inch deep depression about 100 feet south of the junction of two pipelines (Photo 5). An adjacent stream discharges to Constantine Harbor about 250 feet downstream of the site.

Photo 5: Setting of POL site at base of bluff southeast of Fox Runway; Constantine Harbor at upper right. Site is just right of center of photo, immediately below intersection of two pipe trenches, just hidden by bluff in foreground.

With a very limited source area and no adverse impact to the marine environment, no further action is recommended for this site.

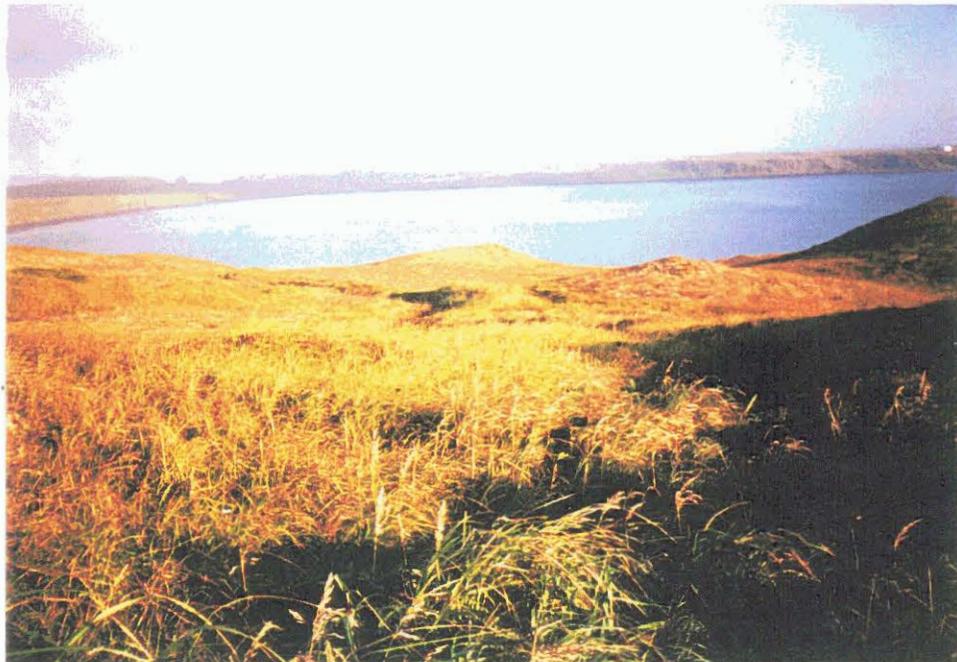
During the 1998 Phase II RI, a reconnaissance was performed of the stream from the beach at Constantine Harbor to its headwaters above the site at Lake Carmen, where WWII gasoline tanks were formerly located. Surface water and sediment samples were collected from the stream at the impacted area and both upstream and downstream from it to evaluate the possible source areas and the extent of contaminant migration. During the reconnaissance, evidence of contamination was found only in the original 1997 location, where a slight sheen was generated on the water when the stream sediment was disturbed. GRO was not detected in any sediment samples, and was detected only in the upstream surface water sample, at a concentration of 94 ug/L. This sample also contained 3.8 ug/L isopropylbenzene. Several alkylated benzenes were detected in the sediment samples, at a maximum total concentration of 4.6 mg/kg. None of these occurrences exceed applicable cleanup standards or risk-based comparison criteria. Lead in the downstream sediment sample, at 41 mg/kg, exceeded the background level and slightly exceeded the NOAA ER-Low value of 34 mg/kg, but is well below the EPA soil cleanup level.

The 1998 Phase II RI results show that the impacted area in the stream is not significantly contaminated by gasoline, nor is it extensive. The data suggest that the pipeline and tanks near Lake Carmen are a possible source of low levels of contamination. Based on the field observations and analytical results, significant impacts due to gasoline contamination are unlikely at this site. No further action is recommended.

Photo 6: POL pipeline site east of Bomb Ready Area, standing at upstream sampling location facing north, view of stream channel extending toward Constantine Harbor.

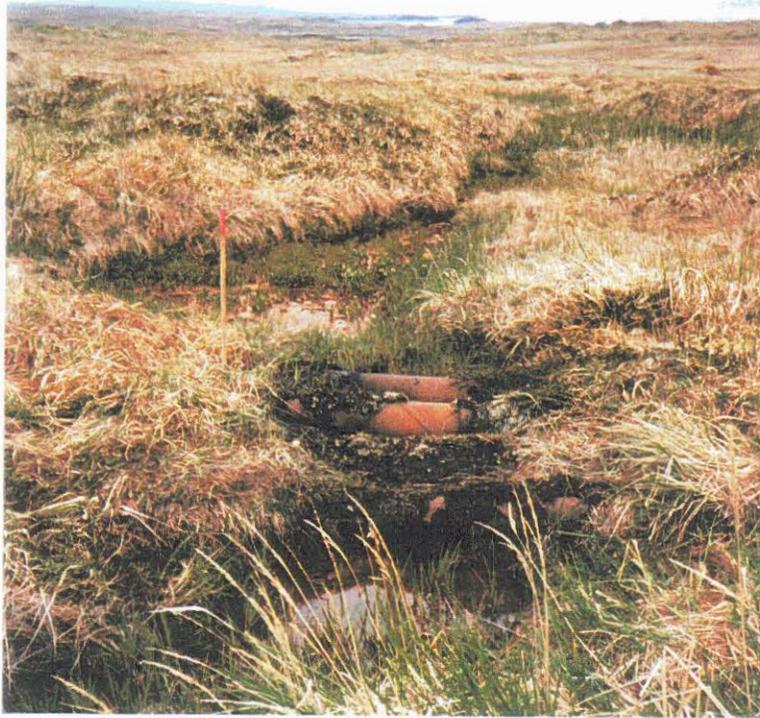
The pump station for the fog-dispersing gasoline flare (FIDO) system was located about 1,000 feet east of the eastern end of Baker Runway, connected by four, 6-inch pipelines to the Avgas Road Tank Farm. The four pipes cross a stream about 600 feet east of the FIDO Pump Station (Photo 7). In 1997 it was noted that one pipe is disintegrated and water was leaking from a hole on the underside of another pipe. Stream sediment below the pipes had a moderate to strong hydrocarbon odor, and when the sediment in the streambed was disturbed, a prominent hydrocarbon sheen formed on the water.

The 1998 Phase II RI investigation at this site was designed to determine the levels of contamination near, downstream, and upstream of the pipeline crossing. No evidence of contamination was found in the stream except within the 20-foot-long zone immediately

downstream of the pipeline crossing, where a slight hydrocarbon sheen was observed on the water surface. Immediately upstream (6 inches) of the pipeline crossing, small blebs of free product were released and floated to the water surface when the sediment was disturbed, resulting in a heavier sheen. Surface water and sediment samples were collected at the pipeline crossing and at 80 and 240 feet downstream. Sampling was not performed upstream of the pipeline crossing because reconnaissance revealed no evidence of upstream sources.

Photo 7: View downstream of stream crossing of four, 6-inch pipes east of the FIDO Pump Station. Note deteriorated condition of closest pipe.

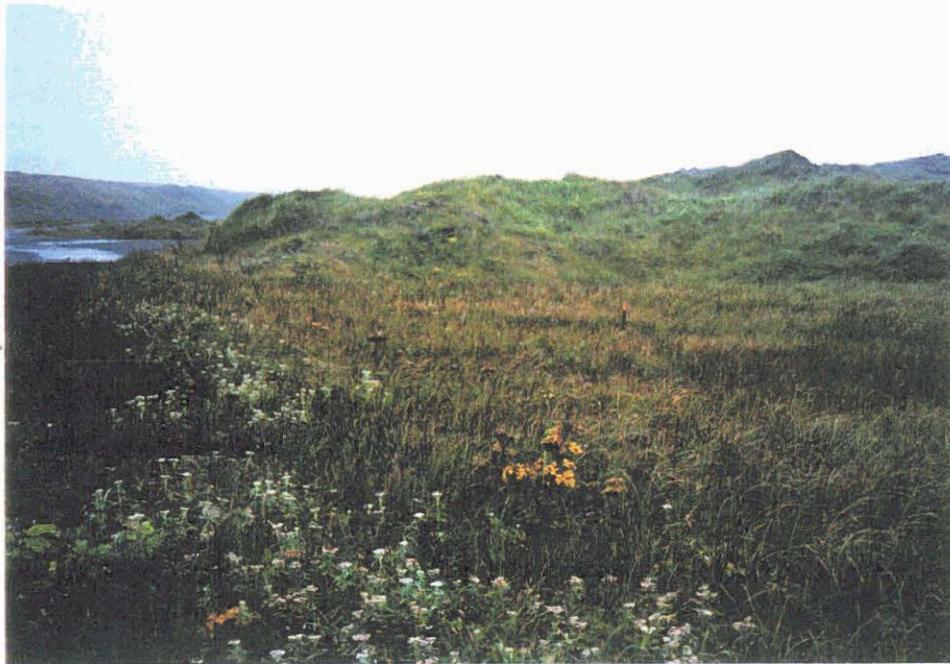
An area north of the middle of Fox Runway was searched for two fill stands during the 1997 Phase I RI, based on WWII fuel system maps that showed two fill stands in this vicinity. Although no pipelines were identified during the site reconnaissance, remnants of two wooden boxes were found that were considered to have possibly been part of the fill stand construction (Photo 8). Nearby, an area with a light hydrocarbon sheen and faint hydrocarbon odor was observed.

observed, each with about 2 to 5 inches of standing water. A hydrocarbon sheen was noted at two locations about 20 feet apart on the northern boundary of the western wetland. No other visible evidence of impacts was found around the borders of the wetlands during the 1998 reconnaissance. GRO was not detected in any surface water or sediment sample. No VOCs were detected in either surface water sample. Two VOCs, 1,2-dibromo-3-chloropropane (a pesticide included in the Method 8260B list of VOCs) and naphthalene, were detected in the sediment sample collected from the western wetland, at concentrations of 22 and 2.7 mg/kg, respectively. The 1,2 dibromo-3-chloropropane concentration exceeds the human health RBC of 0.46 mg/kg for this chemical, while the naphthalene concentration slightly exceeds the NOAA Effects Range-Median concentration. Lead was detected below the background concentration in the sediment samples. Metals concentrations in water samples were near or below background levels.

Based on the 1998 Phase II RI, there does not appear to be any widespread contamination associated with these possible former fill stands. Neither GRO nor elevated levels of lead are present; only 1,2-dibromo-3-chloropropane and naphthalene exceed their comparison criteria. This contamination appears to be restricted in extent at this site, and this is the only reported occurrence of this pesticide compound in the entire RI. The 1998 analytical results do not explain the hydrocarbon sheen or odor that were observed, unless a carrier oil containing naphthalene (other than gasoline) is responsible for the sheen and odor. It is considered unlikely that the sediment contamination will spread far beyond its present localized extent. No further action is recommended at this site.

Photo 8: Fill Stands FS01 and FS02 site, view west from Nashville Runway, site overview and FS01.

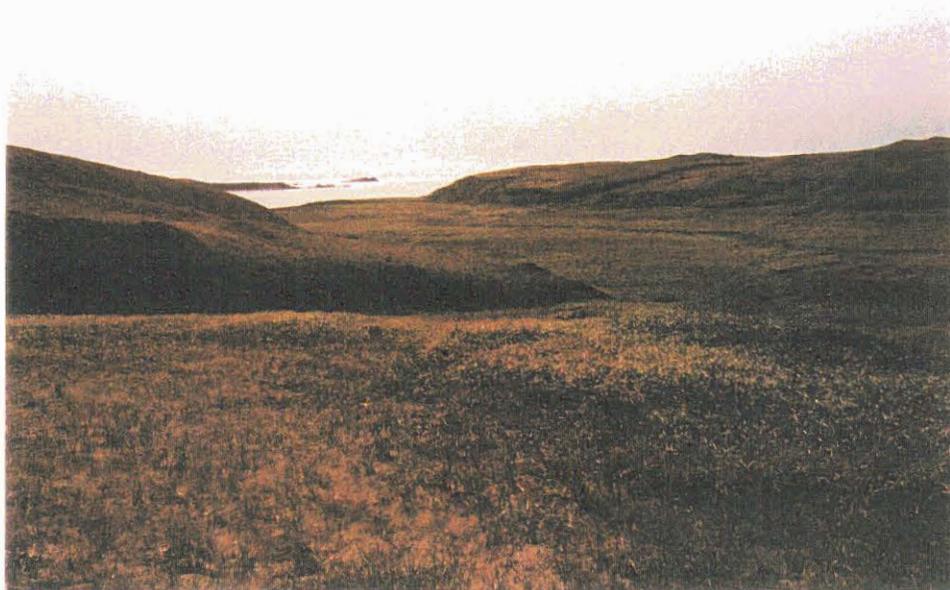
Although the soil in some of the drum dumps exceeds ADEC cleanup standards for several compounds, it does not appear that in the 50 years since WWII that these compounds have migrated to surface water or sediment at levels of concern. ADEC maximum allowable concentrations are exceeded for GRO at Drum Dump DM50, and for DRO at DM01, DM09, DM10, DM11, and DM43. However, in each case these exceedances are based on single samples biased to represent worst-case conditions. In addition, in each case the volume of soil represented by these samples is quite limited. In no case was pooled free product observed in

Photo 9: St. Makarius Drum Dumps site, view looking south toward valley where streams draining the drum dumps converge and flow to St. Makarius Bay.

No further action is recommended either for the drum dumps or the streams in this area above St. Makarius Bay.

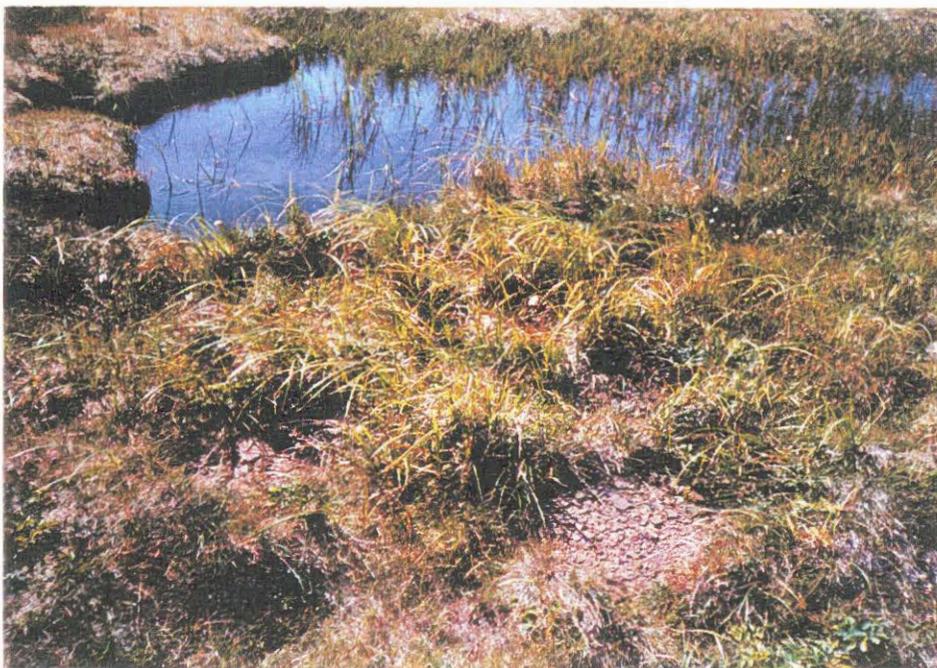
Photo 10: Drum Dump DM43, area of stressed vegetation and circular depressions. This drum dump had the highest concentration of DRO: 21,500 mg/kg.

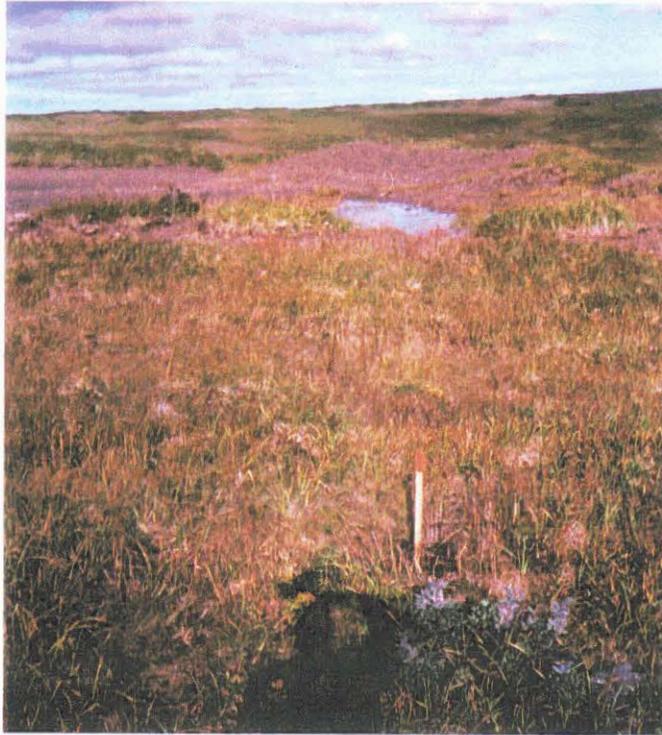
The 53,400 mg/kg GRO and 1,091 mg/kg total of associated alkylated benzenes at Drum Dump DM50 (Photo 11) represent the highest concentrations of these compounds found during the RI. The GRO concentration at DM50 exceeds the ADEC 1,400 mg/kg "maximum allowable concentration." However, neither GRO nor fuel-related volatiles were detected in any surface water or sediment samples during 1997 or 1998.

Photo 11: Drum Dump DM50, facing west. Stake in foreground was sample collection location with the highest concentration of GRO: 53,400 mg/kg.

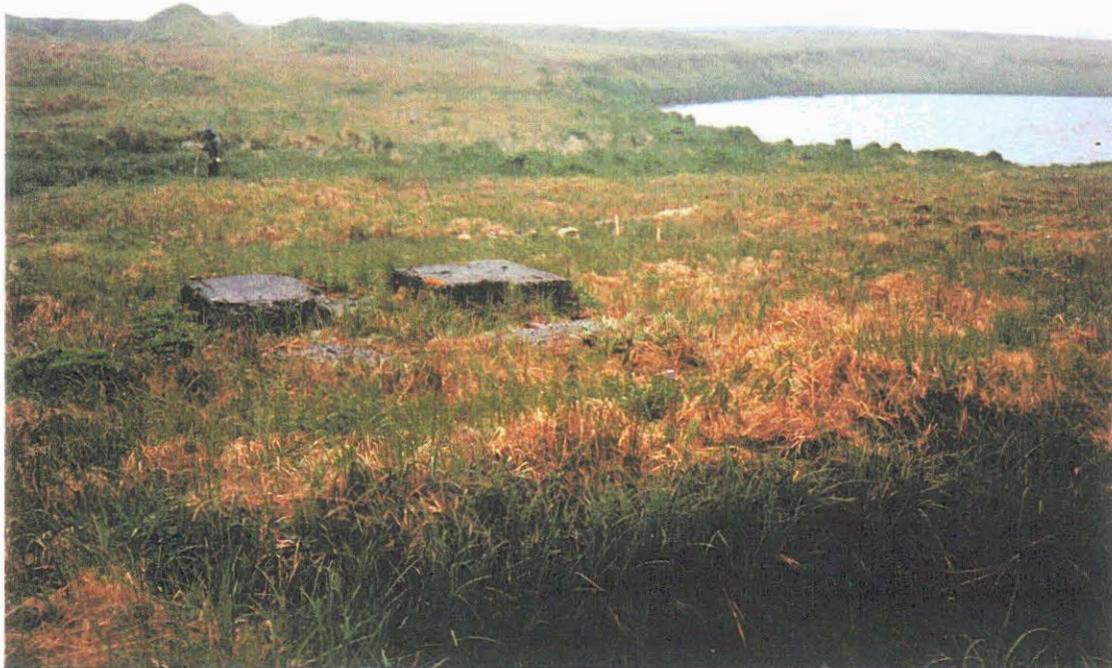
The objective of the Phase II RI investigation of this site was to characterize the extent of the hydrocarbon contamination originating in the water-filled pit. Samples were collected from the soil at the base of the pit, from a boring and monitoring well installed along the probable migration path between the pit and the stream, and from water and sediment in the stream. When the stream sediment was found to be impacted, two more sediment and water samples were collected: about 50 feet farther downstream, and 20 feet upstream from the stream's outlet across the beach at Constantine Harbor.

Photo 12: Jones Lake Generator Building site, view facing east. Suspected former UST pit in foreground, concrete pad of generator building beyond. Stream in middle background, flowing to left.

There is no reason to expect accelerated migration of contaminants beyond that which has occurred during the past 50 years. No further action is recommended at this site.

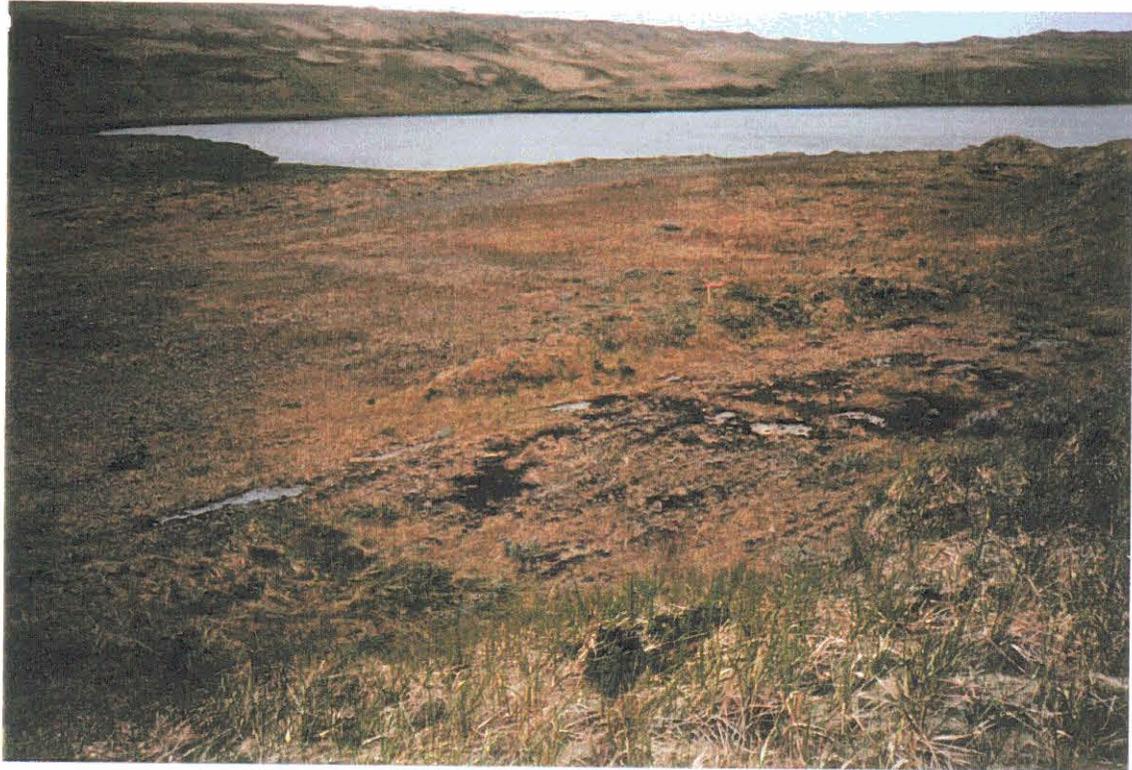
Suspect Building ST10, thought to be a former WWII motor pool garage, is located about 200 feet north of the northeast corner of Clevenger Lake. During the 1997 Phase I RI, stressed vegetation was observed in a poorly drained area at the base of the sandy bluff, about 100 feet west-southwest of the former motor pool garage location (Photo 13). A 6-inch-deep hole exposed green-gray sand that had a moderate to strong hydrocarbon odor and a PID headspace reading of 40 ppm. It was speculated that the green color was the result of dye in gasoline. The objective of the Phase II RI investigation of this site was to confirm the presence or absence of hydrocarbon contamination at the location observed in 1997, and determine the potential of downstream impacts.

Surface water and sediment samples collected downstream from the site contained much lower concentrations of organic constituents. DRO was reported at 53 mg/kg in the Clevenger Lake sediment sample, and at 84 and 157 ug/L in the two surface water samples. These low levels of DRO are comparable to levels of biogenic hydrocarbons found in the 1997 Phase I RI background samples. The Clevenger Lake sediment sample also contained 0.14 mg/kg toluene. The sediment sample from the drainage trench west of the site contained a total concentration of 0.47 mg/kg of nine PAHs. No VOCs or PAHs were reported in the water samples. Similarly, the metals detected in these samples were at or below their corresponding background concentrations, with a few exceptions. Zinc concentrations were slightly elevated above background in both sediment samples, and were slightly higher than the NOAA Effects Range-Low values for zinc in sediment. The lead in the sediment sample from the drainage trench was about double background, but lower than the NOAA Effects Range-Low value and much less than the concentration reported in the green-gray sand. Metals concentrations in water were at or below background except for antimony in Clevenger Lake, and chromium and lead in the drainage depression; none of these metals exceeded surface water quality criteria.

The diesel, heavy oil, and metals contamination found in the green-gray sand appears to be localized. Slightly elevated metals levels in the downstream water samples may be related to the site, but Clevenger Lake does not appear to be significantly impacted. No further action is recommended at this site.

Photo 13: Suspect Building ST10 site facing southwest. Building foundation in middle foreground, Clevenger Lake in background. Gray-green sand area is near center right edge of photo; surface water drainage path goes around base of bluff at upper right.

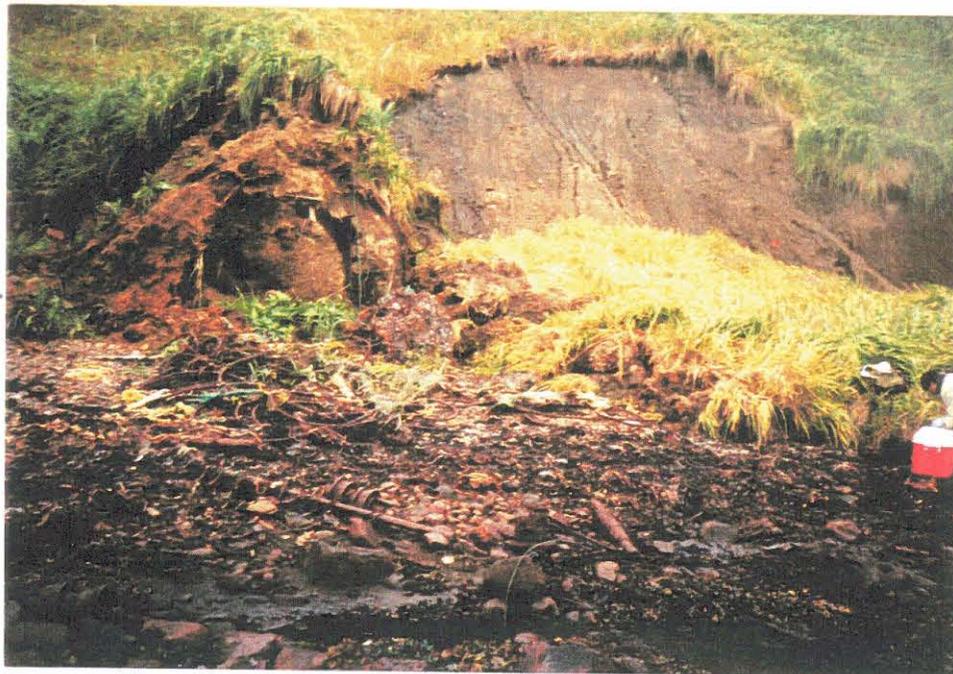
The St. Makarius Bay Landfill is a WWII disposal site on the bluff overlooking St. Makarius Bay that contains a variety of metal debris and ordnance. In 1993 the USFWS observed leachate on the beach at the toe of the bluff. Debris extends approximately 400 feet along the toe of the bluff, and also into the intertidal zone as a result of large slump blocks that have fallen from the bluff face (Photo 14). Elevated levels of cadmium, chromium, and lead were detected by the USFWS in a sediment sample collected in 1993 downgradient from the leachate seeps. Foster Wheeler Environmental Corporation conducted a Site Inspection of the St. Makarius Bay Landfill for the USFWS in 1995, and found elevated concentrations of chromium, nickel, arsenic, and lead in a soil sample from the base of the bluff. One tide pool surface water sample contained cadmium, copper, zinc, arsenic, lead, and mercury above the Phase I RI surface water background concentrations. Copper, lead, and zinc concentrations were significantly higher than background, at 6,400 ug/L, 1,200 ug/L, and 1,700 ug/L, respectively. The anomalously high concentrations of these metals were the primary reason that additional sampling was conducted during the 1998 Phase II RI. Based on their analytical work, Foster Wheeler concluded that organic compounds were not present at significant levels at this site.

It was concluded that metal debris piled on the beach and scattered in the intertidal zone has resulted in concentrations of some metals that are above both background levels and ecological risk-based screening concentrations in seep surface water and sediment, and in marine surface water and sediment. While some of this contamination may be transported via water from the landfill on top of the bluff, it appears that the majority of contamination is being transported via water filtering through the large slump block on the beach that contains a large quantity of rusted metal debris.

Photo 14: St. Makarius Bay Landfill site, standing on beach facing inland, debris visible on beach, sampling Station 5 on slump block in background.

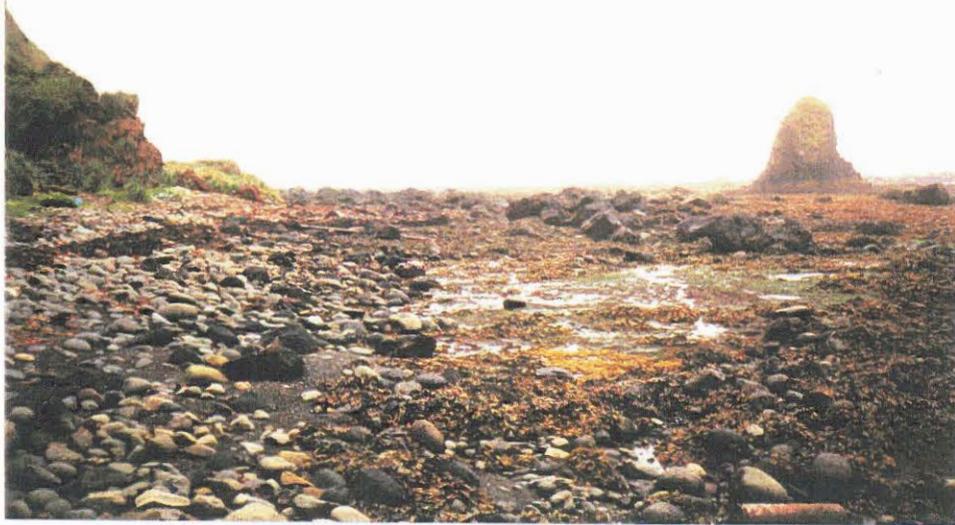
Photo 15: St. Makarius Bay Landfill site, looking east along beach from west of the landfill, view of intertidal area. Slump block at left center.

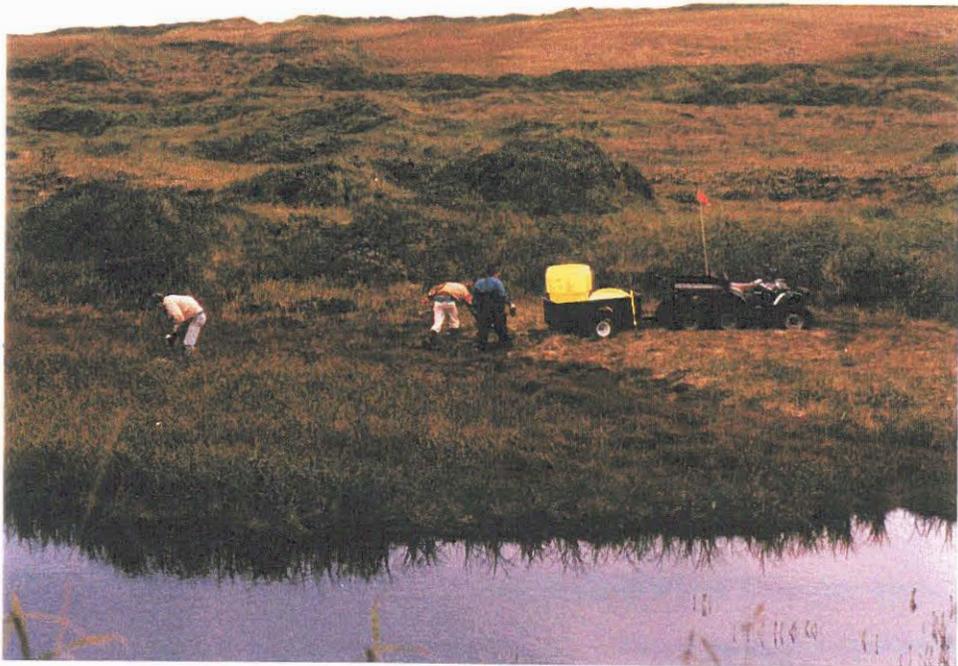
The surface water sample contained 532 ug/L of lead, which was not detected in any of the 1997 background surface water samples. This level of lead exceeds all surface water comparison criteria, but is not unexpected considering the batteries were in contact with this water. However, the source has now been removed, and it is likely that the level of contamination diminishes rapidly with distance from the former source. No further action is recommended at this site.

Photo 16: Battery Dump site facing northeast, removing batteries from marshy area.

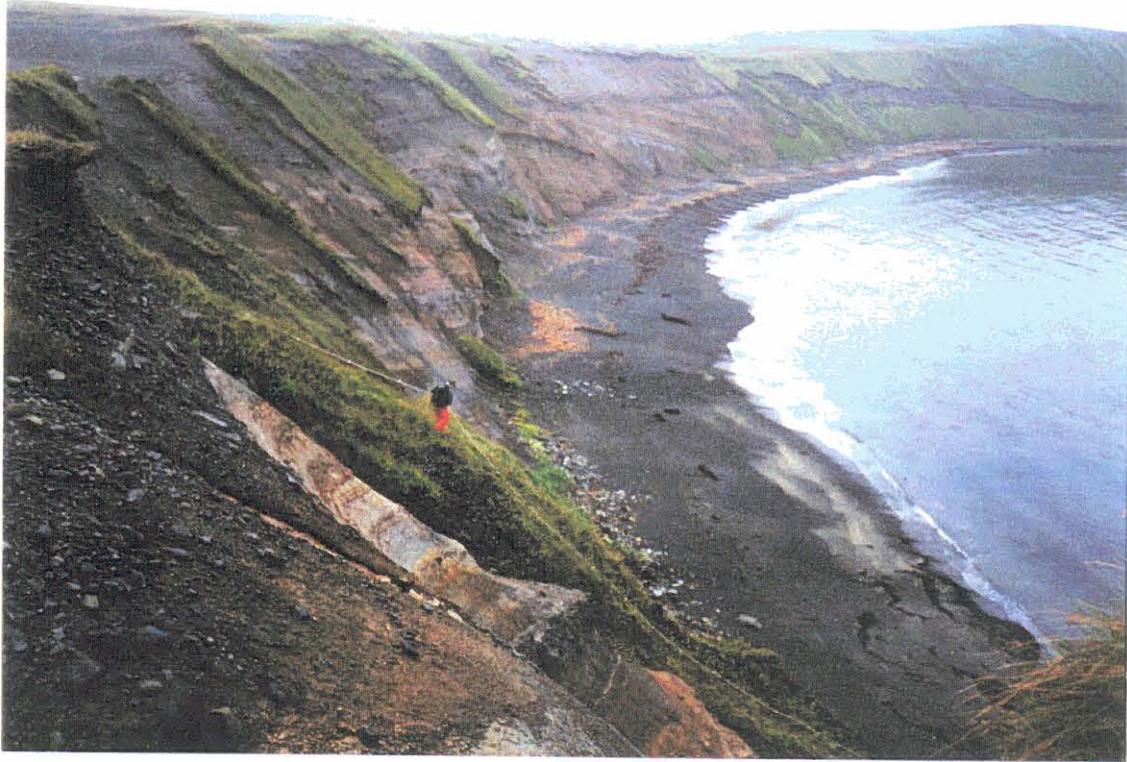
A UXO subcontractor working for Shannon & Wilson, Inc. during the 1998 field effort observed a hydrocarbon release at the beach below the South Bight Landfill. After the release was confirmed and reported to the Corps of Engineers, investigation of leachate from the debris was added to the scope of the Phase II RI. This site is on the beach below South Bight Quarry, which was previously an unexploded ordnance (UXO) demolition area. In 1993, the USFWS

noted the presence of debris dumped over the bluff face southwest of the quarry. UXO was noted mixed with the debris at the toe of the bluff in 1998. It appears that during or after the war, scrap metal and munitions were dumped over the edge of the bluff. Some of this debris is now scattered down the face of the steep bluff (Photo 17), but much of it has slumped and is piled on the beach below (Photo 18). Relatively little debris has been washed into the intertidal area compared with the conditions observed at the St. Makarius Bay Landfill. Most of the debris on the beach is found within about a 250-foot-wide stretch of beach.

Photo 17: South Bight Landfill, view from top of bluff.

Although the data suggest that some organic chemicals from the seep may be released to the intertidal environment, it is unlikely that the detected concentrations would result in any significant ecological effects, especially given the volume of the receiving water in South Bight. Similarly, the concentrations of metals found in tide pool water and sediment do not appear to pose a significant risk, since those that exceed background concentrations do not exceed risk-based benchmarks. No further action is recommended for this site.

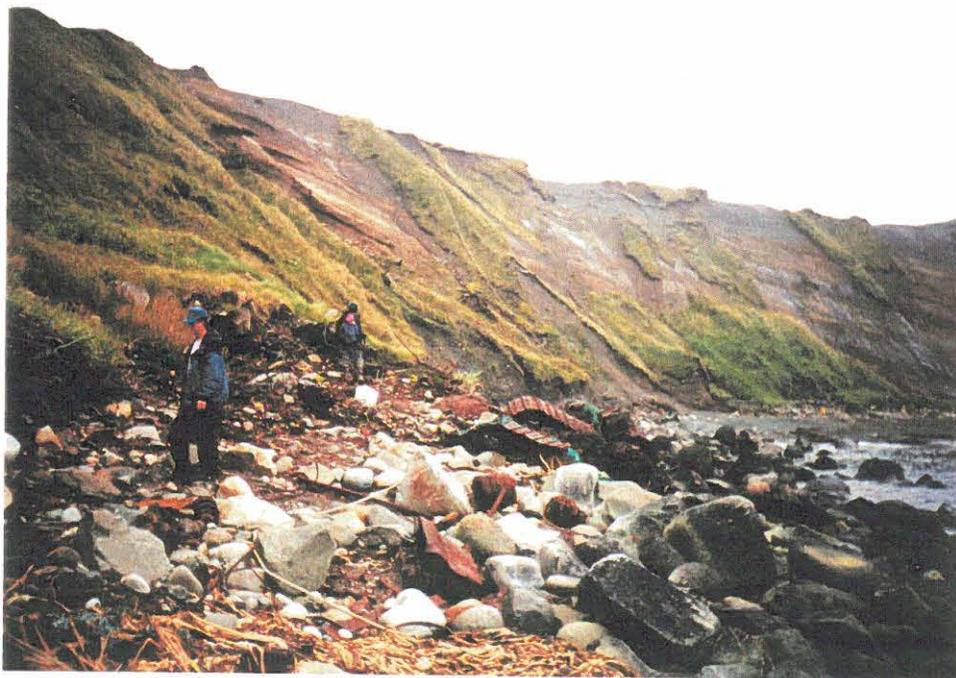
No seeps were noted on the face of the bluff above the debris pile. However, water was seeping from the debris pile, possibly originating from shallow subsurface water filtering through the slump, from deeper groundwater, or a combination of both. A slight hydrocarbon sheen and black discolored soil were noted at the seeps during the initial reconnaissance of the site. The surface water and sediment below the debris pile contained 1,110 ug/L and 1,990 mg/kg DRO, respectively. Low levels of fuel-related alkylated benzenes and PAHs were also present in these samples. The 1,110 ug/L DRO in the seep water at one location does not exceed the ADEC groundwater cleanup level, although the DRO concentration in sediment exceeds the ADEC cleanup level for the migration to groundwater pathway. The absence of BTEX compounds, and the low level of PAHs, results in no exceedance of ADEC surface water criteria for total aromatic or total aqueous hydrocarbons. The only exceedances of ecological risk-based screening criteria for the organic compounds detected in the sediment were fluorene at a slightly higher concentration than the Effects Range-Low value, and a naphthalene concentration midway between the Effects Range-Low and -Median values. The tide pool sediment and water are unimpacted by organics, with the exception of the reported occurrence of 2.4 ug/L of PCE in the water sample; this concentration is well below the Ambient Water Quality Criterion. Since this compound was not reported in the sediment or seep water uphill of this tide pool, it is difficult to attribute a source to the PCE.

Photo 18: South Bight Landfill, beach to the east of landfill.

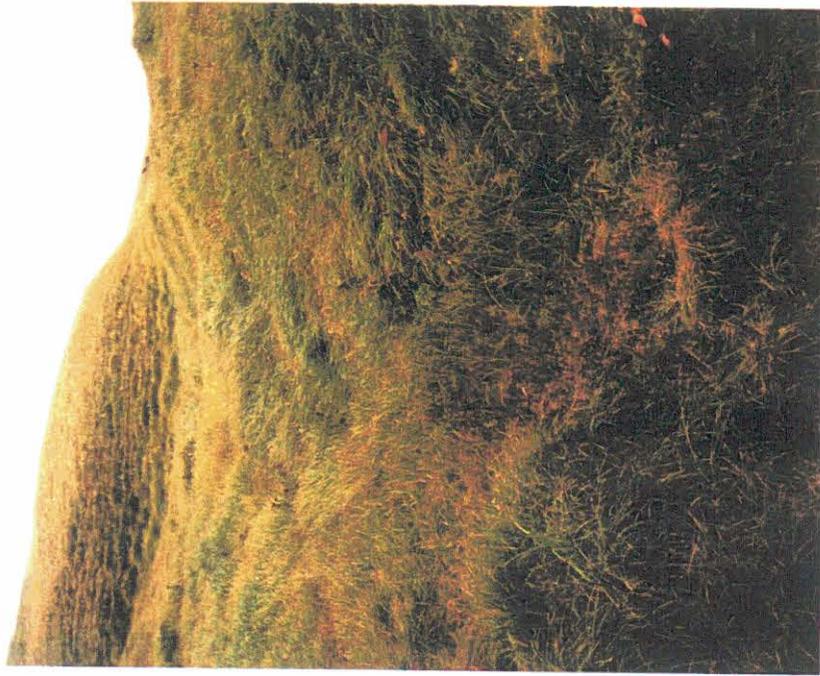
Based on the findings of both the 1997 and 1998 work, none of the 1986 Disposal Areas appear to pose a risk of contamination. Surface water was found migrating from a disposal area only at DA04. The compounds leaching from this disposal area are doing so at very low concentrations, and based on field observations over two field seasons, only during or following periods of heavy rainfall. No further action is recommended for the 1986 disposal areas.

Photo 19: View east toward Disposal Area DA04 (in background, upper right) from stream (foreground) that runs in valley west of disposal area; sample was collected from stream.

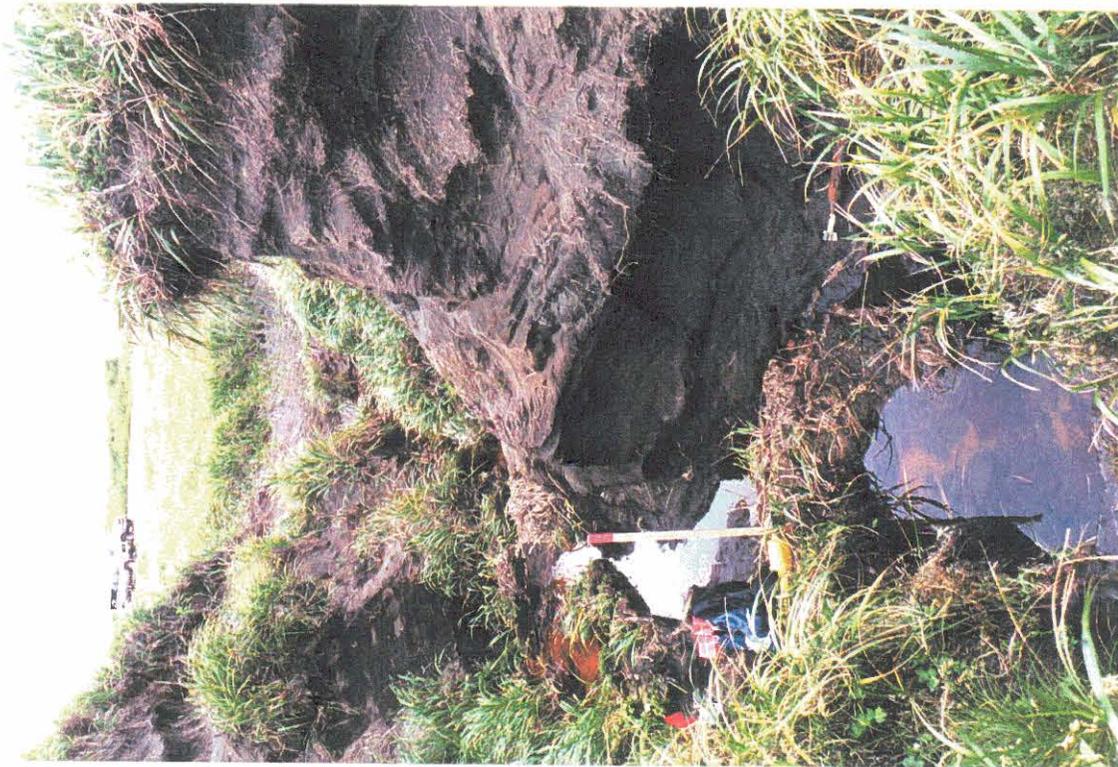
Photo 20: Bird Cape, view west to parking area from stream north of parking area. In bottom right corner above grass is 81mm mortar that eroded from the sand bank since 1997.

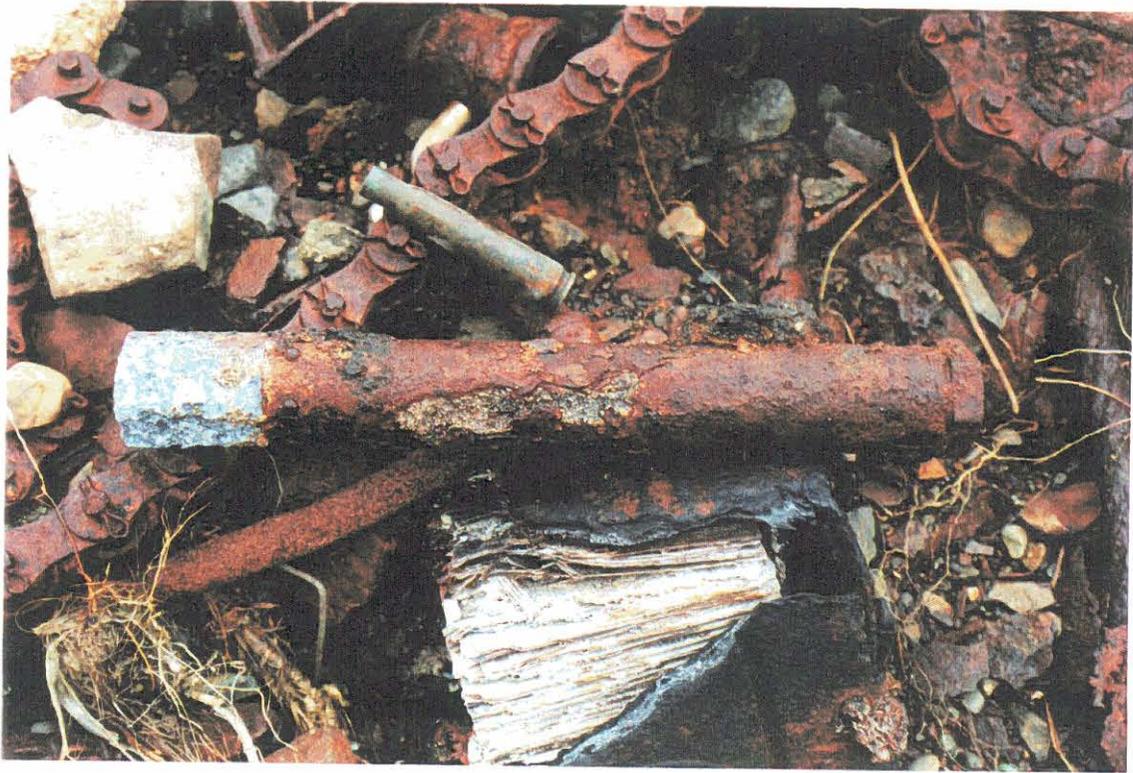
Photo 21: Beach at South Bight Landfill. Close-up of M54 incendiary bomblet resting on deteriorated lead-acid battery.
