2010 Inspection and Status Report for the Former Boiling Nuclear Superheater (BONUS) Reactor Facility, Rincón, Puerto Rico

This report presents the findings of the U.S. department of Energy (DOE) inspection of the decommissioned Boiling Nuclear Superheater (BONUS) Reactor Facility, in Rincón, Puerto Rico, on Thursday June 24, 2010. The BONUS Decommissioned Reactor Site consists of a containment building that houses the entombed reactor system and outside support facilities.

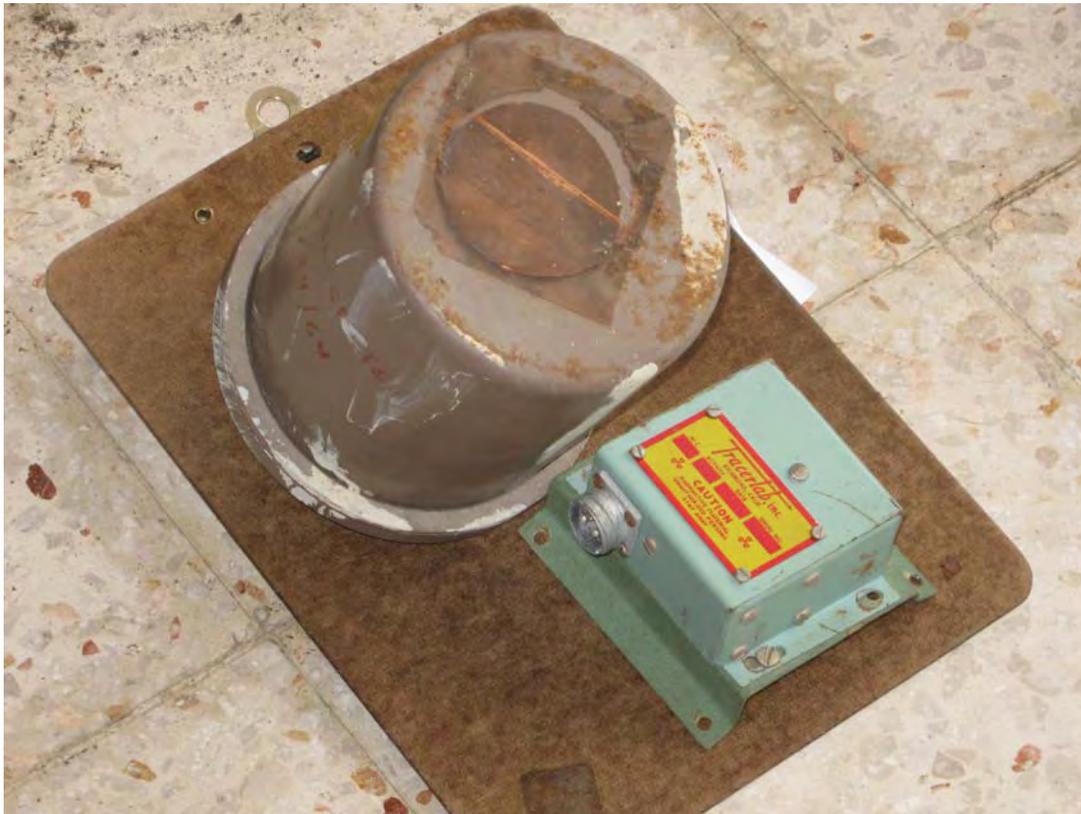
Two legacy radioactive sources (Cs-137 and Sr-90) were safely packaged and shipped from the BONUS facility to the INL (PL-1). Due to the low radioactivity of the sources, the shipment was not regulated. The radiation survey showed that radiation was <0.1 mr/hr at contact (less than background) when shipped and upon arrival at INL. The sources were shipped in a small drum (PL-2) on Monday June 28th. They arrived in Idaho on Tuesday June 29th and are currently being stored in the INL source storage facility. Uses for the sources have yet to be determined.

BON 6/2010. PL-1. Old Sr-90 and Cs-137 sources being packaged for shipping to INL.

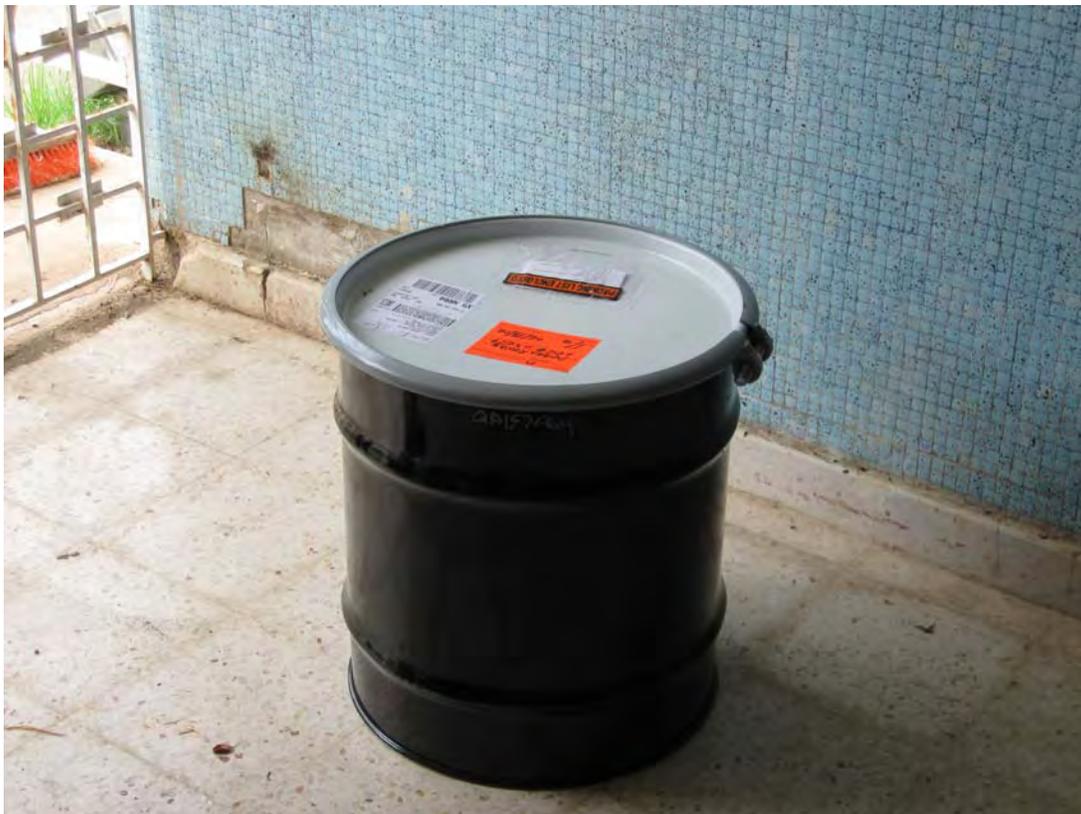
BON 6/2010. PL-2. Shipping drum for two sources being packaged for shipping to INL.

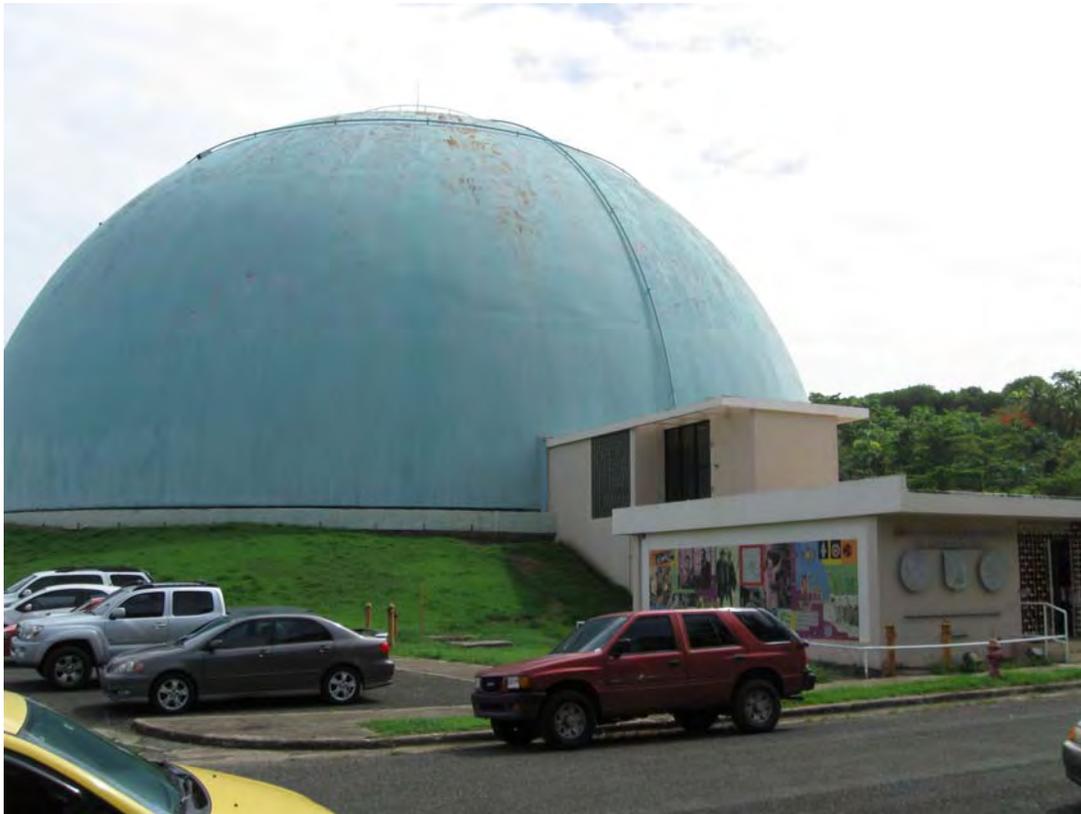
The Containment Dome houses the entombed reactor system (PL-3). The outer painted surface of the southeast side of the domed building is starting to peel and looks weathered (PL-4). It is recommended that the outer surface of the containment dome be painted within the next three years.

BON 6/2010. PL-3. South side of containment dome.

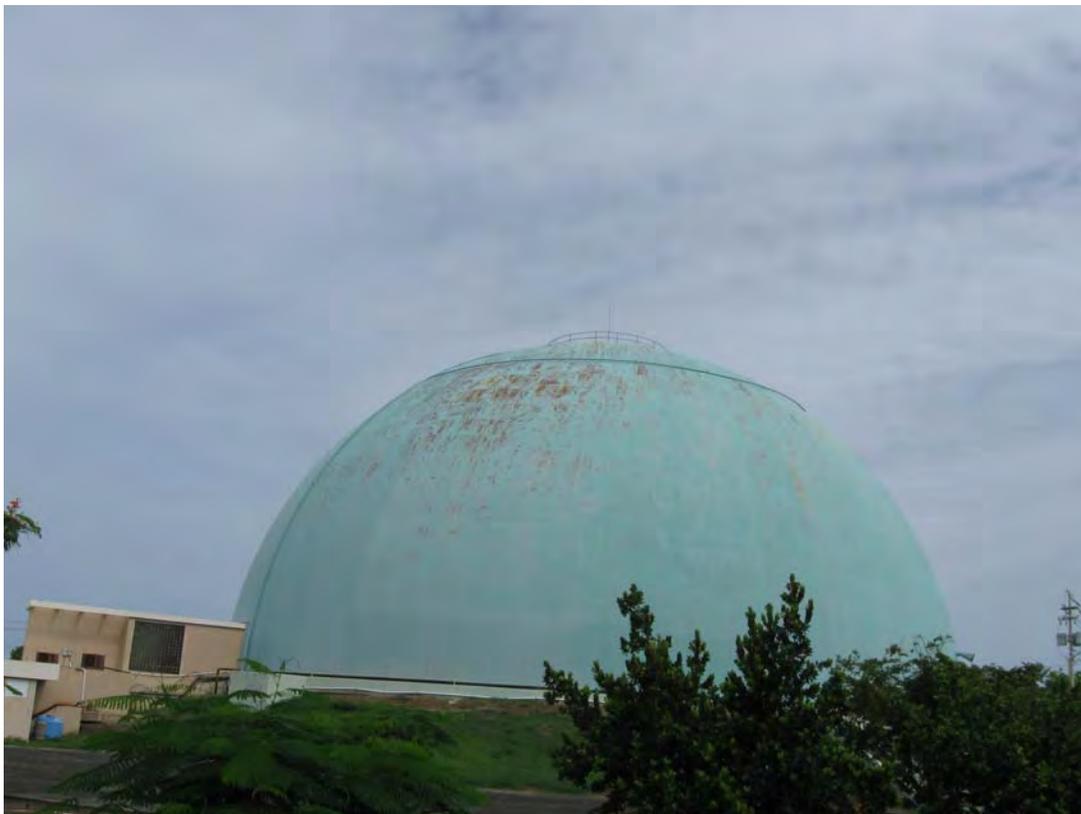
1. The outer painted surface of the containment building is starting to peel and looks weathered (page 2).

BON 6/2010. PL-4. Southeast side of containment dome. Paint shows signs of weathering.

Recommendation: It is recommended that the outer surface of the containment building be painted within the next three years.

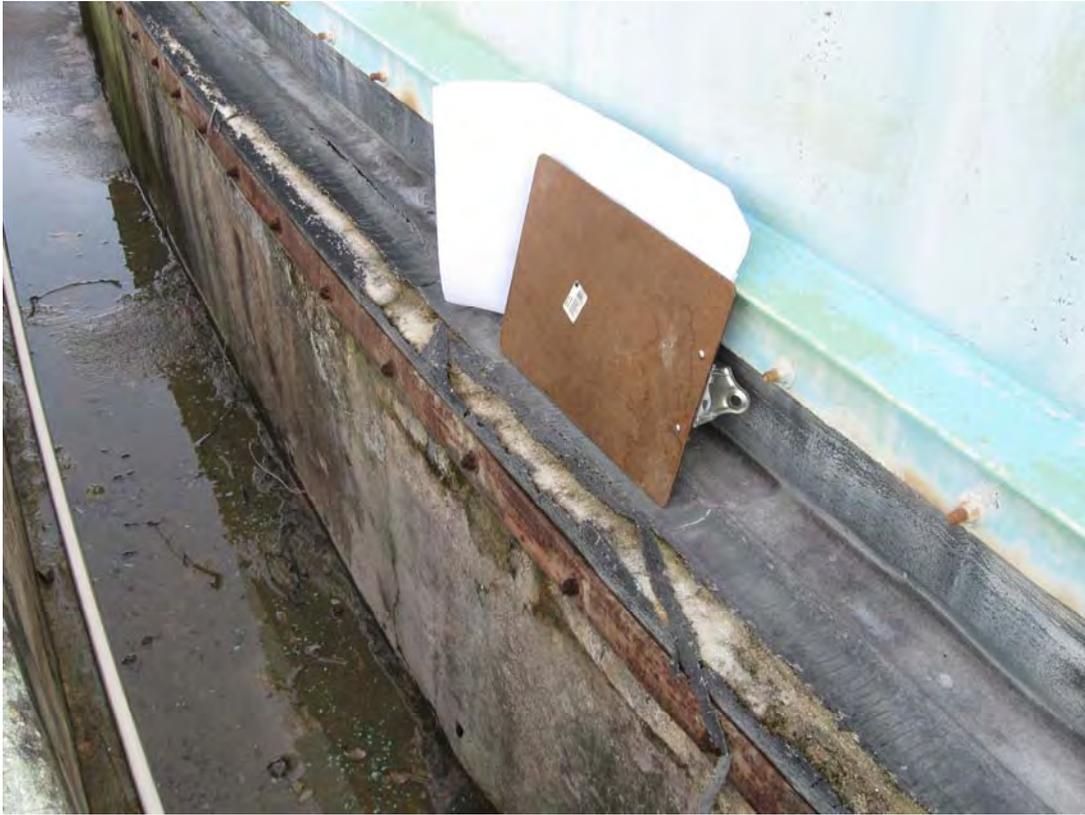
Around the base of the containment dome is a rubber seal/gasket that serves to direct water away from the base of the outer curved surface of the dome. The dome has a diameter of approximately 160 feet, and a corresponding circumference of approximately 502.4 feet. The rubber seal was in bad shape. Around the southwest quadrant of the dome, the rubber seal was cracked and ripped (PL-5, PL-6, and PL-7). The seal was in much worse shape around the southeast and northeast quadrants of the dome. In long stretches, it was missing altogether (PL-8 and PL-9) leaving the concrete exposed.

BON 6/2010. PL-5. Rubber seal at base of containment dome.

Recommendation: It is recommended that the gasket/seal and flashing around the base of the containment dome be repaired and/or replaced to prevent further water from entering the building, which could, over time, compromise the integrity of the entombed reactor.

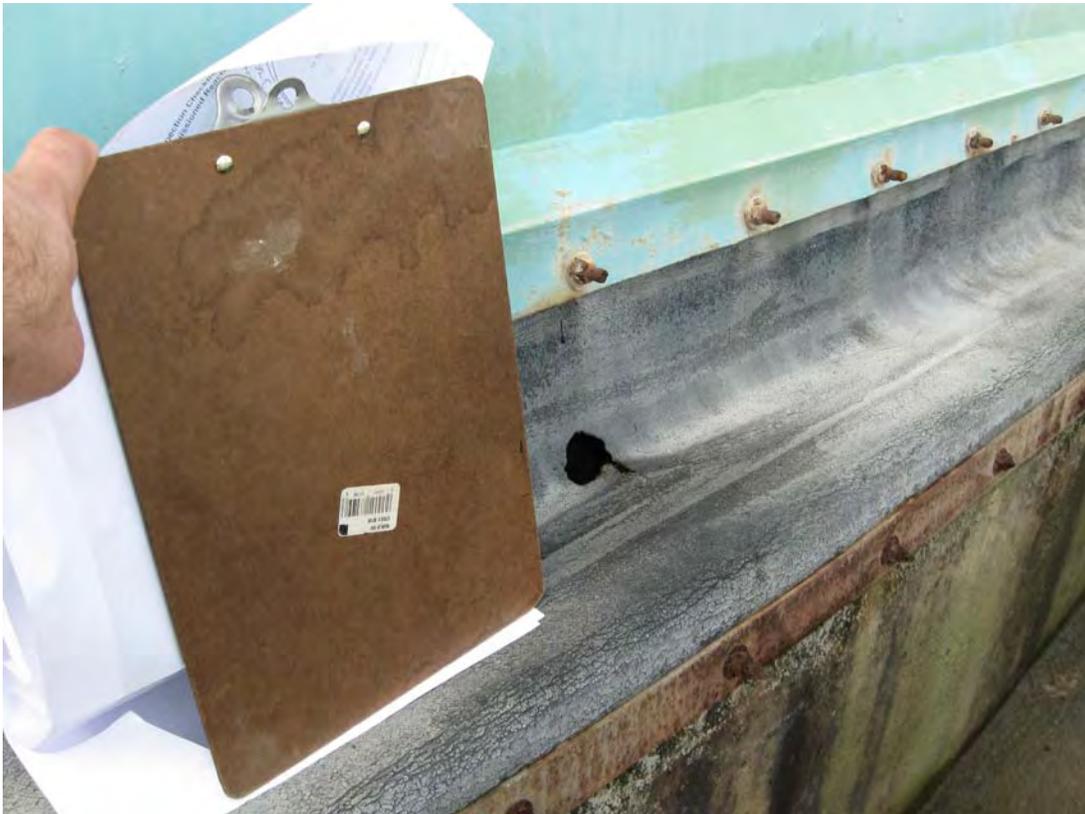
BON 6/2010. PL-6. Rubber seal at base of containment dome.

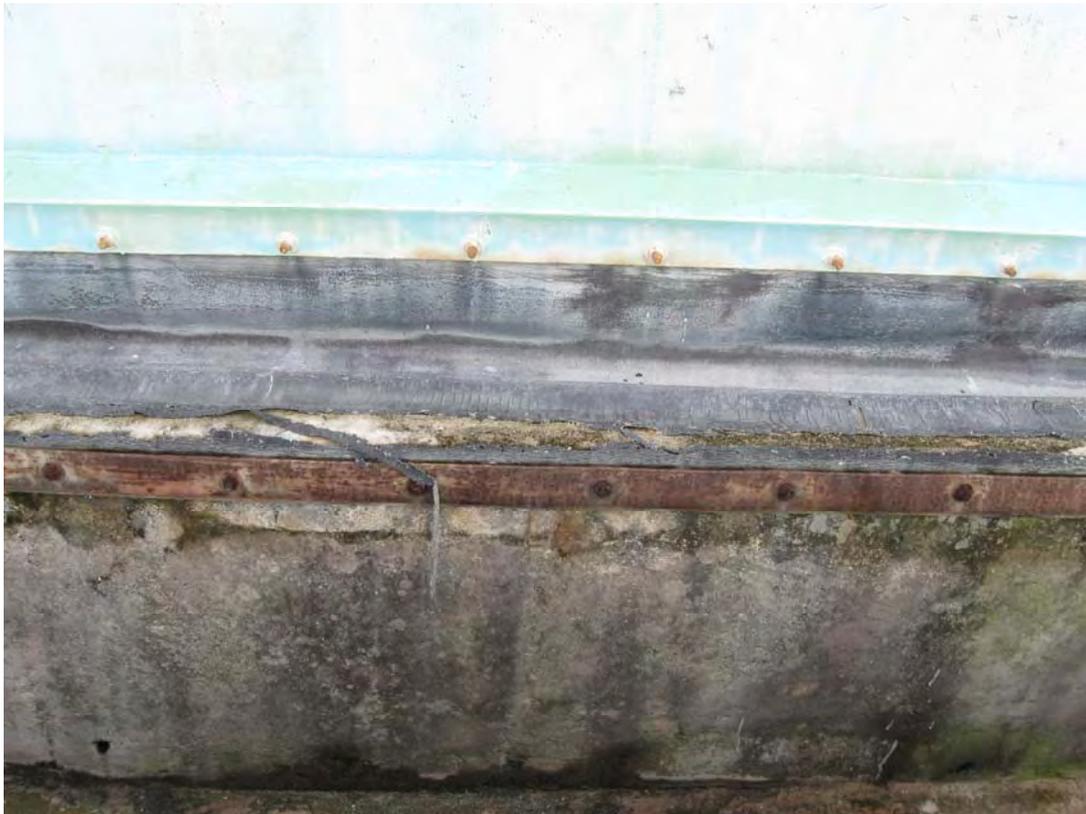
BON 6/2010. PL-7. Rubber seal at base of containment dome.

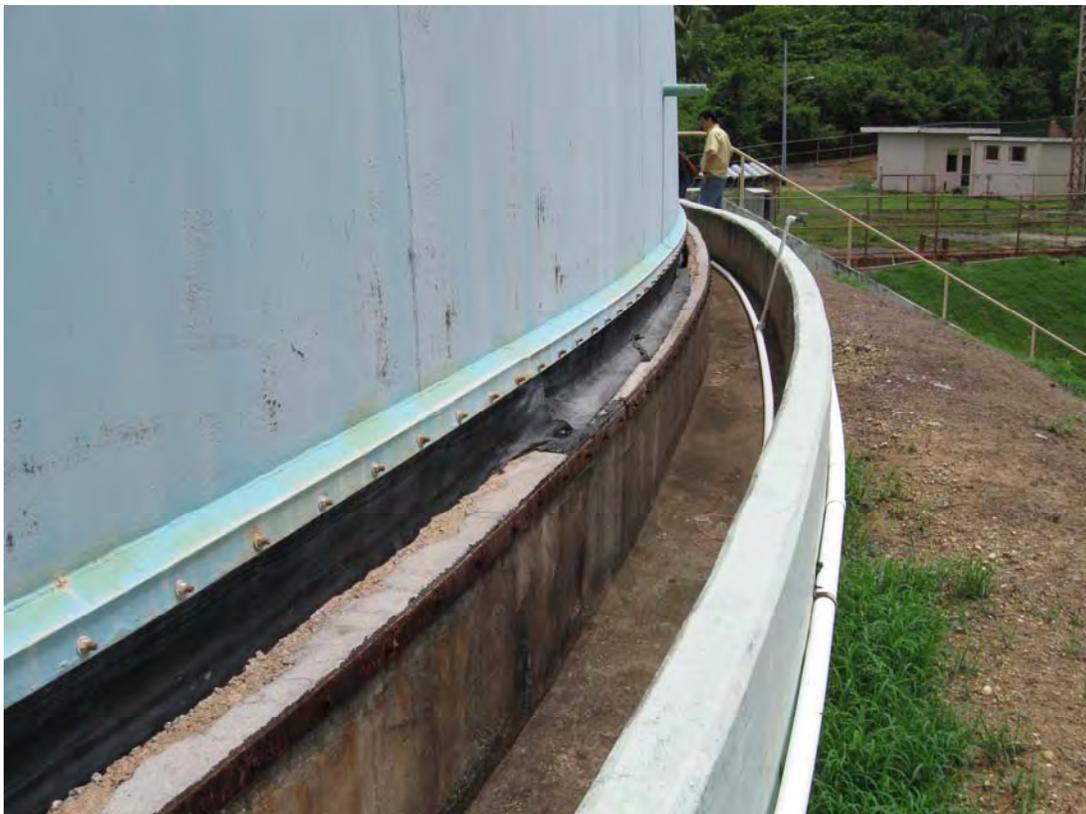
BON 6/2010. PL-8. Rubber seal at base of containment dome.

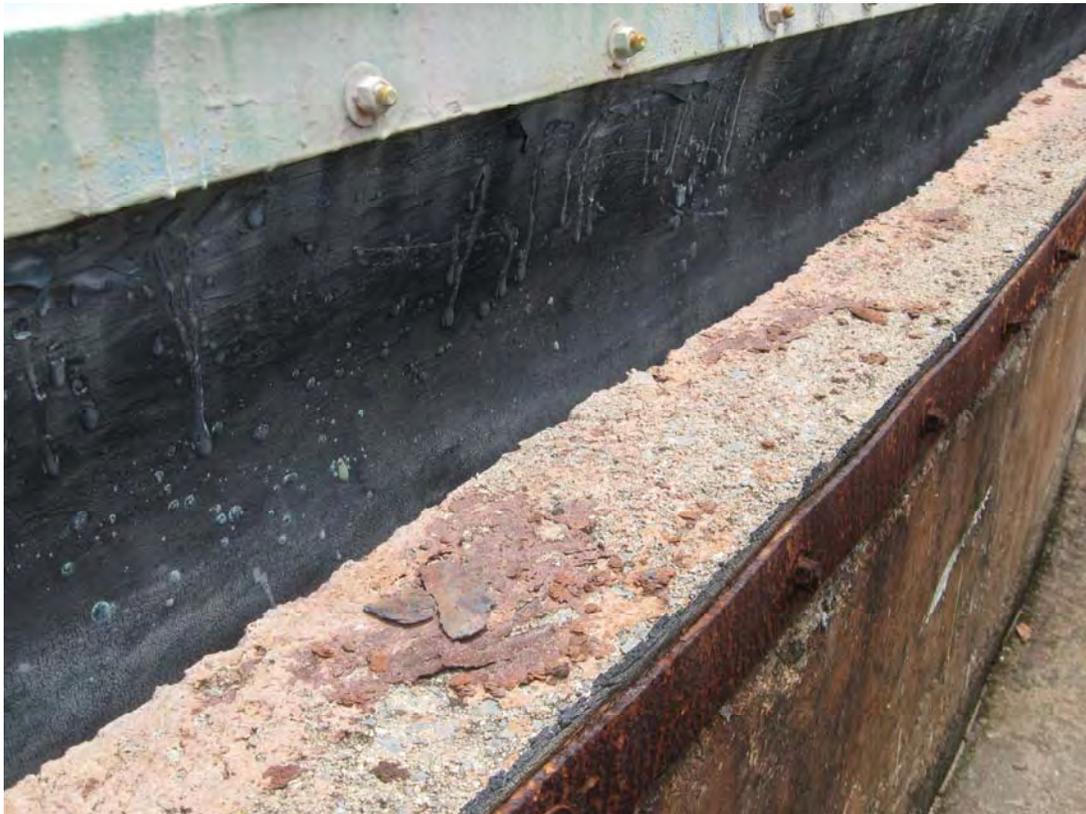
BON 6/2010. PL-9. Rubber seal at base of containment dome.

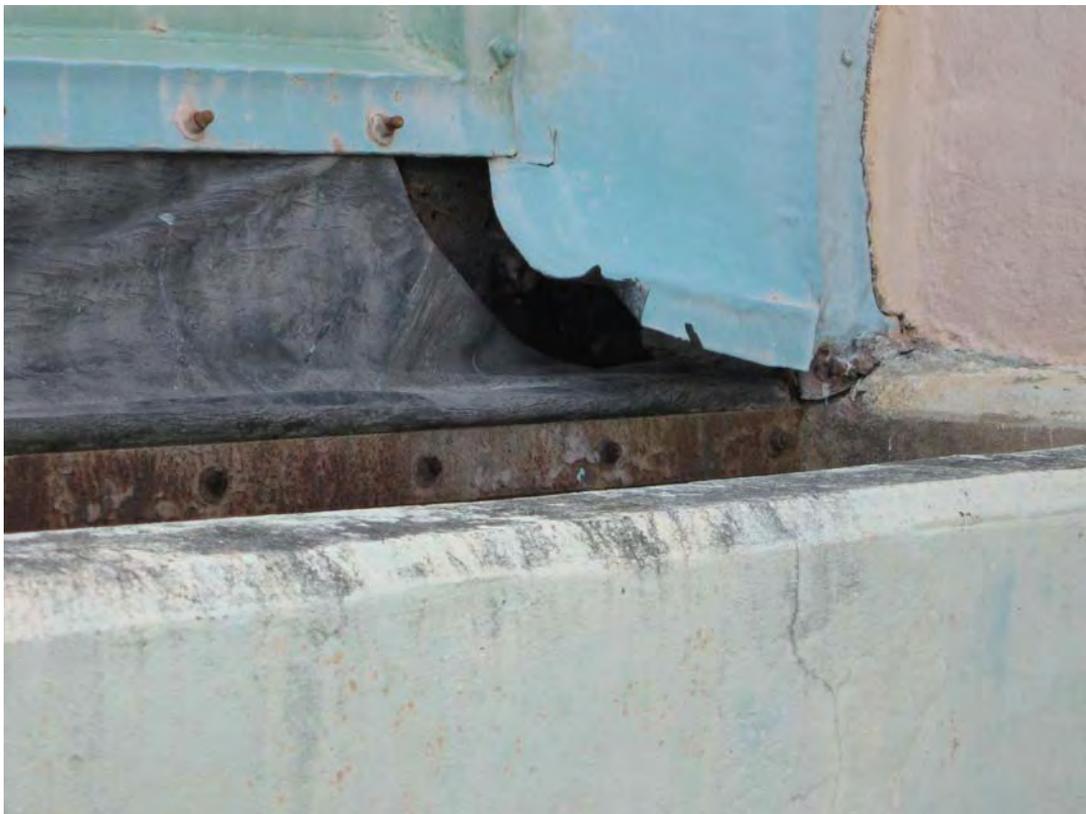
The flashing near the administrative offices at the base of the dome was bent out away from the dome creating a large void for water to enter the building (PL-10). Inspectors found evidence for fresh water leaks due to this void down the inside basement wall of the domed building near the retention tank room (PL-11). Recent water staining was also present on the basement floor beneath the wall stain (PL-12). It is recommended that the seal/gasket and flashing around the base of the containment dome be repaired and/or replaced to prevent further water from entering the building, which could over time compromise the integrity of the entombed reactor.

2. The flashing near the administrative offices was bent out away from the dome creating a large void for water to enter the base of the dome. Inspectors found evidence of recent water leaks down the inside basement wall of the domed building near the retention tank room. Water staining also was present on the basement floor beneath the wall stain. It appears that the water staining within the facility is a direct cause of the hole that is present due to the bent flashing (page 3).

BON 6/2010. PL-10. Rubber seal at base of containment dome.

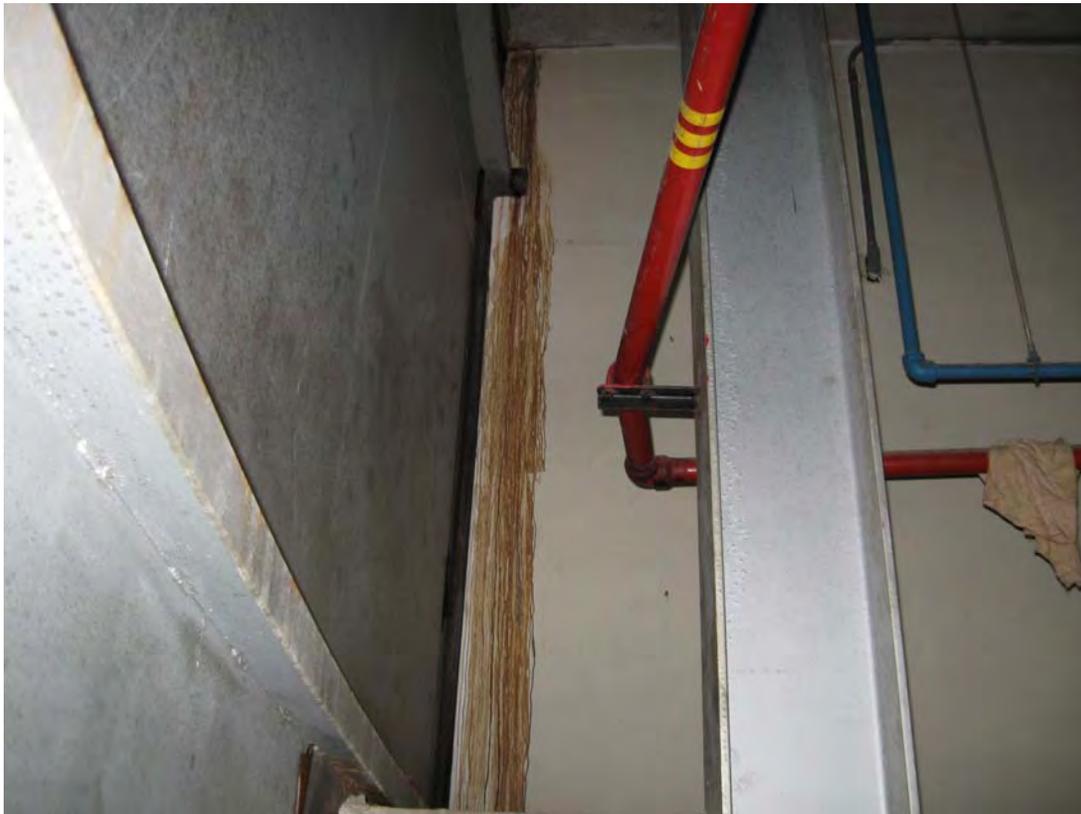
BON 6/2010. PL-11. Water staining down the inside wall of the basement of containment dome.

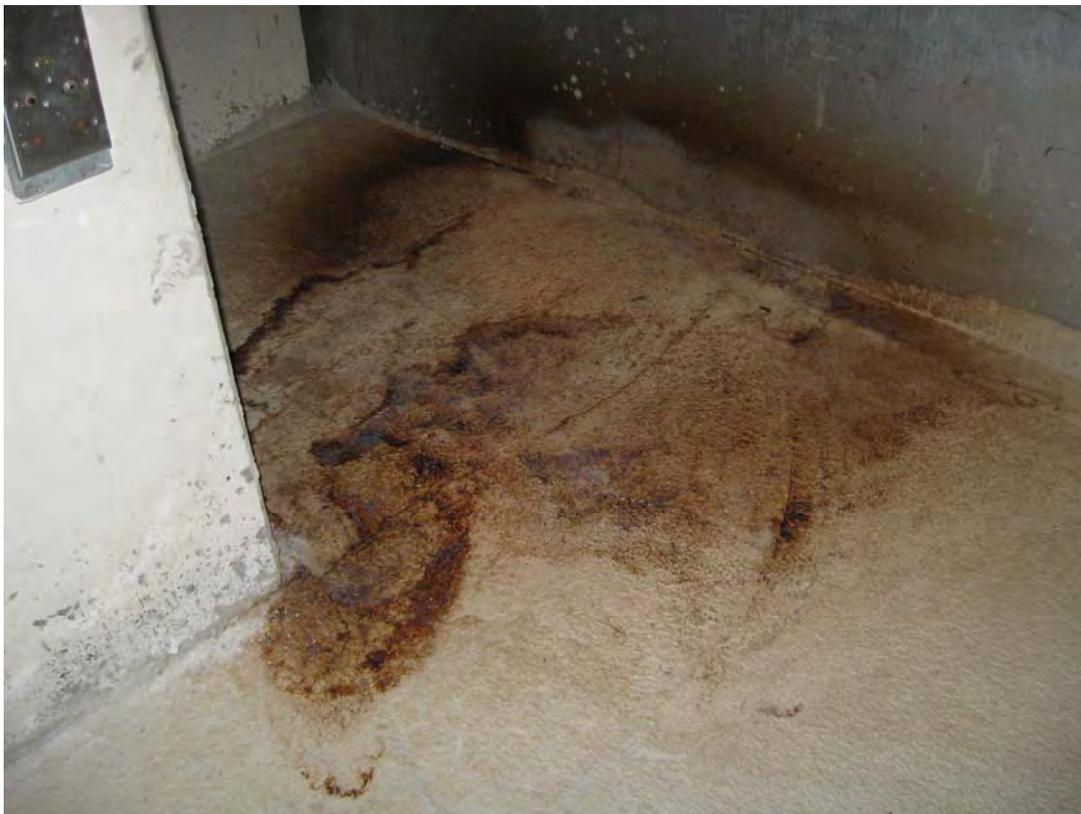
BON 6/2010. PL-12. Water staining on floor of basement within containment dome.

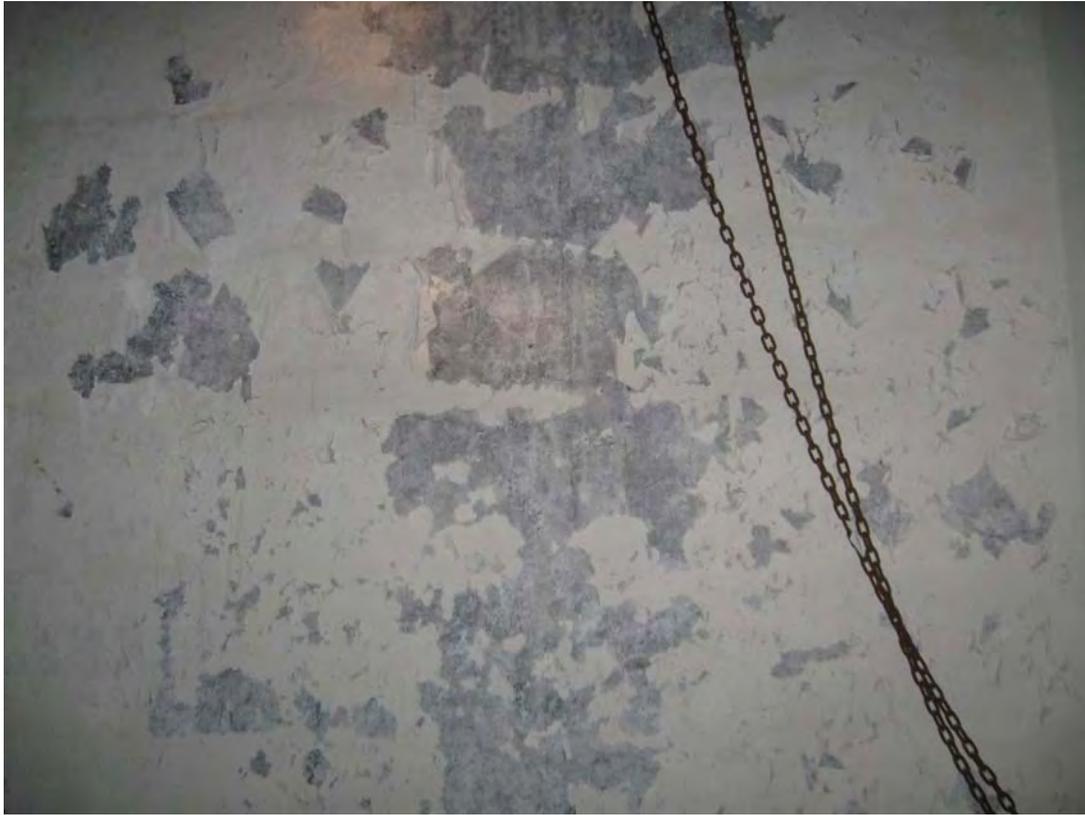
PREPA opens up portions of the containment building to the public as a museum. Inspectors found peeling paint on painted surfaces in the basement (PL-13). Given the age of the facility, it is possible that the peeling paint could contain lead. It is recommended that the peeling paint be tested for lead.

3. Inspectors found peeling paint on painted surfaces in the basement. Given the age of the facility, it is possible that the peeling paint could contain lead (page 3).

BON 6/2010. PL-13. Peeling paint in basement.

Recommendation: It is recommended that the peeling paint be tested for lead.

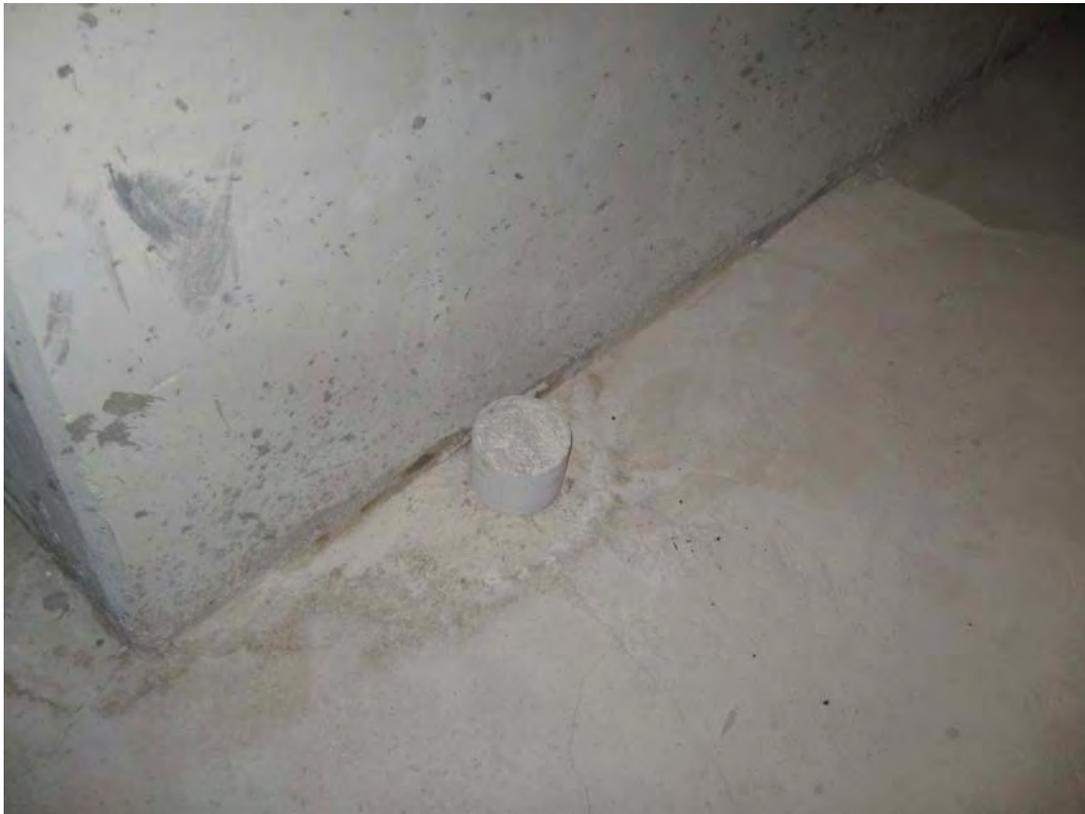
A few inches of concrete have been added to the basement floor of the containment building since Hurricane Georges to provide shielding for some isolated and discrete areas of fixed radioactive contamination on the basement floor. Floor drains in the basement floor were filled in with concrete (PL-14), raising the question of how will water drain from the facility should it flood again. It is recommended that PREPA provide DOE with the plans that will be followed to address future flooding events at the facility.

4. Floor drains in the basement were filled in with concrete making it unclear as to how water will drain from the facility should it flood again (page 3).

BON 6/2010. PL-14. Drain in floor of basement filled in with concrete.

Recommendation: It is recommended that PREPA provide DOE with the plans that will be followed to address potential future flooding events at the facility.

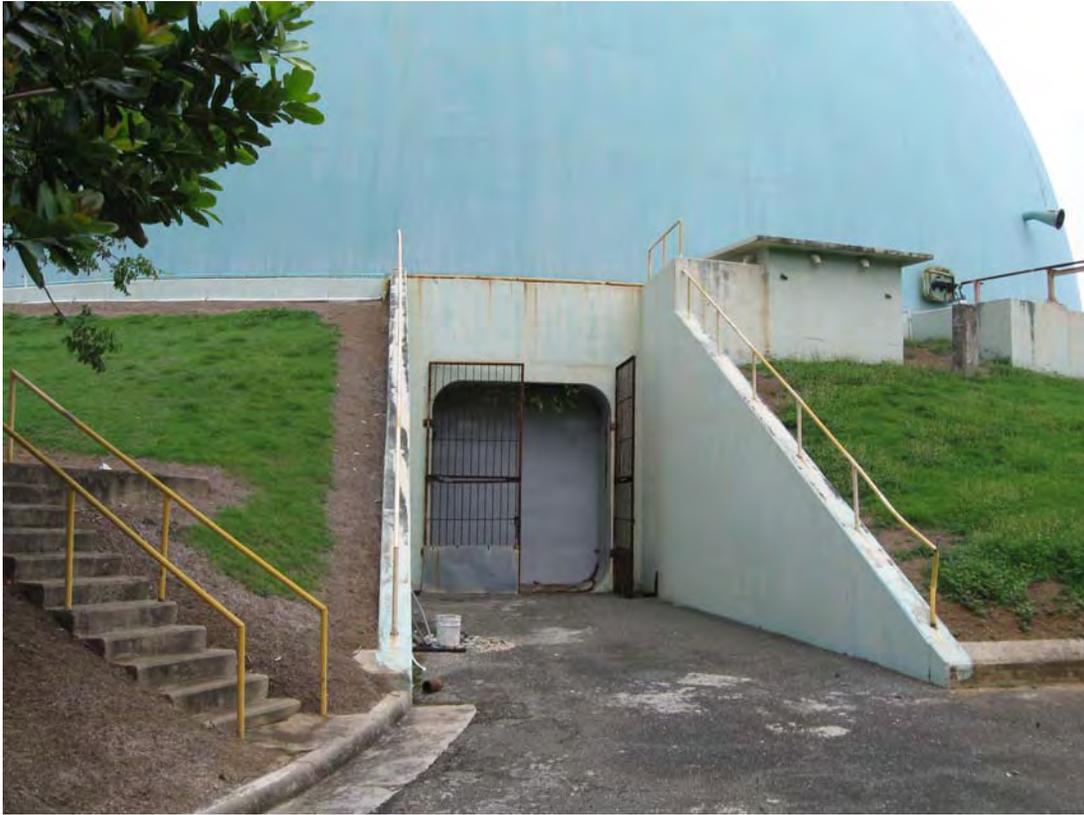
The freight door on the east side of the containment building, leading to the basement (PL-15), was sealed shut with scale (PL-16). Metal flashing in front of the freight door had large holes in it due to corrosion of the metal (PL-17). These large holes would allow water to enter the basement of the containment dome should the entry way to the freight door flood (PL-18) as it did during Hurricane Georges in 1998. Because the door seal around the freight door is encrusted with scale it appears that the door has not been opened and inspected in a long time. It is recommended that the corroded flashing around the freight door be repaired, and the door be opened and the door seal cleaned, inspected, and replaced if deemed appropriate.

BON 6/2010. PL-15. Freight door on the east side off the containment dome.

Recommendation: It is recommended that the corroded flashing around the freight door be repaired, and the door be opened, the door seal cleaned, inspected, and replaced if deemed appropriate.

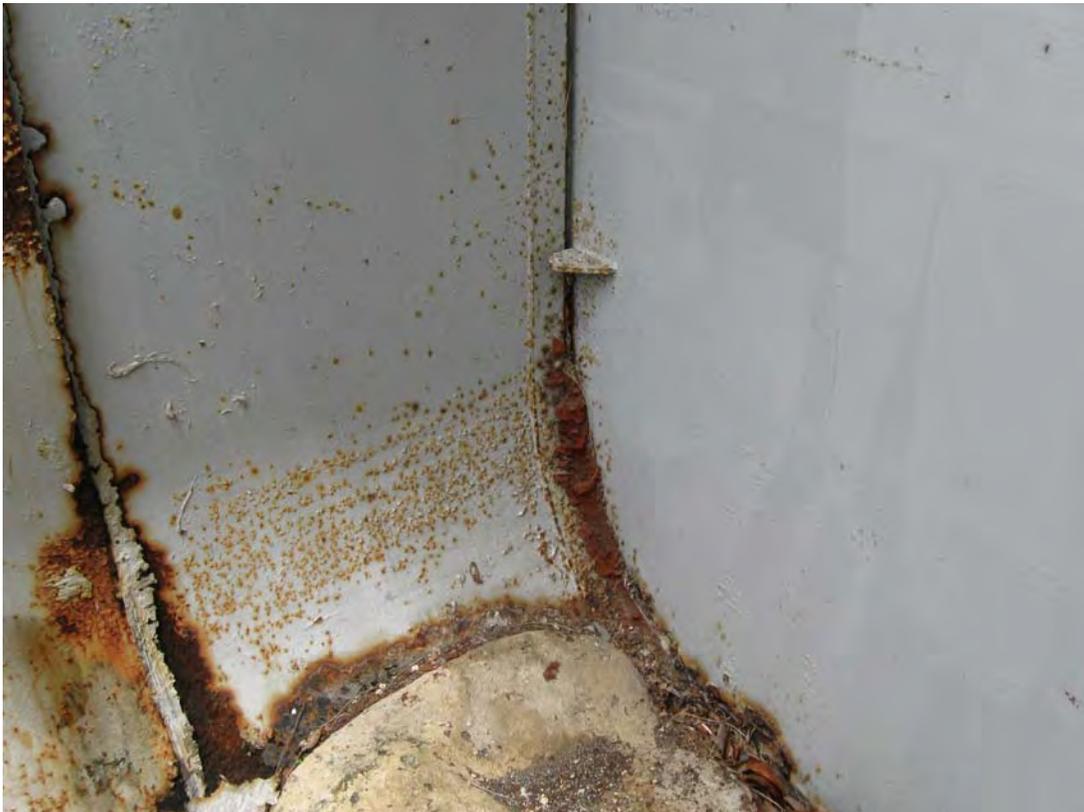
BON 6/2010. PL-16. Seal around freight door on east side of the containment dome.

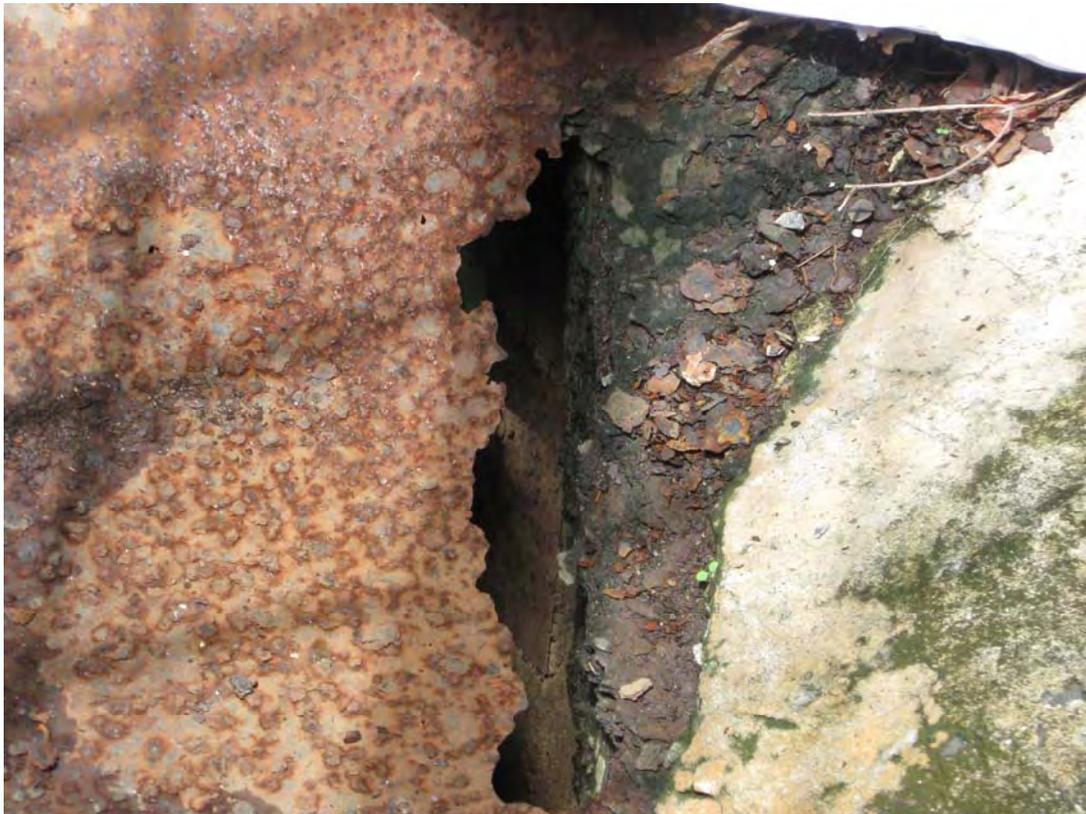
5. The freight door on the east side of the containment building, leading to the basement, was sealed shut with scale. Metal flashing in front of the freight door had large holes in it due to corrosion of the metal. These large holes would allow water to enter the basement of the containment dome should the entry way to the freight door flood as it did during Hurricane Georges in 1998. Because the door seal around the freight door is encrusted with scale it appears that the door has not been opened to check the seal in a long time (page 3).

BON 6/2010. PL-17. Base of freight door on east side of containment dome is rusted through.

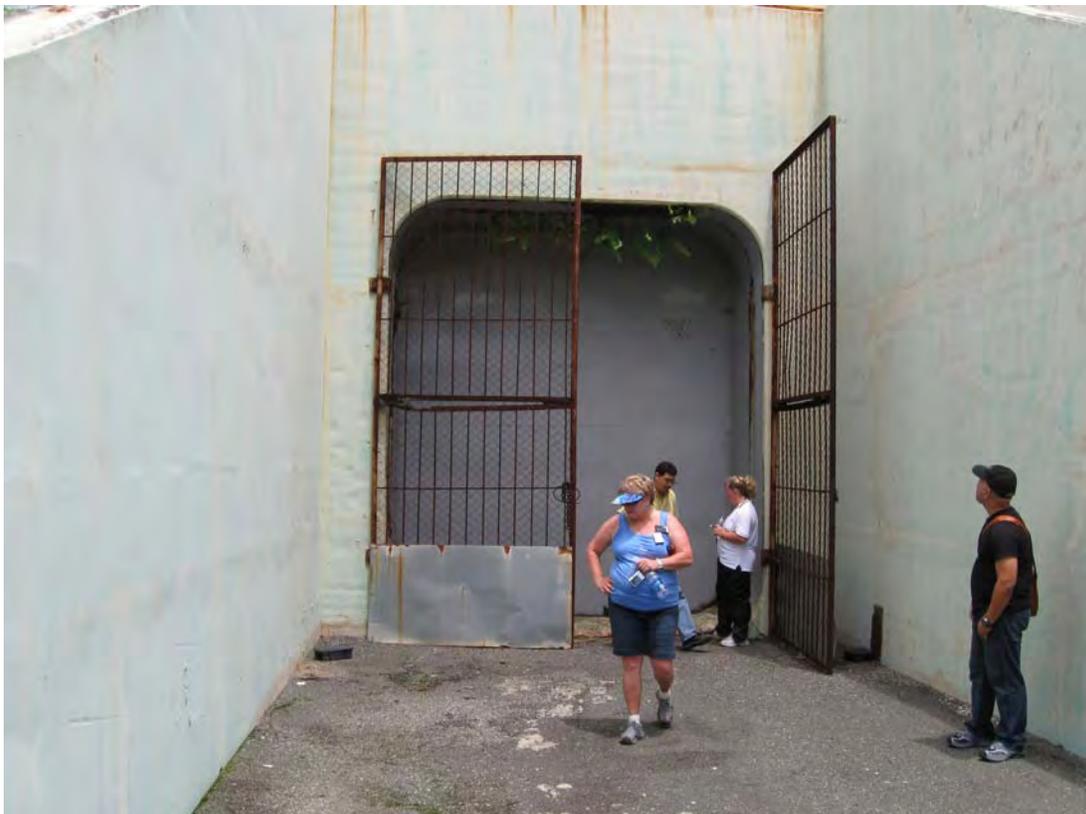
BON 6/2010. PL-18. Freight door on east side of containment dome.

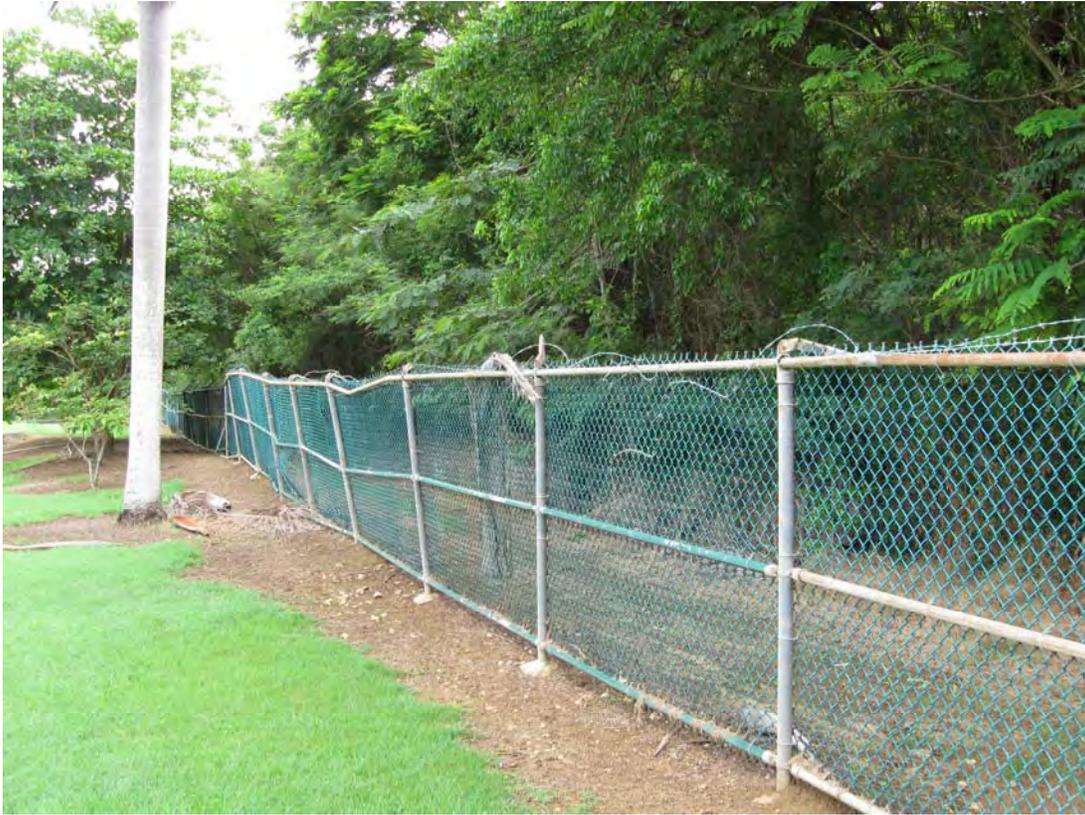
Inspectors walked the length of the security fence and found it to be in poor condition. The barbed wire along much of the top of the fence was damaged (PL-19). Several large holes were cut in the fence large enough for people to pass through (PL-20). In several areas the fence was overgrown with vegetation (PL-21).

6. The security fence was in poor condition. The barbed wire along much of the top of the fence was damaged. Several holes, large enough for people to pass through, were cut in the fence. In several areas the fence was overgrown with vegetation (page 4).

BON 6/2010. PL-19. Perimeter fence.

Recommendation: It is recommended that the site security fence be repaired or replaced as soon as possible.

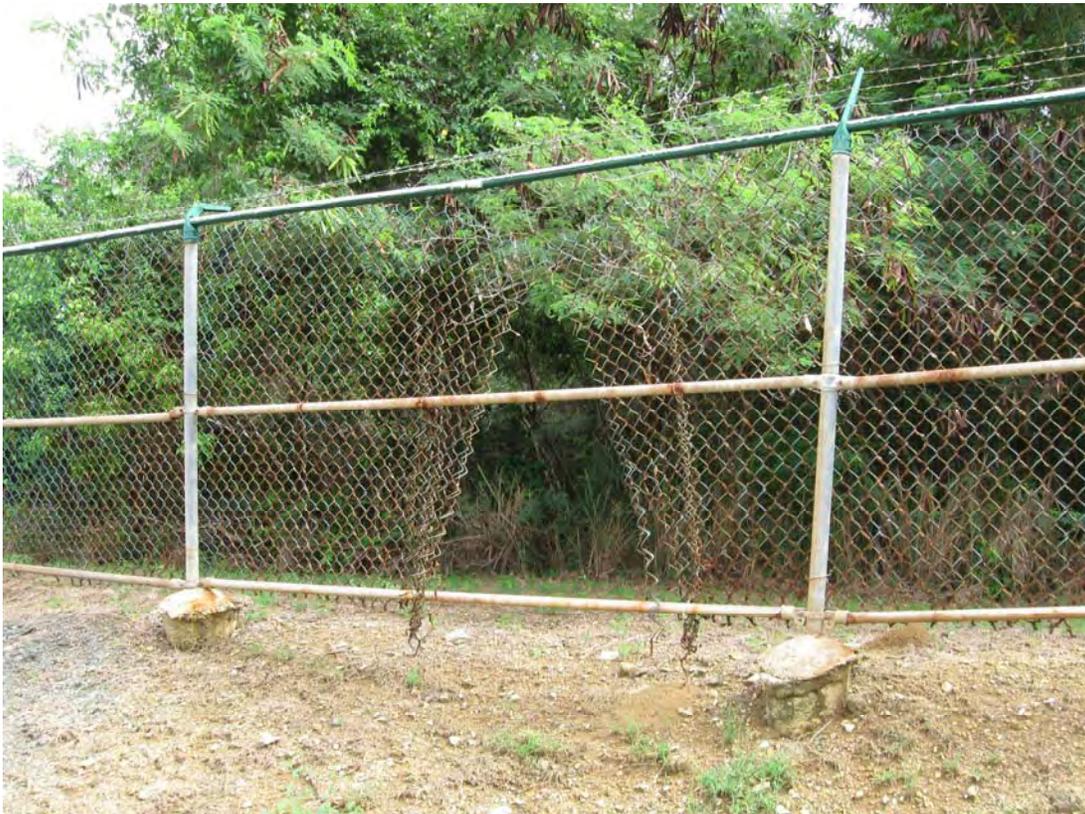
BON 6/2010. PL-20. Large hole cut in perimeter fence.

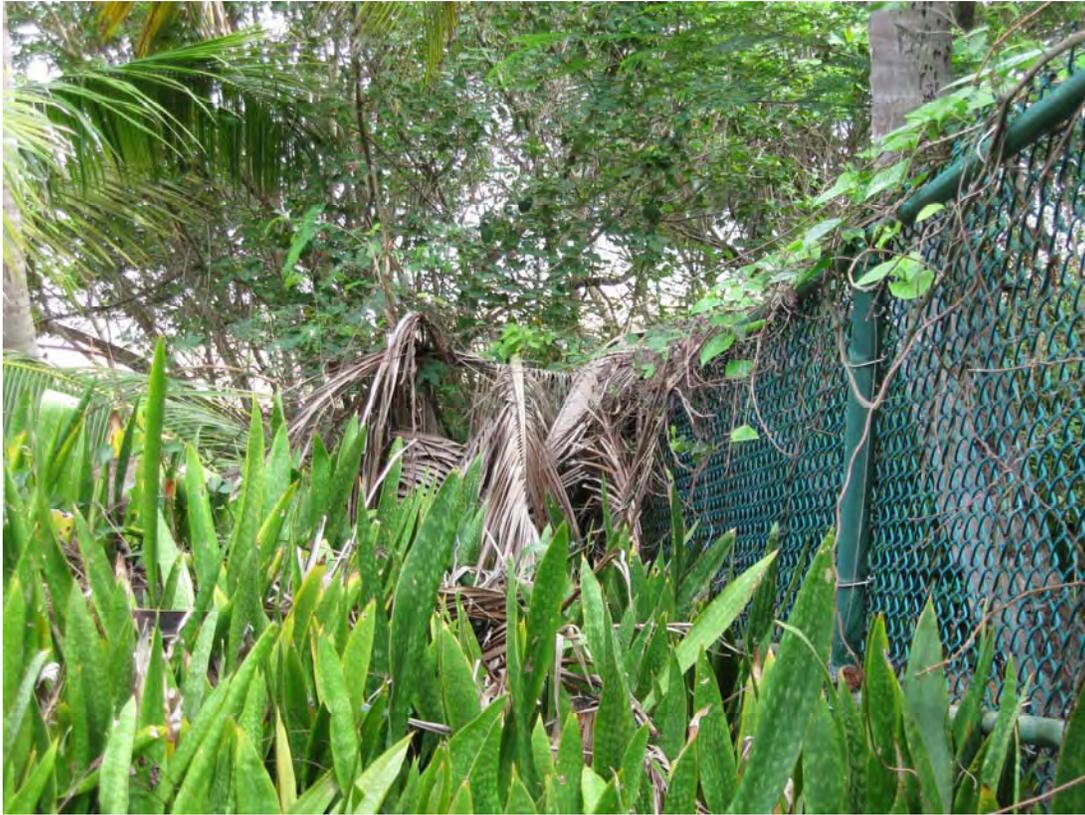
BON 6/2010. PL-21. Vegetation on perimeter fence.

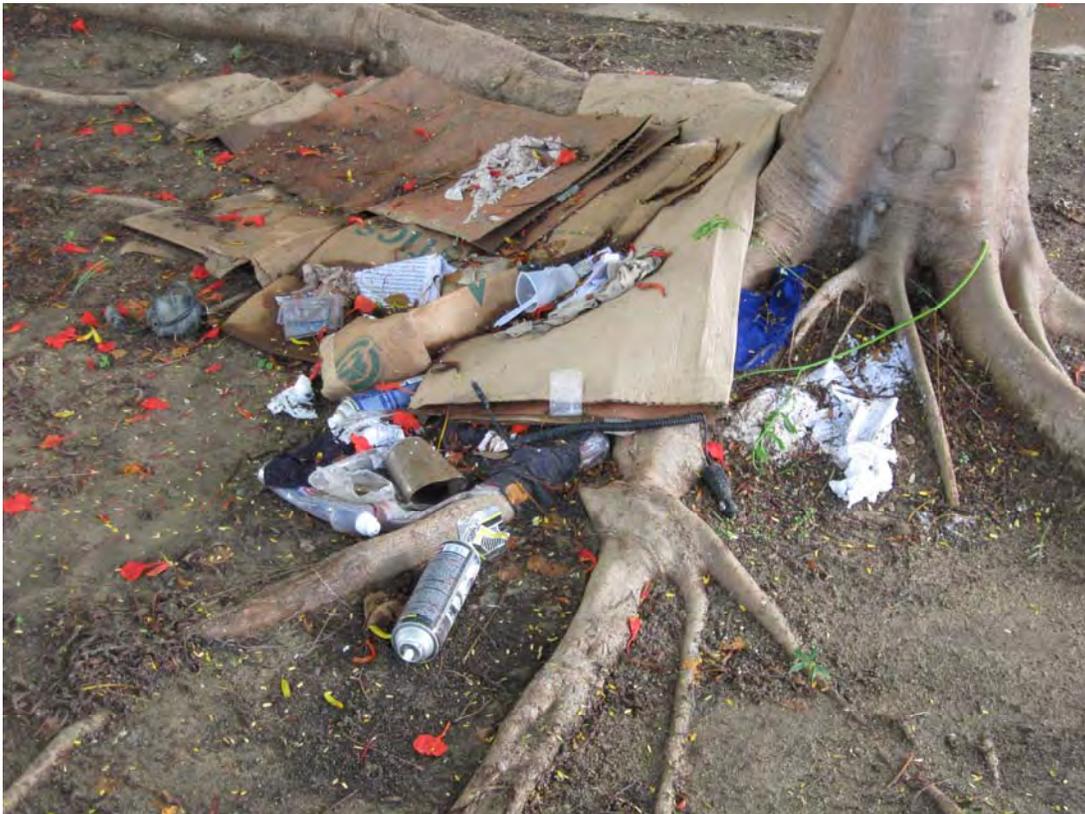
Inspectors noted a small pile of trash near the auditorium building (PL-22) as well as many site features that are abandoned in place such that they can be considered as eyesore (PL-23). It is recommended that PREPA personnel remove the pile of trash near the auditorium.

7. Inspectors noted a small pile of trash near the auditorium building as well as many site features that are abandoned in place such that they can be considered as eyesore (page 4).

BON 6/2010. PL-22. Pile of trash outside of auditorium.

Recommendation: It is recommended that PREPA personnel remove the pile of trash near the auditorium.

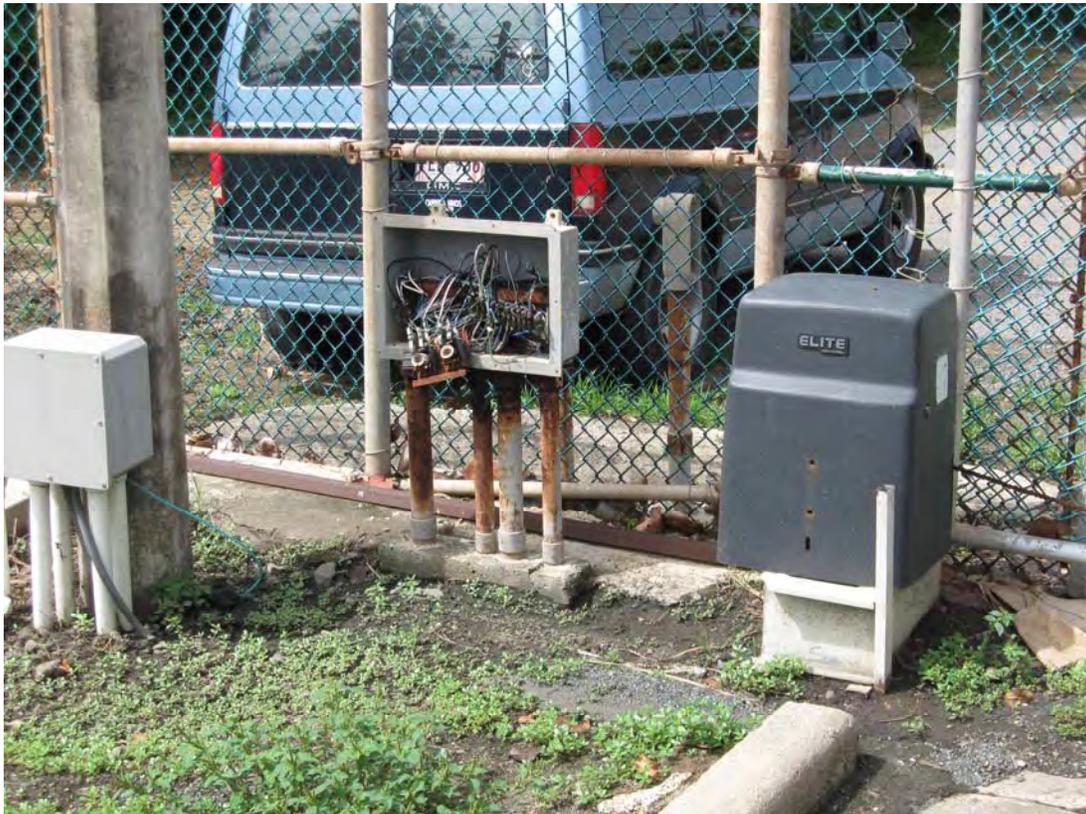
BON 6/2010. PL-23. Open electric box near guard shack.
