2010 Inspection and Status Report for the Former Boiling Nuclear Superheater (BONUS) Reactor Facility, Rincón, Puerto Rico

This report presents the findings of the U.S. department of Energy (DOE) inspection of the decommissioned Boiling Nuclear Superheater (BONUS) Reactor Facility, in Rincón, Puerto Rico, on Thursday June 24, 2010. The BONUS Decommissioned Reactor Site consists of a containment building that houses the entombed reactor system and outside support facilities.

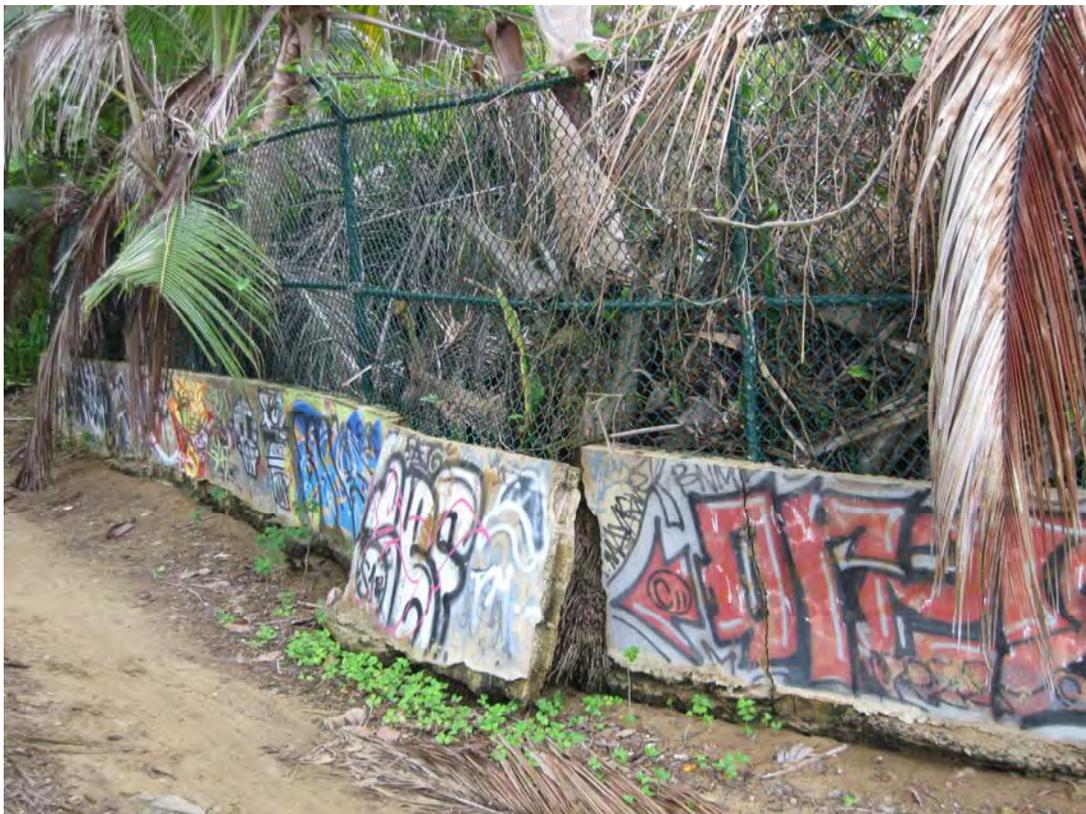
The retaining wall on the west side of the facility, near the beach was broken due to a close growing palm tree (PL-24). The area surrounding the retaining wall and perimeter fence was overgrown with vegetation. It is recommended that PREPA address the retaining wall at the same time they address the perimeter fence, and make repairs to the wall as deemed appropriate. Paths were recently cleared through the vegetation around the facility, and work clearing additional paths was underway during the inspection (PL-25).

8. The retaining wall on the west side of the facility near the beach was broken due to a close-growing palm tree. The area surrounding the retaining wall and perimeter fence was overgrown with vegetation (page 5).

BON 6/2010. PL-24. Retaining wall, west side of property.

Recommendation: It is recommended that PREPA address the retaining wall at the same time they address the perimeter fence, and make repairs to the wall as deemed appropriate.

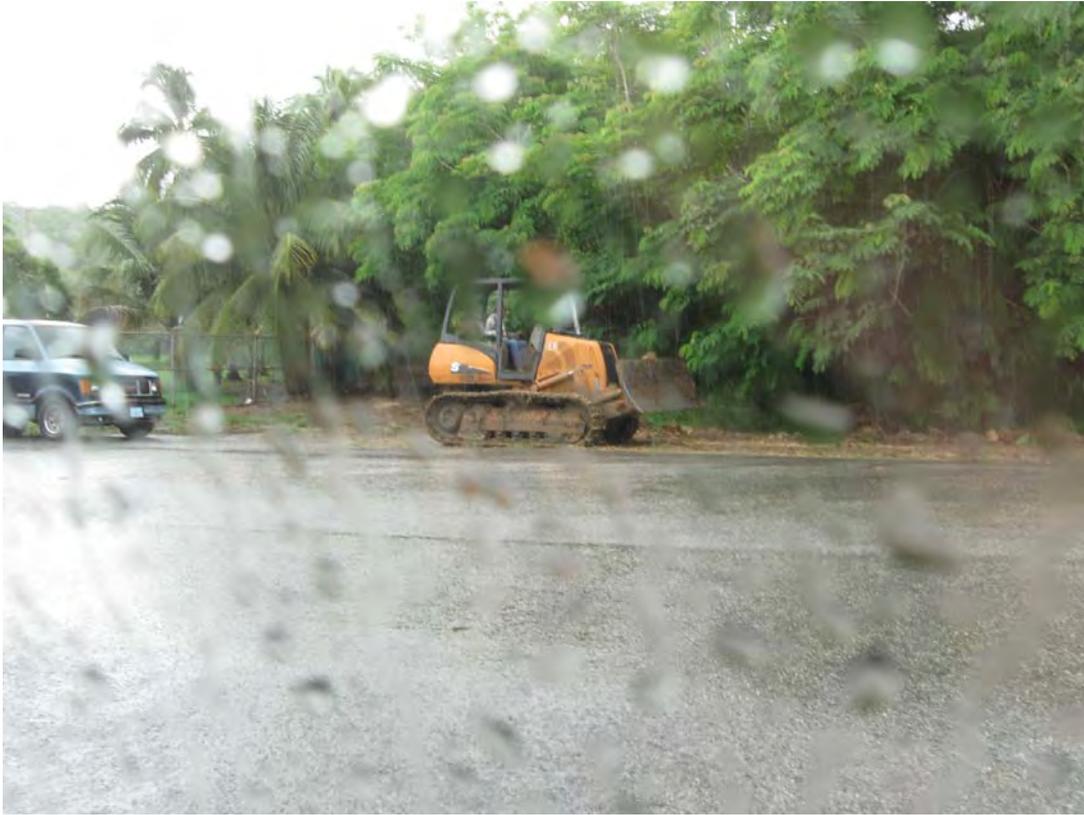
BON 6/2010. PL-25. Construction activity taking place around facility grounds. Paths being cleared of vegetation.
