**DR. MODESTO IRIARTE TECHNOLOGICAL
MUSEUM (FORMER BONUS FACILITY)**

2015 ANNUAL RADIOLOGICAL SURVEY REPORT

**RINCON
PUERTO RICO**

August 2015

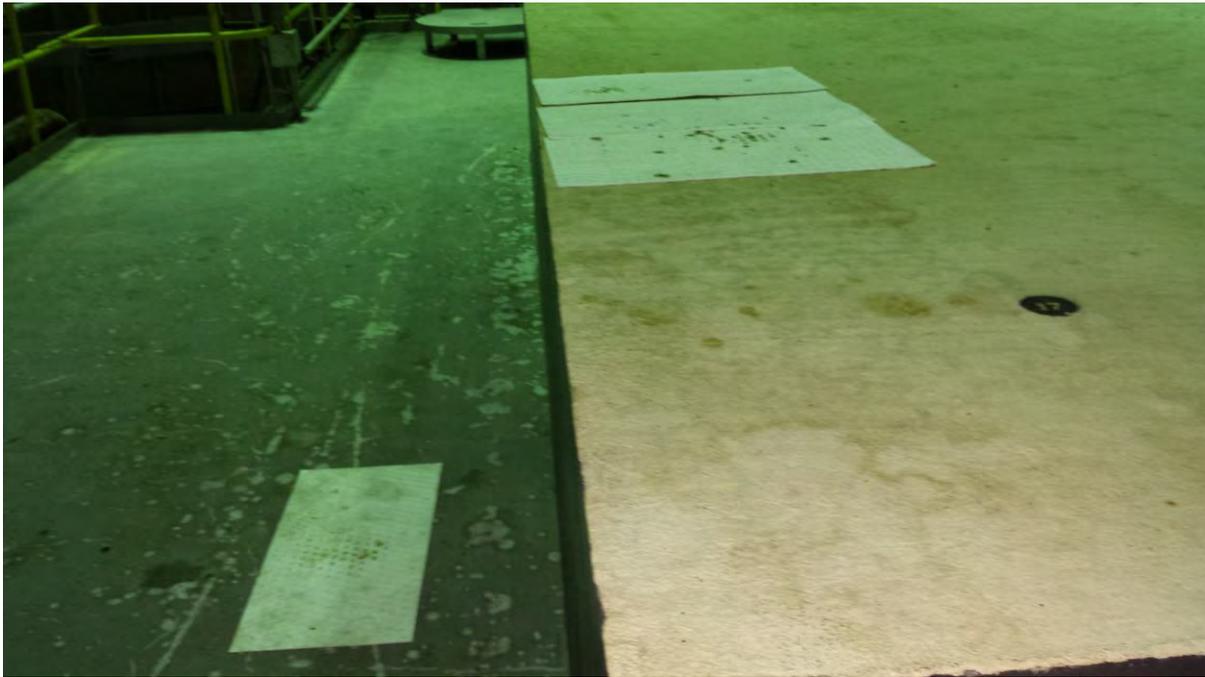
- Absorbent clothe has been placed to collect oil/grease dripping from the crane system above (Appendix A, Figures 1 and 3), however, a new leak was noted this year (Appendix A, Figure 2). It appears that the crane may be used periodically to change overhead light bulbs and/or inspect fire suppression system. It is recommended that absorbent clothes continue to be placed at those locations where oil/grease is accumulating on the Concrete Monolith and, especially, after the crane is moved.

Figure 1. Entombment Top (Top Plug, Northwest Side) – Sampling Point 17 and Oil Pads Due to Overhead Crane

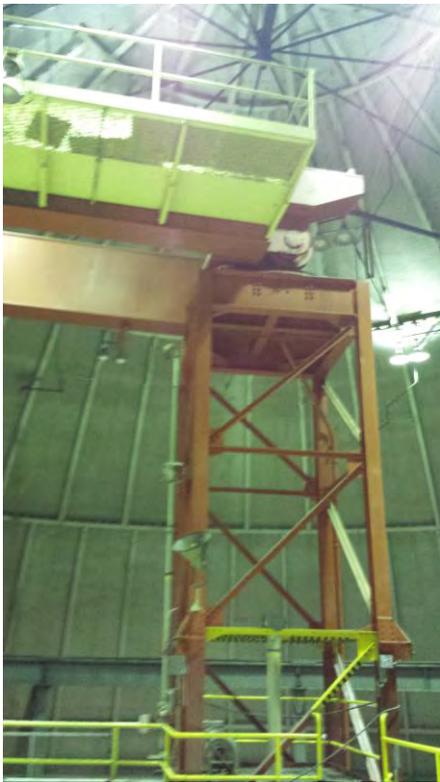
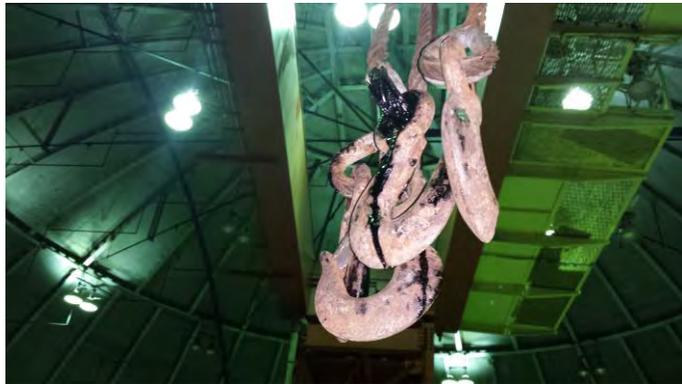
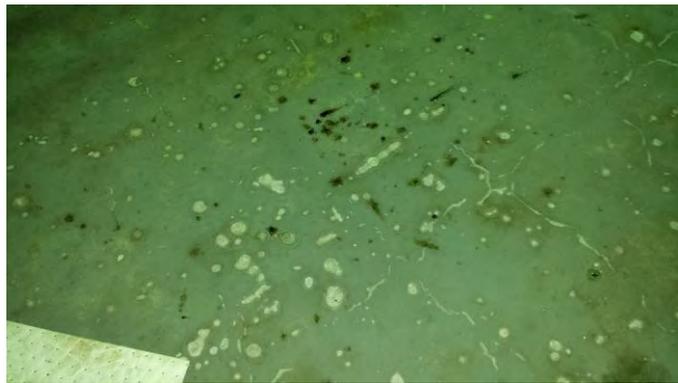
Figure 2. Entombment Top (Crane) – New Oil/Lubricant Drips from Overhead Crane Equipment

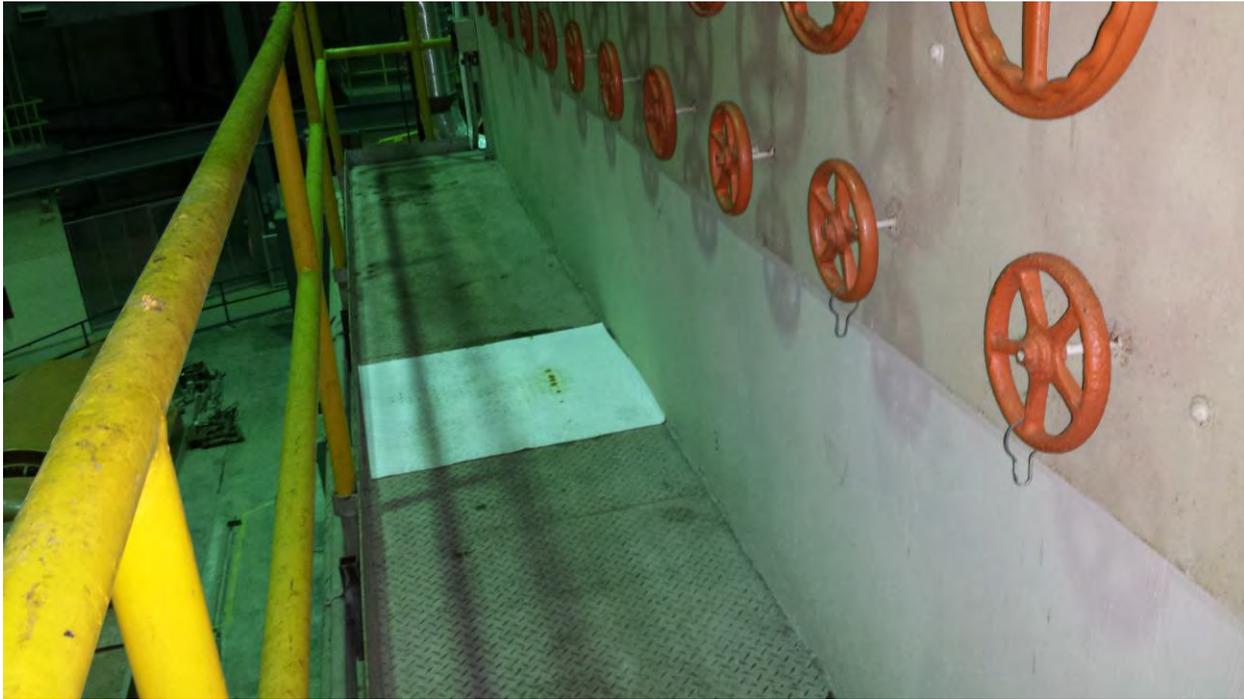
Figure 3. Entombment Top – Pad has been Placed to Address Oil Leaking from Overhead Crane (Near Sampling Points 1, 2, 3, and 4)

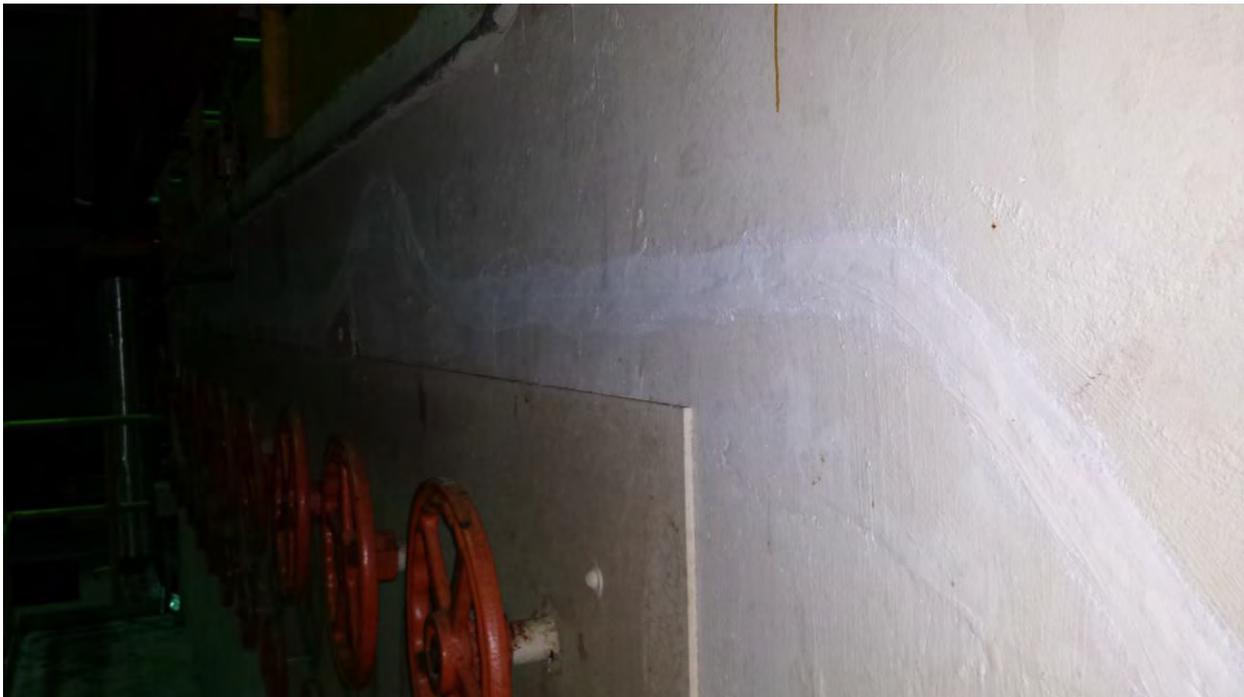
- **Dome-Entombed Concrete Monolith and Monolith Penetrations:** Inspection of the Concrete Monolith area revealed superficial cracks throughout the surface of the structure (Appendix A, Figure 4). Superficial cracks are also present along the base of the “top plug” of the concrete monolith top, but with no change from past inspections. All dose rate measurements taken around the structure were not significantly different from background measurements taken. No immediate action is necessary. Absorbent clothe has been placed to collect oil/grease dripping from the crane system above (Appendix A, Figures 1 and 3), however, a new leak was noted this year (Appendix A, Figure 2). It appears that the crane may be used periodically to change overhead light bulbs and/or inspect fire suppression system. It is recommended that absorbent clothes continue to be placed at those locations where oil/grease is accumulating on the Concrete Monolith and, especially, after the crane is moved.

Figure 4. Entombment Top – Surficial Cracks (Typical)

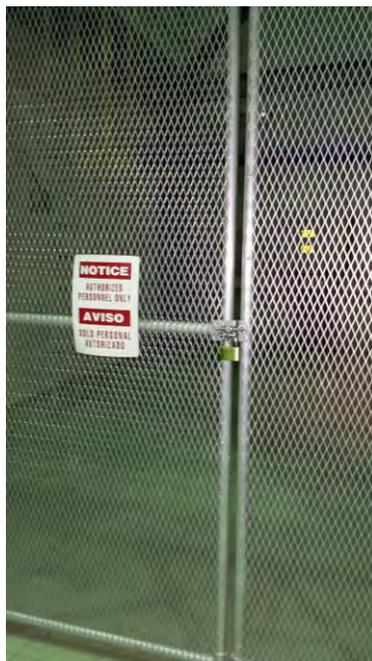
- **Dome-Mezzanine Level:** Access to ladders and stairways leading to the mezzanine level are being effectively maintained and controlled (Appendix A, Figures 11, 12, and 13). The structure appears sound and in good condition. No immediate action is necessary.

Figure 11. Main Level – Locked and Controlled Access to East Mezzanine and Electrical Panels

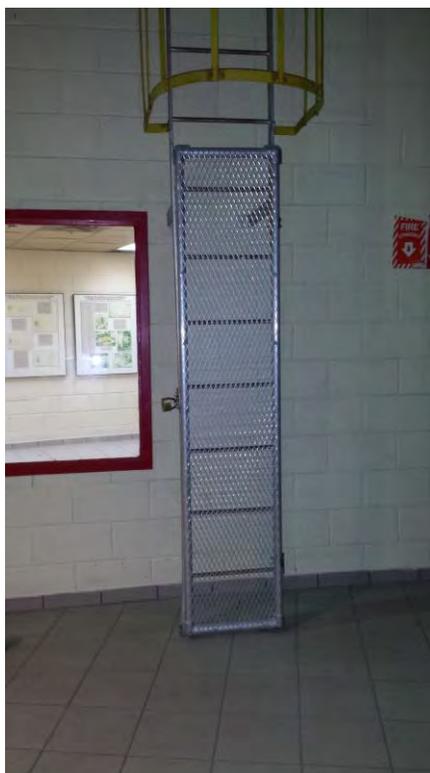
Figure 12. Main Level – Locked and Controlled Access to South Mezzanine

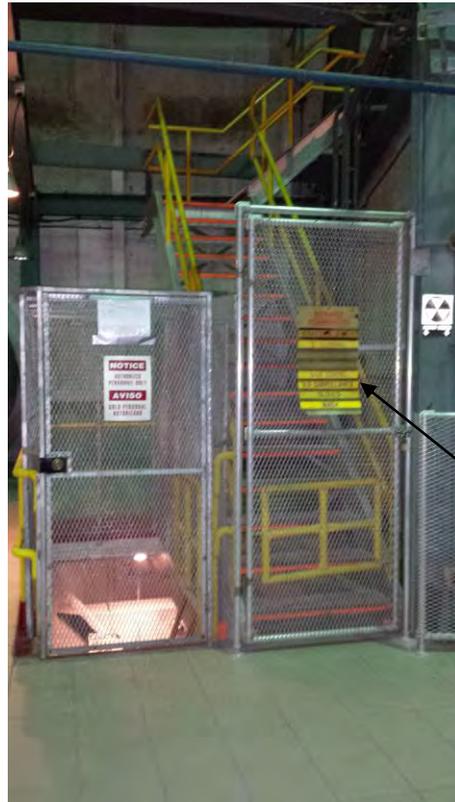
Access to stairways leading to the Basement Level is being effectively maintained and controlled (Appendix A, Figures 13 and 14). No action is necessary.

Figure 13. Main Level (Museum Area) – Locked and Controlled Access to South Side of Basement Level (Left) and Mezzanine (Right)

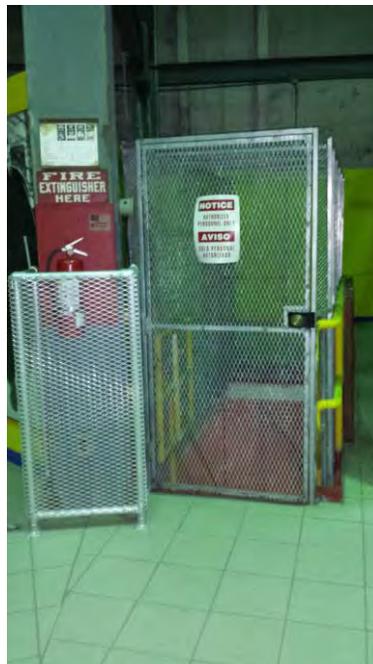
Figure 14. Main Level (Museum Area) – Locked and Controlled Access to North Side of Basement Level

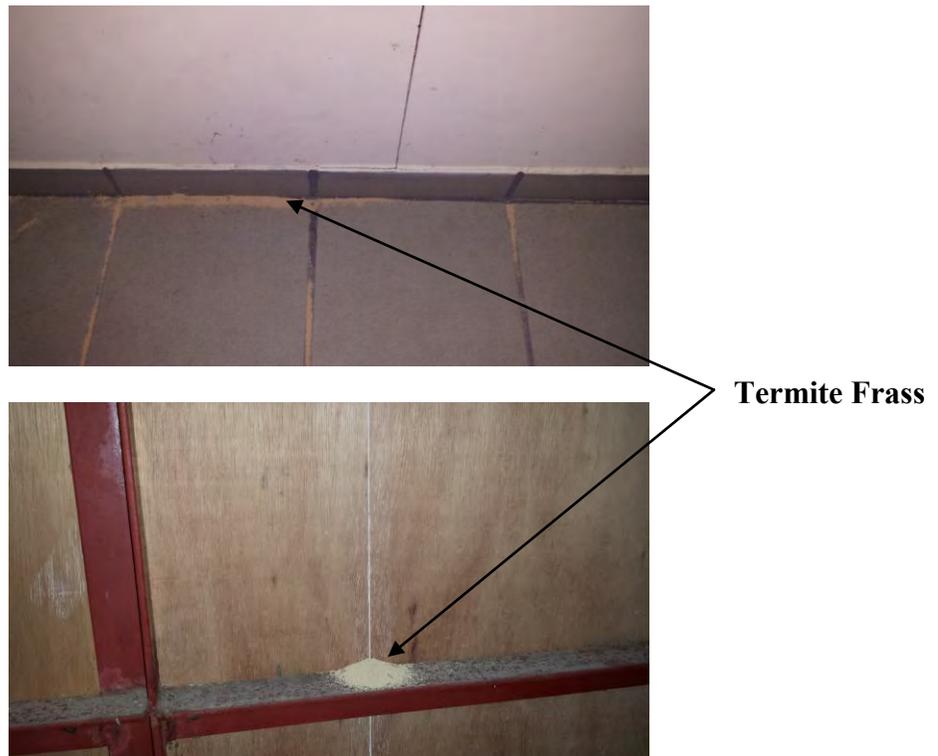
Evidence of termites (termite frass) was observed on the east side of Main Level (Museum Area) where plywood walls were constructed in recent years (Appendix A,

Figure 22. Main Level (Museum Area) – Wood Paneling with Evidence of Termites (East Side)

Figure 22). It is recommended that this area be inspected by a termite professional and treated, as necessary.

- Evidence of termites (termite frass) was observed on the east side of Main Level (Museum Area) where plywood walls were constructed in recent years (Appendix A, Figure 22). It is recommended that this area be inspected by a termite professional and treated, as necessary.

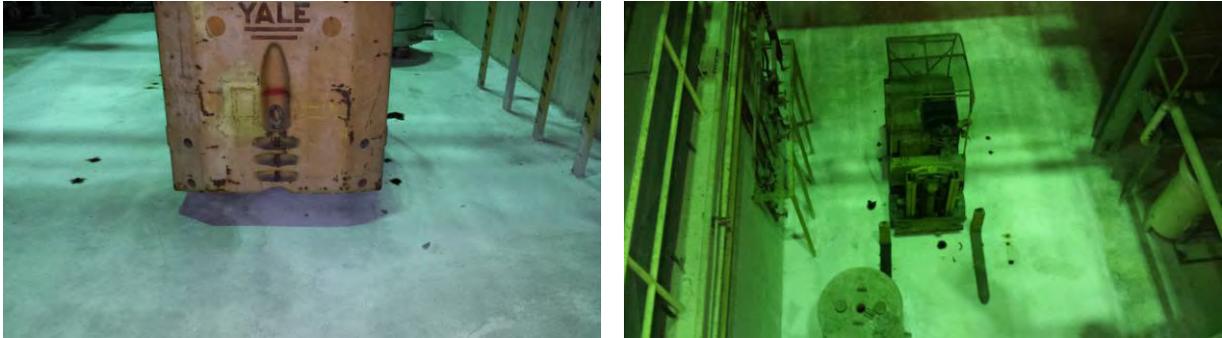
Figure 23. Basement Level – Oil/Lubricant Spots on Basement Floor from Overhead Equipment

- Near Sample Locations 50A and 50B, fresh oil/lubricant stains were noted (Appendix A, Figure 23). It is recommended that absorbent clothes continue to be placed at these locations during quarterly surveys.

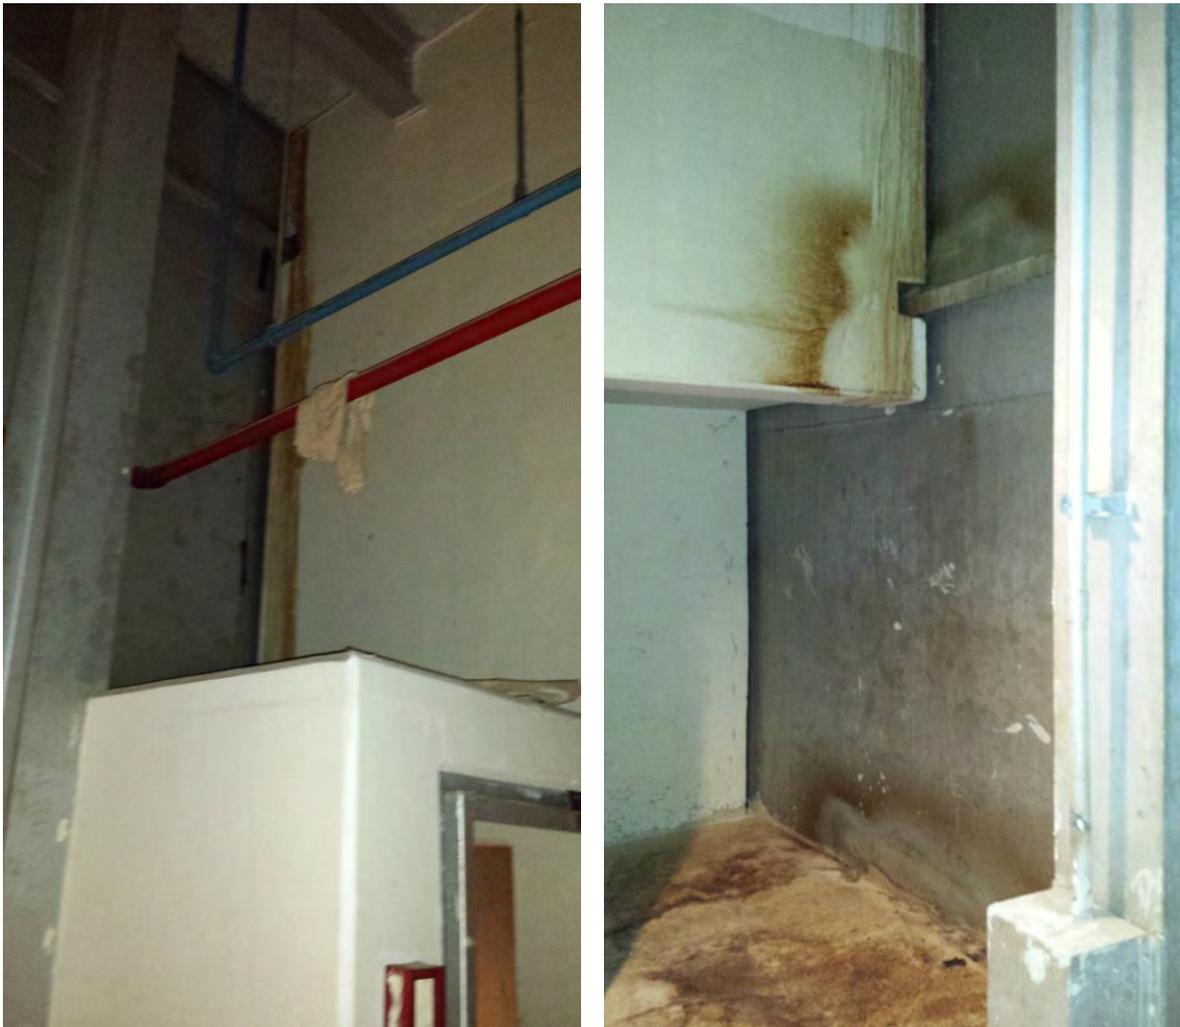
The gasket around the exterior base of the Dome, which is at ceiling level of the basement, has been replaced and subsequent “patches” placed at the north entrance/air lock (Appendix A, Figures 24 and 35) remains intact and effective. The gasket is showing signs of weathering and surficial cracks in the low areas of the gasket where it holds rain water and dries in the sun (Appendix A, Figure 35). The drains in the trough below the gasket are clear and draining rain water properly (Appendix A, Figure 36). The large bay door at the Basement Level remains sealed with expanding foam to prevent rainwater infiltration into the Basement Level.

Figure 24. Basement Level – Beneath North Entrance Air Lock (No Signs of Recent Water Infiltration – Older Stains Persist)

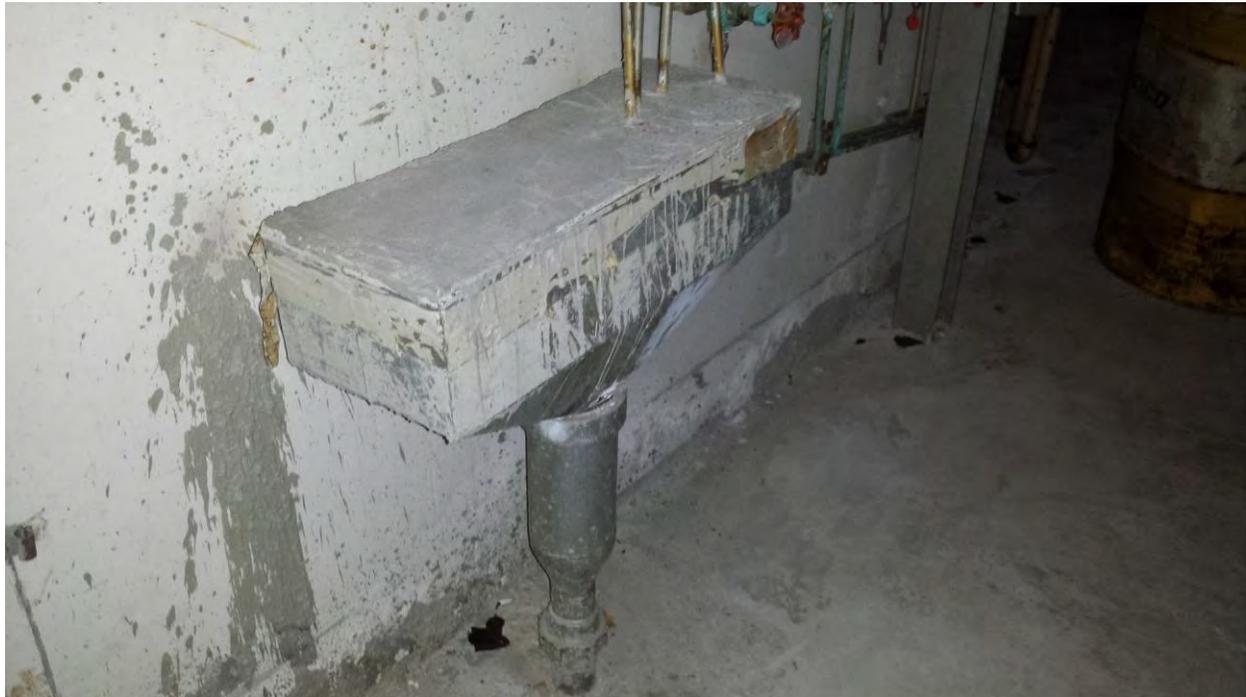
Control measures (fixed with paint and concrete layer in some places), which were previously implemented, were inspected (Appendix A, Figures 25, 27, and 29). The yellow paint on the Liquid Water Retention Tanks is starting to show signs of thinning, but smears indicated no removable contamination at this time. Ongoing and routine assessment of accessible surfaces in the basement is recommended to evaluate the continued effectiveness of the concrete cover flooring and control measures (e.g., paint) emplaced on previous contamination areas. Although immediate action is not critical, it is recommended that yellow paint be re-applied to the three liquid water retention tanks within the next two years (Appendix A, Figure 29). Access to areas with historical removable contamination is being effectively controlled.

Figure 25. Basement Level – Concrete Filled Sink

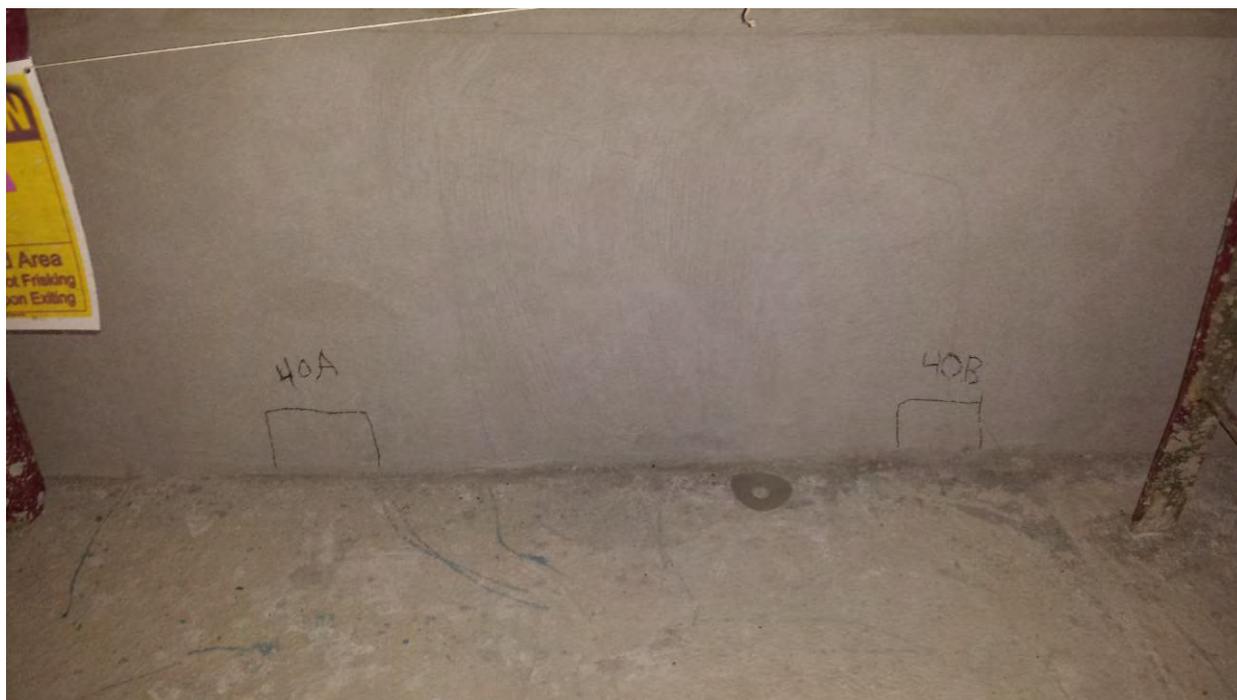
Figure 27. Basement Level – Sample Locations 40A and 40B Covered by Engineering Control (~1/2 Inch Concrete) with Caution Sign Reading “Controlled Area – Hand and Foot Frisking Required Upon Exit”

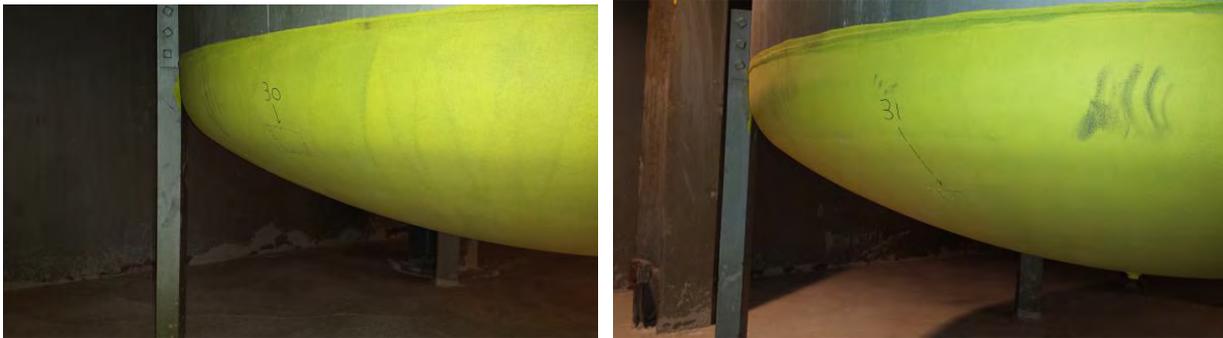
Figure 29. Basement Level – Sample Locations #30 and #31 on Liquid Water Retention Tanks with Engineering Control (Yellow Paint)

- Control measures (fixed with paint and concrete layer in some places), which were previously implemented, were inspected and do not require maintenance at this time (Appendix A, Figures 25, 27, and 29). Although no immediate action is necessary, it is recommended that yellow paint be re-applied to the three liquid water retention tanks within the next two years (Appendix A, Figure 29).

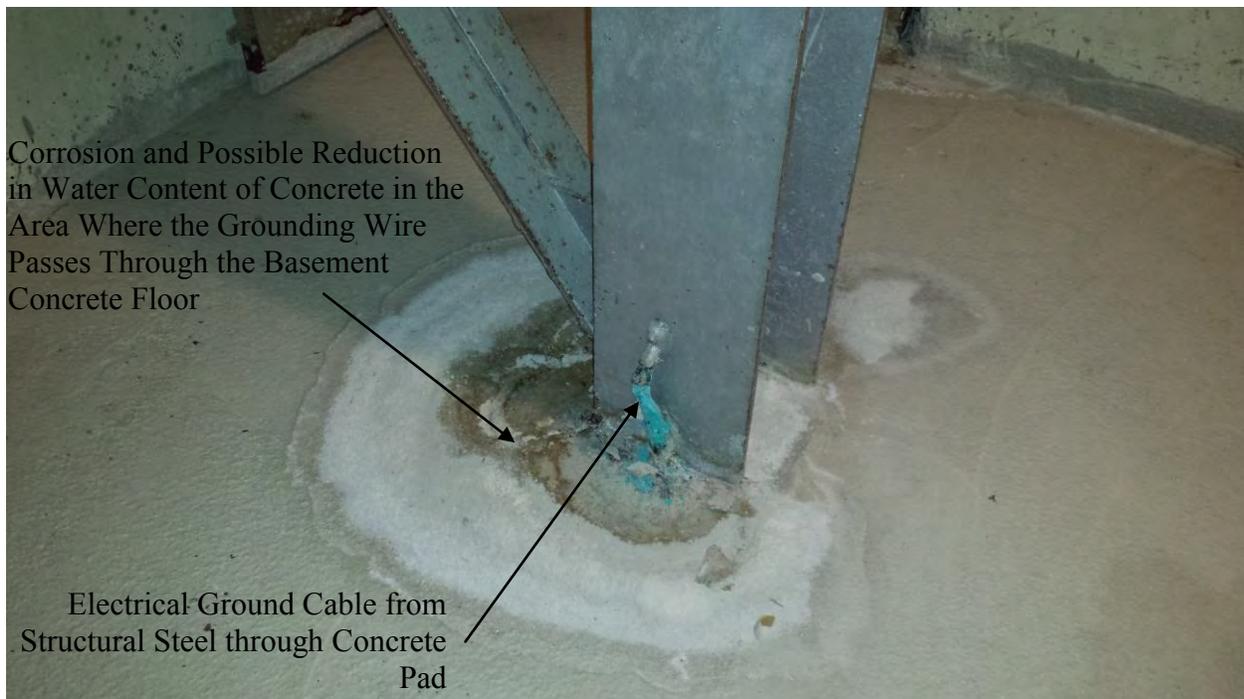
On the concrete flooring and structural steel near Sample Locations 50A and 50B, significant corrosion and concrete spalling is occurring (this is a repeat observation from 2013 and 2014). This appears to be centered on the grounding wire in this location which is attached to a structural steel column and passes through the concrete flooring (Appendix A, Figure 30). The spalling area does not appear any larger than noted in 2014. It is recommended that an electrician be contacted to inspect the grounding of structural steel in the basement. Also near Sample Locations 50A and 50B, fresh oil/lubricant stains were noted (Appendix A, Figure 23). It is recommended that absorbent clothes continue to be placed at these locations during quarterly surveys.

Figure 30. Basement Level – Corrosion Issues on Concrete Floor near Sample Locations 50A and 50B

- On the concrete flooring and structural steel near Sample Locations 50A and 50B, significant corrosion and concrete spalling is occurring (repeat from 2013 and 2014). The spalling area does not appear any larger than noted in 2014. This appears to have been caused by the grounding wire in this location which is attached to a structural steel column and passes through the concrete flooring (Appendix A, Figure 30). It is recommended that an electrician be contacted to inspect the grounding of structural steel in the basement.

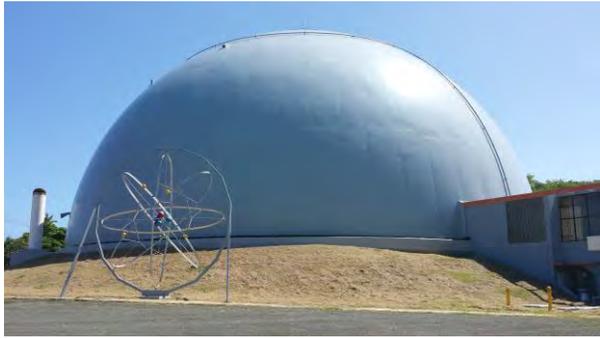
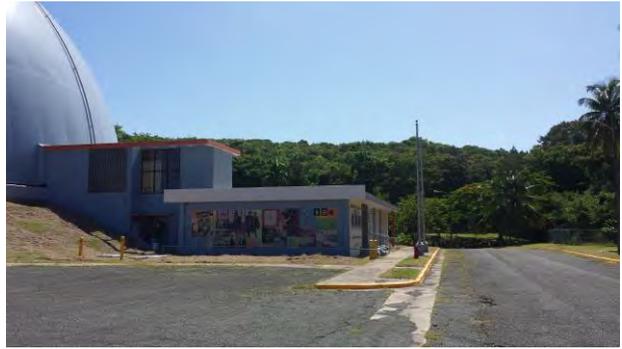
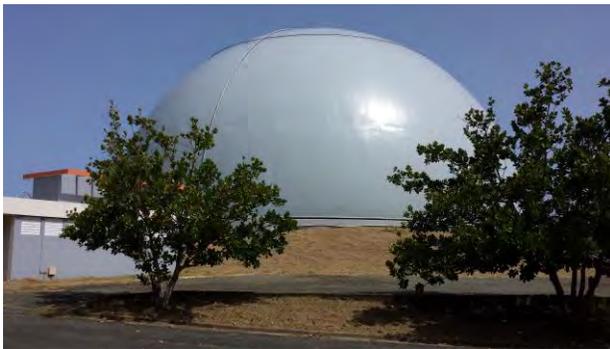
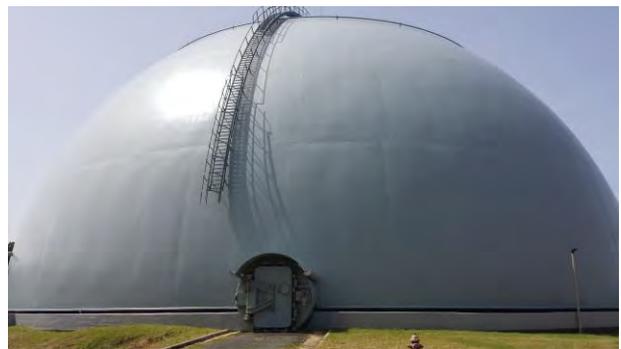
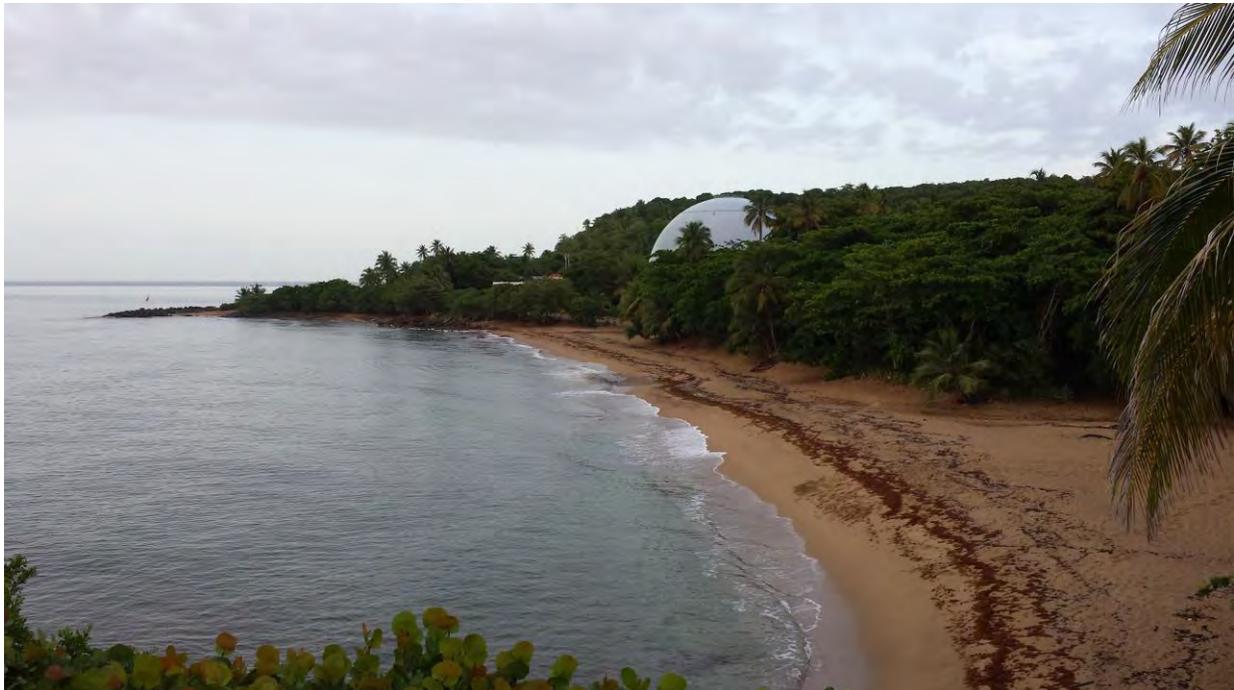
- **Dome-Exterior:** Inspection of the Dome structure did not reveal any significant structural discrepancies. The Dome structure exterior was re-sealed and painted since the last annual survey (Appendix A, Figure 31). Both entrance portals are in good condition.

Figure 31. Dome Structure – Exterior With Protective Coating and Paint

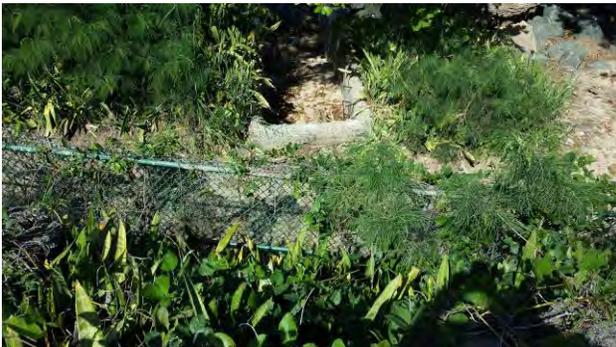
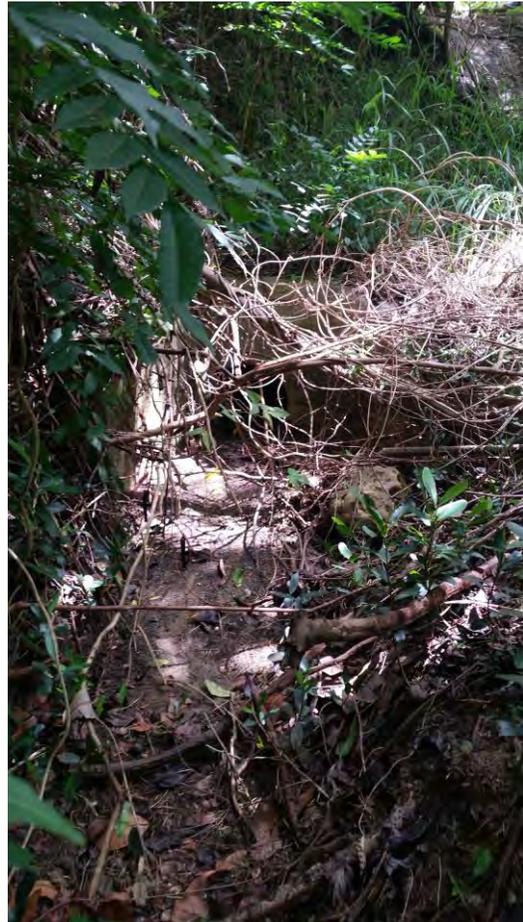
- **Dome-External Piping Systems:** Inspection of accessible external piping systems revealed no significant indications of deterioration. Outfall pipes on the west side of the property (on the beach outside of perimeter fence) and south side of the property (outside of perimeter fence) were inspected (Appendix A, Figure 33). Dead vegetation has accumulated at the southern outfall. It is recommended that vegetation be cleared from the opening of the southern outfall pipe.

Figure 33. Dome Structure – Drainage Outfall Points and Ditches (Western Outfall on Left and Southern Outfall on Right)

- Dead vegetation has accumulated at the southern outfall (Appendix A, Figure 33). It is recommended that vegetation be cleared from the opening of the southern outfall pipe.

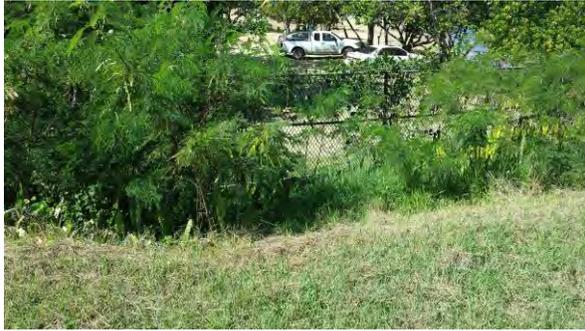
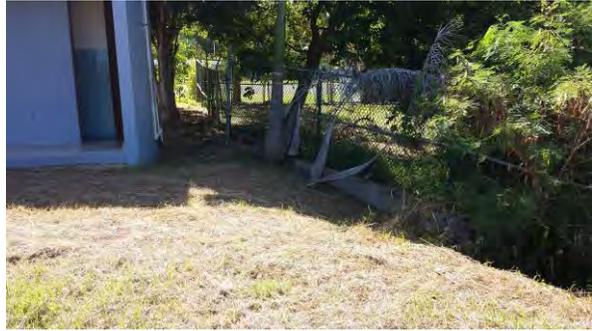
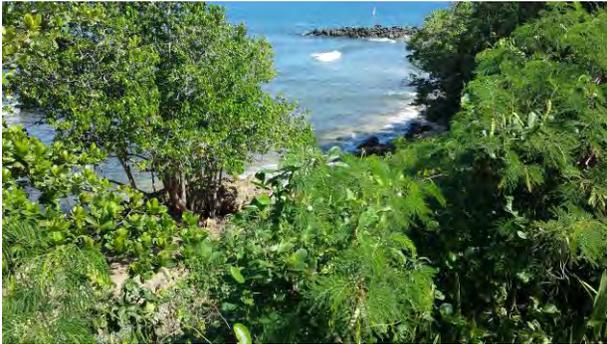
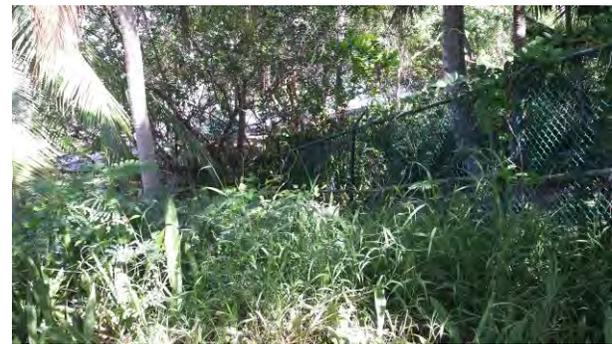
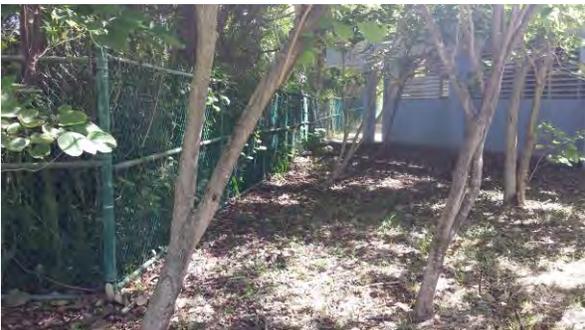
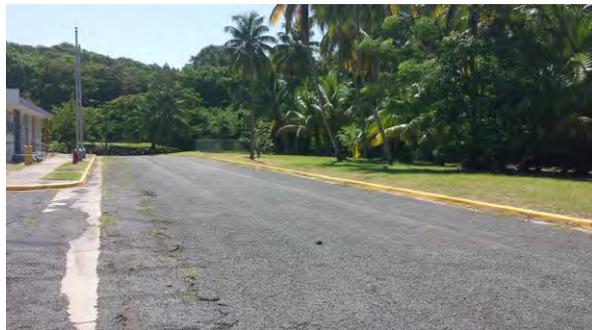
Figure 34. Fence –Fencing and Perimeter – Some Areas with Overgrown Vegetation

- Physical Condition:
 - The fence surrounding the property is functional at controlling access; however, vegetation is climbing the fence in some areas (Appendix A, Figure 34). Recommend instructing the maintenance contractor to cut vegetation away from fencing.

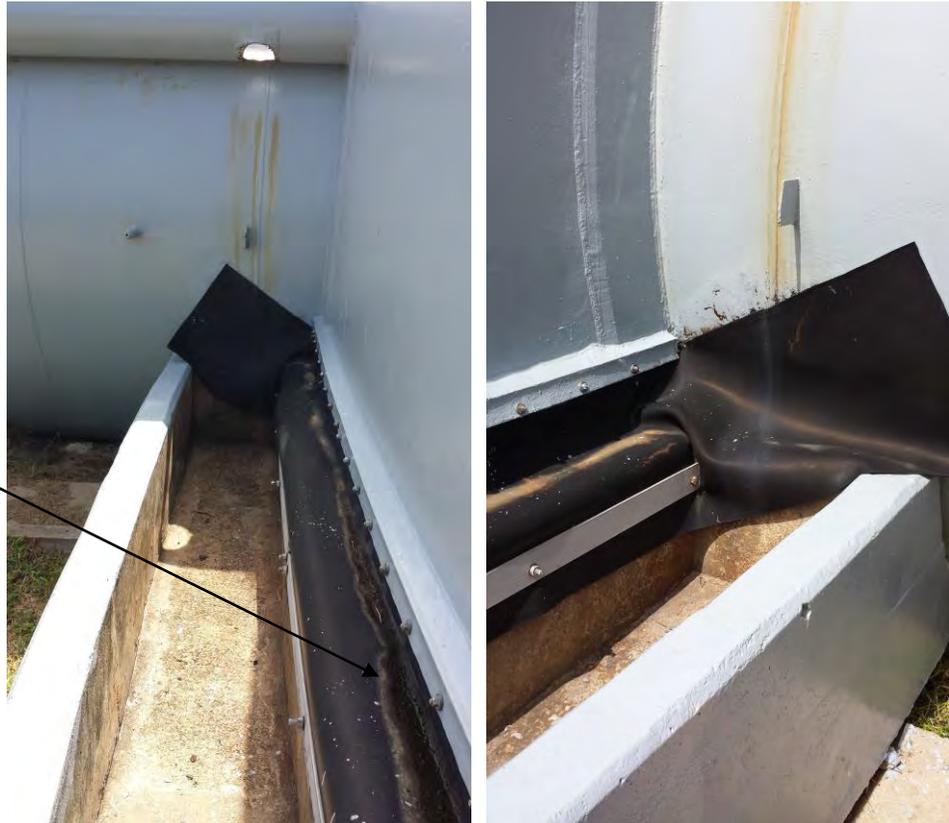
Figure 35. Dome Structure – Flexible Gasket/Seal – North Entrance Air Lock

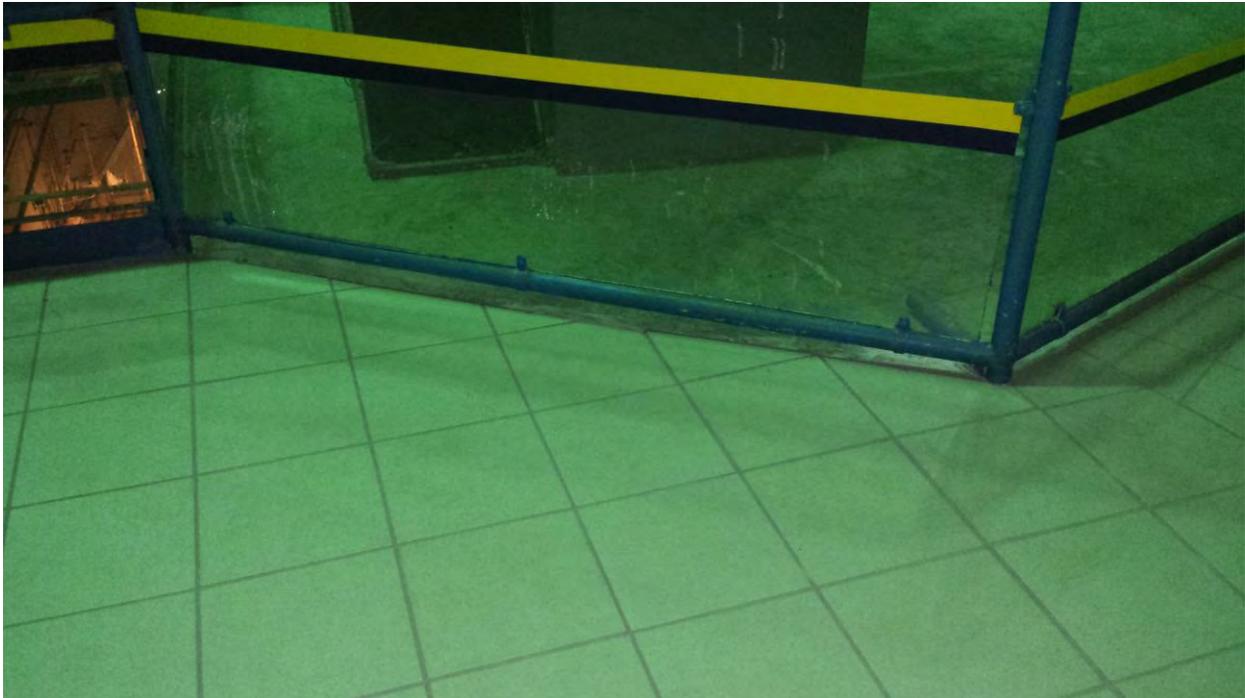
Figure 37. Main Level (Museum Area) – Some Tiles Starting to Loosen or “Float” (No Cracks in Mortar Joints)

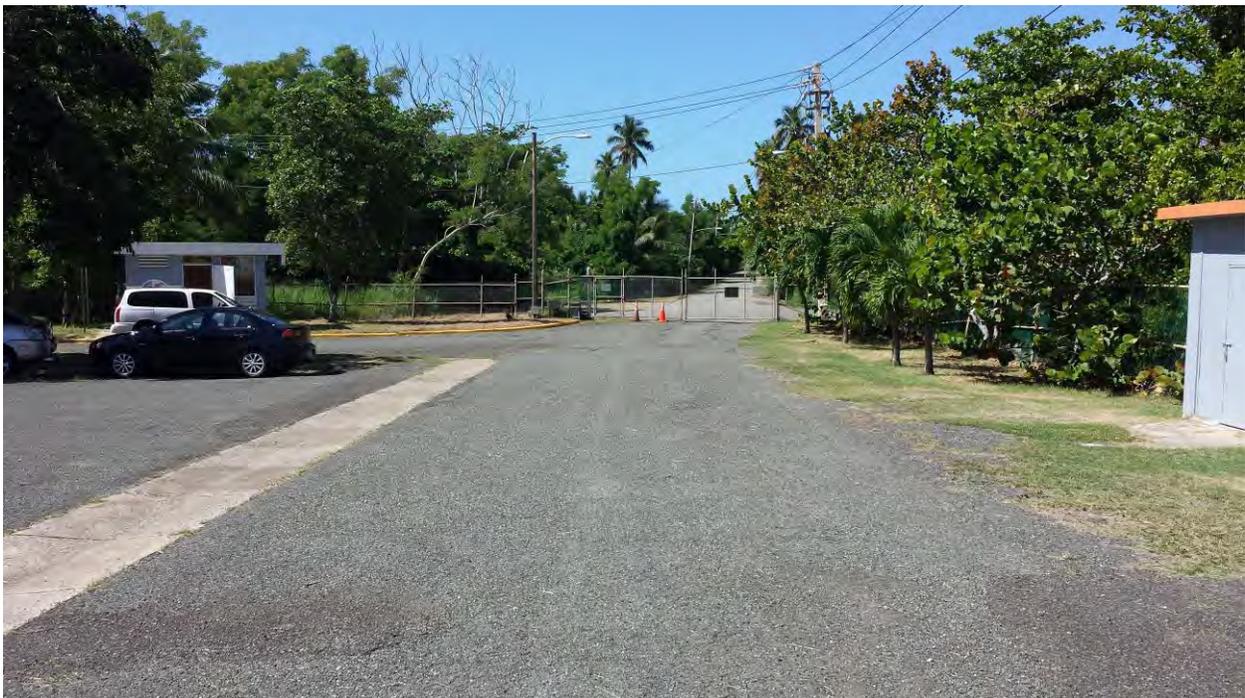
- **Site Surveillance Features:** Asphalt of the access road and parking area remains in fair and usable condition. The entrance gate is manually operated by the attending guard (Appendix A, Figure 38). The security guard controlled access into the gated facility and kept log of visitors. The Dome monolith plaques were in fair condition. The fence surrounding the property is functional at controlling access; however, vegetation is climbing the fence in some areas (Appendix A, Figure 34). Recommend instructing the maintenance contractor to cut vegetation away from fencing.

Figure 38. Security – Main Gate in Good Working Condition (Manual Open/Close)

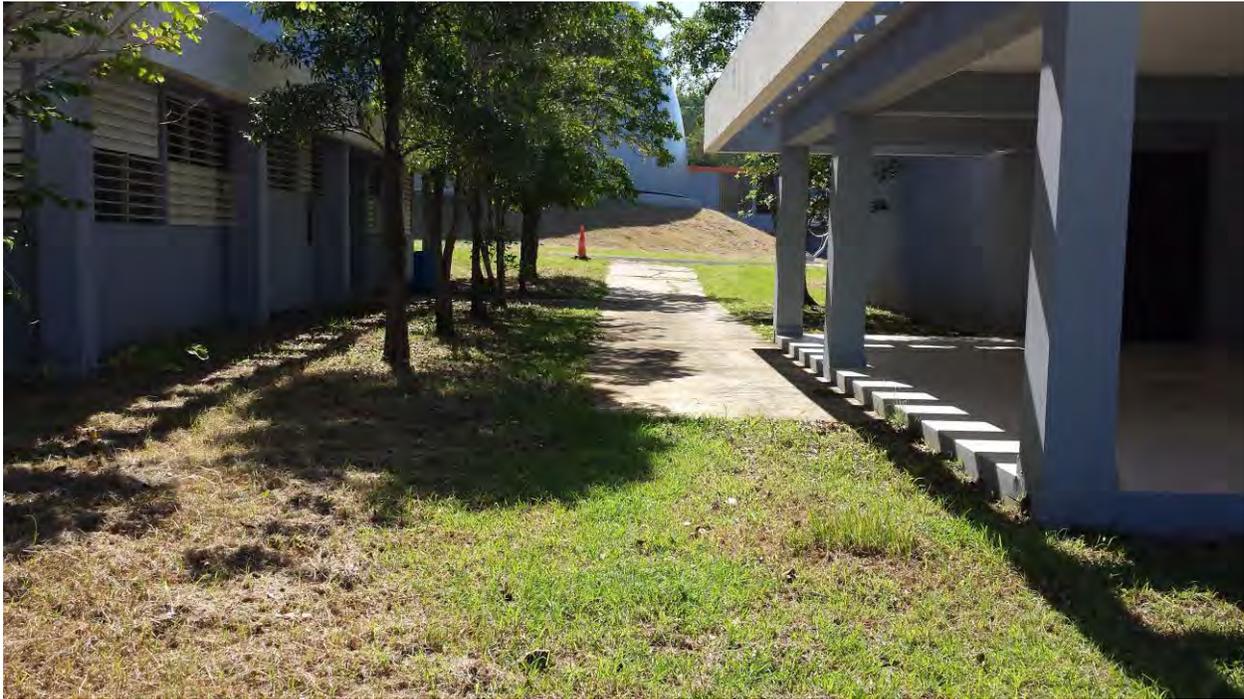
Figure 39. Ancillary Buildings and Structures – Theatre Building (on Right) with Active Bee Hive Present, Evidence of Rodents and Termites, and the Air Conditioning Units are Not Working Properly

- Evidence of a bee hive, rodents, and termites was noted in the Theatre Building. The air conditioning units in the Theatre Building were also not working properly. Evidence of termites (Appendix A, Figure 40) was also noted in the administrative building at the southern portal/entrance to the Dome. It is recommended that pest control inspection and treatment be administered at the Theatre Building and administrative building at the southern portal/entrance to the Dome. It is also recommended that routine maintenance and repair, if necessary, be performed on the air conditioning units in the Theatre Building.

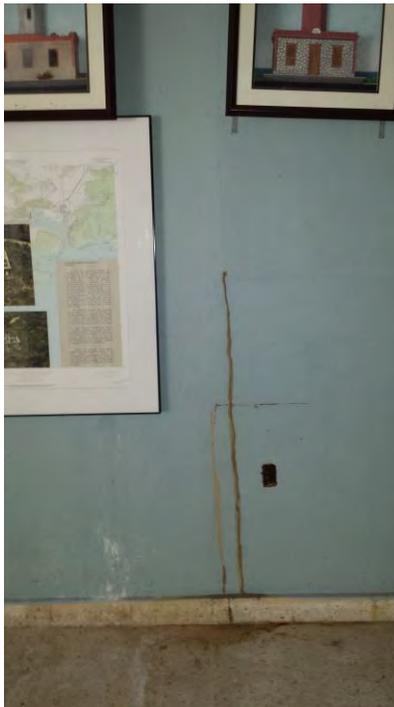
Figure 40. Ancillary Buildings and Structures – Entrance/Administrative Building at Southern Entrance to Dome – with Signs of Termites (“Mud Tubes”)
