## 1.0 Bluewater, New Mexico, Disposal Site

### 1.1 Compliance Summary

The Bluewater, New Mexico, Uranium Mill Tailings Radiation Control Act (UMTRCA) Title II Disposal Site was inspected on August 27, 2008, and was in excellent condition. Overall, the disposal cells and their cover materials are in excellent condition; however, several shallow depressions on the cover along the north edge of the main tailings disposal cell have been monitored since the site was transferred to DOE in 1997. They were surveyed prior to the inspection and the results will be evaluated to determine if repairs are necessary. Groundwater monitoring results indicate that all compliance requirements continue to be met. No cause for a follow-up inspection was identified.

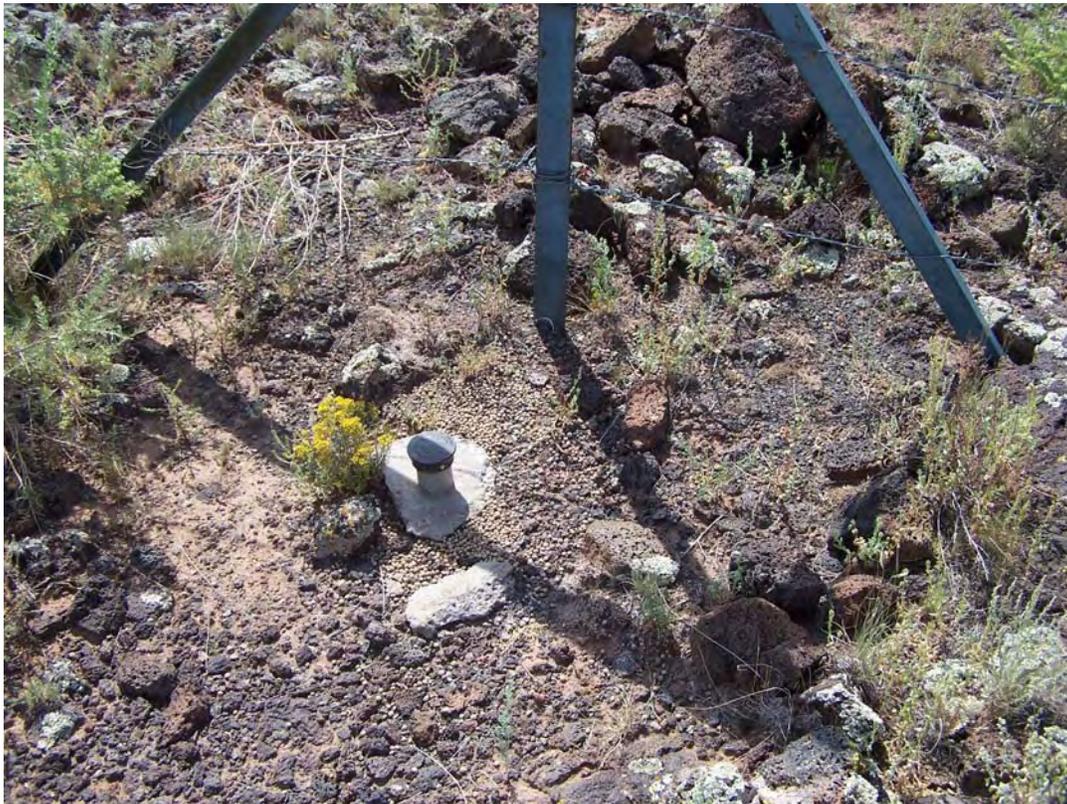
*BLU 8/2008. PL-1. Boundary monument BM-4.*

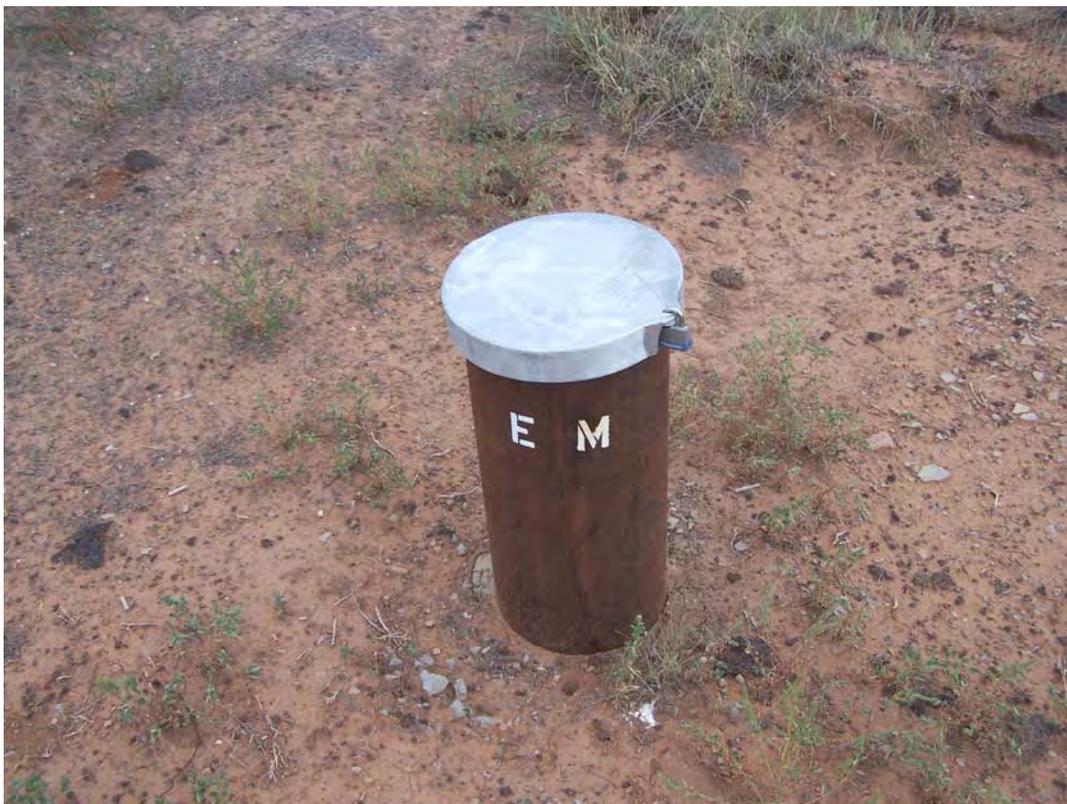
**1A Monitor Wells**—The groundwater-monitoring network consists of nine wells located inside the site boundary. Five wells are screened in the alluvial aquifer and the other four wells are screened in the bedrock San Andres Limestone-Glorieta Sandstone, which is the regulated uppermost aquifer at the site. The aluminum cap of well MW-E(M) was broken and the lock was missing; a new cap and lock were installed during the inspection (PL-2). The other well surface casings and locked caps were in good condition.

*BLU 8/2008. PL-2. New cover and lock on monitor well MW-E(M).*

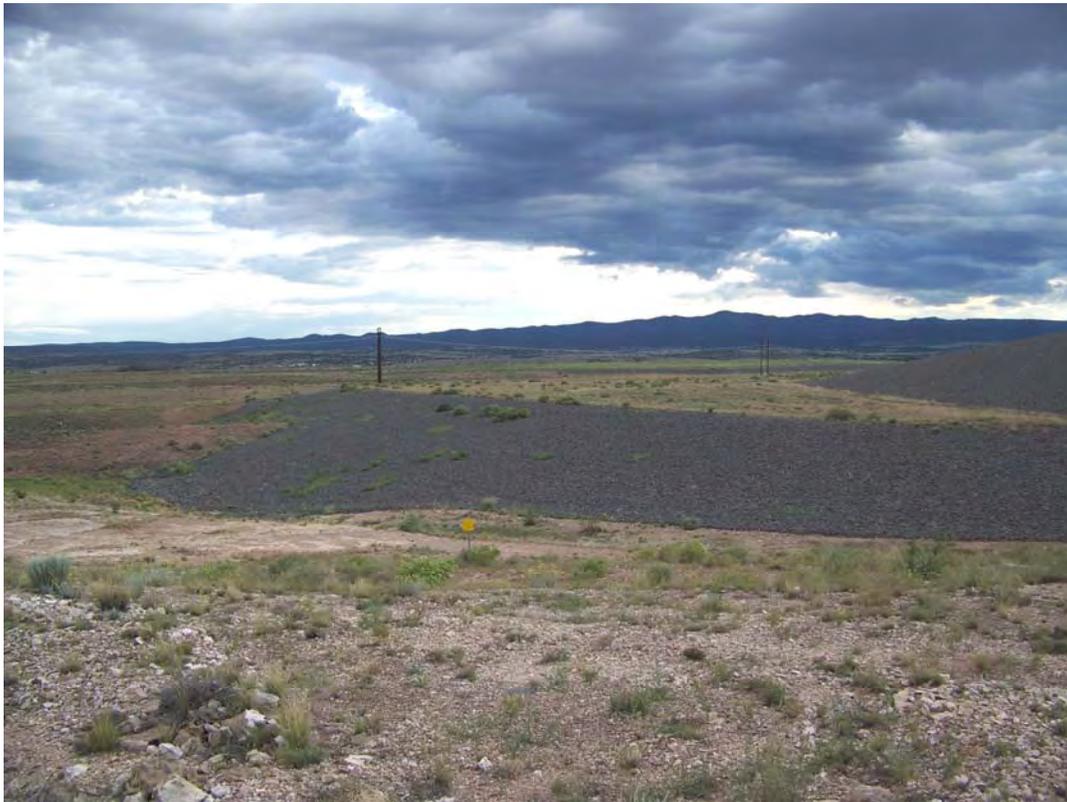
*BLU 8/2008. PL-3. South bench of the main tailings disposal cell.*

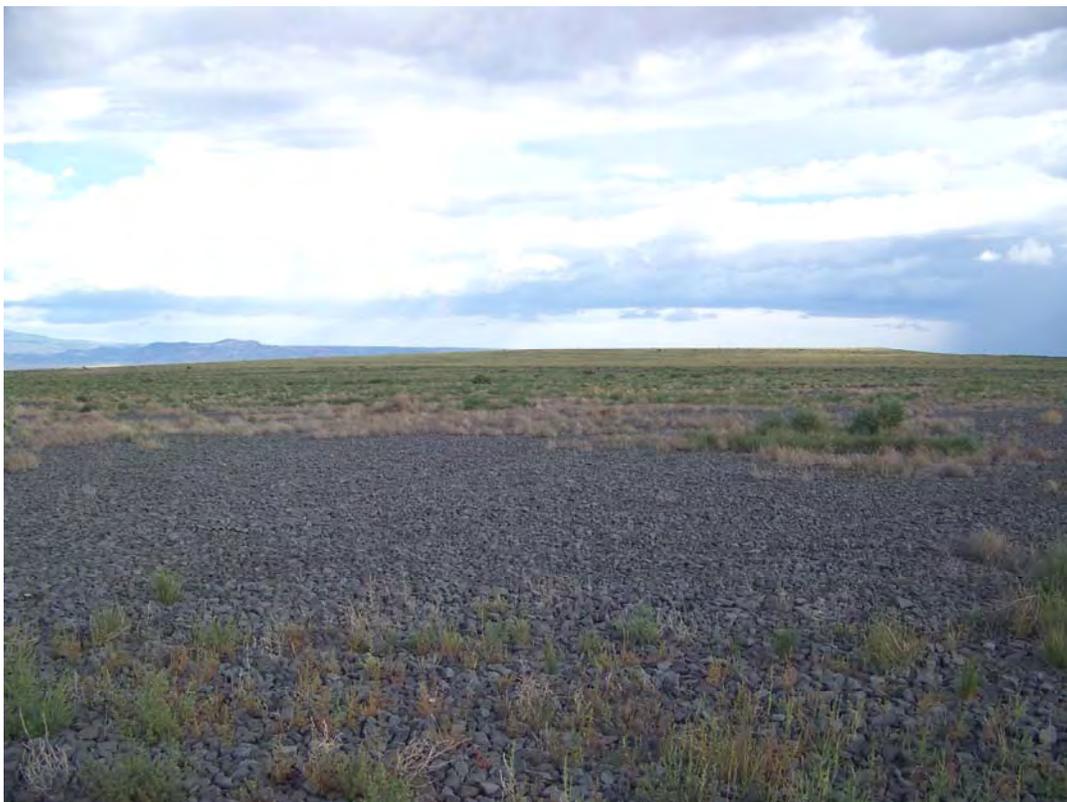
As shown on photo PL–4, the top of the main tailings disposal cell had an extensive cover of annual weeds (primarily Russian thistle, which is not a listed noxious weed in New Mexico), along with some wildflowers and deep-rooted shrubs (rabbitbrush and four-wing saltbush). Patches of annual weeds also were present on the east side slope of the cell. Control of plant encroachment is not required by the LTSP.

*BLU 8/2008. PL-4. Vegetation on the main tailings disposal cell cover.*

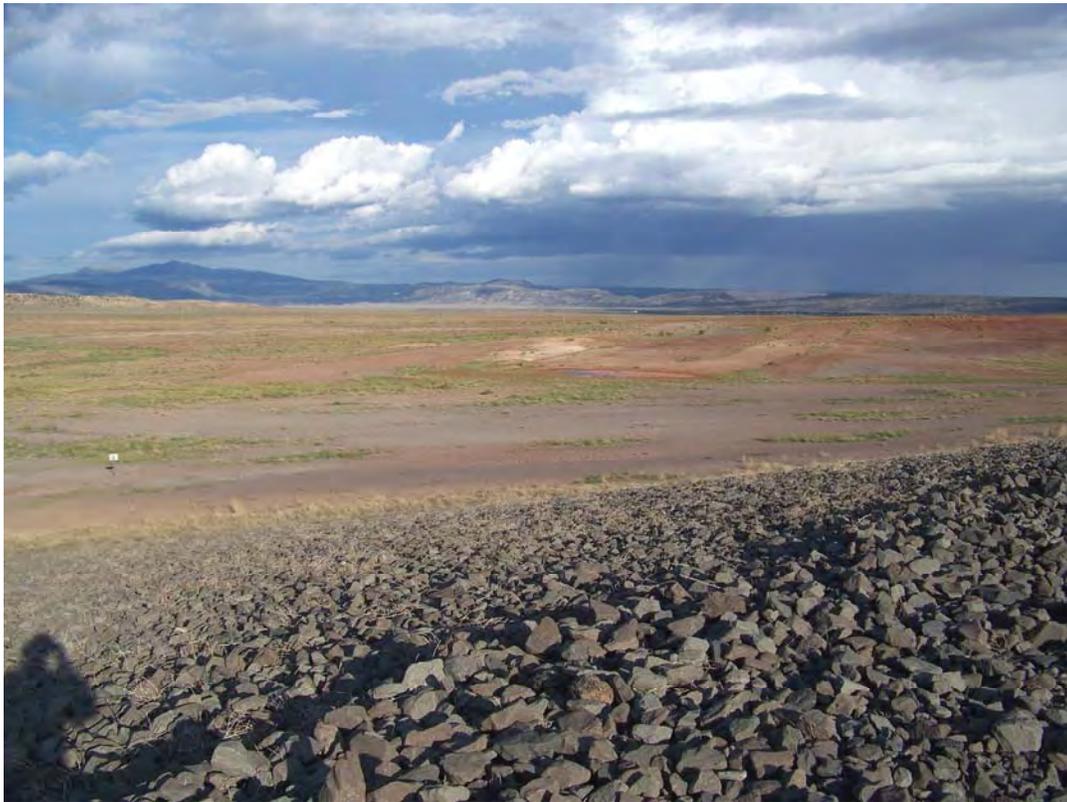
Desiccation cracks are present in the soil adjacent to the northeast corner of the main tailings disposal cell. The features are caused by shrinkage of clay-rich backfill materials and do not degrade the stability of the cell. Small ponds often form in an area along the east side of the disposal cell and in other low spots following storm events and provide water for wildlife and wild burros that inhabit or travel through the site; the pond locations were dry at the time of the inspection (PL–5). The areas of ephemeral ponding are far enough from the cell to not impact it.

*BLU 8/2008. PL-5. View toward ephemeral pond area (dry) and well OBS-3.*

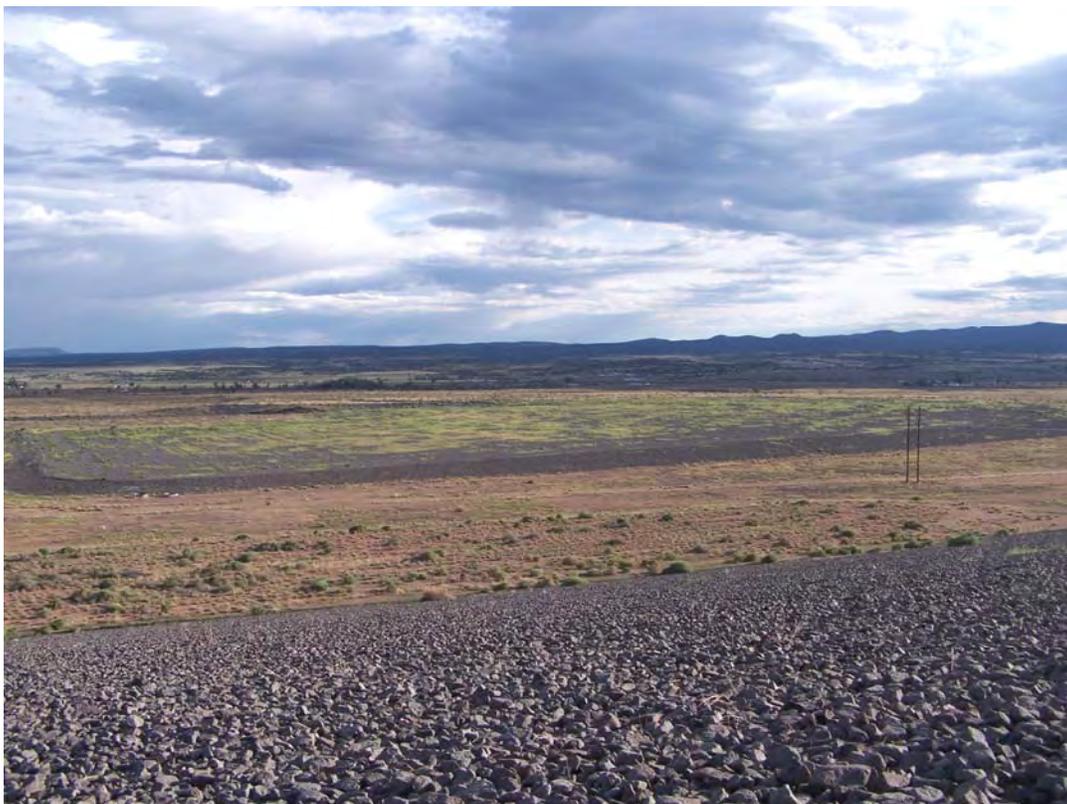
**Carbonate Tailings Disposal Cell, Asbestos and PCB Disposal Areas, and Landfills**—The top and side slopes of the carbonate tailings disposal cell are covered by basalt riprap. The top, for the most part, slopes gently eastward. The small northwest and southeast extensions slope in their respective directions. Annual weeds and scattered woody shrubs were present on the cell and its extensions (PL–6). The carbonate tailings disposal cell was in excellent condition.

*BLU 8/2008. PL-6. Carbonate tailings disposal cell.*

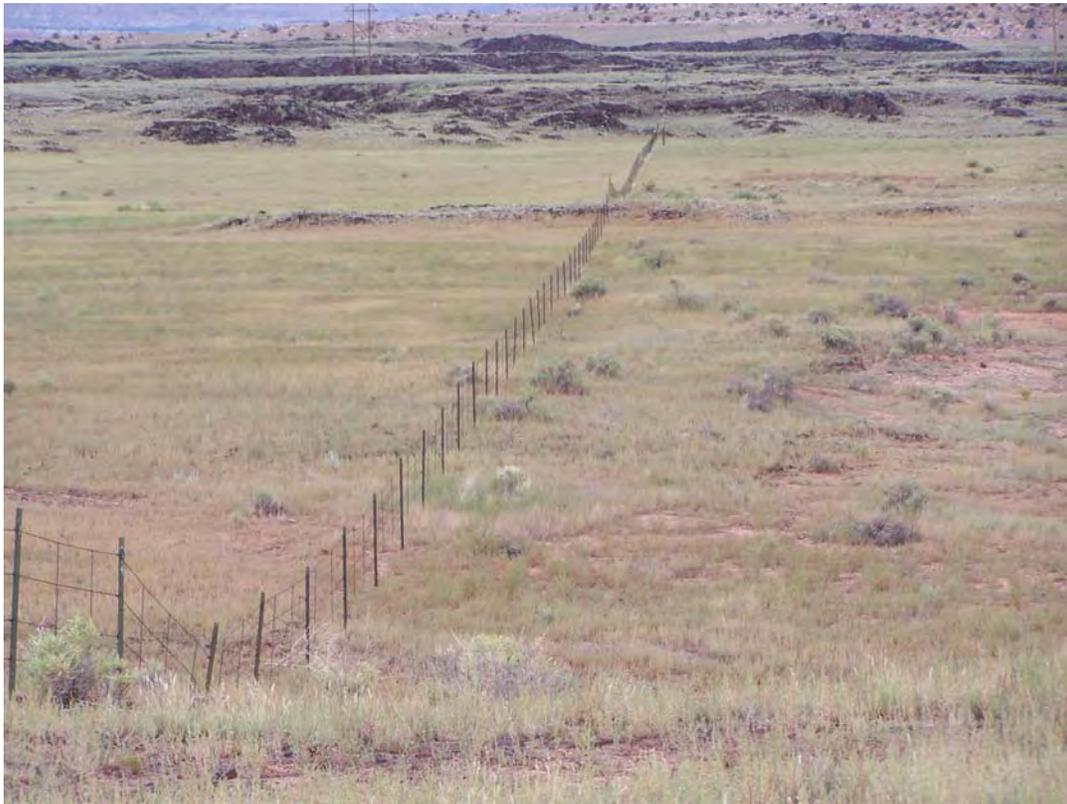
*BLU 8/2008. PL-7. View north from boundary monument BM-2.*

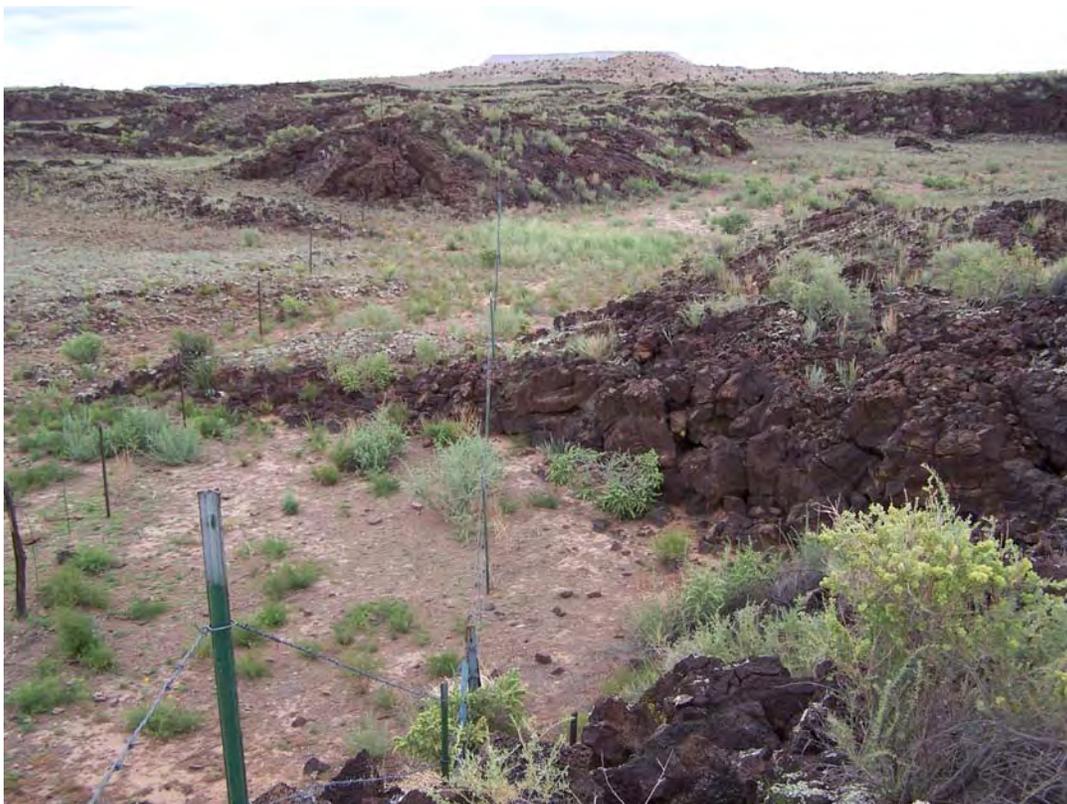
*BLU 8/2008. PL-8. View north from perimeter sign P9.*

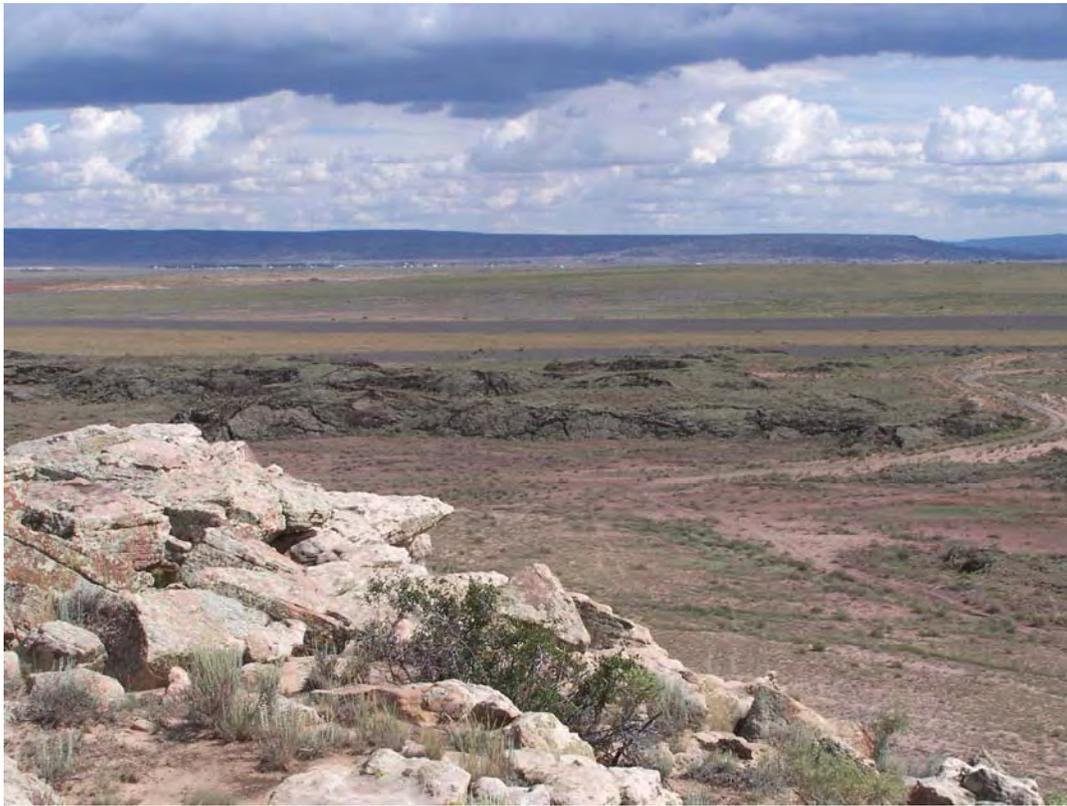
*BLU 8/2008. PL-9. Main tailings disposal cell viewed from the hilltop near boundary monument BM-5.*

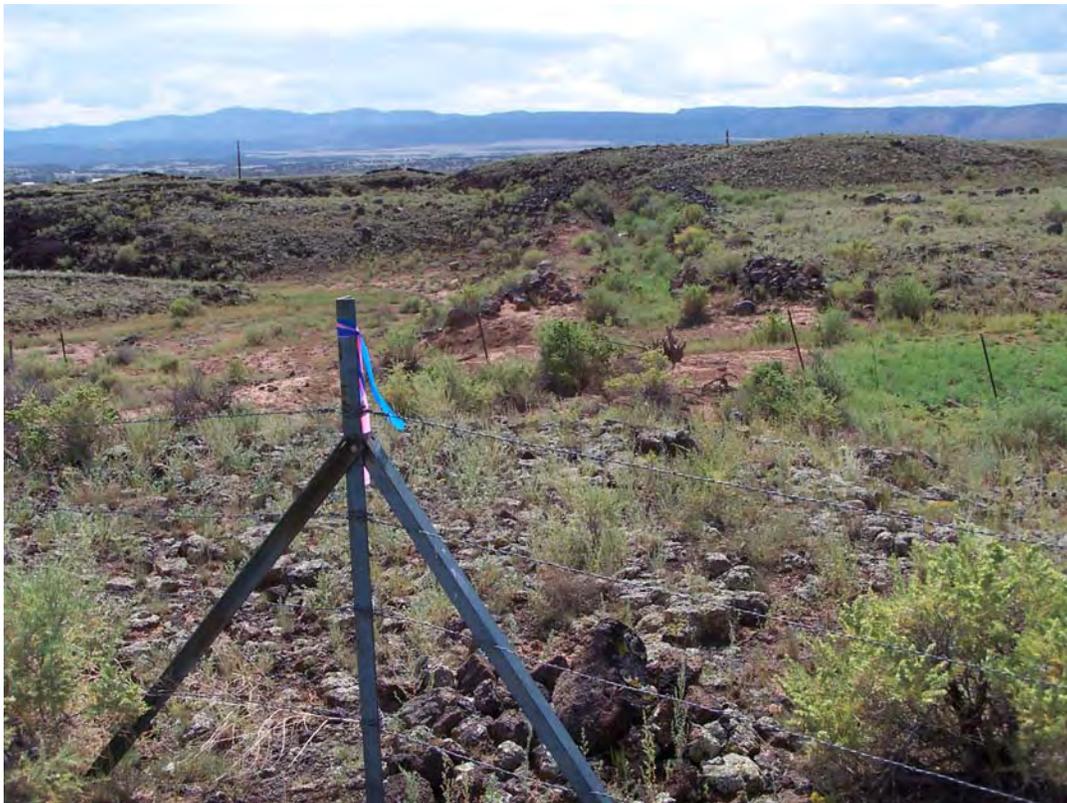
*BLU 8/2008. PL-10. Old canal near boundary monument BM-4.*

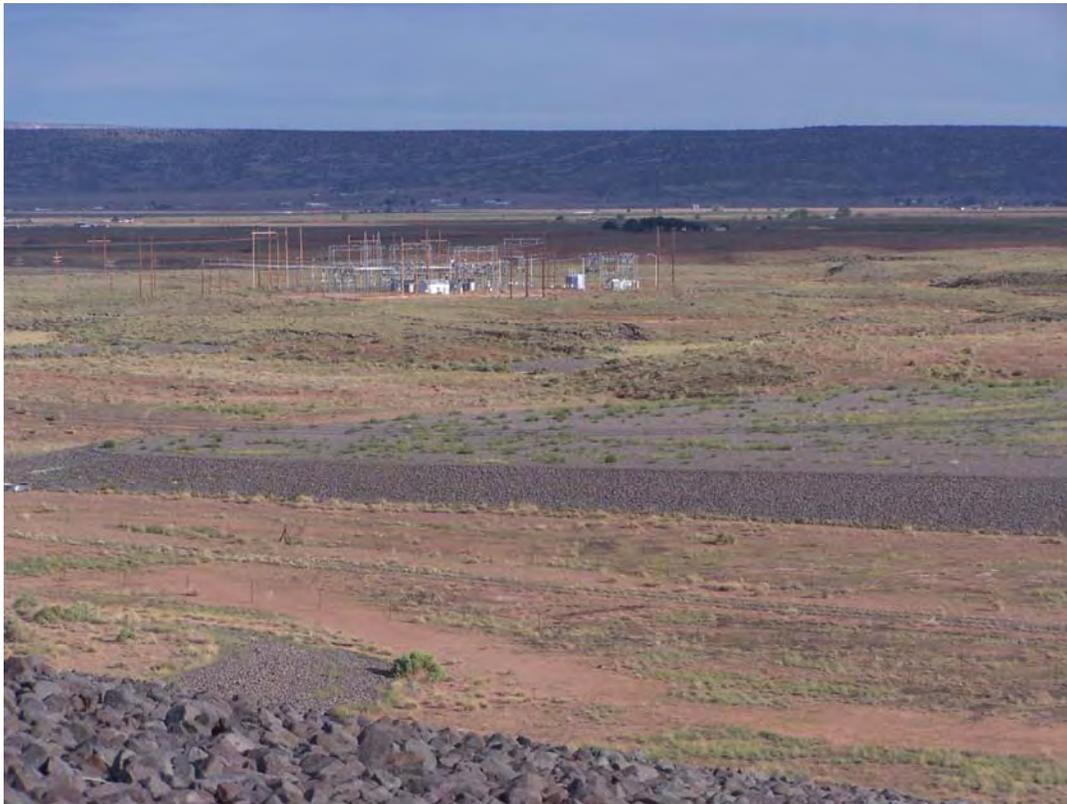
An electric power substation is enclosed by a security fence near the center of the site along the Plains Electric Company right-of-way (PL-11). Fencing around this station was in good condition.

*BLU 8/2008. PL-11. Electrical substation.*
