2.0 Burrell, Pennsylvania, Disposal Site

2.1 Compliance Summary

Figure 2-1. 2015 Annual Inspection Drawing for the Burrell Disposal Site

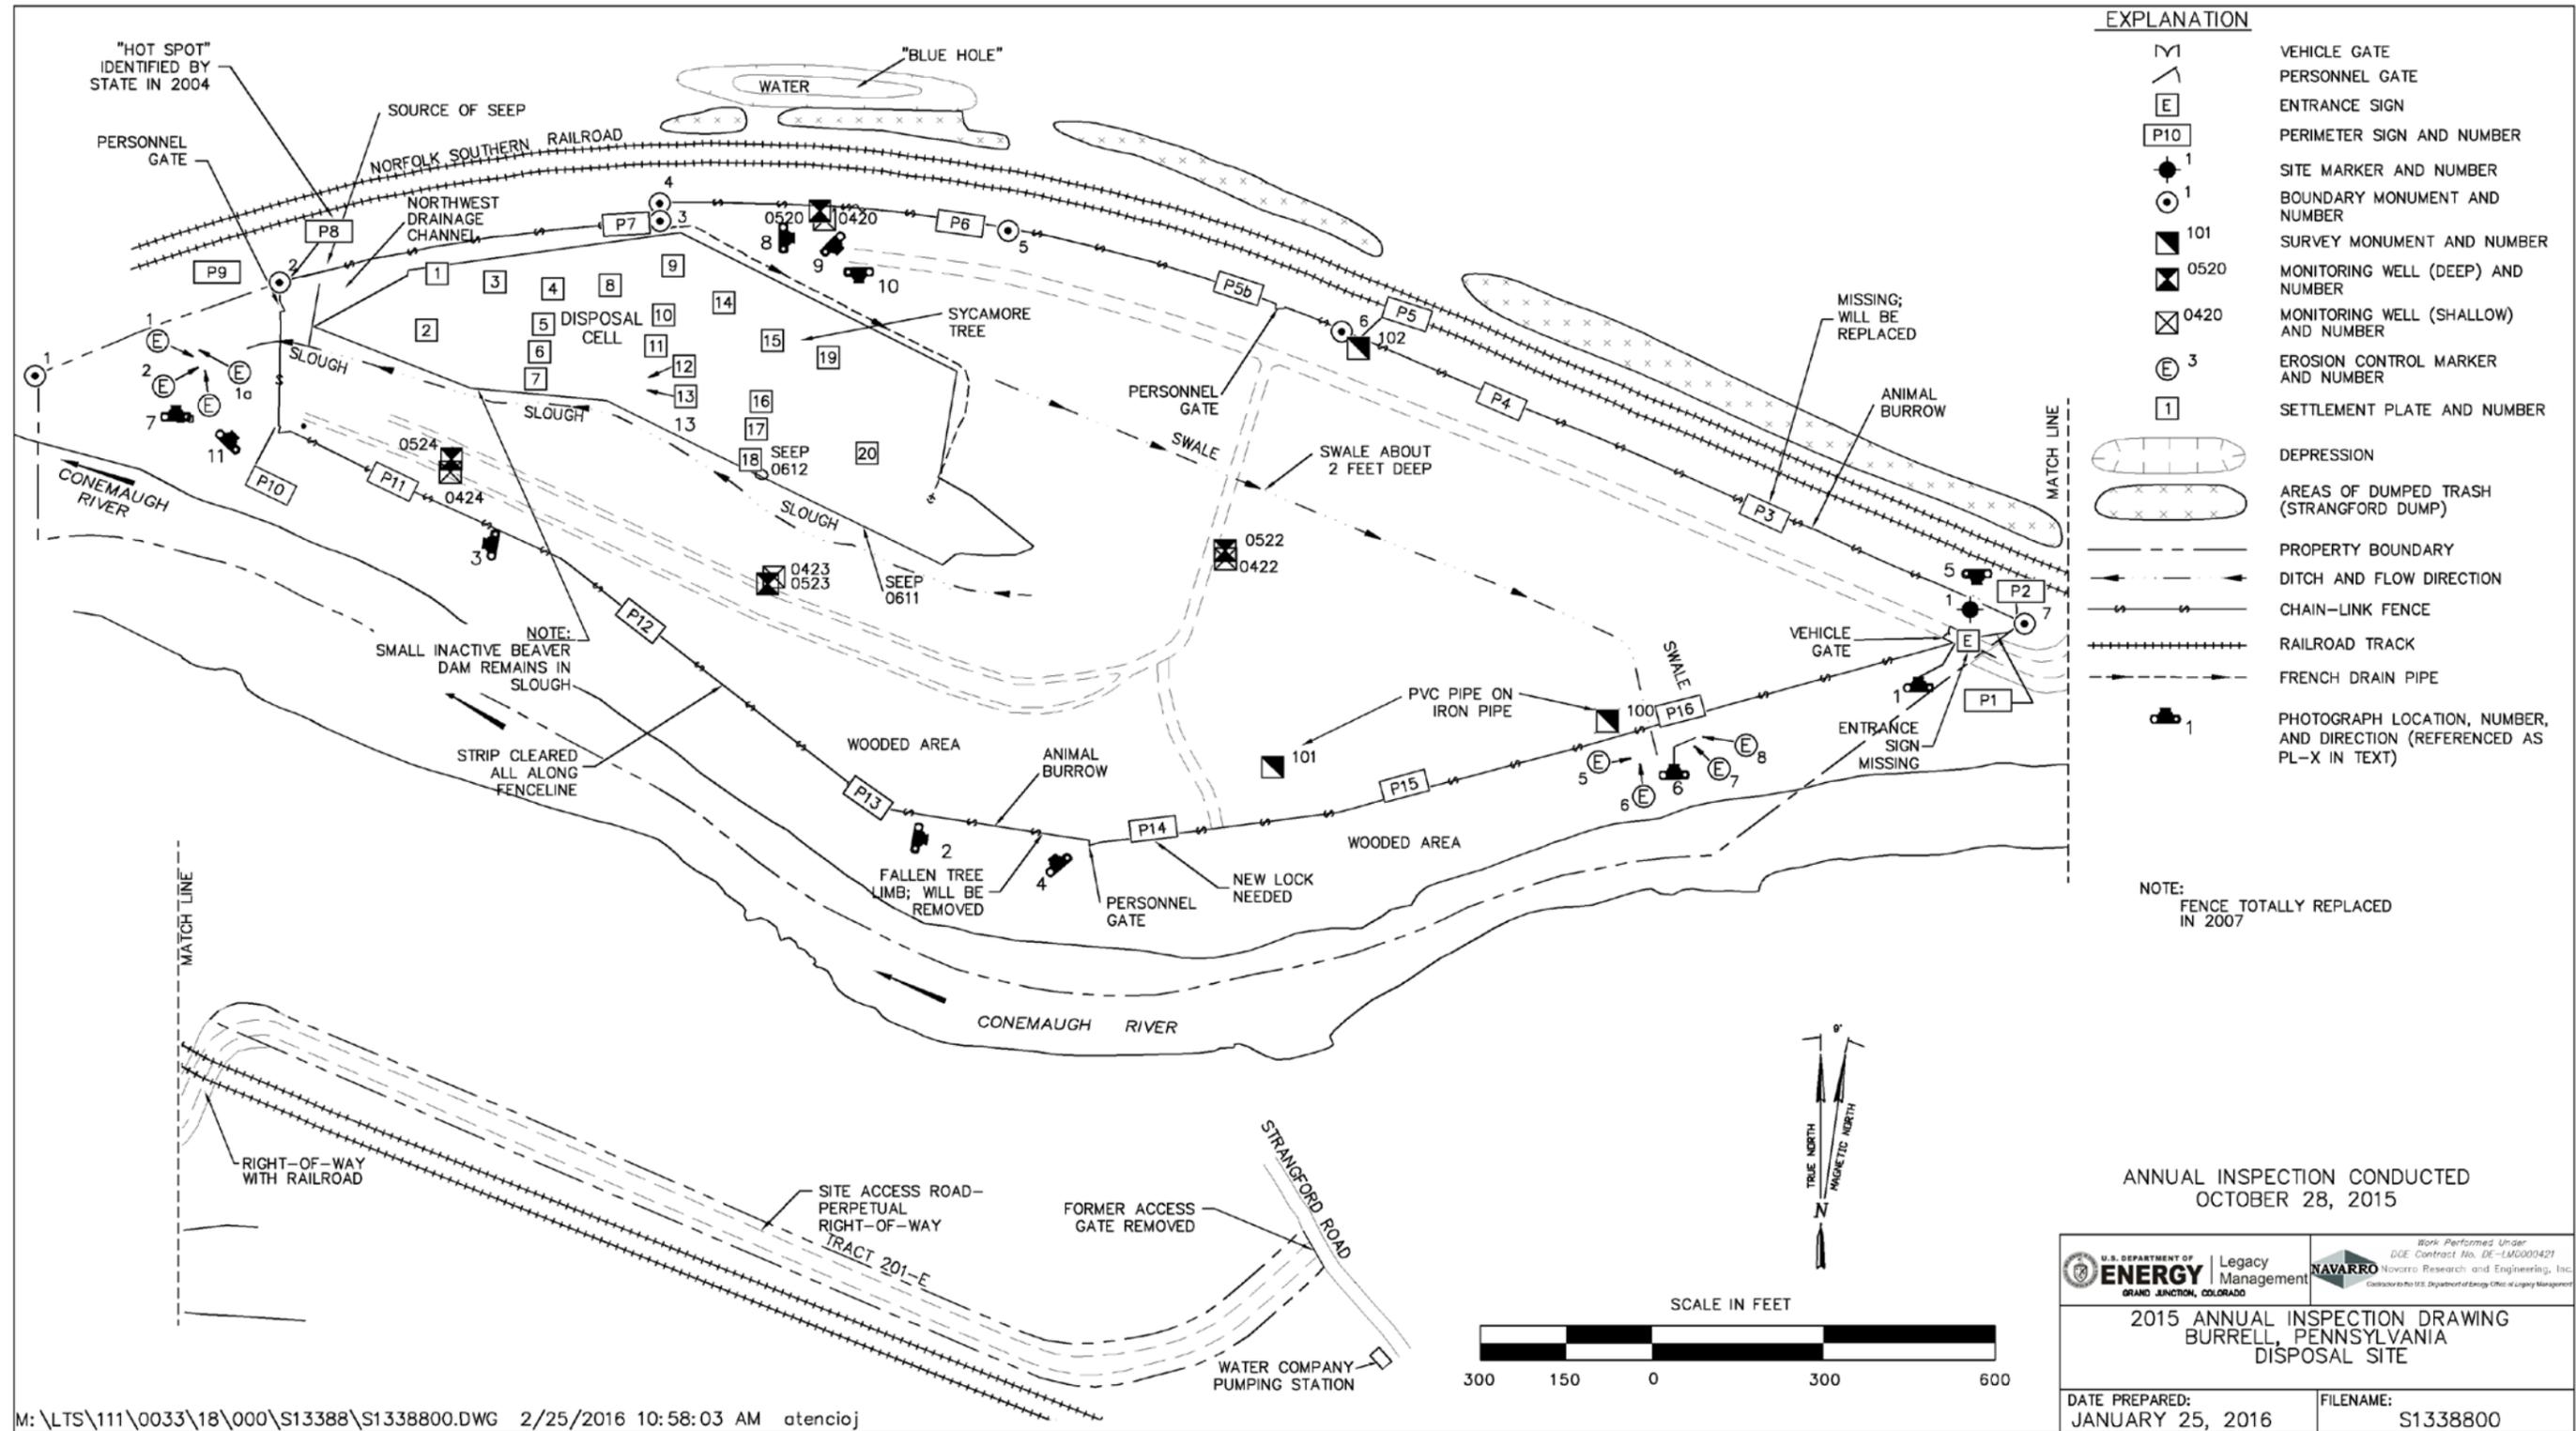
The locations of site surveillance features are shown in Figure 2-1. Inspection results and recommended maintenance activities associated with site surveillance features are included in the following subsections. Photographs to support specific observations are identified in the text and in Figure 2-1 by photograph location (PL) numbers.

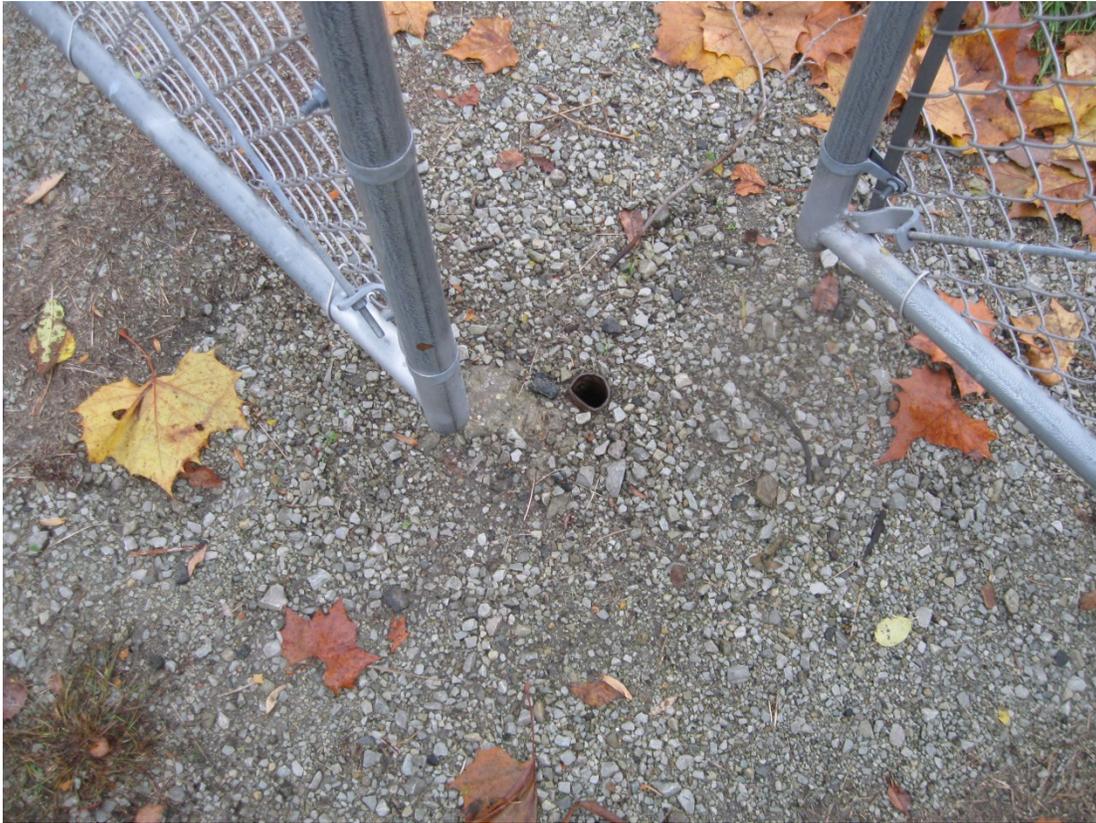
be made in 2016 to have the existing lock replaced with a new waterproof lock. It was noted during the inspection that the main entrance gate could be further secured by installing a lockable J-post. A pipe is already installed in the ground beneath the gates that could easily receive the J-post (PL-1). The site entrance sign was missing from the main site entrance gate. A J-post will be installed and the site entrance sign will be replaced.

BUR 10/2015. PL-1. Pipe in ground, vehicle gate, east side of site.

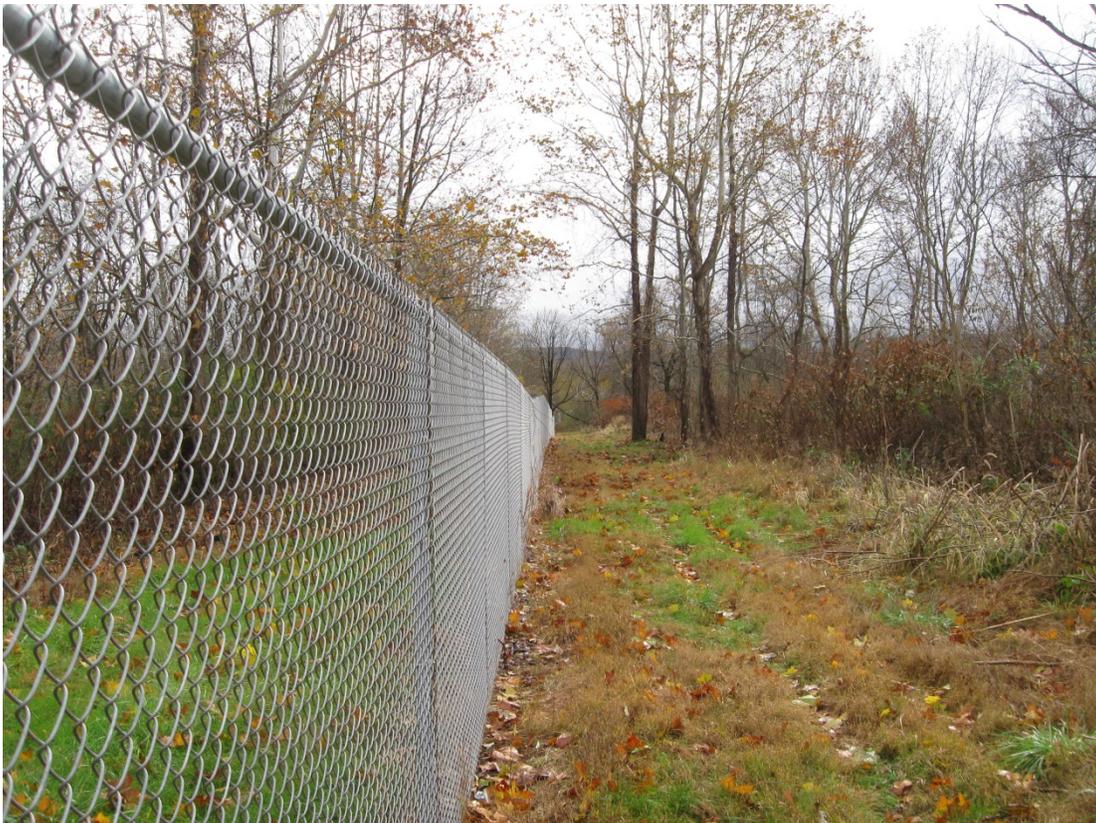
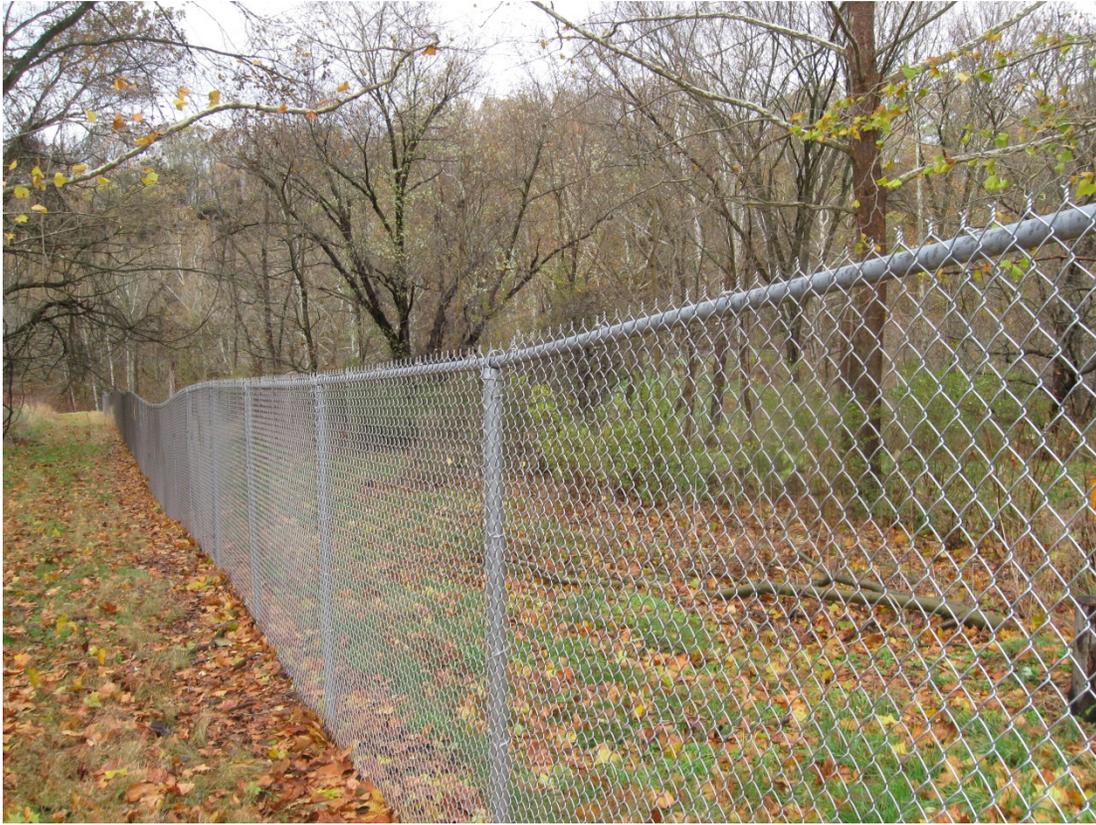
The chainlink perimeter fence that encircles the site was replaced in 2007, and it remains in good condition. The site herbicide subcontractor is doing an excellent job keeping the fence line clear of vegetation, which should prolong the life of the fence (PL-2 and PL-3).

BUR 10/2015. PL-2. South perimeter fence line.

BUR 10/2015. PL-3. South perimeter fence line.

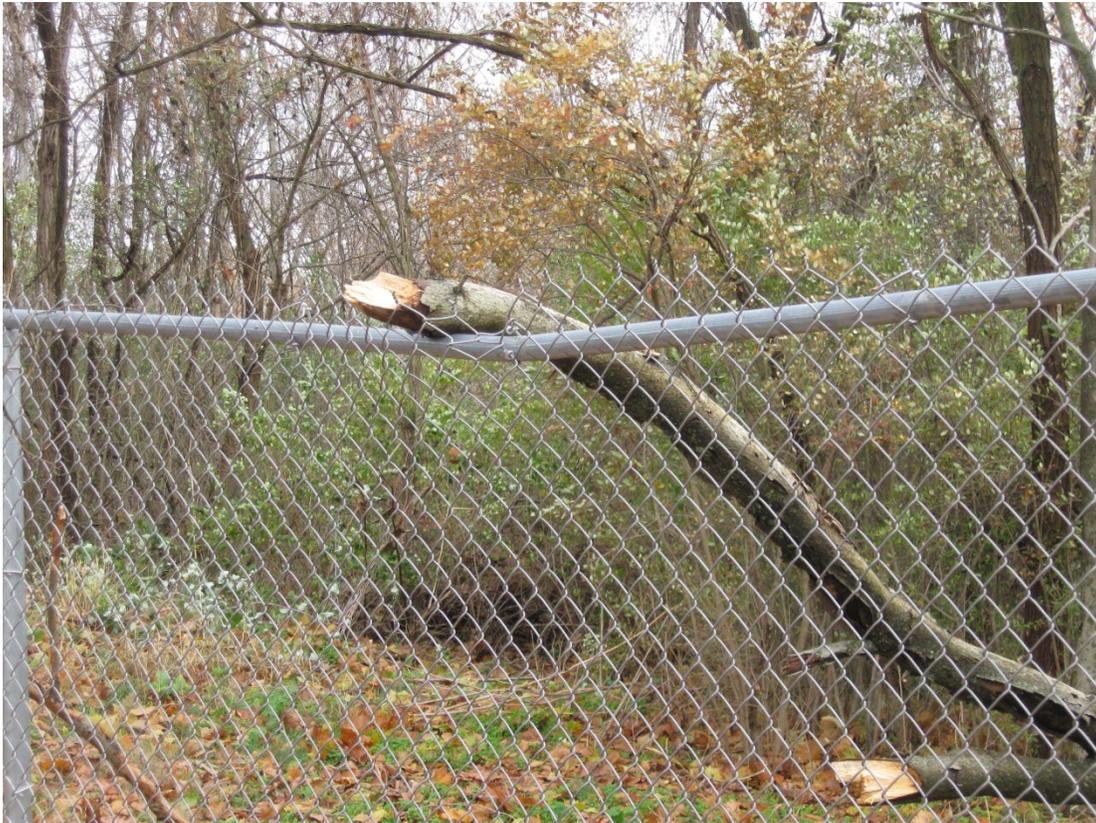
The south fence received minor damage at several locations in 2014 due to fallen trees. All of the damage areas identified in the 2014 inspection report were repaired in 2015. A new area of minor damage was noted in 2015 due to another tree limb falling across the top rail of the south fence (PL-4). The limb was too large for inspectors to safely remove. The site maintenance subcontractor will remove the limb from the fence. Additional repairs to the fence are not needed.

BUR 10/2015. PL-4. Tree limb on top of fence.

Installation of a J-post is planned on the main entrance gate to increase site security. During the inspection the site entrance sign and perimeter sign P3 were identified as missing; they will be replaced. A tree limb was found to be obstructing the south fence and will be removed. Vegetation management continues for both noxious weeds and noxious woody vegetation onsite by herbicide application following seeding. Monitoring well pads will be repaired or installed as needed.

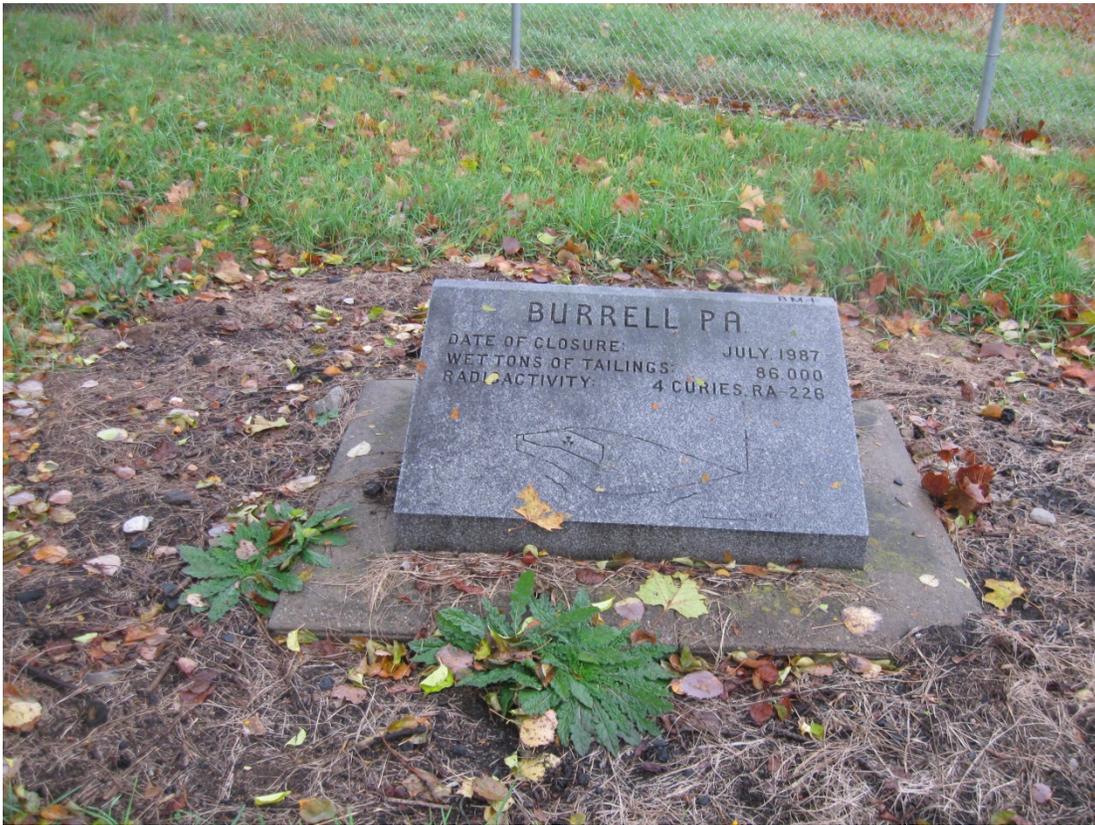
The Burrell site has one site marker. It is just inside the main entrance gate and was in excellent condition (PL-5).

BUR 10/2015. PL-5. Site marker.

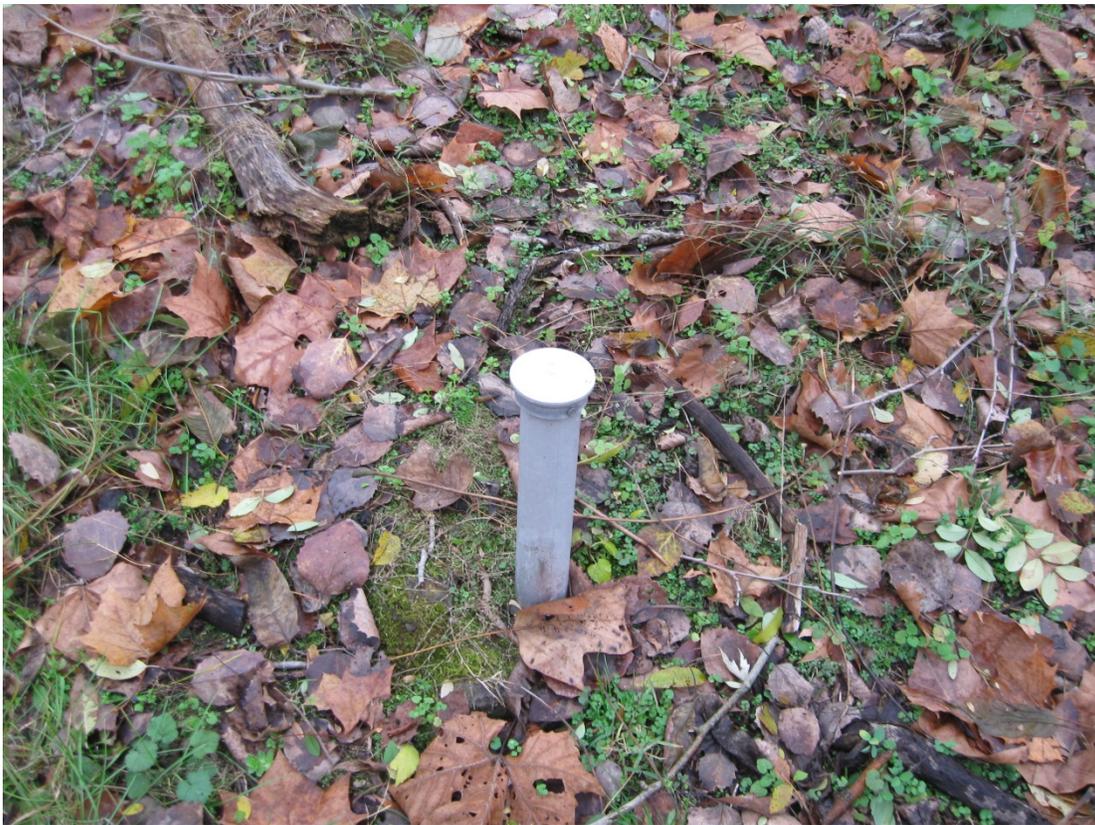
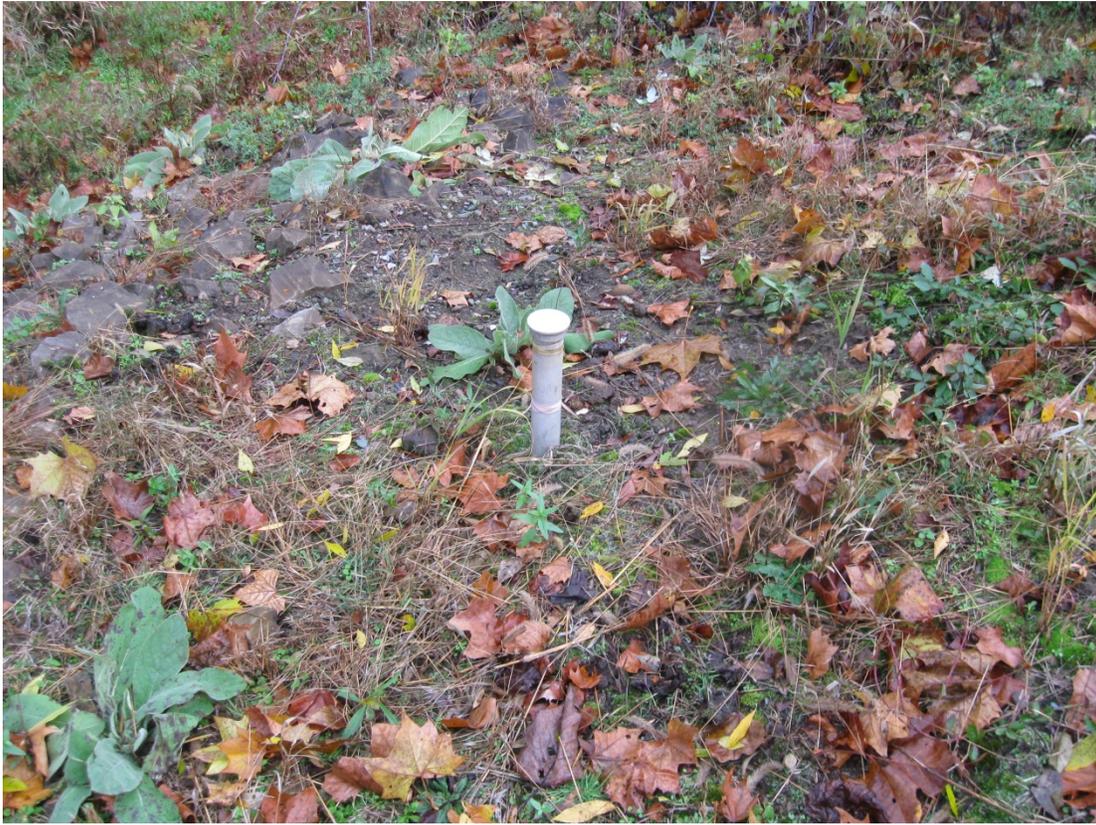
There are eight erosion control markers at Burrell. All eight erosion control markers were located and were in good condition (PL-6 and PL-7).

BUR 10/2015. PL-6. Erosion control marker ECM-8.

BUR 10/2015. PL-7. Erosion control marker ECM-2A.

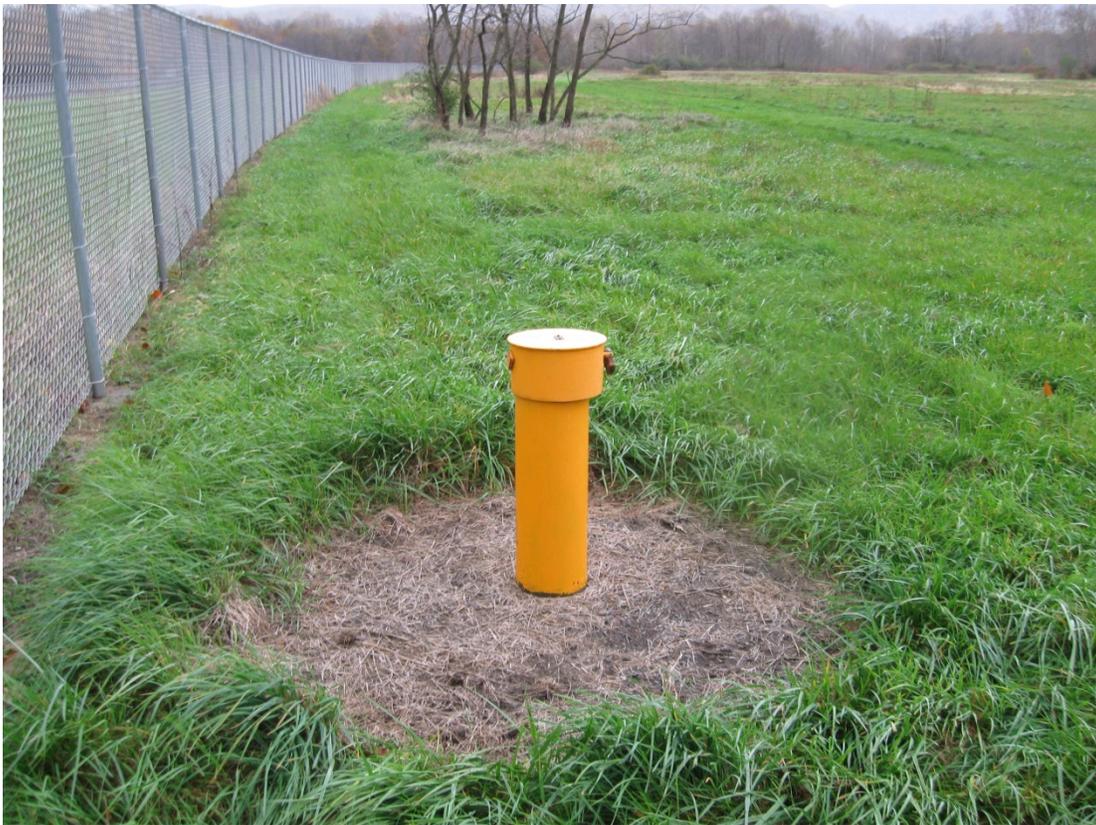
All wells encountered during the inspection were properly locked (PL-8). The interiors of the monitoring wells were not inspected this year. The interiors were last inspected by the water sampling crew in November 2013.

BUR 10/2015. PL-8. Monitoring well 0520.

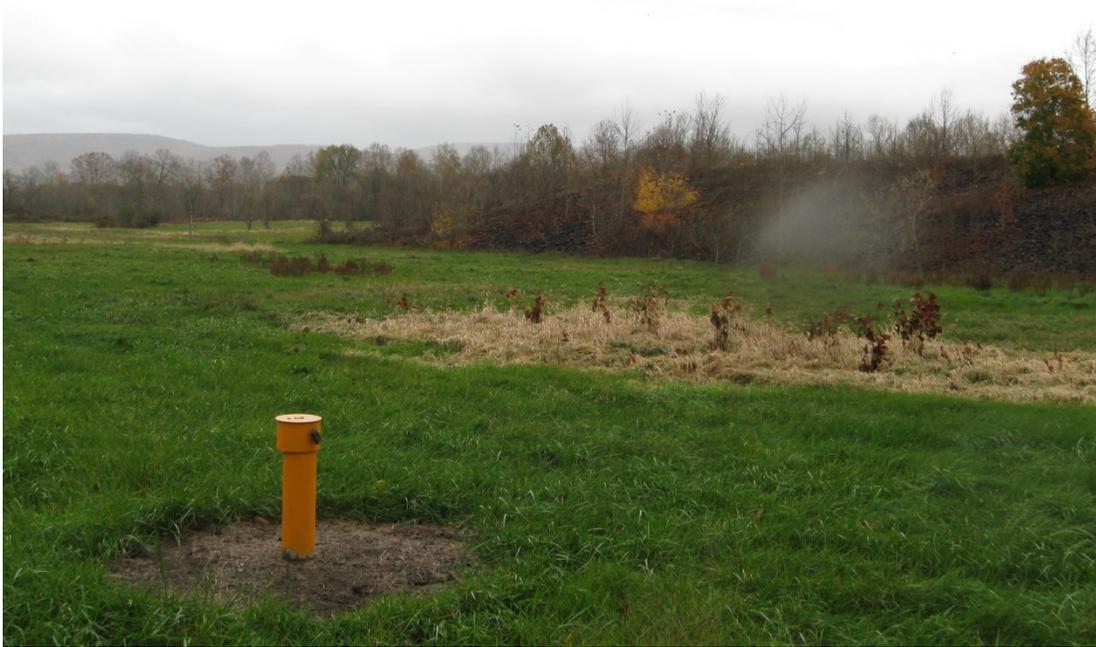
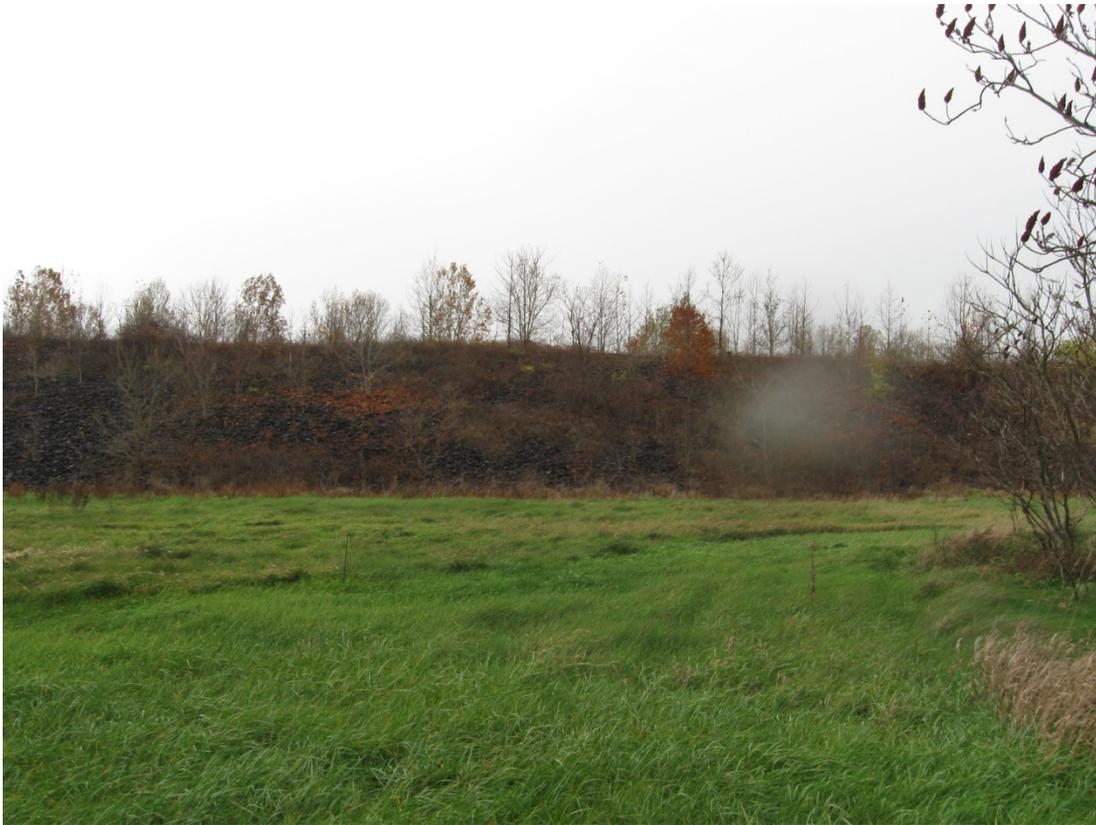
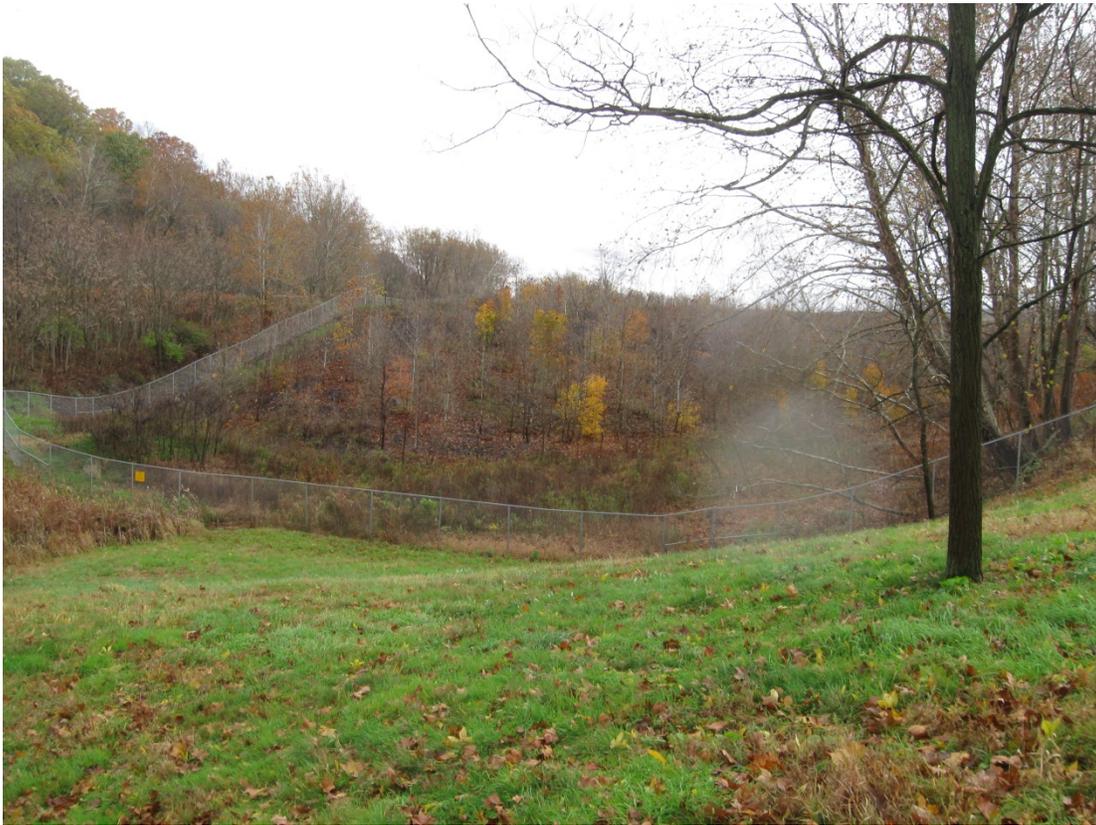
No indications of cell instability (e.g., slumping, bulging, or differential settlement) were noted by the inspectors (PL-9, PL-10, and PL-11). Rock quality remains good; degradation of the riprap was not evident. Due to the rain and slippery conditions, inspectors did not walk across the riprap cover to inspect seep 0611 (located on the south side slope of the disposal cell).

BUR 10/2015. PL-9. Northeast end of the disposal cell.

BUR 10/2015. PL-10. North side of the disposal cell.

BUR 10/2015. PL-11. West side of the disposal cell
