**Post-Closure Inspection and  
Monitoring Report  
for Corrective Action Unit 417:  
Central Nevada Test Area Surface,  
Hot Creek Valley, Nevada**

**January 2009**

Office of  
Legacy Management

LMS/CNT/S04704

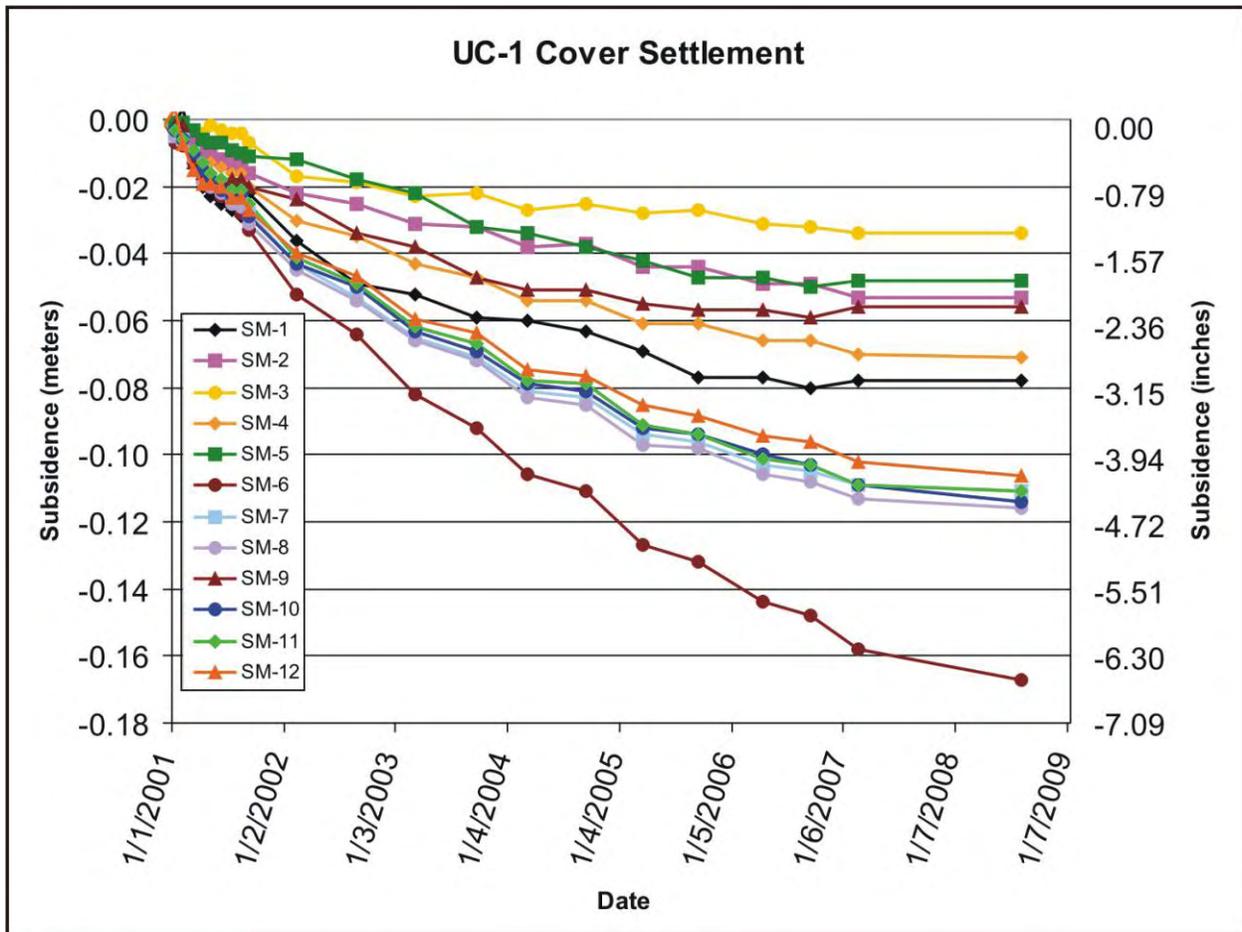
Figure 3–3. UC-1 Cover Settlement

The degree of settlement in both the relocation trench and the CMP is within the predicted range and shows no unusual subsidence. The data collected over the CMP section of the cover indicates that the largest subsidence is located along the centerline of the CMP, including SM-6, SM-7, and SM-8 and along the southern portion of the cap, SM-10, SM-11, and SM-12. This was expected because of the thicker layer of underlying mud in this area. The northern monuments SM-2, SM-3, and SM-4, along with the western-most monuments, SM-1, SM-5 and SM-9, show the least subsidence because of the thinner layer of underlying mud along this margin of the cover. The greatest degree of settlement continues to be on SM-6, which has subsided a total of 16.7 cm (6.6 in.) since the baseline survey in December 2000.

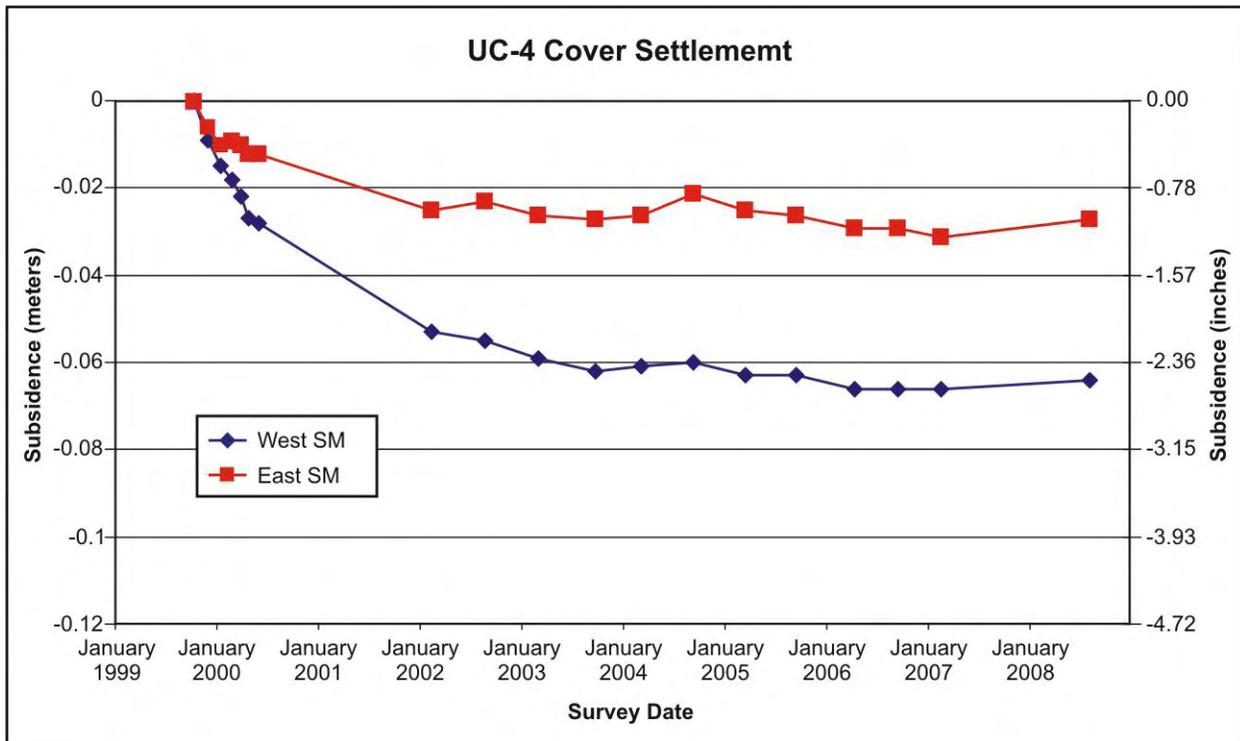
Figure 3–5. UC-4 Cover Settlement

Two permanent SMs (west and east monuments) were installed in the cover to provide elevation control for measuring the subsidence of the cover. These SMs are shown in Figure 3–4. The baseline subsidence survey was completed on October 12, 1999, and is used as the reference survey to calculate subsidence. The UC-4 baseline survey locations and elevations are provided in Table 3–2 and are presented in graphical form in Figure 3–5. Settling of the west monument is still slightly greater than the predicted settling of 5 cm (2 in.); the total subsidence is 6.4 cm (2.5 in.) since the baseline survey in October 1999. The east monument has subsided a total of 2.7 cm (1.1 in.) since the baseline survey. The largest changes occurred within the first year.

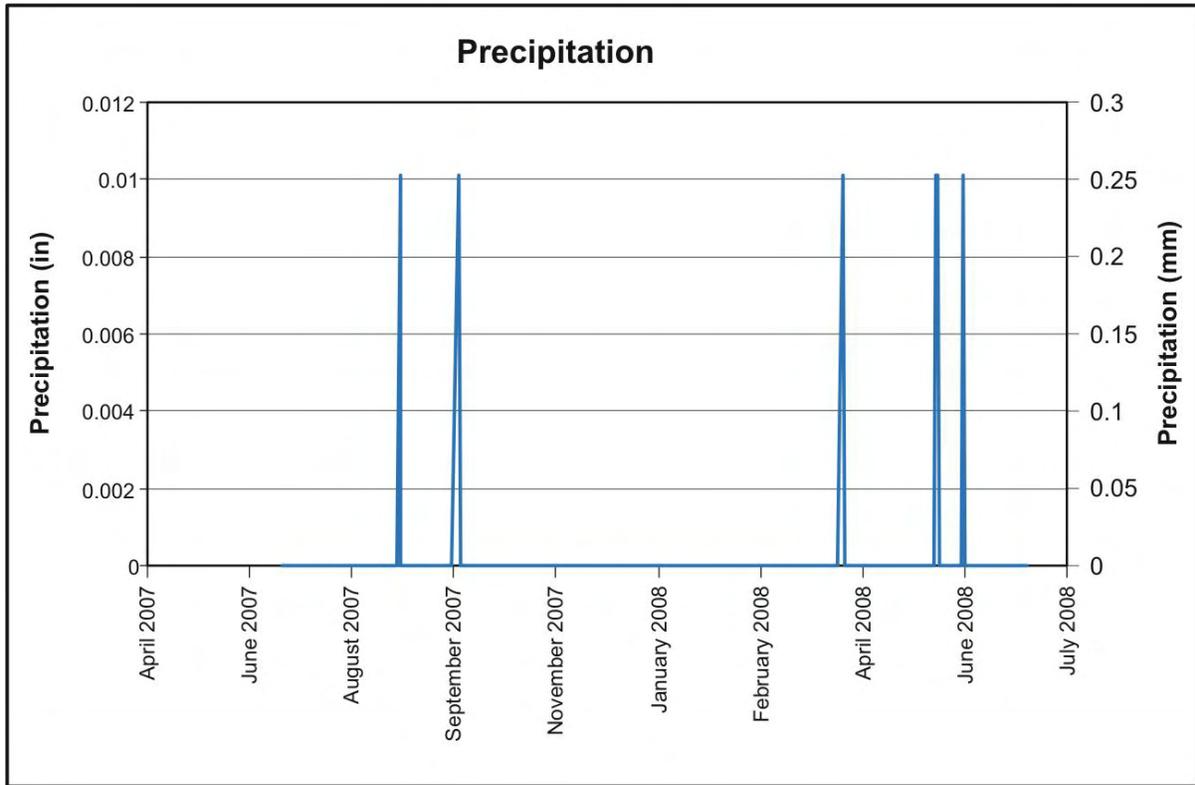
Figure 3–6. July 1, 2007 through June 1, 2008 Precipitation Data

Precipitation data are collected at the UC-1 CMP cover by a Campbell Scientific TE525 tipping bucket rain gauge. A CS705 precipitation adapter is used for snowfall measurements. The rain gauge data are collected and stored by the data logger and sent to an onsite telemetry station where the data are sent and saved to SOARS. The rain gauge was evaluated and repaired during a general site maintenance visit conducted in early October 2008.

1. Figures 3-7, 3-9, 3-9 and 3-10 all show a volumetric moisture content increase around February 2008 but there is no precipitation indicated after September 2007. On Page 3-9, it is stated that the rain gauge was "repaired" during an October 2008 visit. Did the rain and/or snow gauge malfunction during February 2008? Why did the moisture content increase?

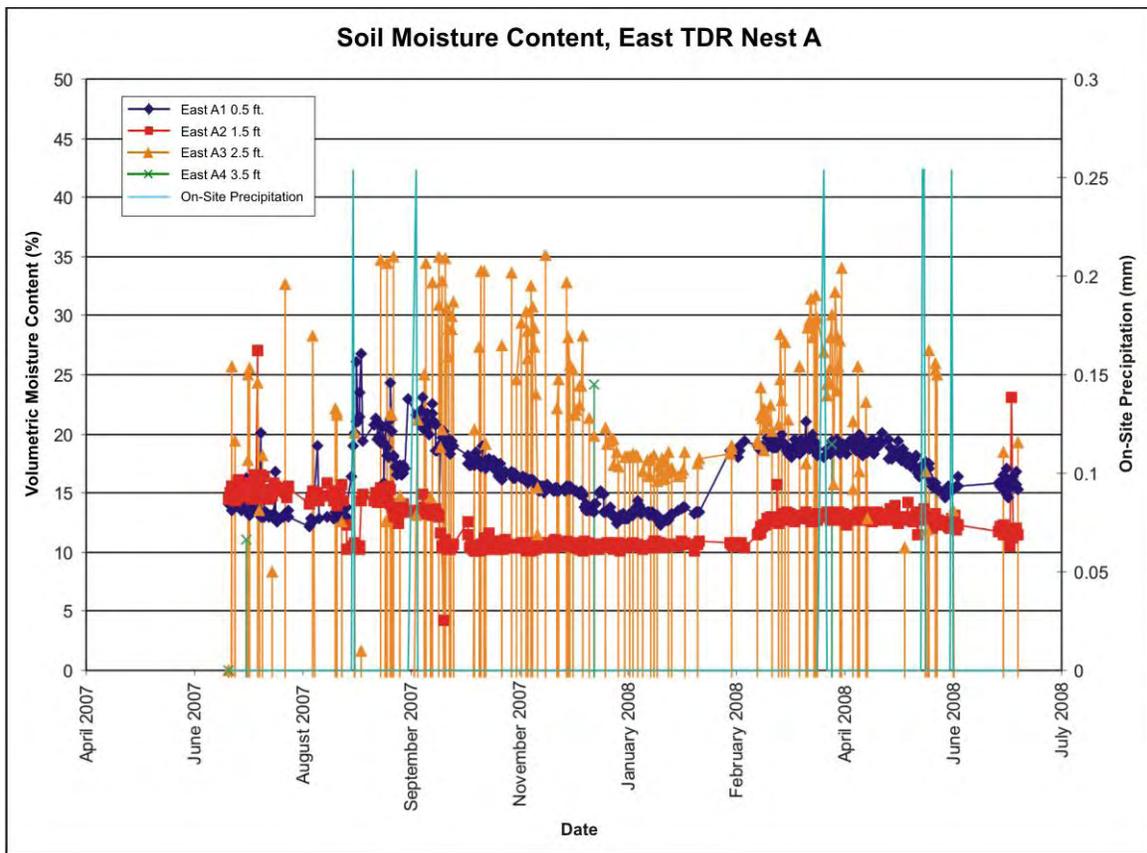
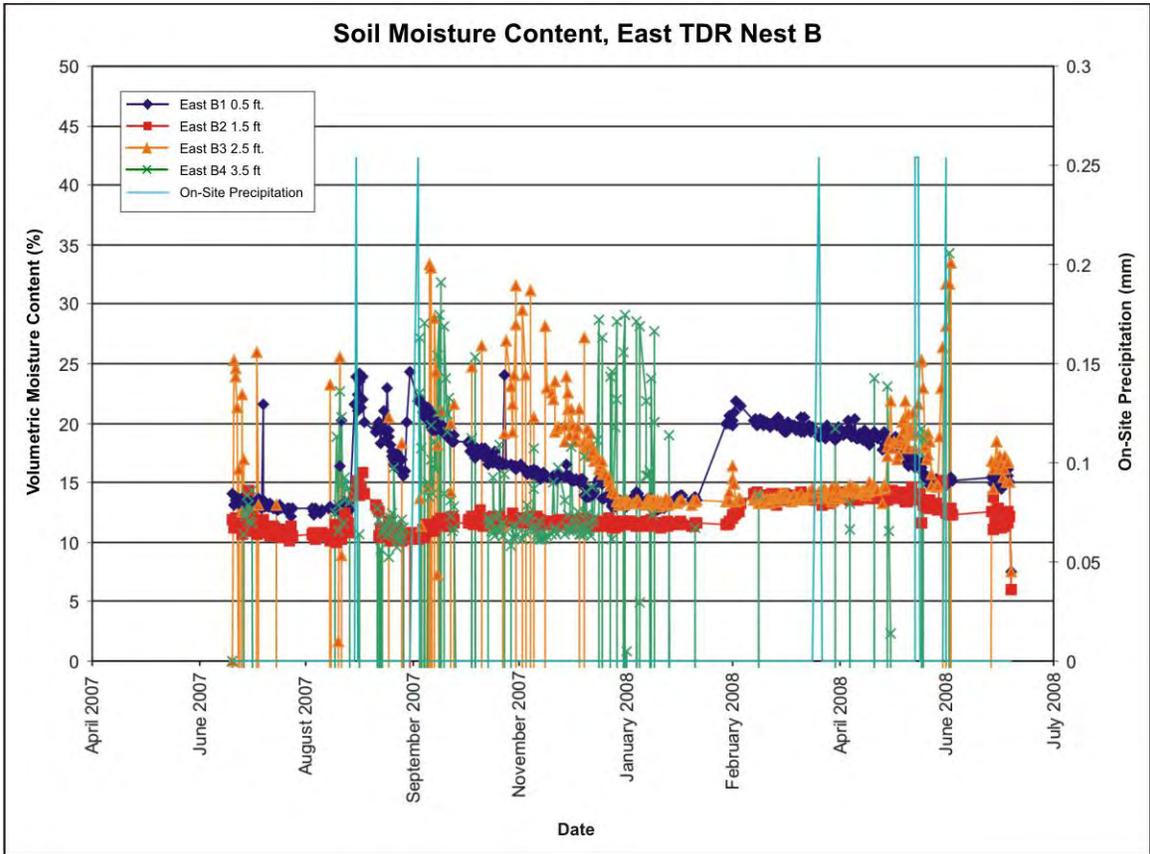
TDR data obtained for the east nests, measured at depths of 0.76 meters and 1.07 meters (2.5 ft and 3.5 ft, respectively), were entirely corrupted from an unknown cause. Previously, the lengthy cable created a problem in measuring the reflected signal from the TDR probes (NNSA/NV 2007). Inappropriate signal responses from the two lower stations in the east TDR nest make interpretation of the data difficult. Only the upper two depths are presented on the respective graphs, and from the profiles, it is difficult to assess performance of the cover. From these data it appears that the volumetric moisture content fluctuates by less than one percent in the upper 1.5 ft of the cap.

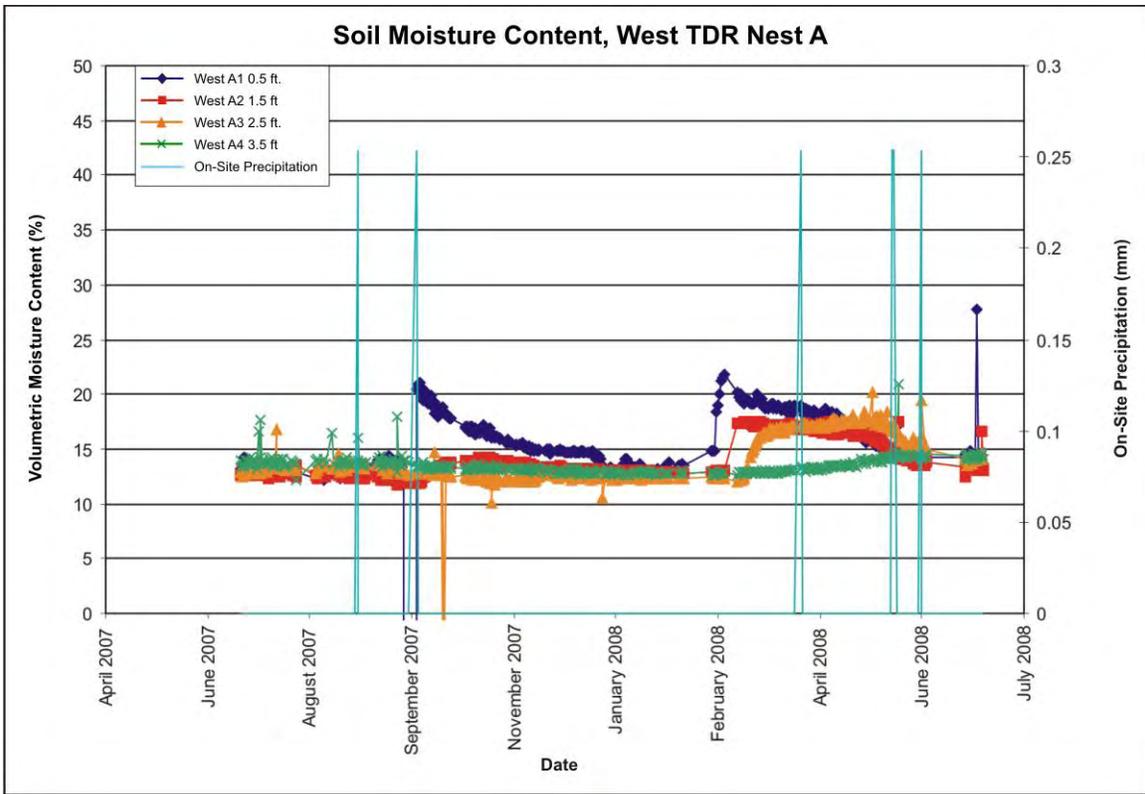
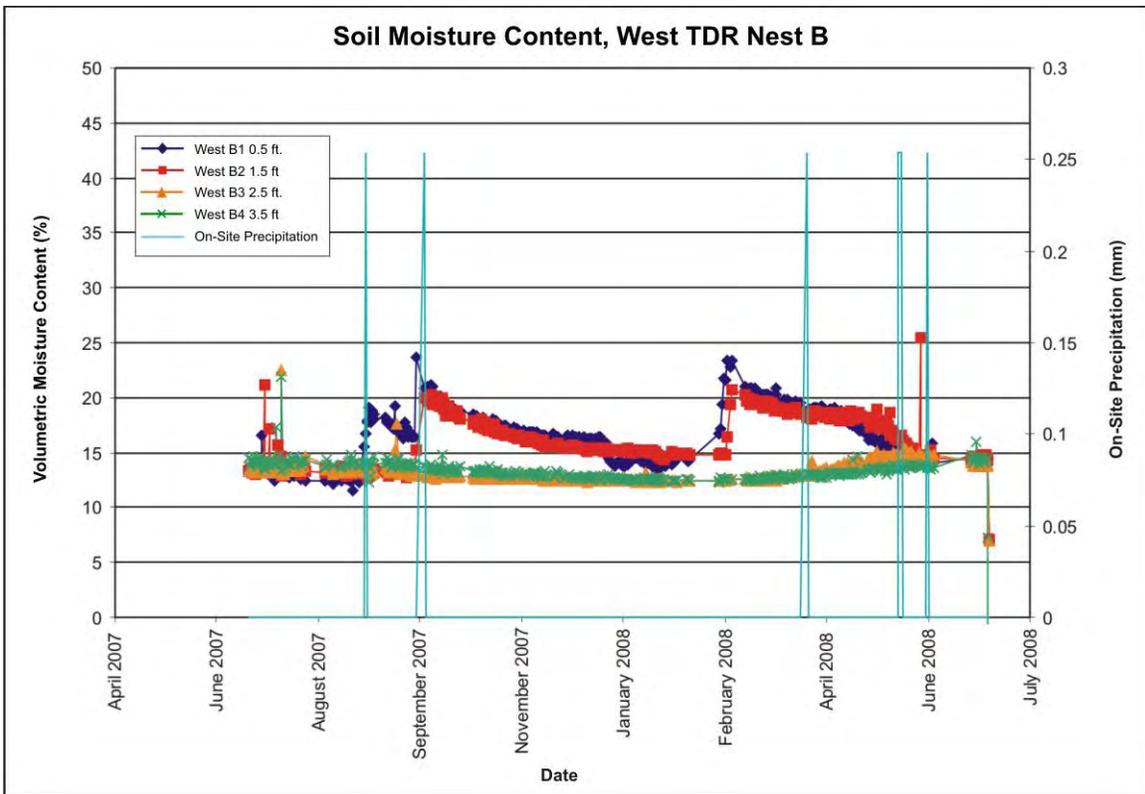
Moisture content measurements indicate steady-state conditions throughout the year with volumetric moisture content varying by less than one percent in the upper 2.5 ft of the cap.

Overall, both nests present similar profiles and indicate that the cover is performing as designed, with evapotranspiration effectively removing water from the cover. The moisture content at the two deeper profiles of the west TDR nest appears to be approaching steady-state conditions. The moisture sensors in the two deeper profiles of the east TDR nest are not functioning.

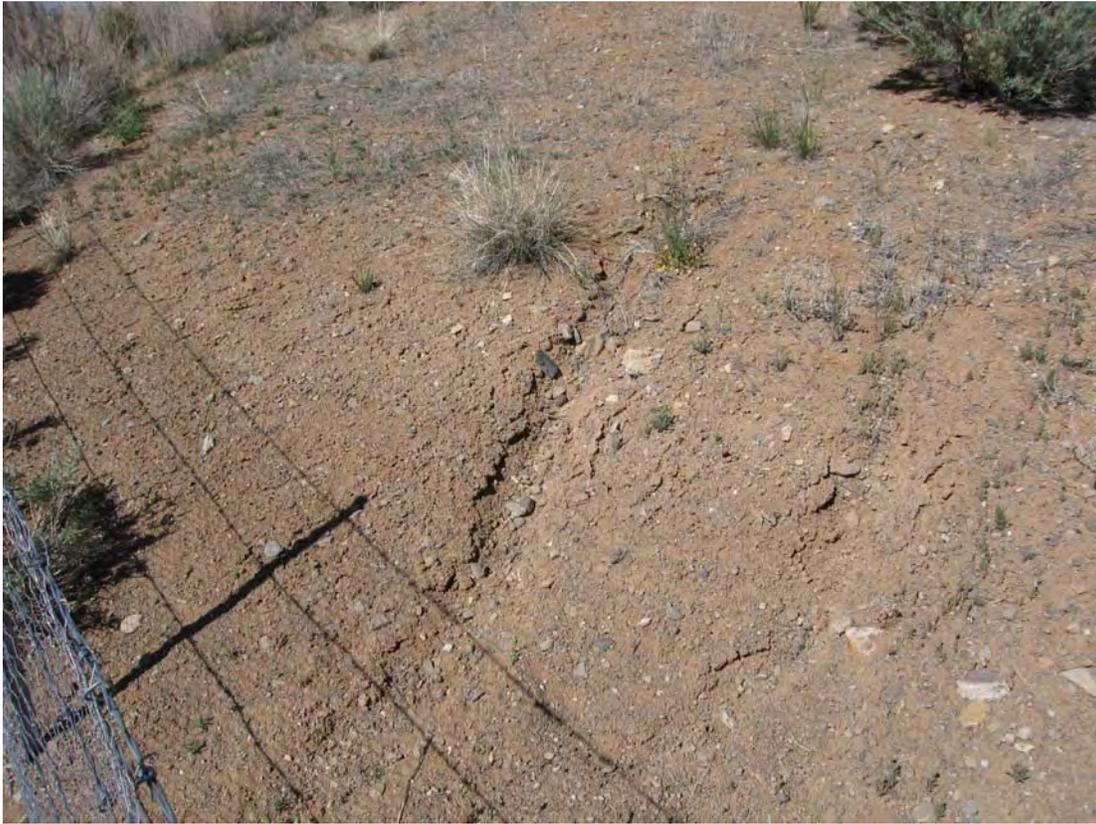
Photograph 9. UC-1 Erosional rill east end of berm
