# Post-Closure Inspection and Monitoring Report for Corrective Action Unit 417: Central Nevada Test Area Surface, Hot Creek Valley, Nevada

March 2013

LMS/CNT/S09307

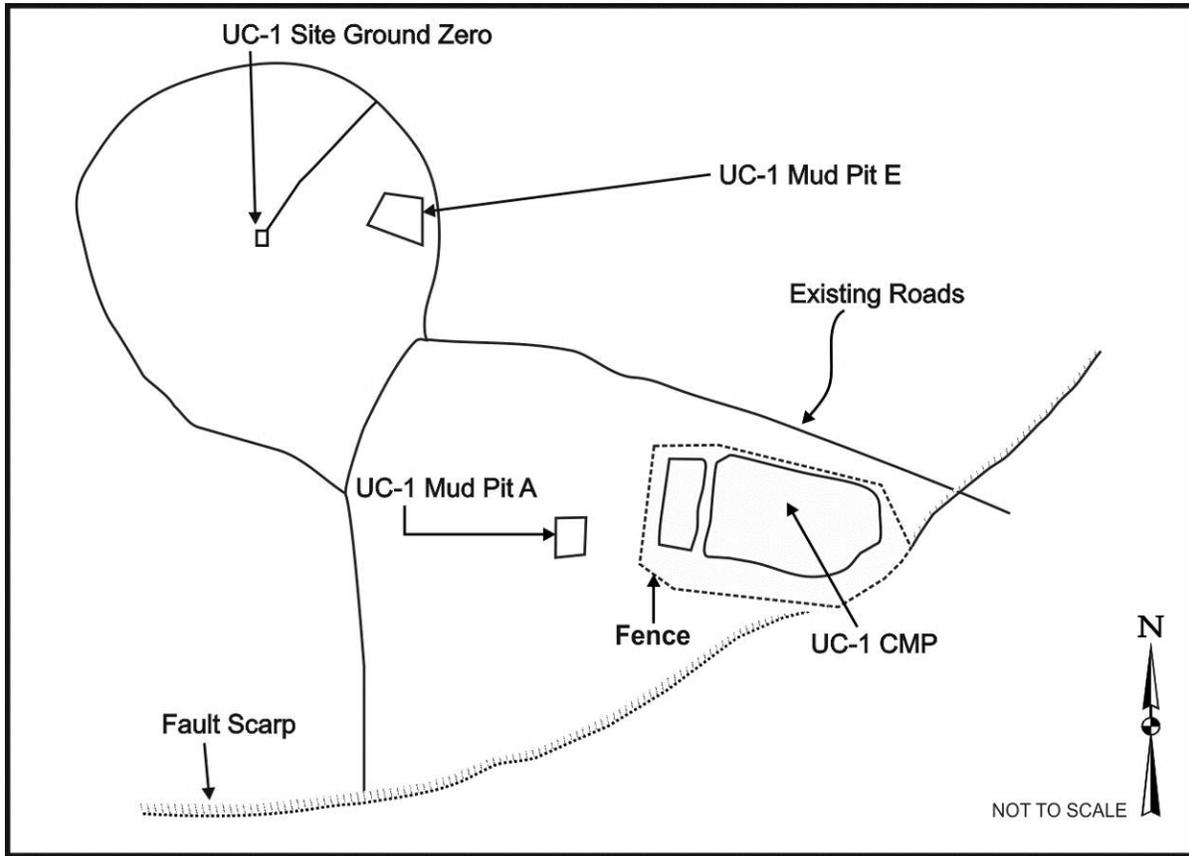
Figure 4. Location of UC-1 Significant Features

The locks, fencing, SMs, and signs associated with the CMP were in good condition, with the exception of one sign that had fallen along the southern side of the fence line. The sign was reattached to the fence at the time of the 2012 inspection. No new cracks or fractures, and no extension of existing cracks or fractures, were identified in the soil cover at the time of the inspections. The vegetation on the cover continues to look healthy. All other signs and monuments at Mud Pits A and E (Figure 4) were in excellent condition.

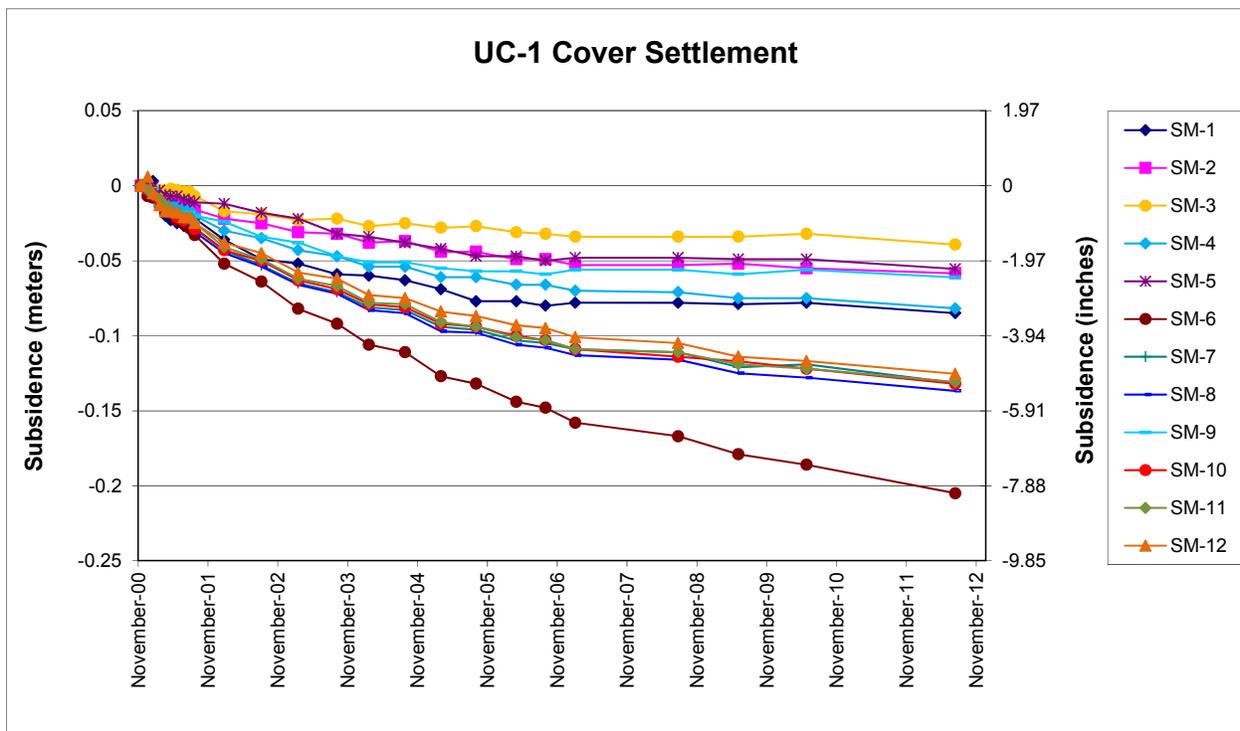
Figure 7. UC-1 Cover Settlement

The degree of settlement in the relocation trench and CMP is within the predicted range and shows no unusual subsidence. The data collected over the CMP section of the cover indicate that the largest subsidence is along the centerline of the CMP, including SM-6, SM-7, and SM-8, and along the southern portion of the cap at SM-10, SM-11, and SM-12. This was expected because of the thicker layer of underlying mud in these areas. The northern monuments (SM-2, SM-3, and SM-4) and the westernmost monuments (SM-1, SM-5, and SM-9) show the least subsidence because the layer of underlying mud along these margins of the cover is thinner. The greatest degree of settlement continues to be on SM-6, which has subsided a total of 0.205 m (8.07 in) since the baseline survey in December 2000.

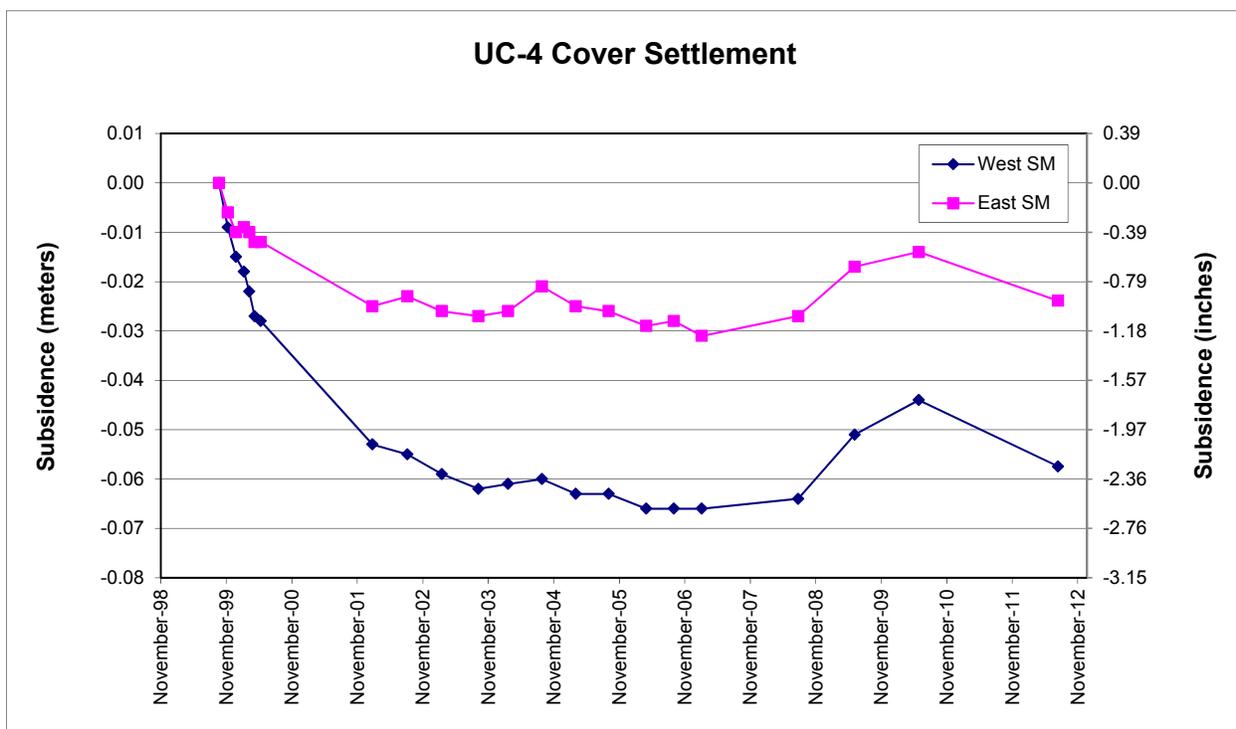
Figure 9. UC-4 Cover Settlement

Historically, settling of the west SM is still slightly greater than the predicted settling of 0.05 m (2 in); the total subsidence is 0.057 m (2.24 in) since the baseline survey in October 1999. The east SM has subsided a total of 0.024 m (0.94 in) since the baseline survey. The largest changes occurred during the first 3 years.

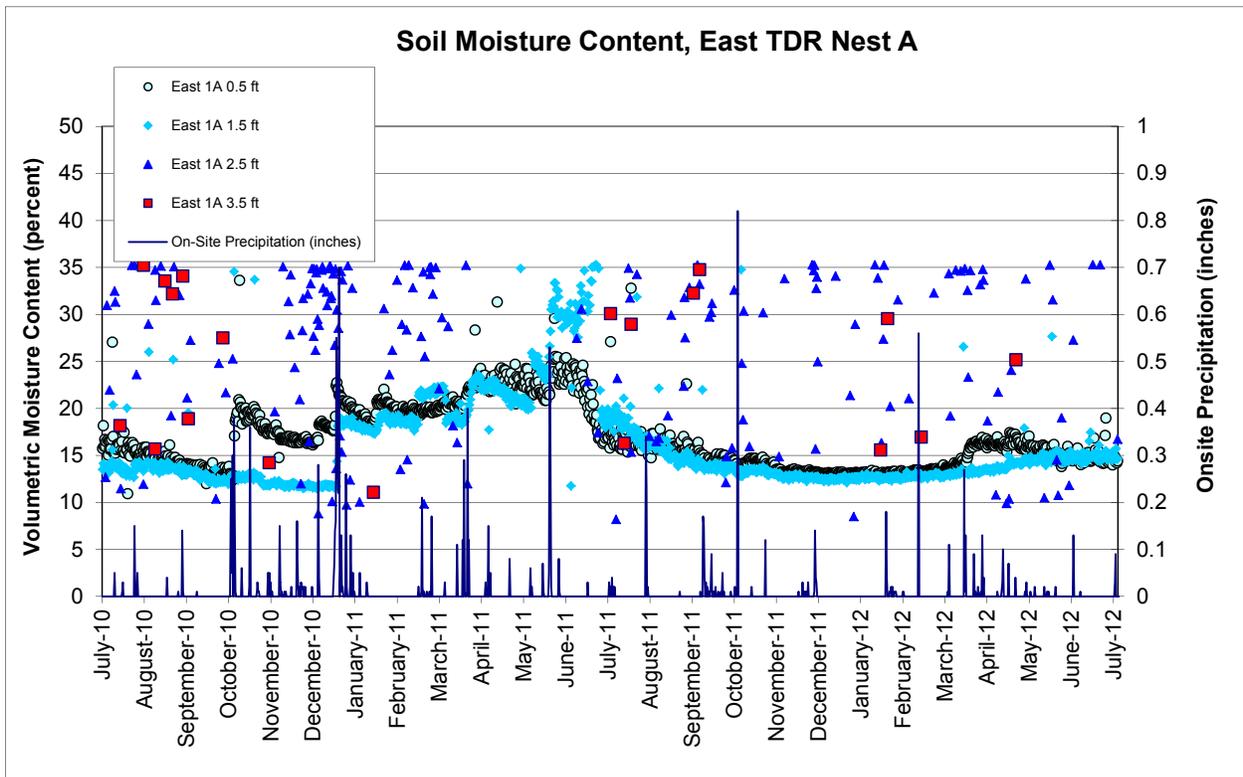
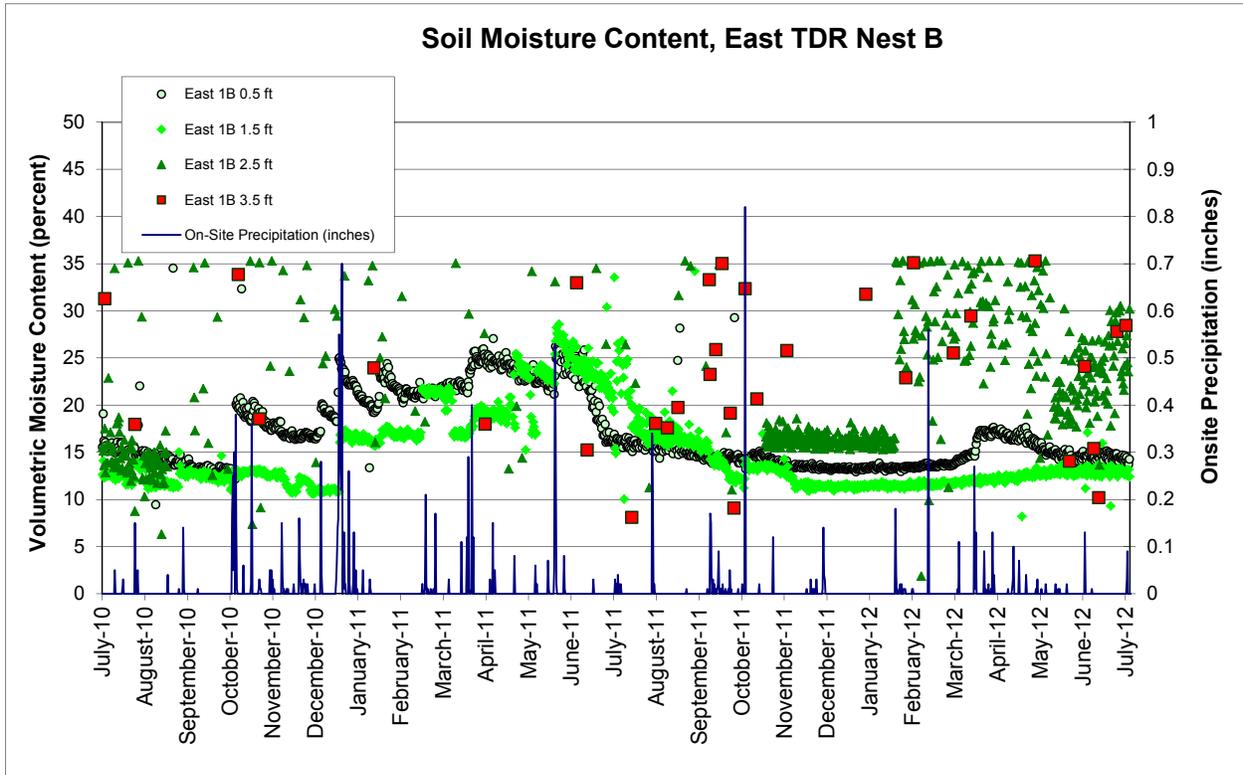
Soil moisture data obtained for the 2.5 and 3.5 ft depths of the east TDR nests (Figure 11 and Figure 12) are discontinuous and may be corrupted or an indication of saturated conditions at these depths. Previously, the lengthy cable created a problem in measuring the reflected signal from the TDR probes (NNSA/NV 2007). The TDR data from the shallower depths appear to be responding to the infiltrating moisture that corresponds to a decrease in precipitation during the 2-year monitoring period. The VMC data fluctuate seasonally in response to snowmelt during spring thaw and precipitation events. Annually, the VMC data are highest during spring thaw, and they slowly decrease throughout the spring and early summer when the VMC reaches steady-state conditions, ranging from 11 to 15 percent in the upper 1.5 ft of the cover. Refer to Appendix B (Figures B-2 and B-3) for historical moisture data obtained from the 0.5, 1.5, and 3.5 ft depths from 2007 through 2012.

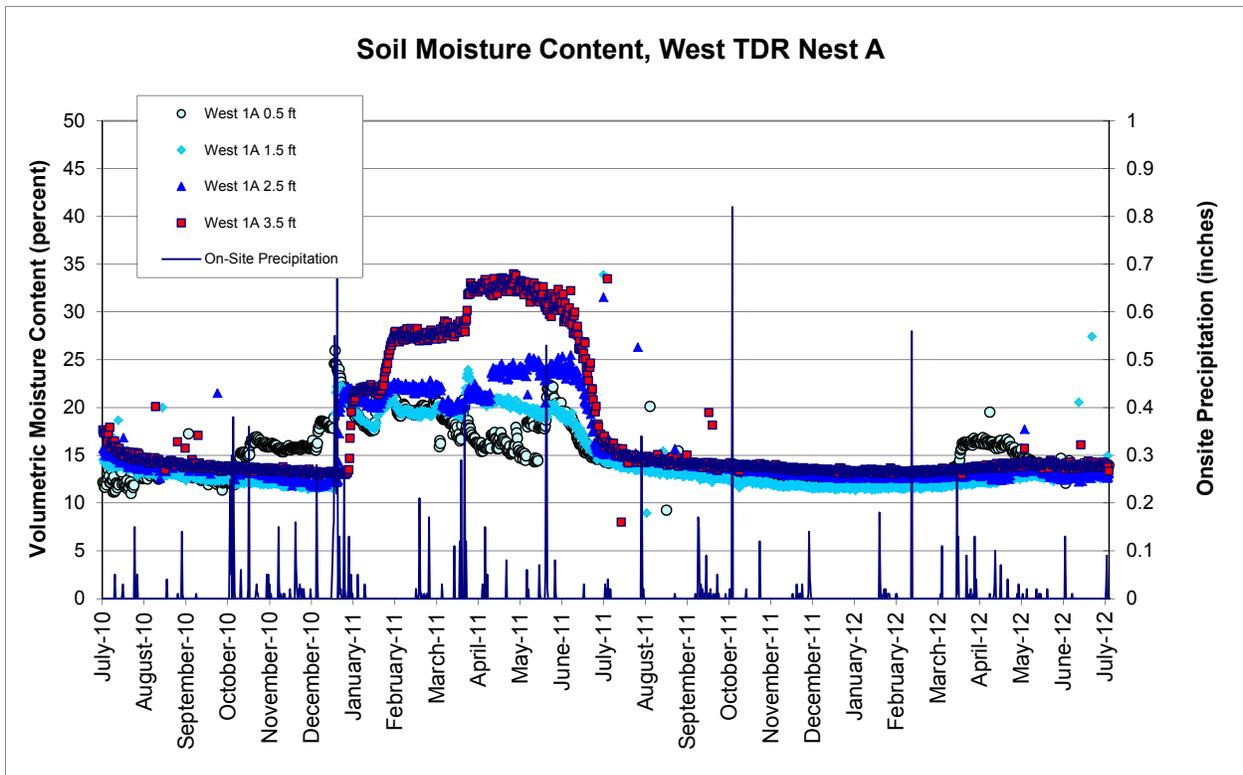
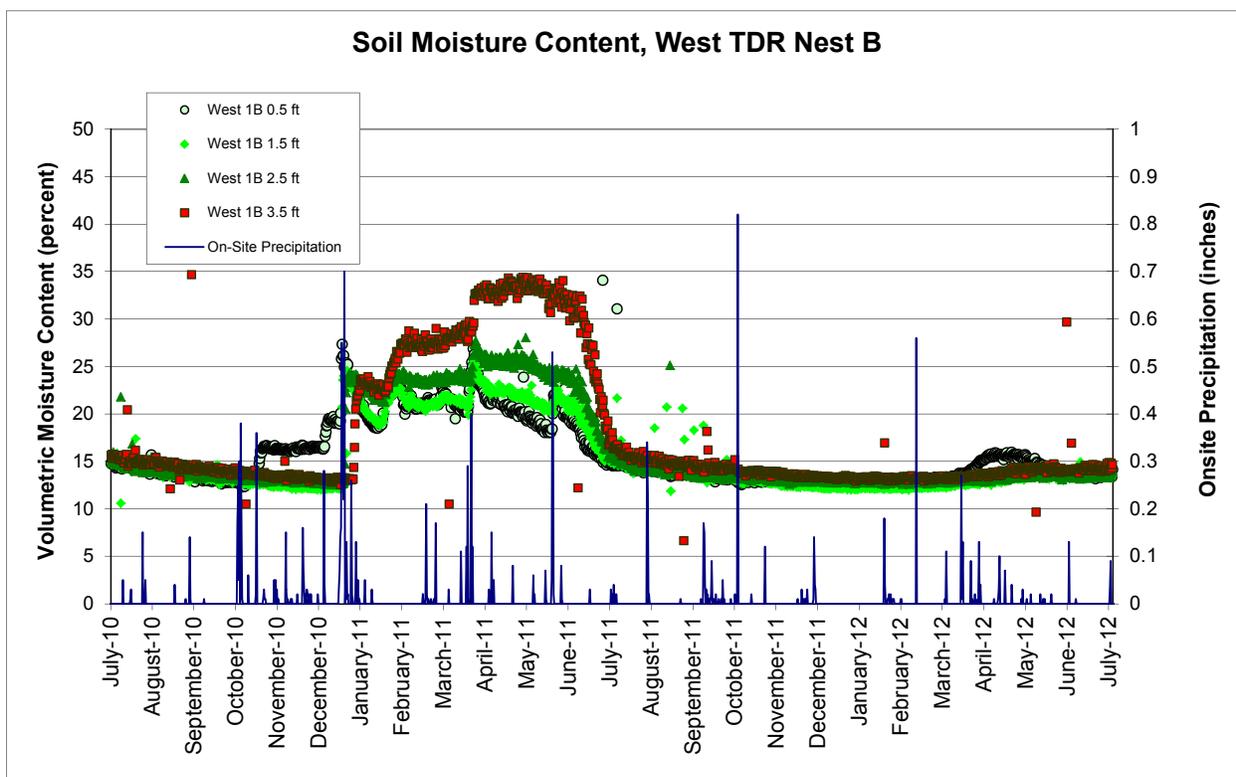
Soil moisture data obtained for the west TDR nests (Figure 13 and Figure 14) corresponds to a decrease in precipitation during the 2-year monitoring period. The VMC data fluctuate seasonally in response to snowmelt during spring thaw. Annually, the VMC data are highest during spring thaw, and they slowly decrease throughout the spring and early summer when the VMC reaches steady-state conditions, ranging from 11 to 15 percent in the upper 3.5 ft of the cover. These trends extended into May and June, when surface temperatures increased and evapotranspiration again began removing moisture from the cover. Refer to Appendix B (Figures B-4 and B-5) for historical moisture data obtained from the 0.5, 1.5, 2.5, and 3.5 ft depths from 2007 through 2012.

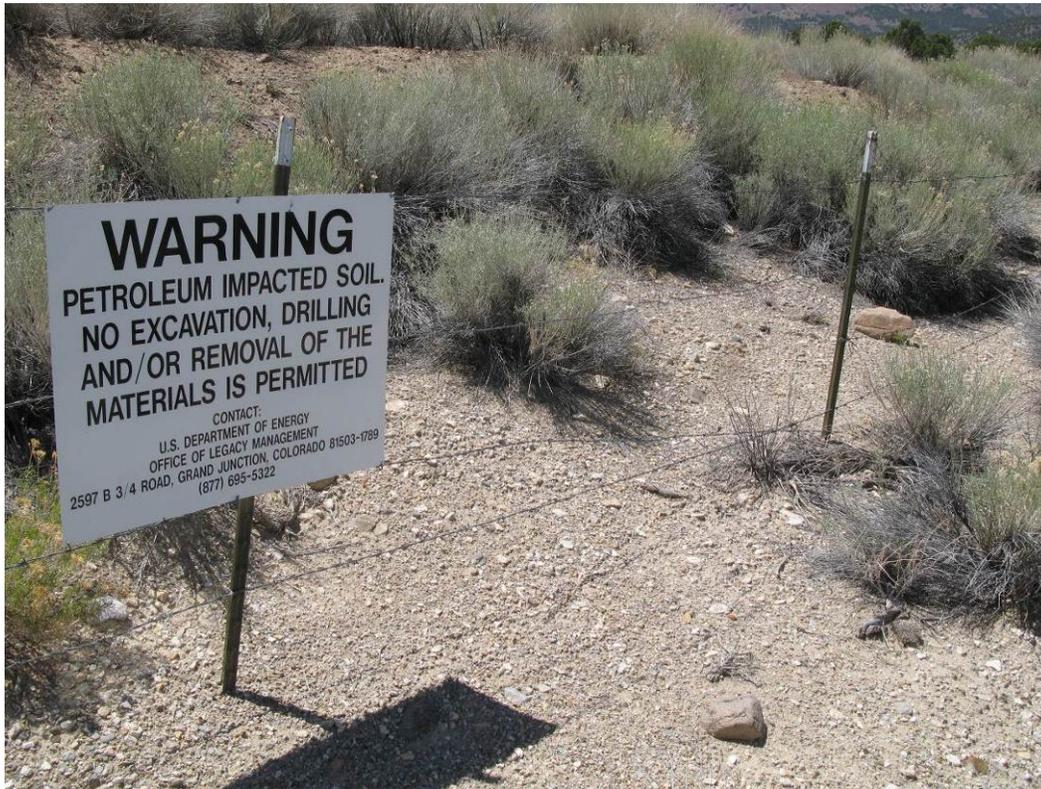
*Photograph 19. UC-4, view of broken barbed-wire strand along north side of cap*
