Post-Closure Inspection and Monitoring Report for Surface Corrective Action Unit 417 at the Central Nevada Test Area, Nevada, Site

January 2015

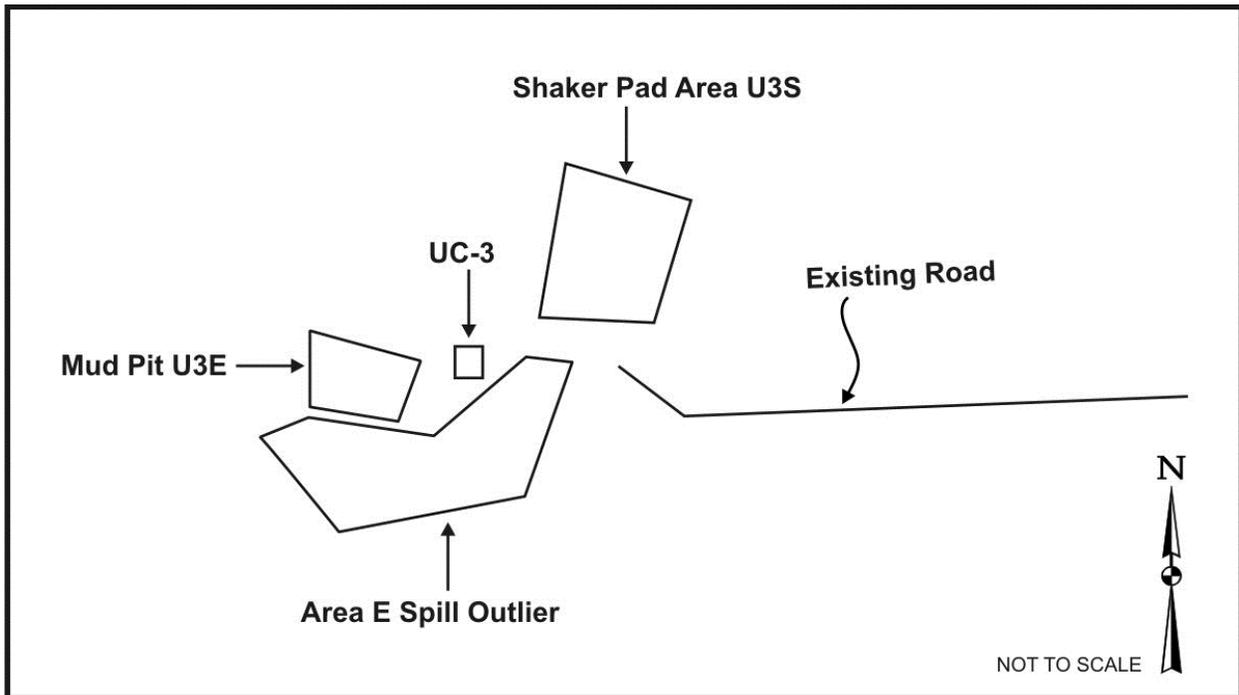
Figure 5. Location of UC-3 Significant Features

The site was in excellent condition (Figure 5). No issues with the monuments or signs were identified at the time of the inspections, and no maintenance or repairs were recommended.

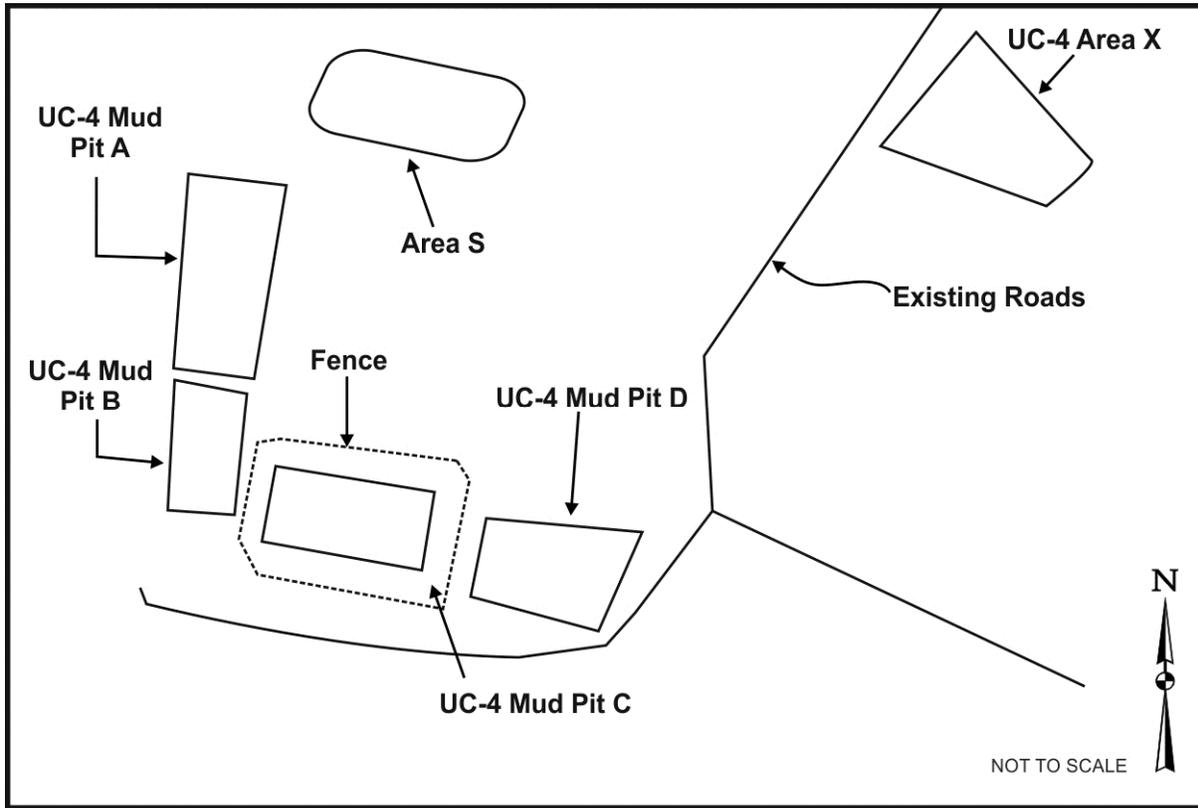
Figure 6. Location of UC-4 Significant Features

The Mud Pit C fence and SMs were in good condition at the time of the inspections. No erosion rills were identified, and previously identified rills showed no further signs of activity. No new erosion concerns were apparent at the time of the inspections. No issues that affected the integrity of the cover and appurtenances were noted. Mud Pits A, B, and D were in excellent condition, and no issues were identified with Area S or Area X (Figure 6).

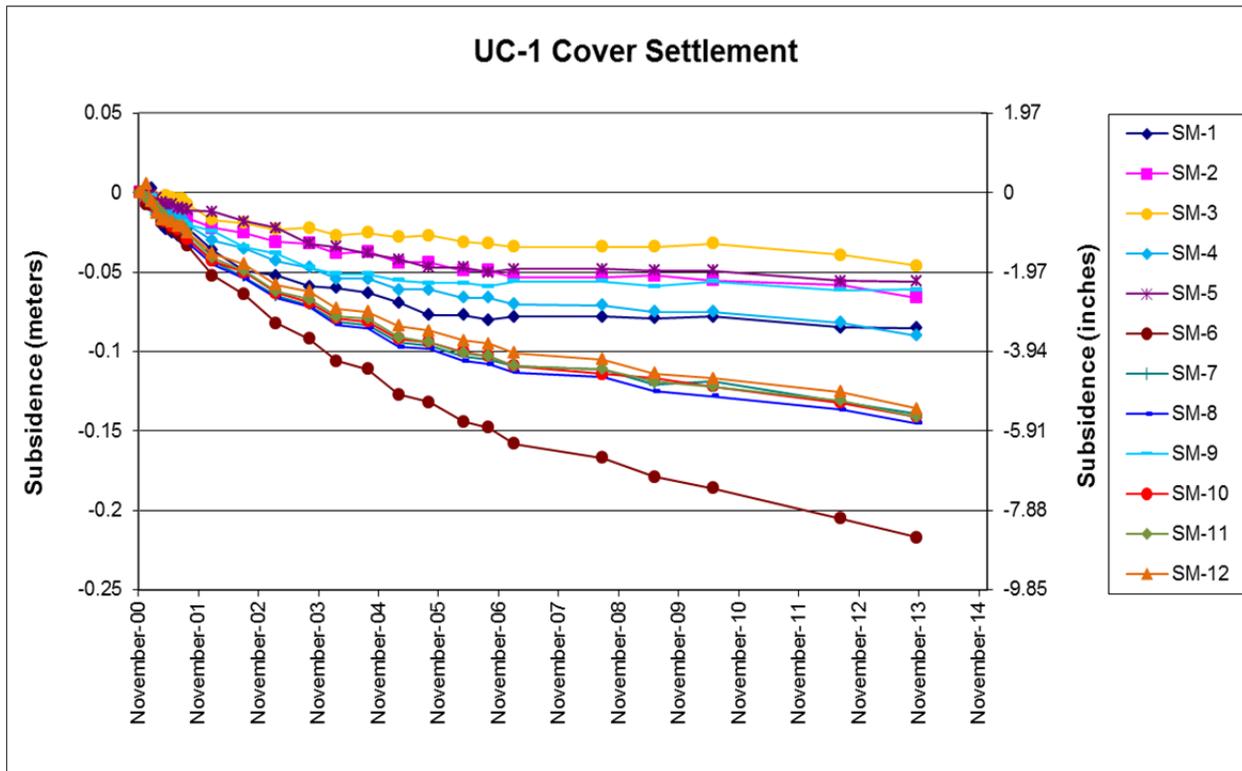
Figure 7. UC-1 CMP Cover Settlement

The degree of settlement in the relocation trench and CMP shows no unusual subsidence, but one SM has exceeded the predicted range of 0.2 m (8 inches). The data collected over the CMP section of the cover indicate that the largest subsidence is along the centerline of the CMP, including SM-6, SM-7, and SM-8, and along the southern portion of the cap at SM-10, SM-11, and SM-12. This was expected because of the thicker layer of underlying mud in these areas. The northern monuments (SM-2, SM-3, and SM-4) and the westernmost monuments (SM-1, SM-5, and SM-9) show less subsidence because the layer of underlying mud along these margins of the cover is thinner. The greatest degree of settlement continues to be on SM-6, which has subsided a total of 0.217 m (8.543 inches) since the baseline survey in December 2000. This exceeds the predicted range of 0.2 m (8 inches).

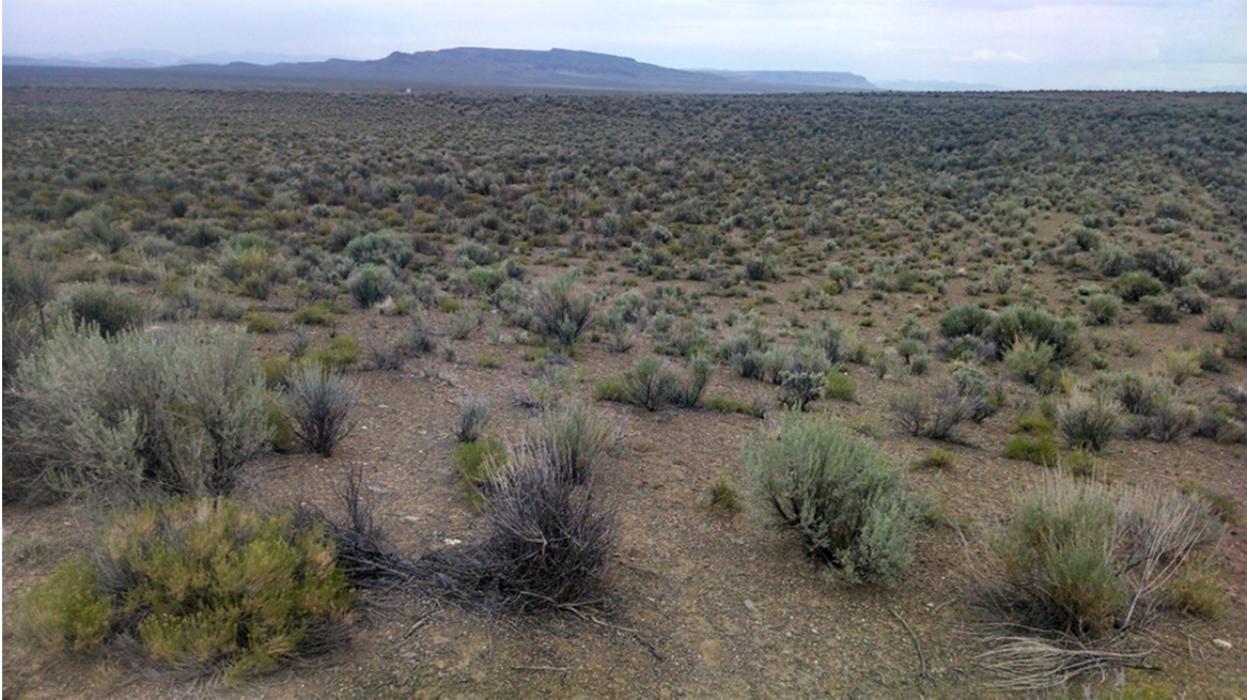
A plant specialist assisting with the 2014 inspection confirmed that vegetation on the UC-1 CMP cover continued to be healthy and sustainable (Figure 10). Total foliar cover was estimated at 25 percent and was dominated by rubber rabbitbrush, sagebrush, and thread snakeweed. Secondary species included fourwing saltbush, galleta grass, indian ricegrass, and bottlebrush squirreltail, all desirable species. The percentage of total foliar cover in the CMP cover area increased from the previous years. In comparison, values for total foliar cover in 2007, 2009, and 2012 were 18, 23, and 20 percent, respectively (DOE 2008, 2009, and 2013). The continued increase in total foliar cover further supports the success of the revegetation effort that was determined as having met the vegetation success criteria in 2006 (Anderson 2005, 2006).

Figure 10. View southeast of UC-1 CMP from middle of gate along north fence line

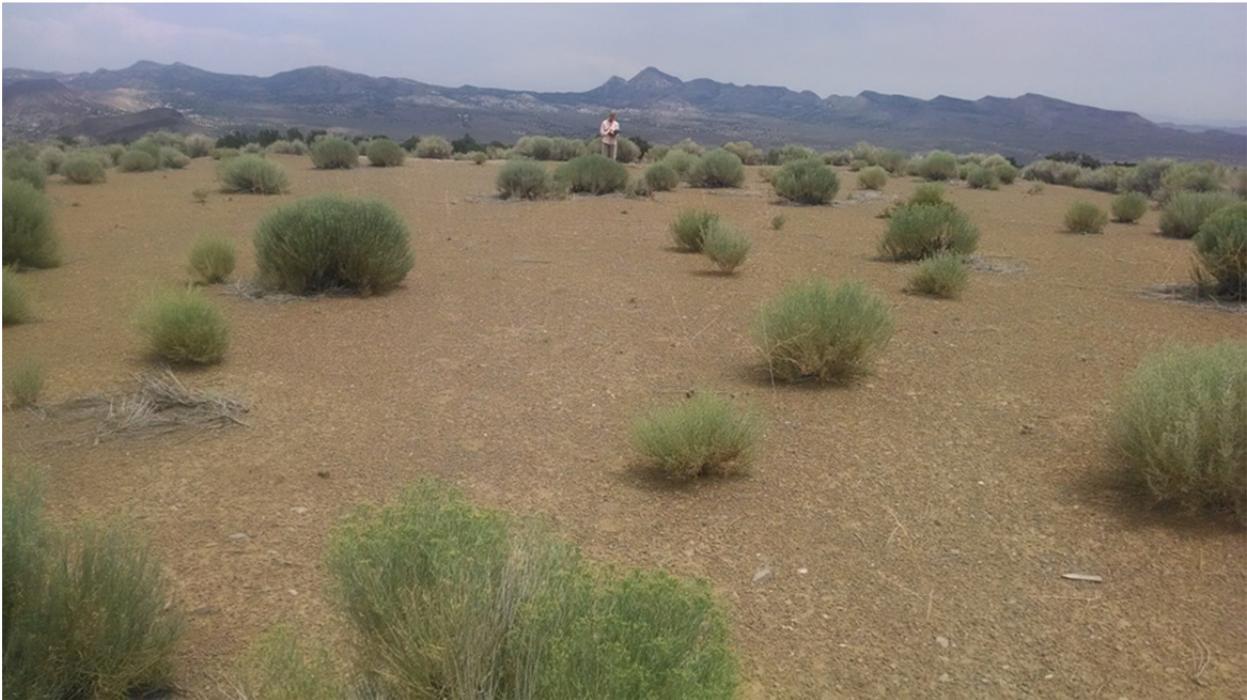
On the UC-4 Mud Pit C cover, vegetation is no longer being controlled, and desirable plants are becoming established (Figure 11). Total foliar cover was estimated at 12 percent and was dominated by rubber rabbitbrush. Secondary species included Mexican cliffrose and bottlebrush squirreltail.

Figure 11. View east of UC-4 Mud Pit Cap from west survey marker

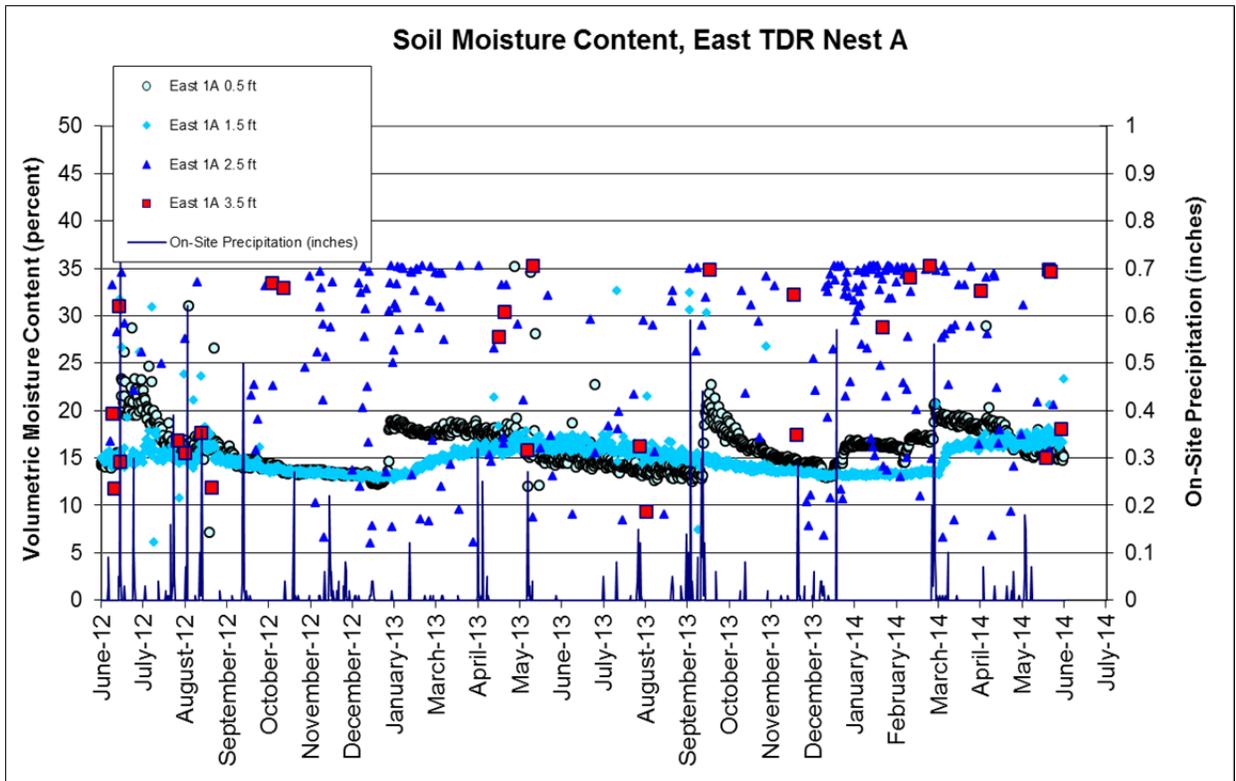
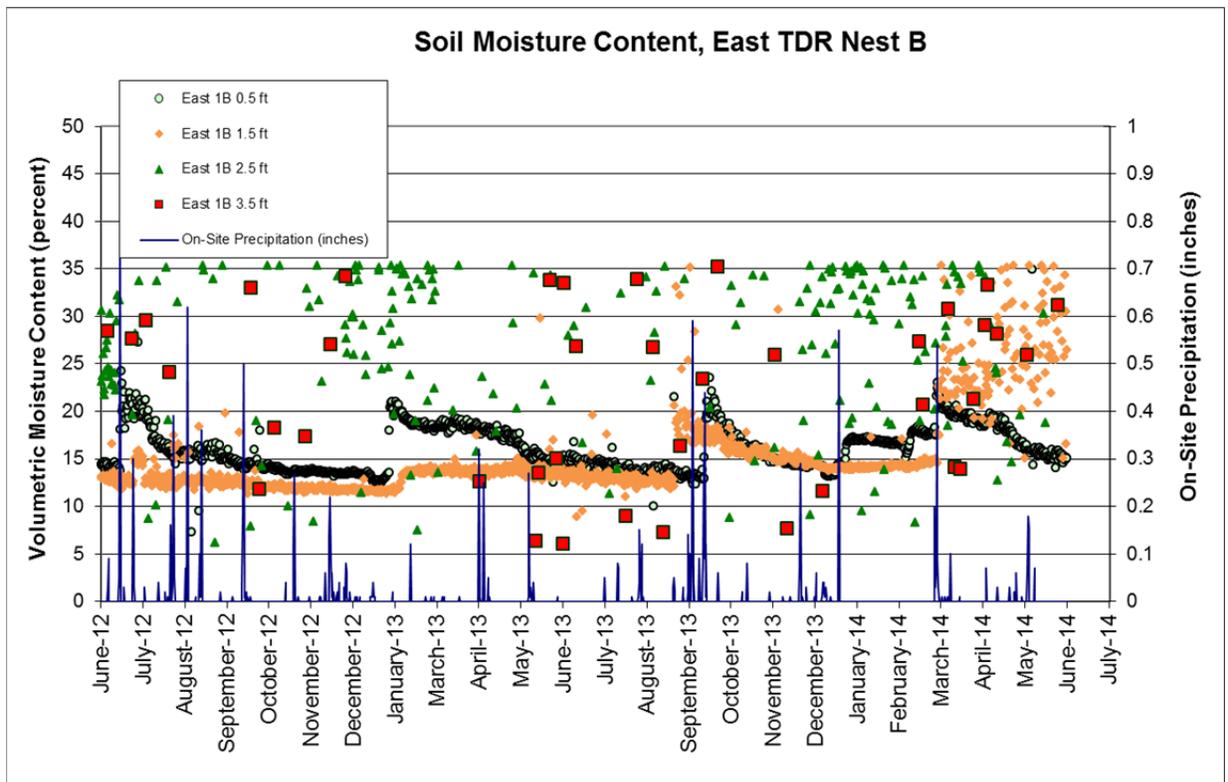
Figure 13. UC-1 Soil Moisture Content, East TDR Nest A

Figure 14. UC-1 Soil Moisture Content, East TDR Nest B

Soil moisture data obtained for the 0.76 and 1.07 m (2.5 and 3.5 ft) depths of the east TDR nests (Figure 13 and Figure 14) continue to be discontinuous and appear to be corrupted. Previously, the lengthy cable created a problem in measuring the reflected signal from the TDR probes (NNSA/NV 2007). It was also thought that the erratic data may be an indication of saturated conditions at these depths. Soil samples were collected near the deepest TDR sensors on August 23, 2013, to evaluate this theory. Soil moisture results indicated the soil was not saturated and that the moisture content at these depths was approximately 8 percent. Data from the two deepest sensors are required to establish soil-moisture-monitoring compliance criteria. A Path-Forward plan is being developed to address the requirement for establishing soil-moisture-monitoring compliance criteria and for future monitoring at the site.

The TDR data from the shallower depths appear to be correct because the data appear to correspond with precipitation events. The VMC data fluctuate seasonally in response to snowmelt during spring thaw and precipitation events. The VMC data are typically highest during spring thaw, and they slowly decrease throughout the spring and early summer when the VMC reaches steady-state conditions, ranging from 11 to 15 percent in the upper 1.5 ft of the cover. This seasonal trend was somewhat disrupted with large precipitation events in September 2013. Refer to Appendix B (Figures B-2 and B-3) for historical moisture data obtained from the 0.5, 1.5, and 3.5 ft depths from 2007 through 2014.

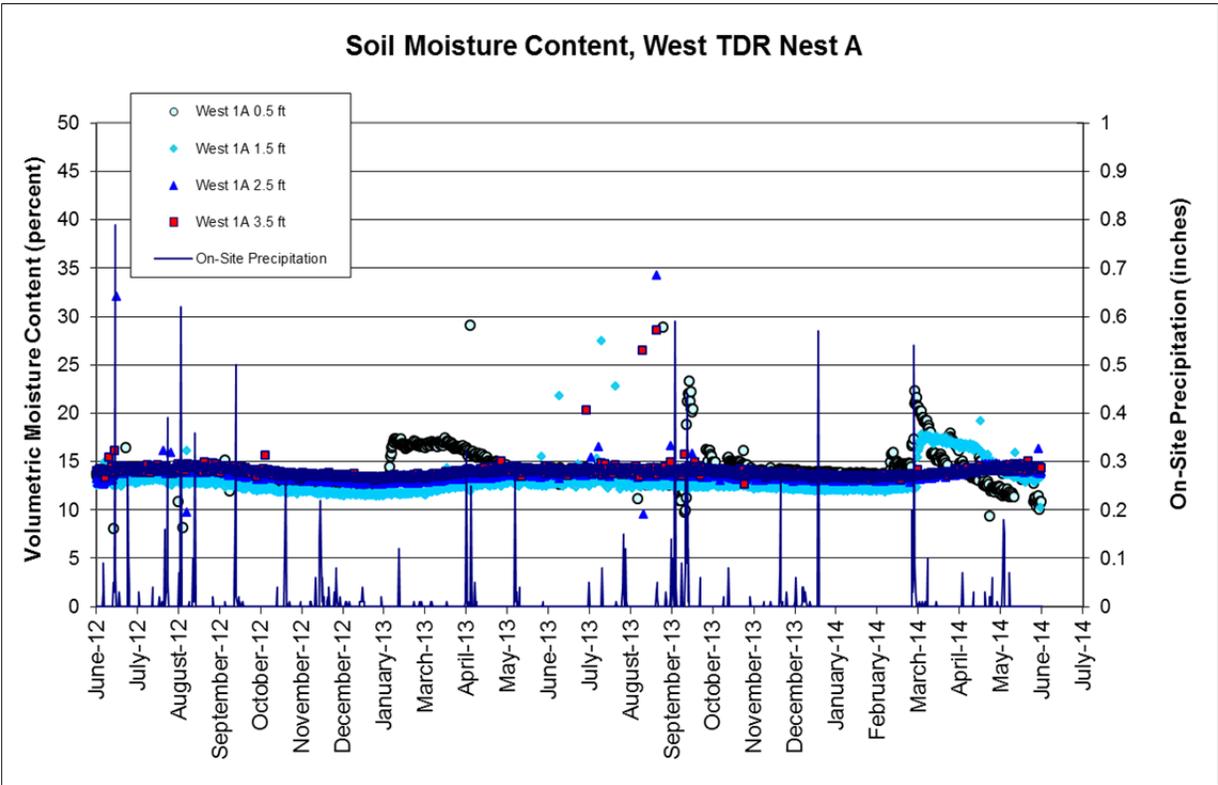
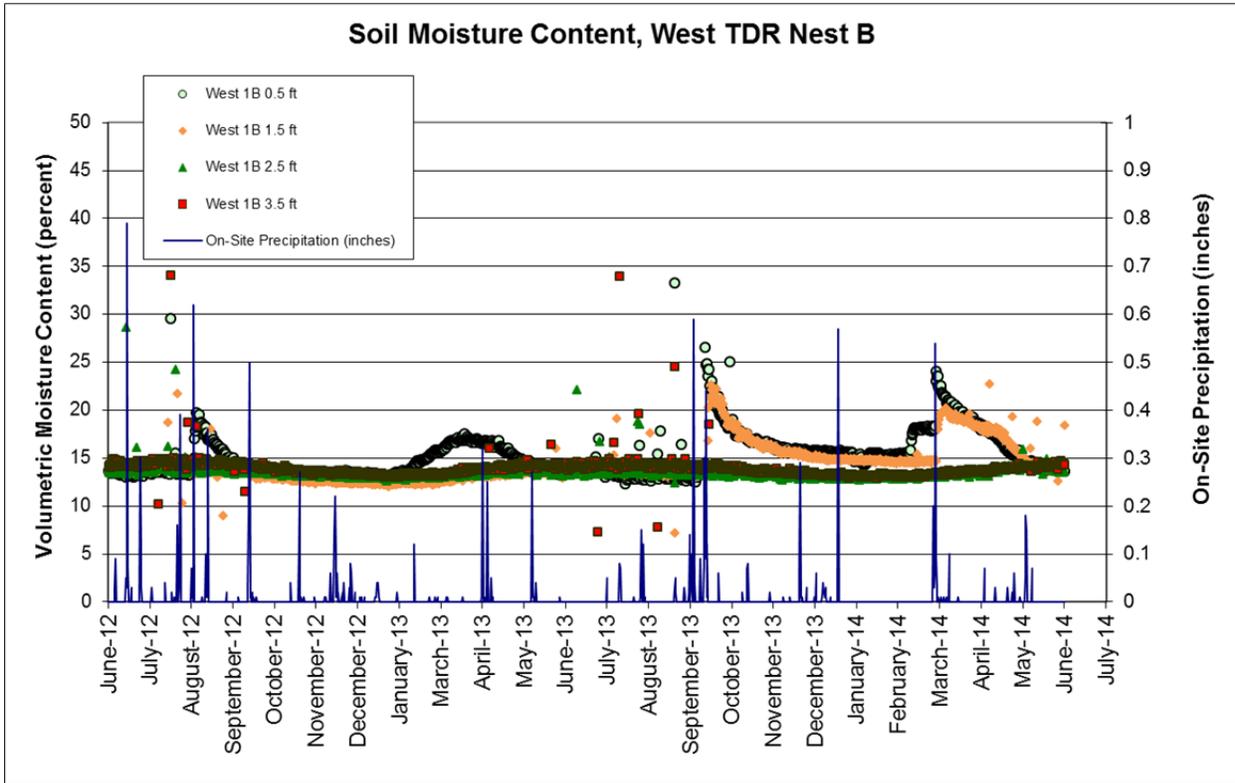
Figure 15. UC-1 Soil Moisture Content, West TDR Nest A

Figure 16. UC-1 Soil Moisture Content, West TDR Nest B

Soil moisture data obtained for the west TDR nests (Figure 15 and Figure 16) corresponds with precipitation events. The VMC data fluctuate seasonally in response to snowmelt during spring thaw and precipitation events. The VMC data are typically highest during spring thaw, and they slowly decrease throughout the spring and early summer when the VMC reaches steady-state conditions, ranging from 11 to 15 percent in the upper 3.5 ft of the cover. This seasonal trend was somewhat disrupted with large precipitation events in September 2013. Refer to Appendix B (Figures B-4 and B-5) for historical moisture data obtained from the 0.5, 1.5, and 3.5 ft depths from 2007 through 2014.
