**RADIOLOGICAL SURVEY REPORT
FOR THE DUPONT
CHAMBER WORKS PLANT
Deepwater, New Jersey**

Bechtel National, Inc.
Advanced Technology Division

June 1984

RADIOLOGICAL SURVEY
OF THE
E. I. DUPONT DE NEMOURS AND COMPANY
CHAMBERS WORKS PLANT
DEEPWATER, NEW JERSEY

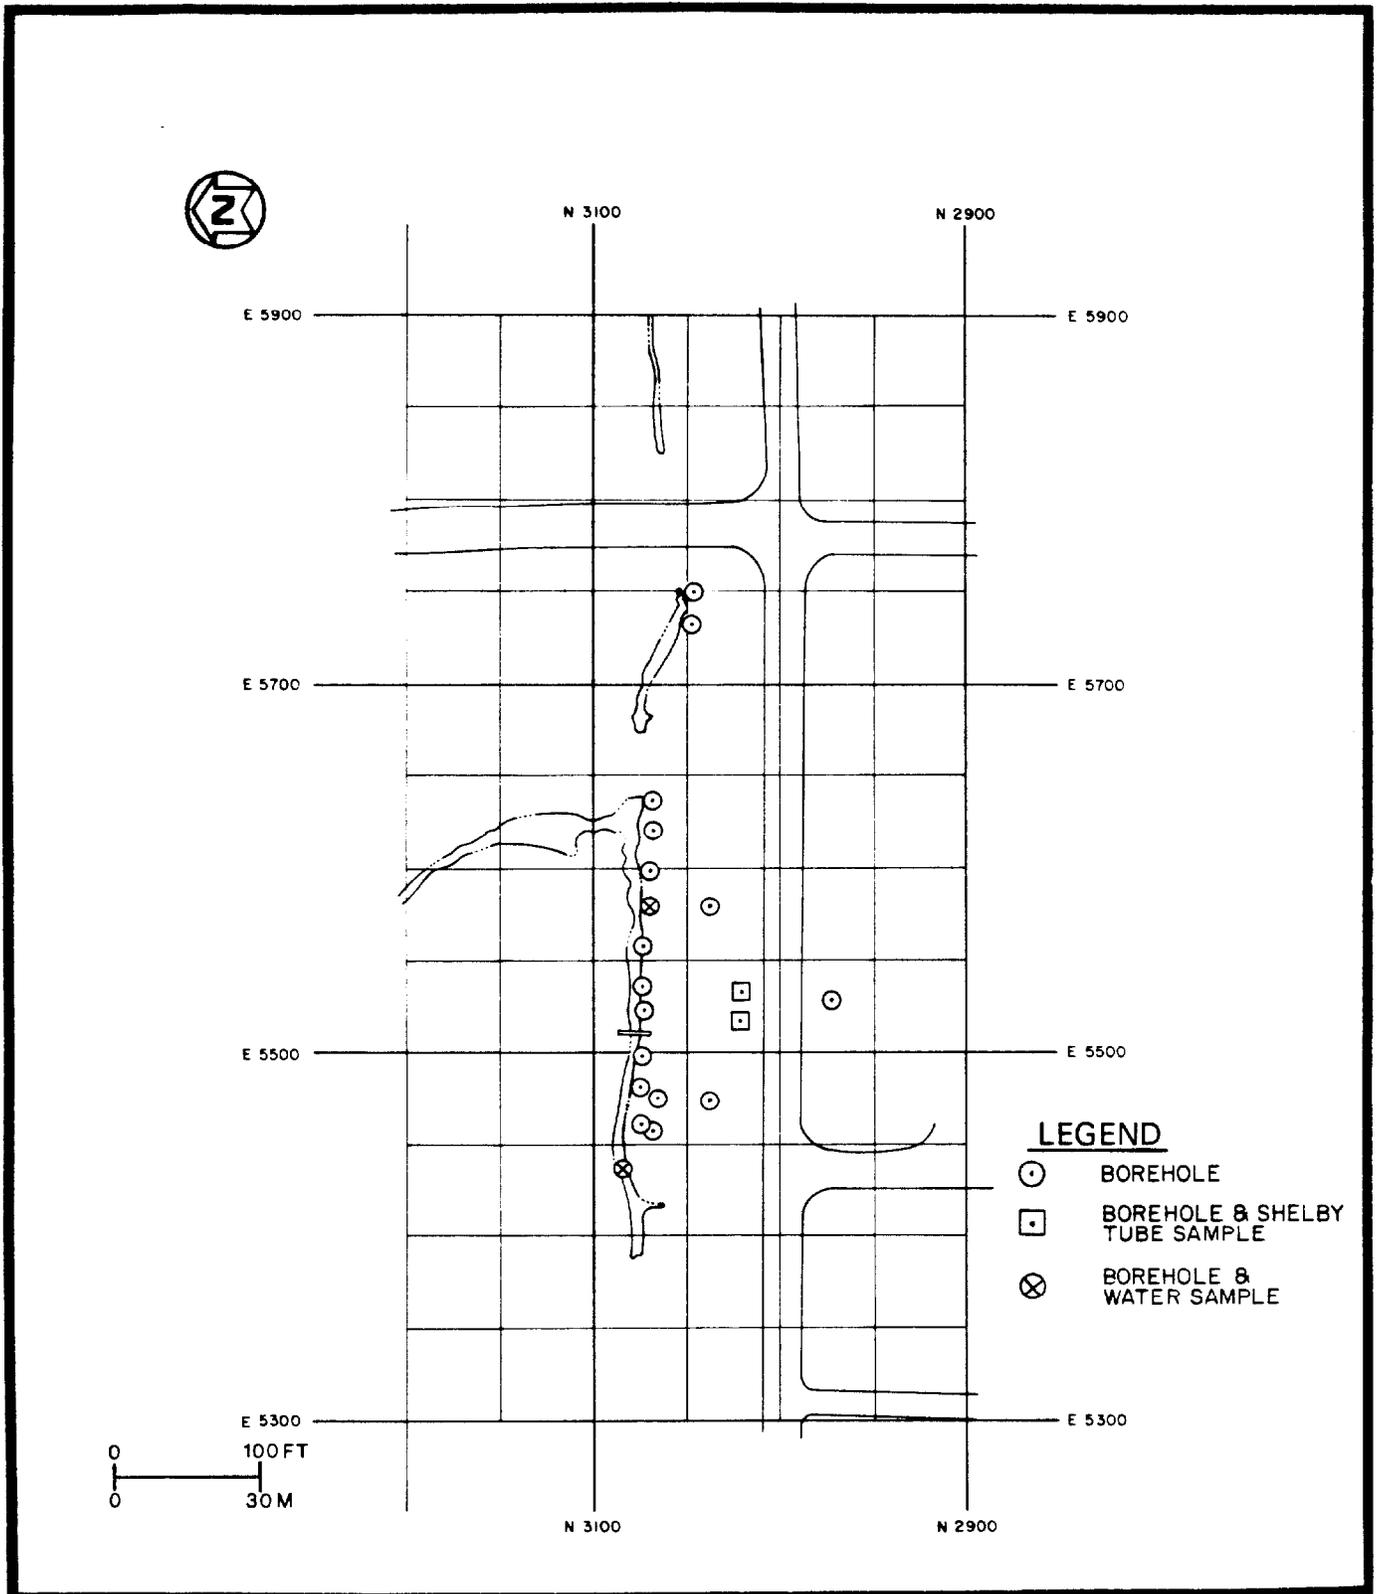
FIGURE 4-5 BOREHOLE AND SAMPLING LOCATIONS, EAST BURIAL AREA

Twenty boreholes were drilled in the East Burial area (refer to Figure 4-5). Gamma loggings indicate contamination exists in layers to depths greater than 2.6 m (8.5 ft). Higher count-rates were observed in the boreholes drilled adjacent to the road.

Two Shelby tube soil samples were collected in the East Burial area, and samples were analyzed for uranium-238, thorium-232, and radium-226. Uranium-238 was the major contaminant found, with concentrations ranging from 297 to 20,810 pCi/g. Both sampling locations also showed concentrations of radium-226 above the DOE guideline, with concentrations ranging from 0.63 to 27.84 pCi/g. All thorium-232 concentrations were below the DOE guideline. Complete results are given in Table 5-5. Due to the high water table, subsurface soil samples could not be collected below 1 m (3 ft).

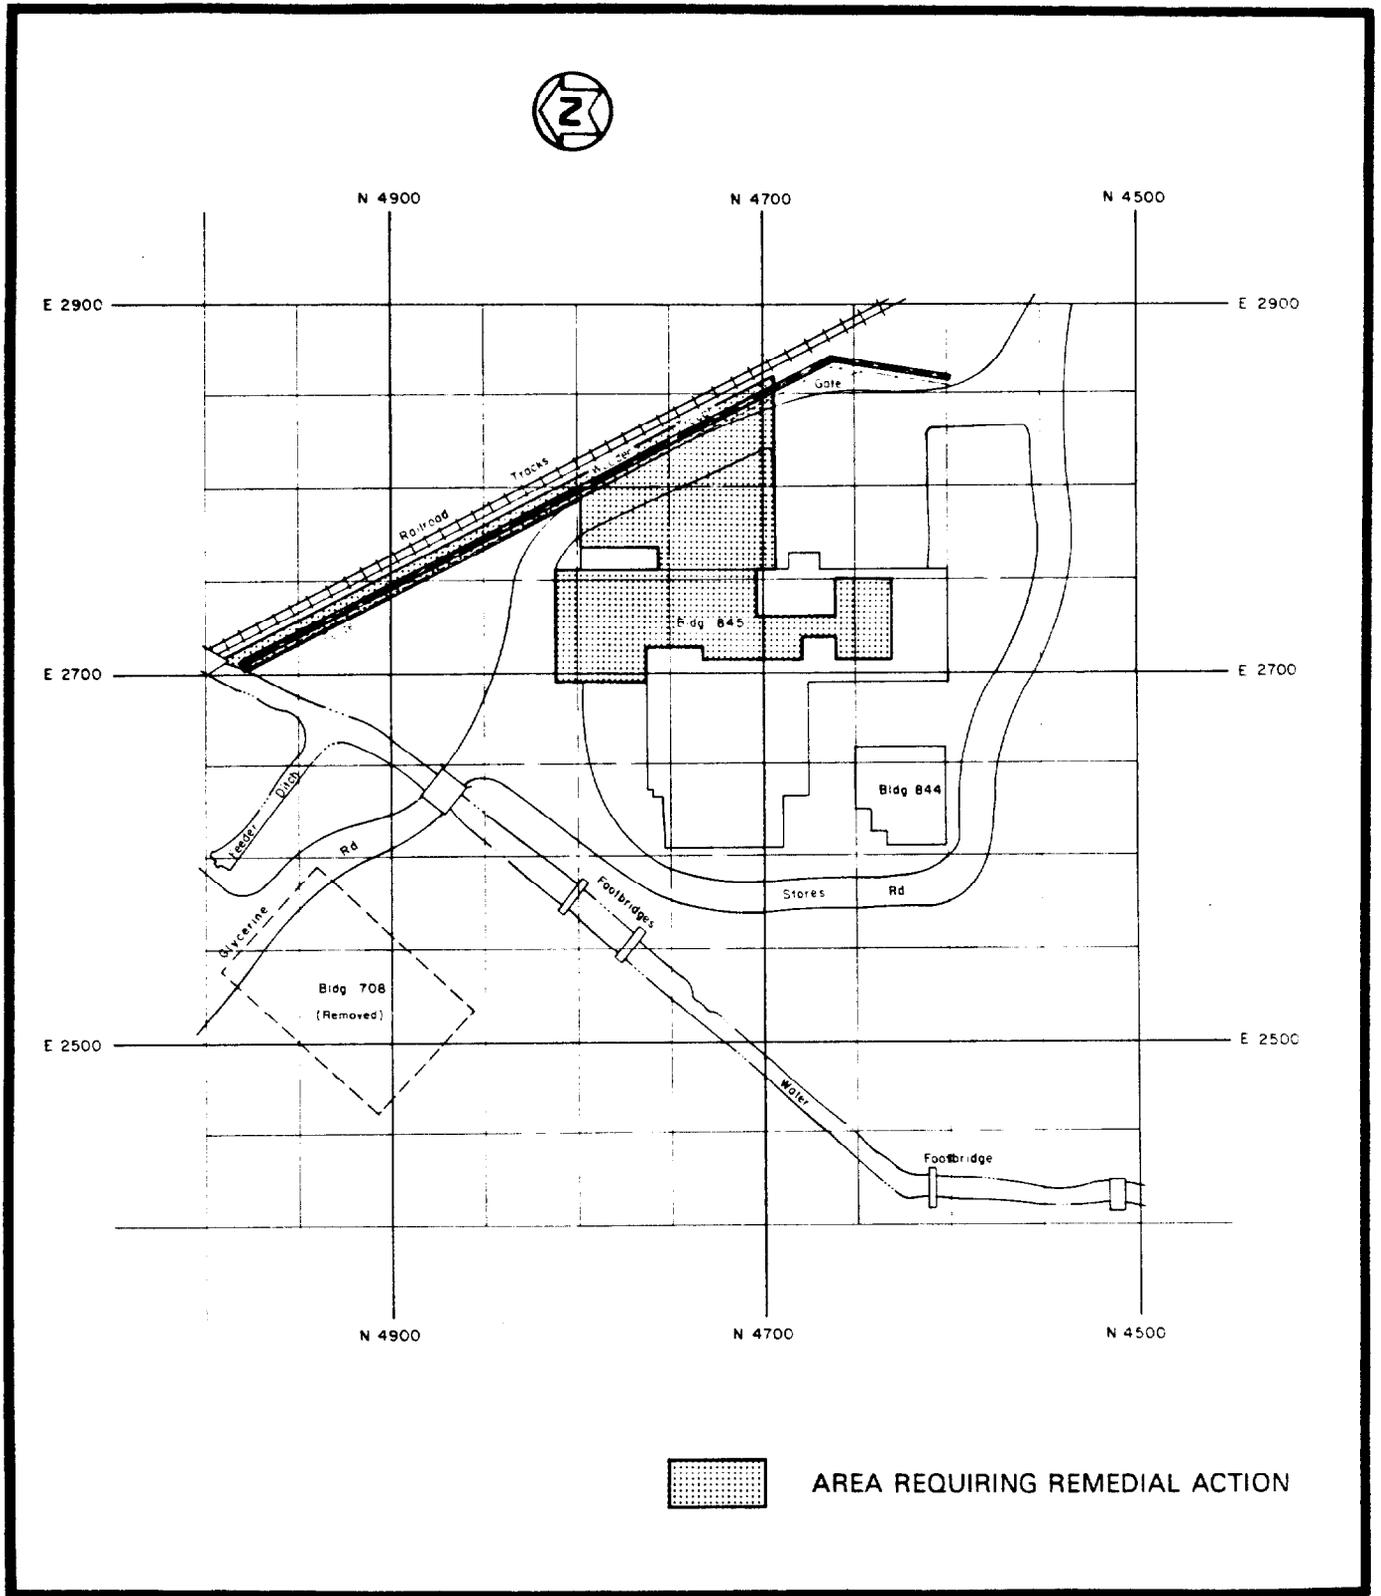
FIGURE 6-1 BUILDING 845 AREA AND WOODEN DRAINAGE TROUGH REQUIRING REMEDIAL ACTION

Results from near-surface gamma-radiation measurements were used to determine the extent of surface contamination. An area east of Building 845 was found to have readings greater than twice background, a finding in agreement with the ORNL survey (Ref. 1). The area which exhibited readings above criteria is shown on Figure 6-1.

Results from borehole gamma logs and subsurface soil samples were used to determine the depth of contamination. The major contaminant was found to be uranium-238, and subsurface contamination appears to be in layers to depths greater than 3 m (9 ft). However, the most significant layer of contamination was located in the upper 1 m (3.5 ft) of soil. Gamma loggings in the soil below the depth of 1 m (3.5 ft) are approaching remedial action criteria.

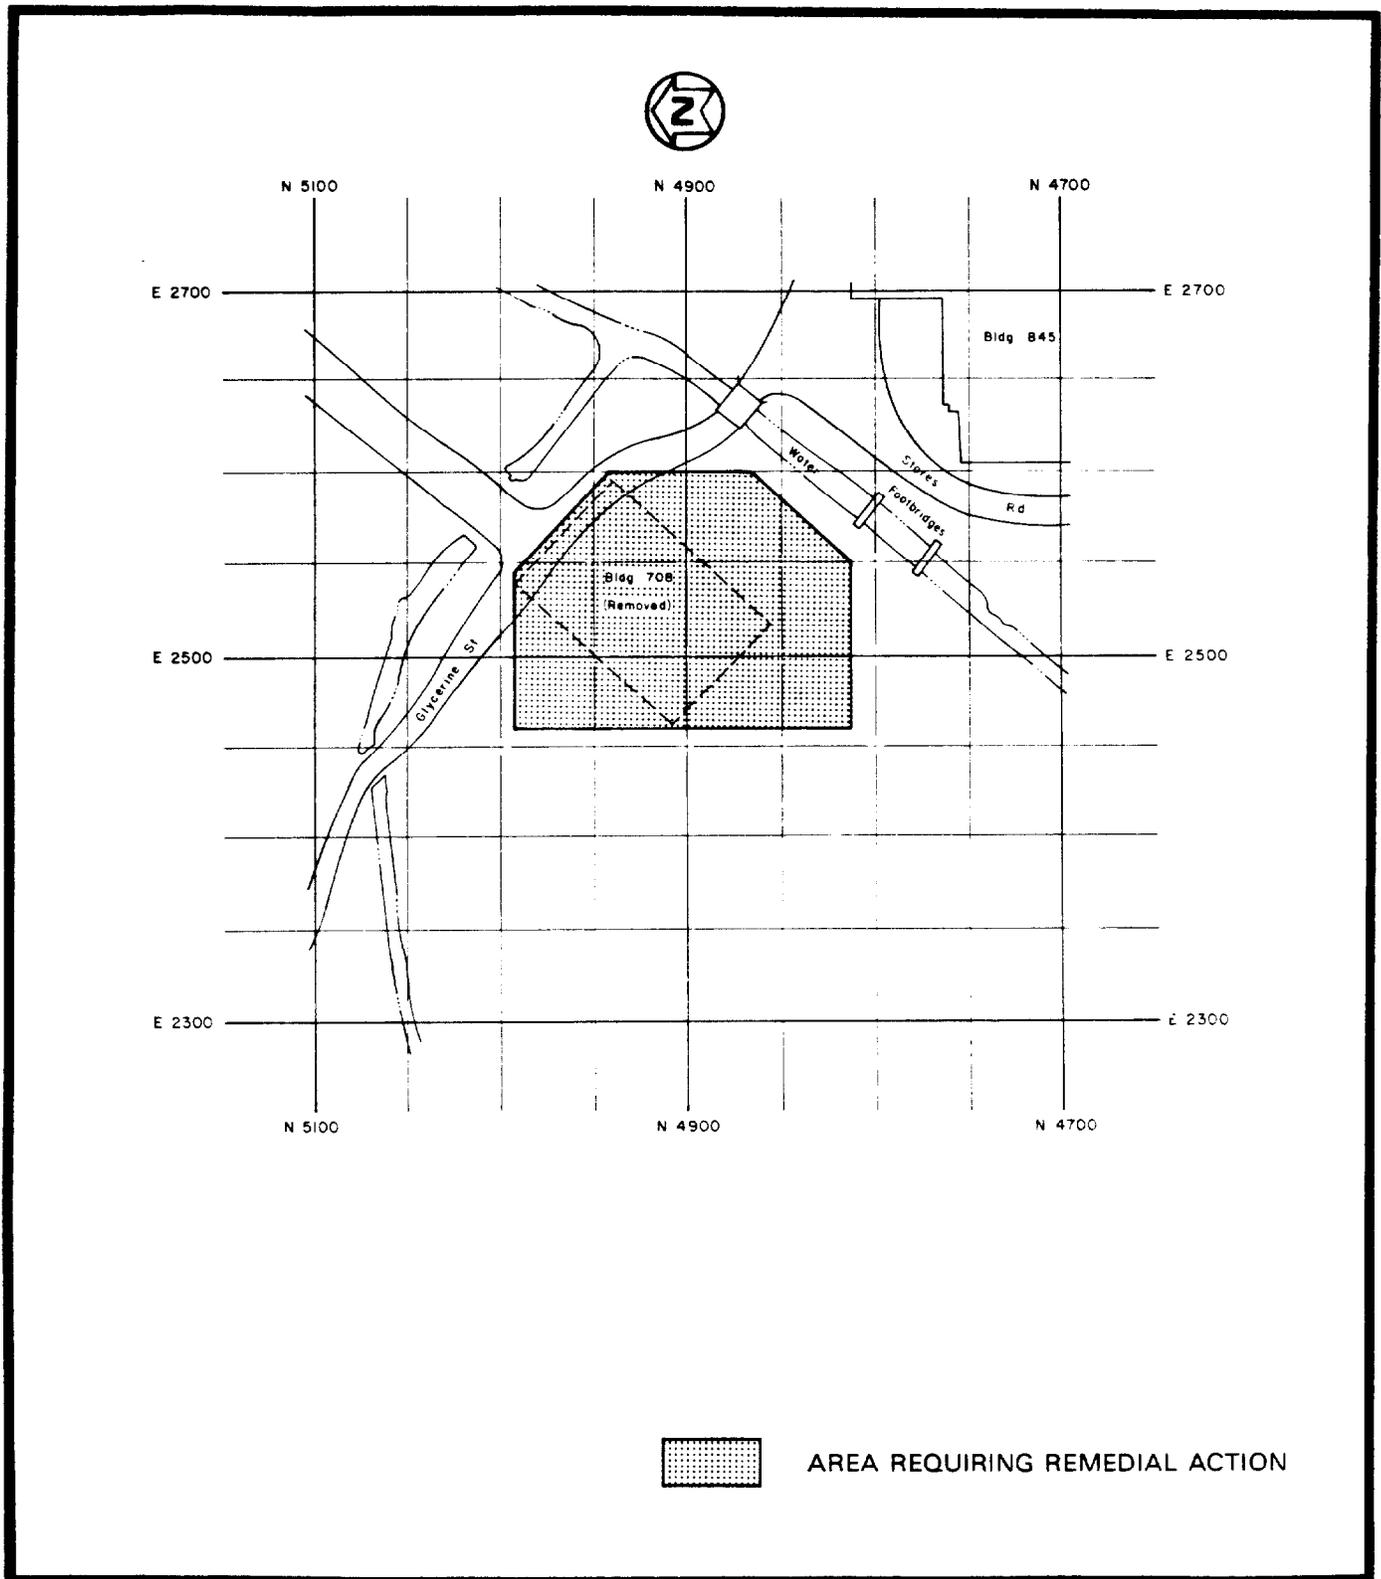
FIGURE 6-2 F CORRAL AREA REQUIRING REMEDIAL ACTION

One near-surface gamma measurement exceeded twice background. All other measurements were within background levels. Borehole gamma loggings indicated contamination at depths greater than 3 m (9 ft), with the most significant layer of contamination located in the upper 1 m (3 ft) of soil. Major readings below this depth approach remedial action guidelines. Soil samples show the contaminant is uranium-238, and the maximum uranium-238 concentration observed in subsurface soil samples was 4247 pCi/g.

Groundwater sample results from the F Corral parking area showed total uranium concentrations above the criteria limit. The maximum concentration observed for uranium-238 was 105105 pCi/l. This sample was collected at a depth of 1 m (3 ft).

The area exhibiting measurements above guidelines is shown in Figure 6-2. During remedial action an estimated 2700 m³ (3500 yd³) would require removal to meet DOE guidelines.

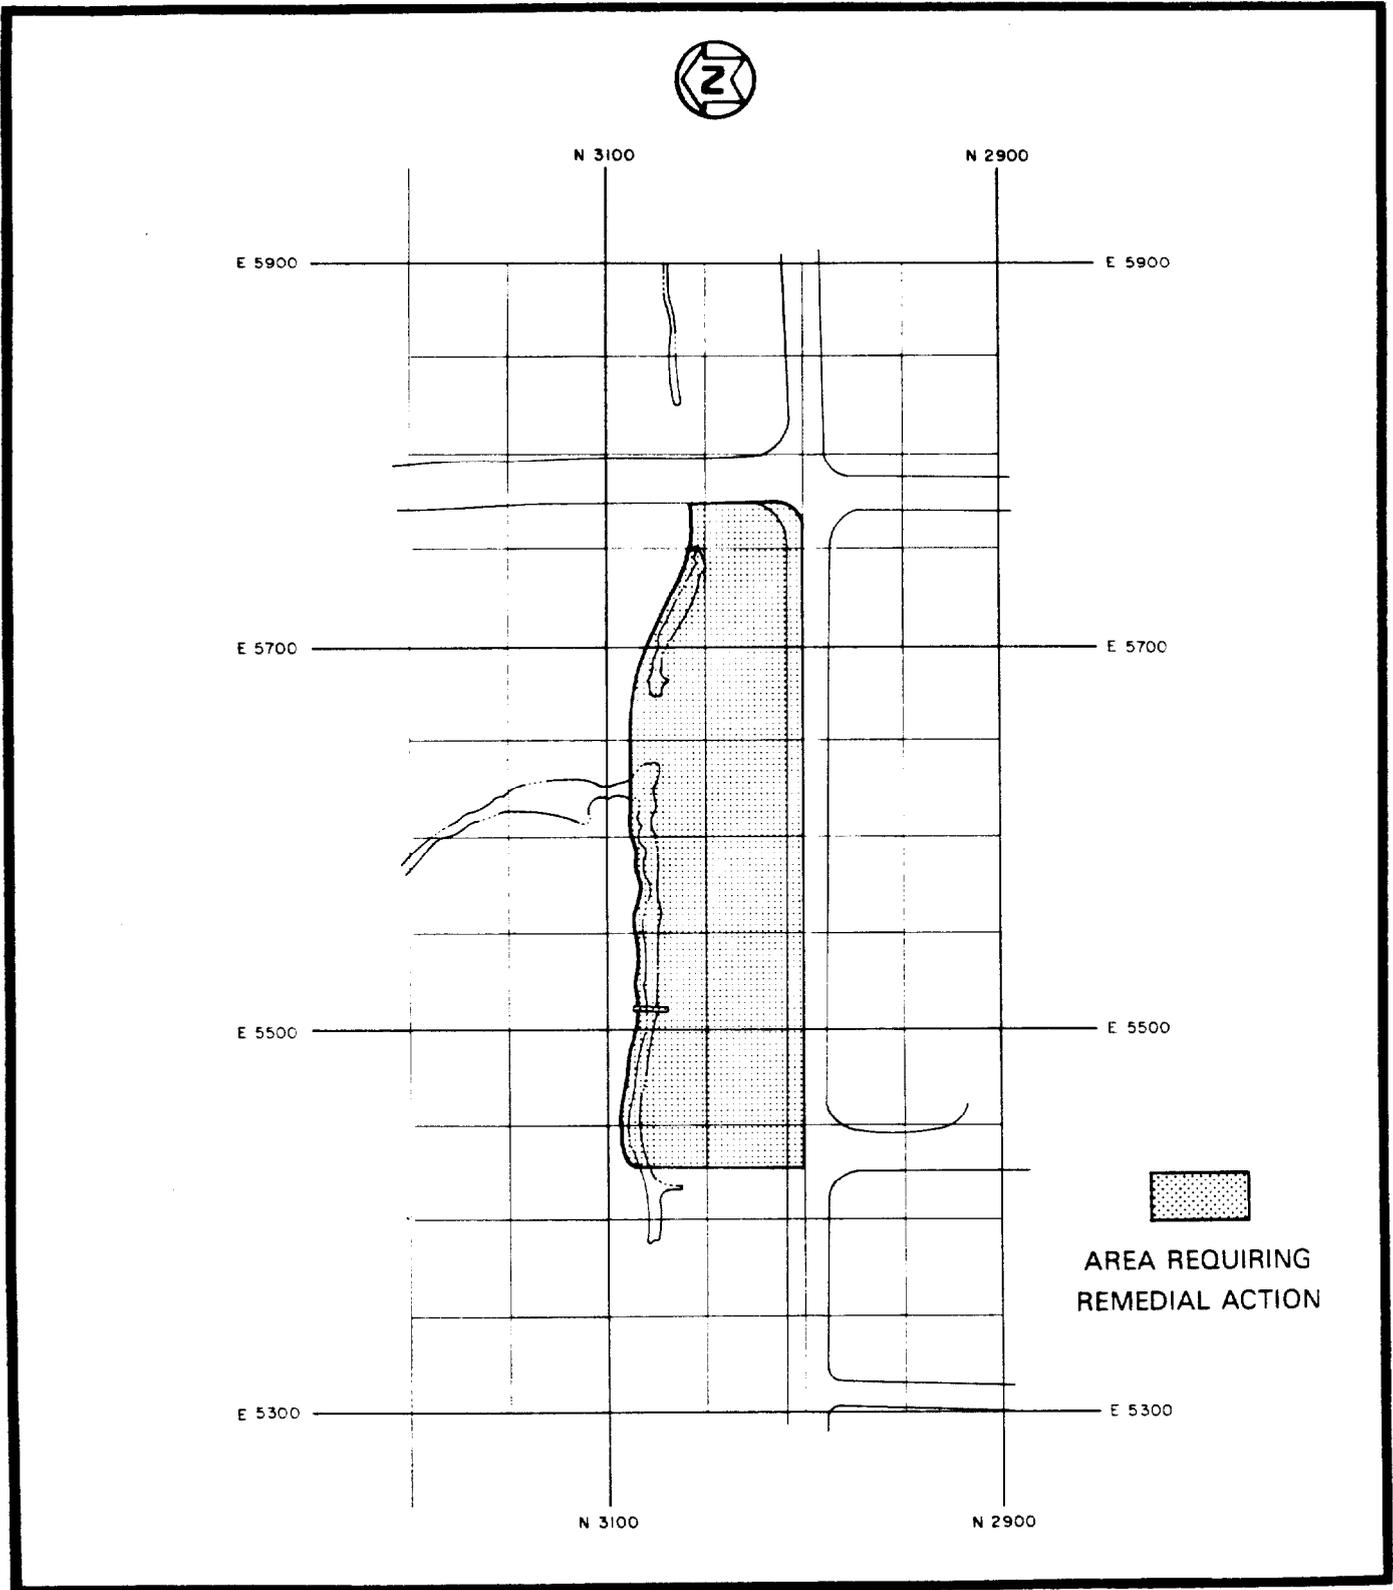
FIGURE 6-3 EAST BURIAL AREA REQUIRING REMEDIAL ACTION

Borehole gamma logging indicated contaminated layers of soil to depths greater than 2.7 m (8.5 ft). The most significant layer of contamination was located in the upper 1 m (3.5 ft). Elevated areas below this depth approach remedial action criteria. Higher count rates were observed in the boreholes drilled adjacent to the road. Areas which exhibited measurements above criteria are shown on Figure 6-3.

Based on soil sample results, uranium-238 is the major contaminant, and the maximum concentration observed was 20,810 pCi/g. Elevated concentrations of radium-226 were observed in some soil samples (see Table 5-5).

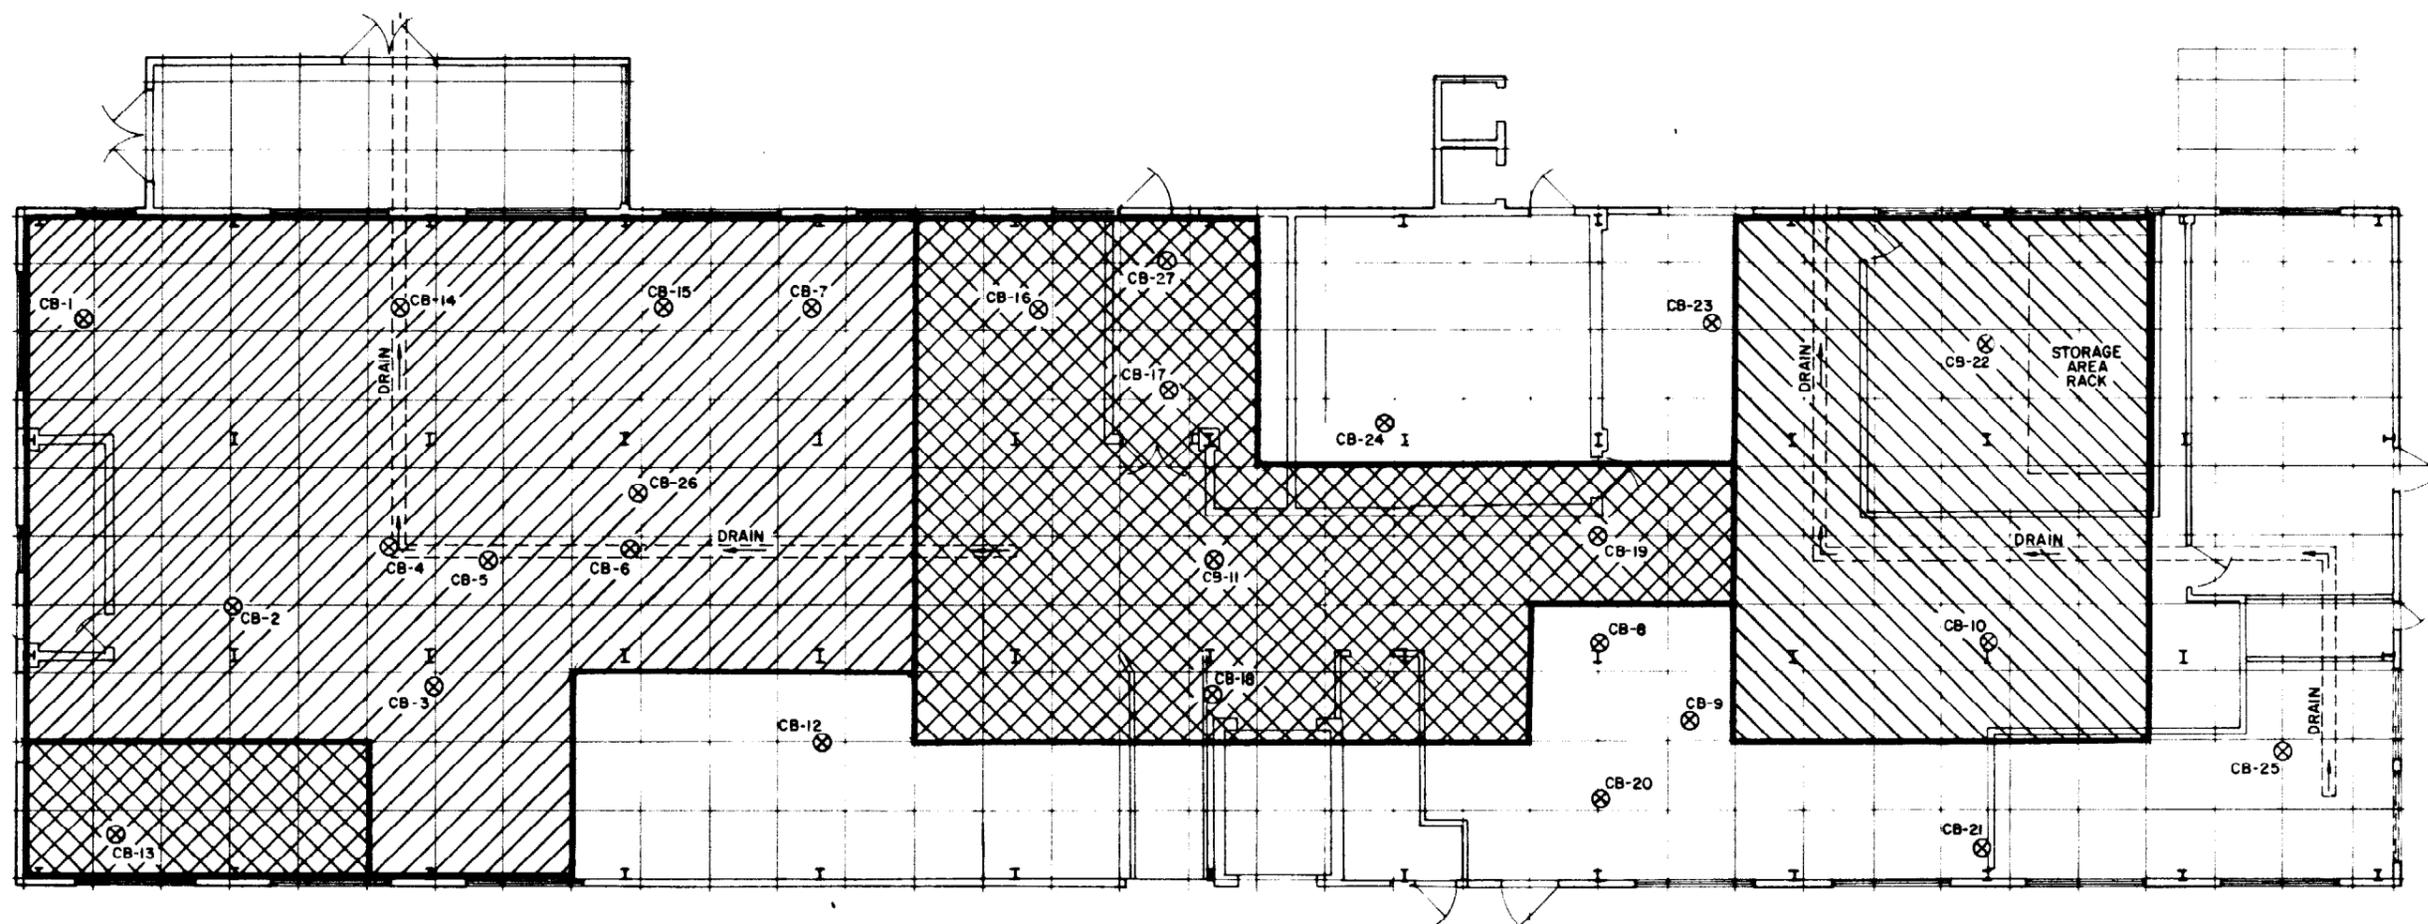
Building 845 first floor corehole loggings, coupled with Shelby tube soil samples indicated areas of contamination beneath the building up to depths of 1.2 m (4 ft). These areas of contamination are illustrated in Figure 6-12.

Based on these results, an estimated 560 m³ (760 yd³) of soil would require removal from beneath Building 845 to comply with criteria. In addition, remedial action would include the decontamination of all areas inside Building 845 which exhibited surface measurements above remedial action criteria limits. Surface decontamination of the building would involve removal of 2.5 cm (1 in.) of material from approximately 2050 m² (22,000 ft²) of contaminated surface areas. This would result in approximately 75 m³ (100 yd³) of material which would require removal. Total demolition of Building 845 would result in approximately 2300 m³ (3000 yd³) of material.
