PRELIMINARY SITE SURVEY REPORT FOR THE
FORMER SUPERIOR STEEL MILL AT
CARNEGIE, PENNSYLVANIA

April 1981

OAK RIDGE NATIONAL LABORATORY
Oak Ridge, Tennessee 37830
operated by
UNION CARBIDE CORPORATION
for the
DEPARTMENT OF ENERGY

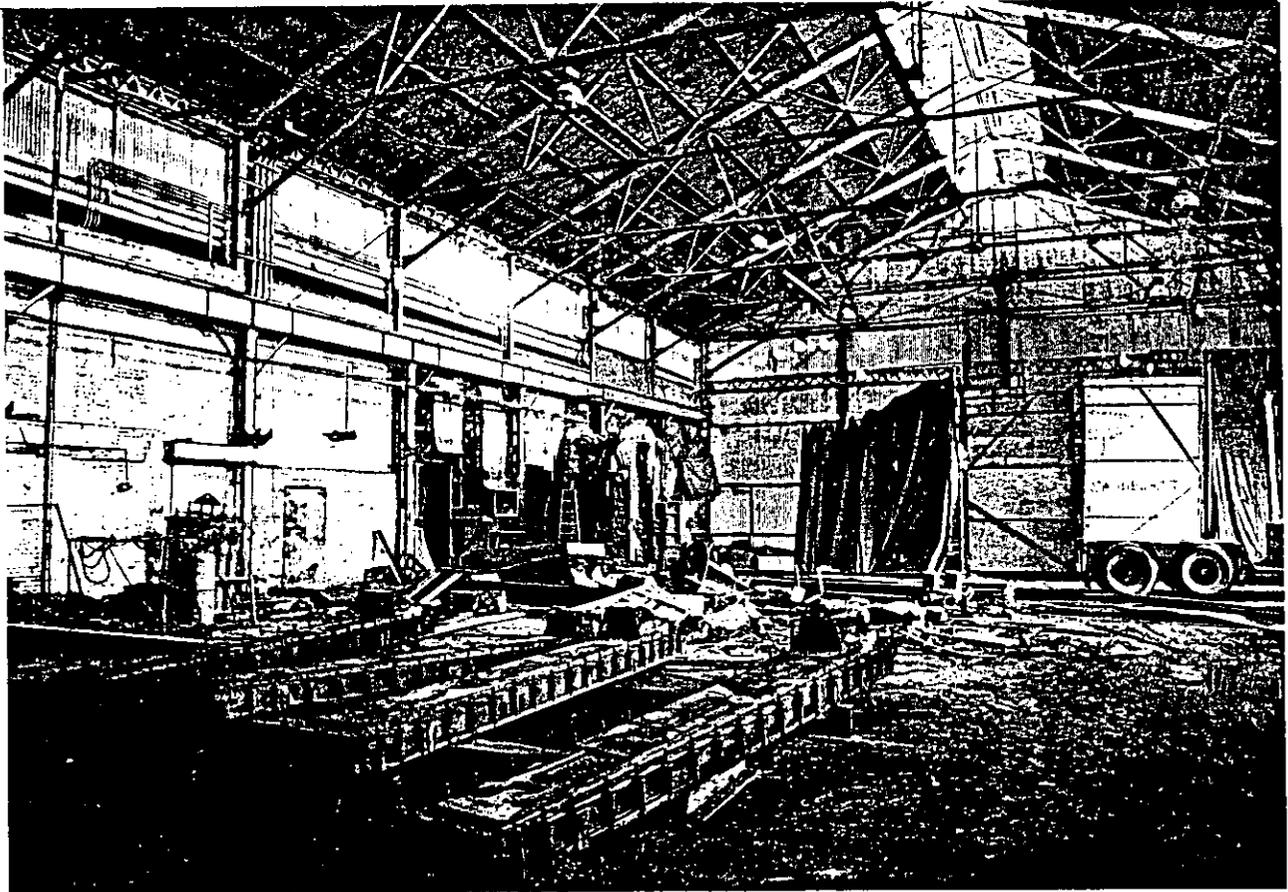
The gamma-ray scan of this area indicated evidence of low-level contamination in the former roughing mill area, in and around the open pits (see Fig. 11). Gamma-ray exposure rates 2 to 8 times the background level for the building were measured in this area (up to 50 $\mu\text{R}/\text{h}$ in open pit). Gamma radiation levels tended to increase toward the bottom of the pits, although, in this area, the bottom could not be reached due to the presence of fill rubble. Gamma radiation levels in the former finishing stands area where the pits had been concreted over were at background values. Beta-gamma measurements in the pit area ranged from 0.01 to 0.04 mrad/h. Fixed alpha levels on walls, floors, and machinery in area A showed no evidence of significant radioactive contamination, with a maximum recorded reading of approximately 50 dpm/100 cm^2 .

Fig. 4. Interior of former mill area (Area A), looking north.
Note the remains of the roughing mill just left of center against the wall.

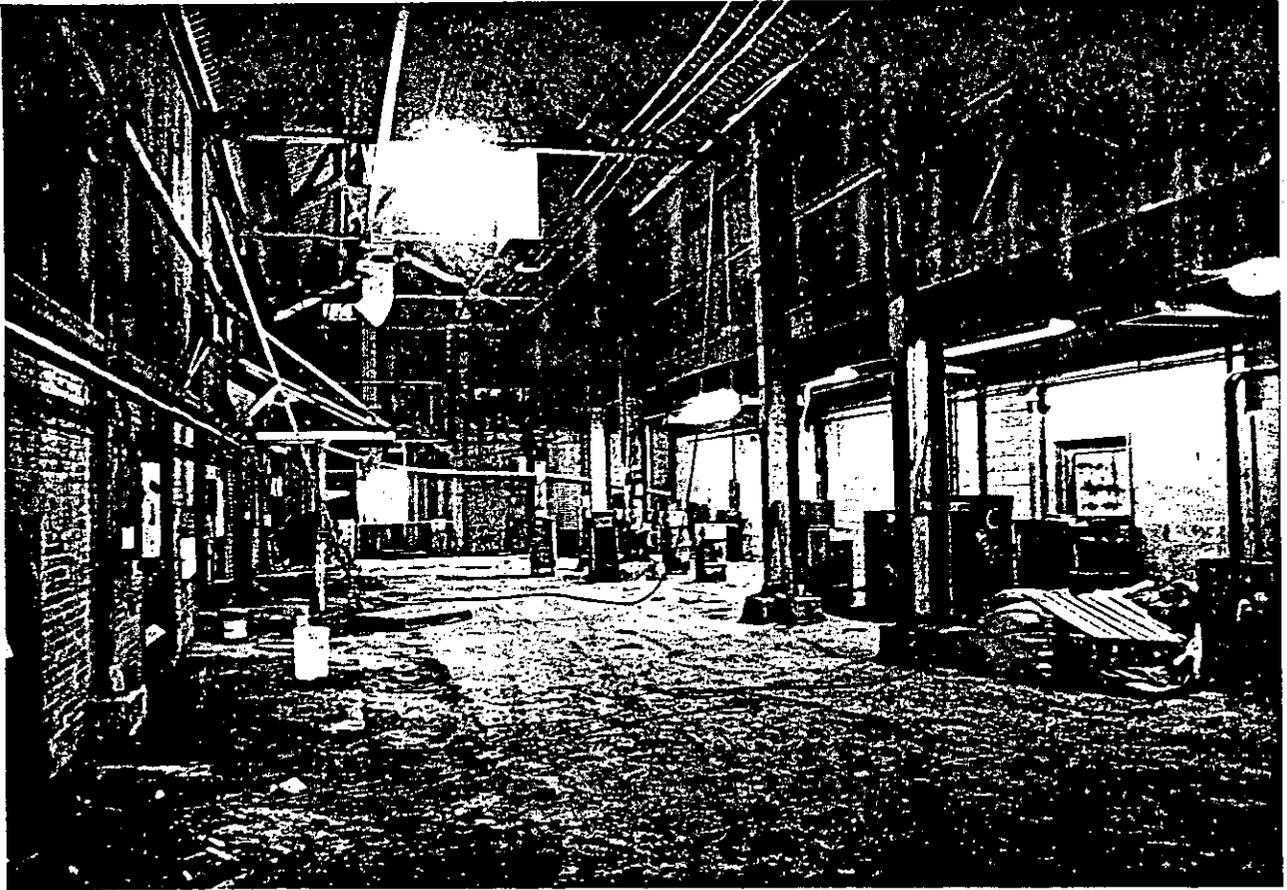
The gamma-ray scan of this area showed no evidence of radioactive contamination. All measurements were at the background level, except for stacks of bagged cement material which read up to 30 $\mu\text{R}/\text{h}$ at the surface. This slightly elevated activity is attributed to natural radioactivity present in the cement. Random fixed alpha measurements on walls and floor showed no signs of alpha contamination (<10 dpm/100 cm^2).

Fig. 6. Interior of former motor room (Area B), looking south.
Wall at left adjoins Area A.

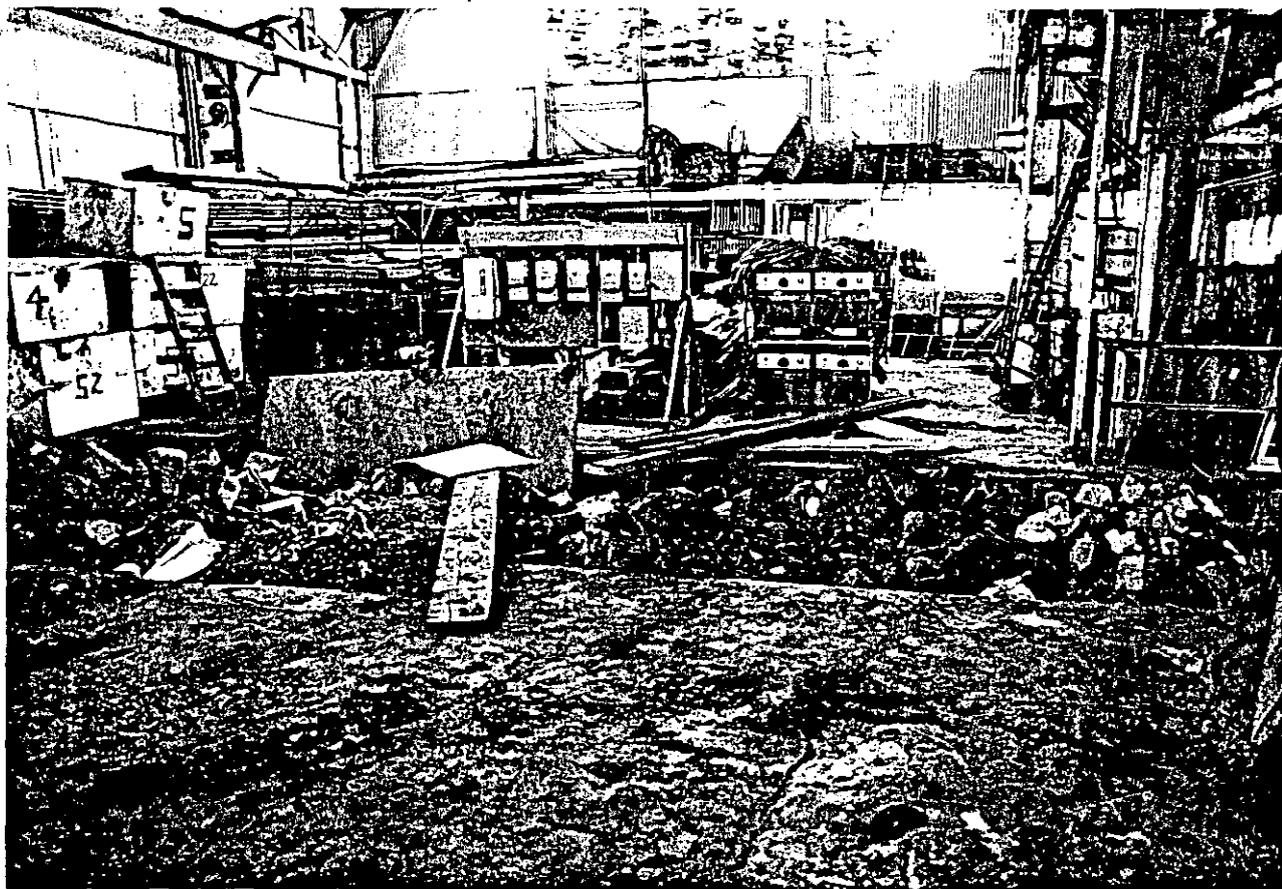
Two areas of significant radioactive contamination were located by the gamma-ray scan of this area (see Fig. 11). The open pits exhibited gamma-ray exposure levels 2 to 50 times the building background, with a maximum reading of approximately 500 $\mu\text{R}/\text{h}$ observed at the bottom of the bliss downcoiler pit. The beta-gamma dose rate at this point was determined to be 0.8 mrad/h, with a beta component of 0.3 mrad/h. The direct alpha measurements on this dirt surface yielded 640 dpm/100 cm^2 . A sample of the residues present at the bottom of the pit at this location was taken and returned to ORNL for analysis. The sample was a combination of steel shavings, soil, and various other unidentified materials. The uranium content of the sample was determined to be 5800 pCi/g ^{238}U (1.4% by wt.). No other radionuclides were present in sufficient quantities to be detected. Alpha measurements taken in the area surrounding the pit also showed evidence of low-level contamination (up to 100 dpm/100 cm^2). In the upender pit, gamma radiation levels of up to 75 $\mu\text{R}/\text{h}$ were recorded, although access to the bottom of the pit was restricted by rubble.

Fig. 9. Pit locations in Area C. Note the use of rubble in filling of pit.

Prior to additional, more comprehensive radiological surveying, significant building cleanup would need to be performed. Included in this action could be the removal of rubble from the open pit areas. This operation would need to be supervised to control the potential spread of radioactive materials suspected to be interspersed within the rubble. The rubble would need to be checked upon removal for possible surface contamination, and handled accordingly.

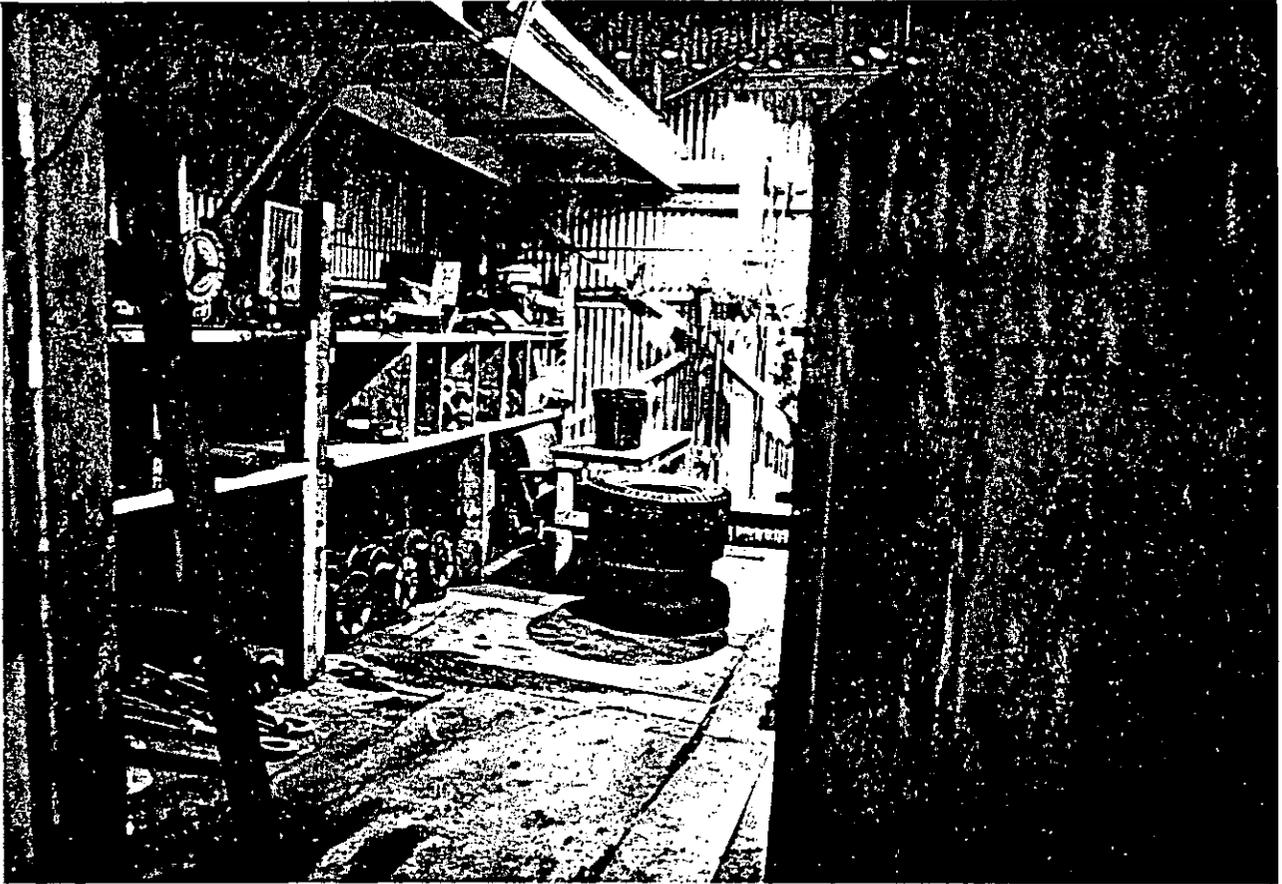
The other area where contamination was found was in the small storage shed attached to the western side of the building. This shed (as shown in Fig. 10) has a wooden floor with fill dirt under the floor. The gamma-ray scan of the shed indicated floor surface exposure rates varying from 75 to 400 $\mu\text{R}/\text{h}$, with a measurement at 1 m in the center of the room of approximately 90 $\mu\text{R}/\text{h}$. At the point of maximum gamma, the beta-gamma dose rate was determined to be 0.25 mrad/h (open-to-closed window ratio of 1:1). Direct alpha contamination at this point was

50 dpm/100 cm². Outside the structure, gamma radiation levels dropped off rapidly away from the shed walls, with a maximum exposure rate of about 200 μR/h nearest the corner with maximum indoor readings. Based on this information, it was suspected that the fill under the floor was the source of radioactive contamination and a sample of the material was collected from the only accessible location (not the point of gamma maximum) for laboratory analysis. The results of this analysis indicate that the material under the floor of the shed was similar in makeup to that found in the downcoiler pit. The ²³⁸U concentration in the sample was determined to be approximately 1100 pCi/g. No other radionuclides were detected.

Fig. 10. Storage shed on west side of Area C.

Under present operating conditions, average radiation exposures to individuals working in the buildings are below the current federal guidelines for continuous exposure. In only two areas, the bliss downcoiler pits and storage shed (both in Area C), is the potential for exposure significant. Contact with the mill residues present in these locations should be minimized. In addition, time spent in the storage shed should be reduced to a minimum until a more detailed assessment of the radiological conditions in this area can be undertaken.

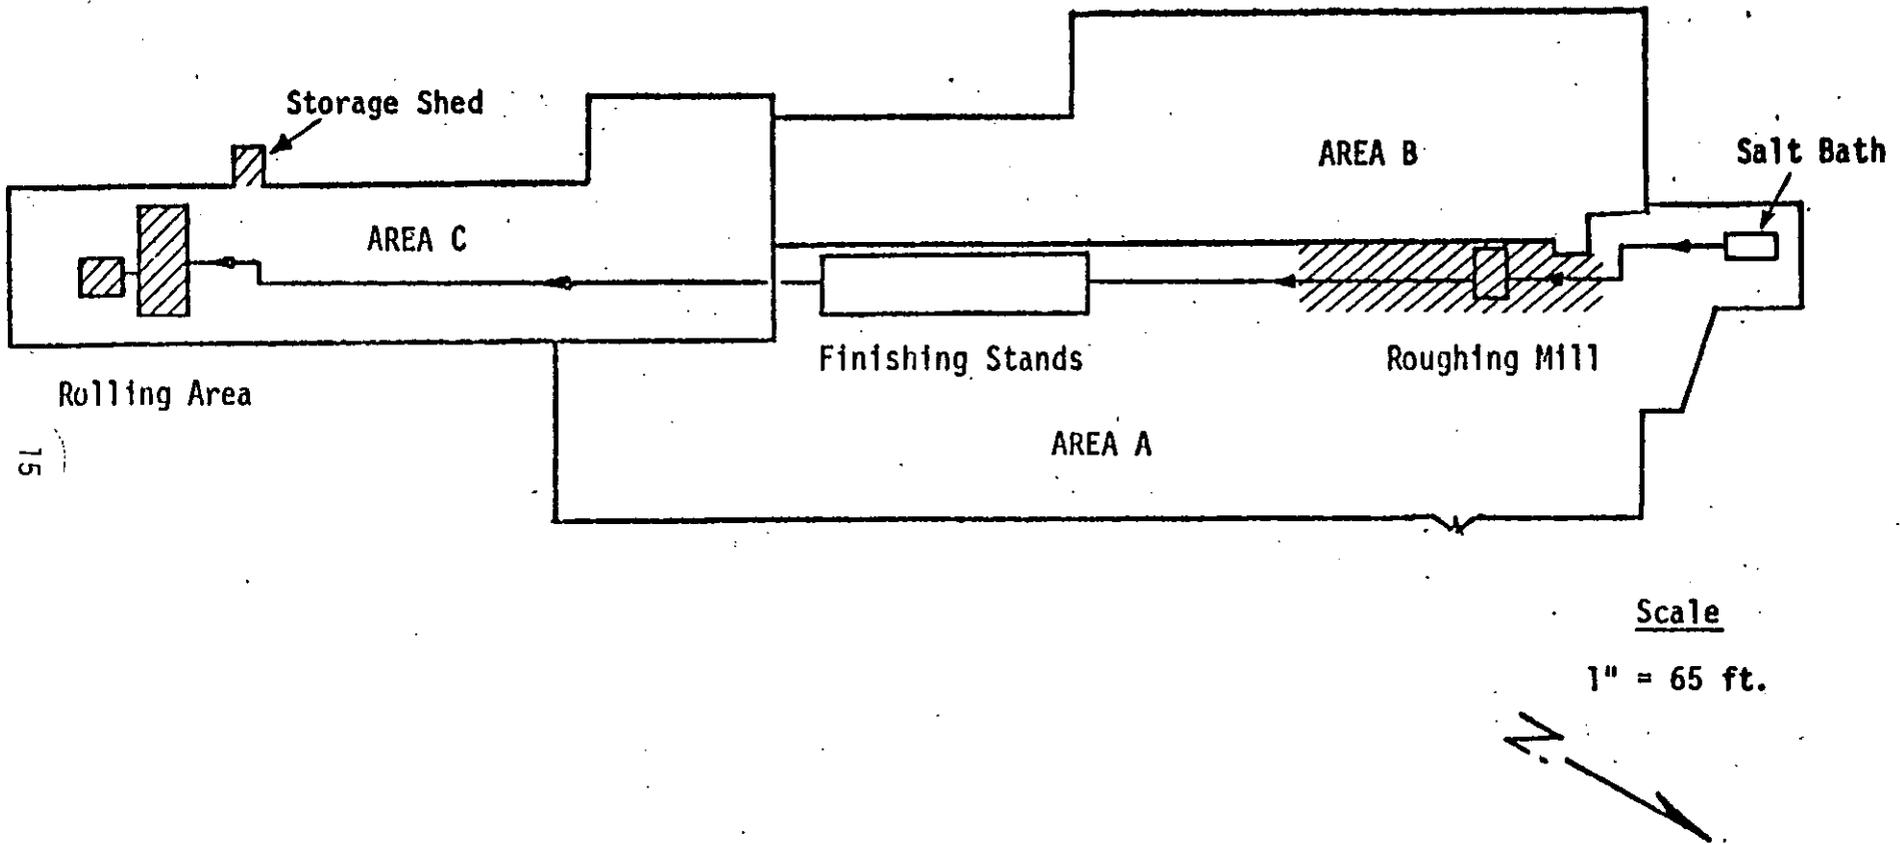
Fig. 11. Location of contaminated areas found during the 1980 preliminary survey.
