Bechtel*Interoffice Memorandum*

Subject Determination of Additional Contaminated Areas at AAS Date March 17, 1994

The purpose of this memorandum is to provide results from characterization activities at the Former Associated Aircraft Site (AAS) in Fairfield, Ohio. Additional areas of contamination requiring remediation were identified during these activities. Areas that are currently known to exhibit elevated readings, and were not in the original scope of work are shown in Figure 3. To summarize, the areas added are located in the following areas;

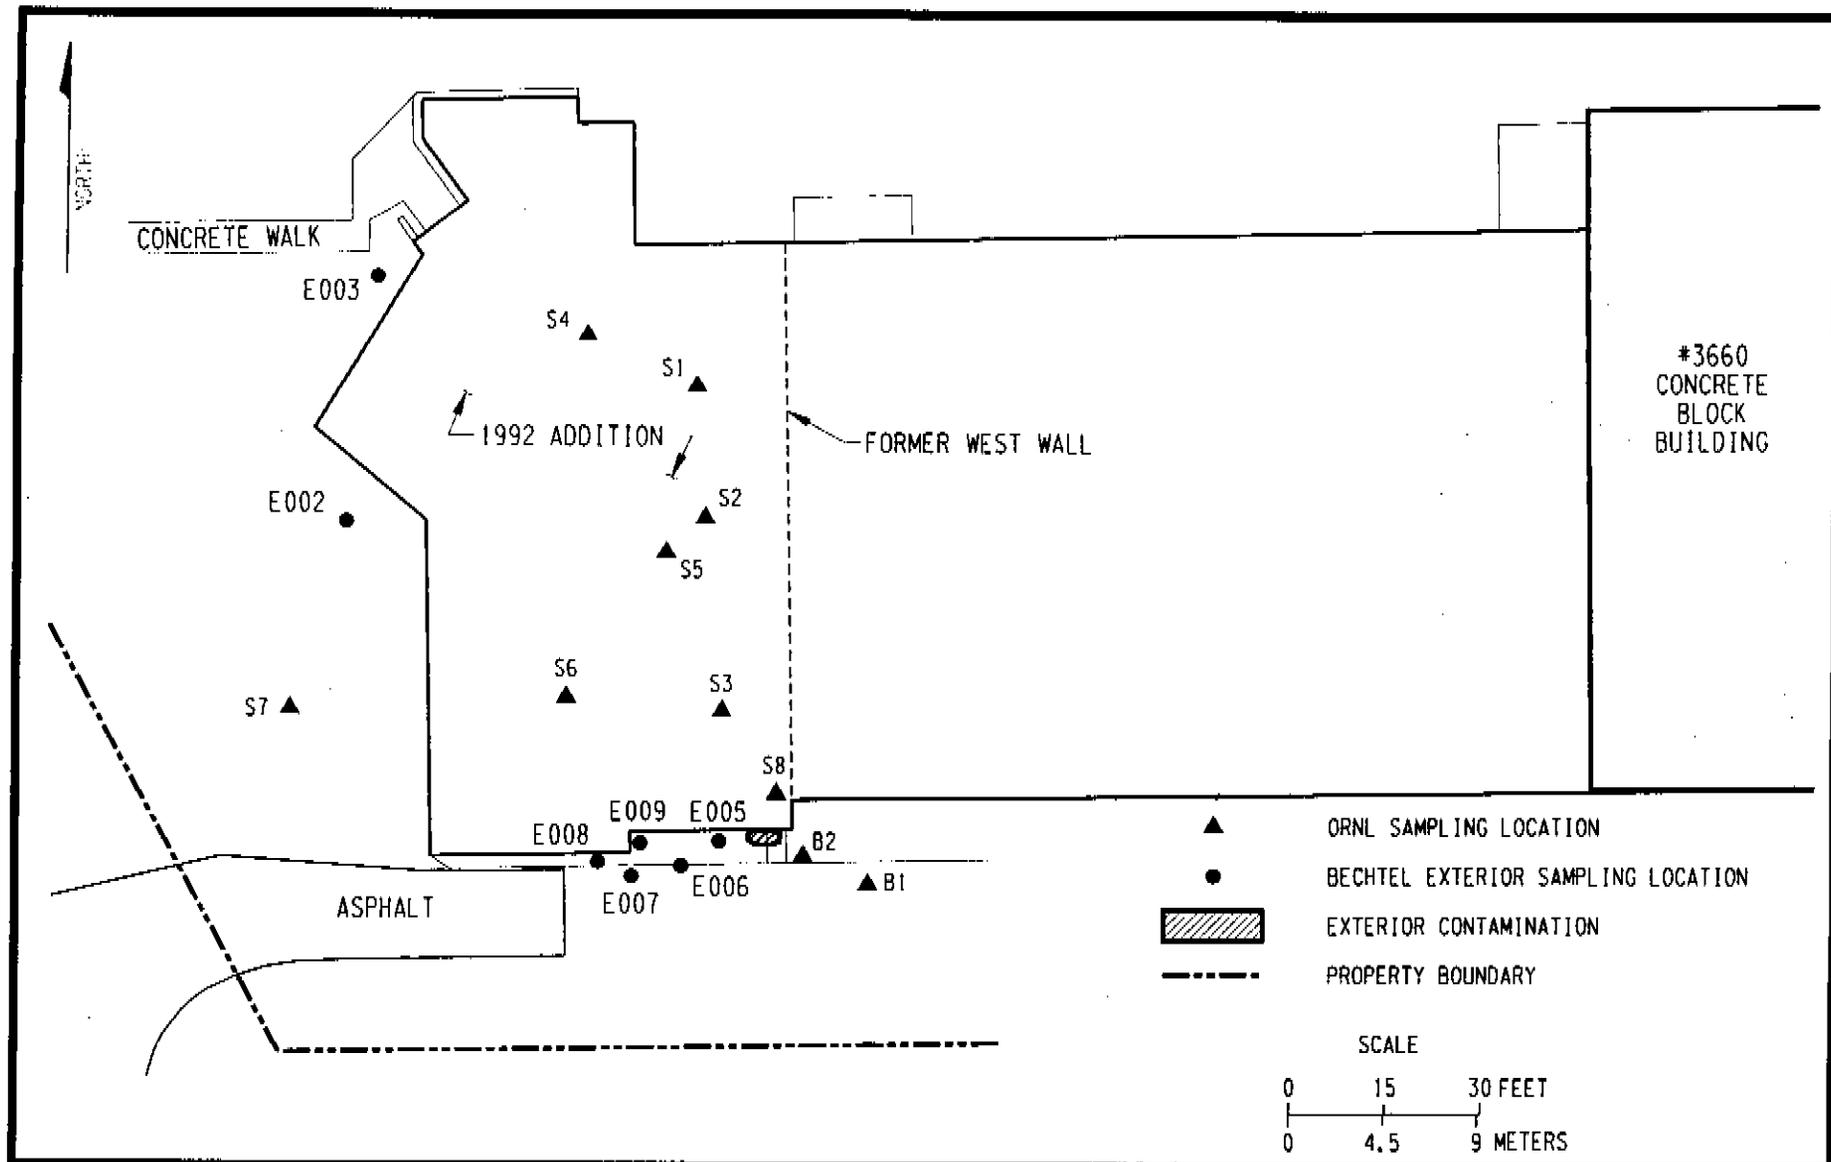
Figure 1
 Characterization Sampling Locations
 at the Former Associate Aircraft Site

Figure 1 shows exterior sampling locations adjacent to the front offices at AAS. Figure 2 shows sampling locations from inside the building as well as sample locations from outside the building near the pipe exit. Uranium-238 concentrations from discrete sampling locations in these areas are presented in Tables 1 and 2 respectively. It should be noted that samples collected during the February 1995 sampling effort have not yet been analyzed. These samples are designated with "TBA". Upon receipt of these sample results from the laboratory, the attached data tables will be completed. Further, final status of the pipe (i.e. where the end is located) has yet to be determined. This determination will dictate if trenching and additional sampling will be required.

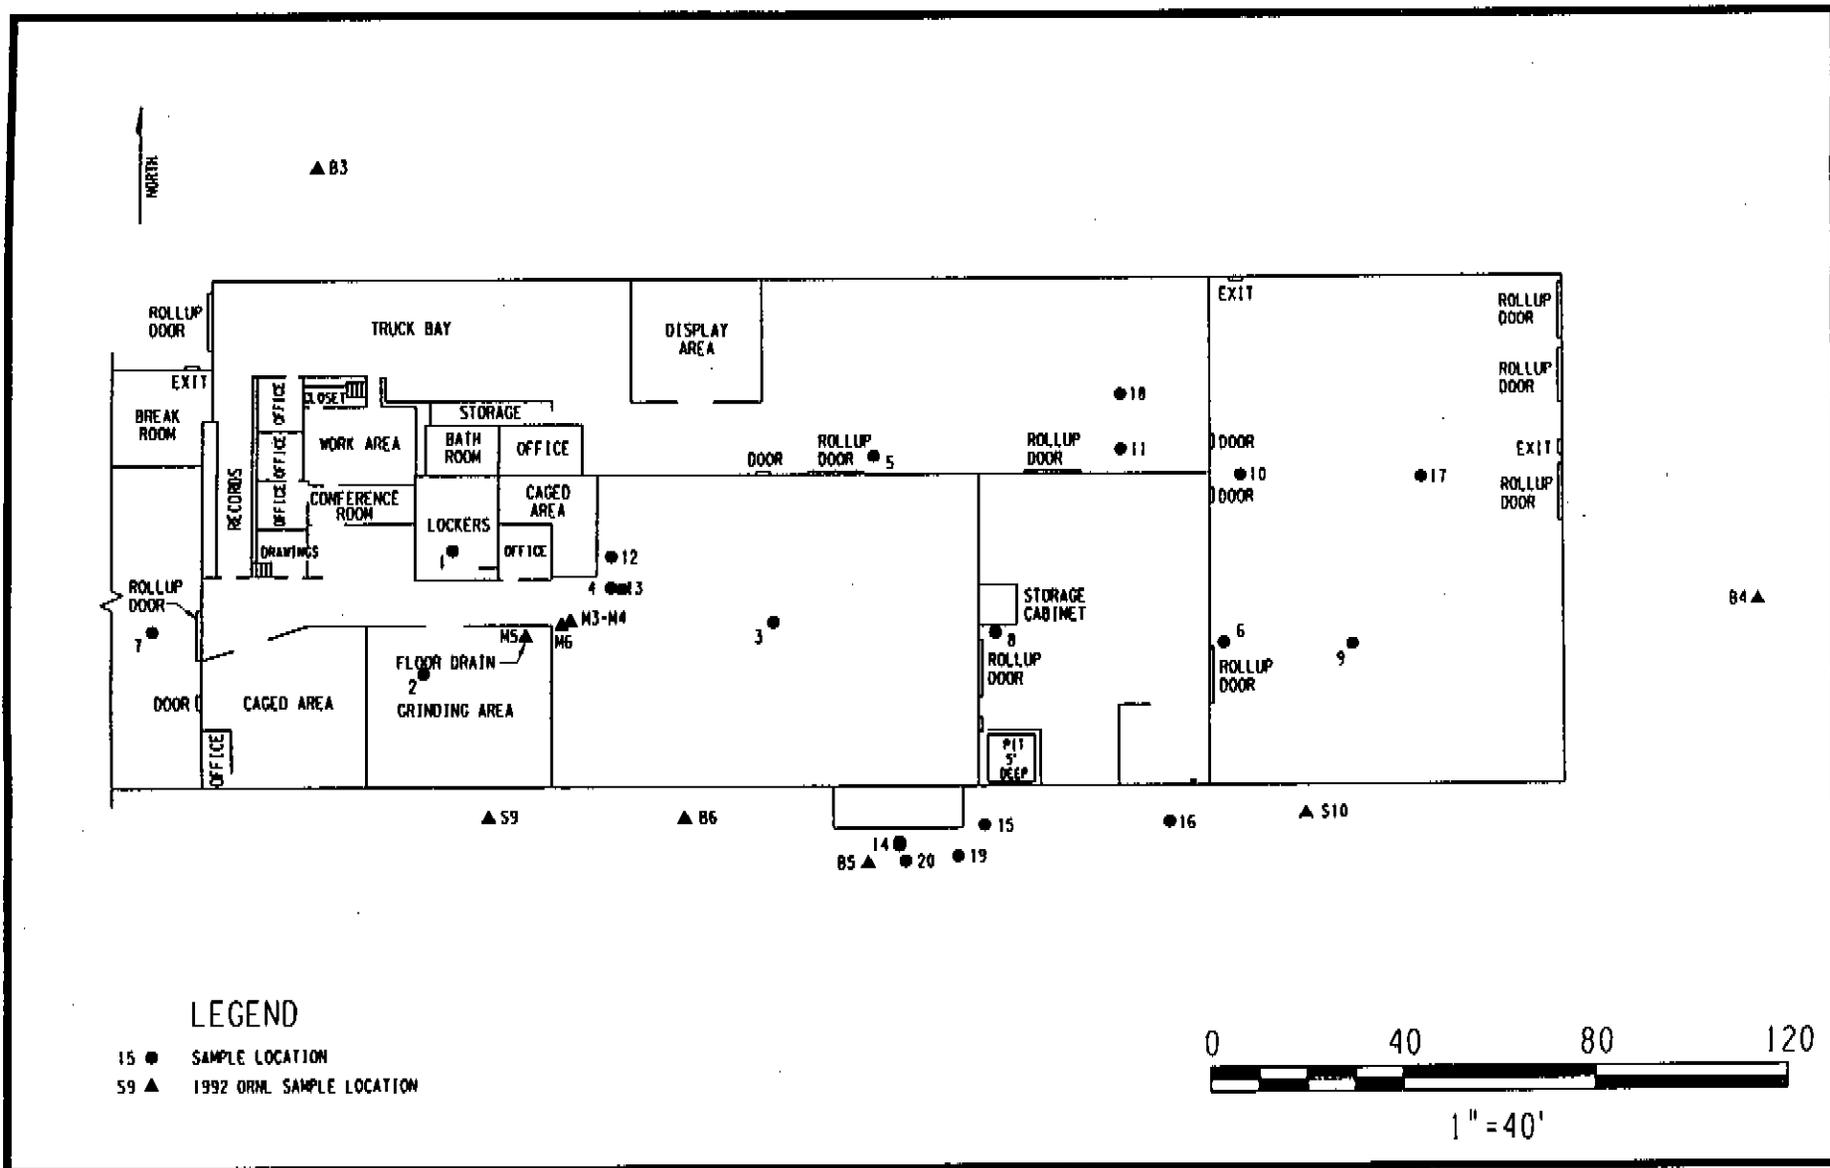
Figure 2
 Characterization Sampling Locations
 at the Former Associate Aircraft Site

Based on the results obtained from the first phase of additional sampling, uranium-238 concentrations above criteria were found at locations 1, 4 and 6. The radioactive contamination detected at locations 4 and 6 were delineated in a second phase of sampling by

placement of boreholes 10, 17 and 16 for location 6, and by placement of boreholes 12 and 13 for location 4. Vertical and areal extent of contamination has thereby been established for these locations. The elevated uranium concentration found at location 1 was from expansion joint material and from soil directly beneath the expansion joint. This material has been scheduled for removal as part of the original scope of work. None of the other additional sampling locations had uranium-238 concentrations above the site specific cleanup criteria of 17.5 Pci/g. Elevated results from area 4 are considered a data anomaly, based on confirmatory results from samples at locations 12 and 13.

Several areas in addition to those identified as contaminated in the ORNL designation report, were surveyed for direct and transferrable contamination in Zone V inside the building. These surveys were conducted the week of December 12, 1994 (see Attachment 1). Based on these surveys, four additional areas were found to be contaminated above the DOE criteria. They include; the bathroom and office north of the locker room in Zone V, section 2 of the building, and on the expansion joint and floor of Zone V. Areas surveyed can be located on Figure 2.

Survey results obtained in the bathroom ranged from background to 86,000 disintegrations per minute (dpm) per 100 cm². Areas above guidelines were found on the floor, horizontal surfaces, drains, and the lower twelve inches of the wall.

Survey results obtained in the office ranged from background to 29,000 dpm/100 cm². Areas above guidelines were found at several locations on the floor.

Survey results obtained in section 2, east of Zone II ranged from background to 9,200 dpm/100 cm². Areas above guidelines included old yellow paint on the floor. Only about 70% of the floor area and the expansion joint could be surveyed. Of the total surveyed, approximately half of the areas were above guidelines.

Survey results obtained from section 5 ranged from background to 7000 dpm/100 cm². Areas above guidelines were found at ten locations from 40 feet of expansion joint surveyed. There were also two isolated and elevated areas on the floor. It should be noted that in Zone VI, machinery placement prohibited a thorough survey of the entire floor. Therefore, less than 10 % of the floor in this Zone has been surveyed.

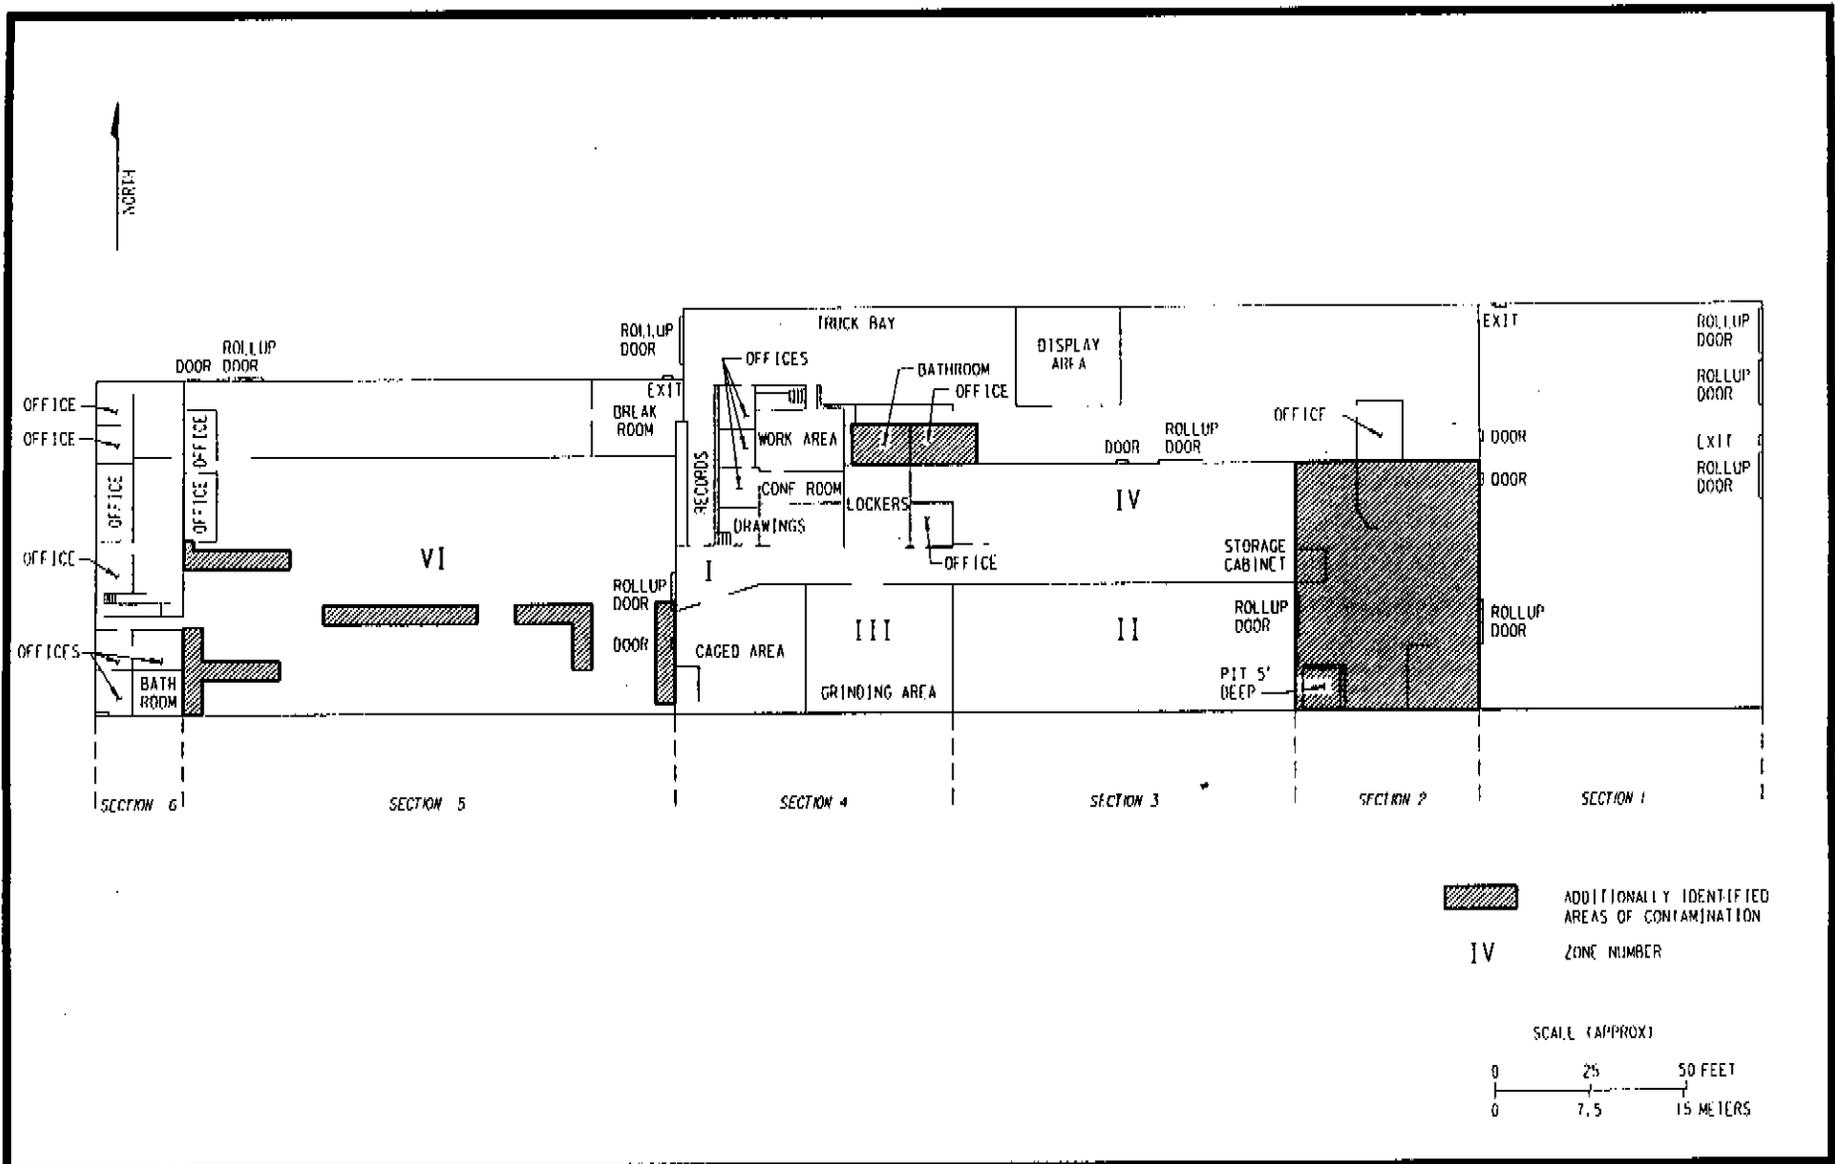
Figure 3
Additionally Identified Areas of Contamination
at the Former Associated Aircraft Site

- North of Zone V in the bathroom area (north of the locker room) and the office (located north of the caged area)
- Zone VI, section 5, five areas within this zone have been identified based on survey of approximately 10 % of the area
- East of Zones II and IV in the storage cabinet area (this area was referred to as section 2 in the ORNL figure).

As noted, not all samples collected have been analyzed, and based on the selected incremental delineation approach, further sampling may become necessary. Based on the results currently available, the identified areas, shown in Figure 3, are the only ones known to be additions to the original scope of remedial action activities at AAS. This could also change due to disposition of the pipe status exiting the building in Zone II. At the time this memo was written, it was discovered that the pipe made an unexpected turn before traveling parallel to the building. The total length of the pipe is currently being determined. Upon this determination, trenching and subsequent characterization of the soils along the pipe trench could be required. In regard to the survey data currently available, it is recommended that additional surveys take place in Zone VI, as only 10 % of this Zone was surveyed. This is due to machinery placement currently preventing access to the entire floor. These additional surveys should be performed at the earliest convenient time, and in conjunction with other remedial action tasks where practical.
