4.0 Durango, Colorado, Disposal Site

4.1 Compliance Summary

The Durango, Colorado, Uranium Mill Tailings Radiation Control Act (UMTRCA) Title I Disposal Site was inspected on May 28, 2009. The disposal cell and all associated surface water diversion and drainage structures were in good condition and functioning as designed. The water level in the disposal cell has dropped, which satisfies criteria for the permanent closure of the transient drainage water collection and treatment system. However, the U.S. Department of Energy (DOE) is evaluating an increase in the downgradient uranium concentration before decommissioning the treatment system. Vandalism, primarily theft and damage to signs, continues at the site. The bases of perimeter signs P41 and P44 have been undercut by erosion but remain stable. Infestations of noxious weeds and deep-rooted plants on the disposal cell continue to be monitored and controlled with herbicide. No other maintenance needs or cause for a follow-up or contingency inspection was identified.

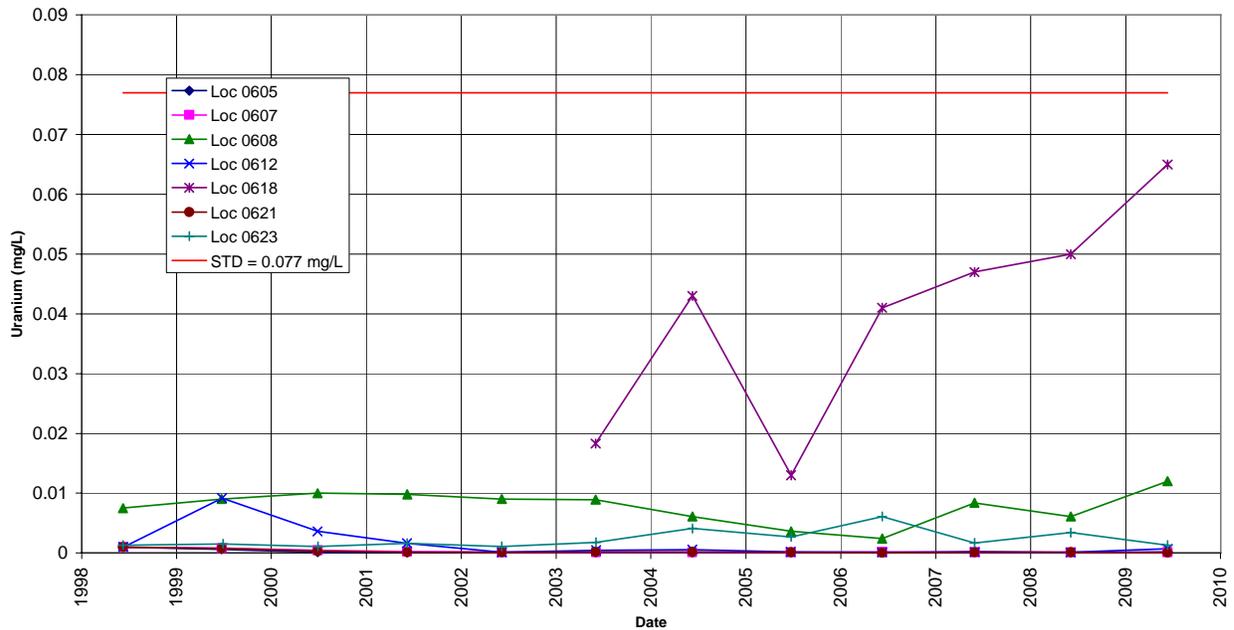
Figure 4-2. Time-Concentration Plot of Uranium in Groundwater at the Durango Disposal Site

Uranium concentrations in monitoring well MW-0618 continued to increase; concentrations in well MW-0608 increased only slightly. Selenium concentrations decreased in both of these wells, and molybdenum remained steady. Analytical results from all other locations are on trend with previous results.

In 2009, the most significant groundwater monitoring result reported was the uranium concentration in well MW-0618. The uranium concentration of 0.065 milligram per liter reported in this well in 2009 is consistent with the 2008 value in that it continues an increasing trend that began in 2005; although, the concentration remains below the site-specific standard of 0.077 mg/L. As mentioned previously, the uranium concentrations in this well are being

evaluated in conjunction with the treatment system closure. In fall 2009, well MW-0618 was redeveloped, and the purging method and pump materials were evaluated. None of these parameters appeared to affect the uranium concentrations. All other concentrations of uranium, along with all concentrations of both selenium and molybdenum, remain on trend and well below their respective standards.

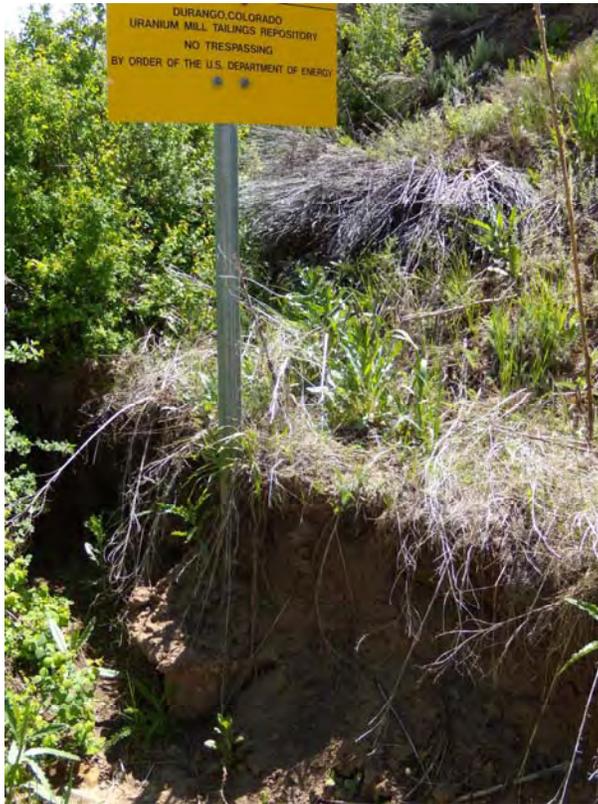
Perimeter sign P1 was missing and will be replaced before the next inspection. Numerous other perimeter signs have bullet holes but remain legible. Perimeter sign P2 has been stolen many times, but because adjacent signs are within sight, it is no longer being replaced. The 81 remaining perimeter signs delineate the site sufficiently. The bases of perimeter signs P41 and P44 (PL-1) are being undercut by erosion but currently remain stable.

DUR 5/2009. PL-1. Undercutting and deposition at perimeter sign P44.

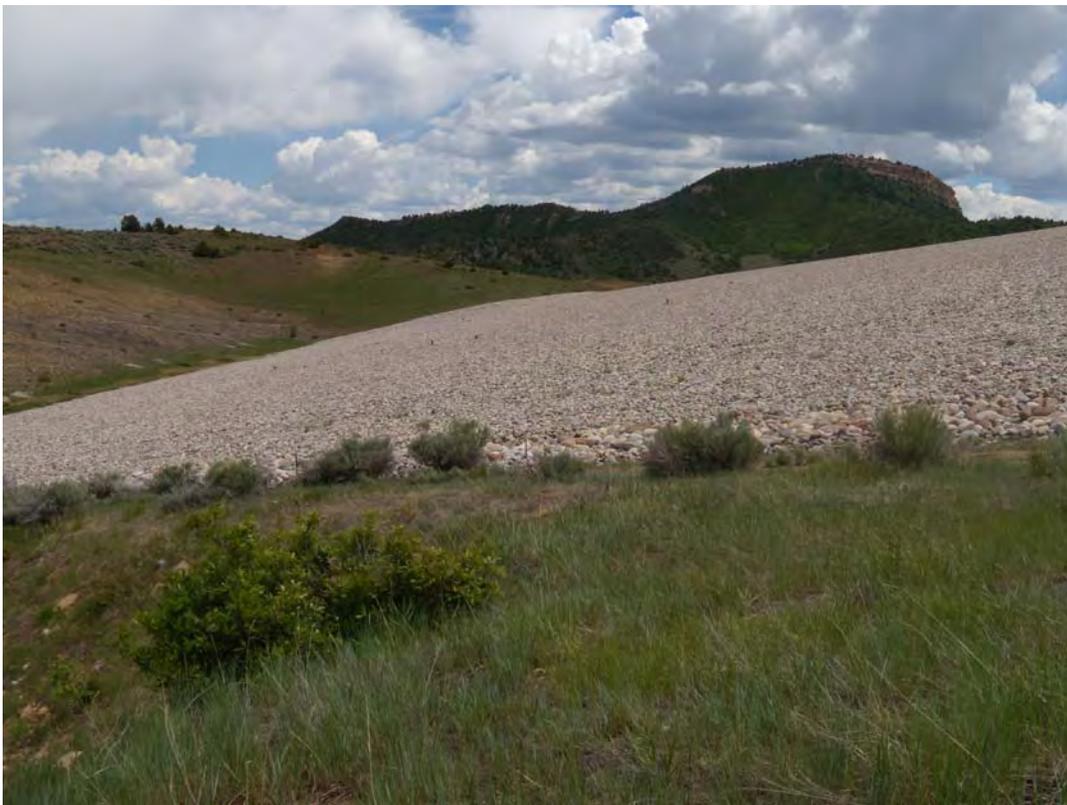
4A Deep-rooted woody shrubs and trees were treated with herbicide in 2006, and woody species observed on the cell in 2009 were all shorter than the 3.5-foot criterion (PL–2). Two noxious weed species—musk thistle and Canada thistle—continue to populate the side slopes. A commercial applicator has treated these plants with herbicide since 2002, and the plants’ populations have decreased significantly. They were most recently treated in June 2009.

DUR 5/2009. PL-2. East-facing sideslope of the disposal cell; note the lack of vegetation.

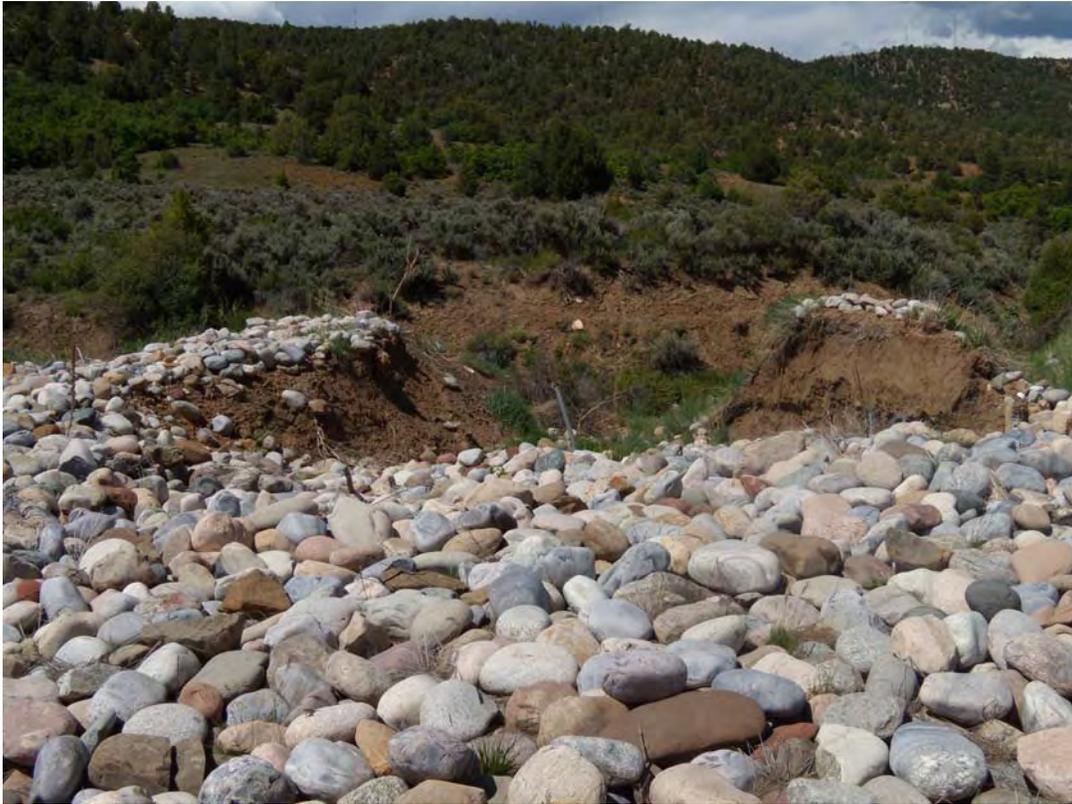
The riprap-covered outflow of Ditch No. 1 was designed to erode back to a rock-filled trench and self-armor in the process. No significant erosion has occurred in Ditch No. 1 since it was last surveyed in 1999 (PL–3).

DUR 5/2009. PL-3. Northeast outflow of Ditch No. 1; no new erosion.

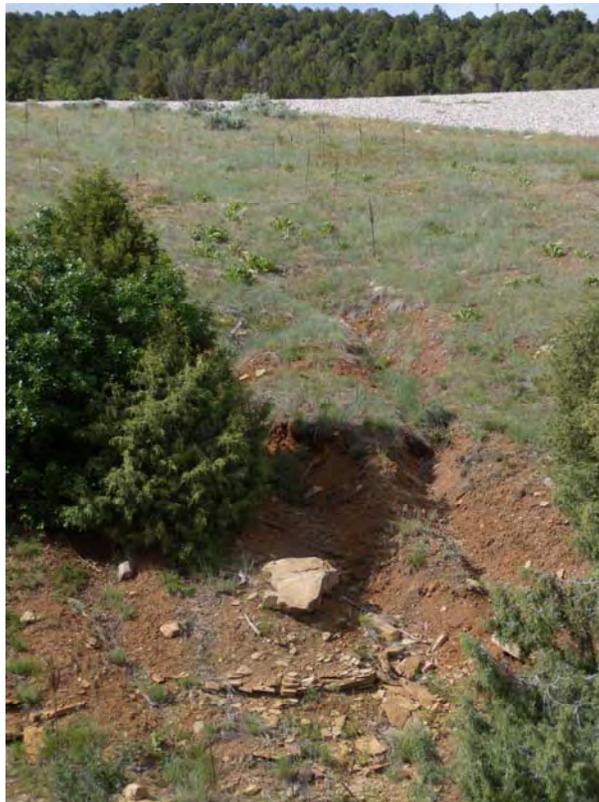
Historical rill and gully erosion has occurred at various locations on site, but most rills and gullies are stabilizing, and none are currently threatening the performance of the disposal cell or its associated surface water diversion structures. The establishment of vegetation and the exposure of resistant bedrock in the gullies are preventing further erosion in most of the gullies (PL-4). DOE will continue to monitor the site for active erosion.

DUR 5/2009. PL-4. Headcuts of gullies below the southwest corner of the disposal cell; no change from 2008.
