**SUBJECT: Transmittal of the March 2010 Fernald Preserve On-Site Disposal Facility
Inspection Forms**

On-Site Disposal Facility Inspection Report

March 2010

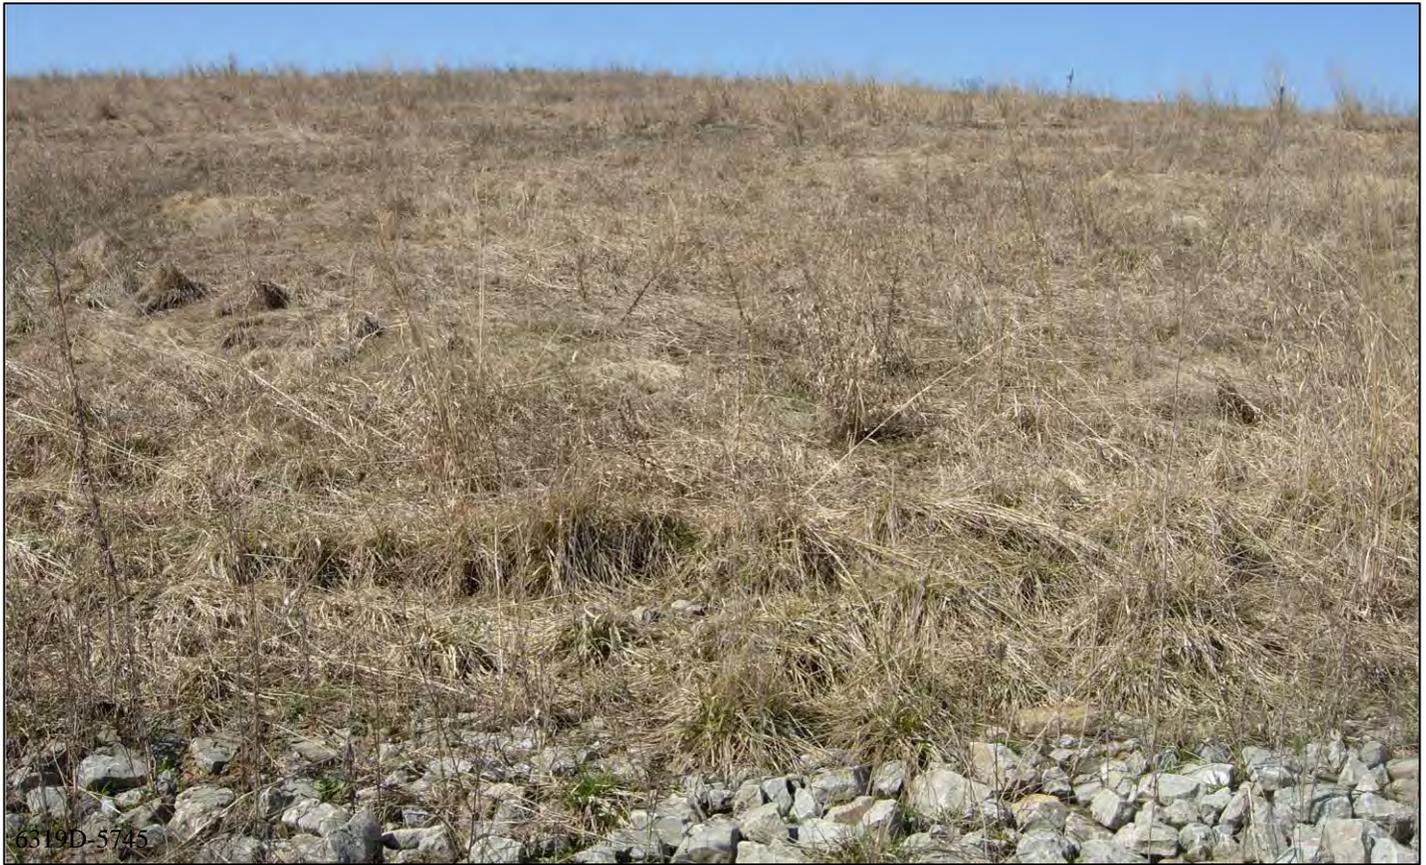
East Face Cell 1

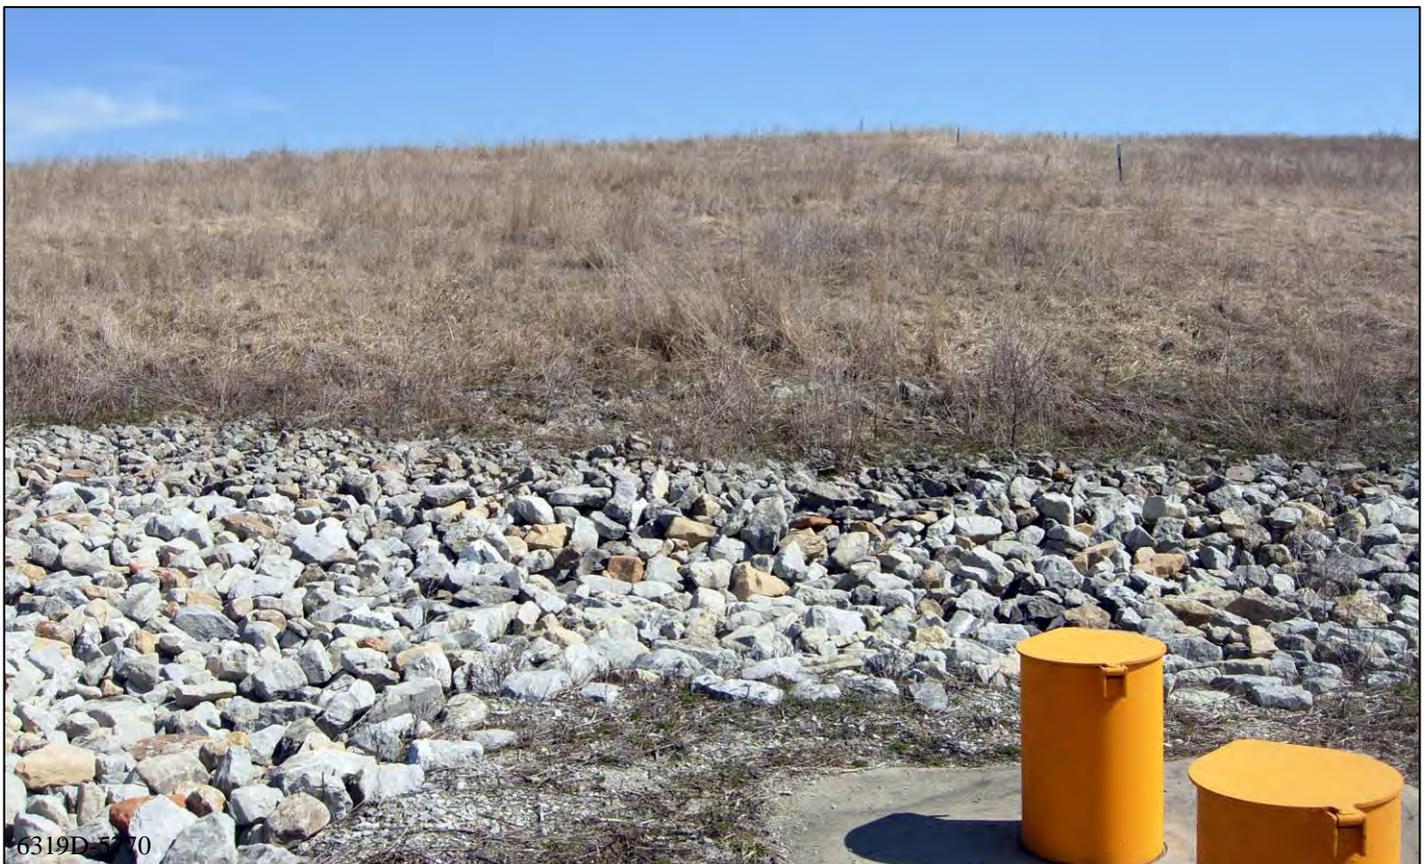
West Face Cell 1

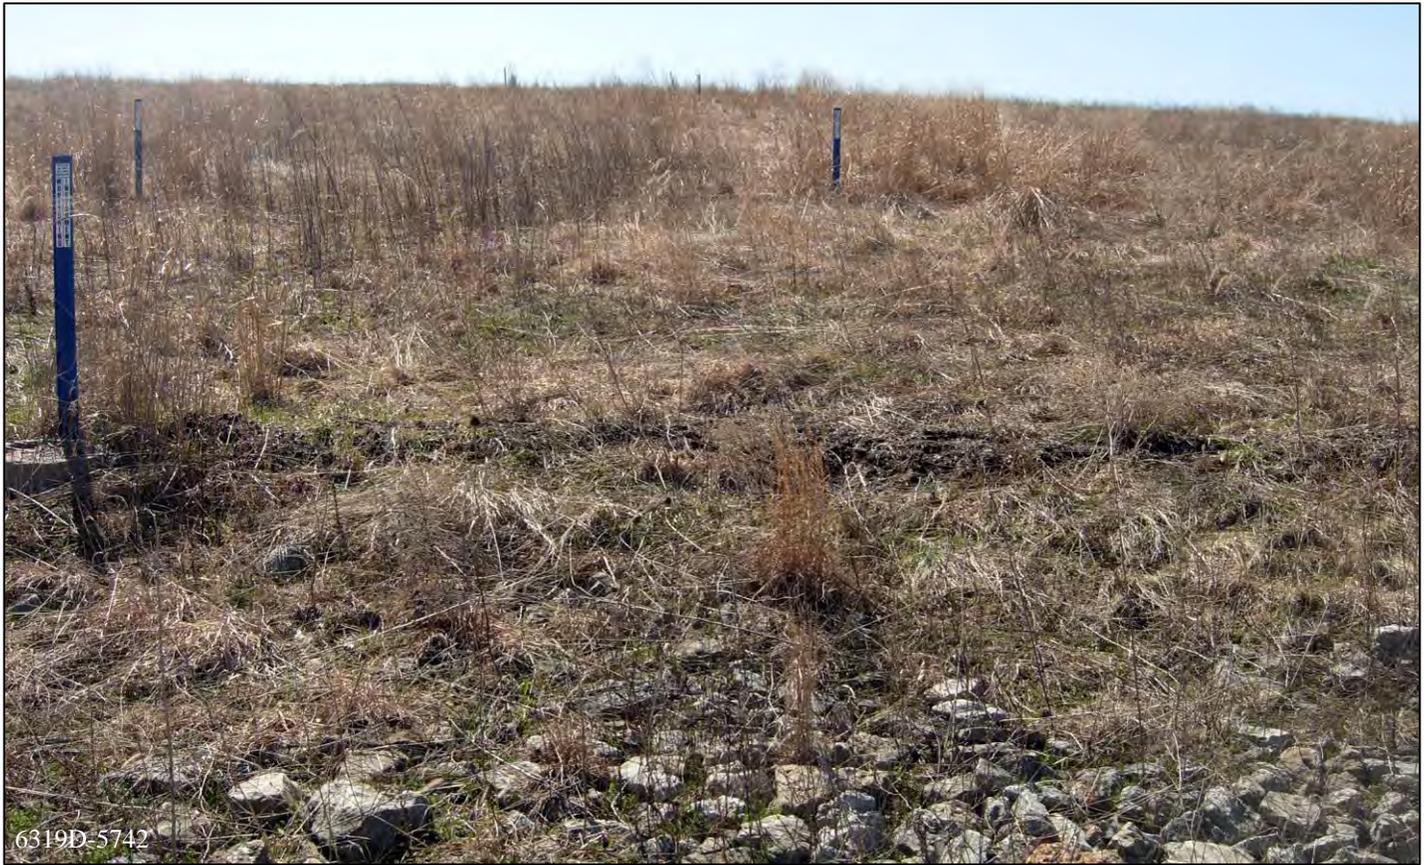
North Face Cell 1

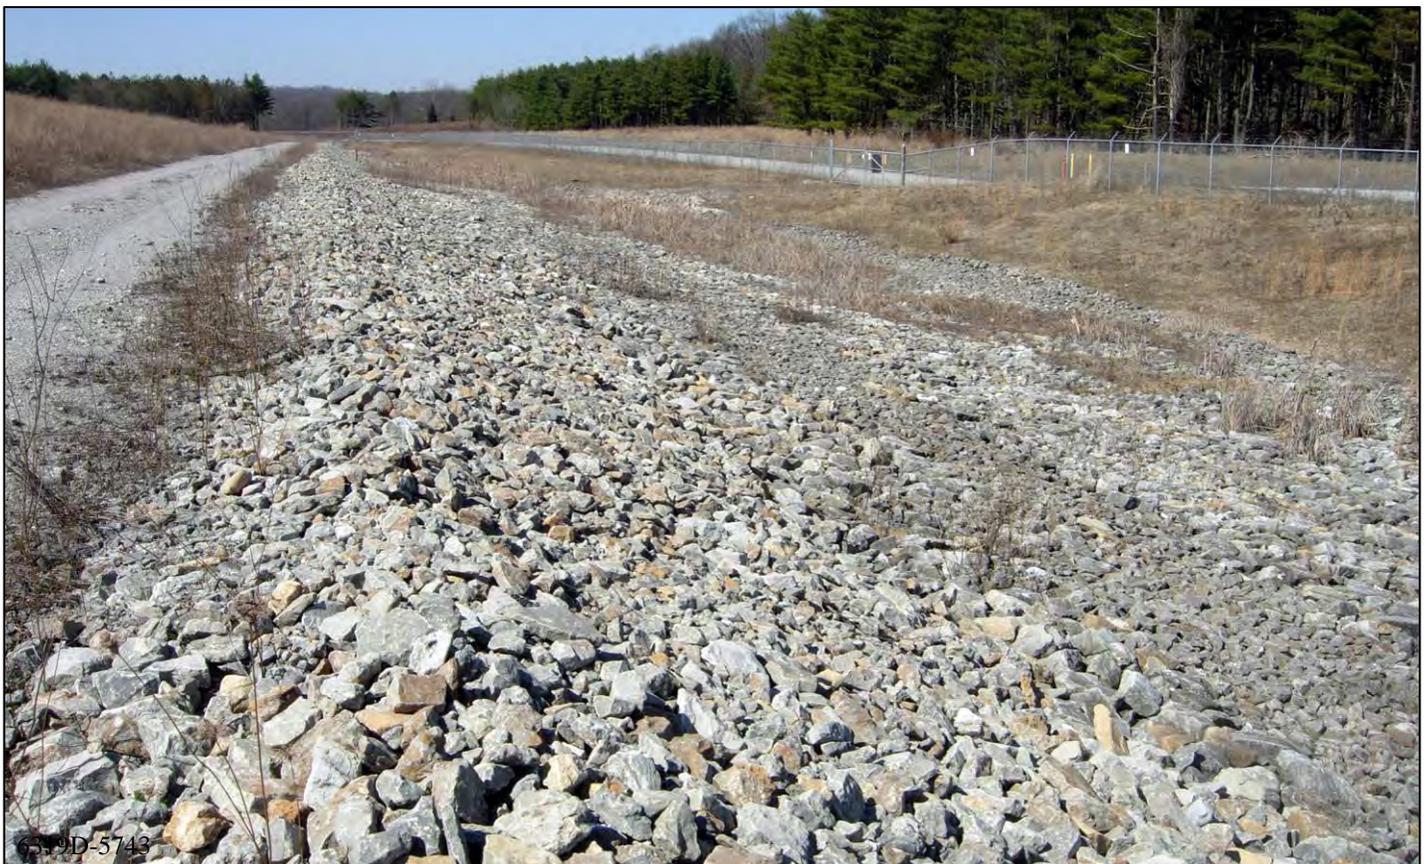
North Drainage (looking west)

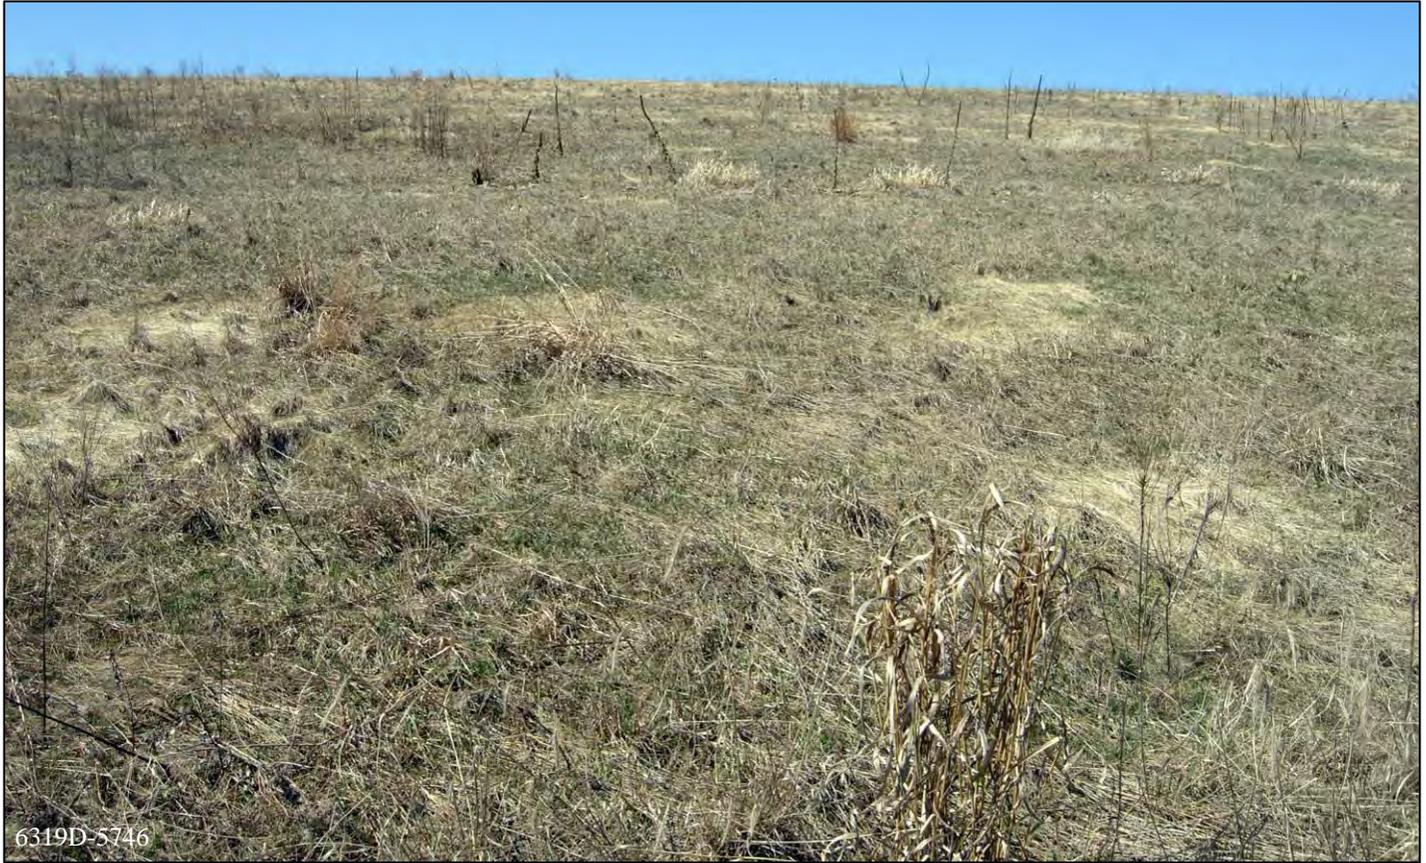
6319D-5746

East Face Cell 2

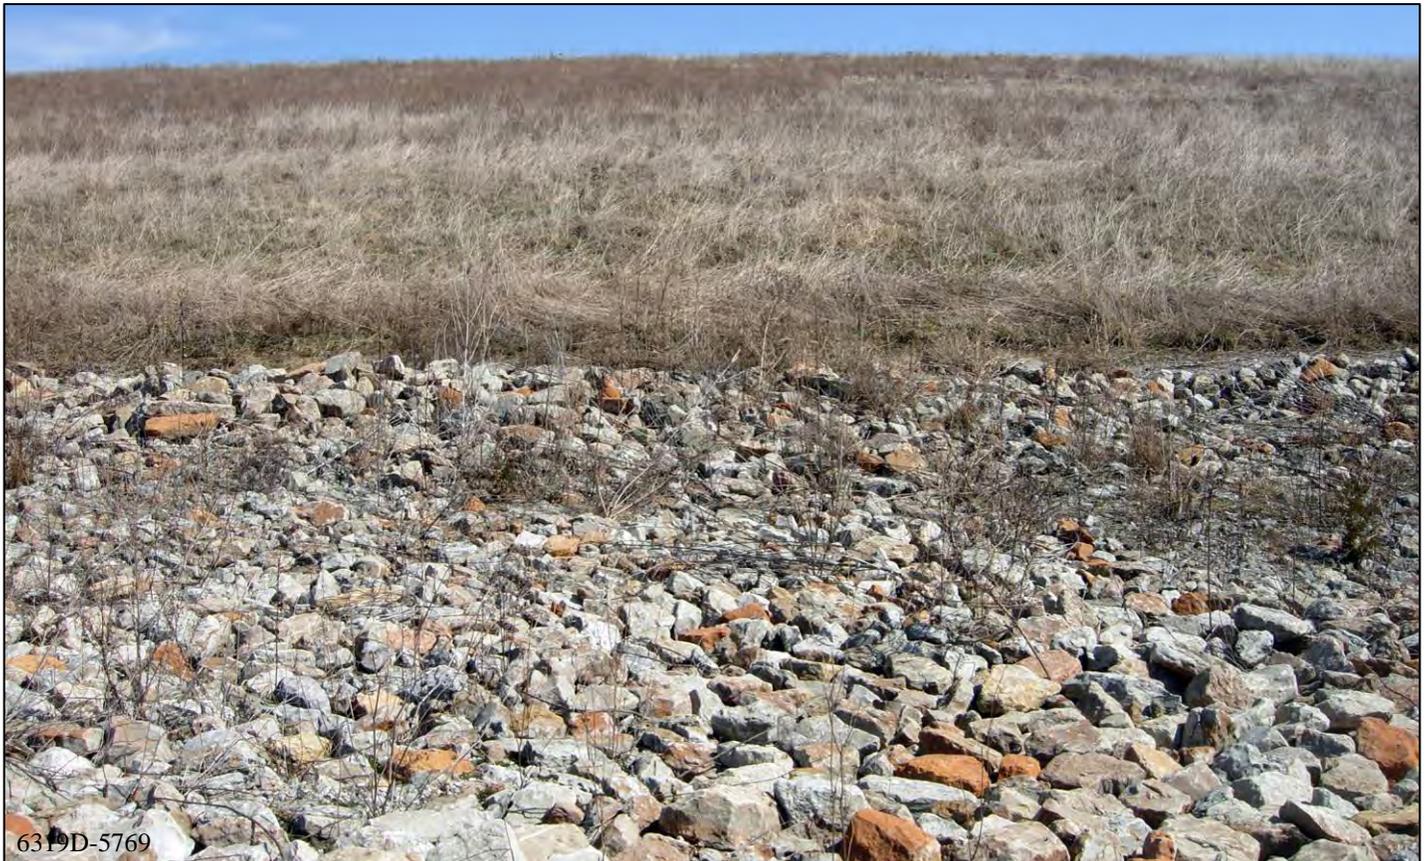
6319D-5769

West Face Cell 2

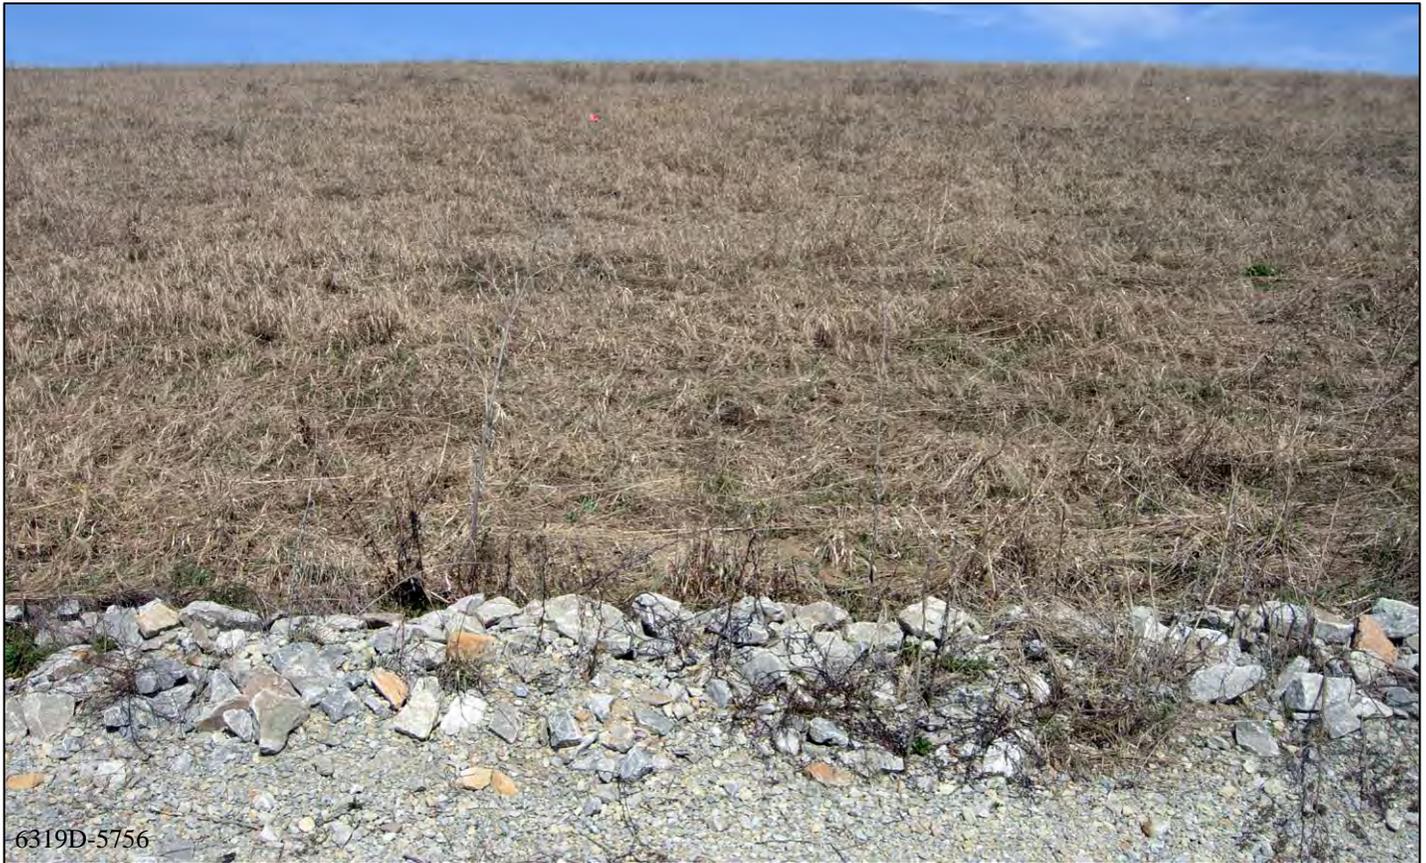
6319D-5756

South Face Cell 8

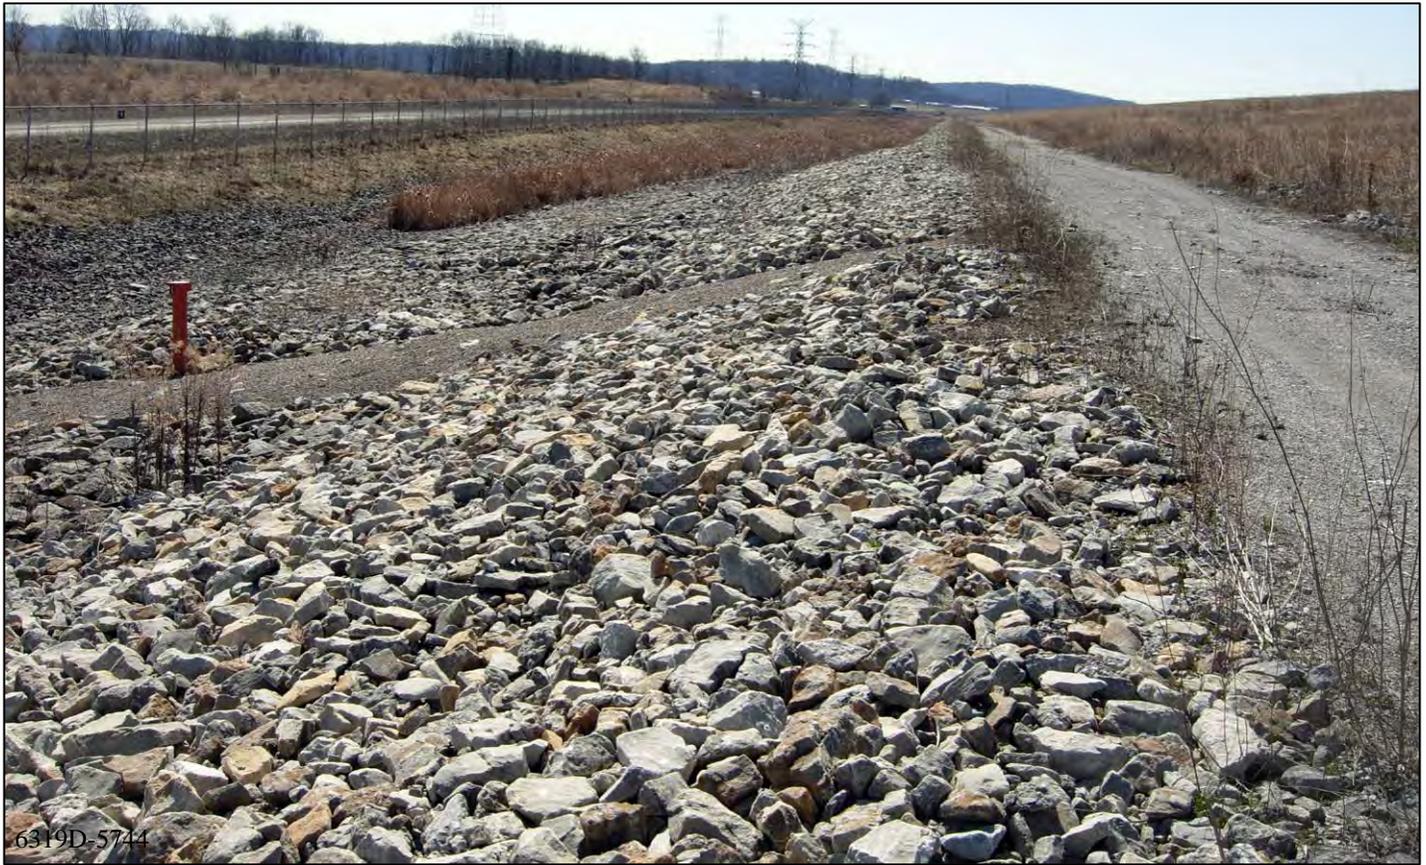
6319D-5744

East Drainage Cell 1 (looking south)

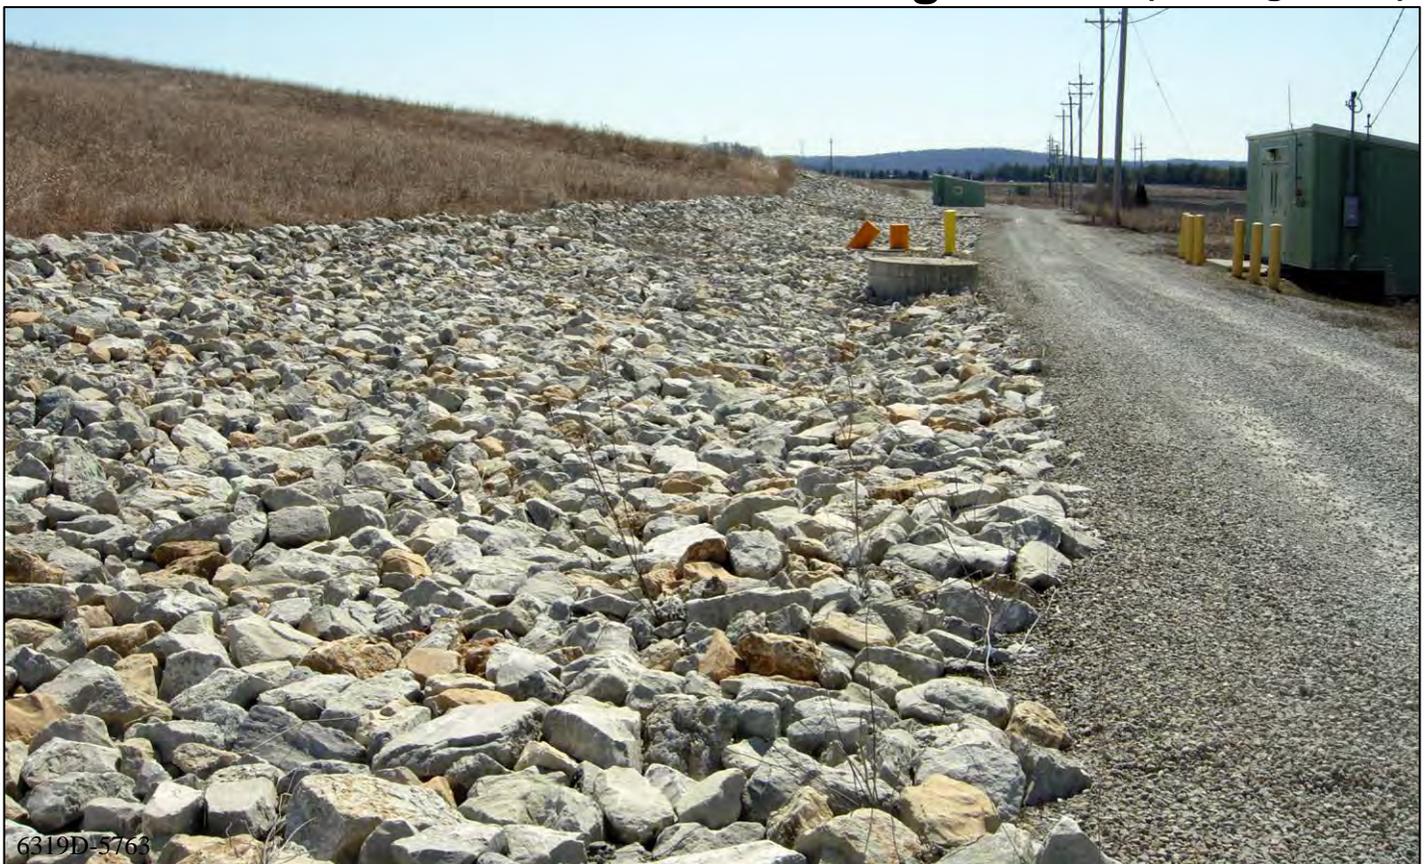
6319D-5763

West Inner Drainage Cell 7 (looking south)

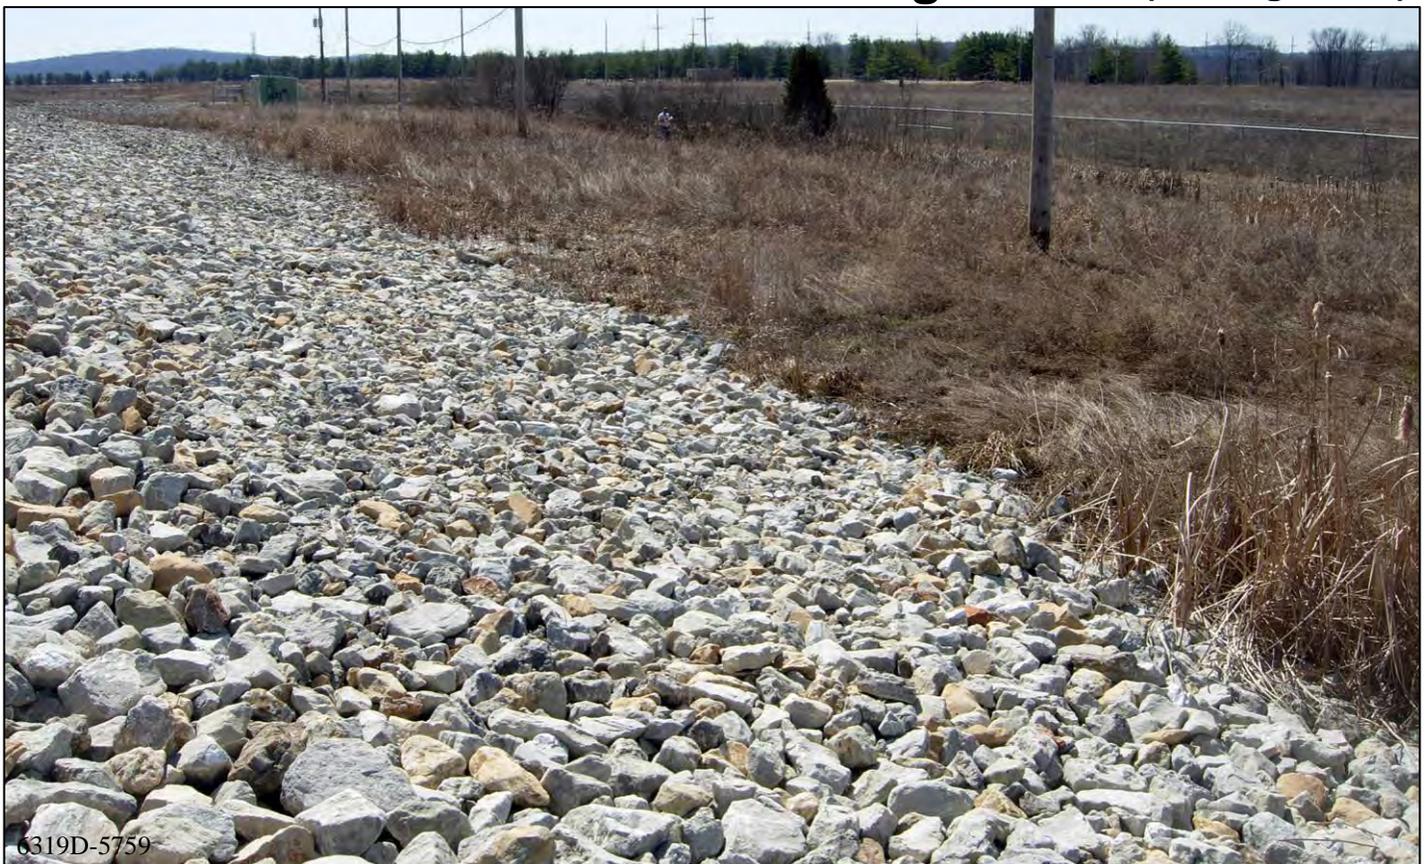
6319D-5759

West Outer Drainage Cell 8 (looking south)
