SUBJECT: Transmittal of the June 2010 Fernald Preserve On-Site Disposal Facility Inspection Forms

On-Site Disposal Facility Inspection Report

June 2010

Fernald Preserve OSDF Walkdown Inspection

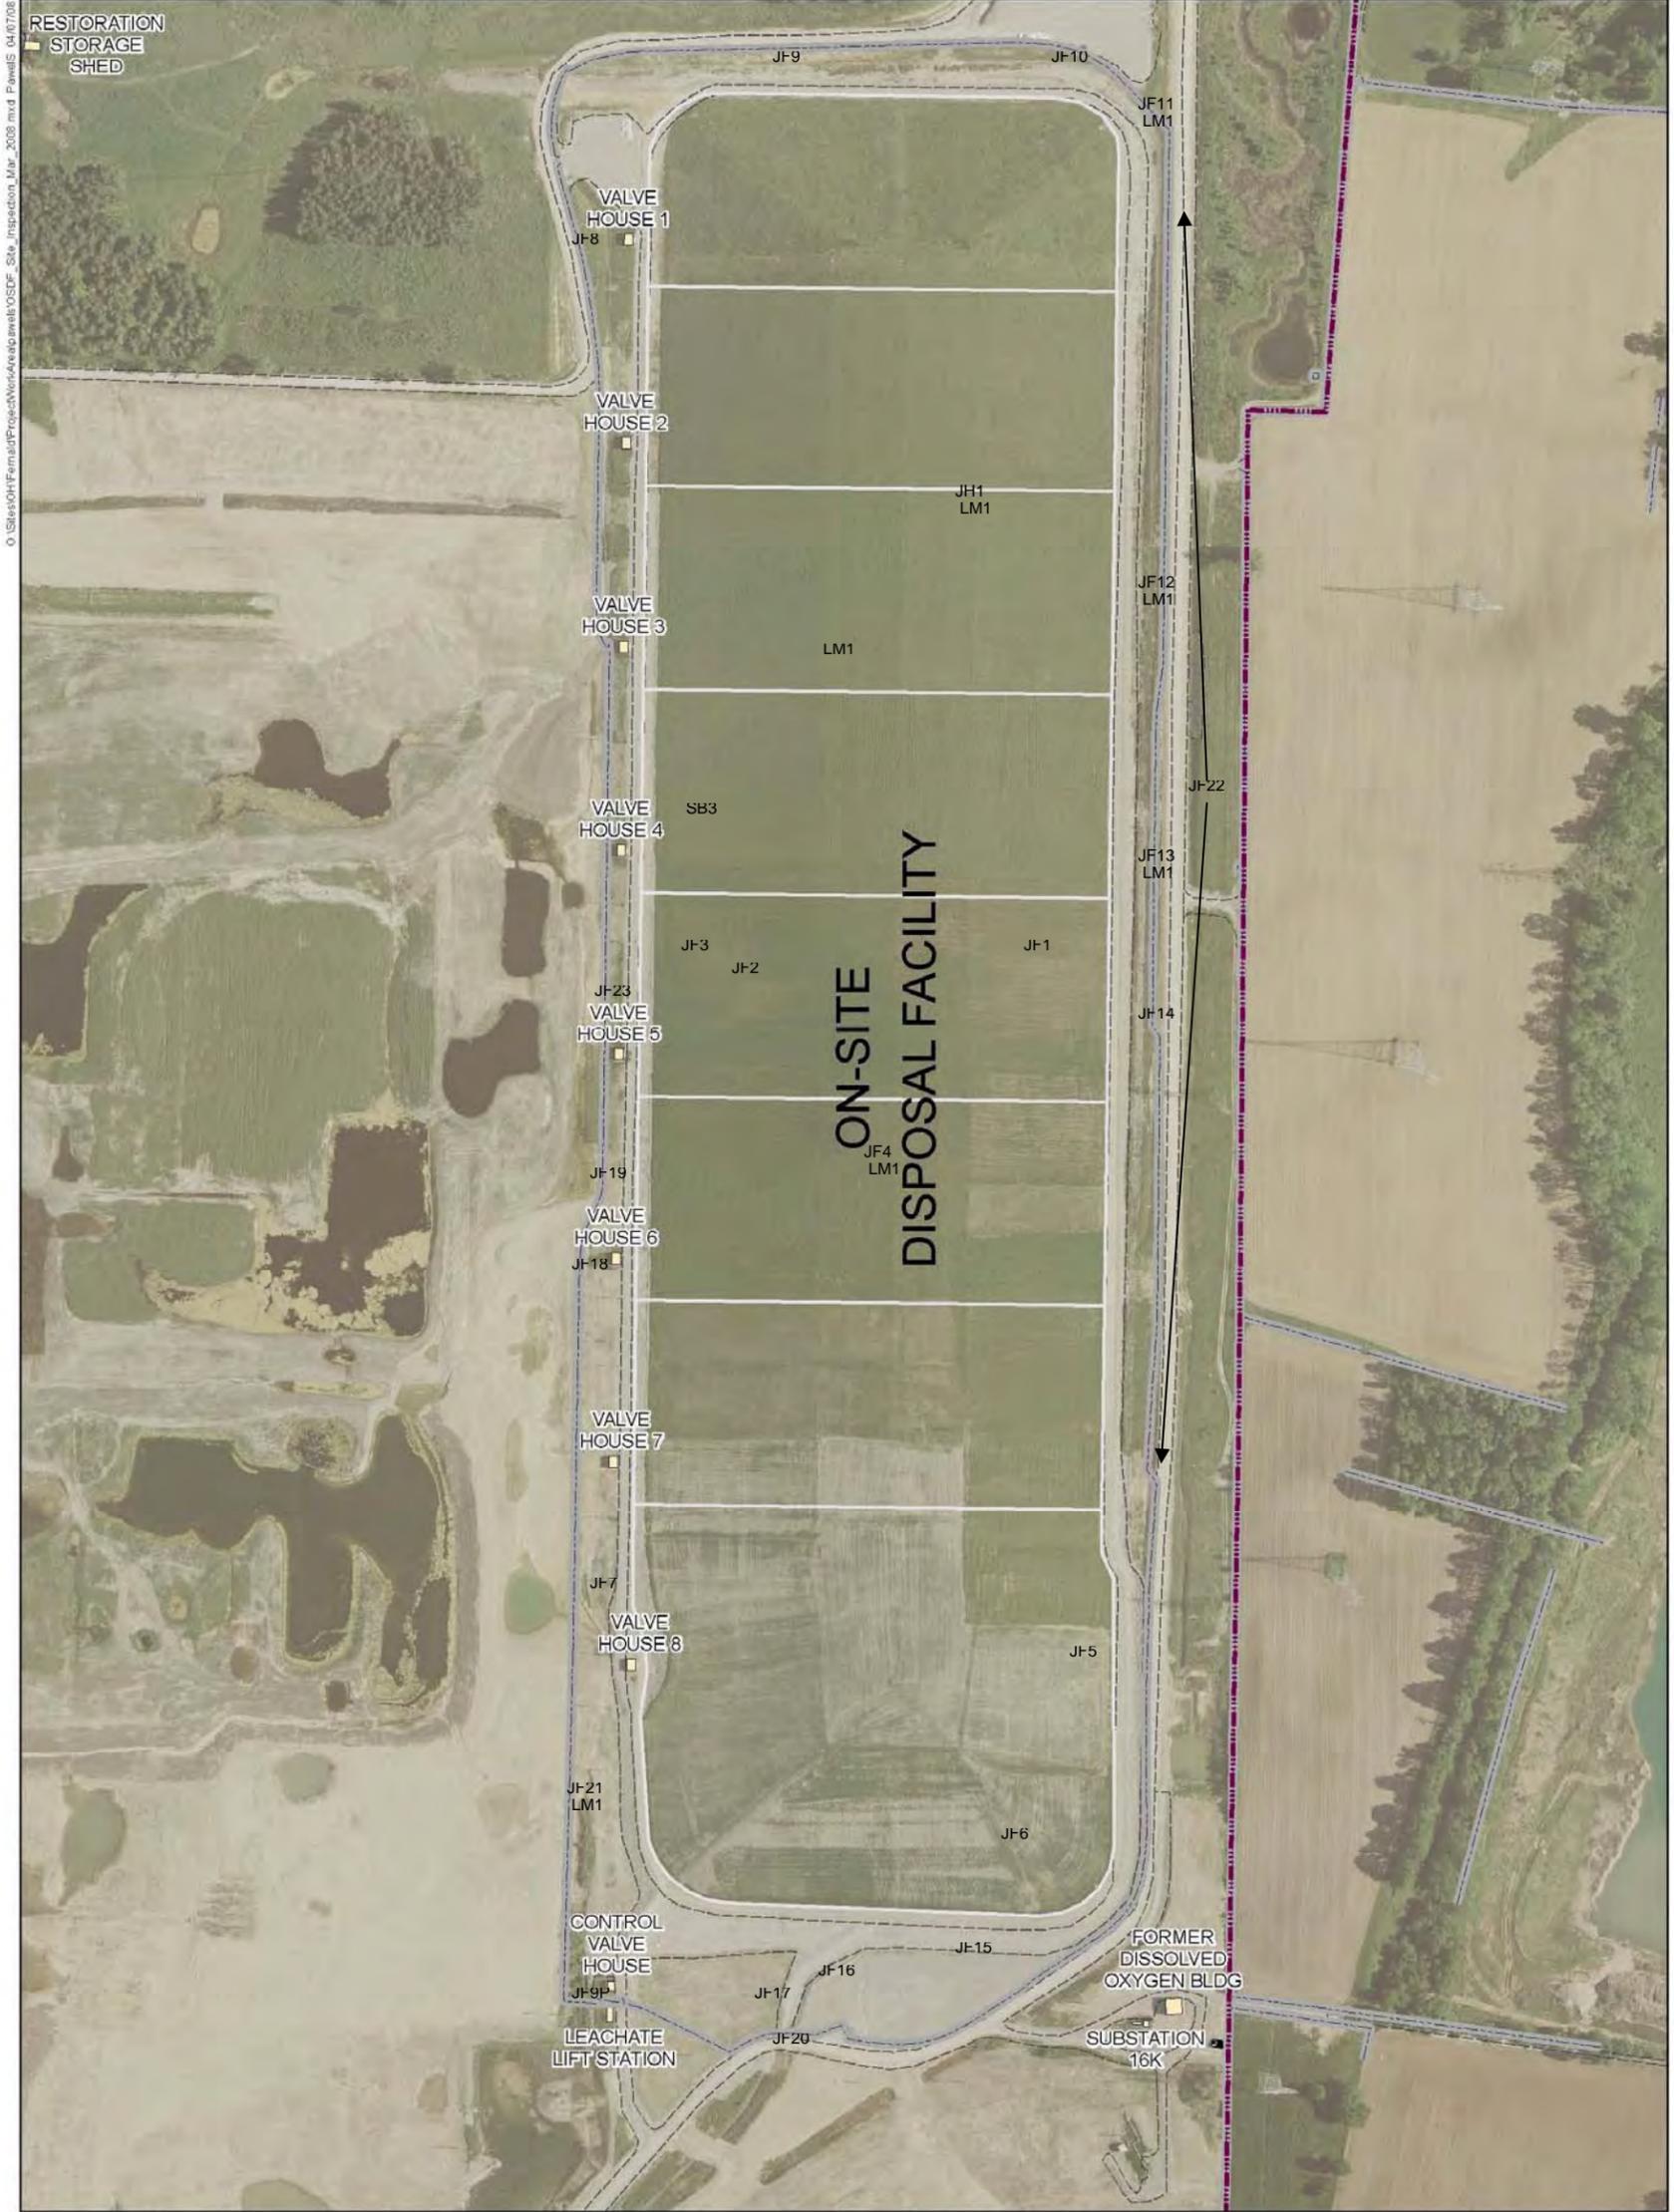
**Fernald Preserve
 OSDF (On-Site Disposal Facility)
 June 2010 Inspection findings requiring
 maintenance or follow-up**

No.	Location (Use Map Whenever Possible)	GPS?	Type of Finding					Description	Photo? (File No.)	Follow Up		
			Erosion	Settlement	Vegetation	Biointrusion	Drainage			Other	Corrected	Maintenance Req'd
SB1	Cell 1, east toe				X			Gray dogwood		X		
SB2	Cell 3, west toe				X			Sumac		X		
SB3	Cell 4, west toe				X			Buckthorn			X	
SB4	Cell 7, top				X			Thistle patch		X		
HS1	Cell 1, NE top				X			Woody stem		X		
HS2	Cell 2, east edge of road				X			Woody stem		X		
HS3	Cell 2, east 6:1				X			Thistle		X		
HS4	Cell 2, west 6:1				X			Teasel		X		
AD1	Cell 2, west at edge of road and riprap				X			Woody stem		X		
AD2	Cell 4, top				X			Teasel		X		
HB1	Cell 2, east top				X			Thistle		X		
HB2	Cell 5/6, east top				X			Thistle		X		
HB3	Cell 8, east				X			Thistle		X		
LH1	Cell 1, north				X			Thistle patches		X		
LH2	Cell 2/3, east, top and west				X			Thistle patches		X		
LH3	Cell 5/6, west				X			Thistle		X		
LH4	Cell 8, west				X			Thistle		X

LM1	Cell 3, west 6:1						X	Rock			X	
LM2	Cell 5, east 6:1				X			Patch of Canada thistle		X		
LM3	Cell 5, top				X			Thistle		X		
LM4	Cell 7, west				X			Crown vetch		X		
JH1	Cell 3, east 6:1						X	Rock			X	
JH2	Cell 7/8, top east				X			Thistle		X		
JF1	Cell 5, east 6:1				X			Woody vegetation			X	
JF2	Cell 5, west 6:1				X			Bull thistle			X	
JF3	Cell 5, west 6:1				X			Bull thistle			X	
JF4	Cell 6, west 20:1				X			Canada thistle, approximately 50'x50' area			X	
JF5	Cell 8, east 6:1				X			Bull thistle (clipped see heads) 30 foot radius – hidden among other vegetation			X	
JF6	Cell 8, south 6:1				X			Bull thistle (clipped seed heads)			X	
JF7	WP, northwest of VH-8				X			Canada thistle patch – 50' radius			X	
JF8	WP, west of VH-1				X			Canada thistle patch – 50' radius			X	
JF9	NP, drainage				X			Woody vegetation (mostly cottonwood and willow) more prevalent west of the centerline			X	
JF10	NEP, drainage and along fence				X			Woody vegetation			X

JF11	NEP, drainage to fence				X			Large patch of Canada thistle			X

JF12	EP, Cell 3, drainage riprap				X				Canada thistle				X
JF13	EP, Cell 4/5 in riprap				X				Canada thistle – 50' north and south of flag				X
JF14	EP, Cell 5, drainage riprap and cattails				X				Woody vegetation and Canada thistle				X
JF15	SEP, Cell 8, east end				X				Canada thistle (most heads clipped)				X
JF16	SP, south of drainage in cattails				X				Phragmites				X
JF17	SP, west of drainage				X				Crown vetch				X
JF18	WP, west of VH-6					X			Groundhog hole. Uncertain about recent activity – JF-10 from previous				X
JF19	WP, GIS structure outlet ditch between Cells 6 and 7						X		ILTS was cut when the ditch from the GIS pipe outlet to the perimeter fence was reworked in 2008. There needs to be additional measures to restrict the possibility of future use of the ILTS (previous inspection item JF-11)				X
JF20	SP culvert pipes						X		West and middle pipes contain 4 inches of sediment (2 inches on east pipe)				X

JF21	WP, southwest of VH-8		X						Erosion – greater than one foot. Grass is growing in erosion rill stopping progression of erosion. Be careful if repaired – Buried pipe! (previous inspection JF13)				X
JF22	EP, fence posts		X						Erosion is occurring around the concrete of several perimeter fence posts. Even with the erosion, the posts remain solid. Continued monitoring is necessary. (Previous inspection JF14)				X
JF23	WP, between VH-4 and 5						X		OSDF perimeter fence repair (previous inspection item JF17) is temporary in nature				X
