Department of Energy
Office of Legacy Management

SUBJECT: Transmittal of the December 2010 Fernald Preserve On-Site Disposal Facility Inspection Forms

On-Site Disposal Facility Inspection Report December 2010

December 2010 Inspection Findings

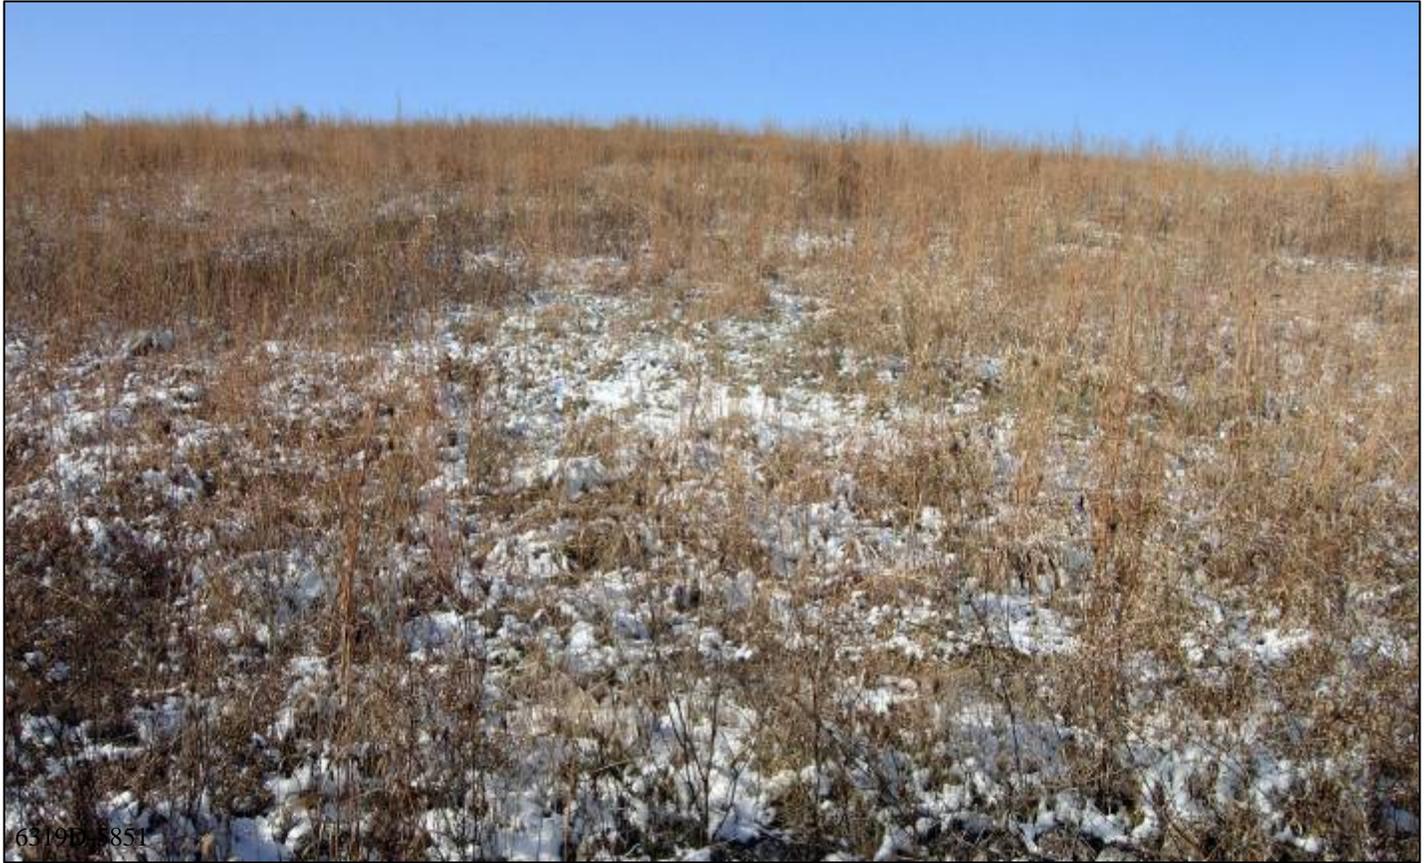
East Face Cell 1

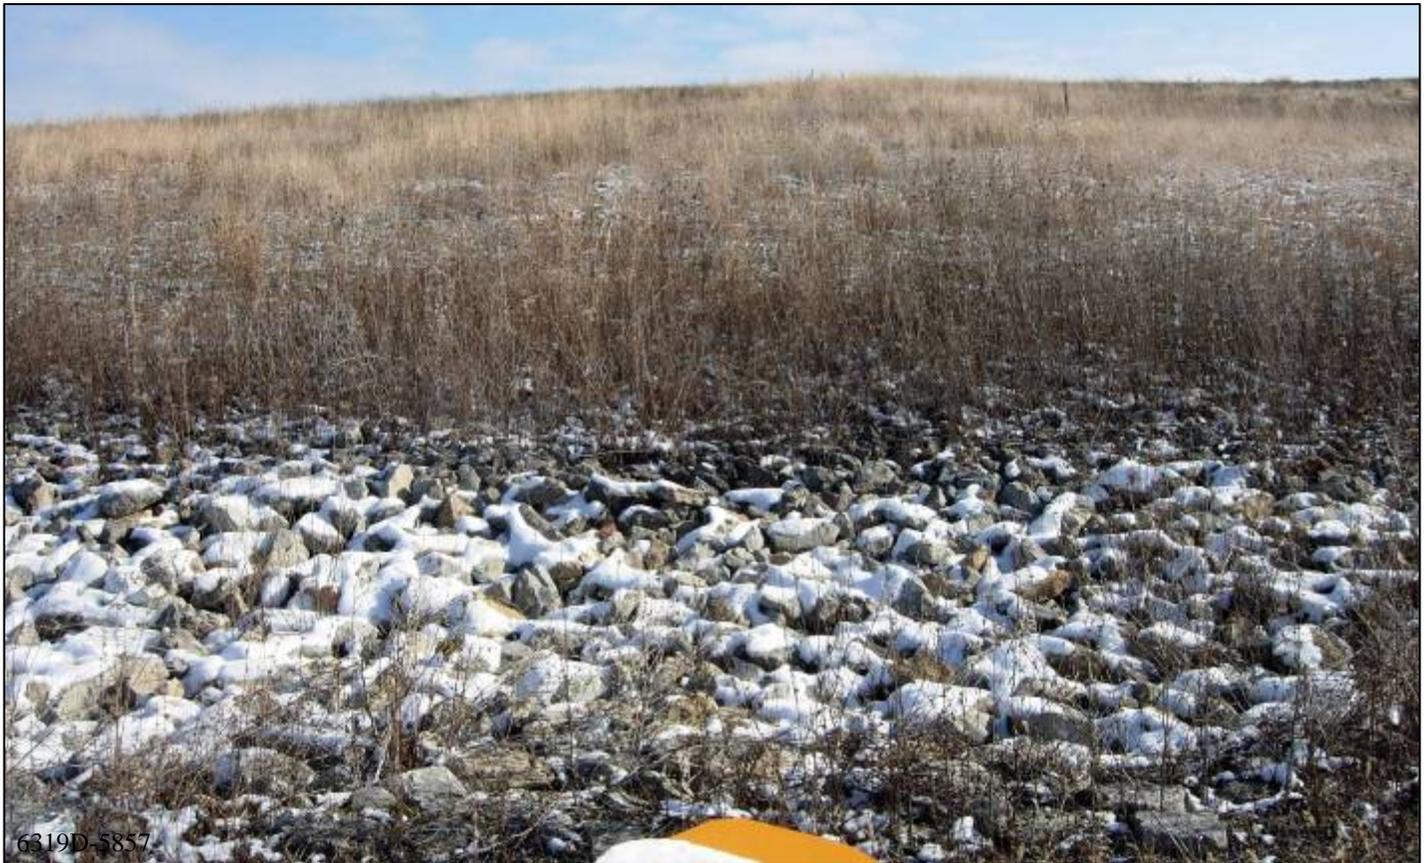
West Face Cell 1

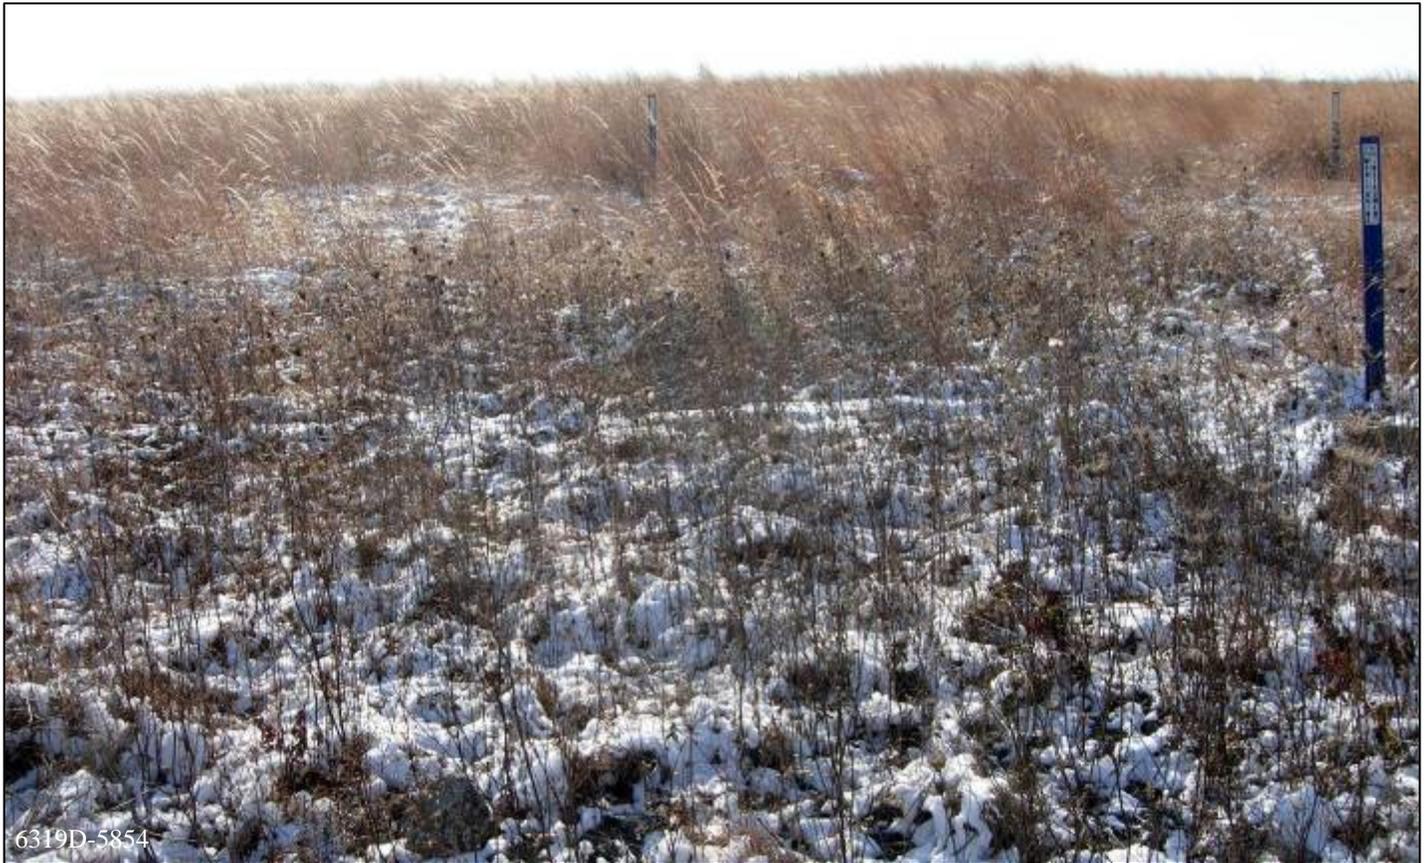
6319D-5854

North Face Cell 1

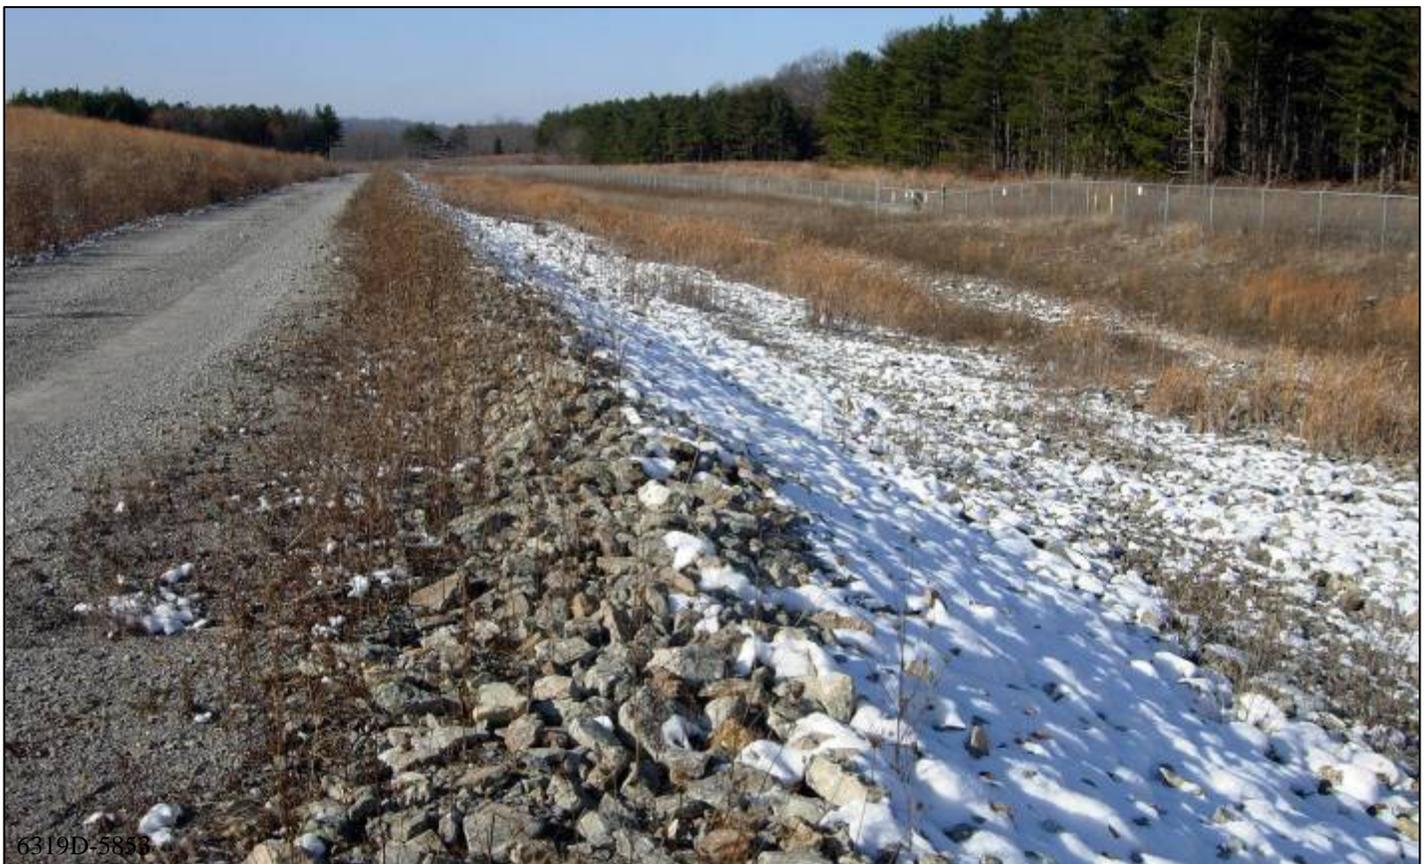
6319D-5853

North Drainage (looking west)

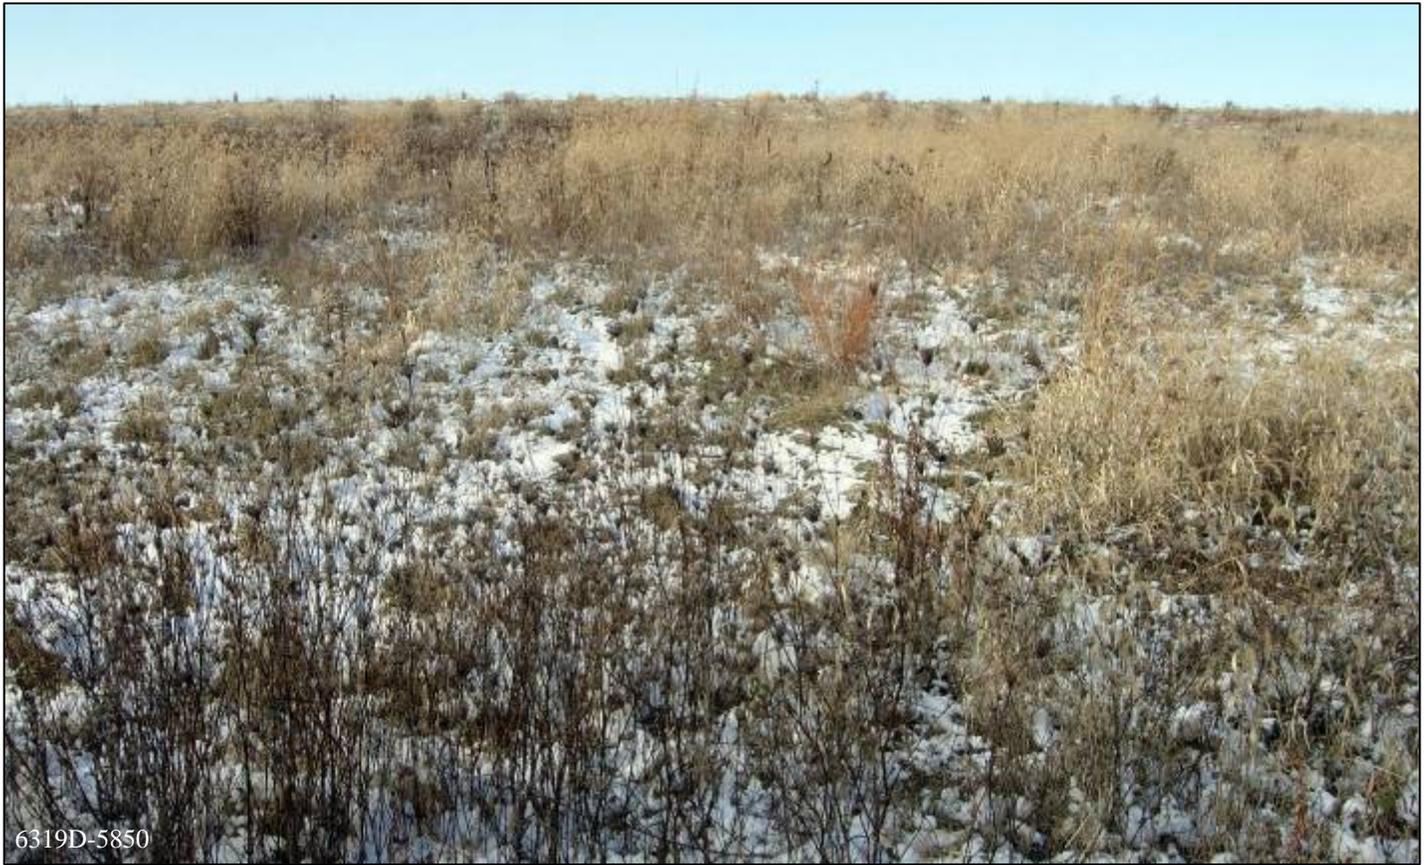
6319D-5850

East Face Cell 2

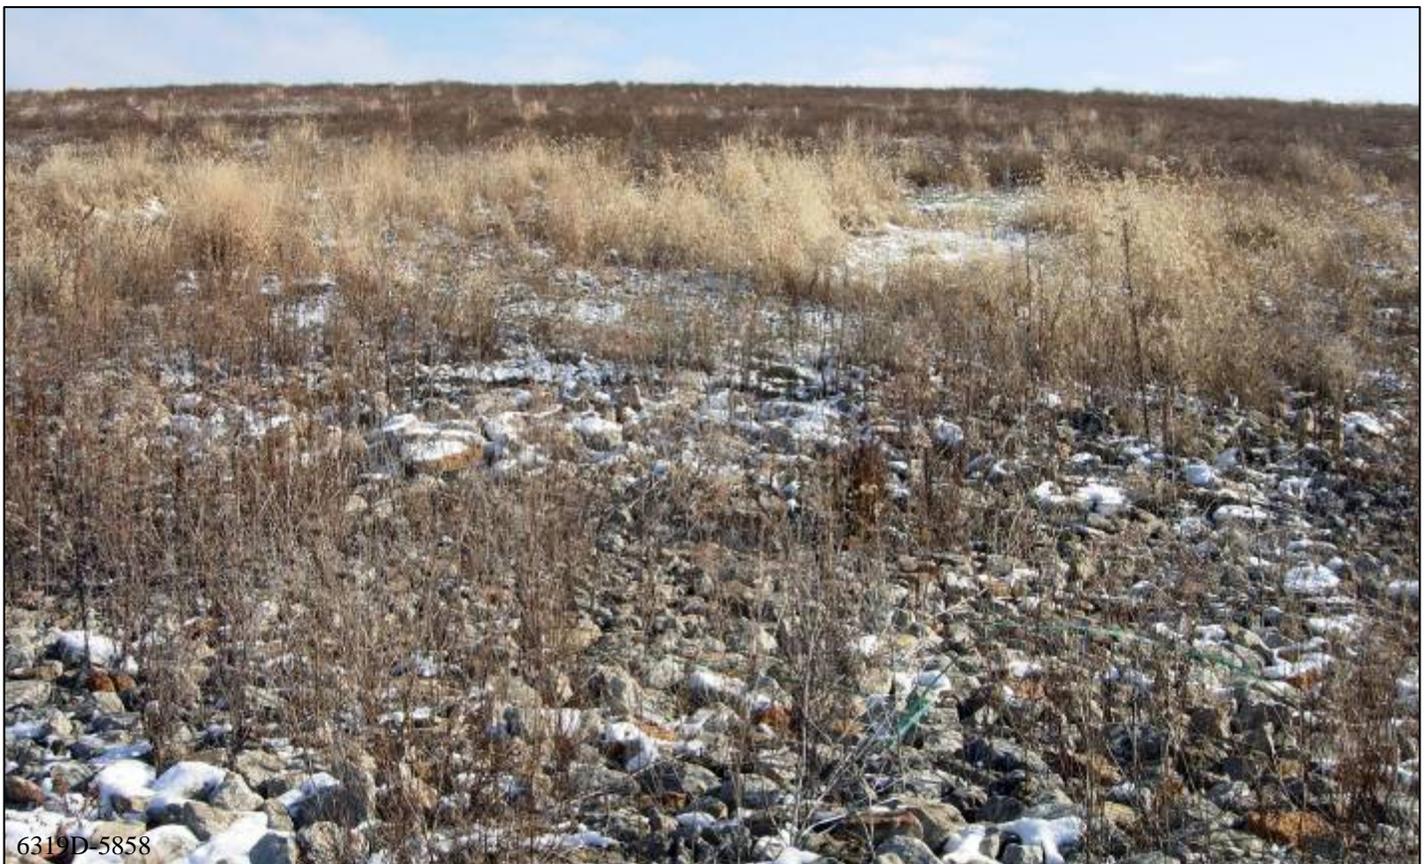
6319D-5858

West Face Cell 2

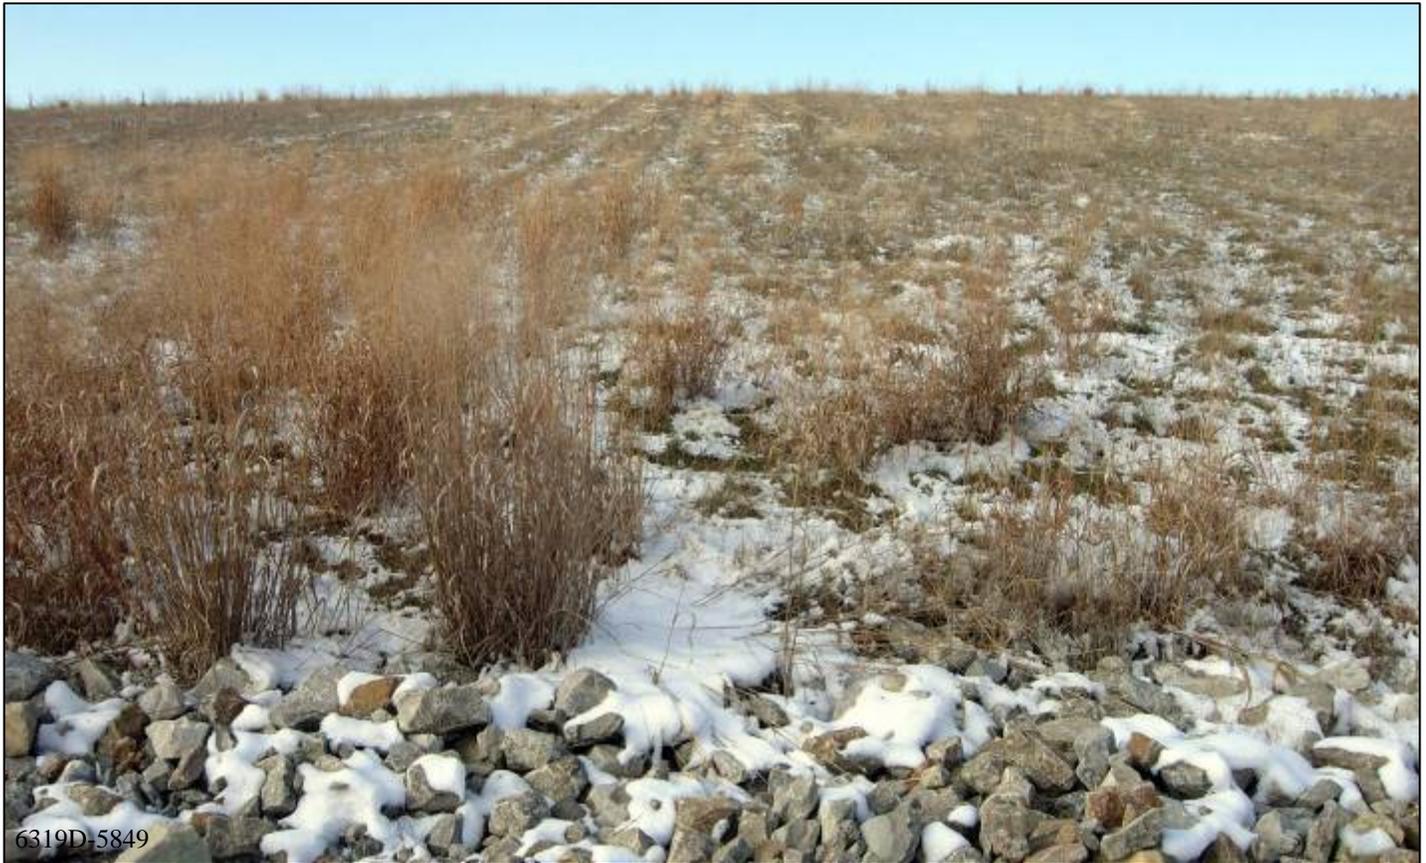
6319D-5849

East Face Cell 3

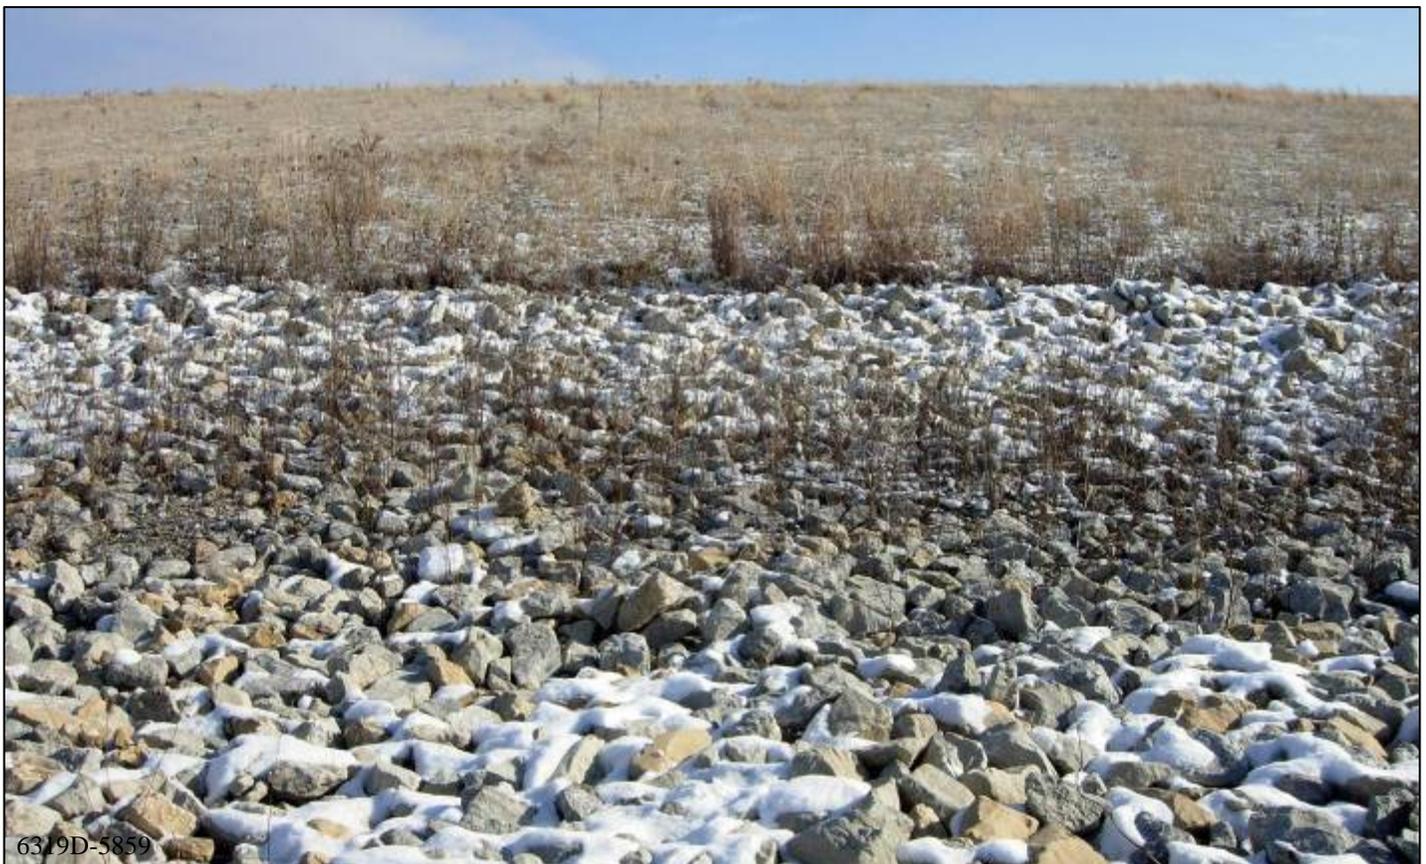
6319D-5859

West Face Cell 3

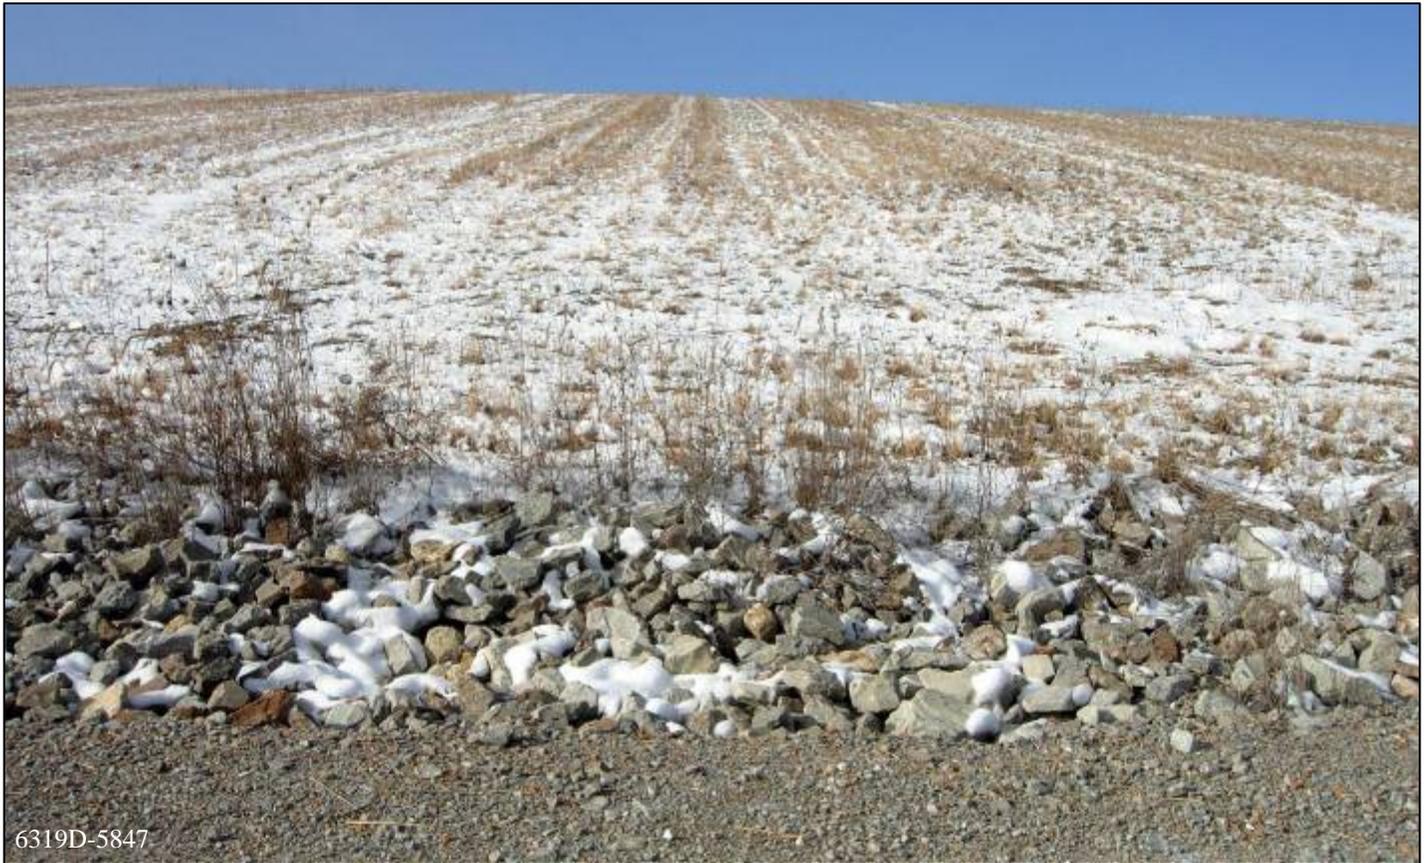
East Face Cell 4

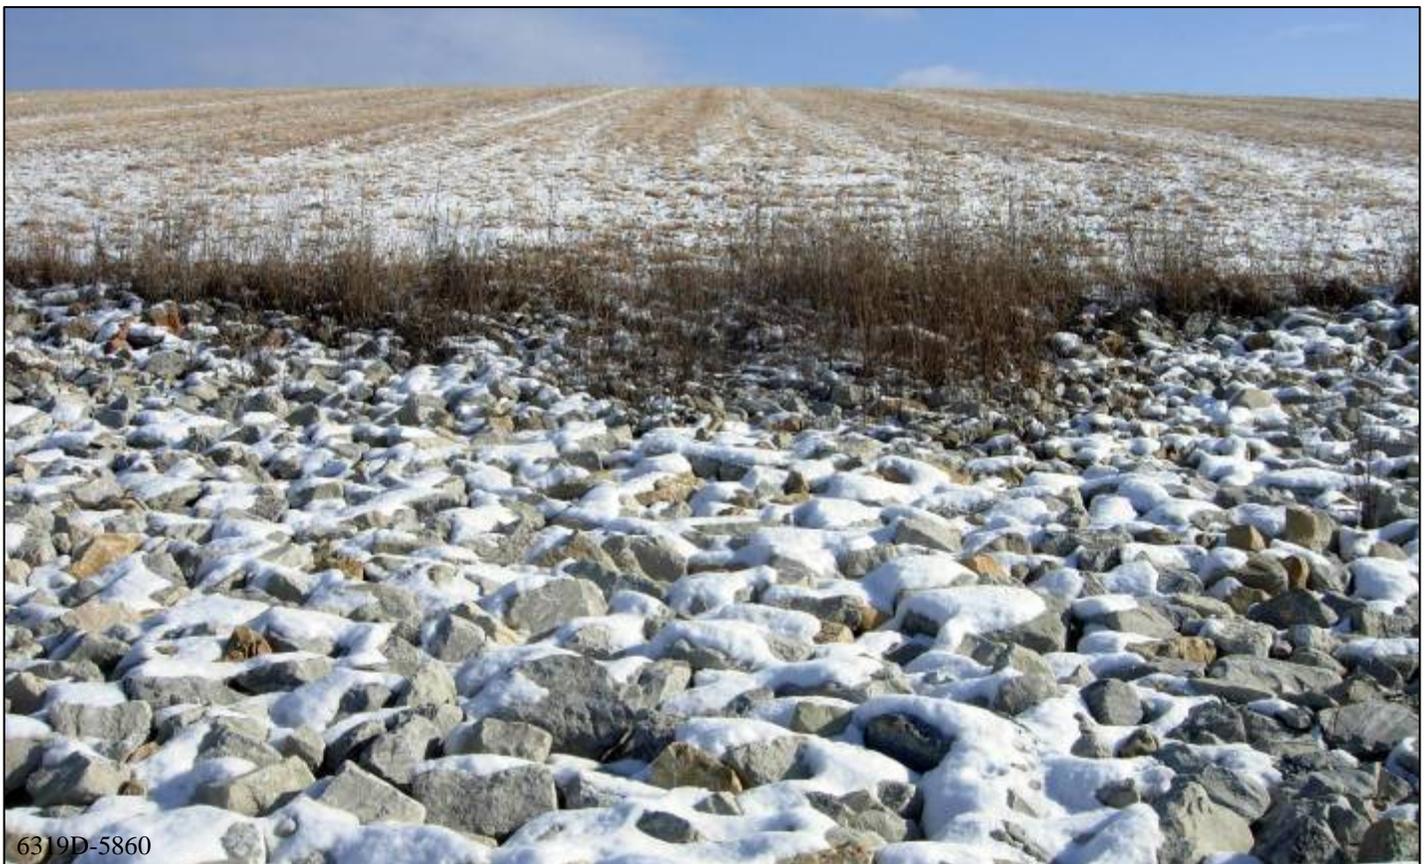
West Face Cell 4

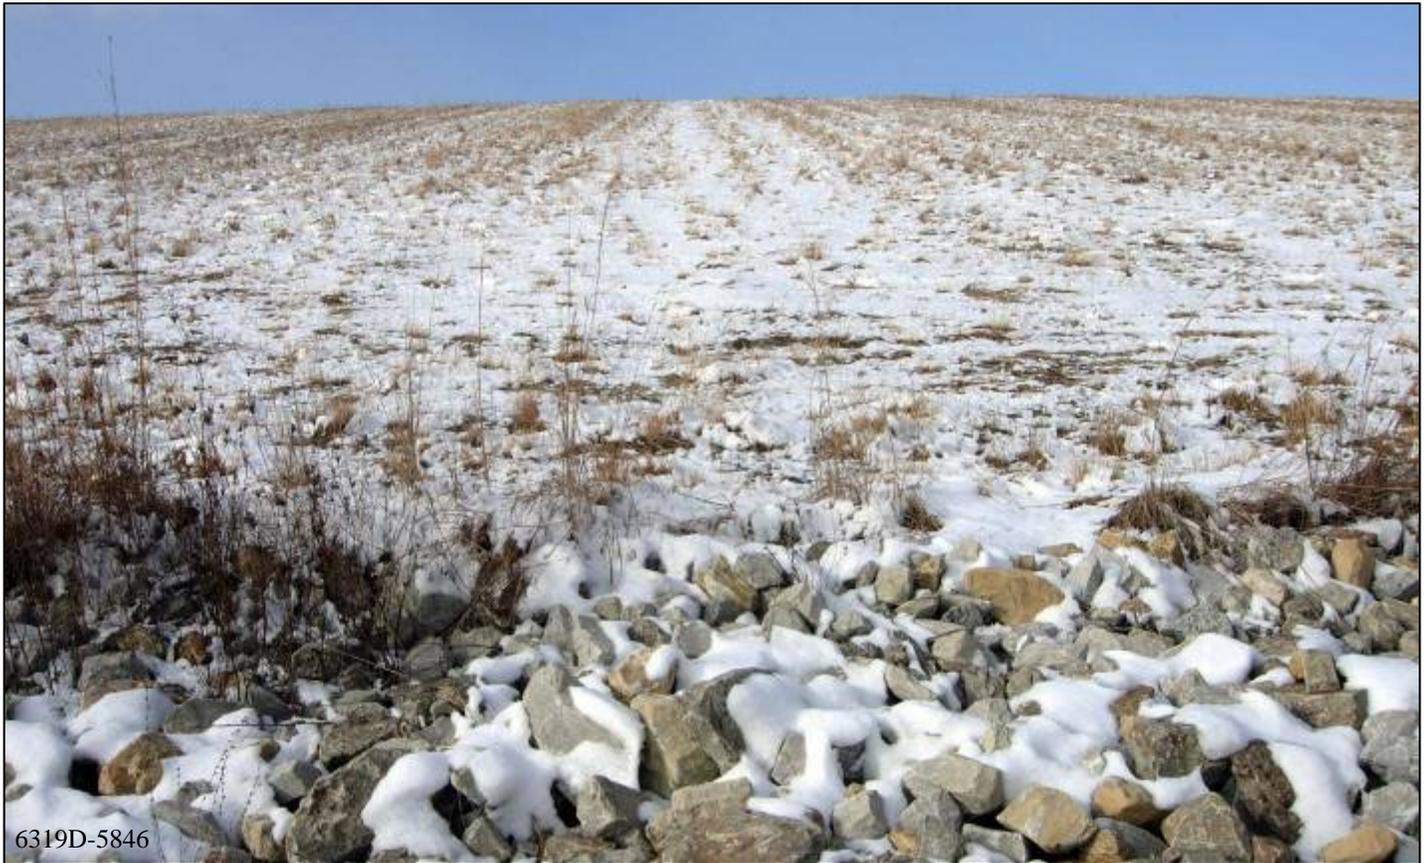
East Face Cell 5

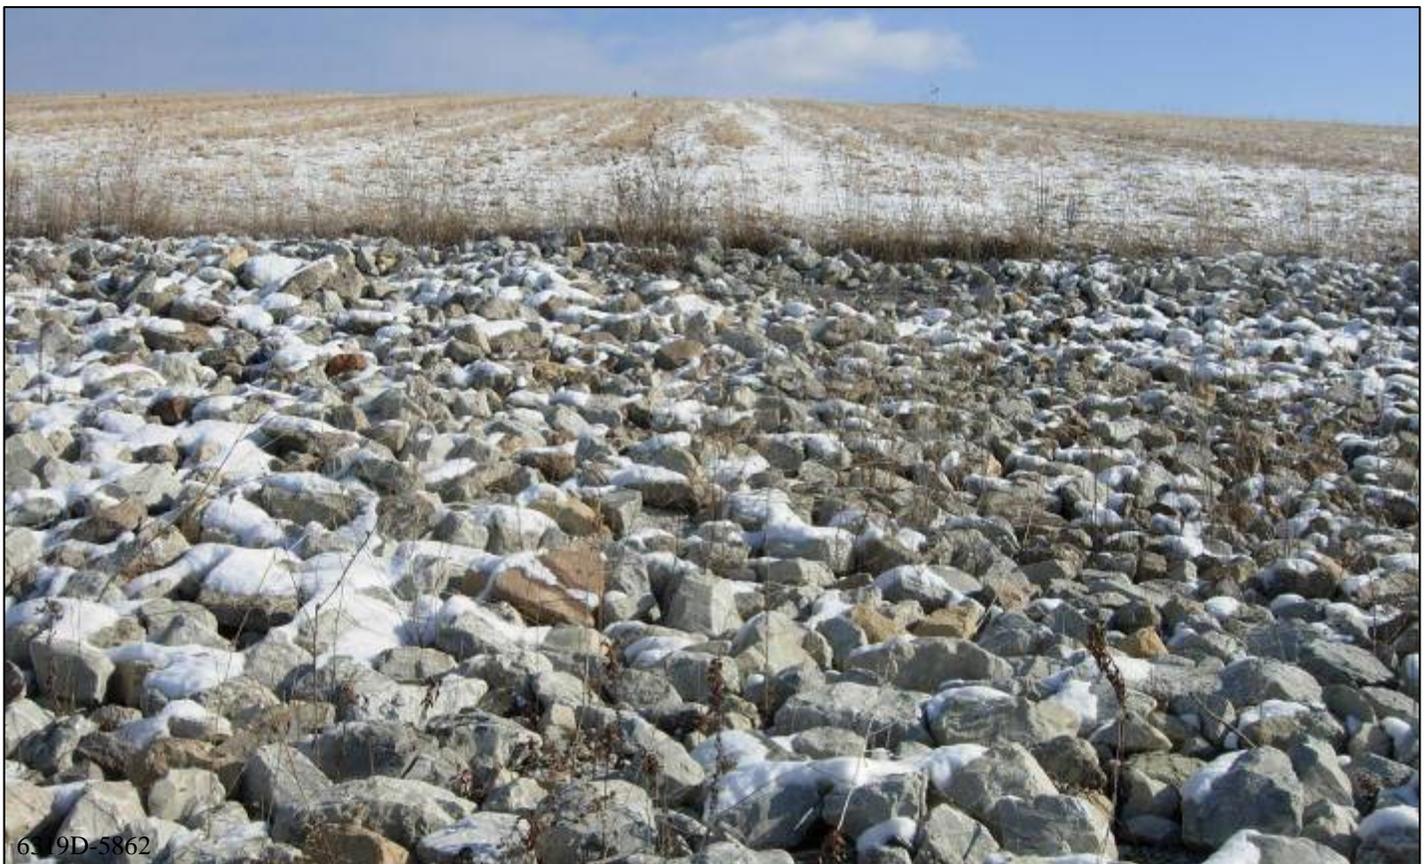
West Face Cell 5

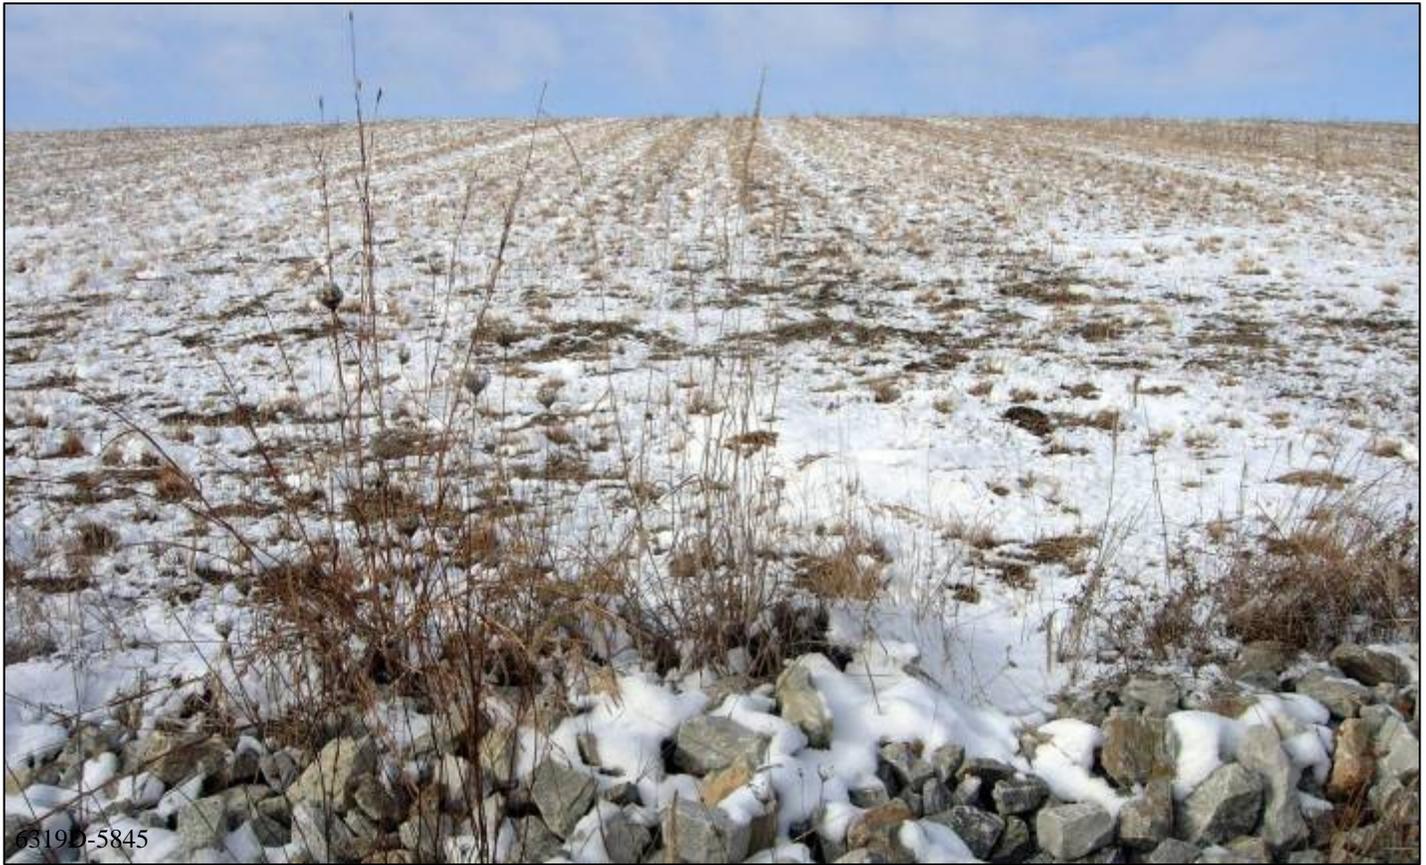
6319D-5845

East Face Cell 6

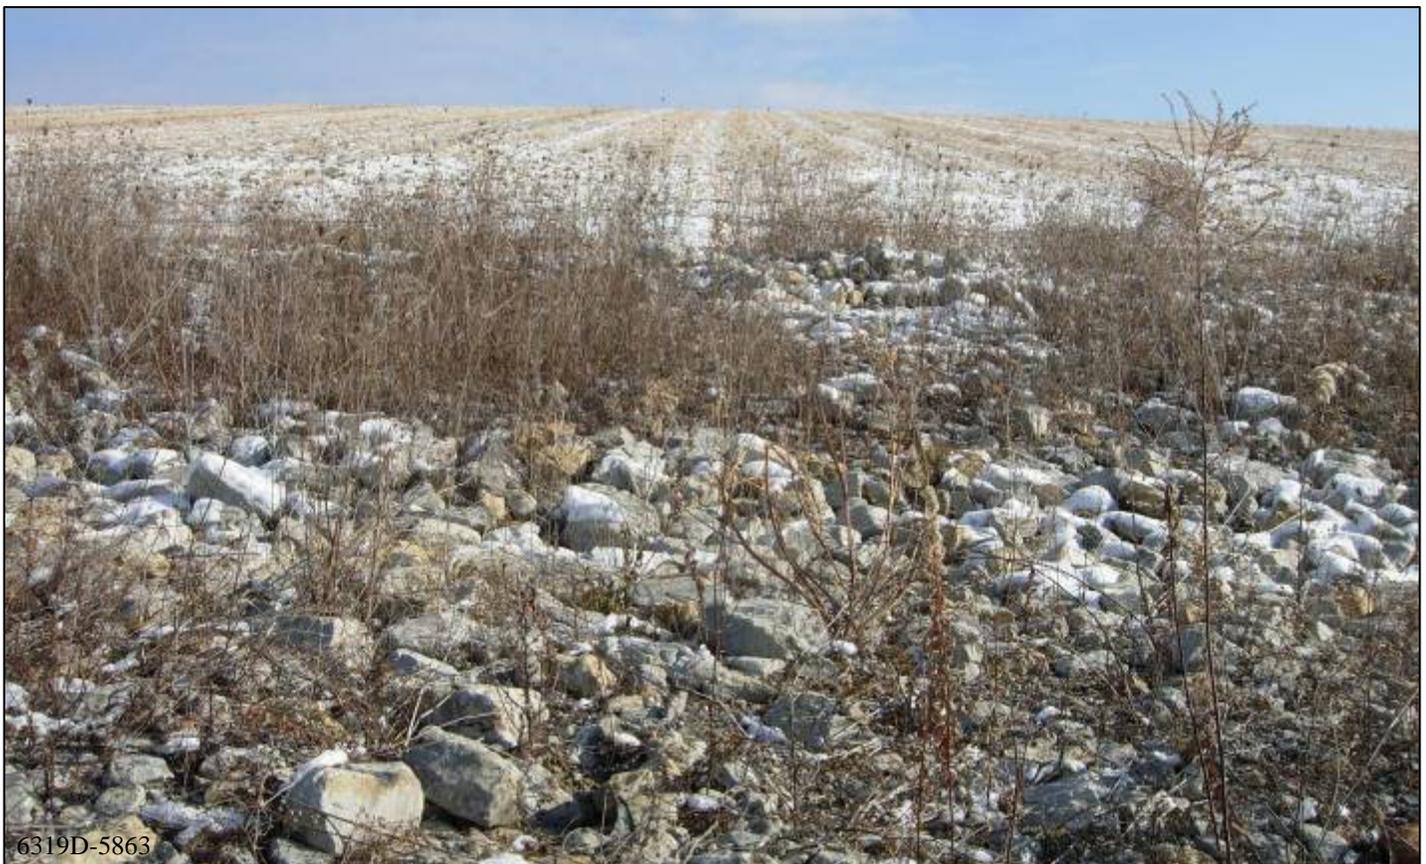
6319D-5863

West Face Cell 6

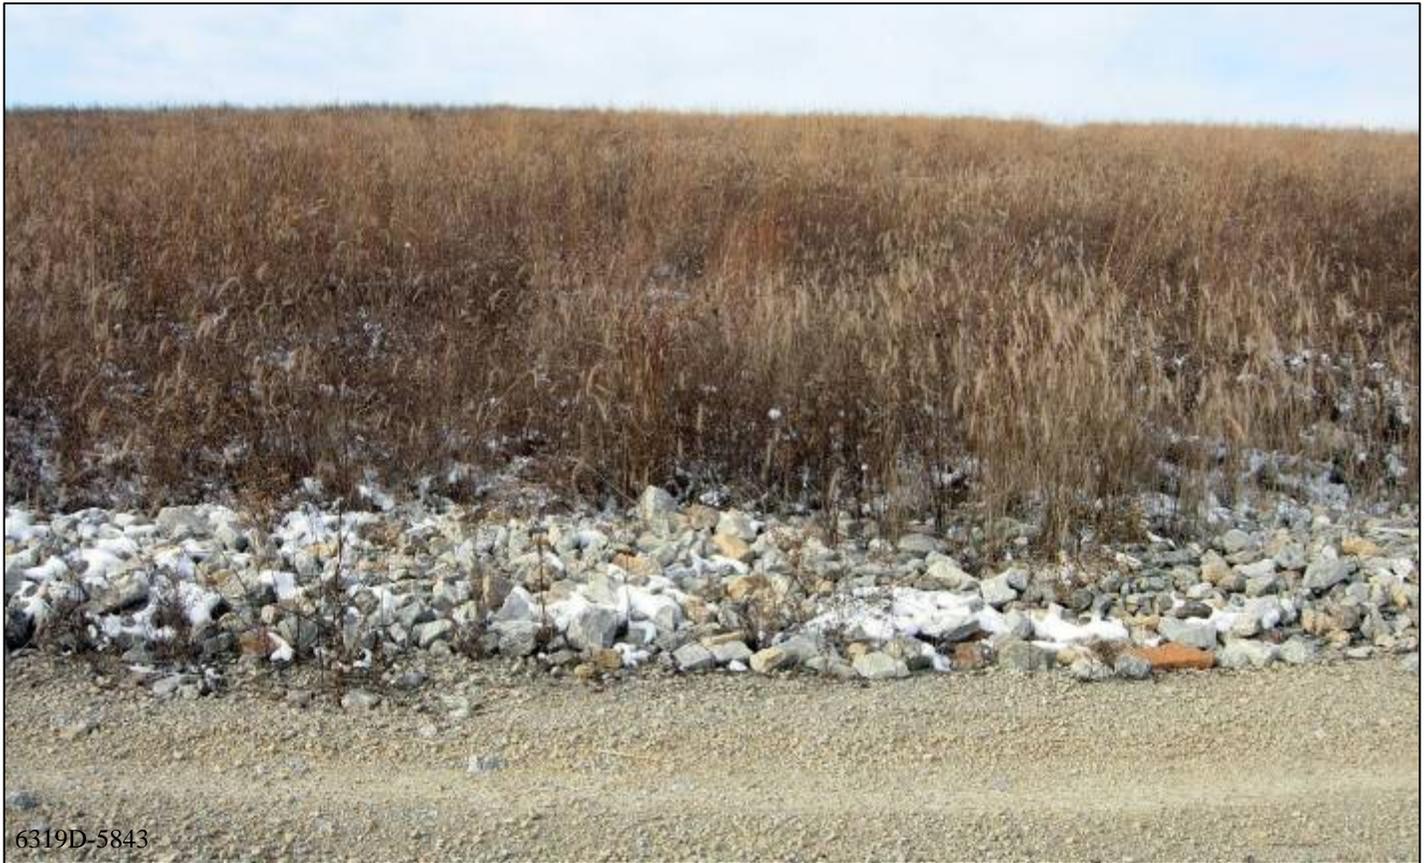
East Face Cell 7

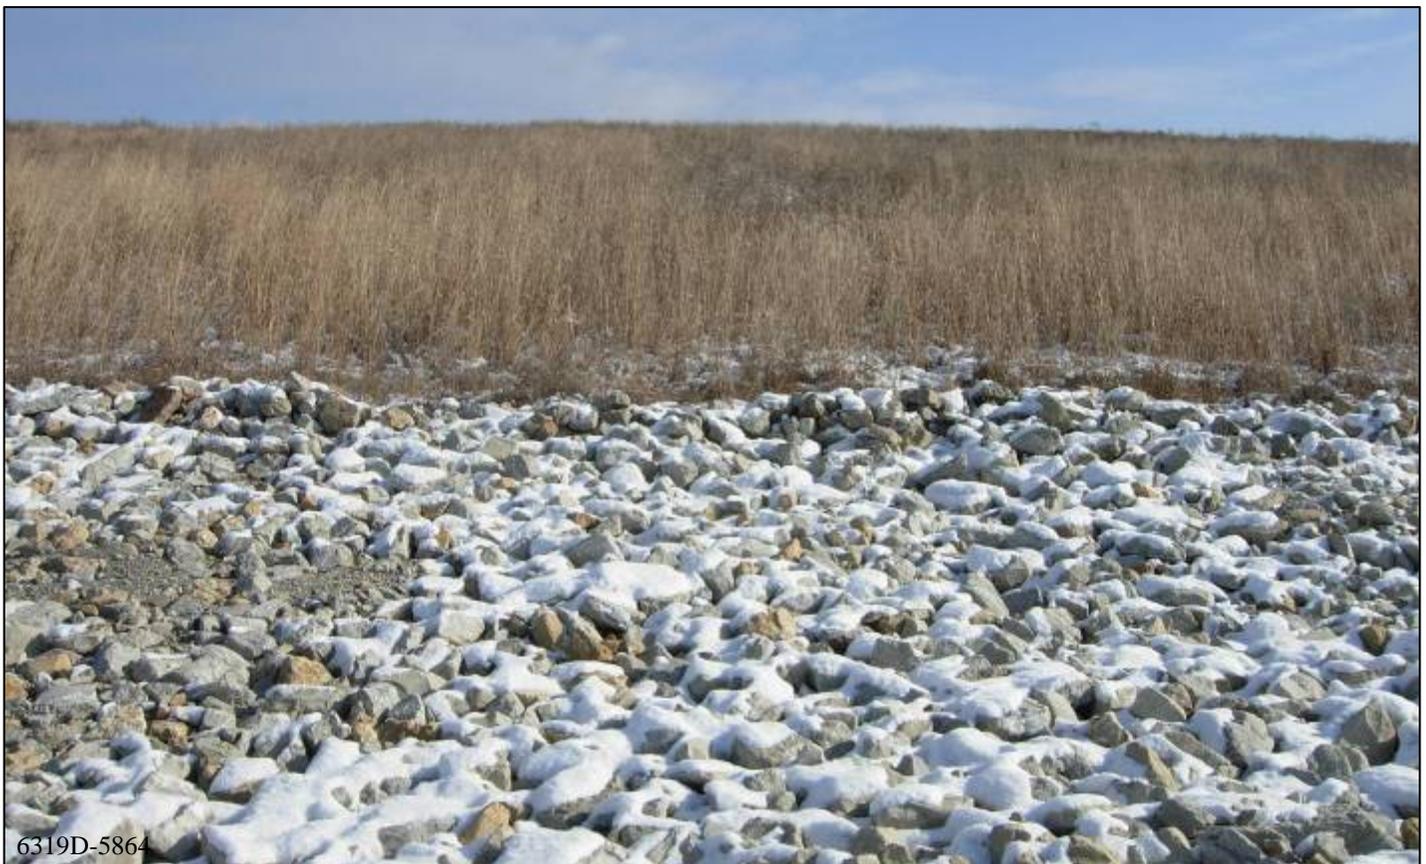
West Face Cell 7

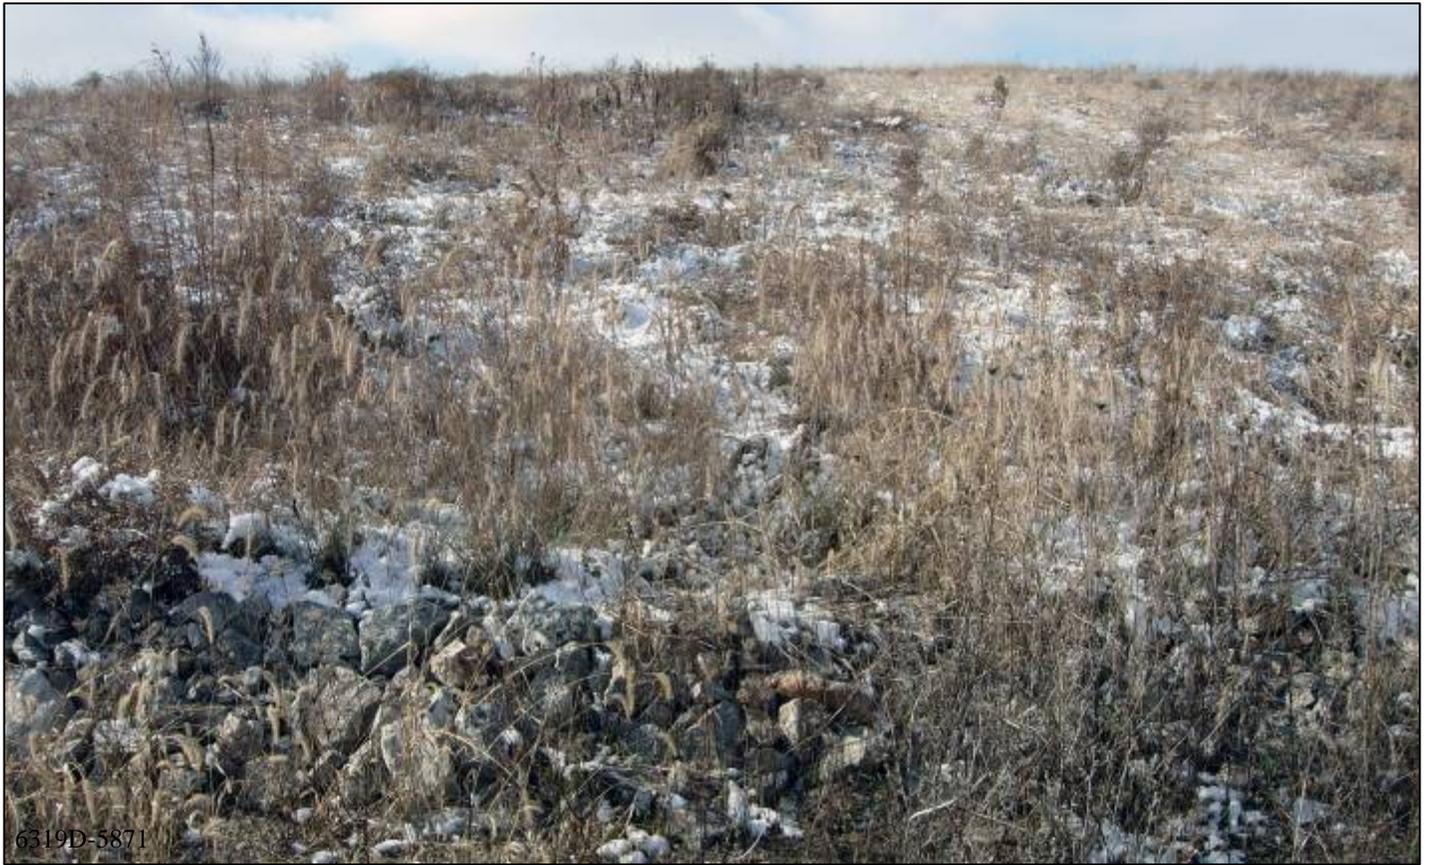
East Face Cell 8

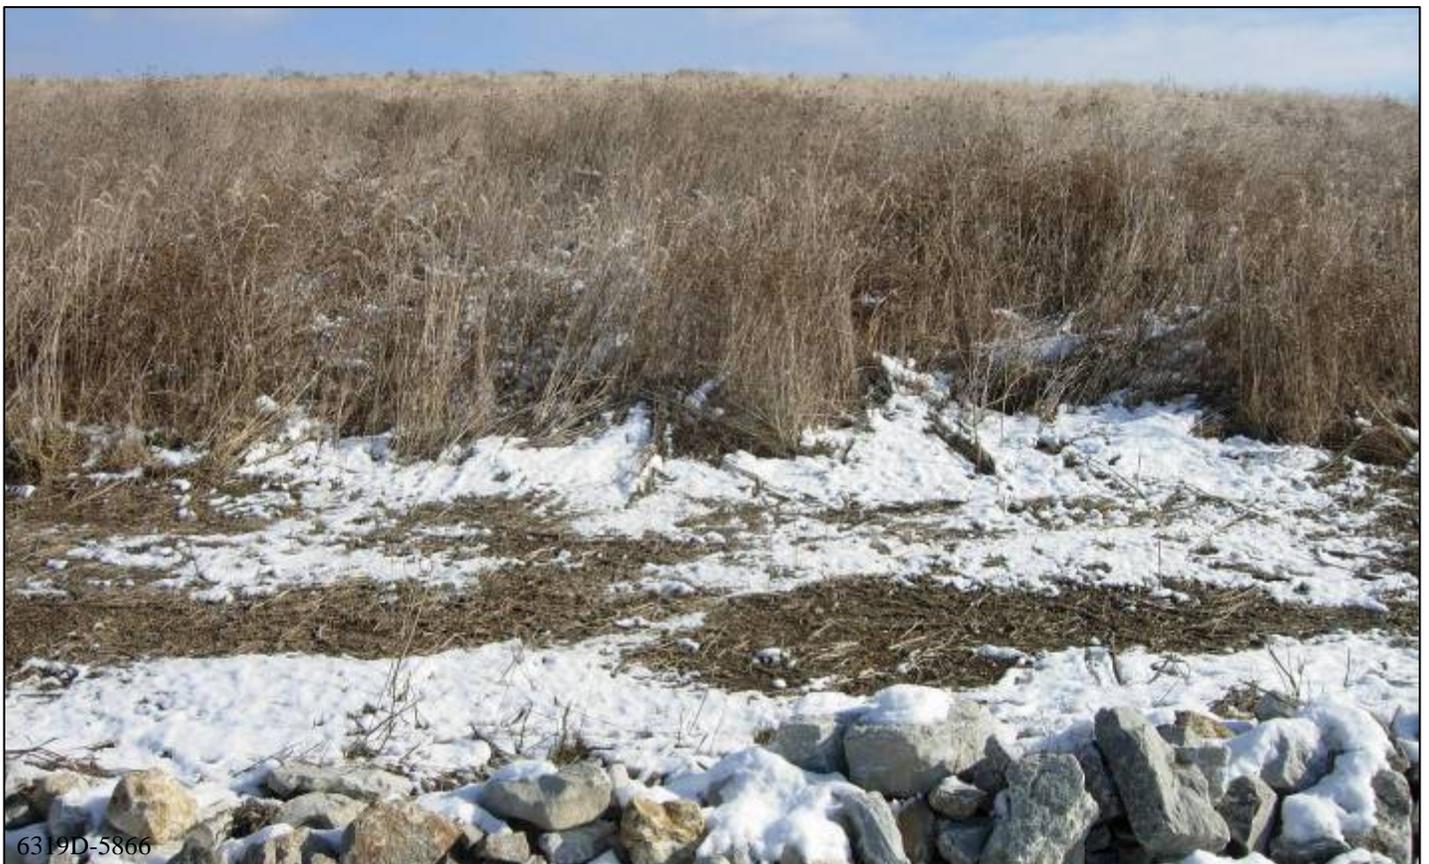
West Face Cell 8
