Department of Energy
Office of Legacy Management

SUBJECT: Transmittal of the December 2010 Fernald Preserve On-Site Disposal Facility Inspection Forms

On-Site Disposal Facility Inspection Report December 2010

December 2010 Inspection Findings

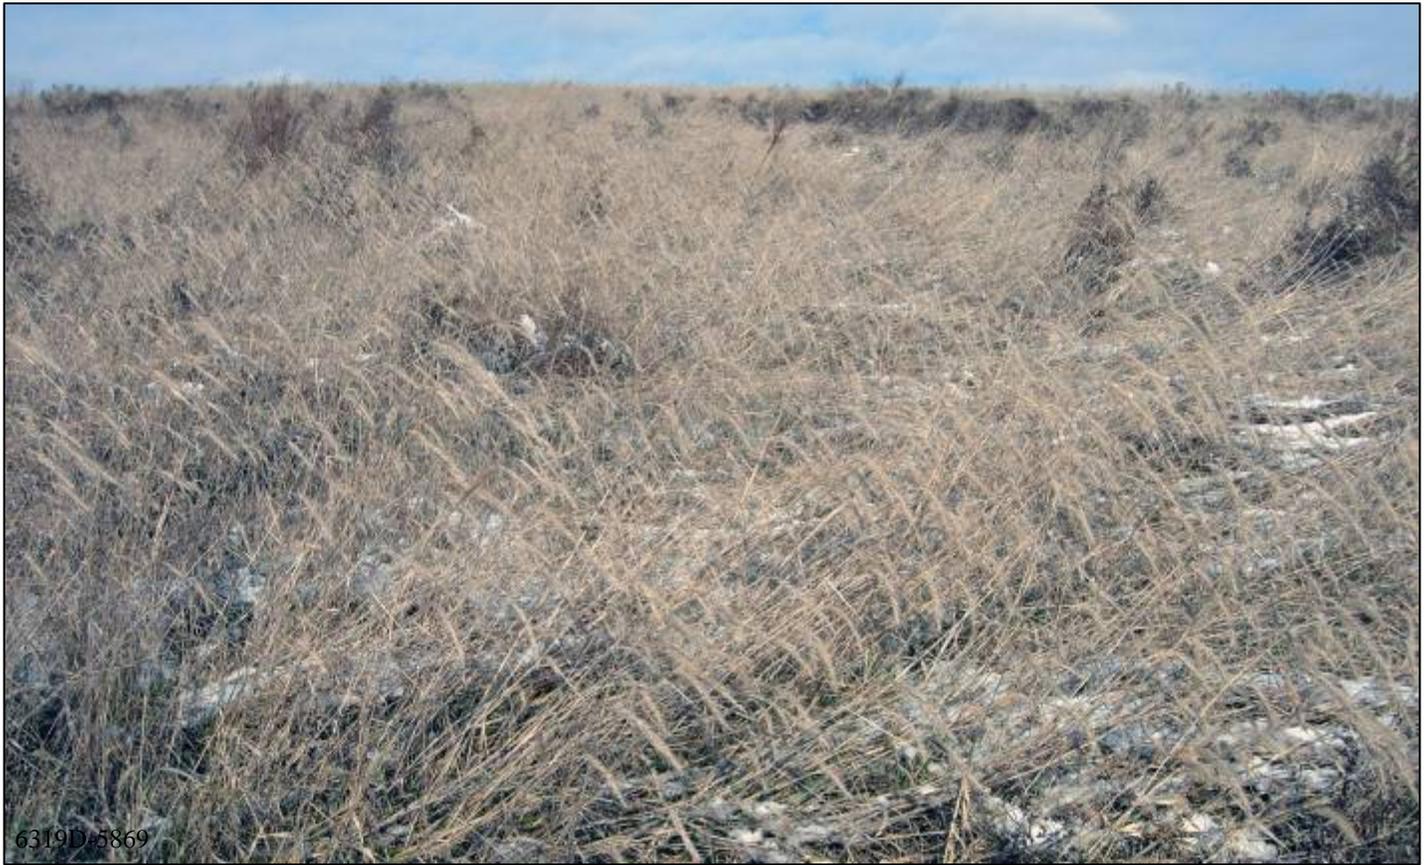
South Face Cell 8

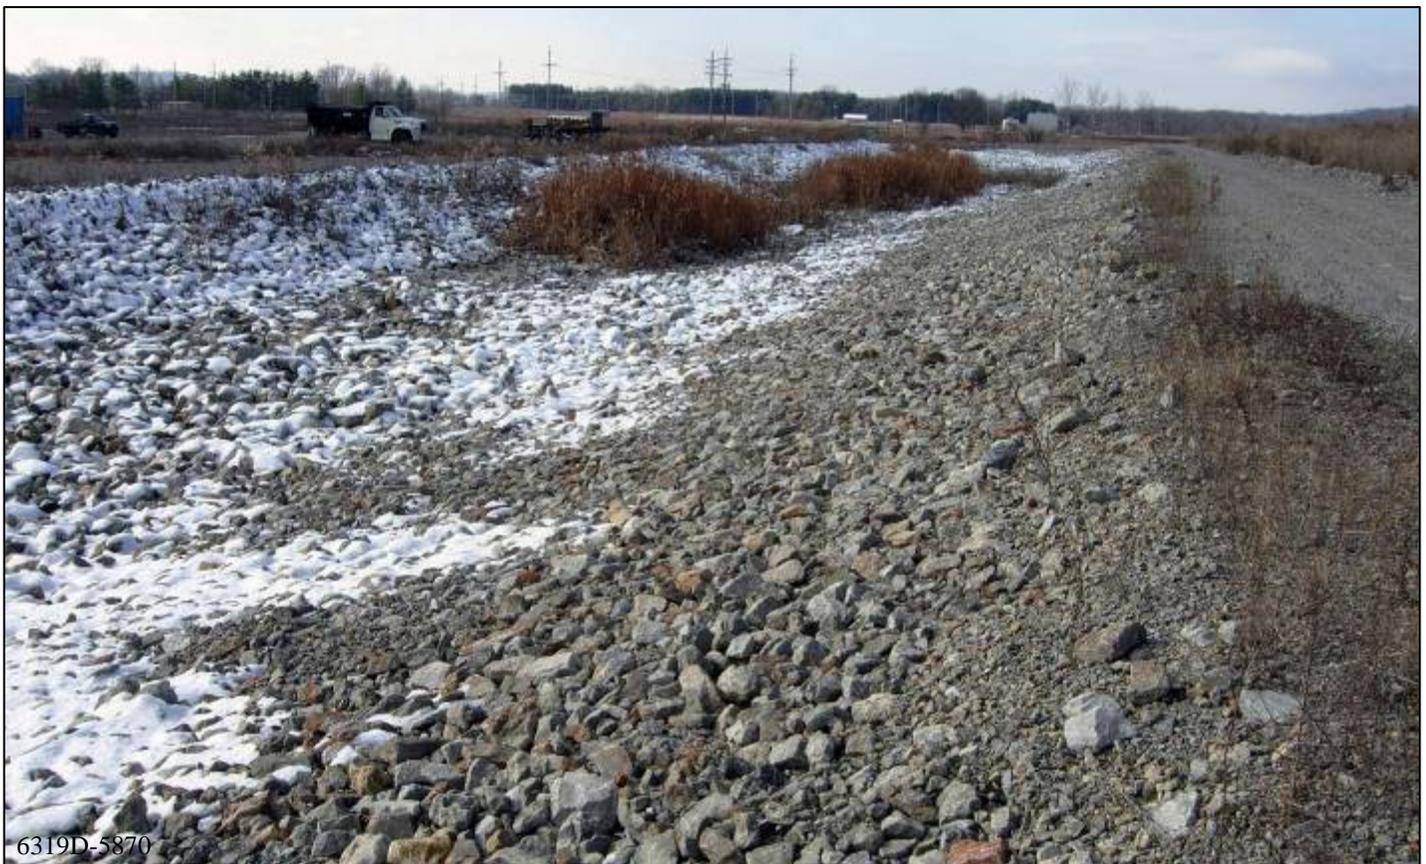
South Drainage (looking west)

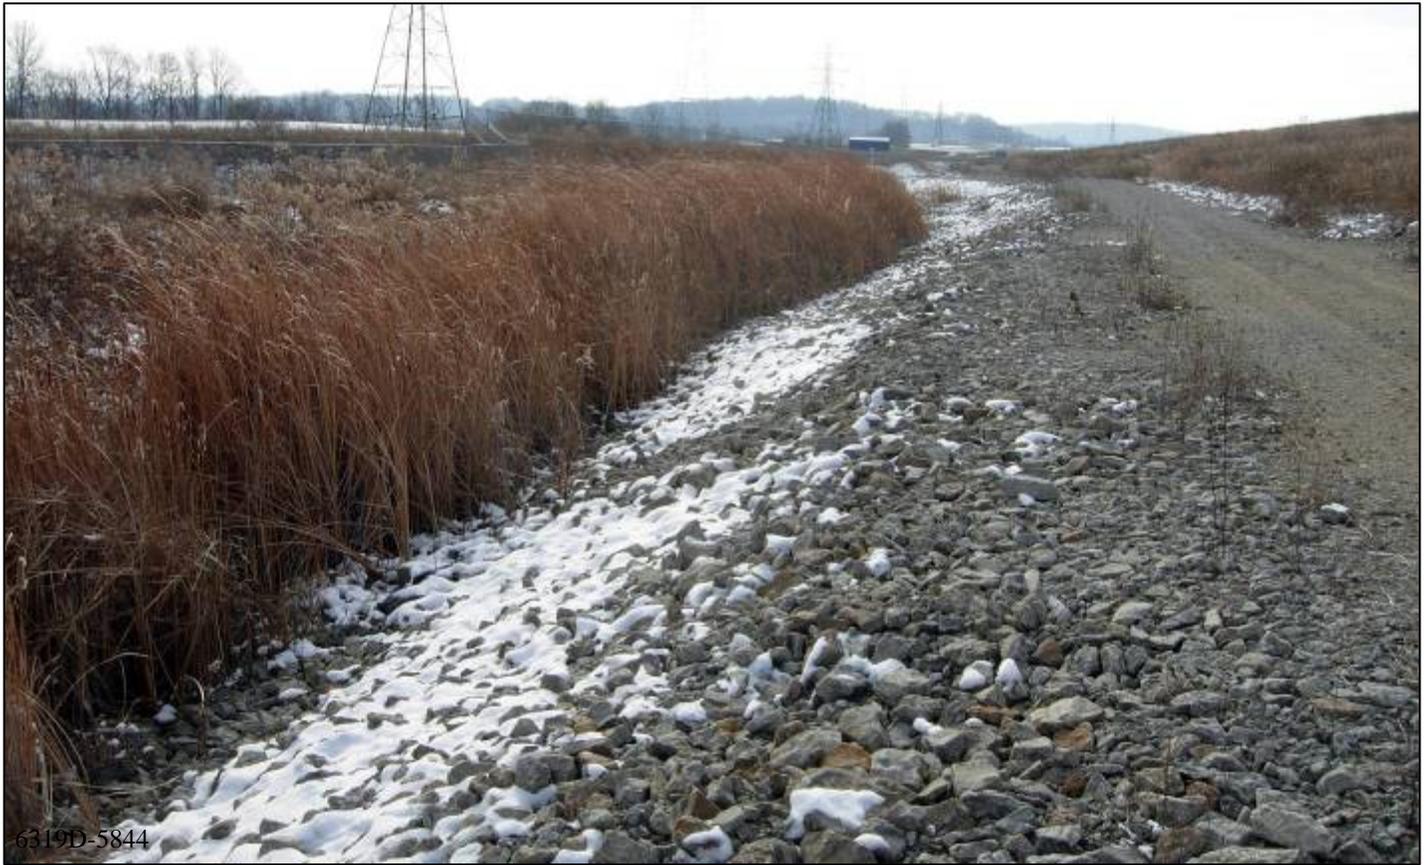
6319D-5844

East Drainage Cell 7 (looking south)

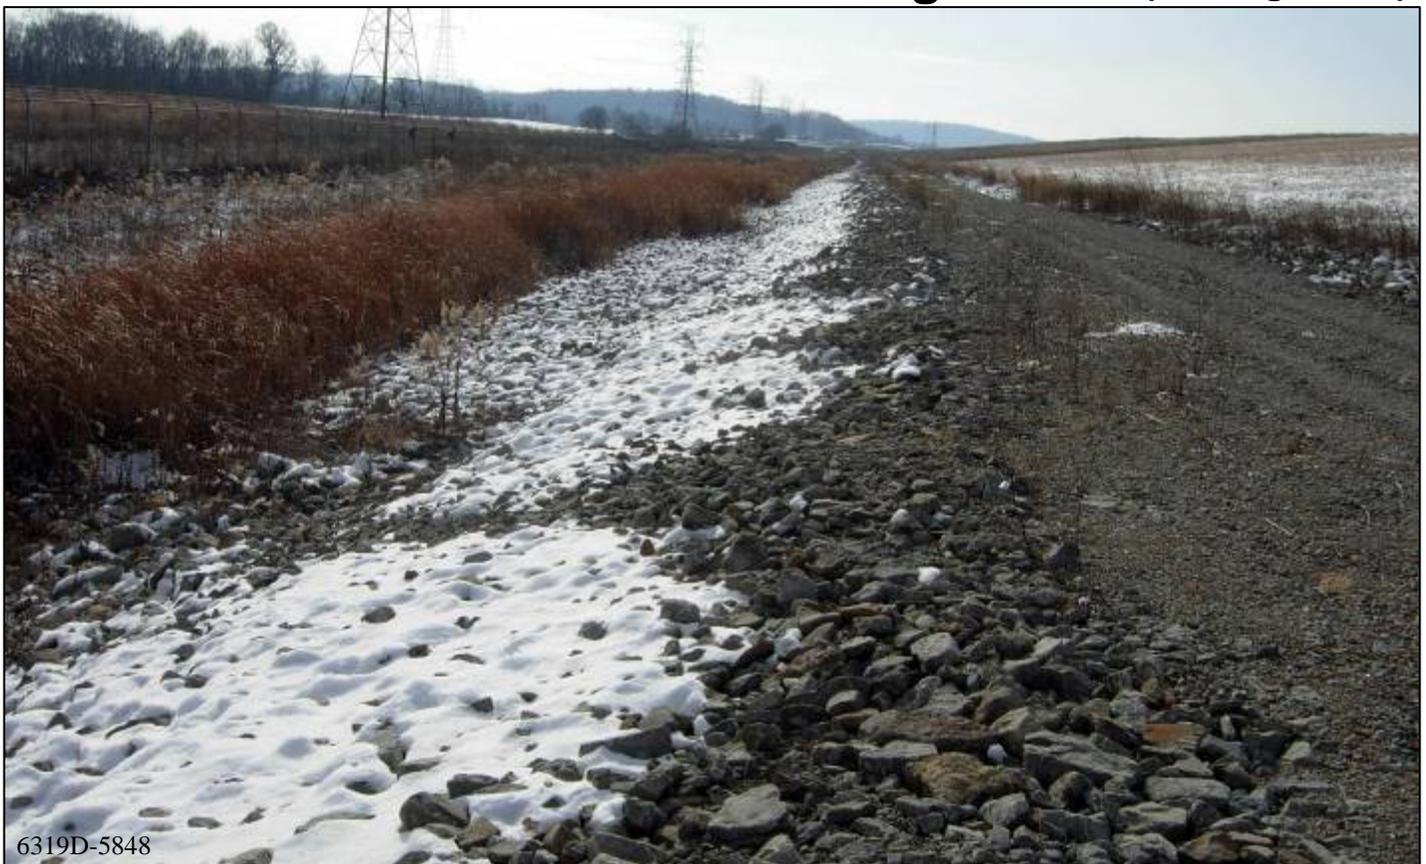
6319D-5848

East Drainage Cell 4 (looking south)

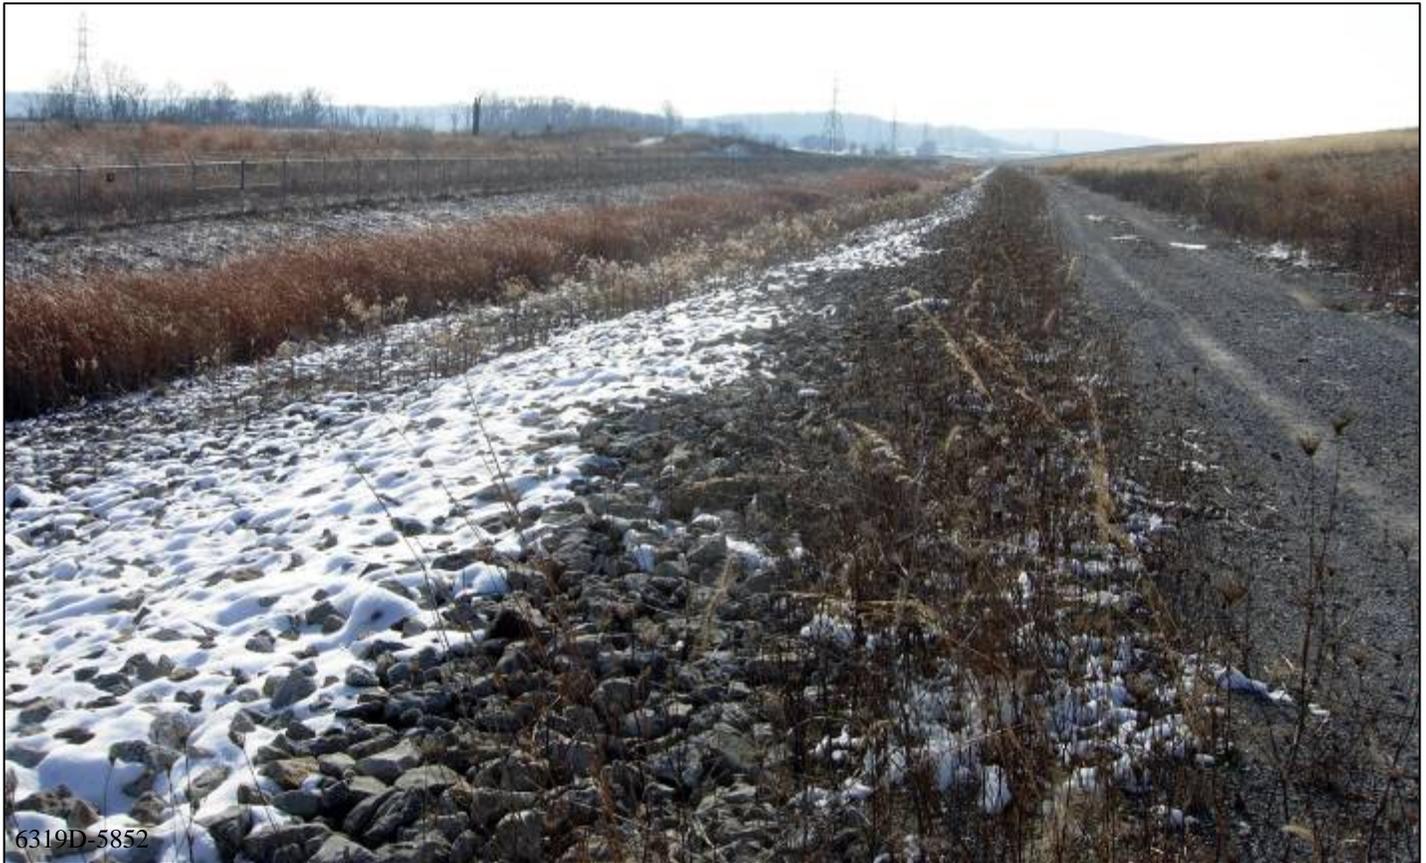
East Drainage Cell 1 (looking south)

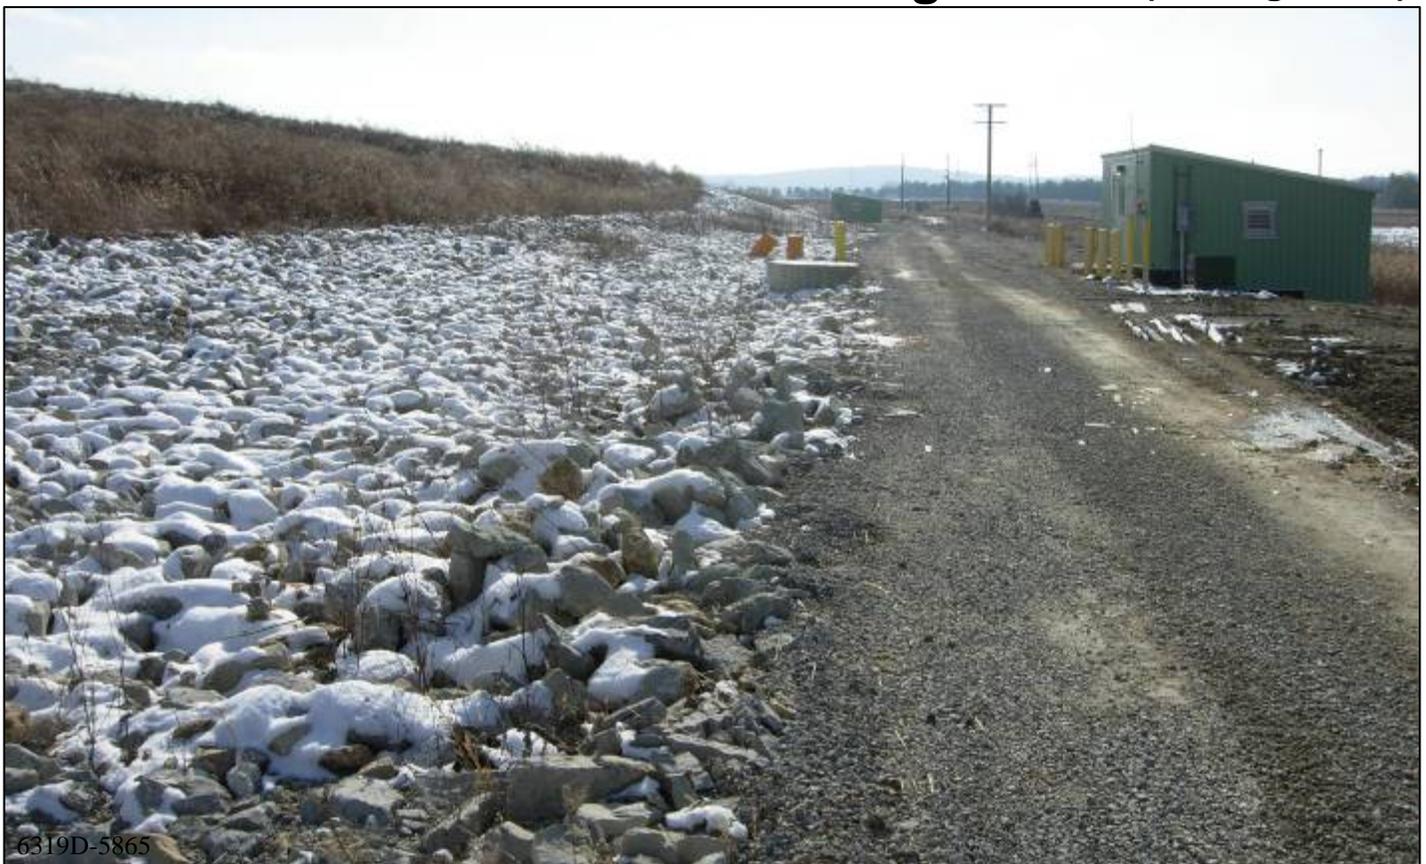
West Inner Drainage Cell 7 (looking south)

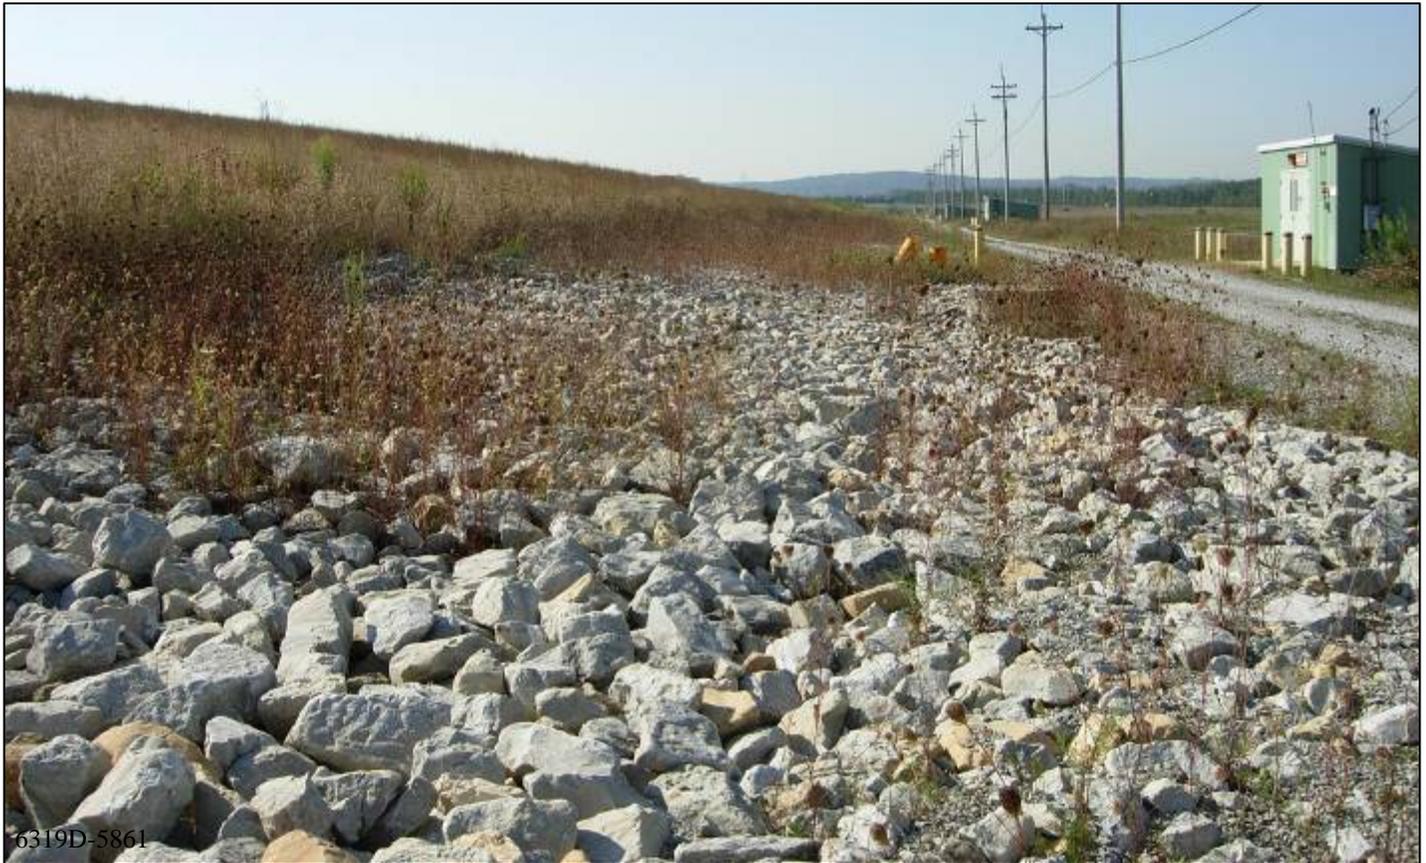
6319D-5861

West Inner Drainage Cell 4 (looking south)

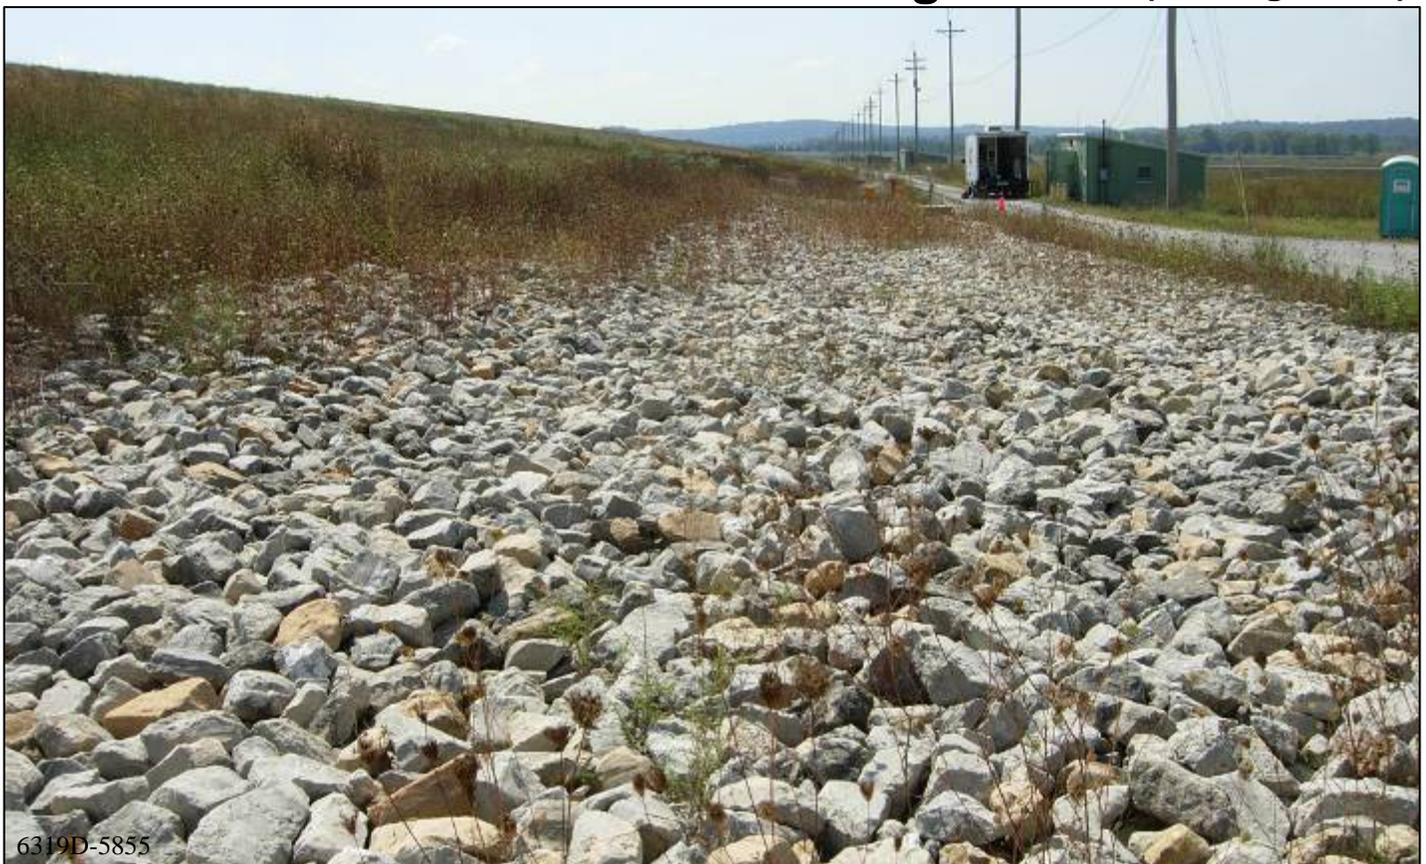
6319D-5855

West Inner Drainage Cell 1 (looking south)

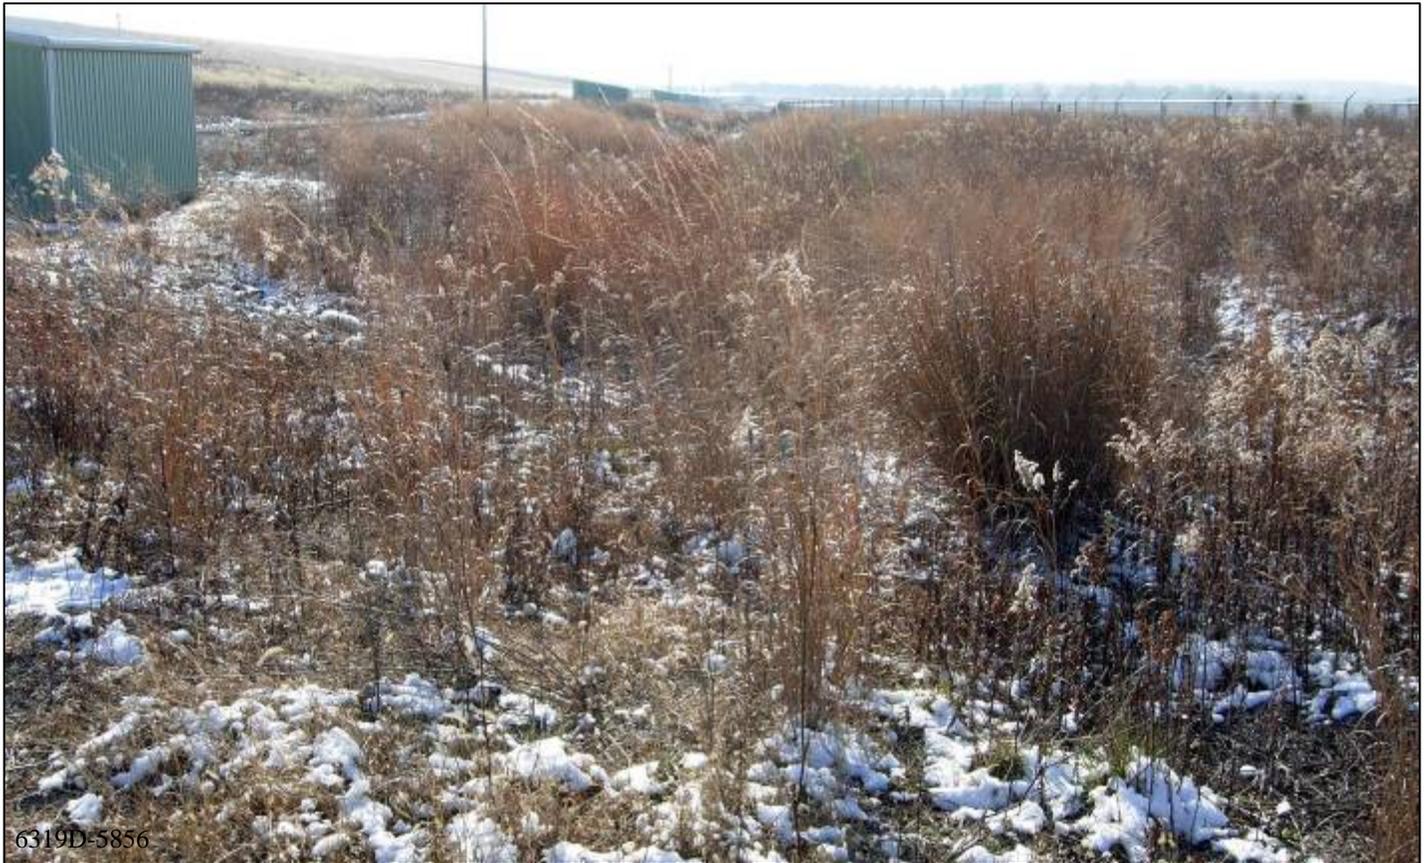
6319D-5856

West Outer Drainage Cell 1 (looking south)

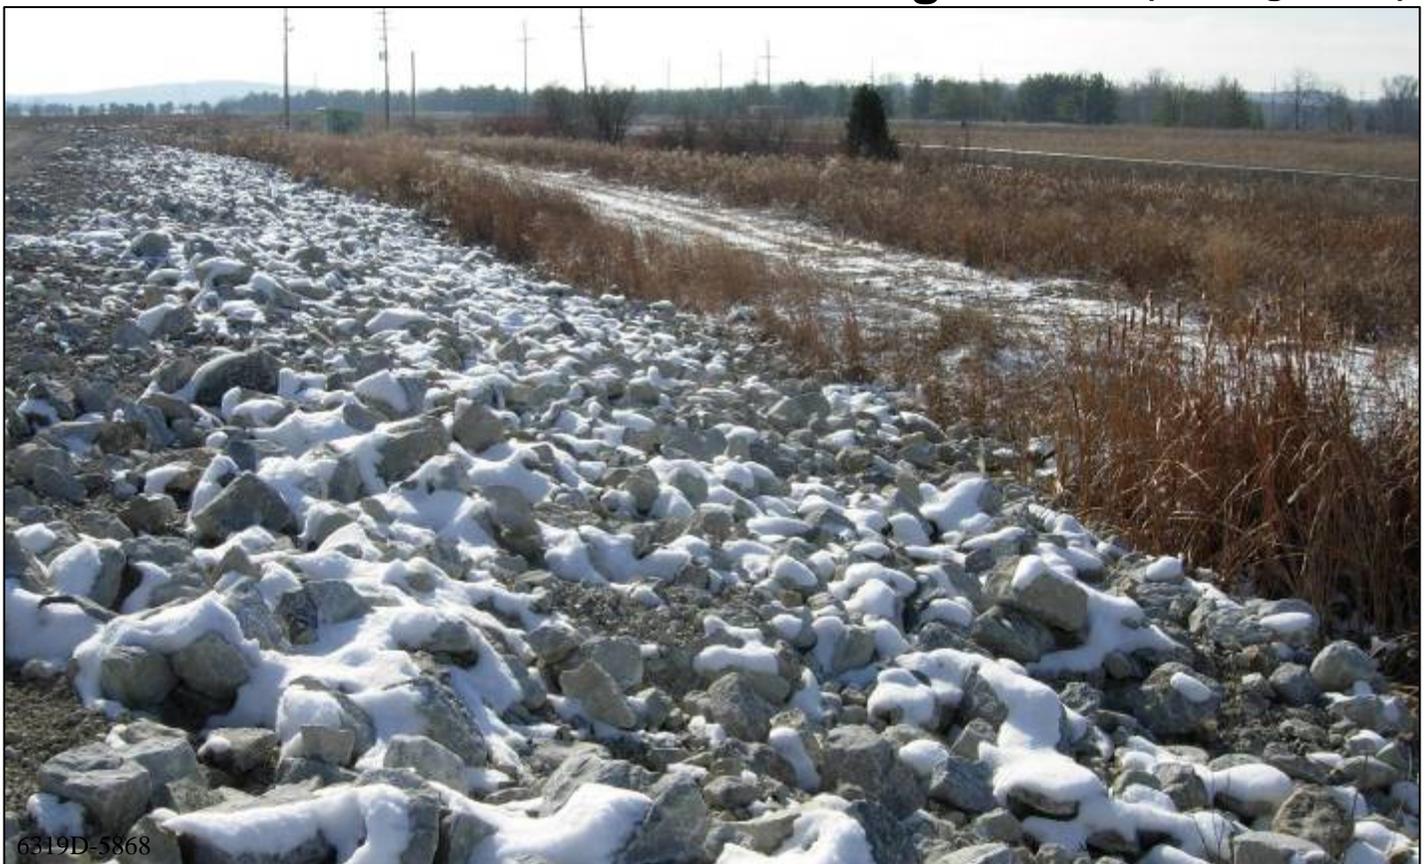
6319D-5868

West Outer Drainage Cell 8 (looking south)

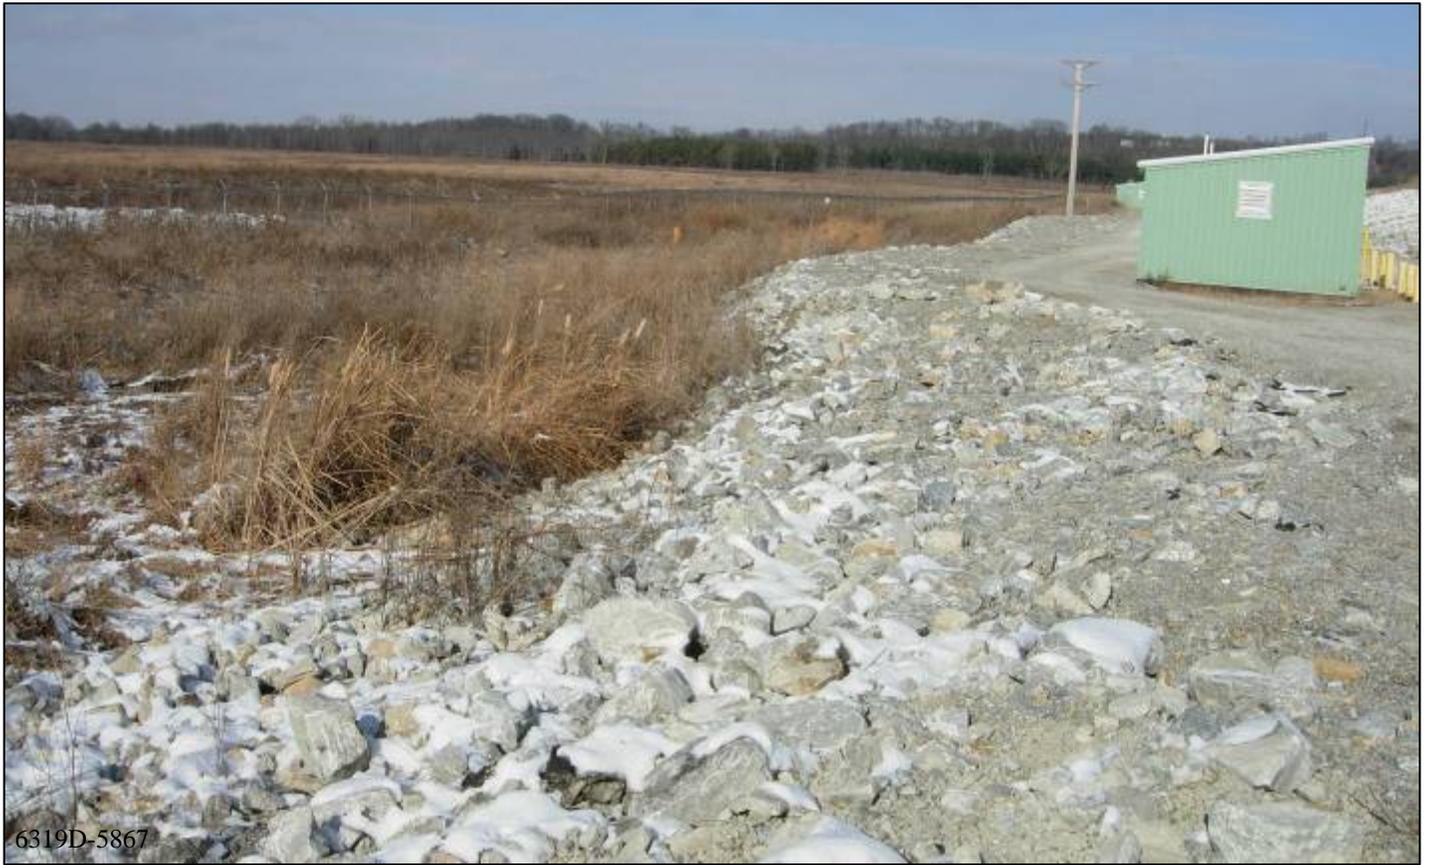
West Outer Drainage Cell 8 (looking north)
