Department of Energy  
Office of Legacy Management

**SUBJECT: Transmittal of the December 2010 Fernald Site Inspection Forms**

**Fernald Preserve Field Walkdown Inspection**

<p><b>U.S. DEPARTMENT OF ENERGY</b> HAMILTON, OHIO</p>	<p><small>Contract No. DE-AC05-04OR21400</small> <b>S. M. Stoller Corporation</b> 14150 W. 12th Street Overland Park, KS 66204</p>
<p><b>Fernald Preserve</b> Consolidated Finding Locations for North Section of December 2010 Site Inspection</p>	
<p>DATE PREPARED: December 15, 2010</p>	<p>REVISION: inspection_areas_ahdr_2010_0916_06.dwg</p>

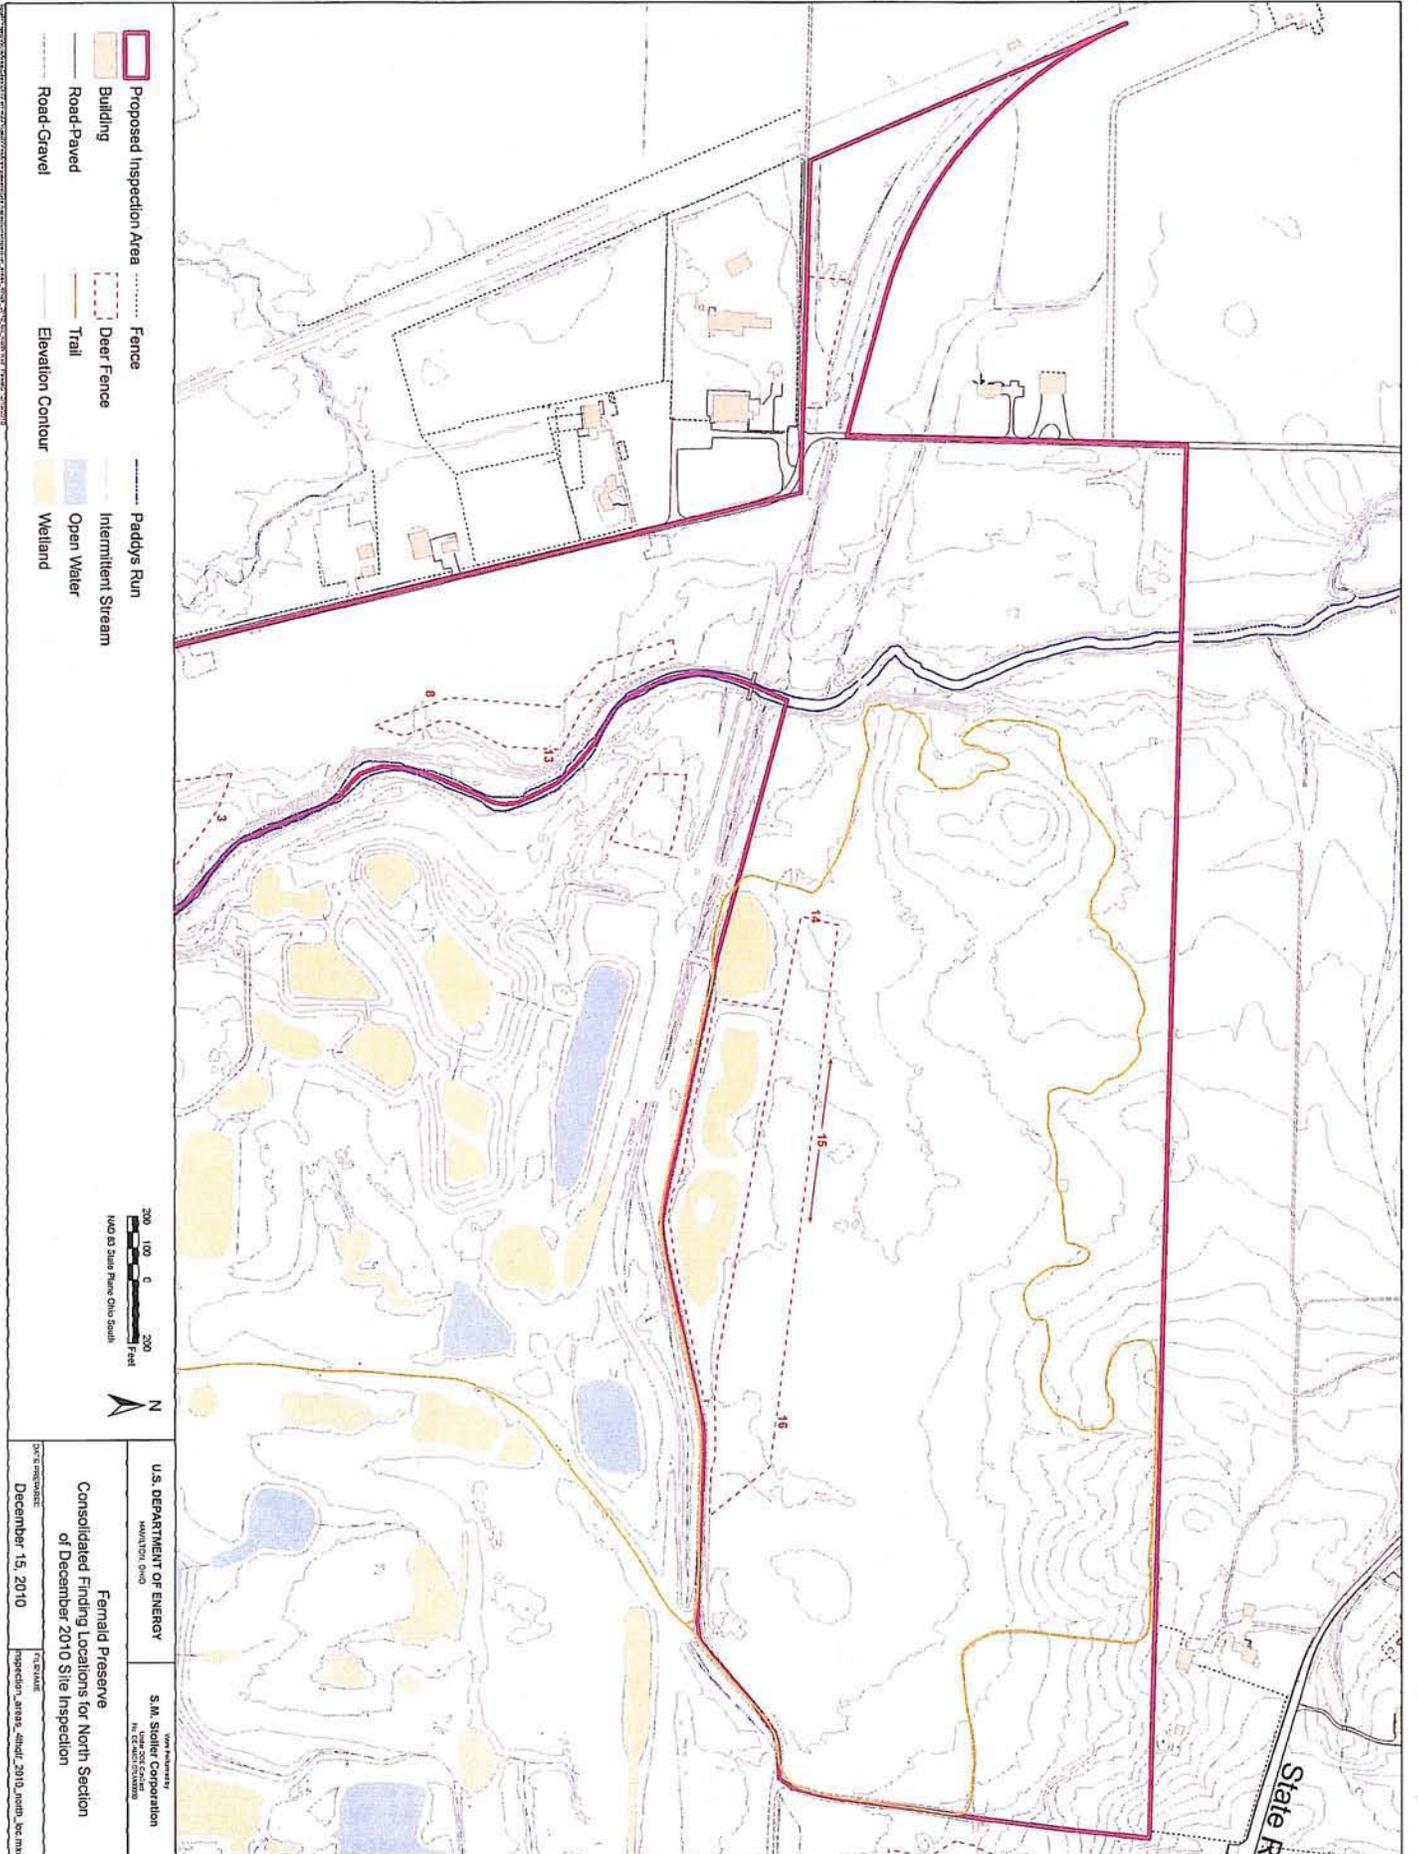
No.	Location (Use Map Whenever Possible)	GPS?	Type of Finding				Description	Photo? (File No.)	Follow Up		
			Unauthorized Use	Disturbance	Vegetation	Other			Corrected	Maintenance Req'd	Cont. Observation
1	Duke substation	NO				X	Debris	NO		X	
2	Duke substation	NO				X	Bluebird box off post	NO		X	
3	A8PIII-N, south deer fence	NO				X	North side of fence down	NO		X	
4	A8PIII-N, south deer fence	NO				X	East gate open	NO		X	
5	A8PIII-N, south deer fence	NO				X	South end of fence down	NO		X	
6	A8PIII-N, south deer fence	NO				X	West side of fence down	NO		X	
7	A8PIII-N, south deer fence	NO				X	West side of fence down	NO		X	
8	A8PIII-N, north deer fence	NO				X	West side of fence down	NO		X	
9	Field north of Duke substation	NO				X	Debris (red clay/brick)	NO		X	
10	A8PIII, south deer fence	NO				X	Southwest corner down	NO		X	
11	Deer fence at rainbow bridge	NO				X	Tree cages need removed. Limbs down on east side of fence.	NO		X

12	Deer fence at rainbow bridge	NO				X	Tree across fence	NO		X	
13	A8PIII-N, north deer fence	NO				X	East side has holes and the fence is slipping down poles	NO		X	
14	A6PI deer fence	NO				X	West end fence is down	NO		X	
15	A6PI deer fence	NO				X	Tree on fence on north side	NO		X	
16	A6PI deer fence	NO				X	Hole in north side	NO		X
