Department of Energy  
Office of Legacy Management

**SUBJECT: Transmittal of the December 2009 Fernald Site Inspection Forms**

**FERNALD PRESERVE FIELD WALKDOWN INSPECTION FORM**

U.S. DEPARTMENT OF ENERGY HAMILTON, OHIO	Work Performed by <b>S.M. Stoller Corporation</b> Under DOE Contract No. DE-AM01-07LM00060
<b>Fernald Preserve</b> Consolidated Finding Locations for December 2009 Site Inspection	
DATE PREPARED: December 15, 2009	FILENAME: inspection_areas_4thqtr_2009_loc.mxd

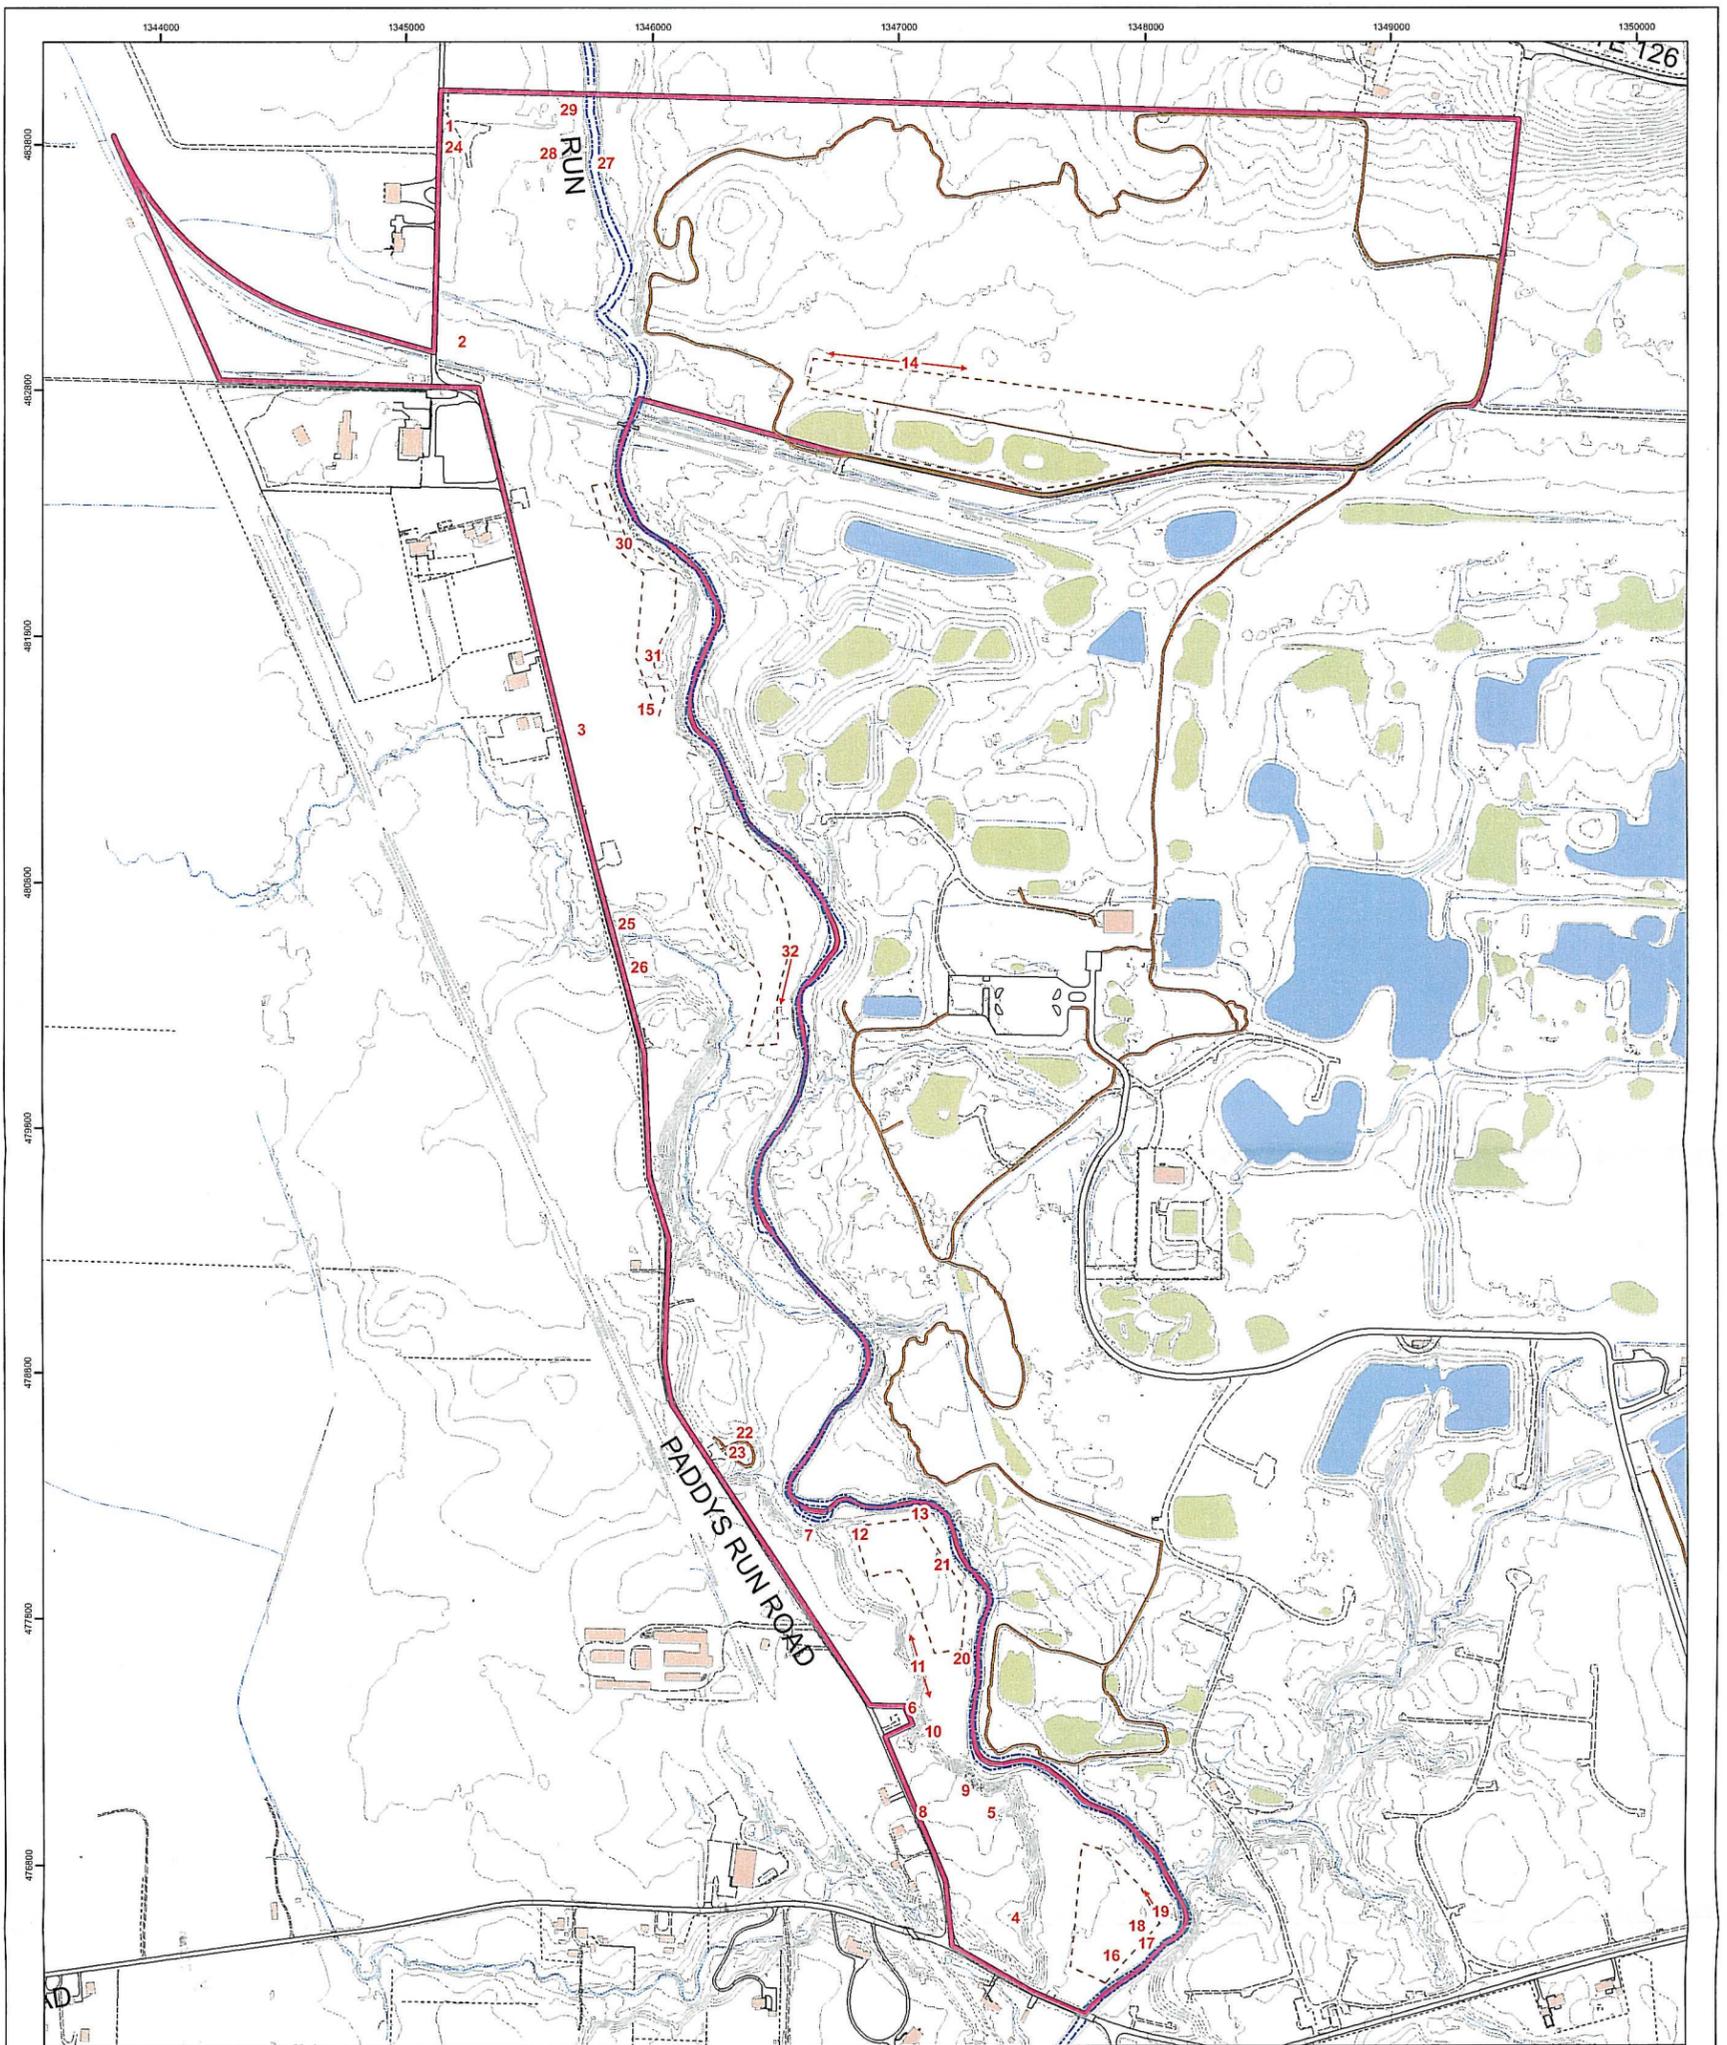
NOTE: Findings are numbered and provided on the December 2009 Field Walkdown Form.  
NOTE: Paddy's Run will be inspected as accessible - Summer/Fall.
