Department of Energy  
Office of Legacy Management

**SUBJECT: Transmittal of the June 20, 2007 Inspection Checklist for On-Site Disposal Facility**

# On-Site Disposal Facility Inspection Report

## June 2007

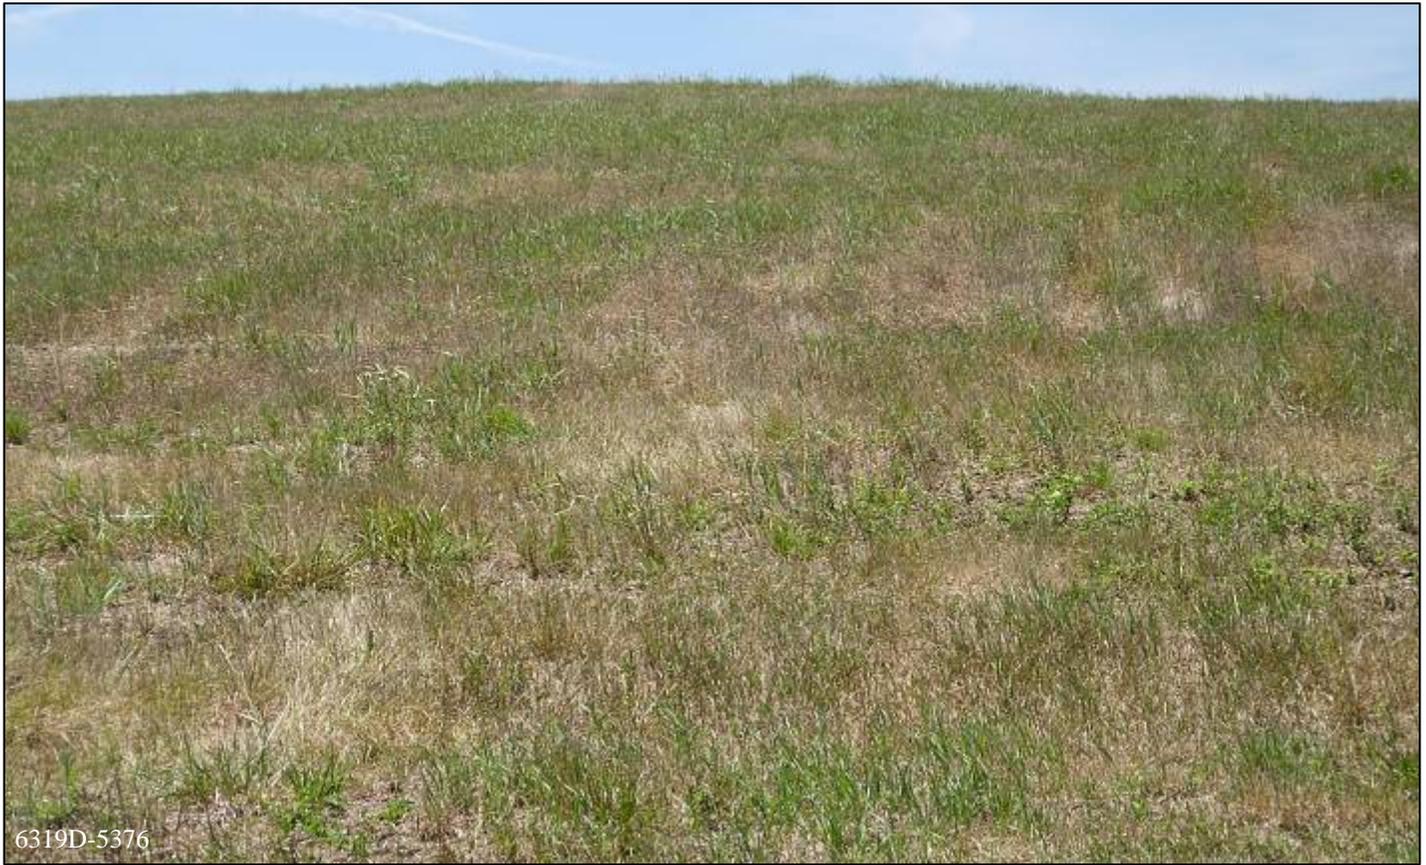
6319D-5376

**East Face Cell 1**

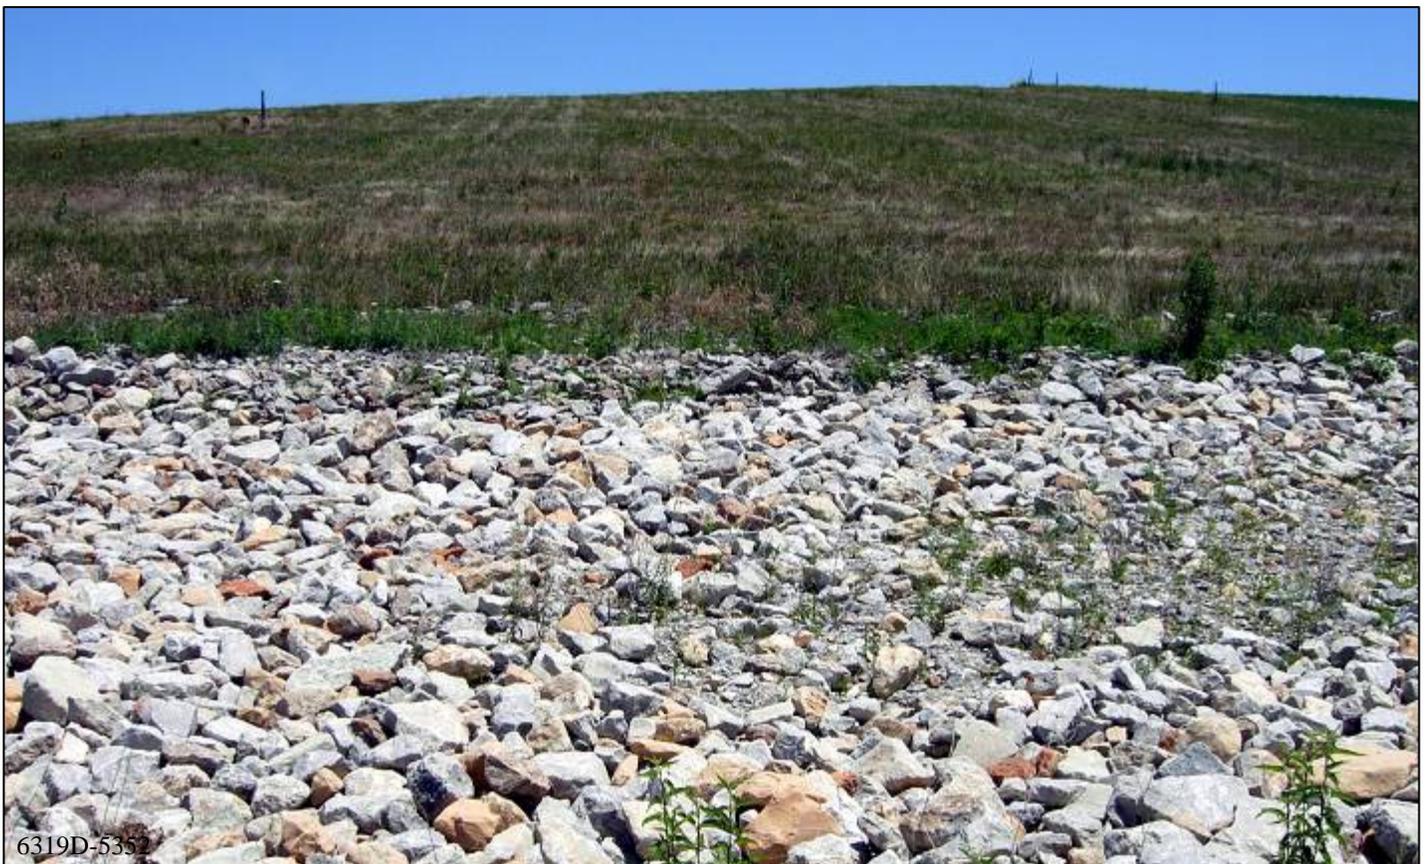
6319D-5352

**West Face Cell 1**

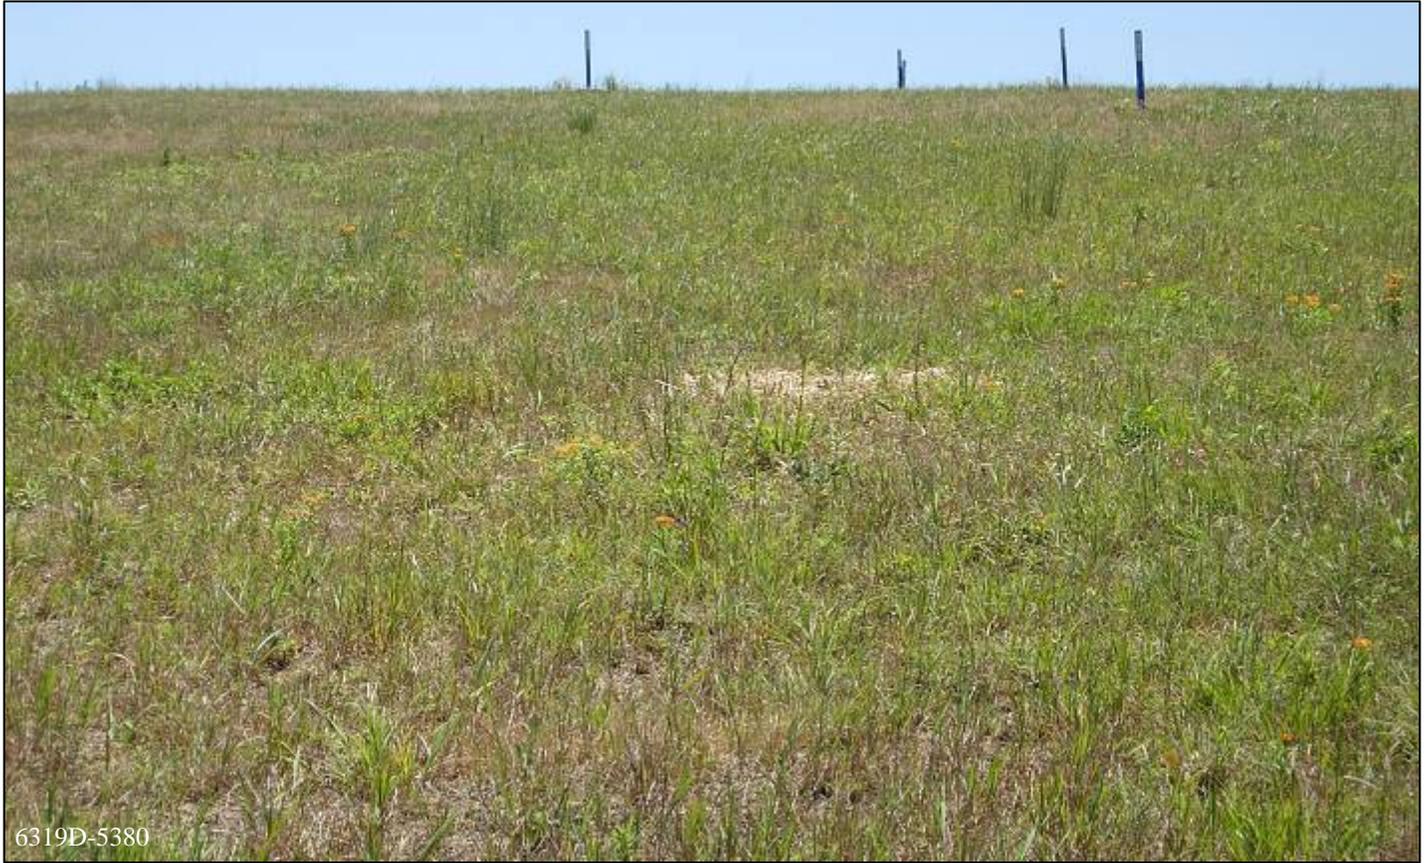
**North Face Cell 1**

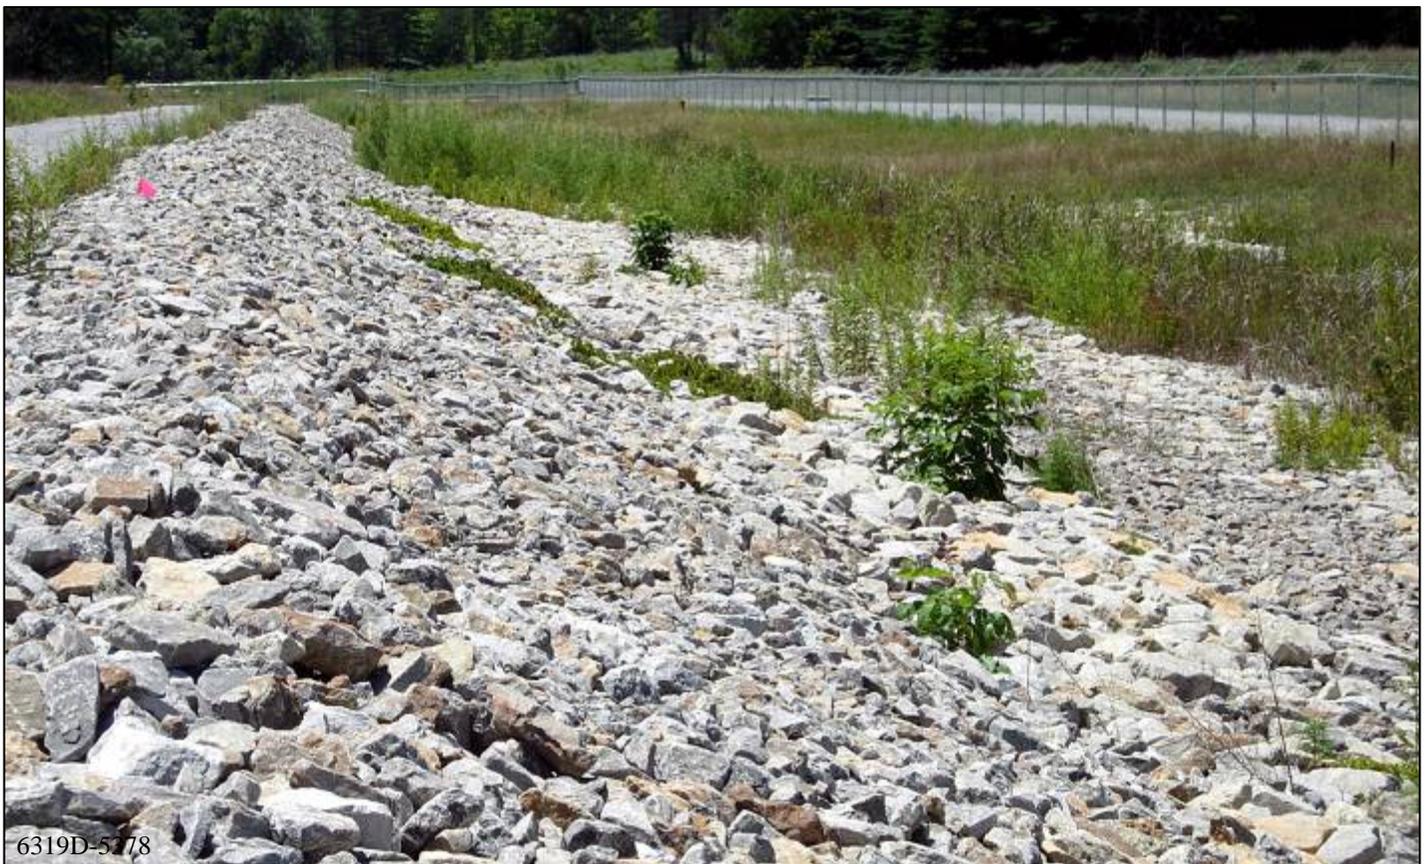
**North Drainage (looking west)**

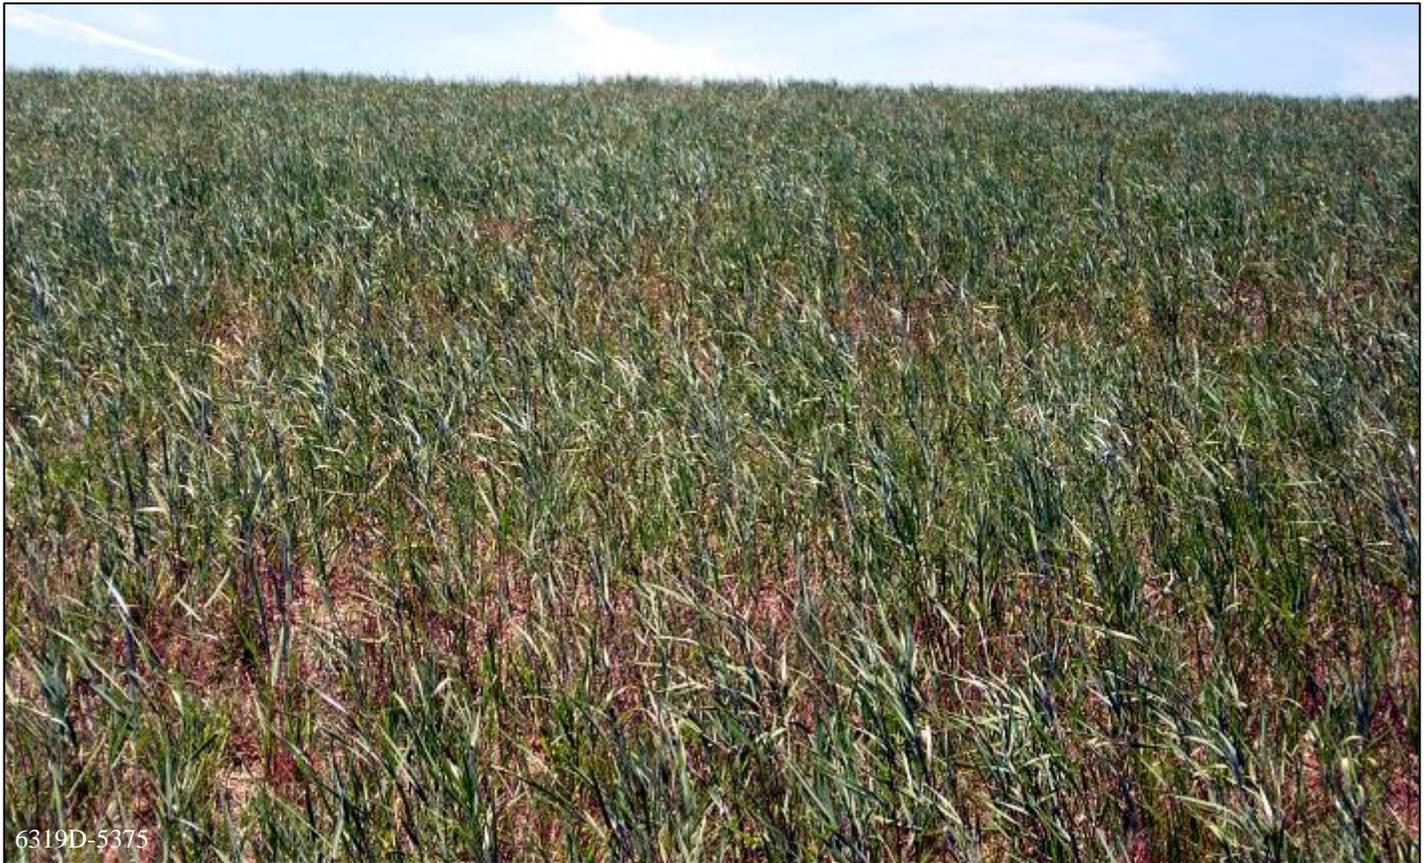
**East Face Cell 2**

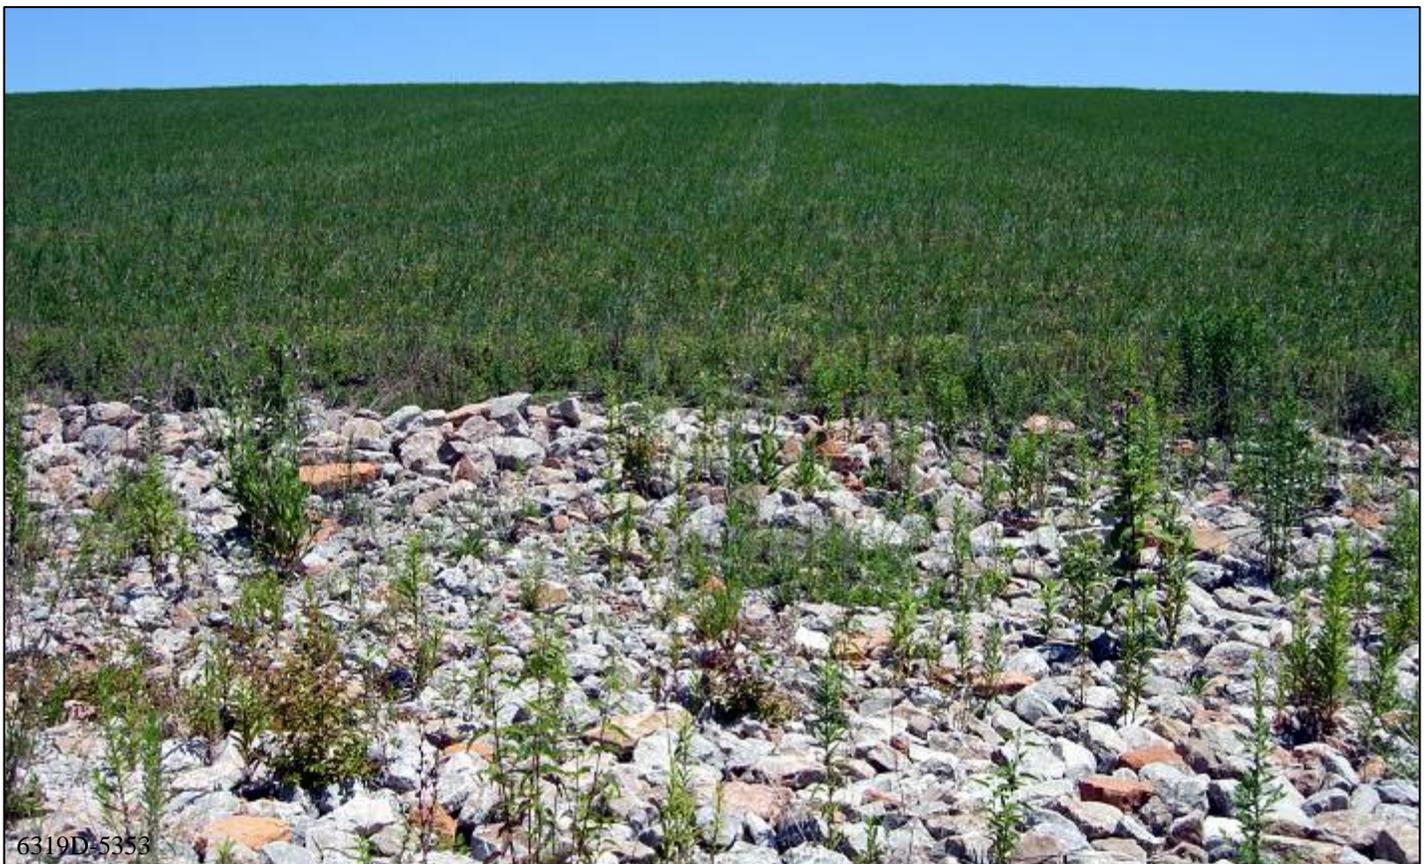
**West Face Cell 2**

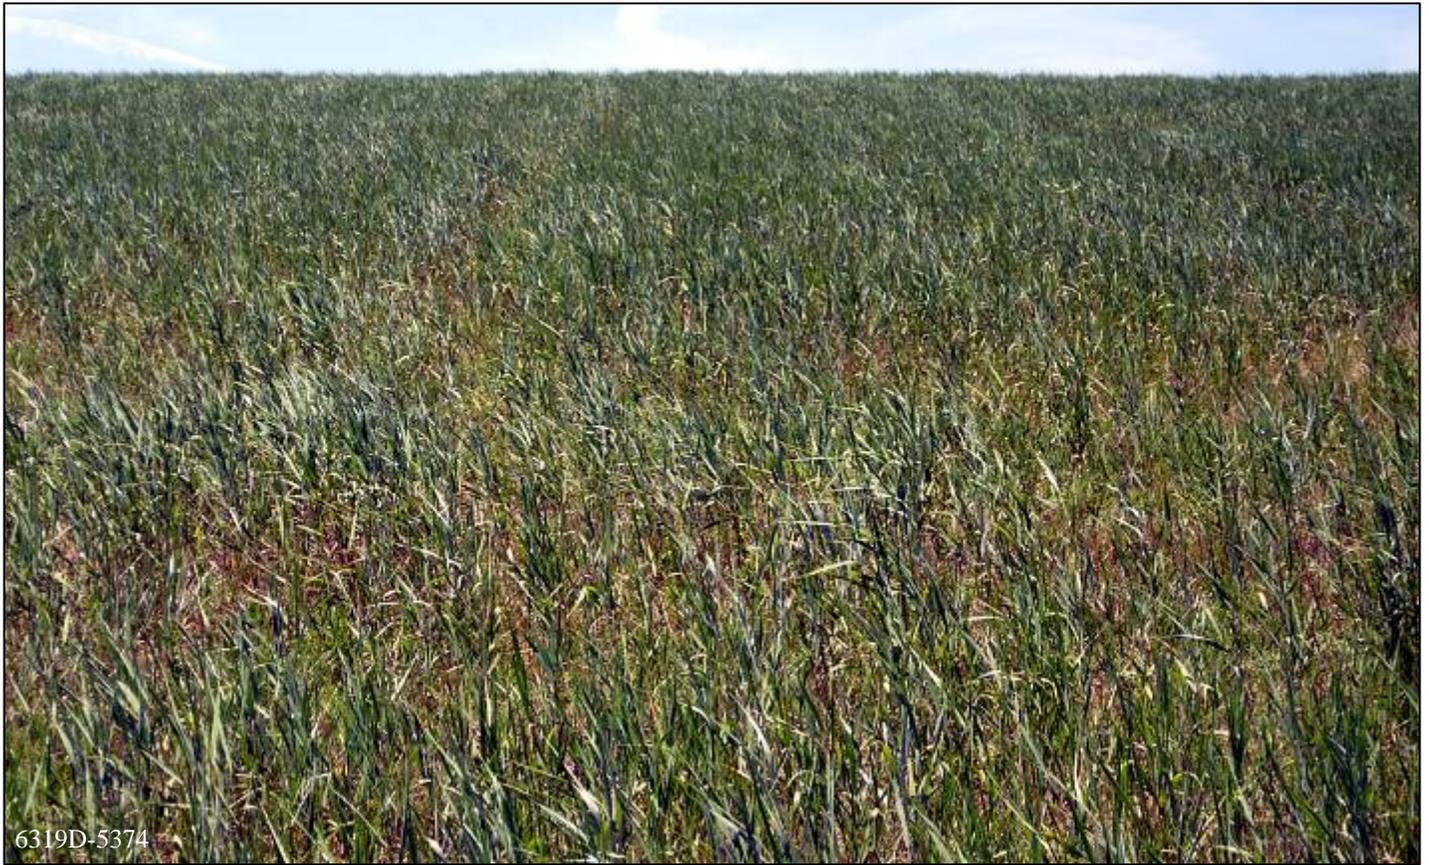
**East Face Cell 3**

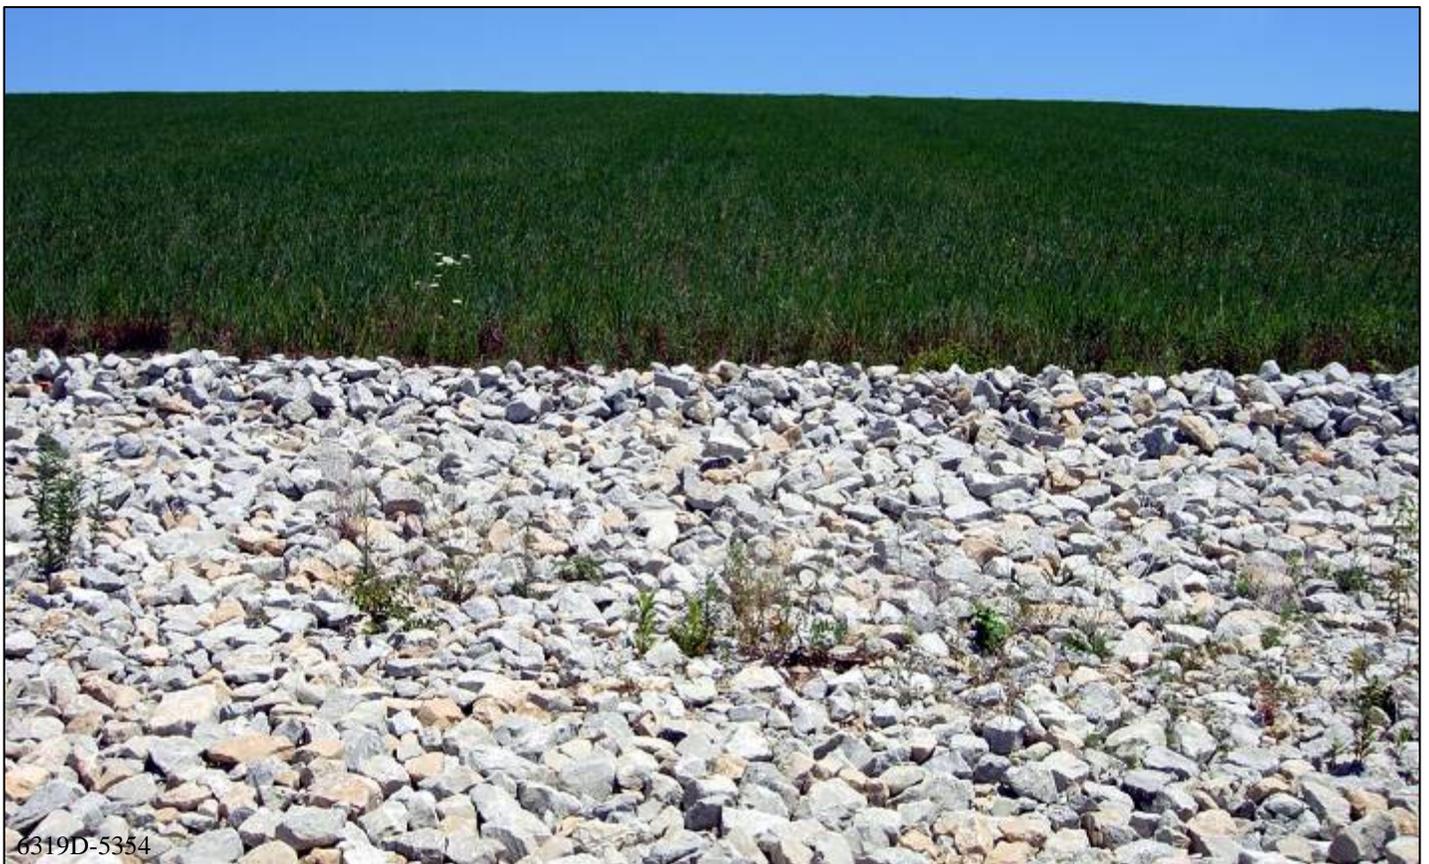
**West Face Cell 3**

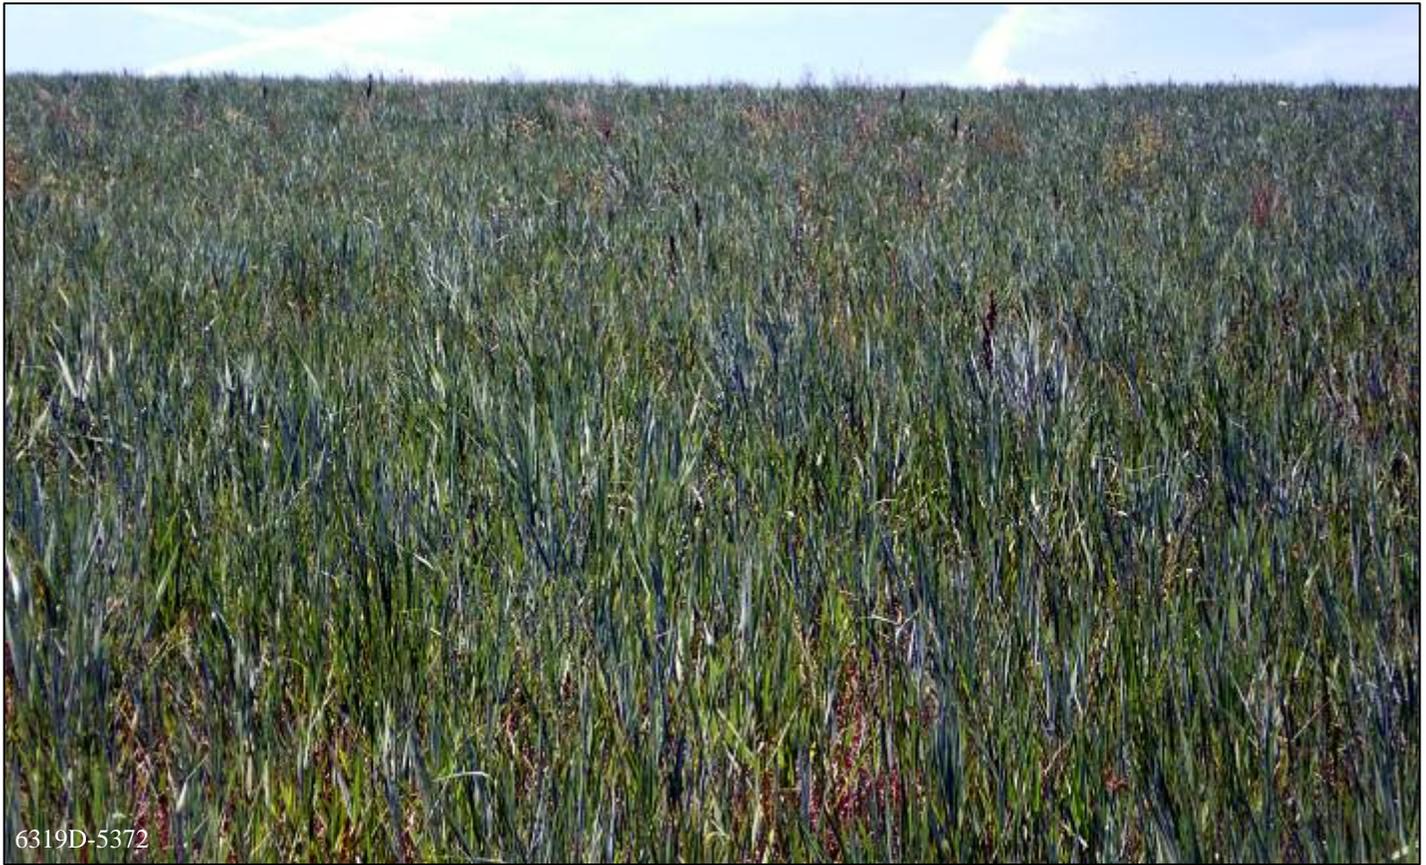
**East Face Cell 4**

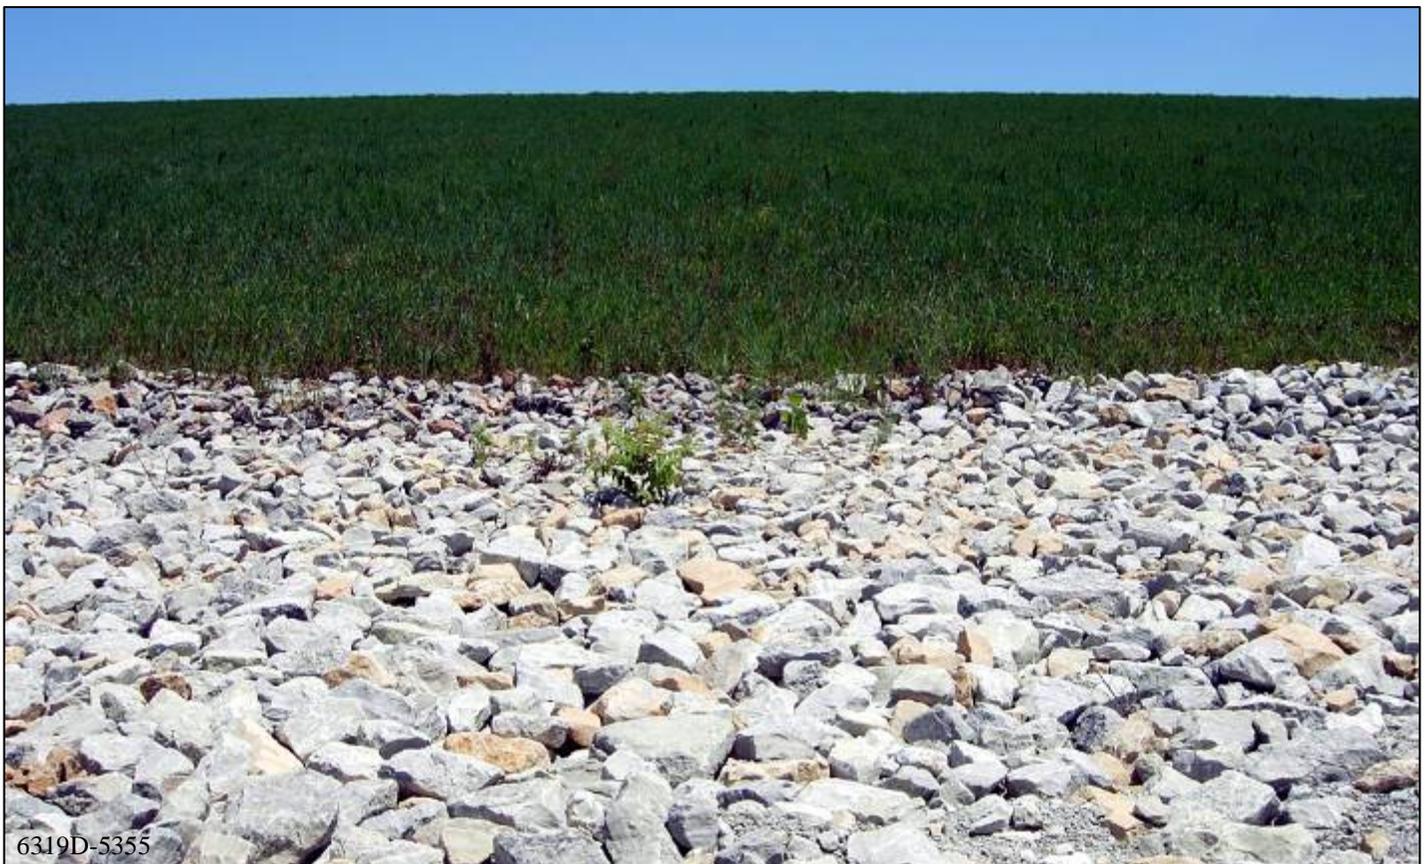
**West Face Cell 4**

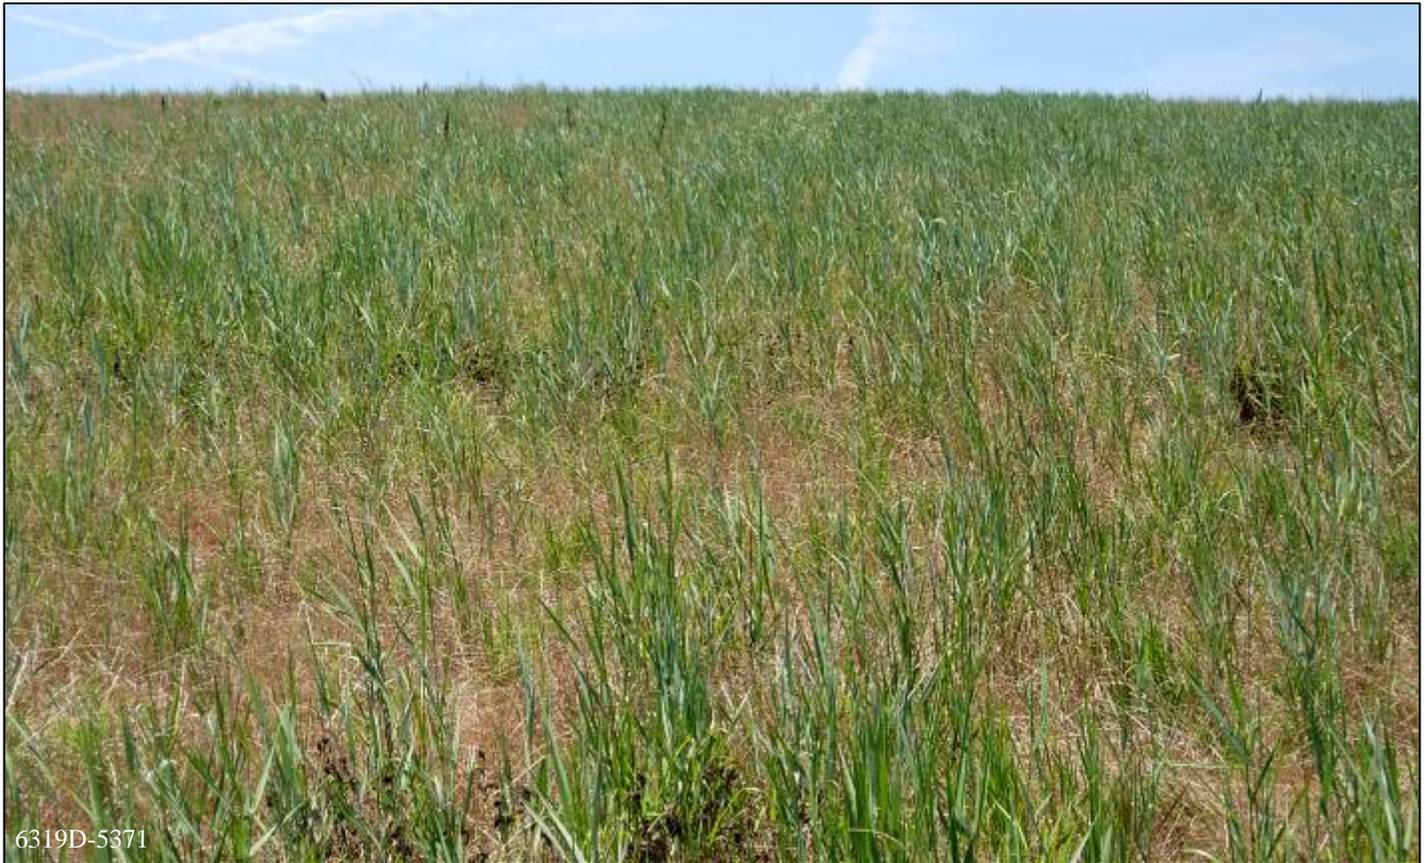
6319D-5371

**East Face Cell 5**

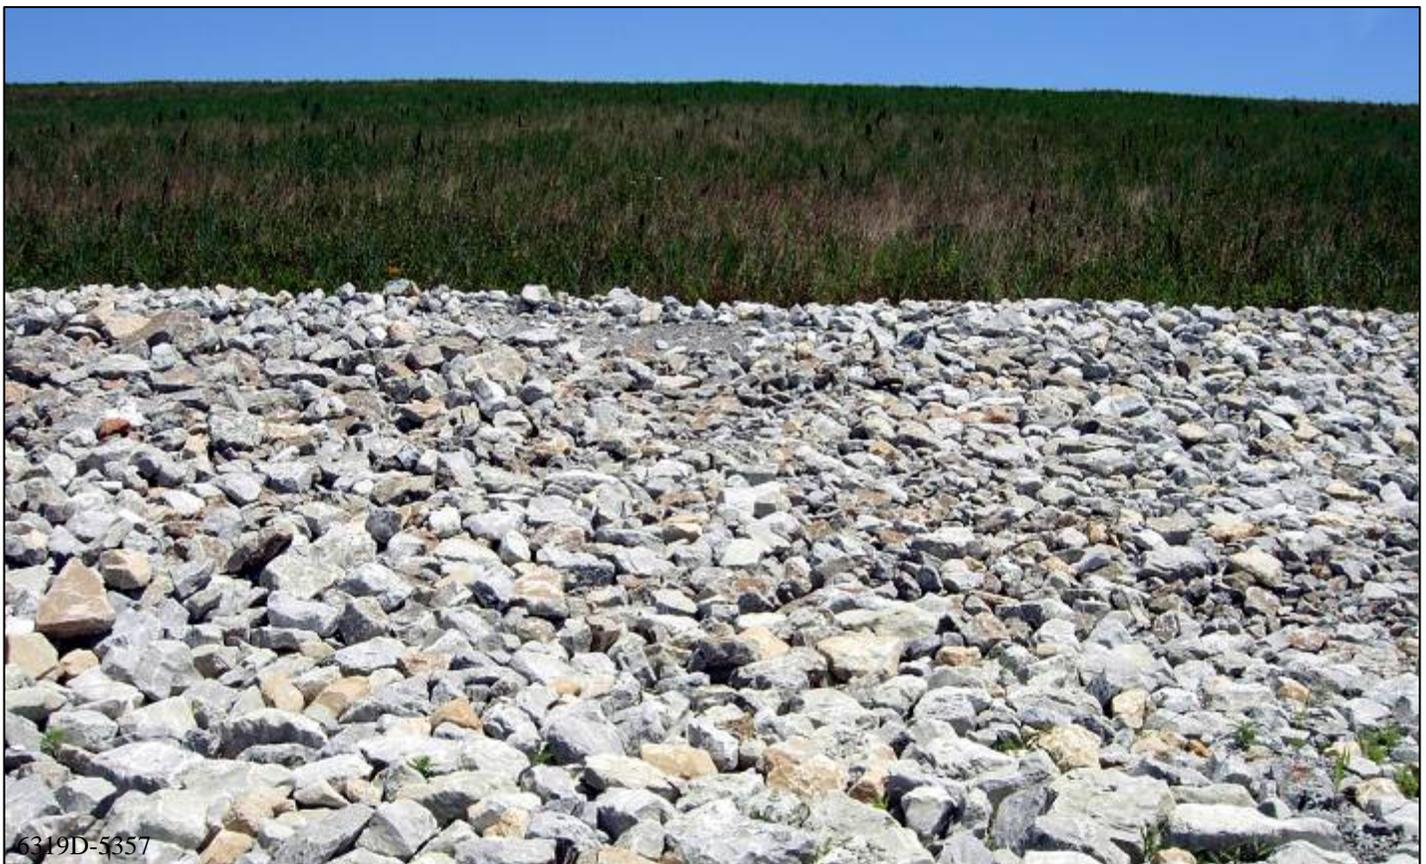
6319D-5357

**West Face Cell 5**

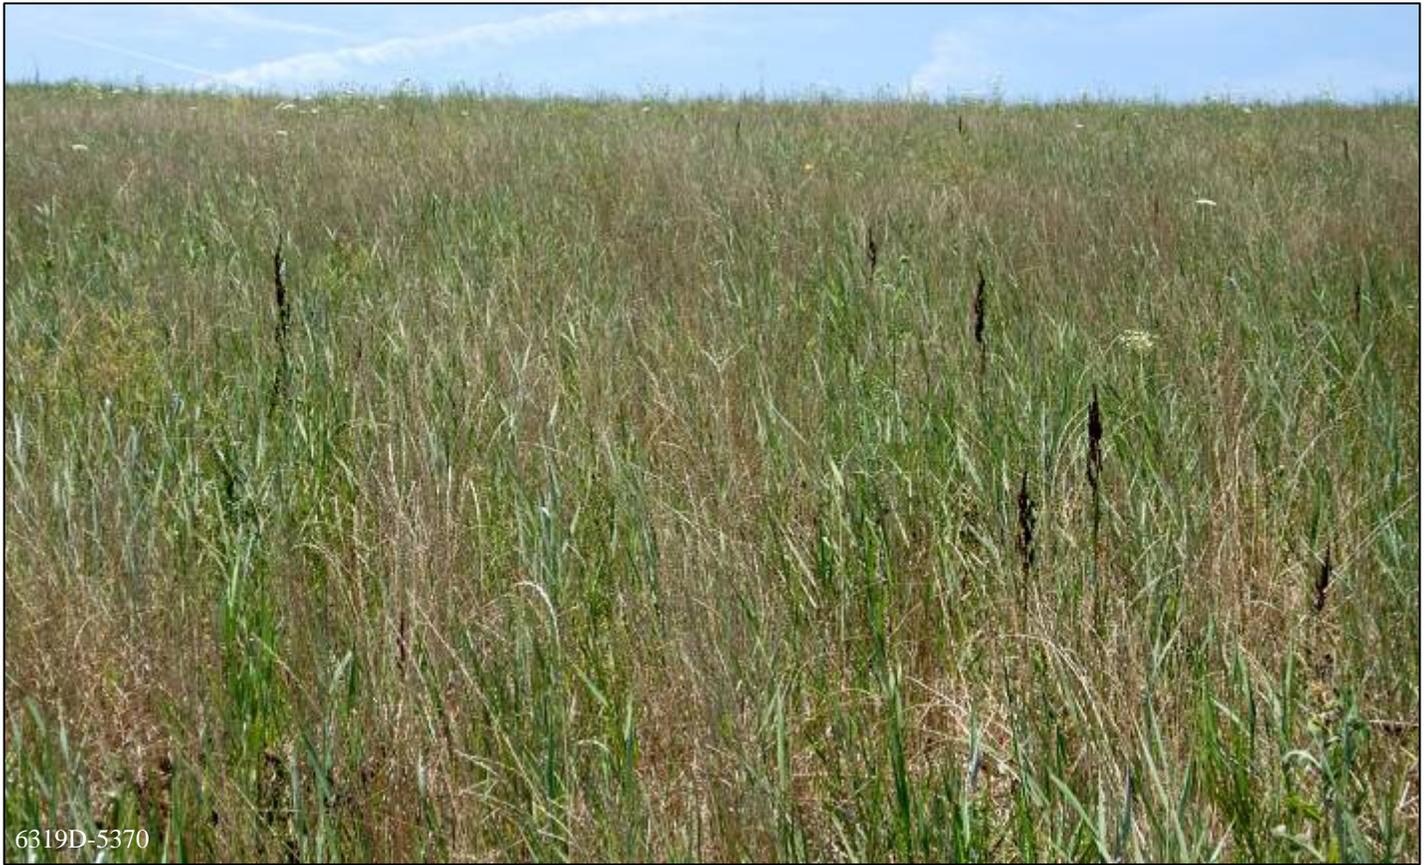
**East Face Cell 6**

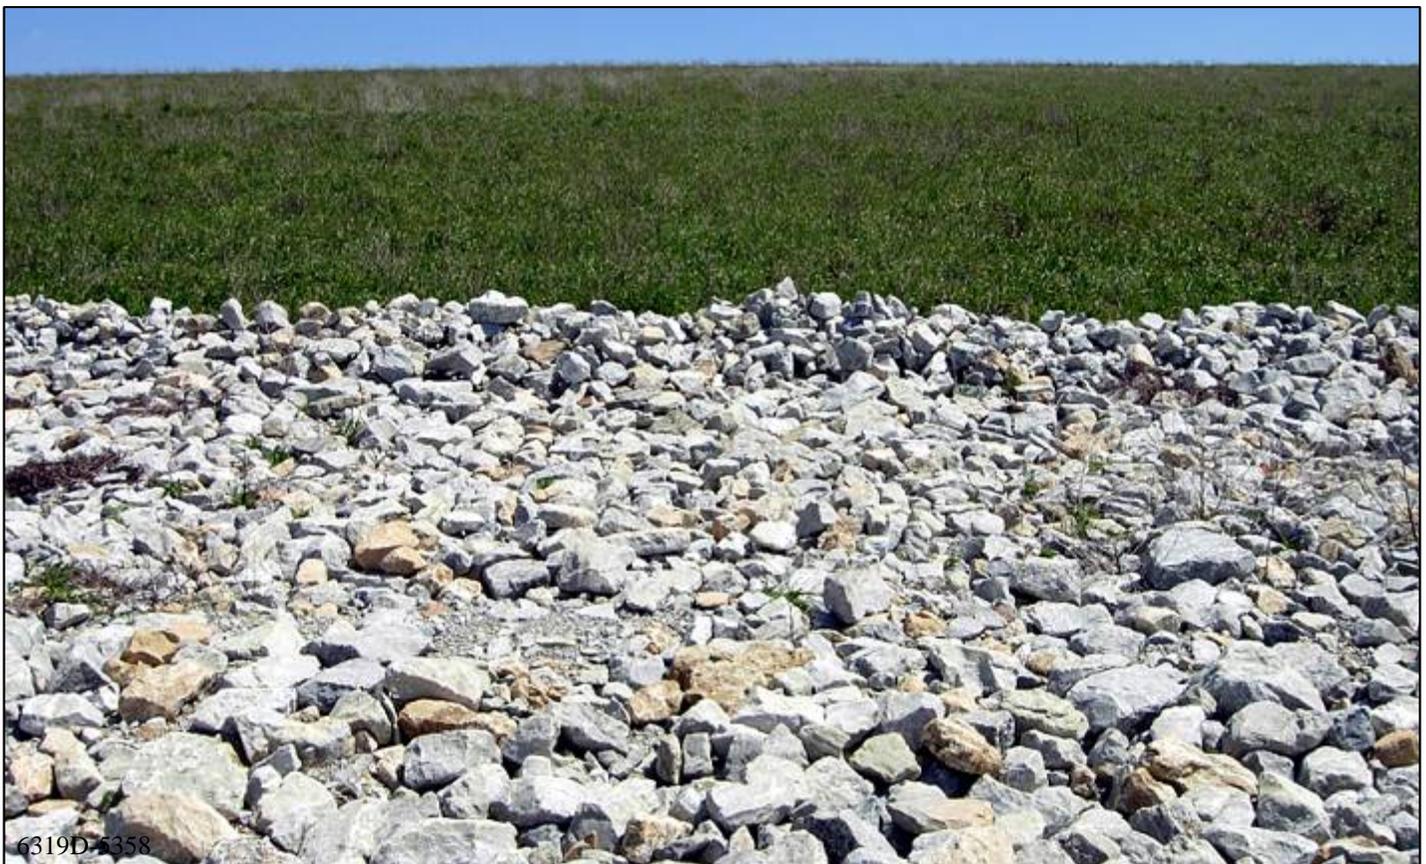
**West Face Cell 6**

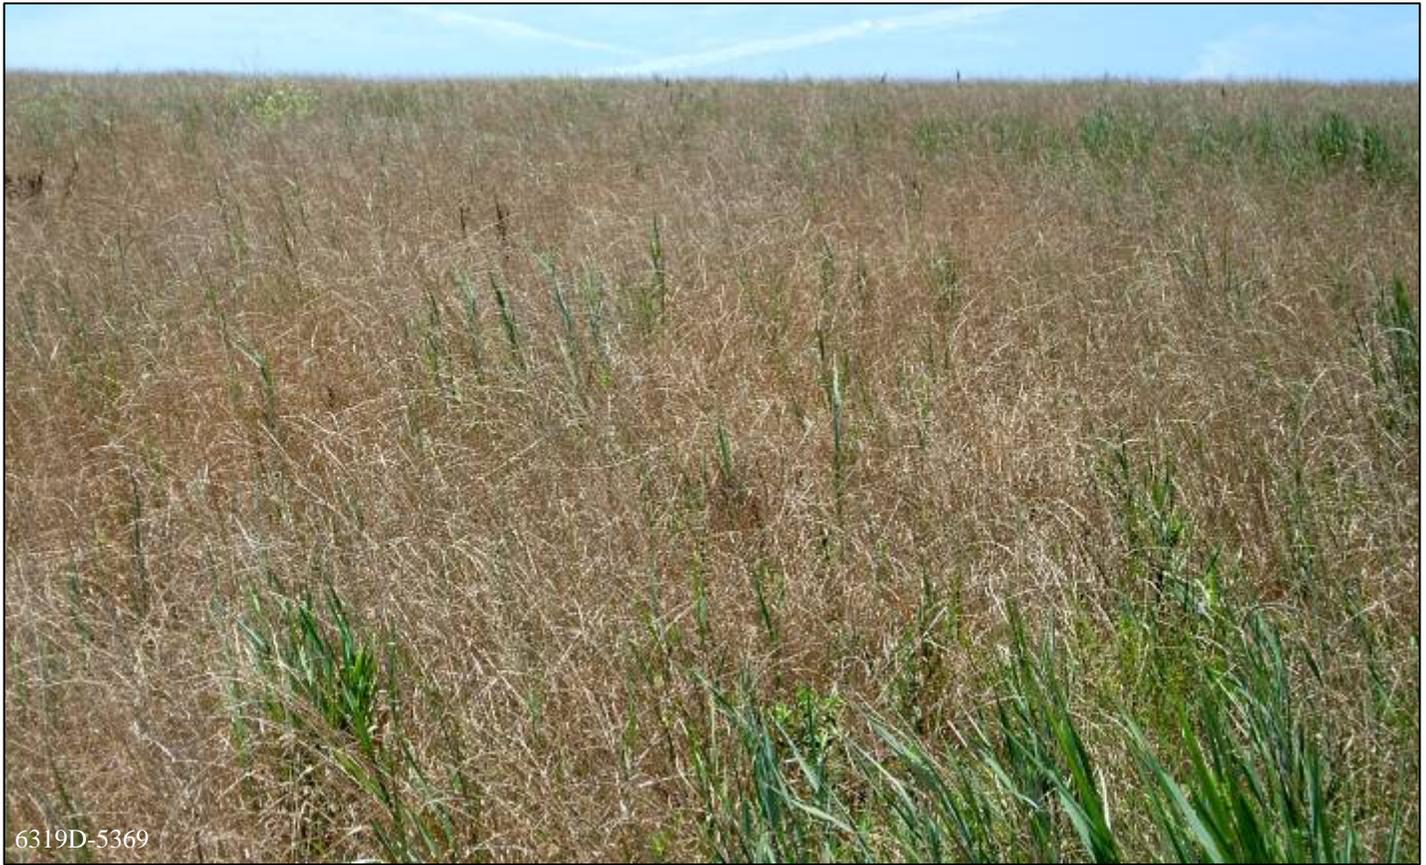
**East Face Cell 7**

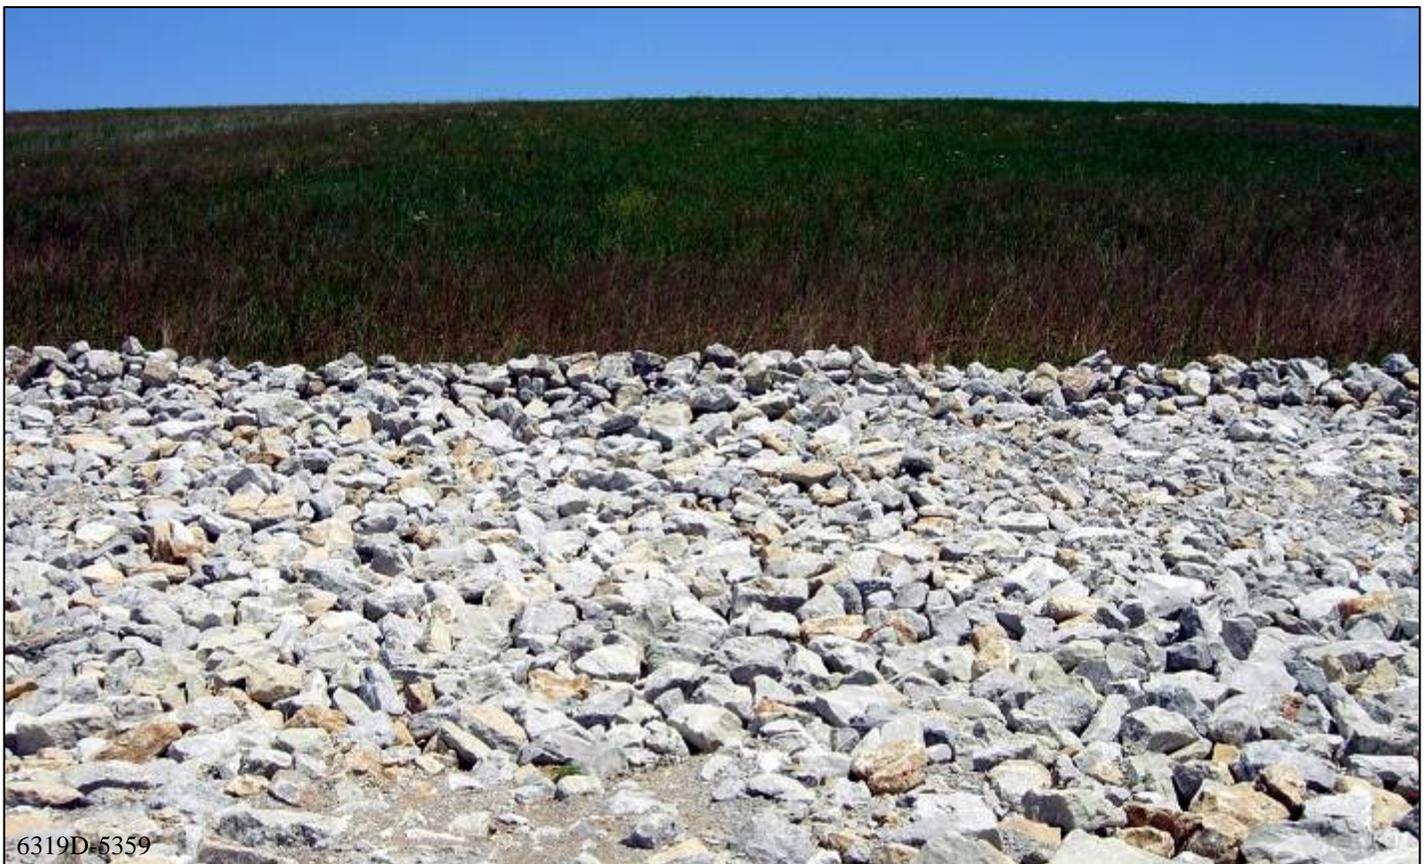
**West Face Cell 7**

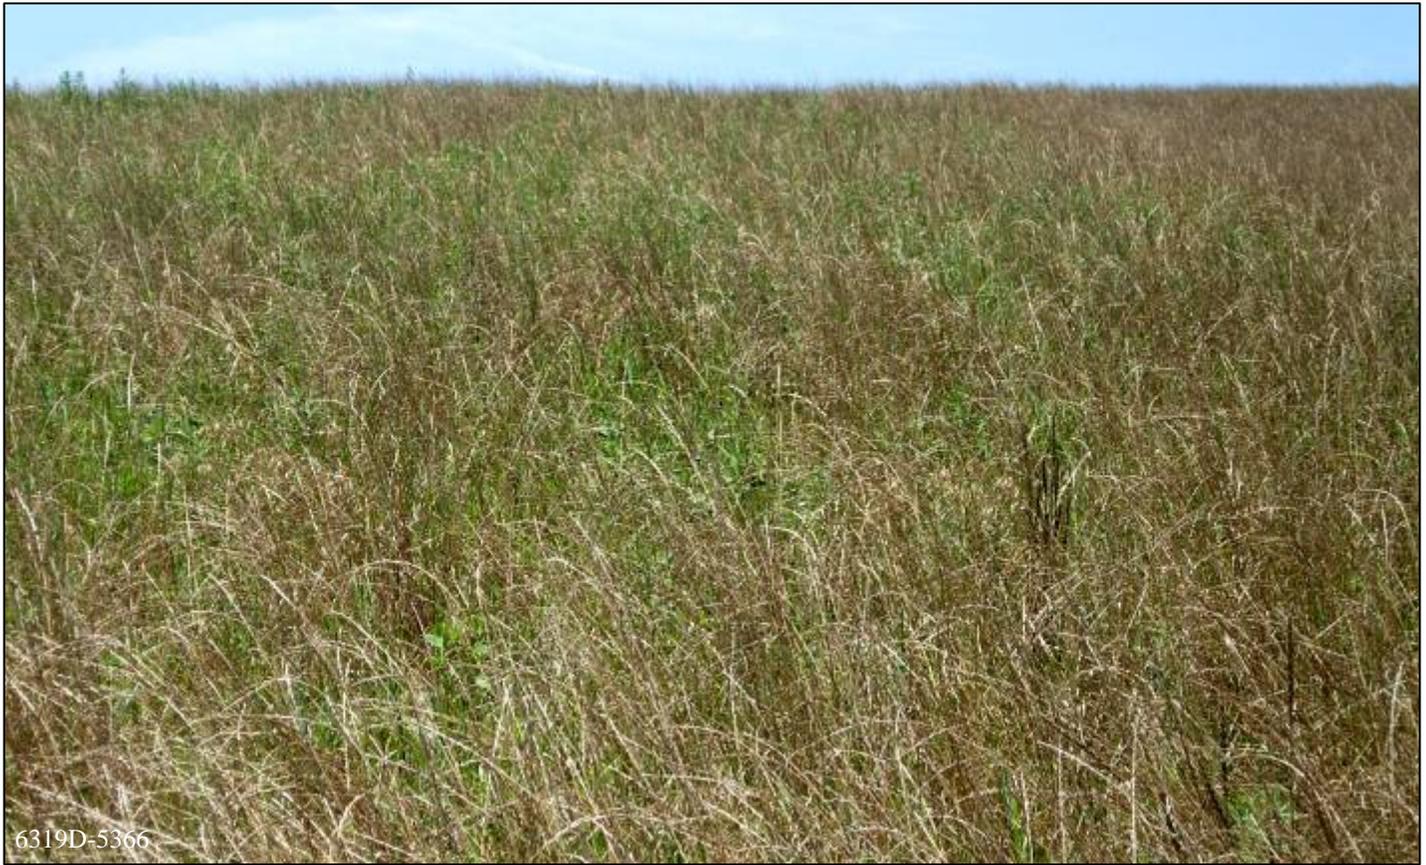
**East Face Cell 8**

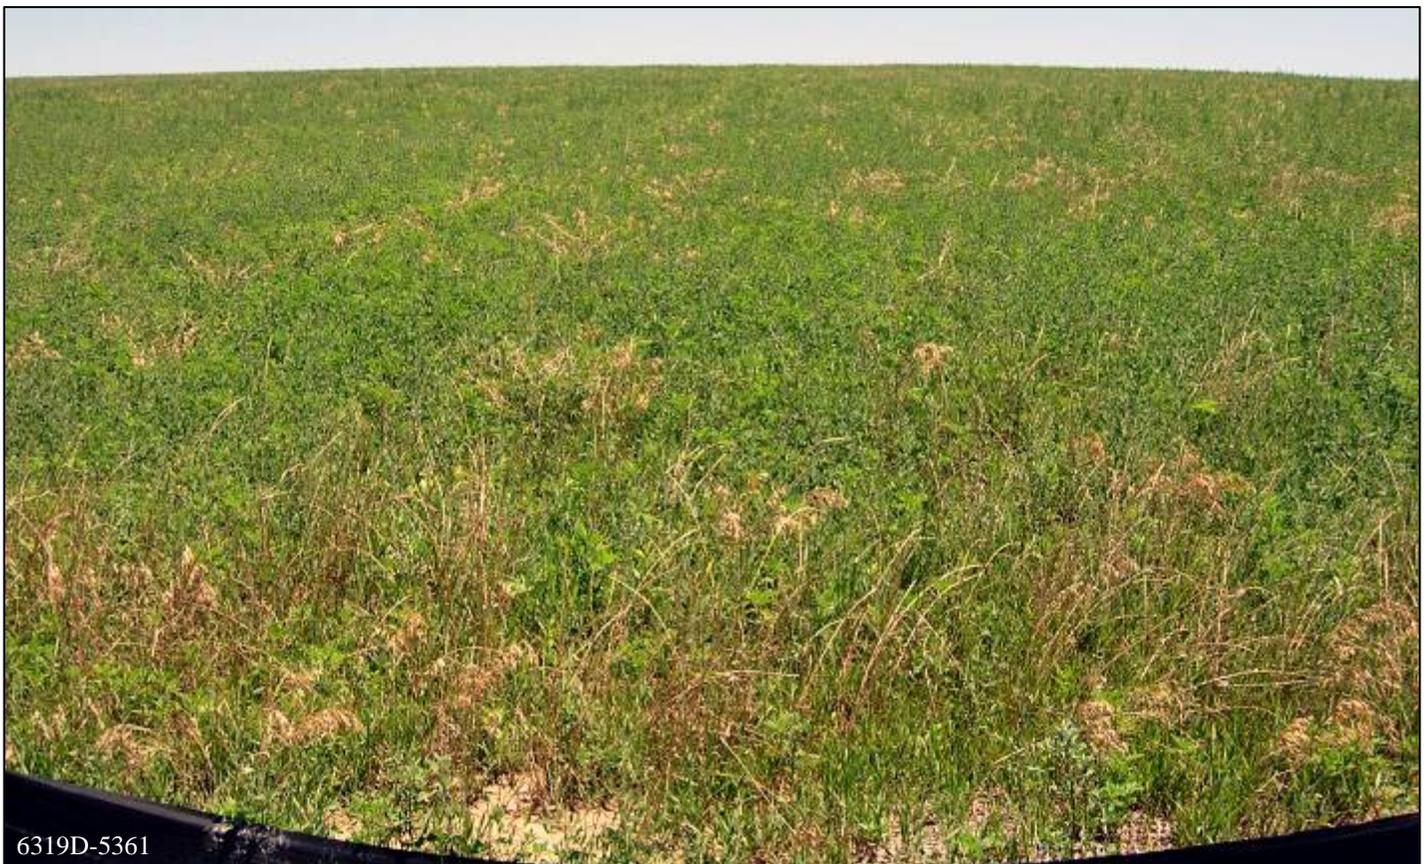
**West Face Cell 8**
