Department of Energy  
Office of Legacy Management

**SUBJECT: Transmittal of the June 20, 2007 Inspection Checklist for On-Site Disposal Facility**

# On-Site Disposal Facility Inspection Report

## June 2007

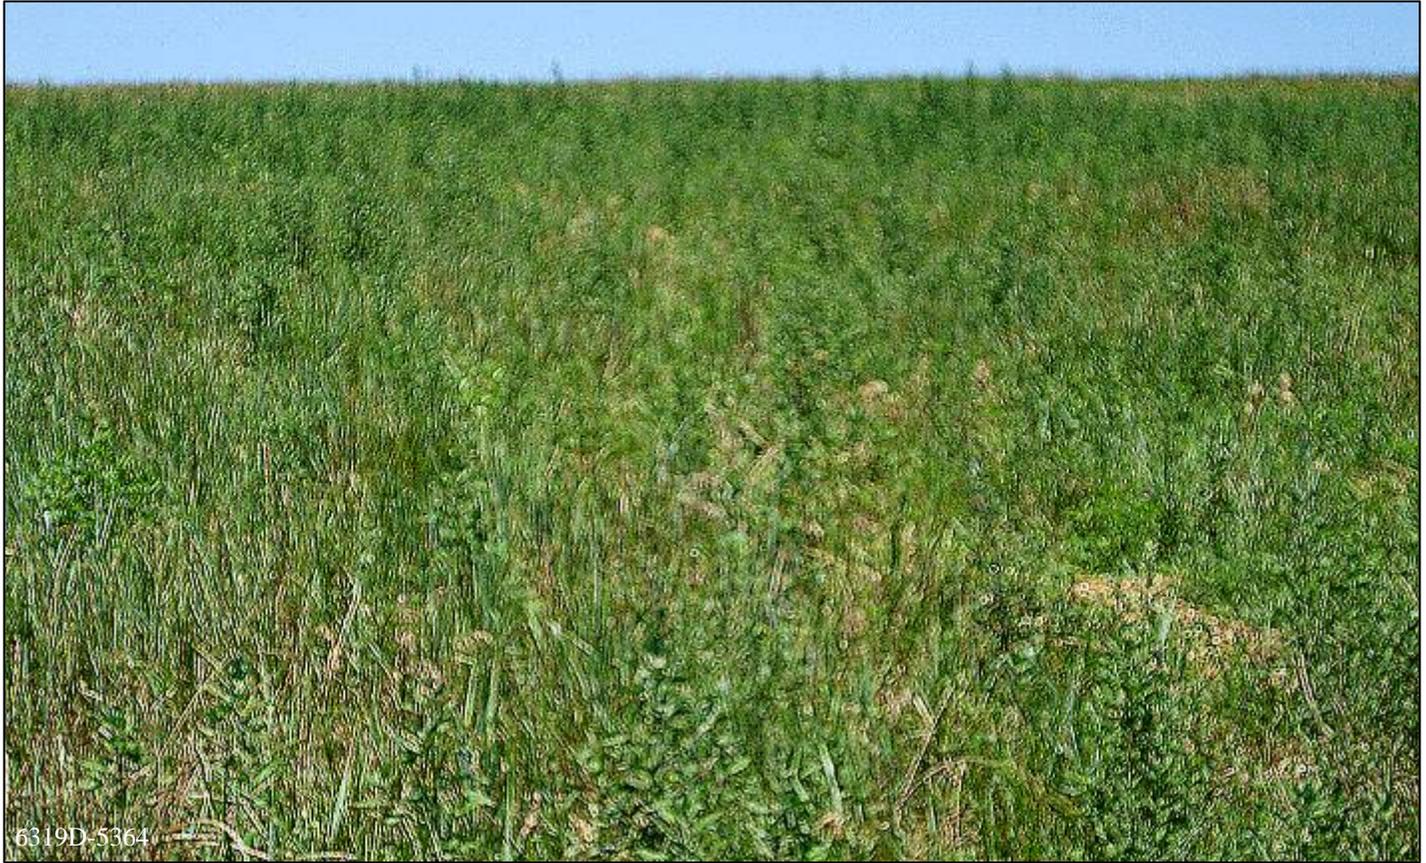
**South Face Cell 8**

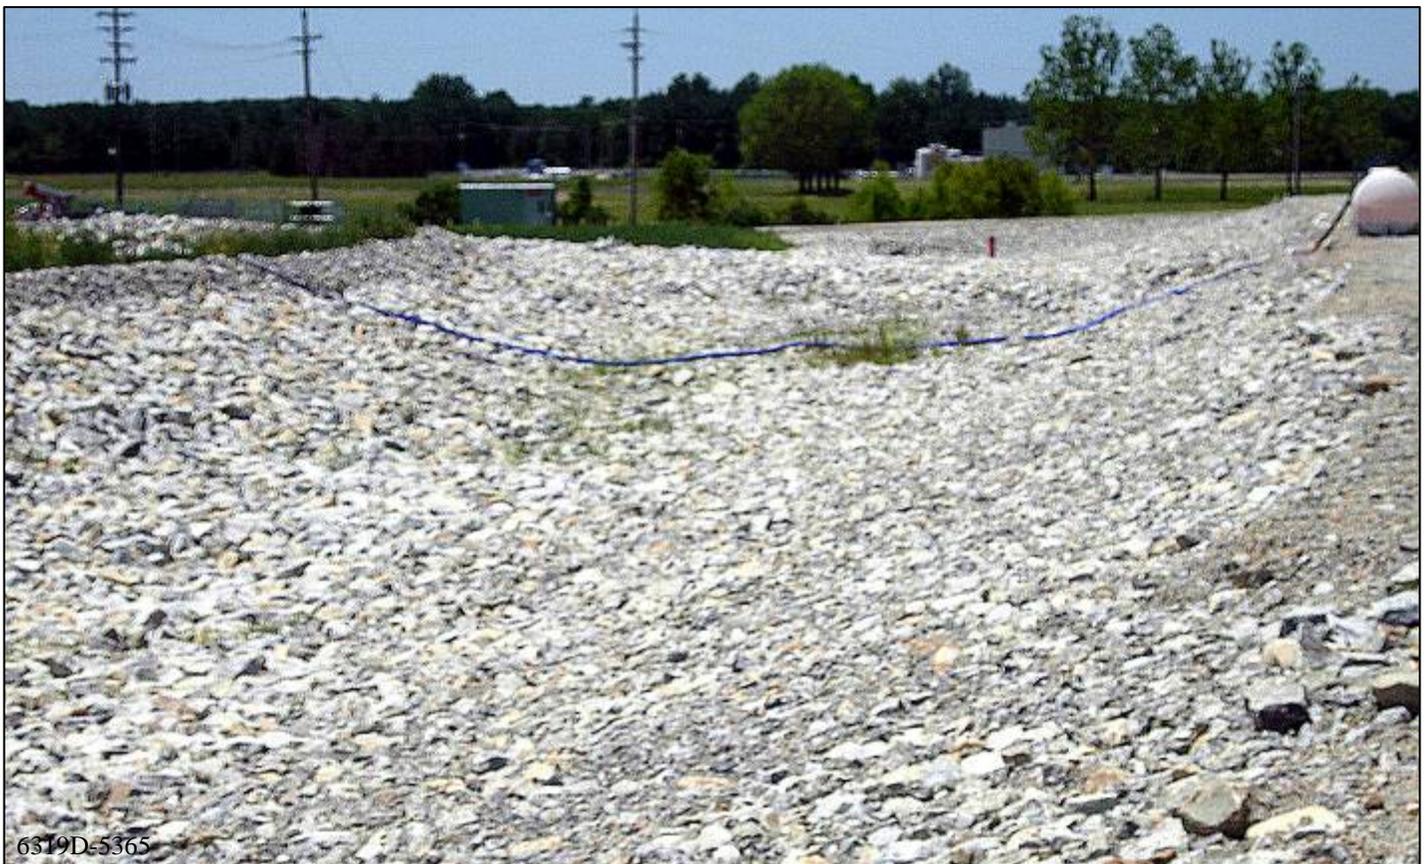
**South Drainage (looking west)**

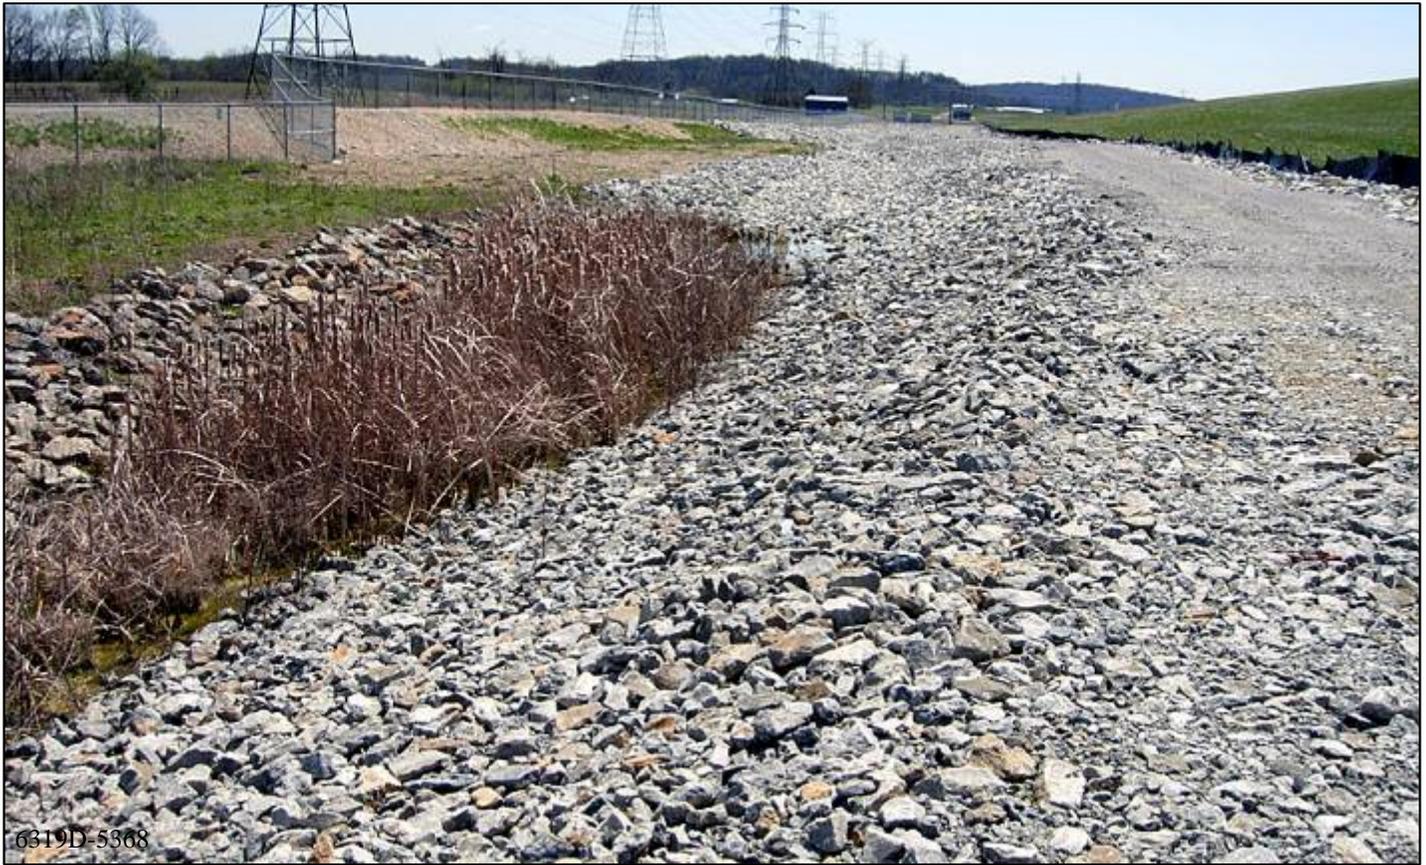
6319D-5368

**East Drainage Cell 7 (looking south)**

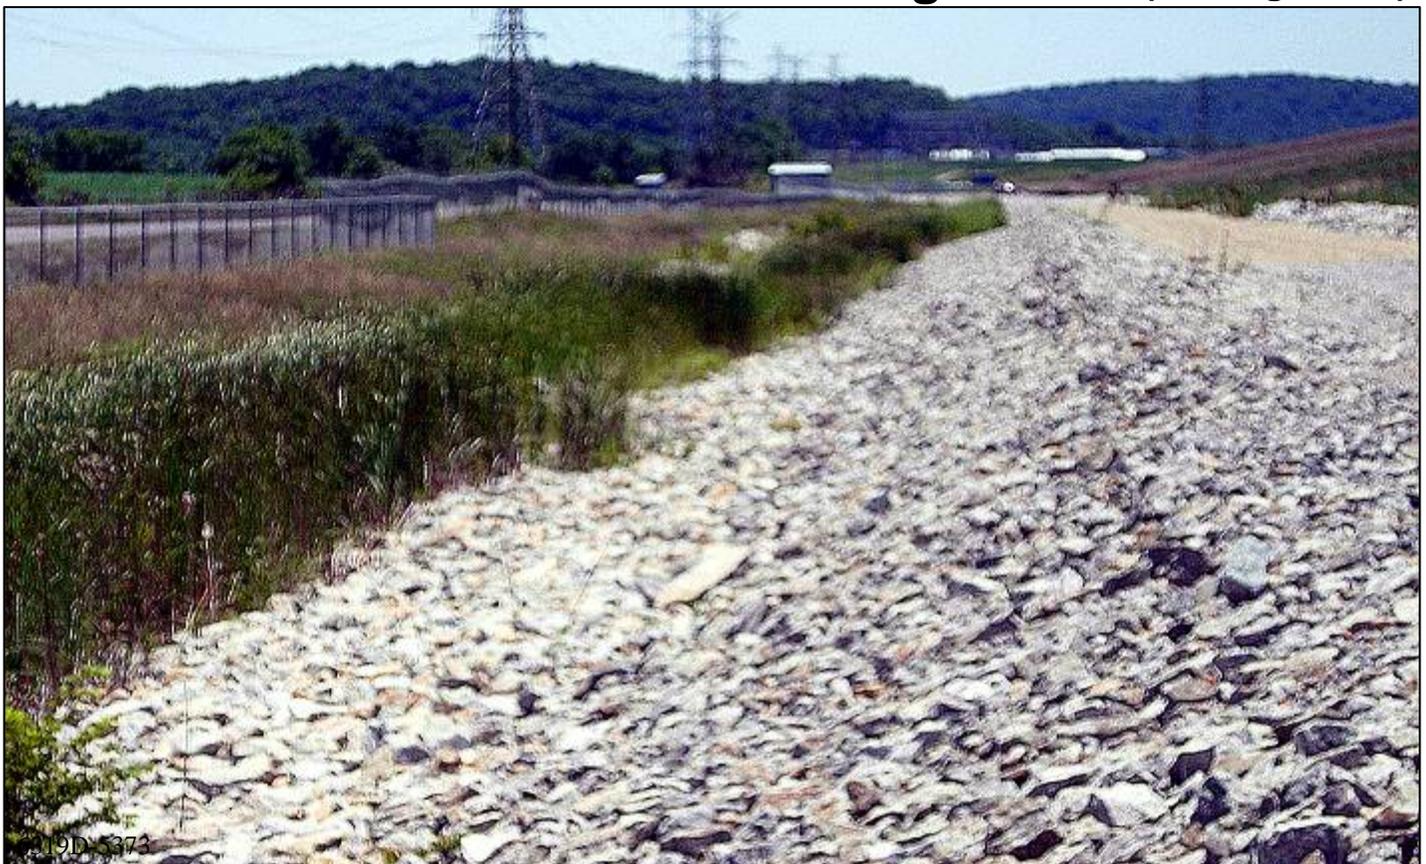
6319D-5373

**East Drainage Cell 4 (looking south)**

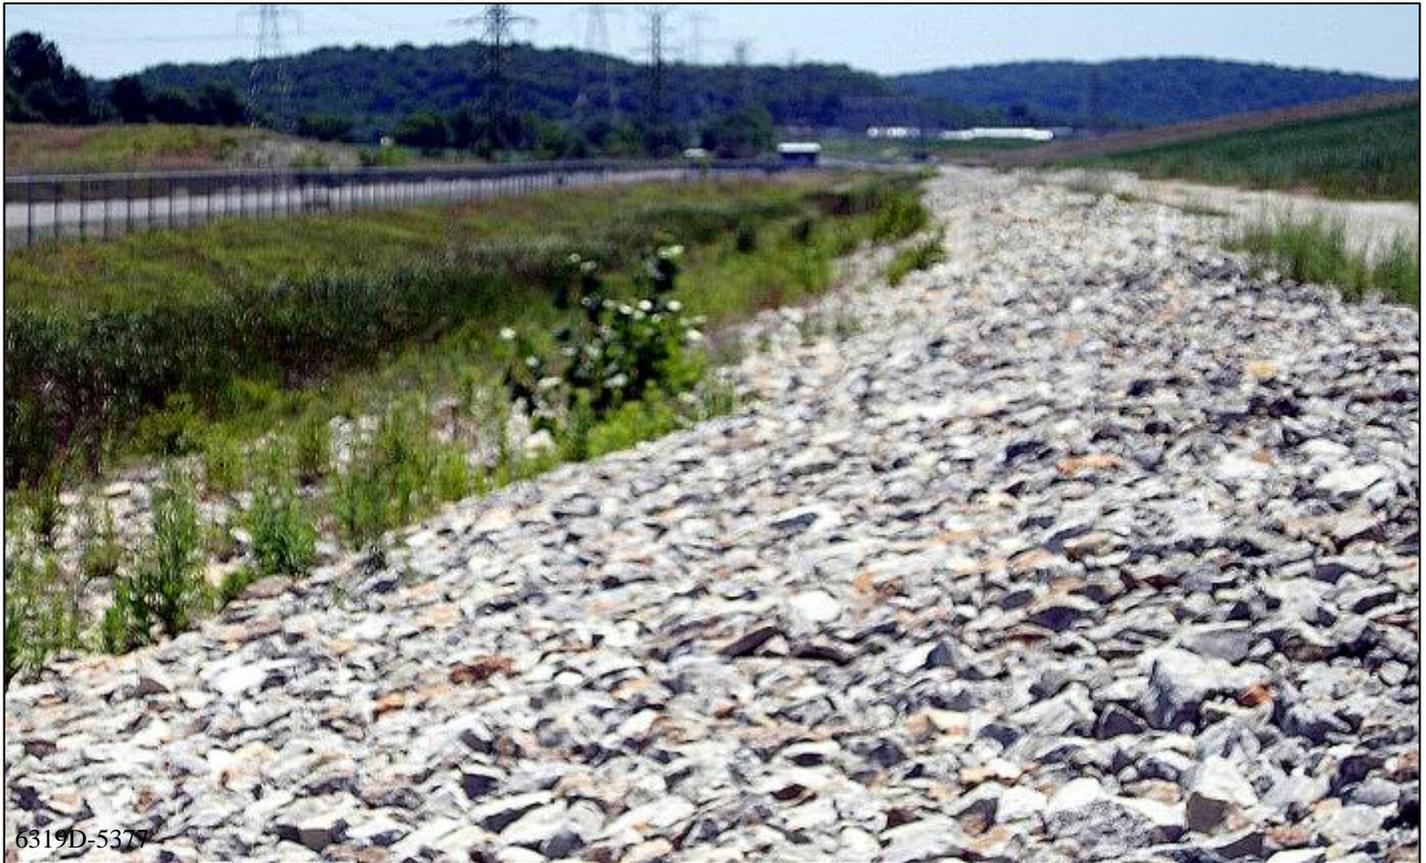
6319D-5377

**East Drainage Cell 1 (looking south)**

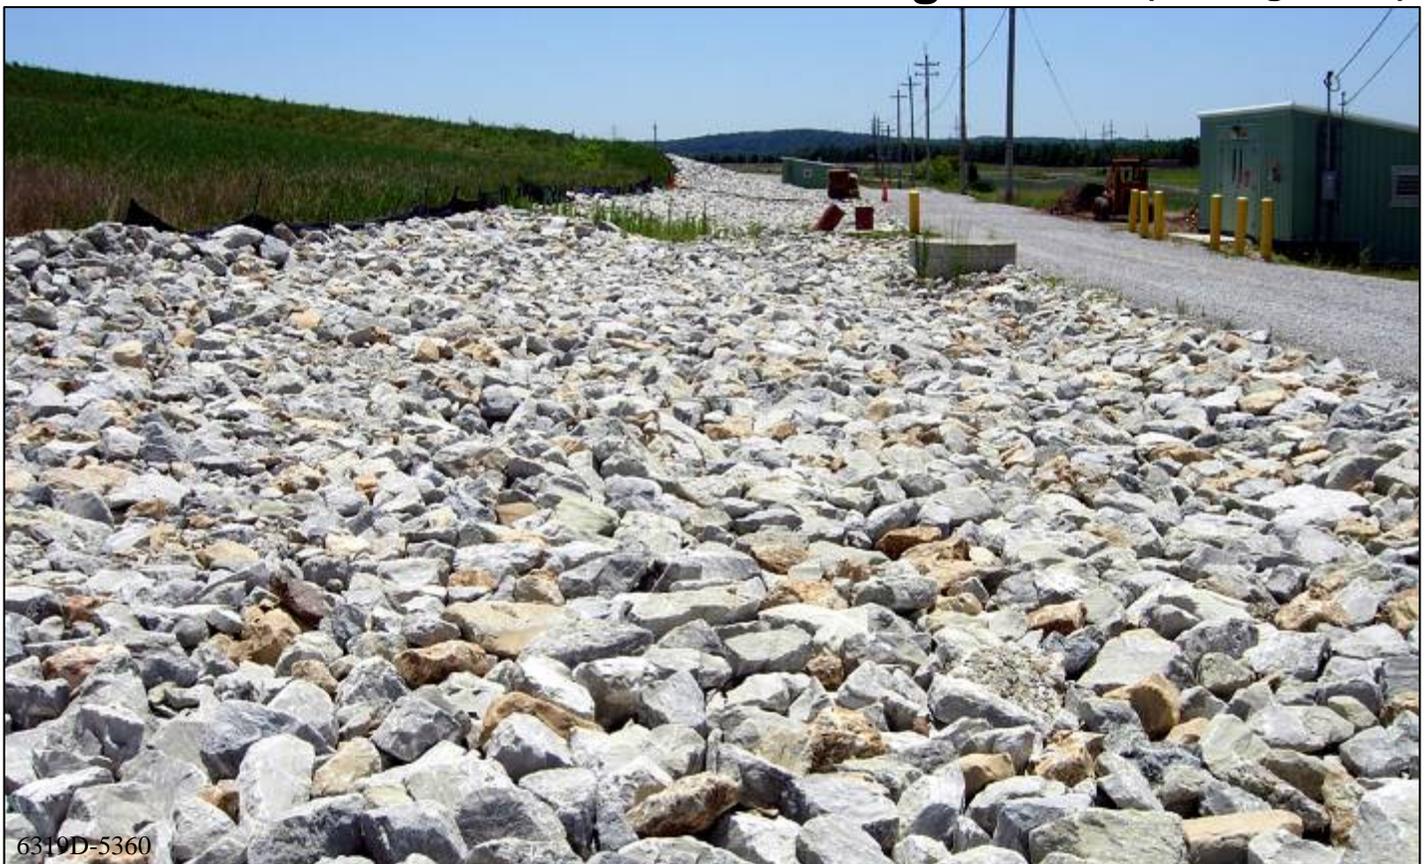
6319D-5360

**West Inner Drainage Cell 7 (looking south)**

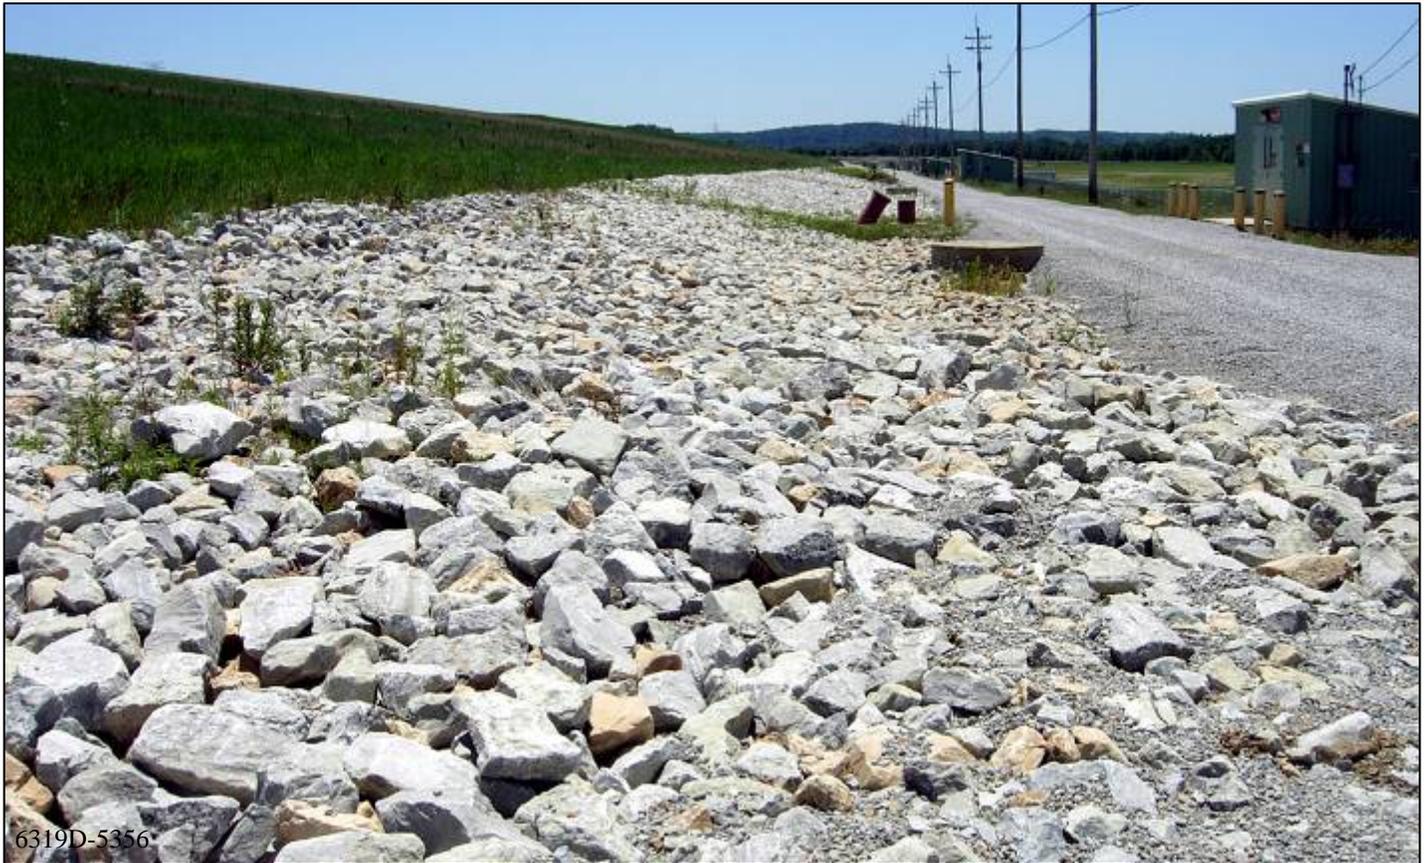
**West Inner Drainage Cell 4 (looking south)**

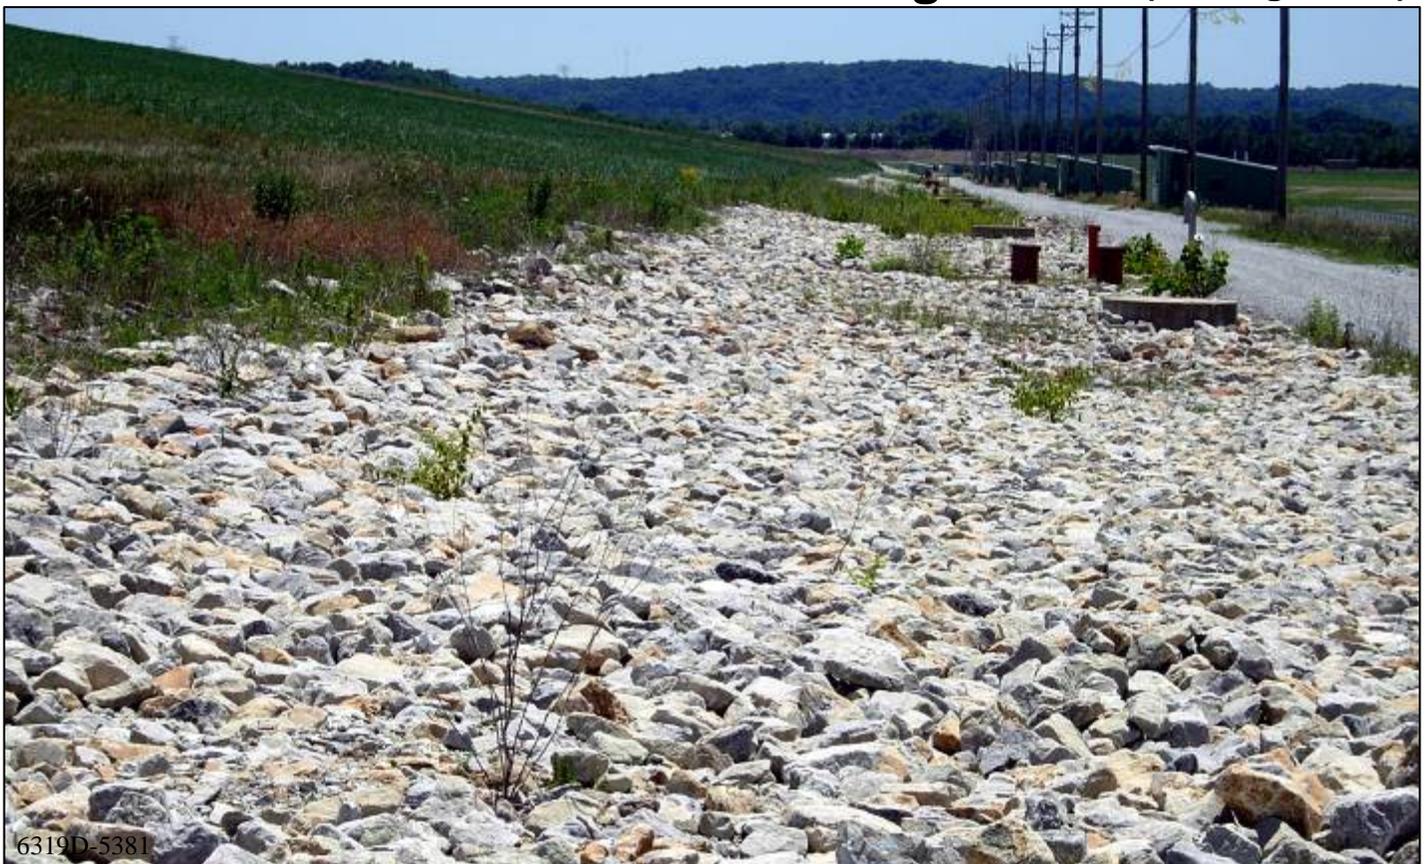
**West Inner Drainage Cell 1 (looking south)**

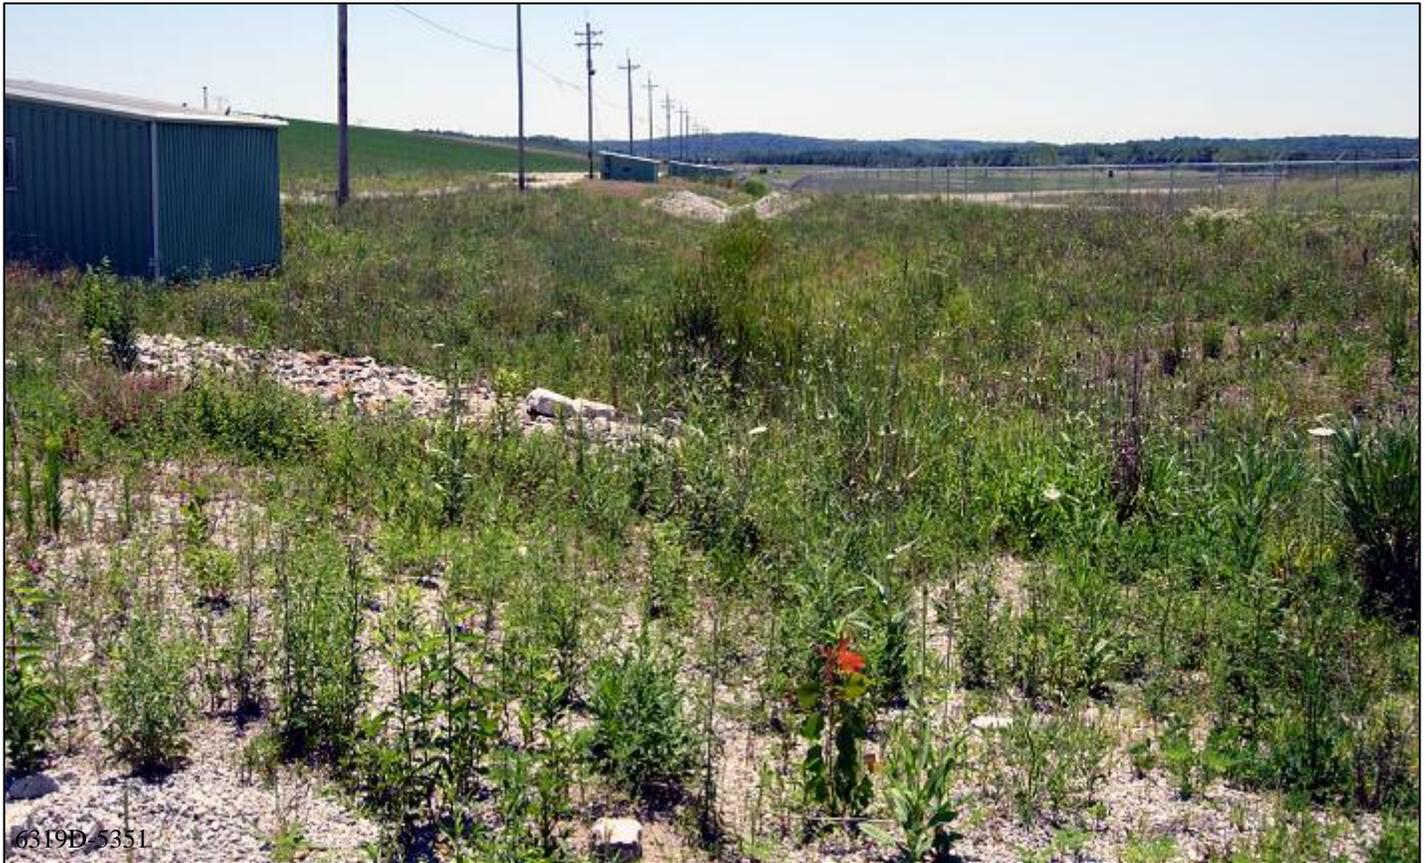
6319D-5351

**West Outer Drainage Cell 1 (looking south)**

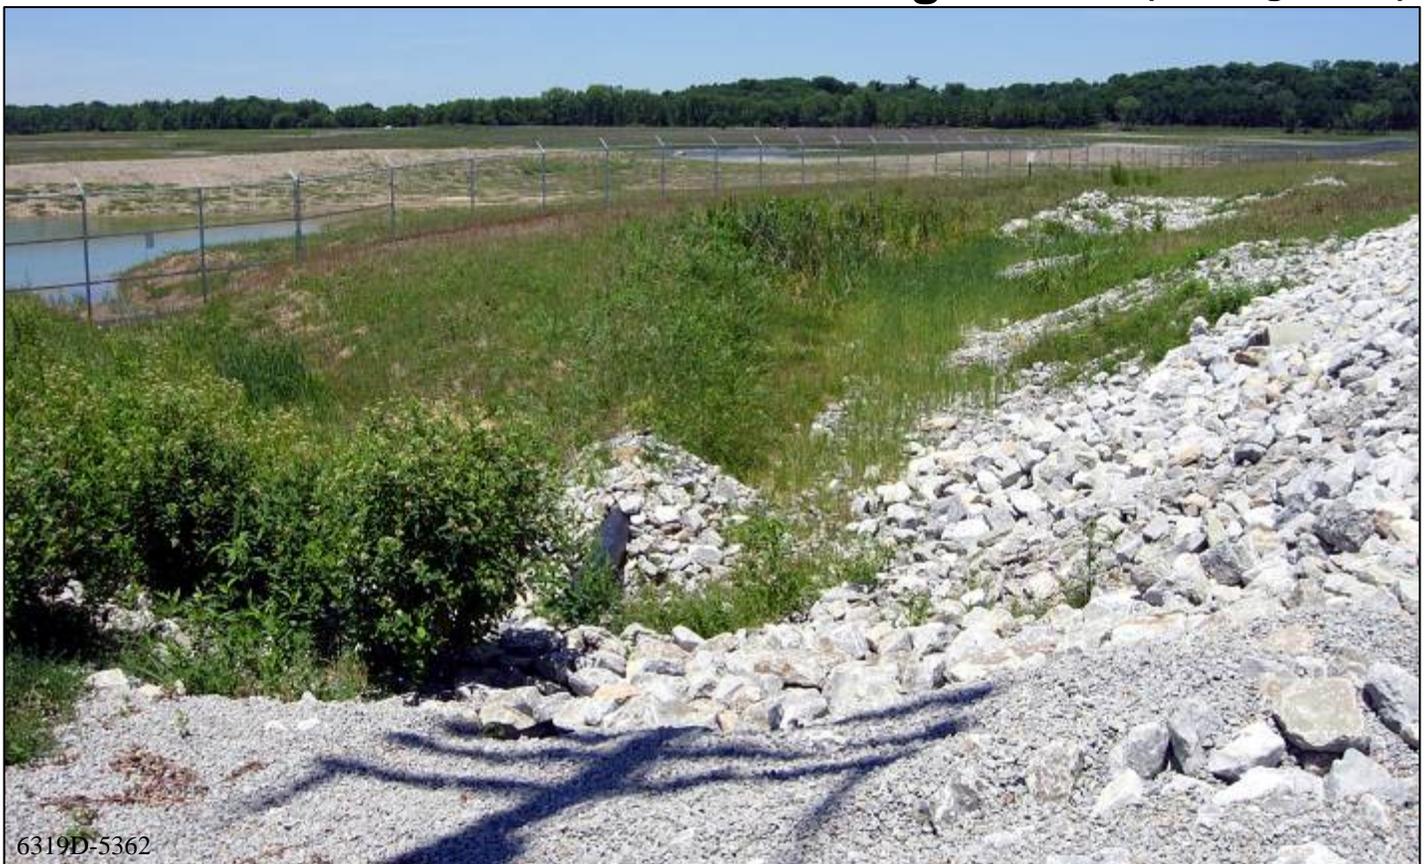
6319D-5362

**West Outer Drainage Cell 8 (looking north)**

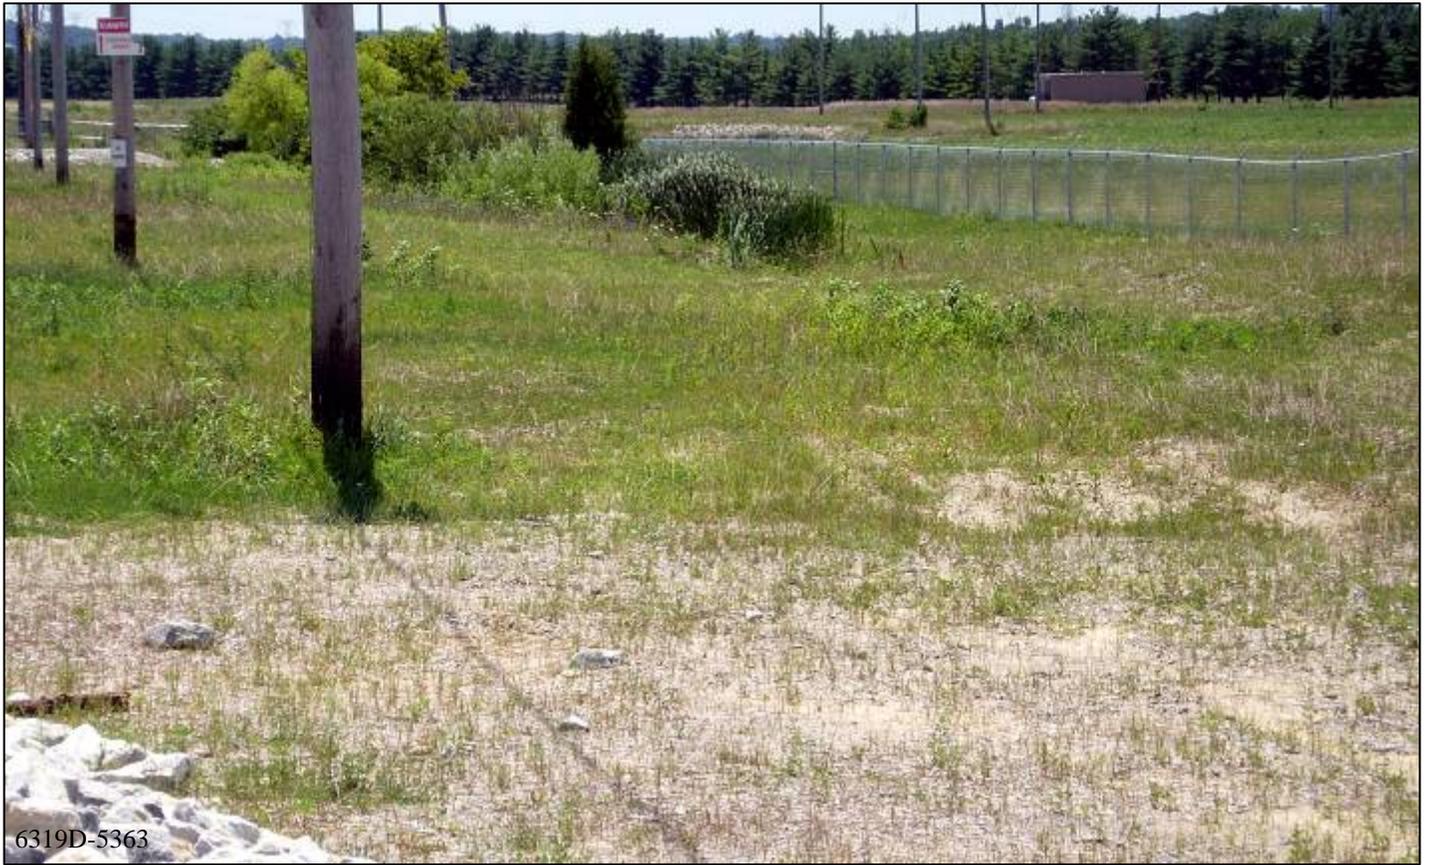
**West Outer Drainage Cell 8 (looking south)**
