Department of Energy  
Office of Legacy Management

**SUBJECT: Transmittal of the September 10, 2007 Inspection Checklist for On-Site Disposal Facility**

# On-Site Disposal Facility Inspection Report September 2007

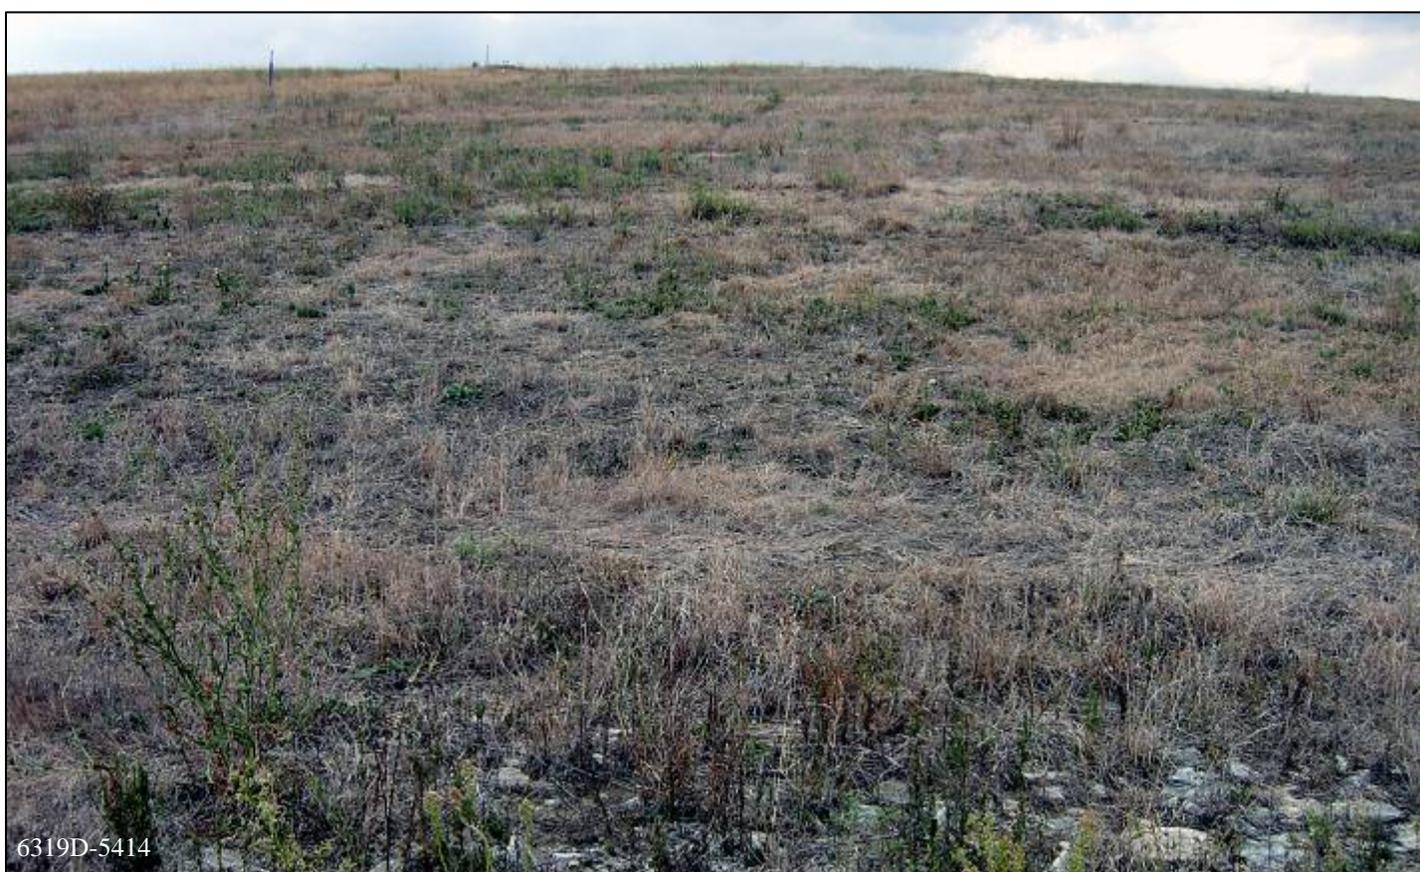
6319D-5414

**East Face Cell 1**

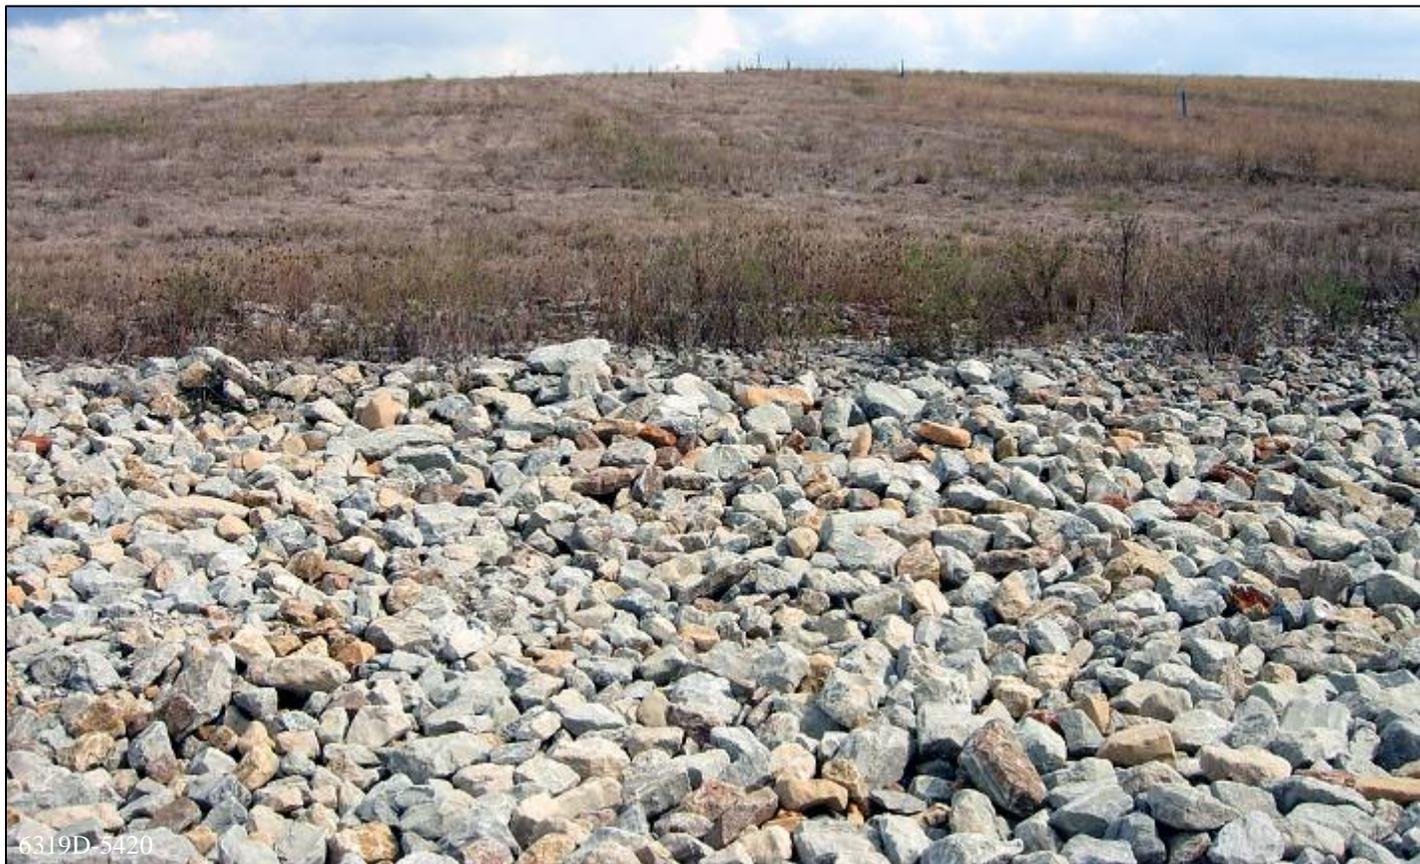
6319D-5420

**West Face Cell 1**

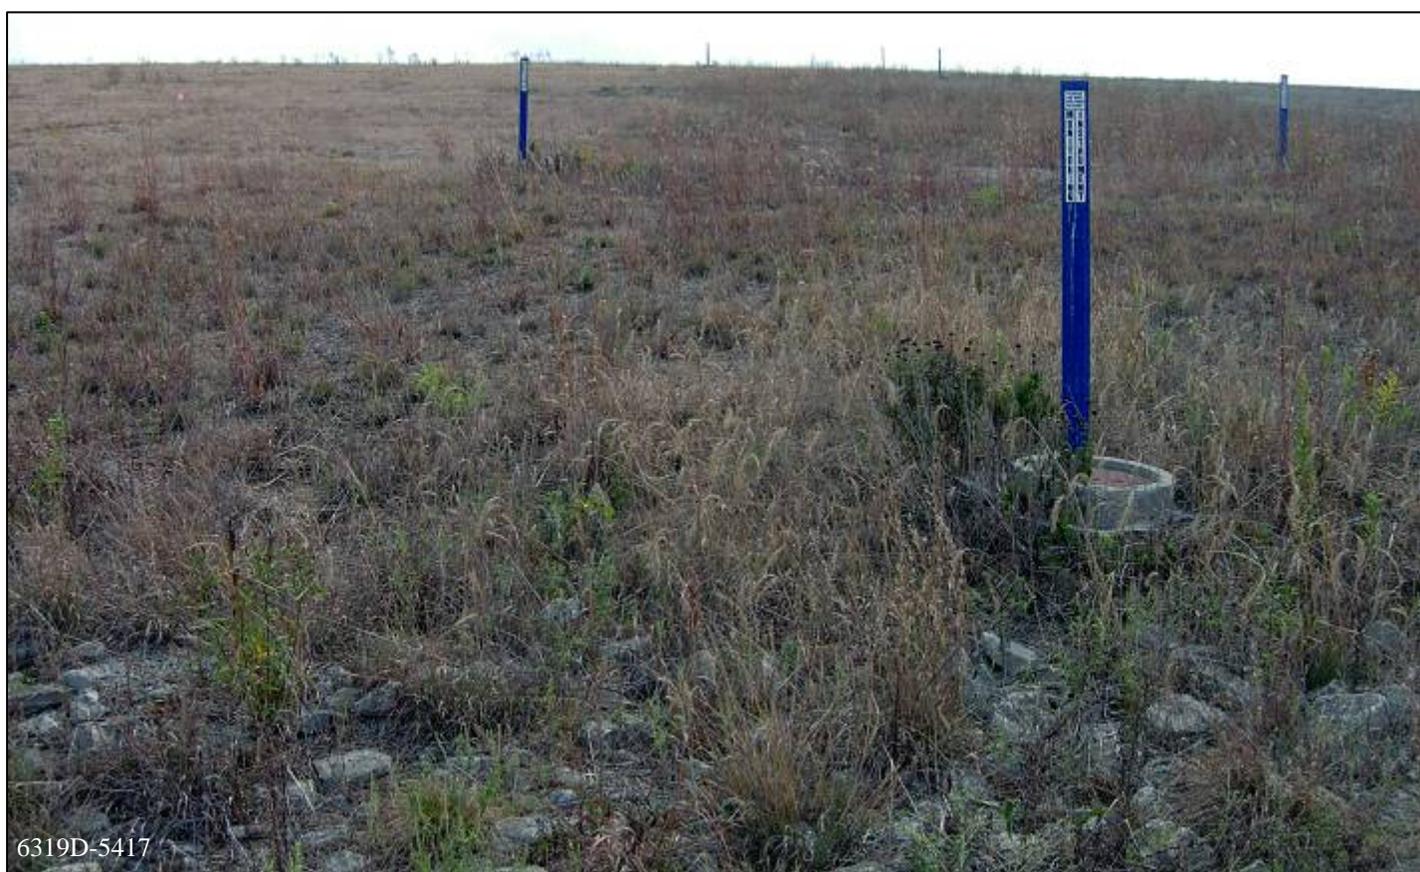
6319D-5417

**North Face Cell 1**

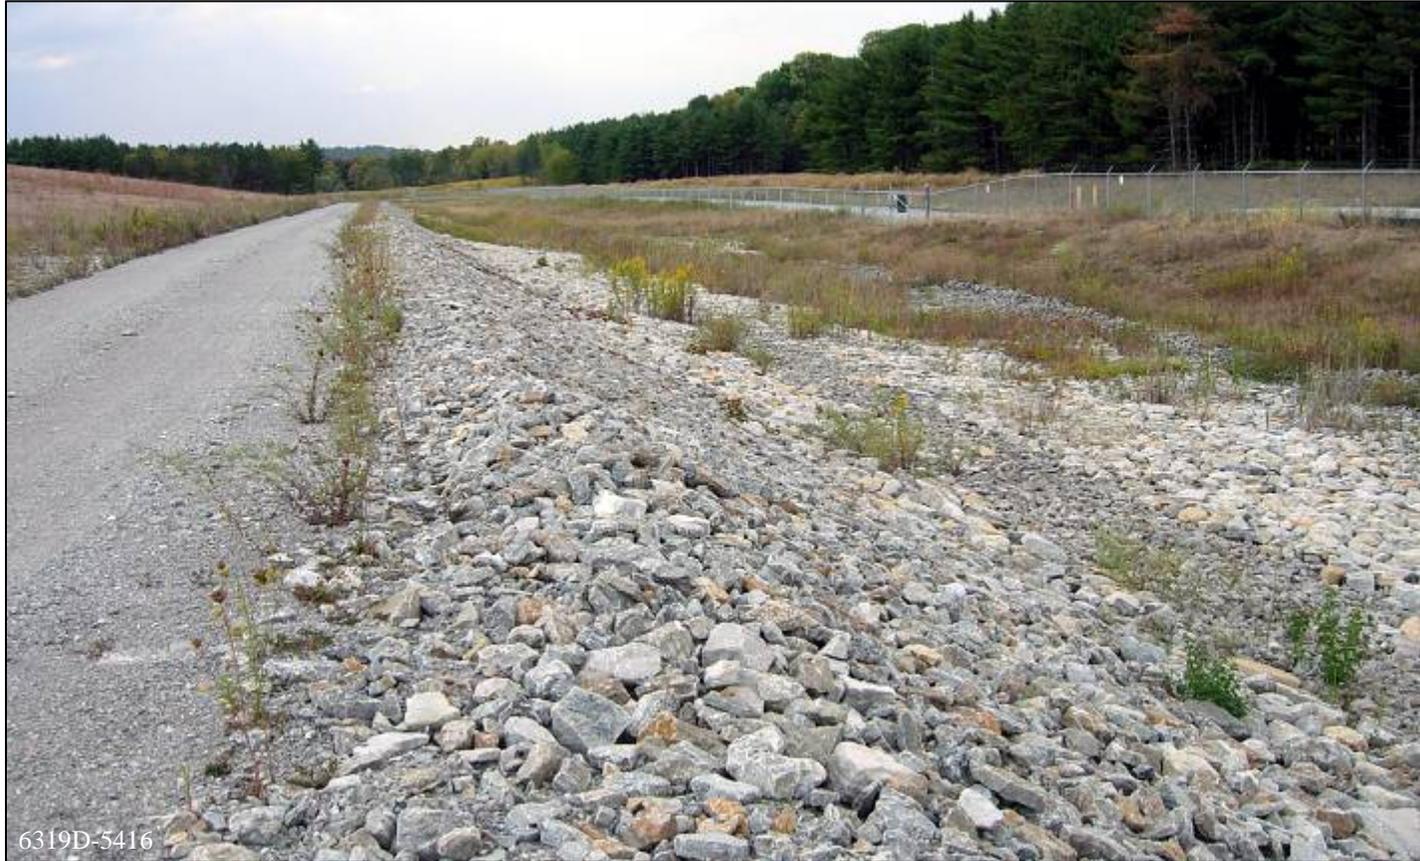
6319D-5416

**North Drainage (looking west)**

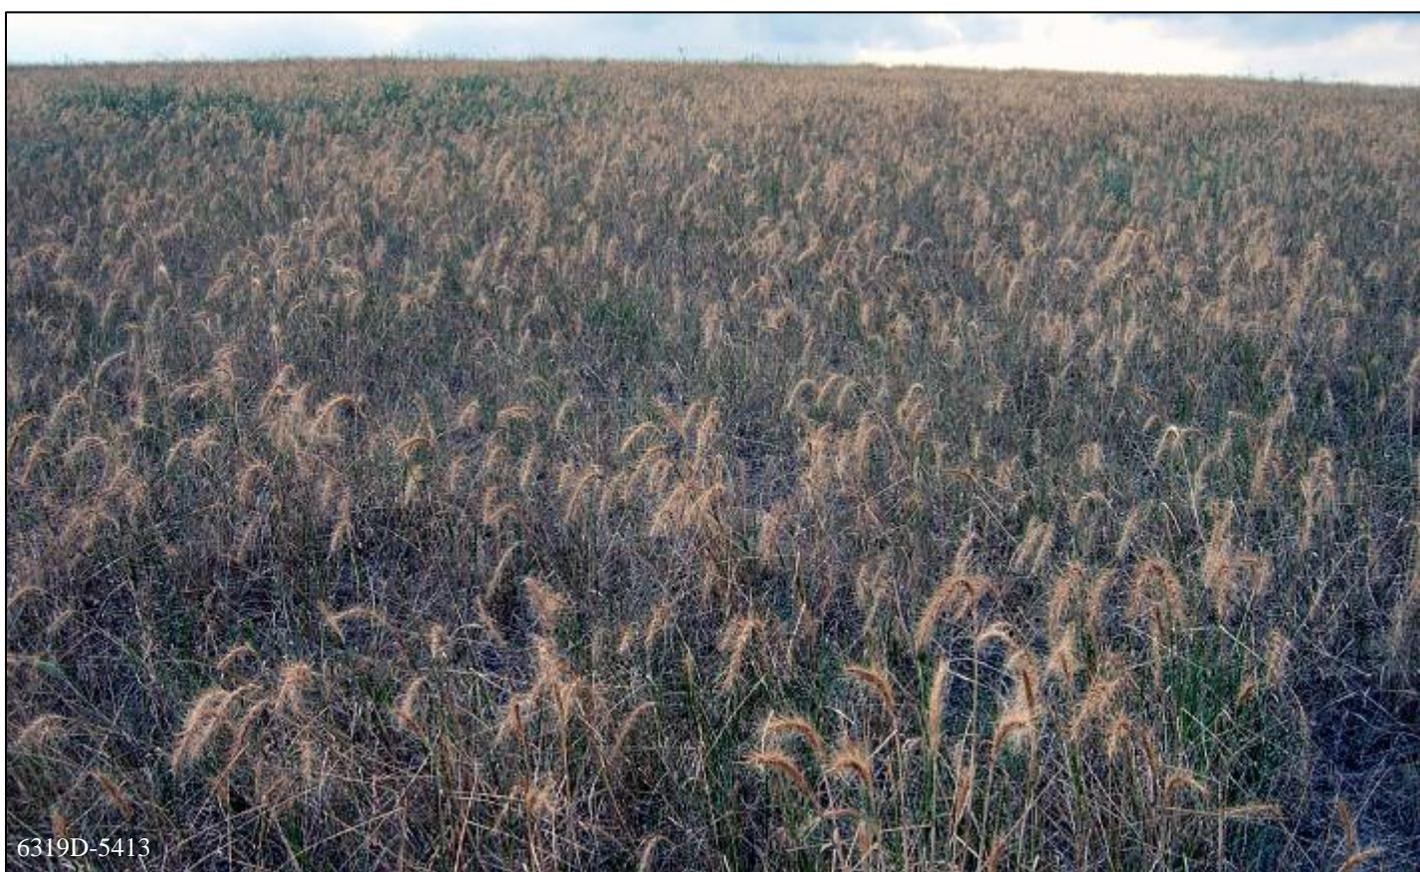
6319D-5413

**East Face Cell 2**

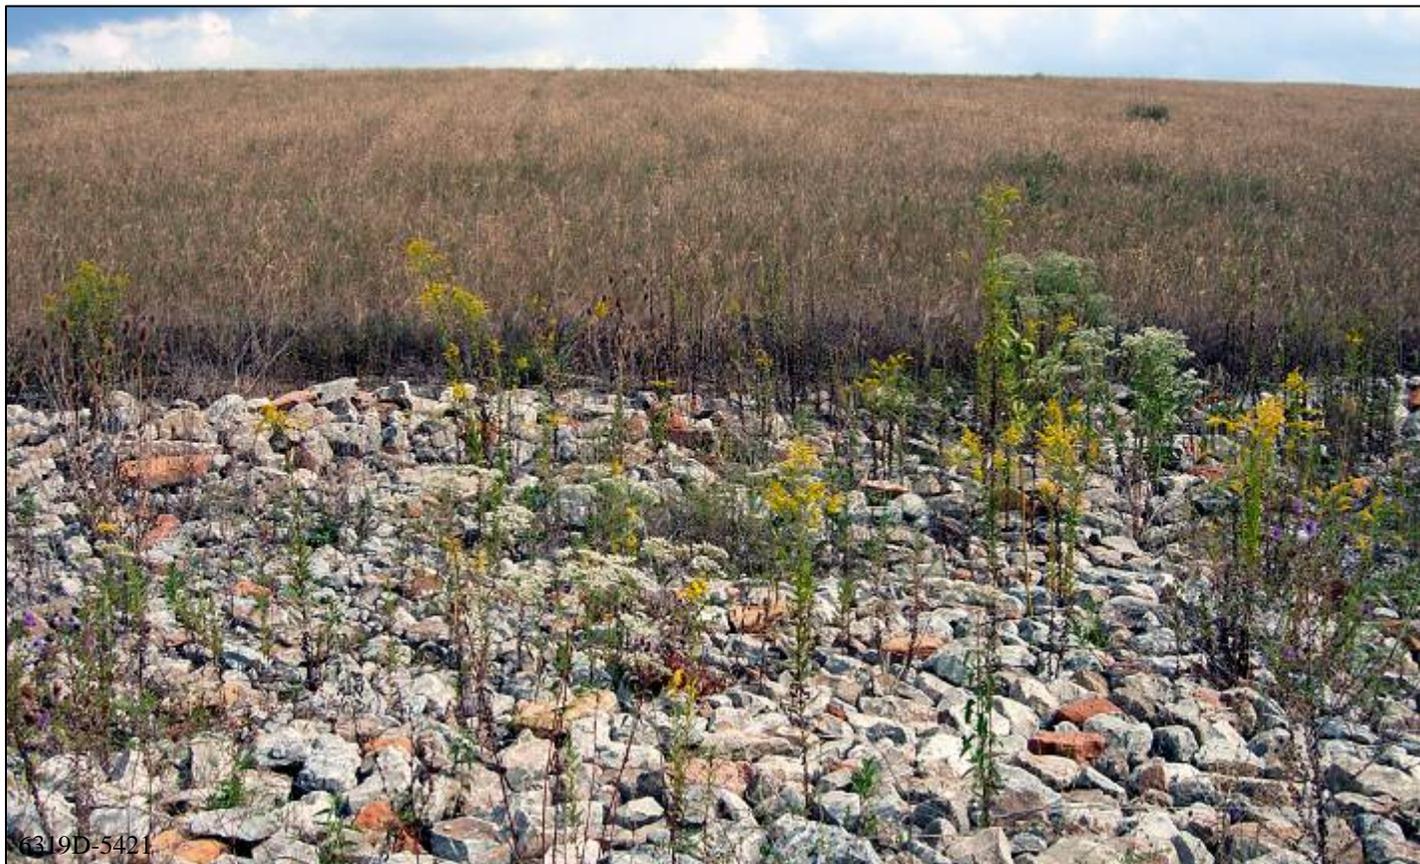
6319D-5421

**West Face Cell 2**

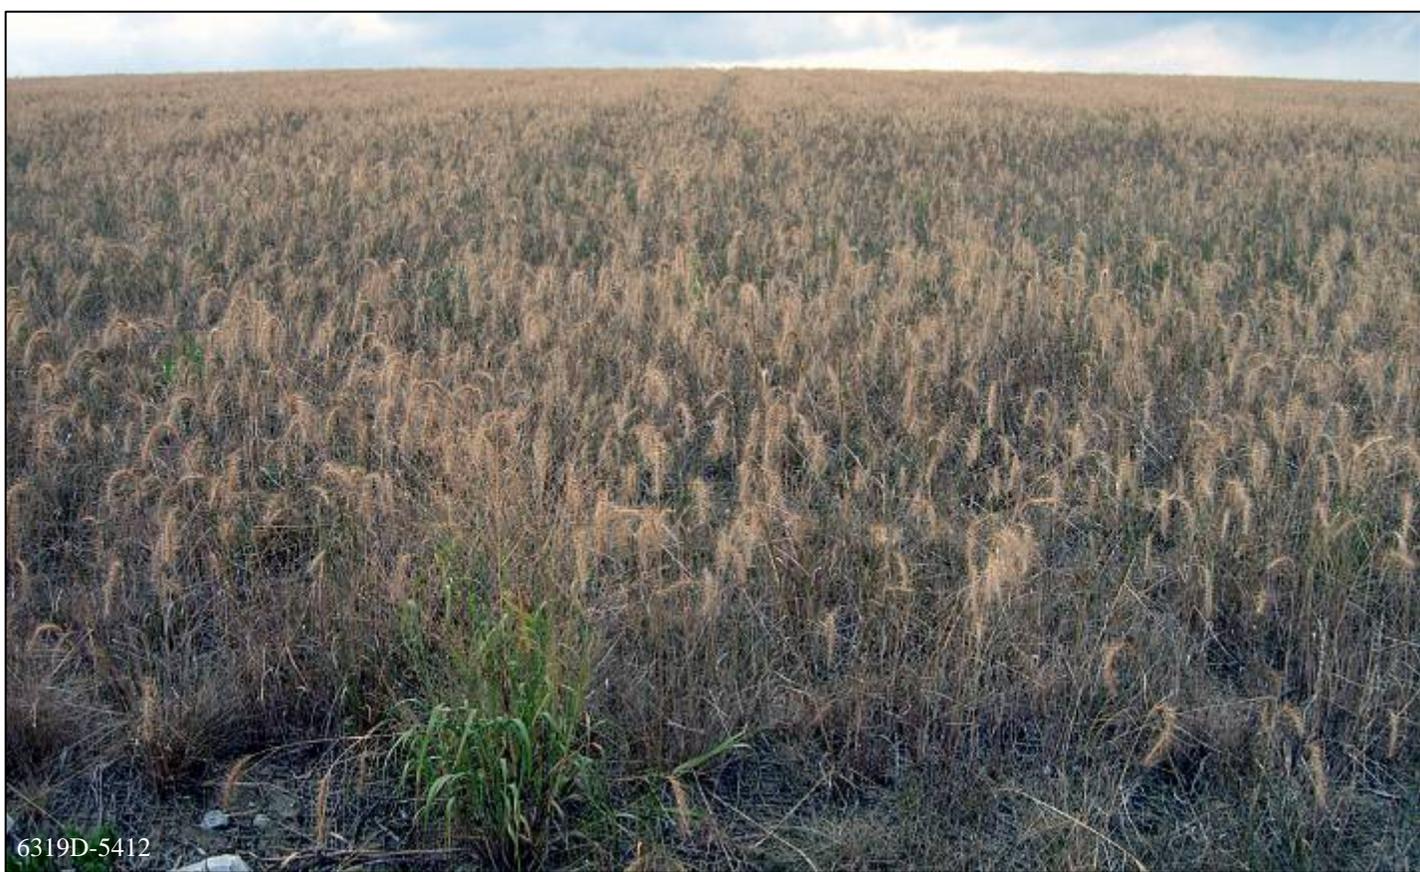
6319D-5412

**East Face Cell 3**

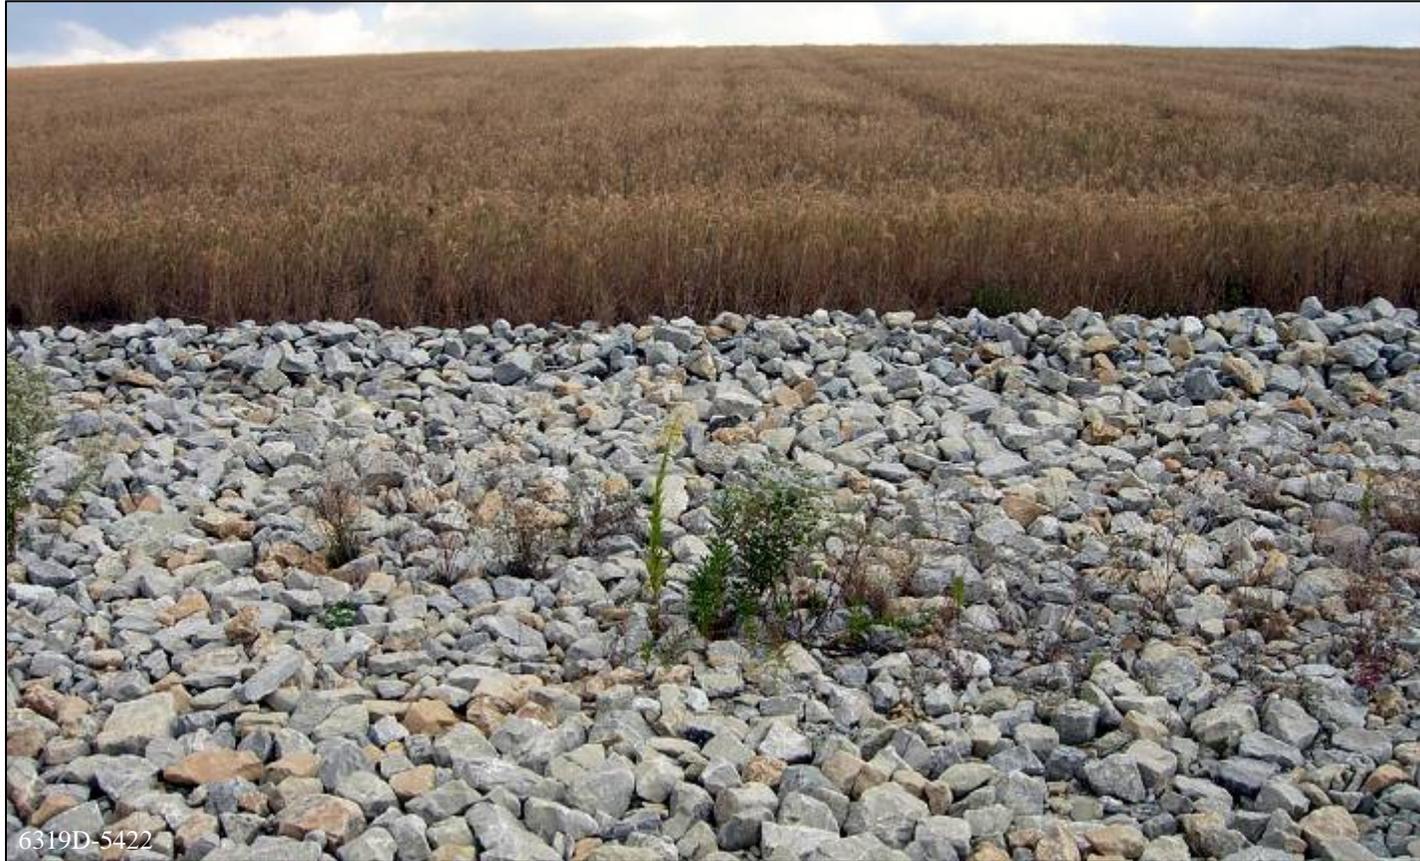
6319D-5422

**West Face Cell 3**

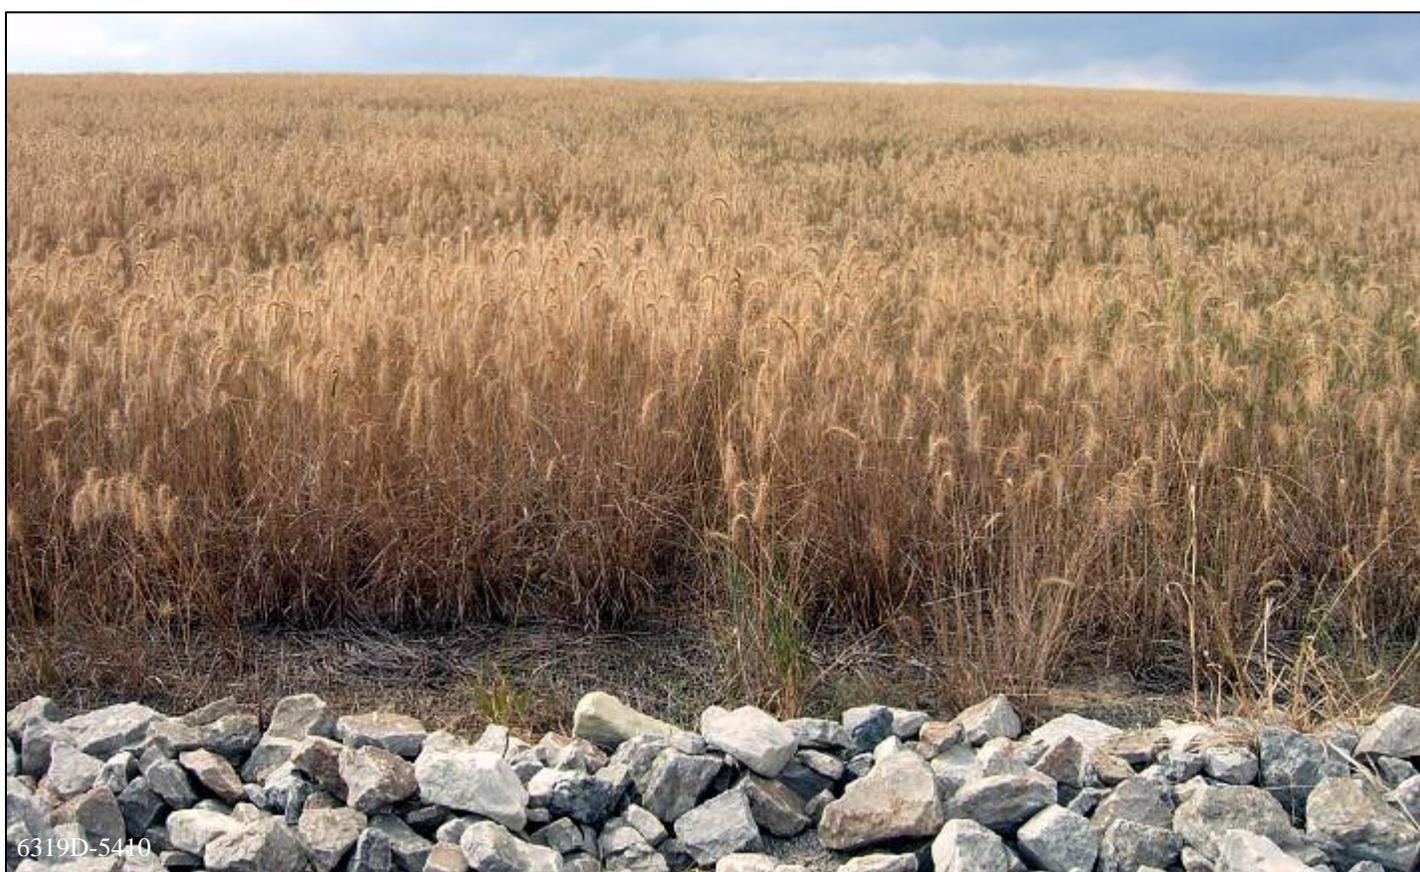
**East Face Cell 4**

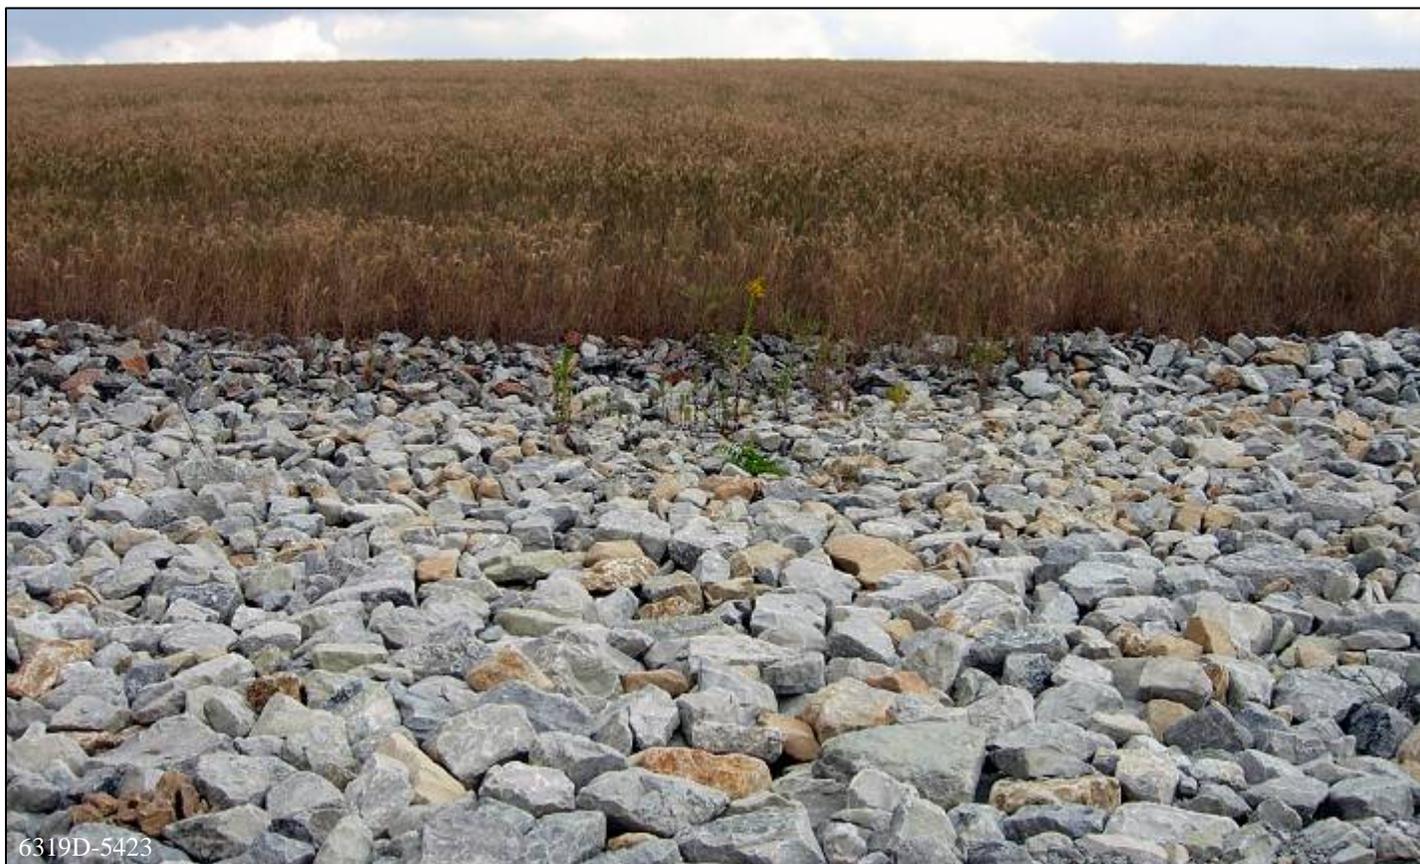
**West Face Cell 4**

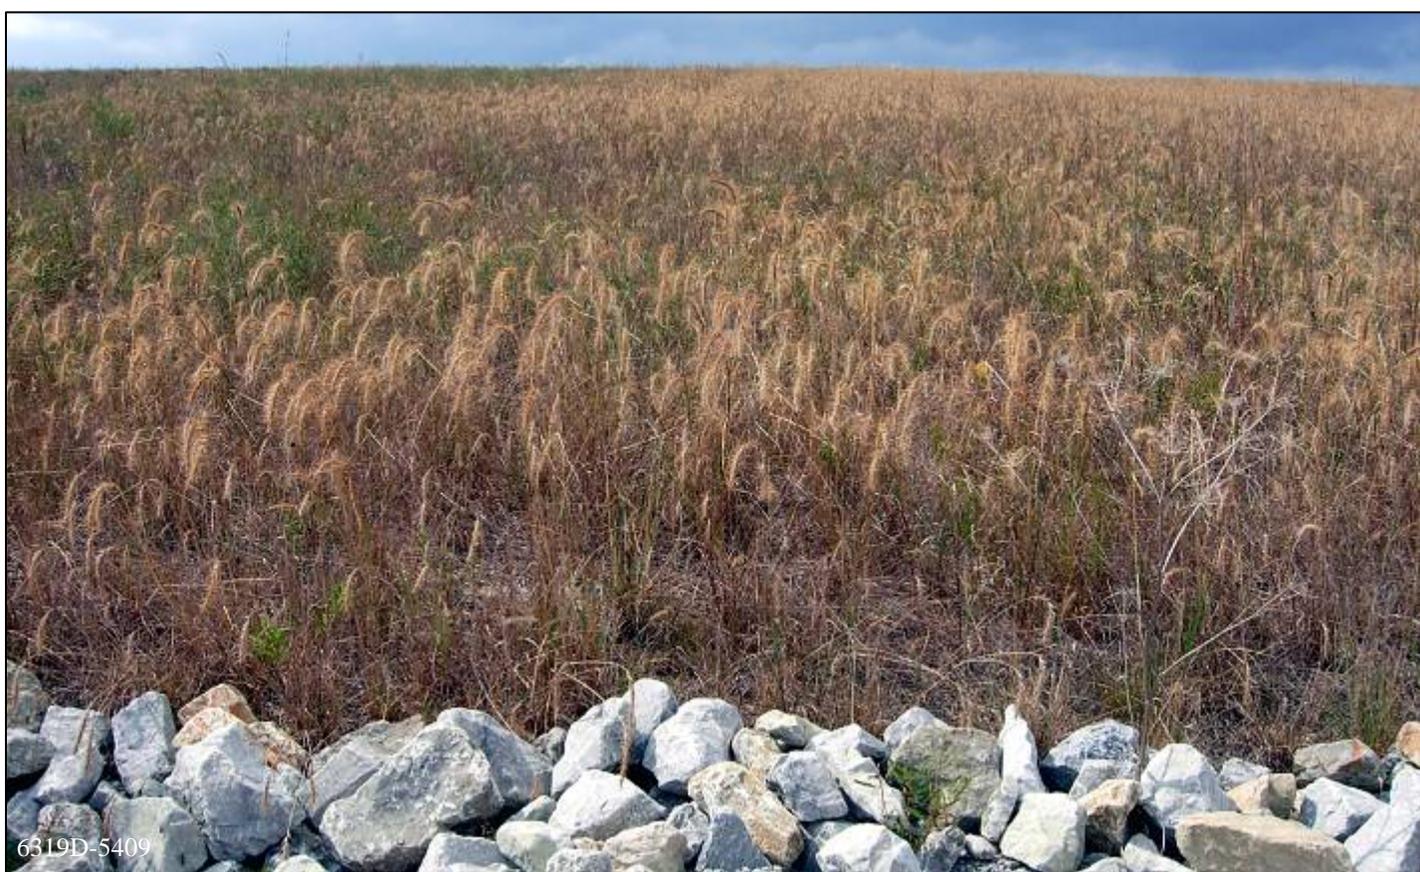
**East Face Cell 5**

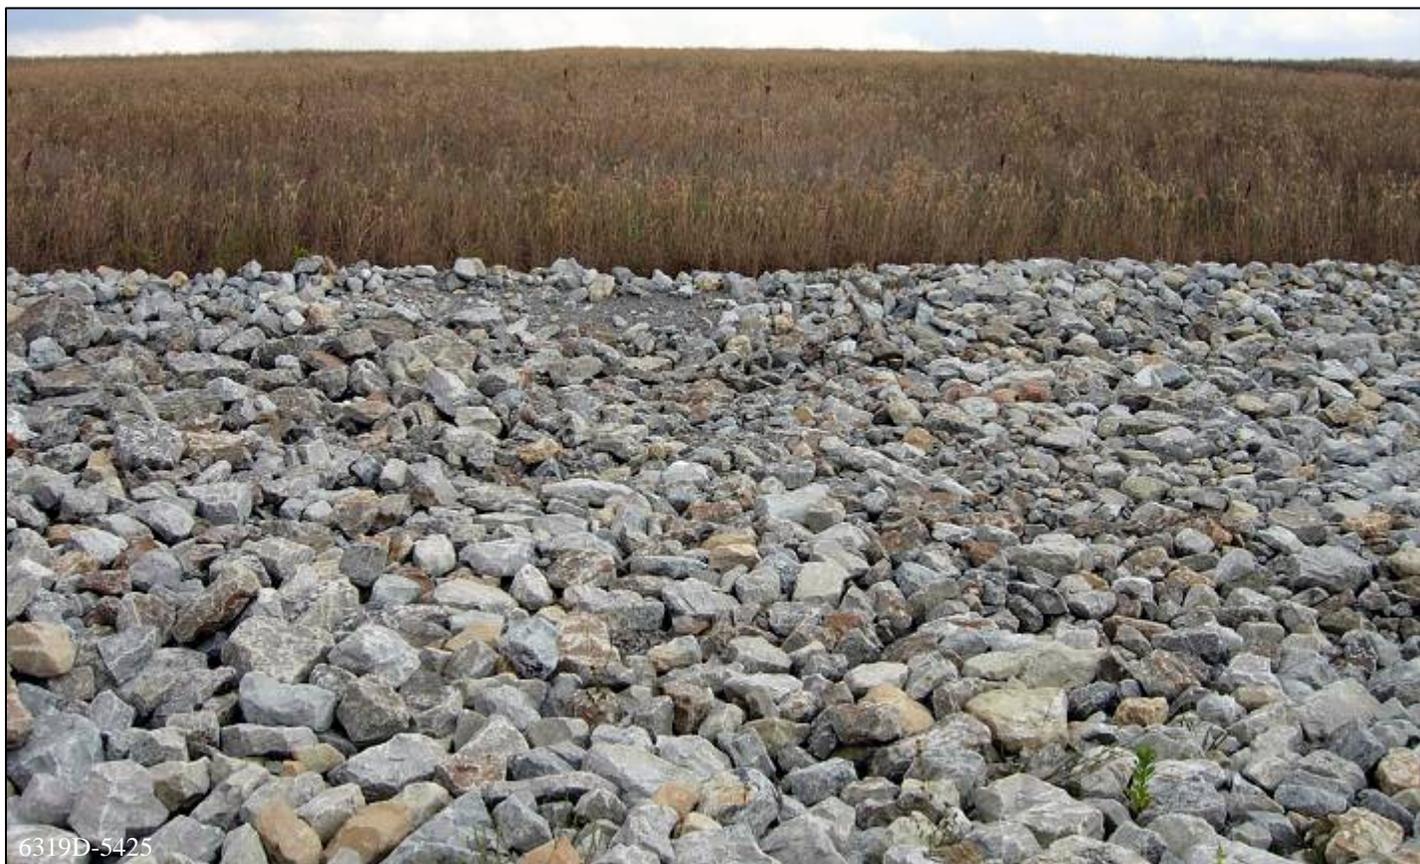
**West Face Cell 5**

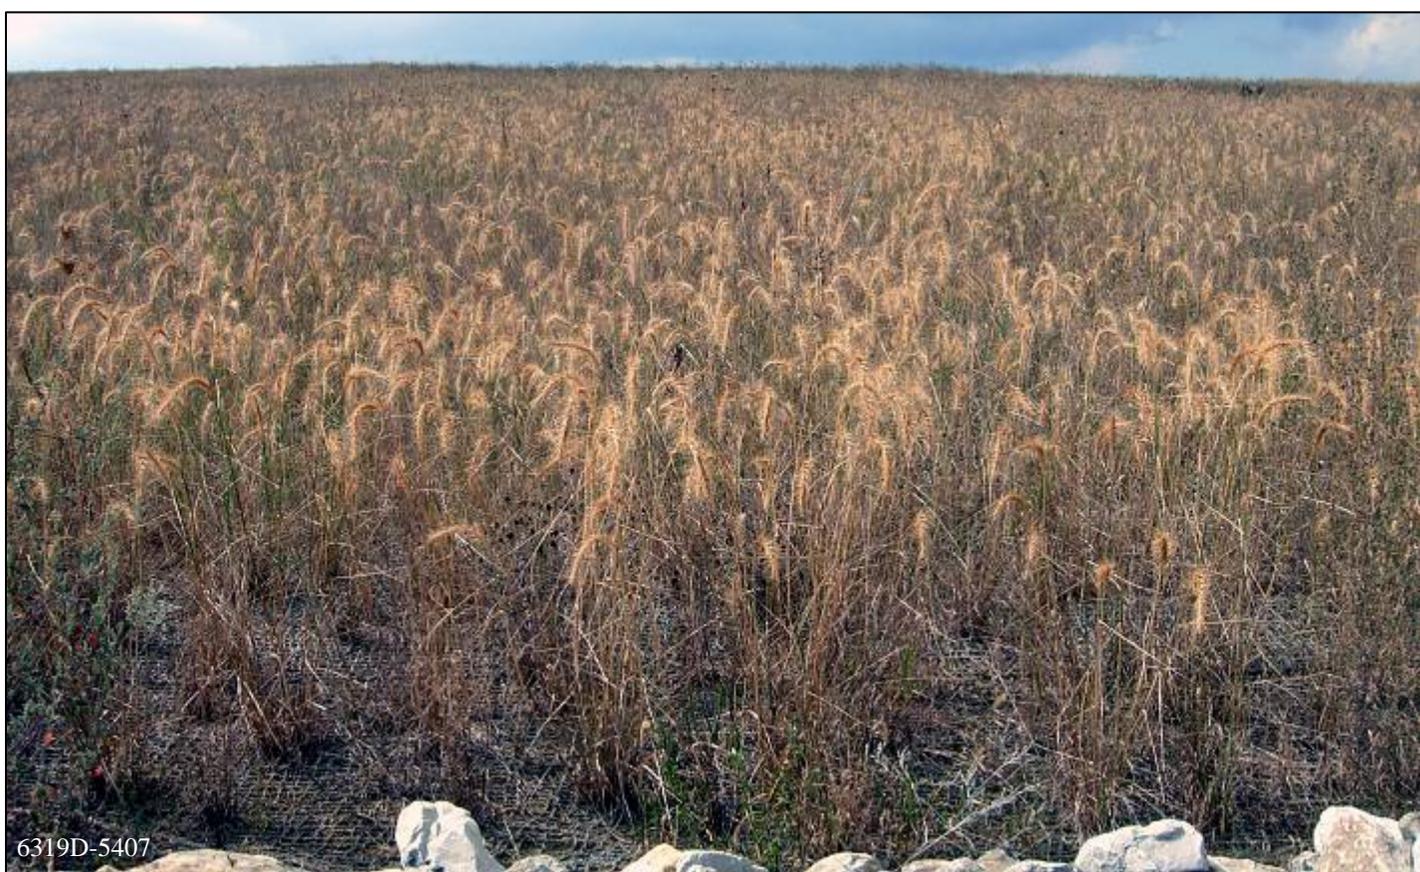
6319D-5407

**East Face Cell 6**

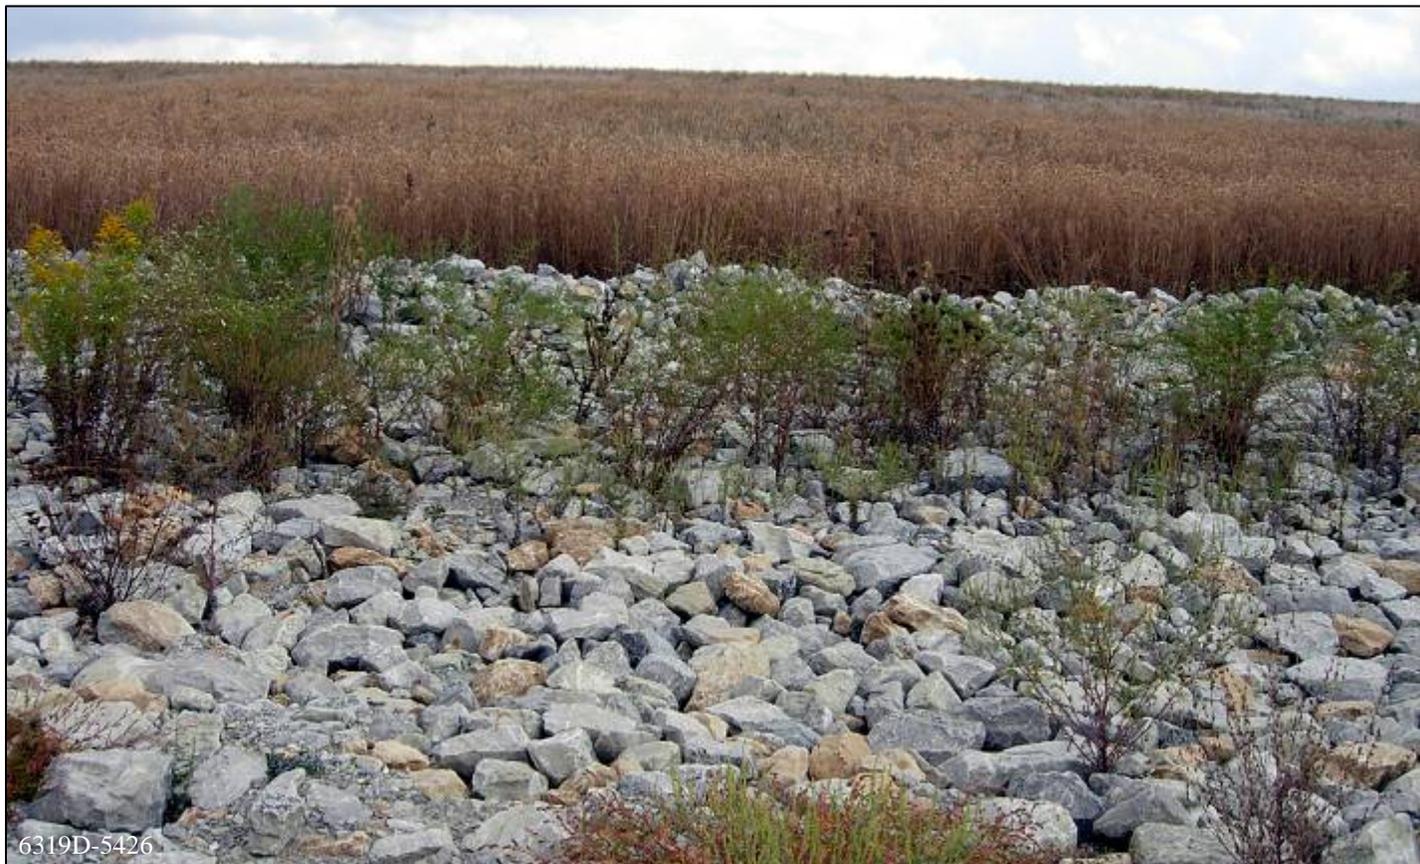
6319D-5426

**West Face Cell 6**

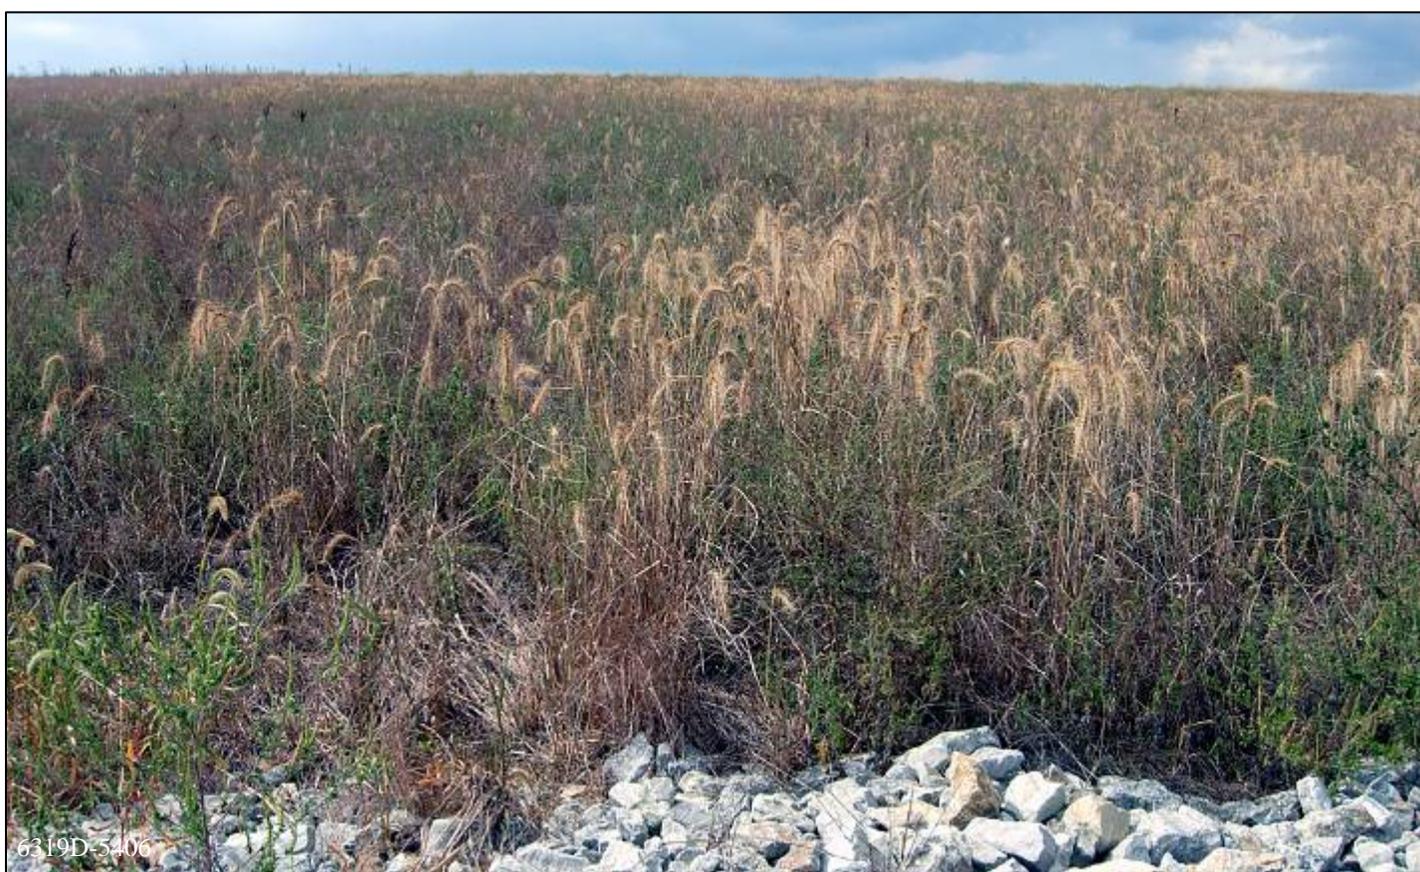
**East Face Cell 7**

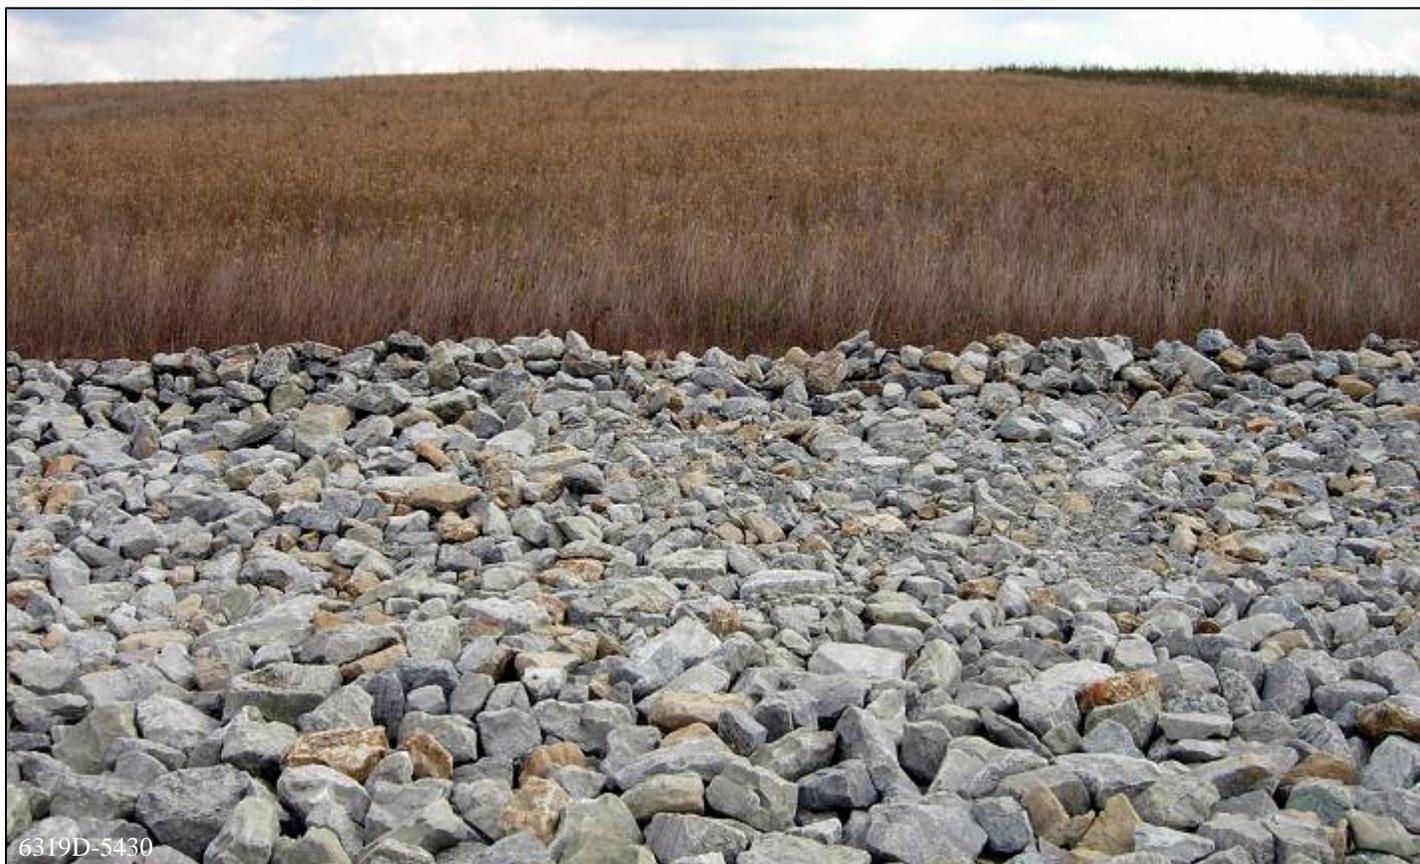
**West Face Cell 7**

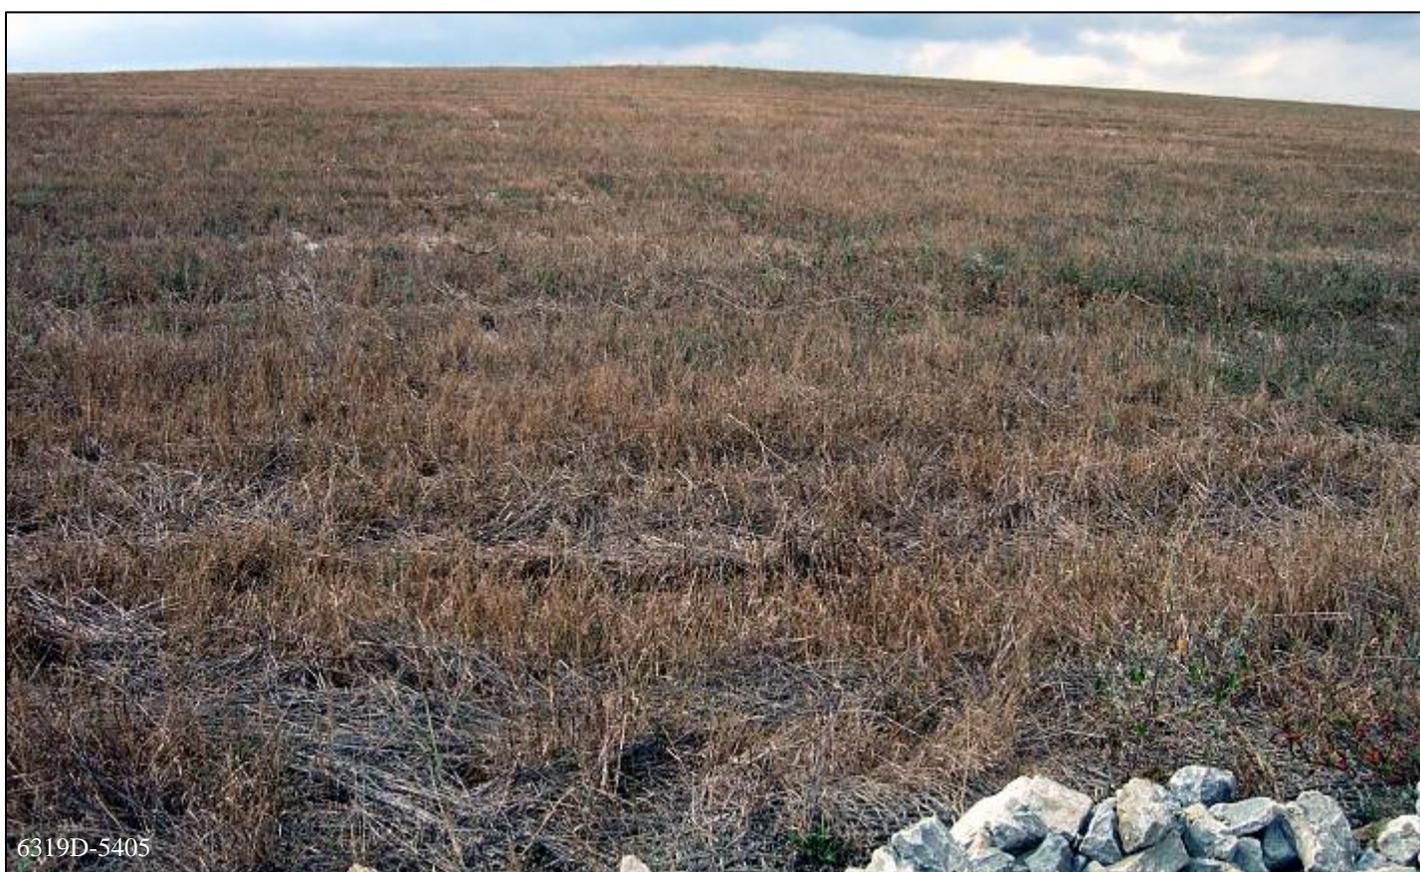
6319D-5405

**East Face Cell 8**

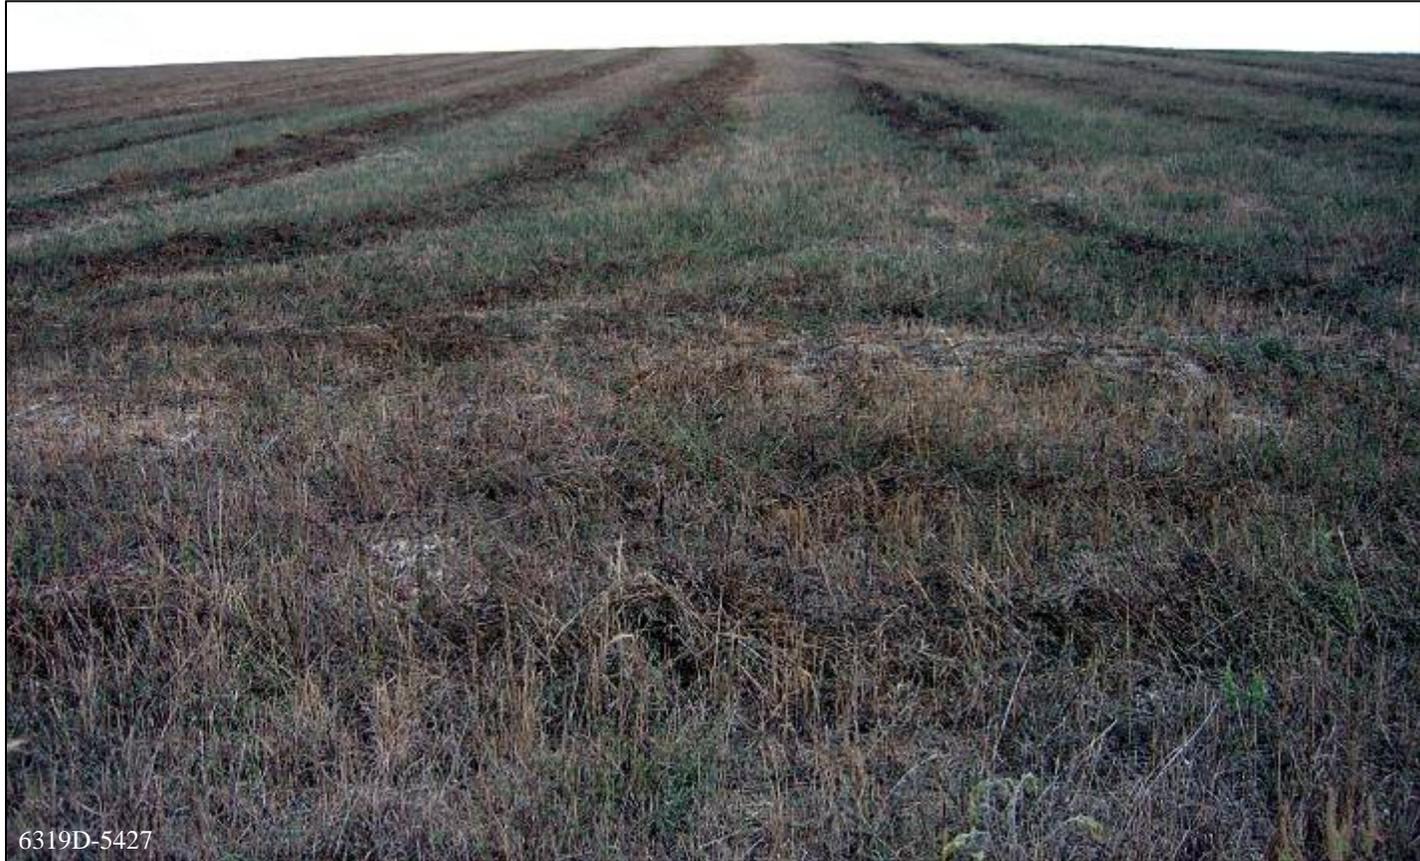
6319D-5427

**West Face Cell 8**
