Department of Energy  
Office of Legacy Management

**SUBJECT: Transmittal of the September 10, 2007 Inspection Checklist for On-Site Disposal Facility**

# On-Site Disposal Facility Inspection Report September 2007

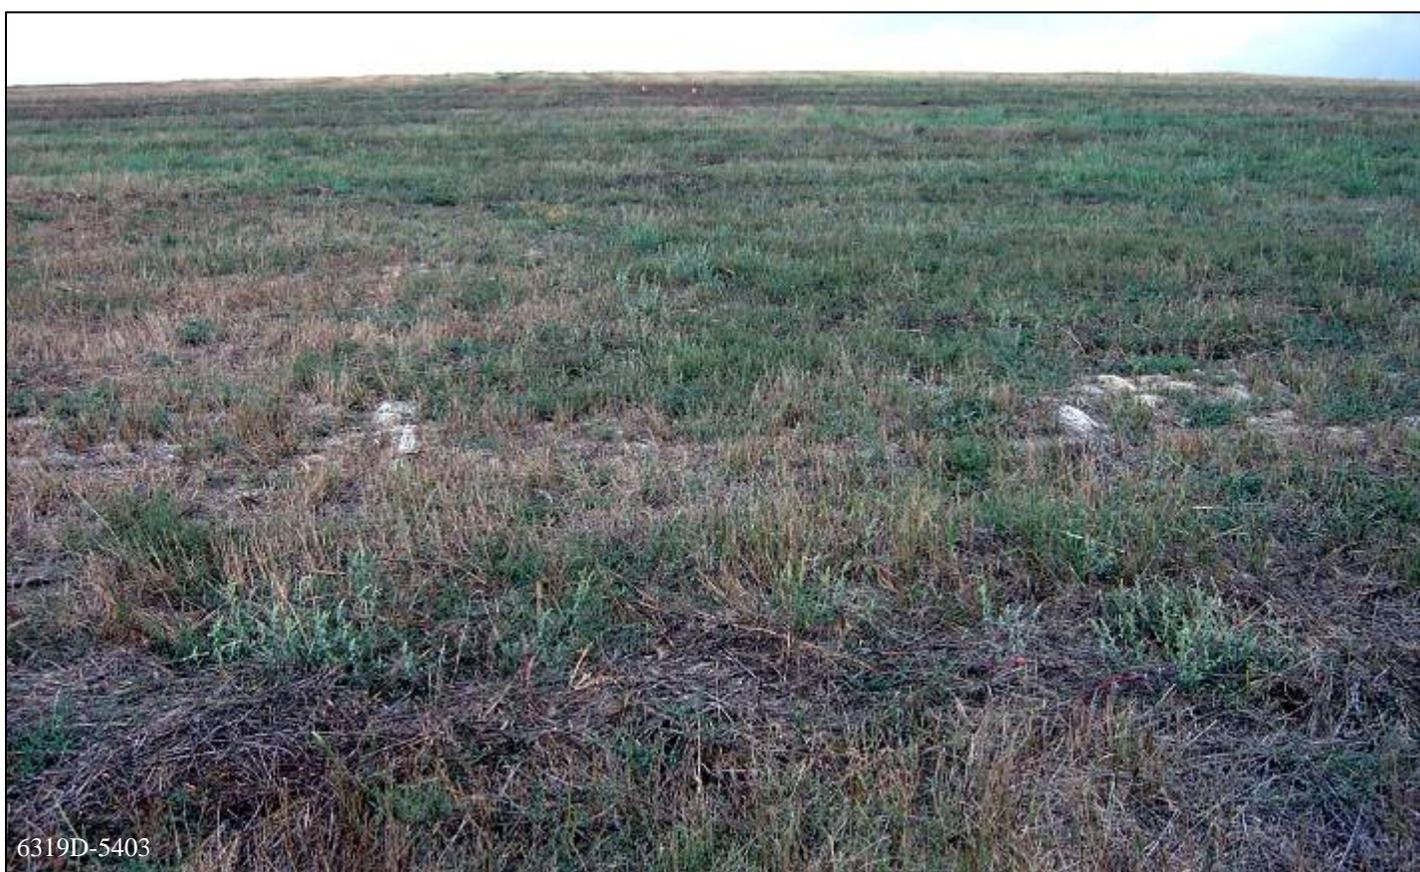
6319D-5403

**South Face Cell 8**

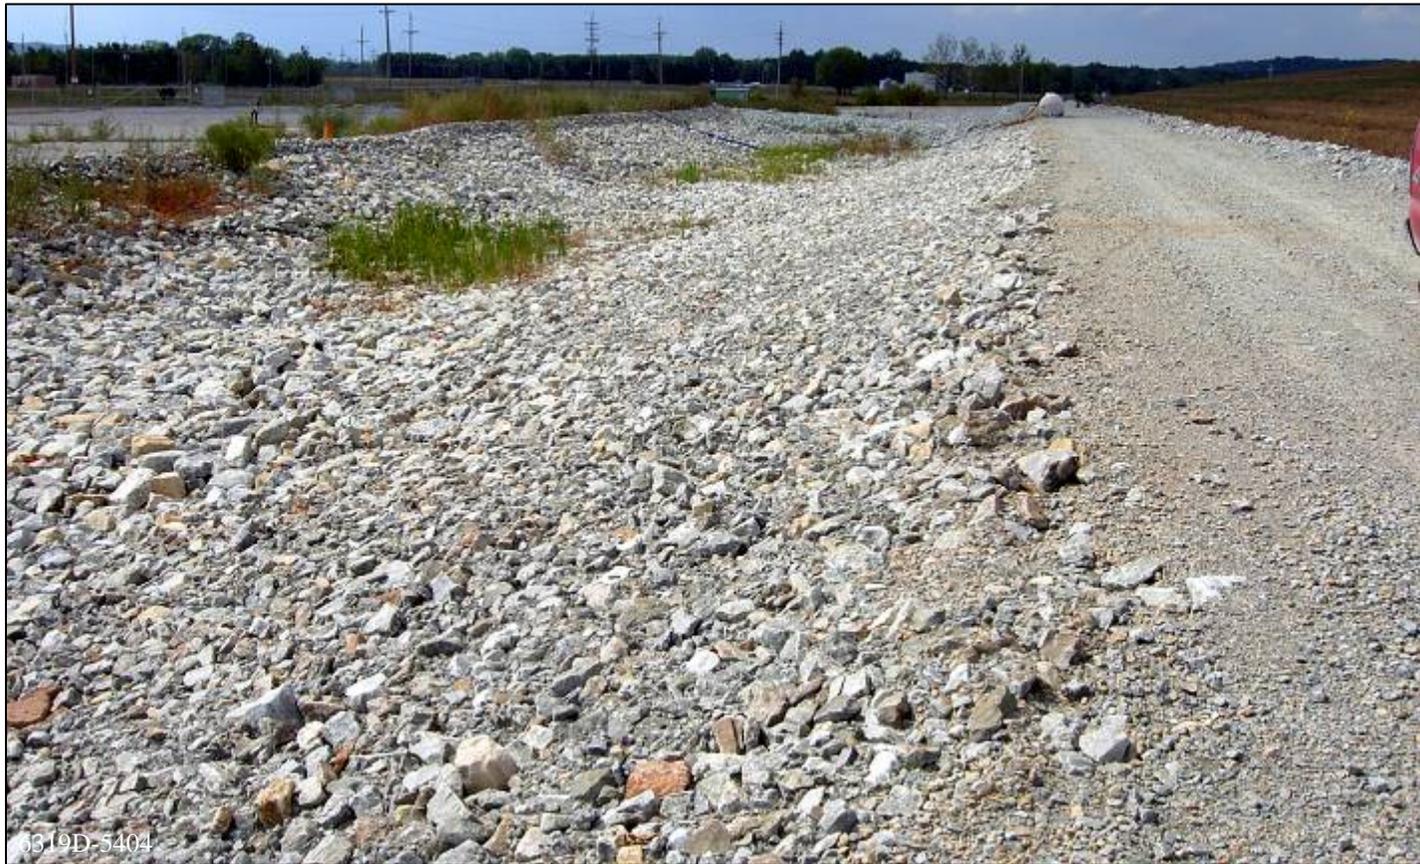
6319D-5404

**South Drainage (looking west)**

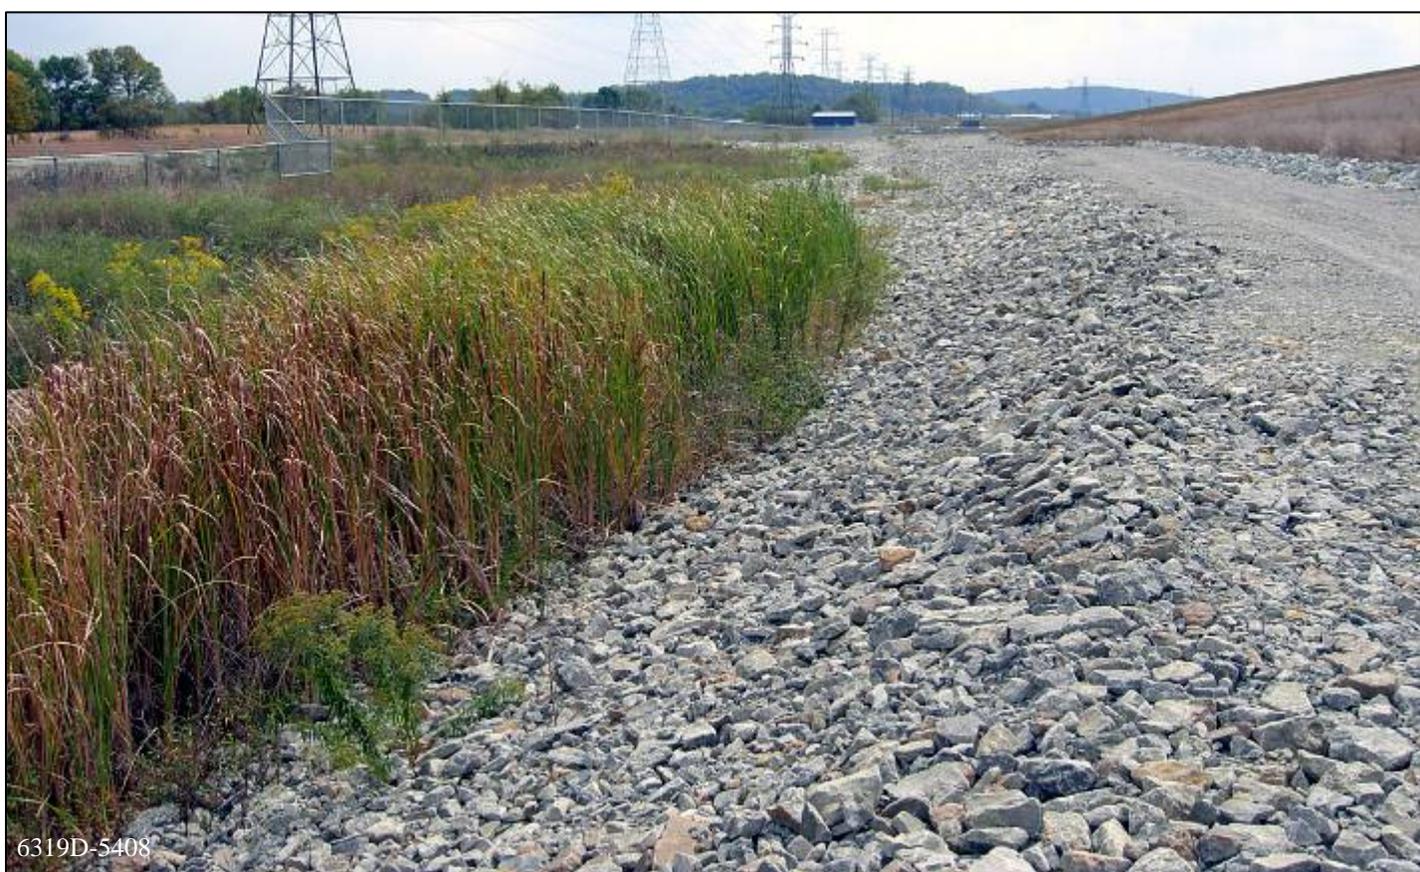
6319D-5408

**East Drainage Cell 7 (looking south)**

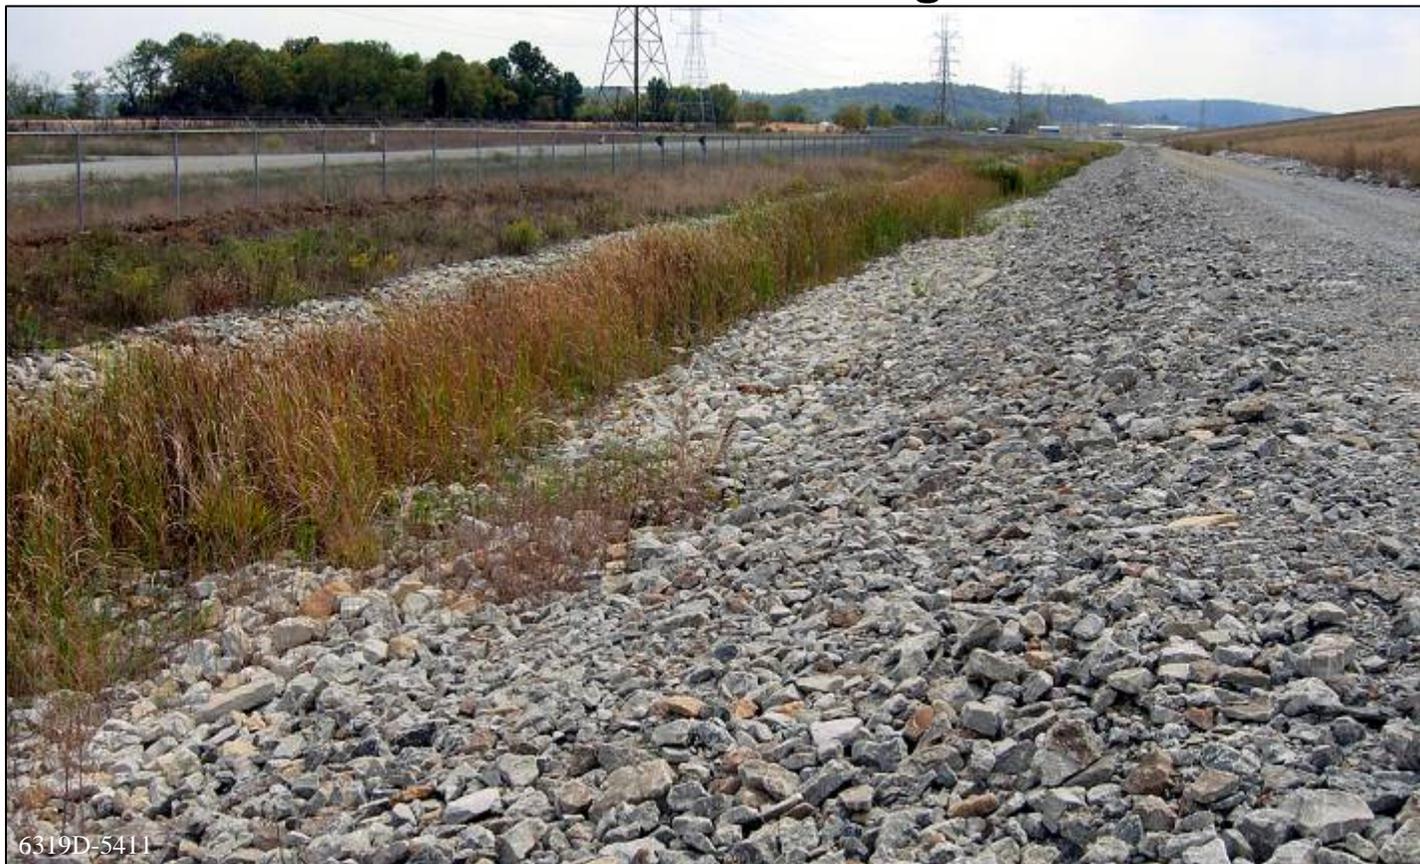
6319D-5411

**East Drainage Cell 4 (looking south)**

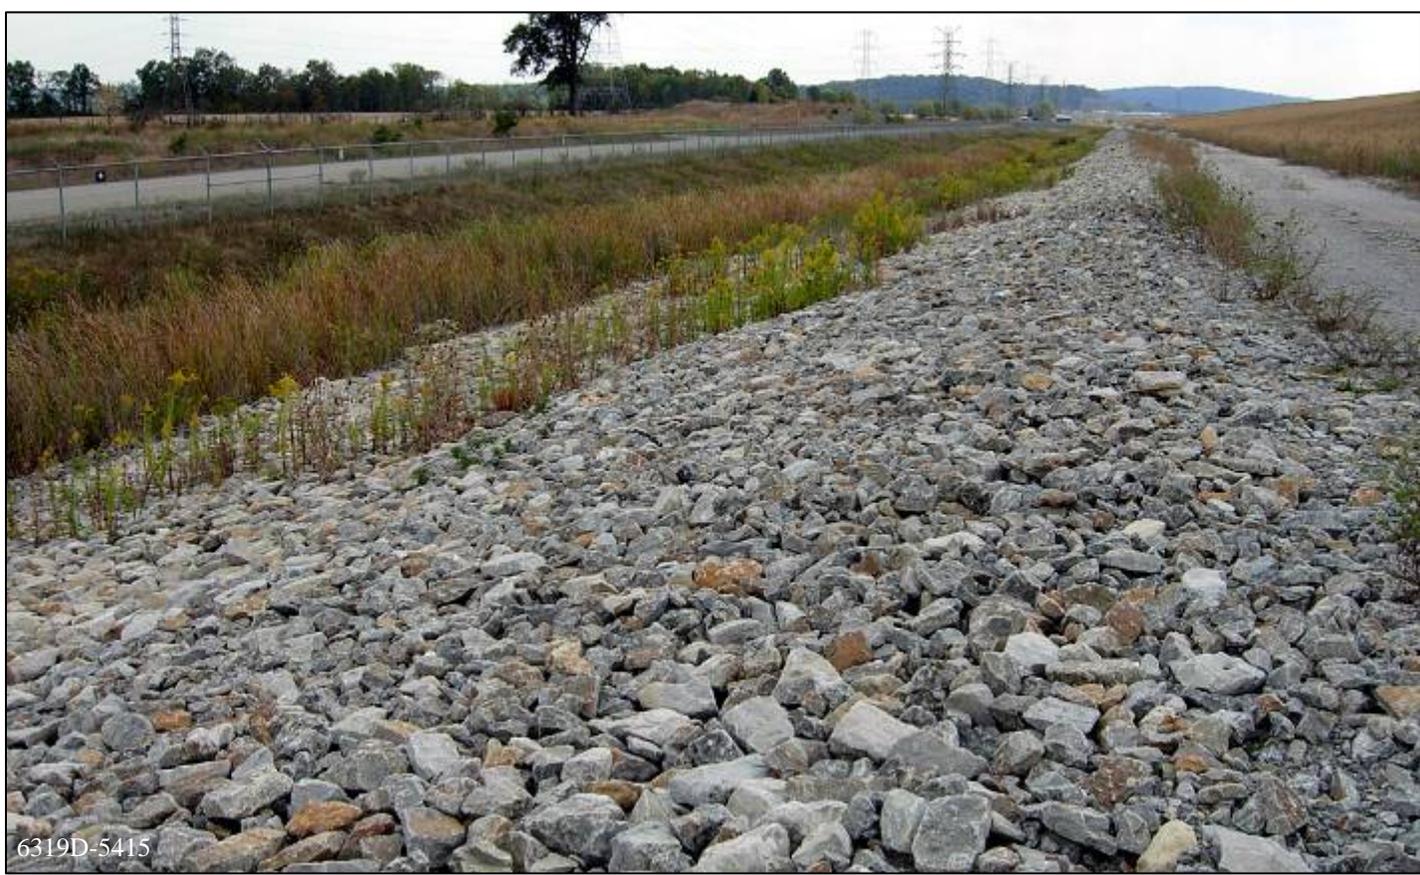
6319D-5415

**East Drainage Cell 1 (looking south)**

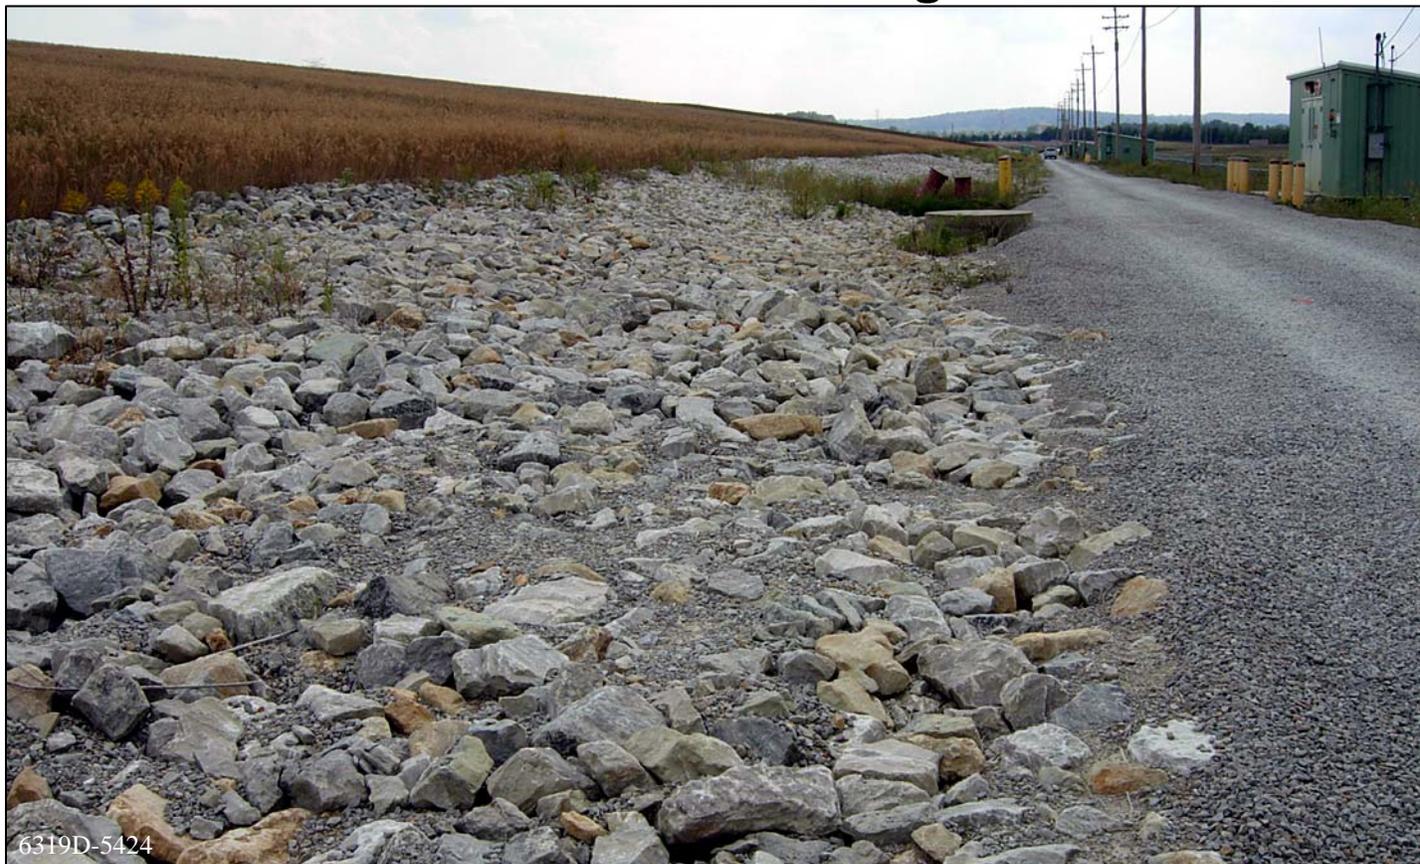
6319D-5424

**West Inner Drainage Cell 4 (looking south)**

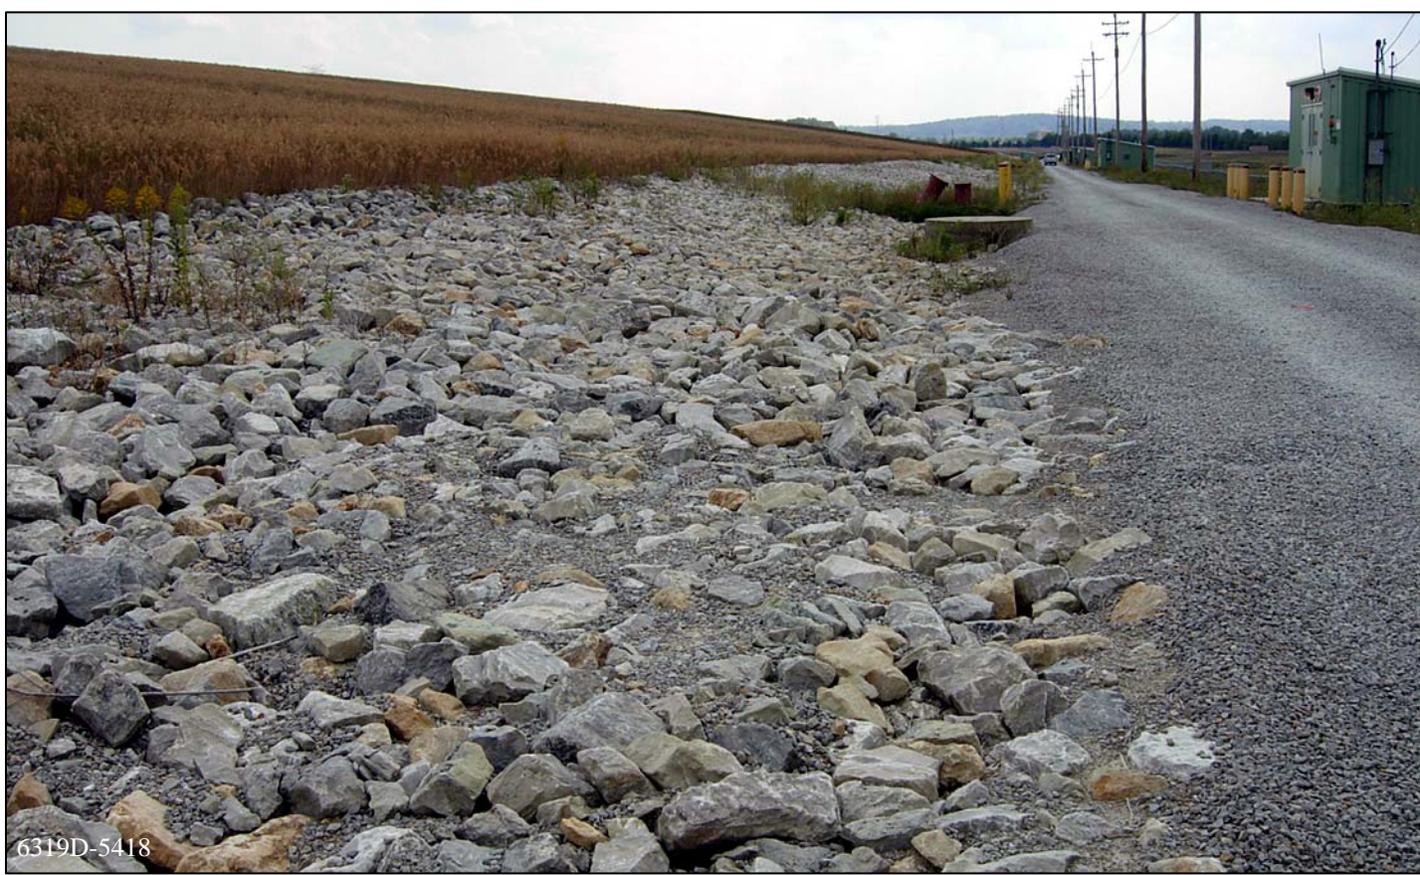
**West Inner Drainage Cell 1 (looking south)**

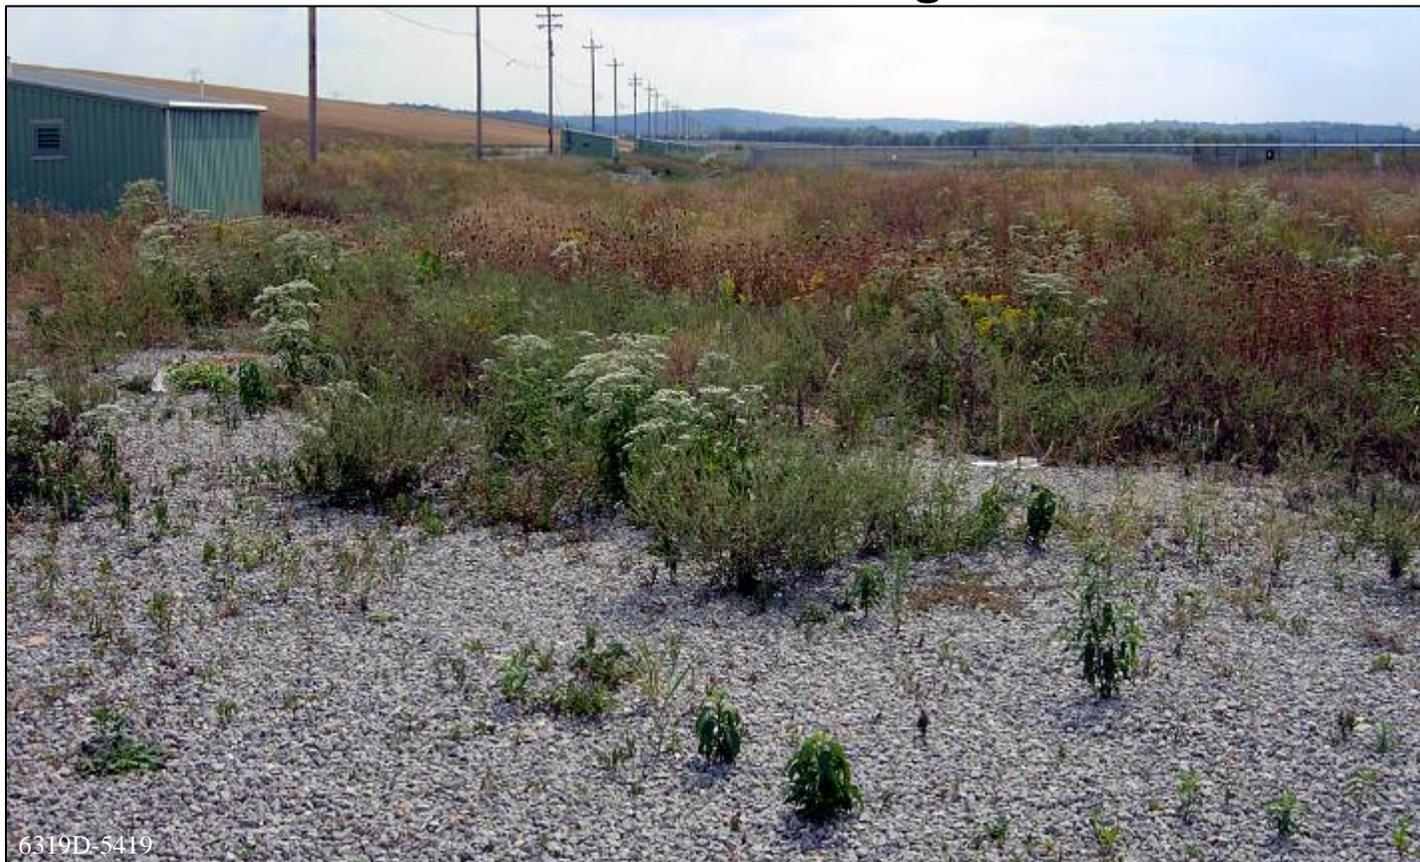
**West Outer Drainage Cell 1 (looking south)**

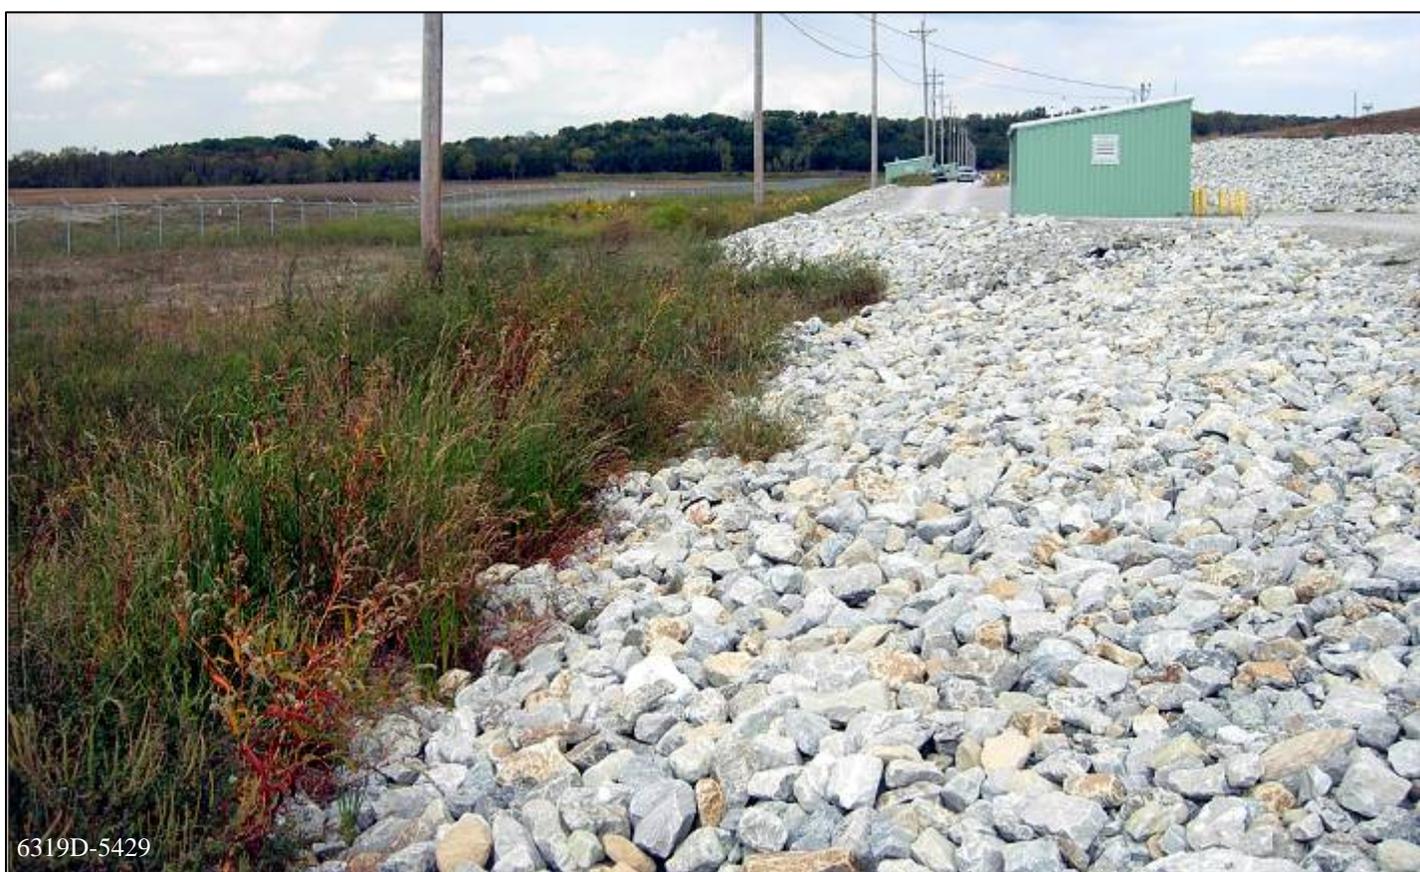
6319D-5429

**West Outer Drainage Cell 8 (looking north)**

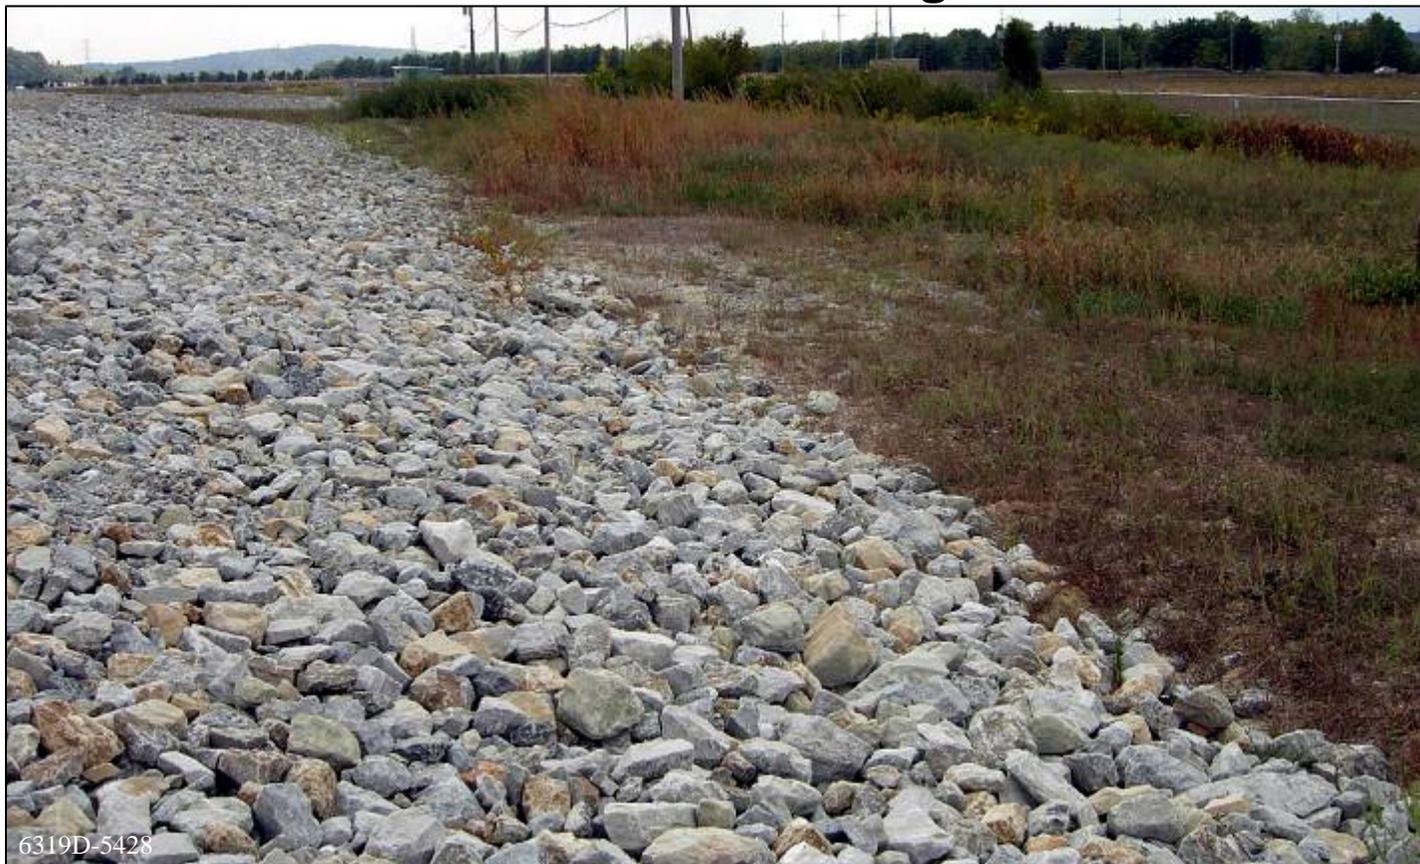
6319D-5428

**West Outer Drainage Cell 8 (looking south)**
