Department of Energy
Office of Legacy Management

**SUBJECT: Transmittal of the March 2008 Fernald Preserve On-Site Disposal Facility
Inspection Forms**

On-Site Disposal Facility Inspection Report

March 2008

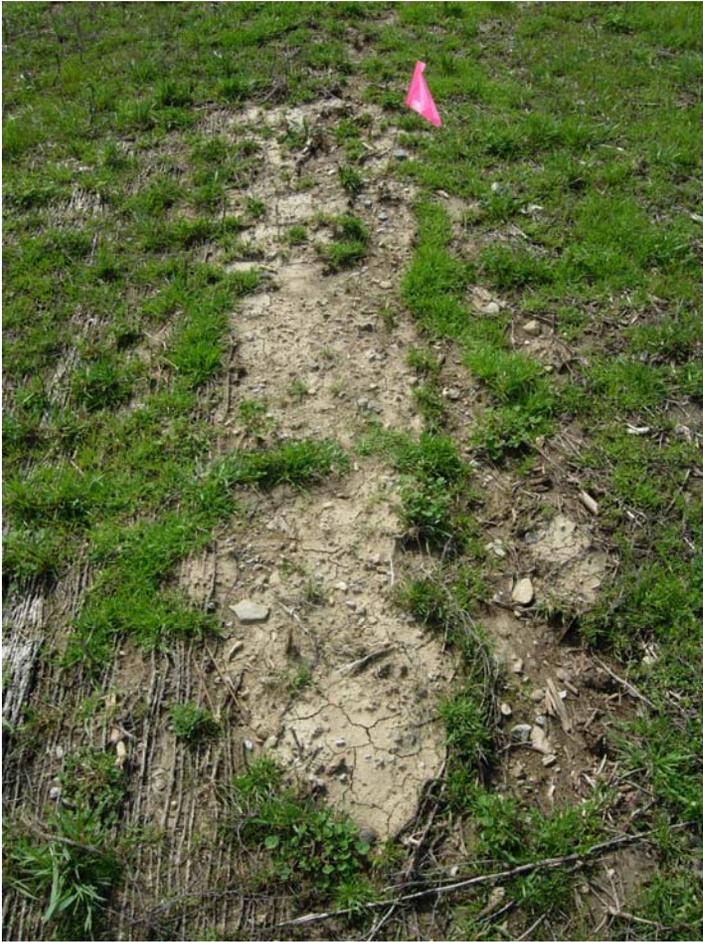
March 2008 OSDF Inspection
Finding LH-9
Photo 851.jpg

LH-7	8	West face		X						rill			X	
LH-8	8	West face		X						long rill			X	
LH-9	8	West face	Yes			X				Bare	851.jpg	X	X
