SUBJECT: Transmittal of the September 2011 Fernald Site Inspection Forms

Fernald Preserve Field Walkdown Inspection

U.S. DEPARTMENT OF ENERGY HAMILTON, OHIO	<small>Work Form No. 43</small> S.M. Stoller Corporation <small>Under DOE Contract No. DE-AC07-01-OR-21400</small>
Fernald Preserve Consolidated Finding Locations for North Section of September 2011 Site Inspection	
DATE PREPARED:	REVISED:
September 12, 2011	#inspection_areas_3rdp_2011_north_loc

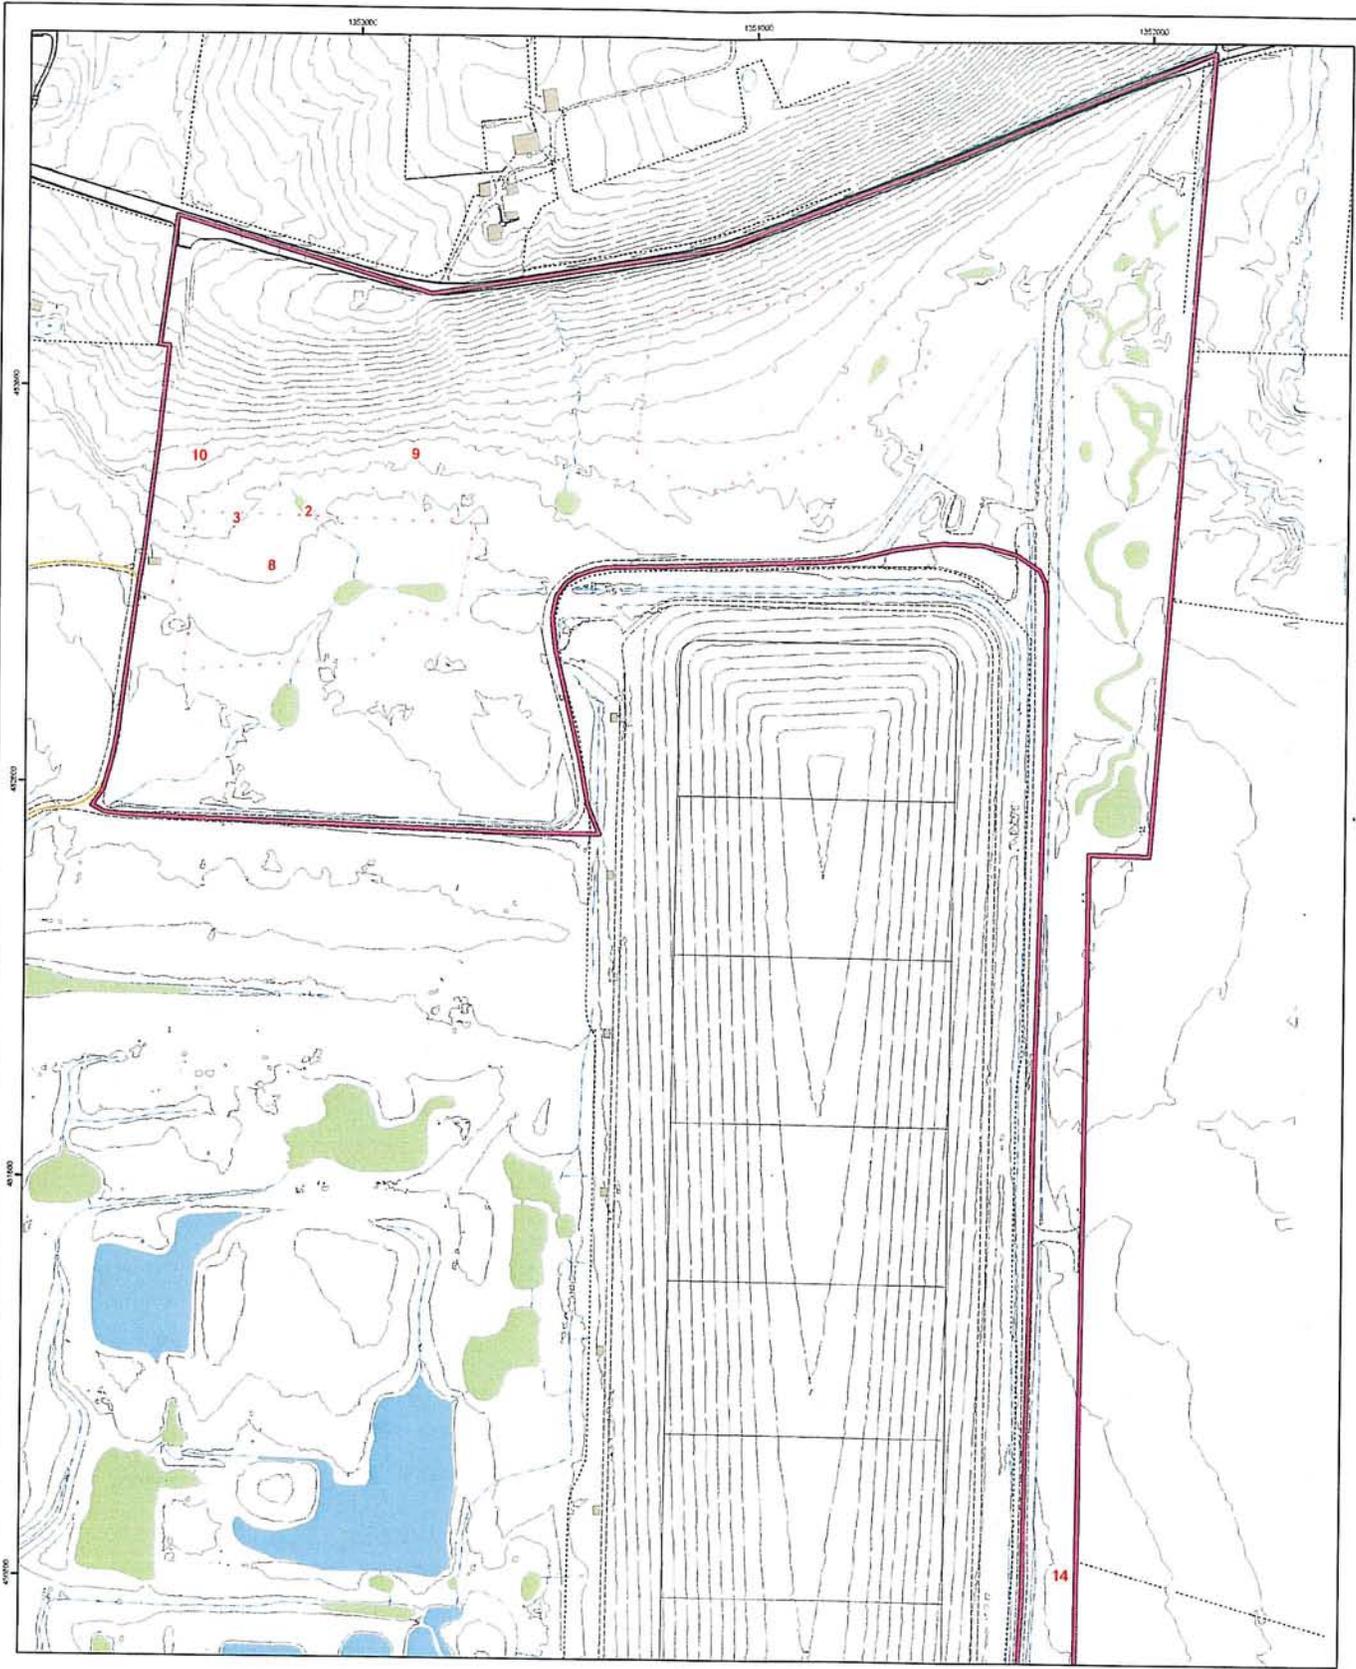
No.	Location (Use Map Whenever Possible)	GPS?	Type of Finding				Description	Photo? (File No.)	Follow Up		
			Unauthorized Use	Disturbance	Vegetation	Other			Corrected	Maintenance Req'd	Cont. Observation
1	East fence, east field				X		Honeysuckle along fence		X		
2	North pines, fence east of shed				X		Tree down on deer fence		X		
3	North pines, fence east of shed				X		Tree down on deer fence		X		
4	Lodge pond basin - south				X		Downed cages		X		
5	Lodge pond basin			X			Thistle		X		
6	Lodge pond basin - southeast				X		Downed cages		X		
7	Lodge pond basin - east			X			Sparsely vegetated with natives			X	
8	Deer fence east of shed			X			Excessive goldenrod			X	
9	North pines, NE of shed			X			Garlic mustard			X	
10	North pines			X			Honeysuckle along wood line		X		
11	Lodge pond - west			X			Olive species		X		
12	East fence line				X		Old culvert			X	
13	East fence line				X		Plastic drain			X	
14	East perimeter			X			Scattered pear		X

15	Lodge pond basin			X			Callery pear		X
