SUBJECT: Contract No. DE-AC01-02GJ79491, Stoller
Task Order Number ST08-02-1-5-506, LM Fernald LTS&M
Transmittal of the December 2007 Fernald Site Inspection Forms

FERNALD PRESERVE FIELD WALKDOWN INSPECTION FORMInspector: Combined group
findingsDate: 12-4-07Area: North Woodlot and Paddys Run West Sheet No. 1 of 1

FERNALD PRESERVE DECEMBER 2007
FIELD WALKDOWN FINDINGS

FERNALD PRESERVE MAINTENANCE AND REPAIR ACTION ITEMS

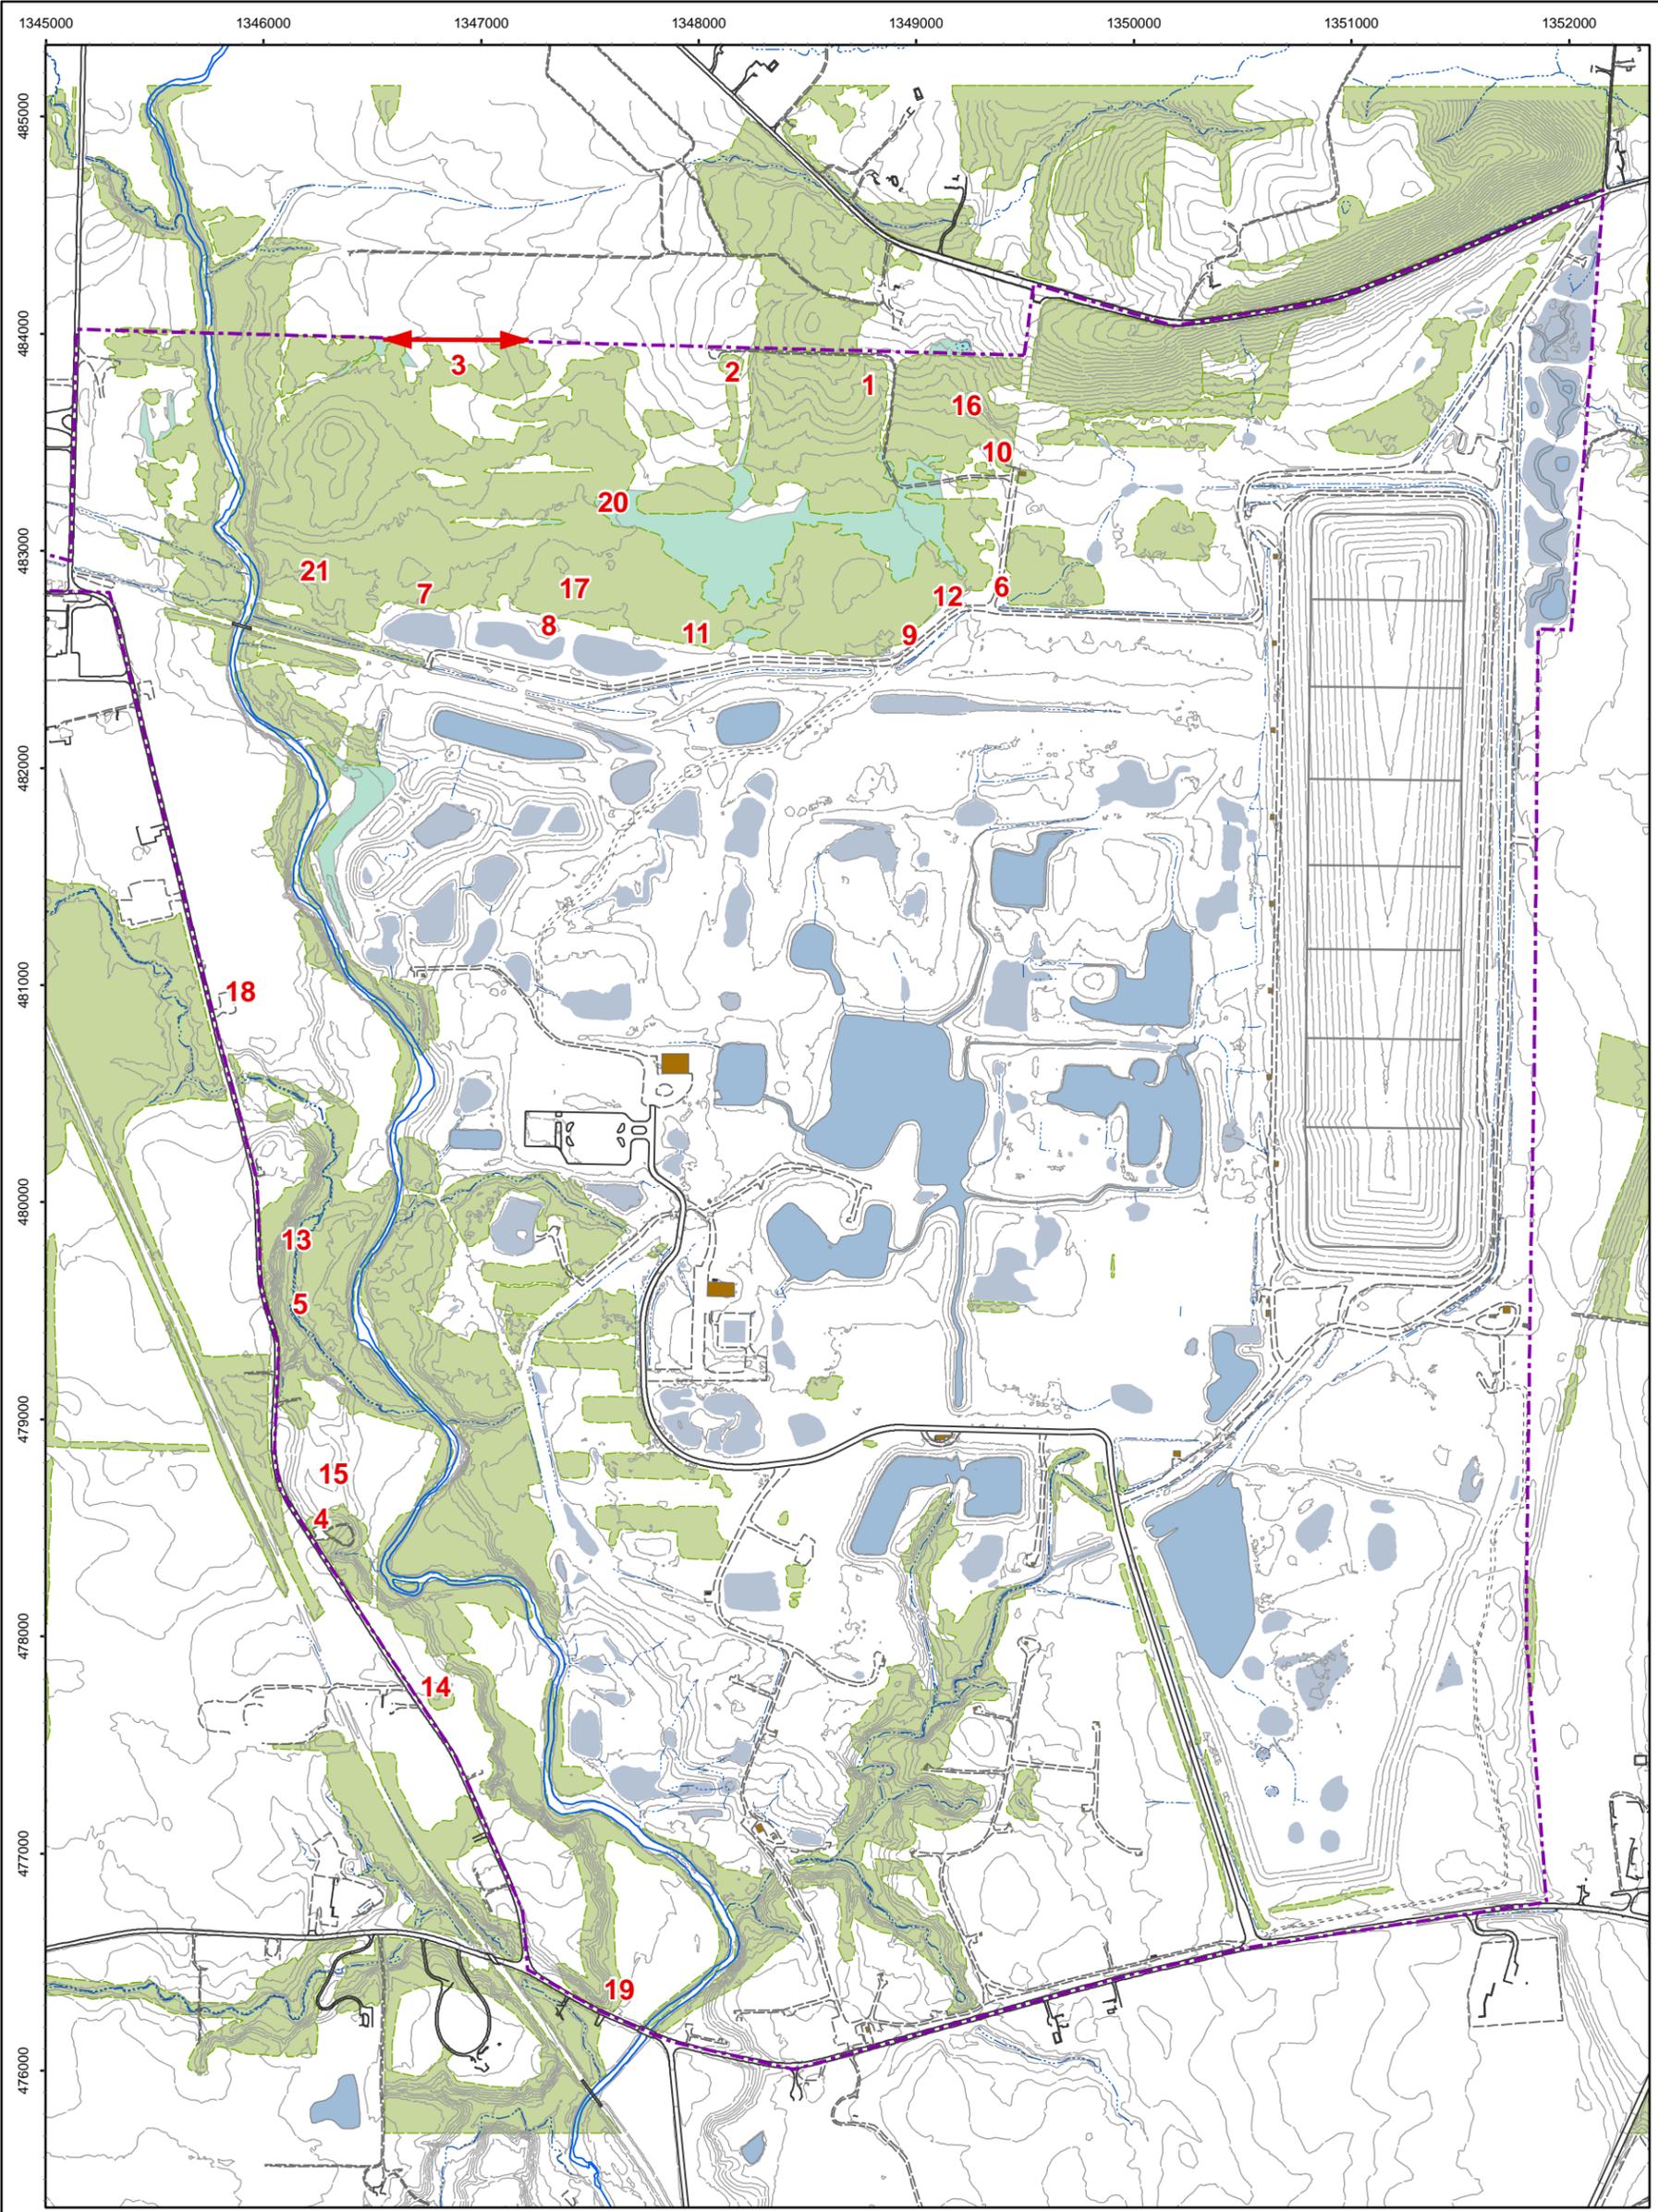
No.	Location (use map whenever possible)	GPS?	Type of Finding (see definitions back page)				Description	Photo? (file No.)	Followup		
			Unauth. Use	Disturbance	Vegetation	Other			Corrected	Maint. Required	Cont. Observation
1	Just west of gravel road, at bend by Neiman's property	no	X					X			
2	Just west of culvert that goes under gravel road, along north property line	no	X					X			
3	Various locations along north fenceline	no				X	Some "No Trespassing" signs are damaged or down		X		
4	Ecological Restoration Park	no	X				Trash is being dumped		X		
5	Oxbow Area, at a sycamore in the old Paddys Run streambed	no				X	Possible old laboratory bottle		X		
6	Old North Access Road	no				X	Bolt lying in road		X

No.	Location (use map whenever possible)	GPS?	Type of Finding (see definitions back page)				Description	Photo? (file No.)	Followup		
			Unauth. Use	Disturbance	Vegetation	Other			Corrected	Maint. Required	Cont. Observation
7	A6PI, north of chain-link fence, inside deer fence	no				X			X		
8	A6PI, inside deer fence	no				X			X		
9	North woodlot, along south road	no		X						X	
10	North woodlot, east side by road	no				X			X		
11	North woodlot deer fence	no		X					X		
12	North woodlot, along south road	no				X			X		
13	Paddys Run west, in trees by road	no				X			X		
14	Paddys Run west, at stand of trees north of substation	no				X			X		
15	North of Ecological Restoration Park	no		X					X

No.	Location (use map whenever possible)	GPS?	Type of Finding (see definitions back page)				Description	Photo? (file No.)	Followup		
			Unauth. Use	Disturbance	Vegetation	Other			Corrected	Maint. Required	Cont. Observation
16	North woodlot, south of Neiman's barn	yes				X	Brick		X		
17	A6PI chain link fence	no				X	Take down "No Trespassing" signs		X		
18	Paddys Run west, south of prairie area	no				X	Roll of welded wire fence		X		
19	Fence line along Willey Road	no				X	"No Trespassing" sign down		X		
20	North woodlot	no	X				Deer stand discovered in tree	X		X	
21	Forest Demo Project	no			X		Tree tubes need to be removed		X
