Department of Energy
Office of Legacy Management

Subject: Transmittal of the September 2009 Fernald Site Inspection Forms

FERNALD PRESERVE FIELD WALKDOWN INSPECTION FORM

Fernald Preserve
 Consolidated Finding Locations
 for September 2009 Site Inspection

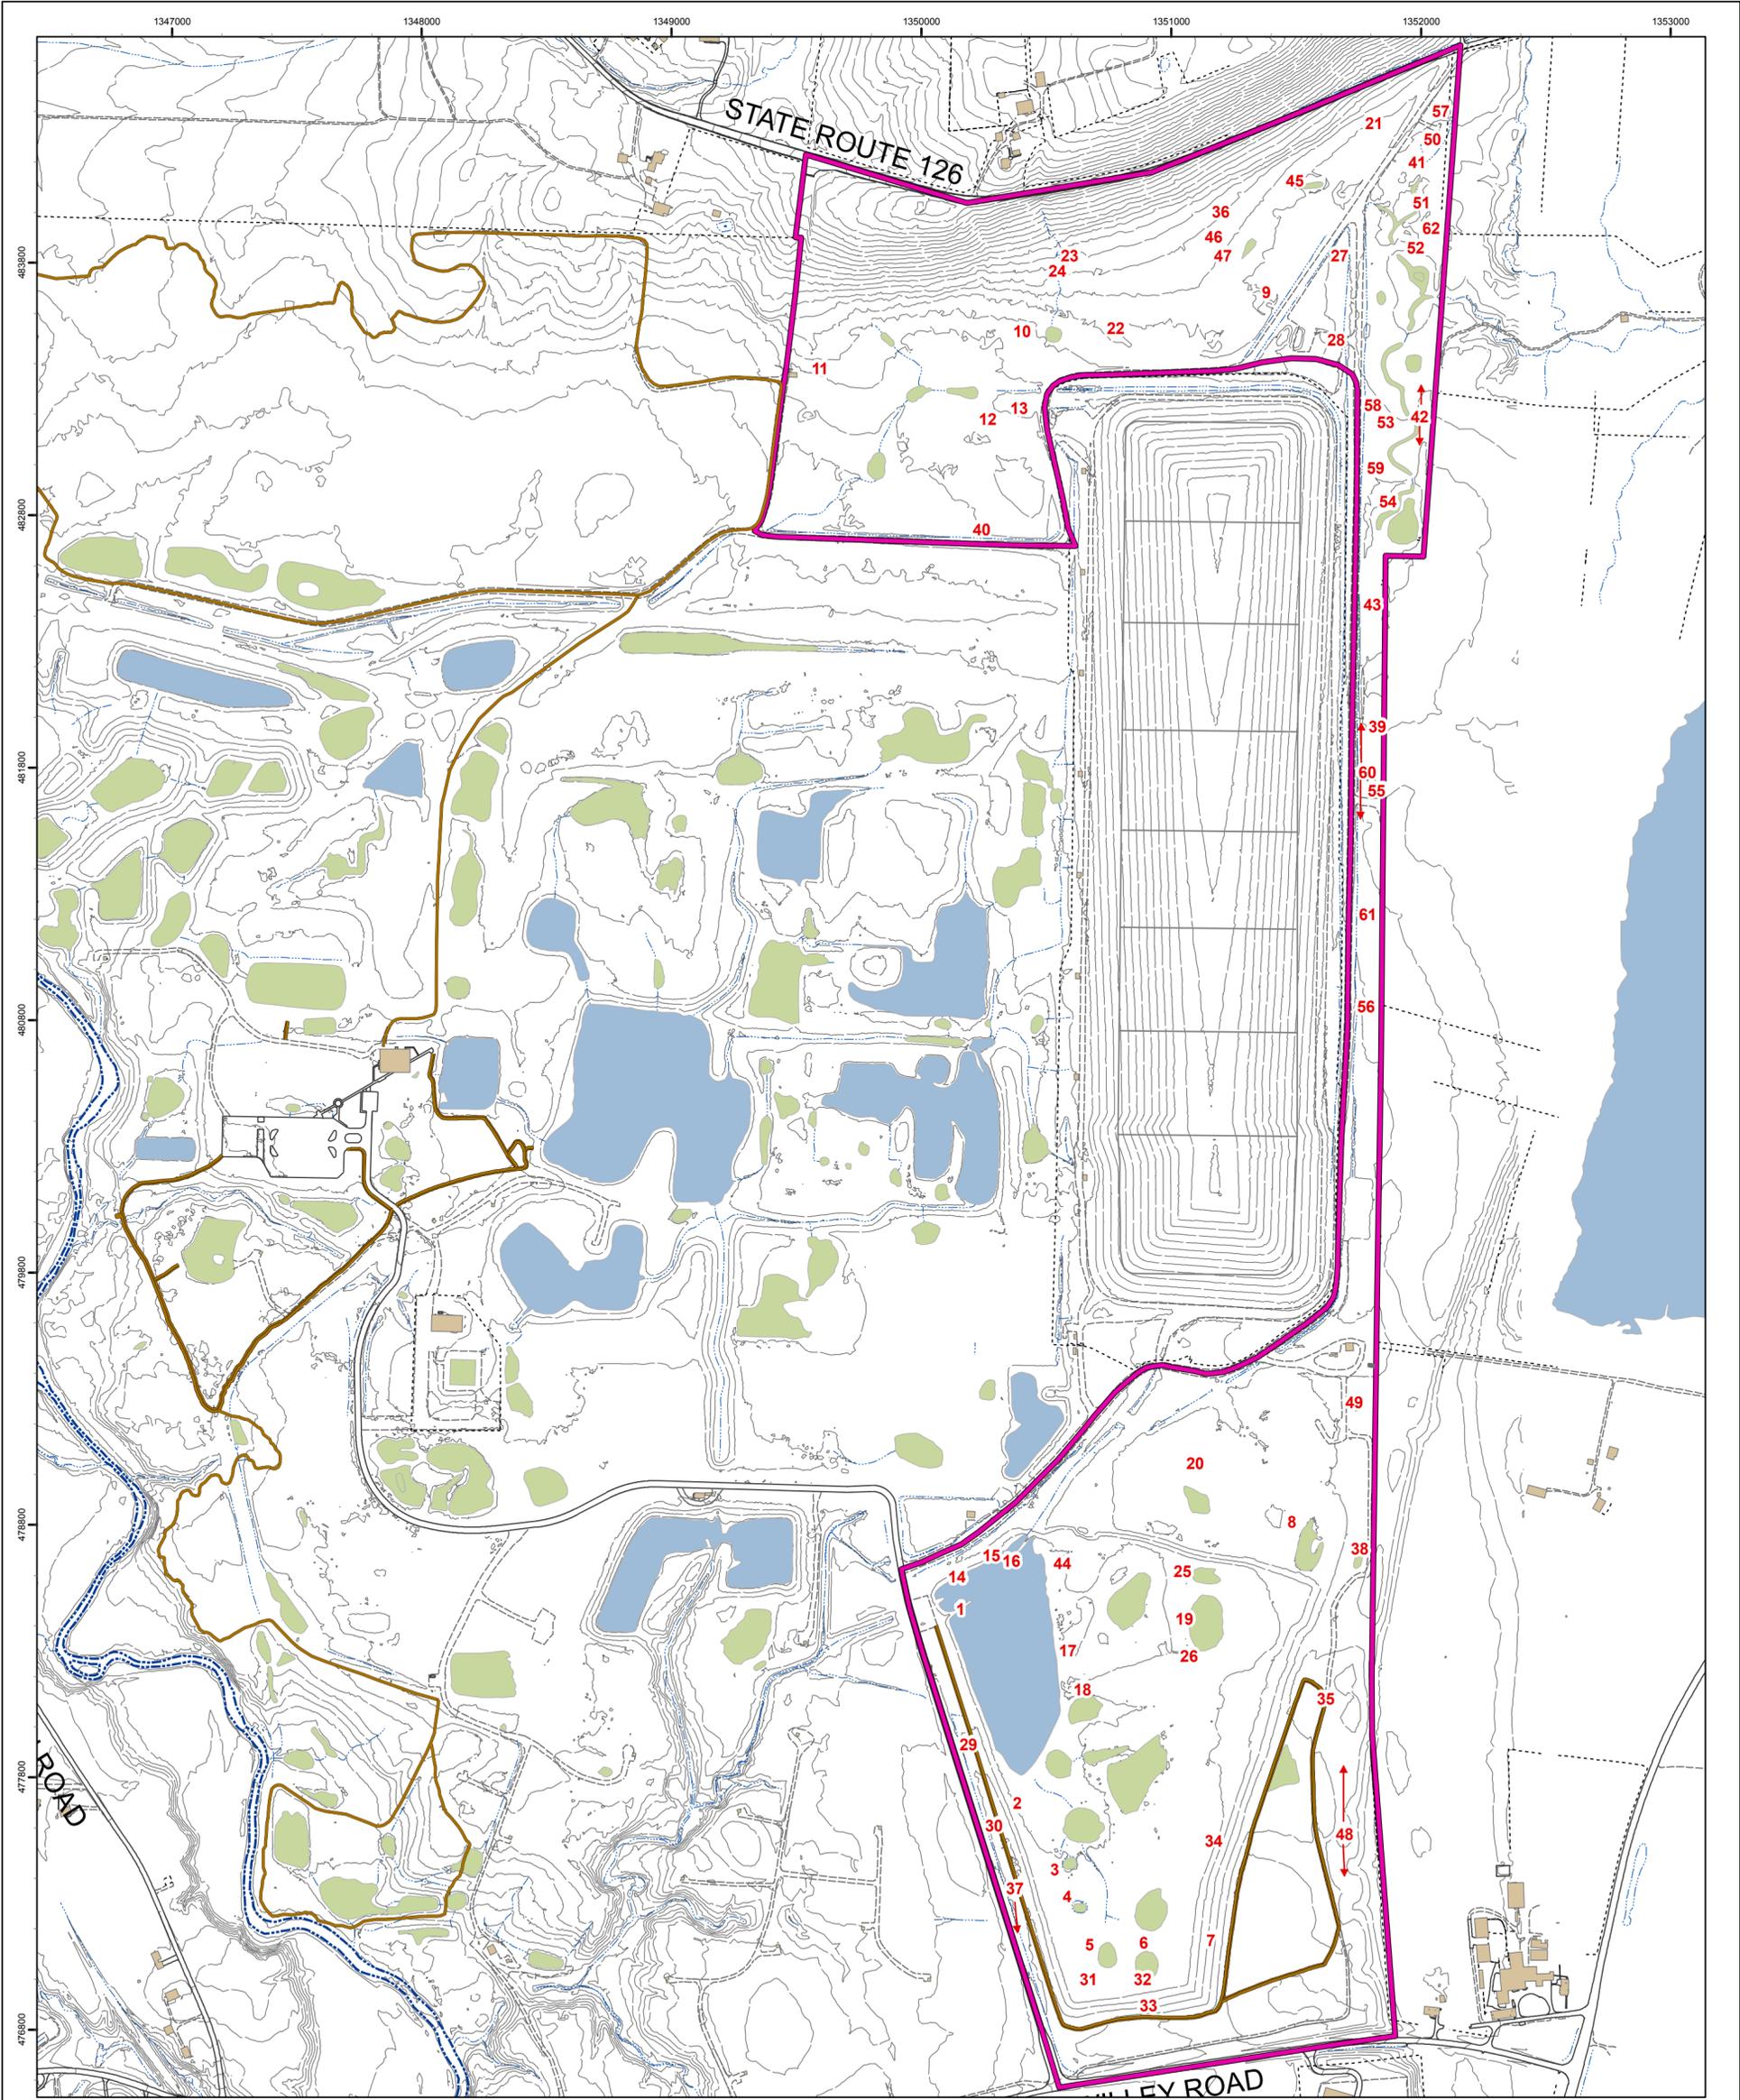
NOTE: Findings are numbered and provided on the September 2008 Field Walkdown Form.
 NOTE: Paddy's Run will be inspected as accessible - Summer/Fall.
