Department of Energy
Office of Legacy Management

SUBJECT: Transmittal of the March 2011 Fernald Site Inspection Forms

Fernald Preserve Field Walkdown Inspection

Fernald Preserve
Consolidated Finding Locations
for March 2011 Site Inspection

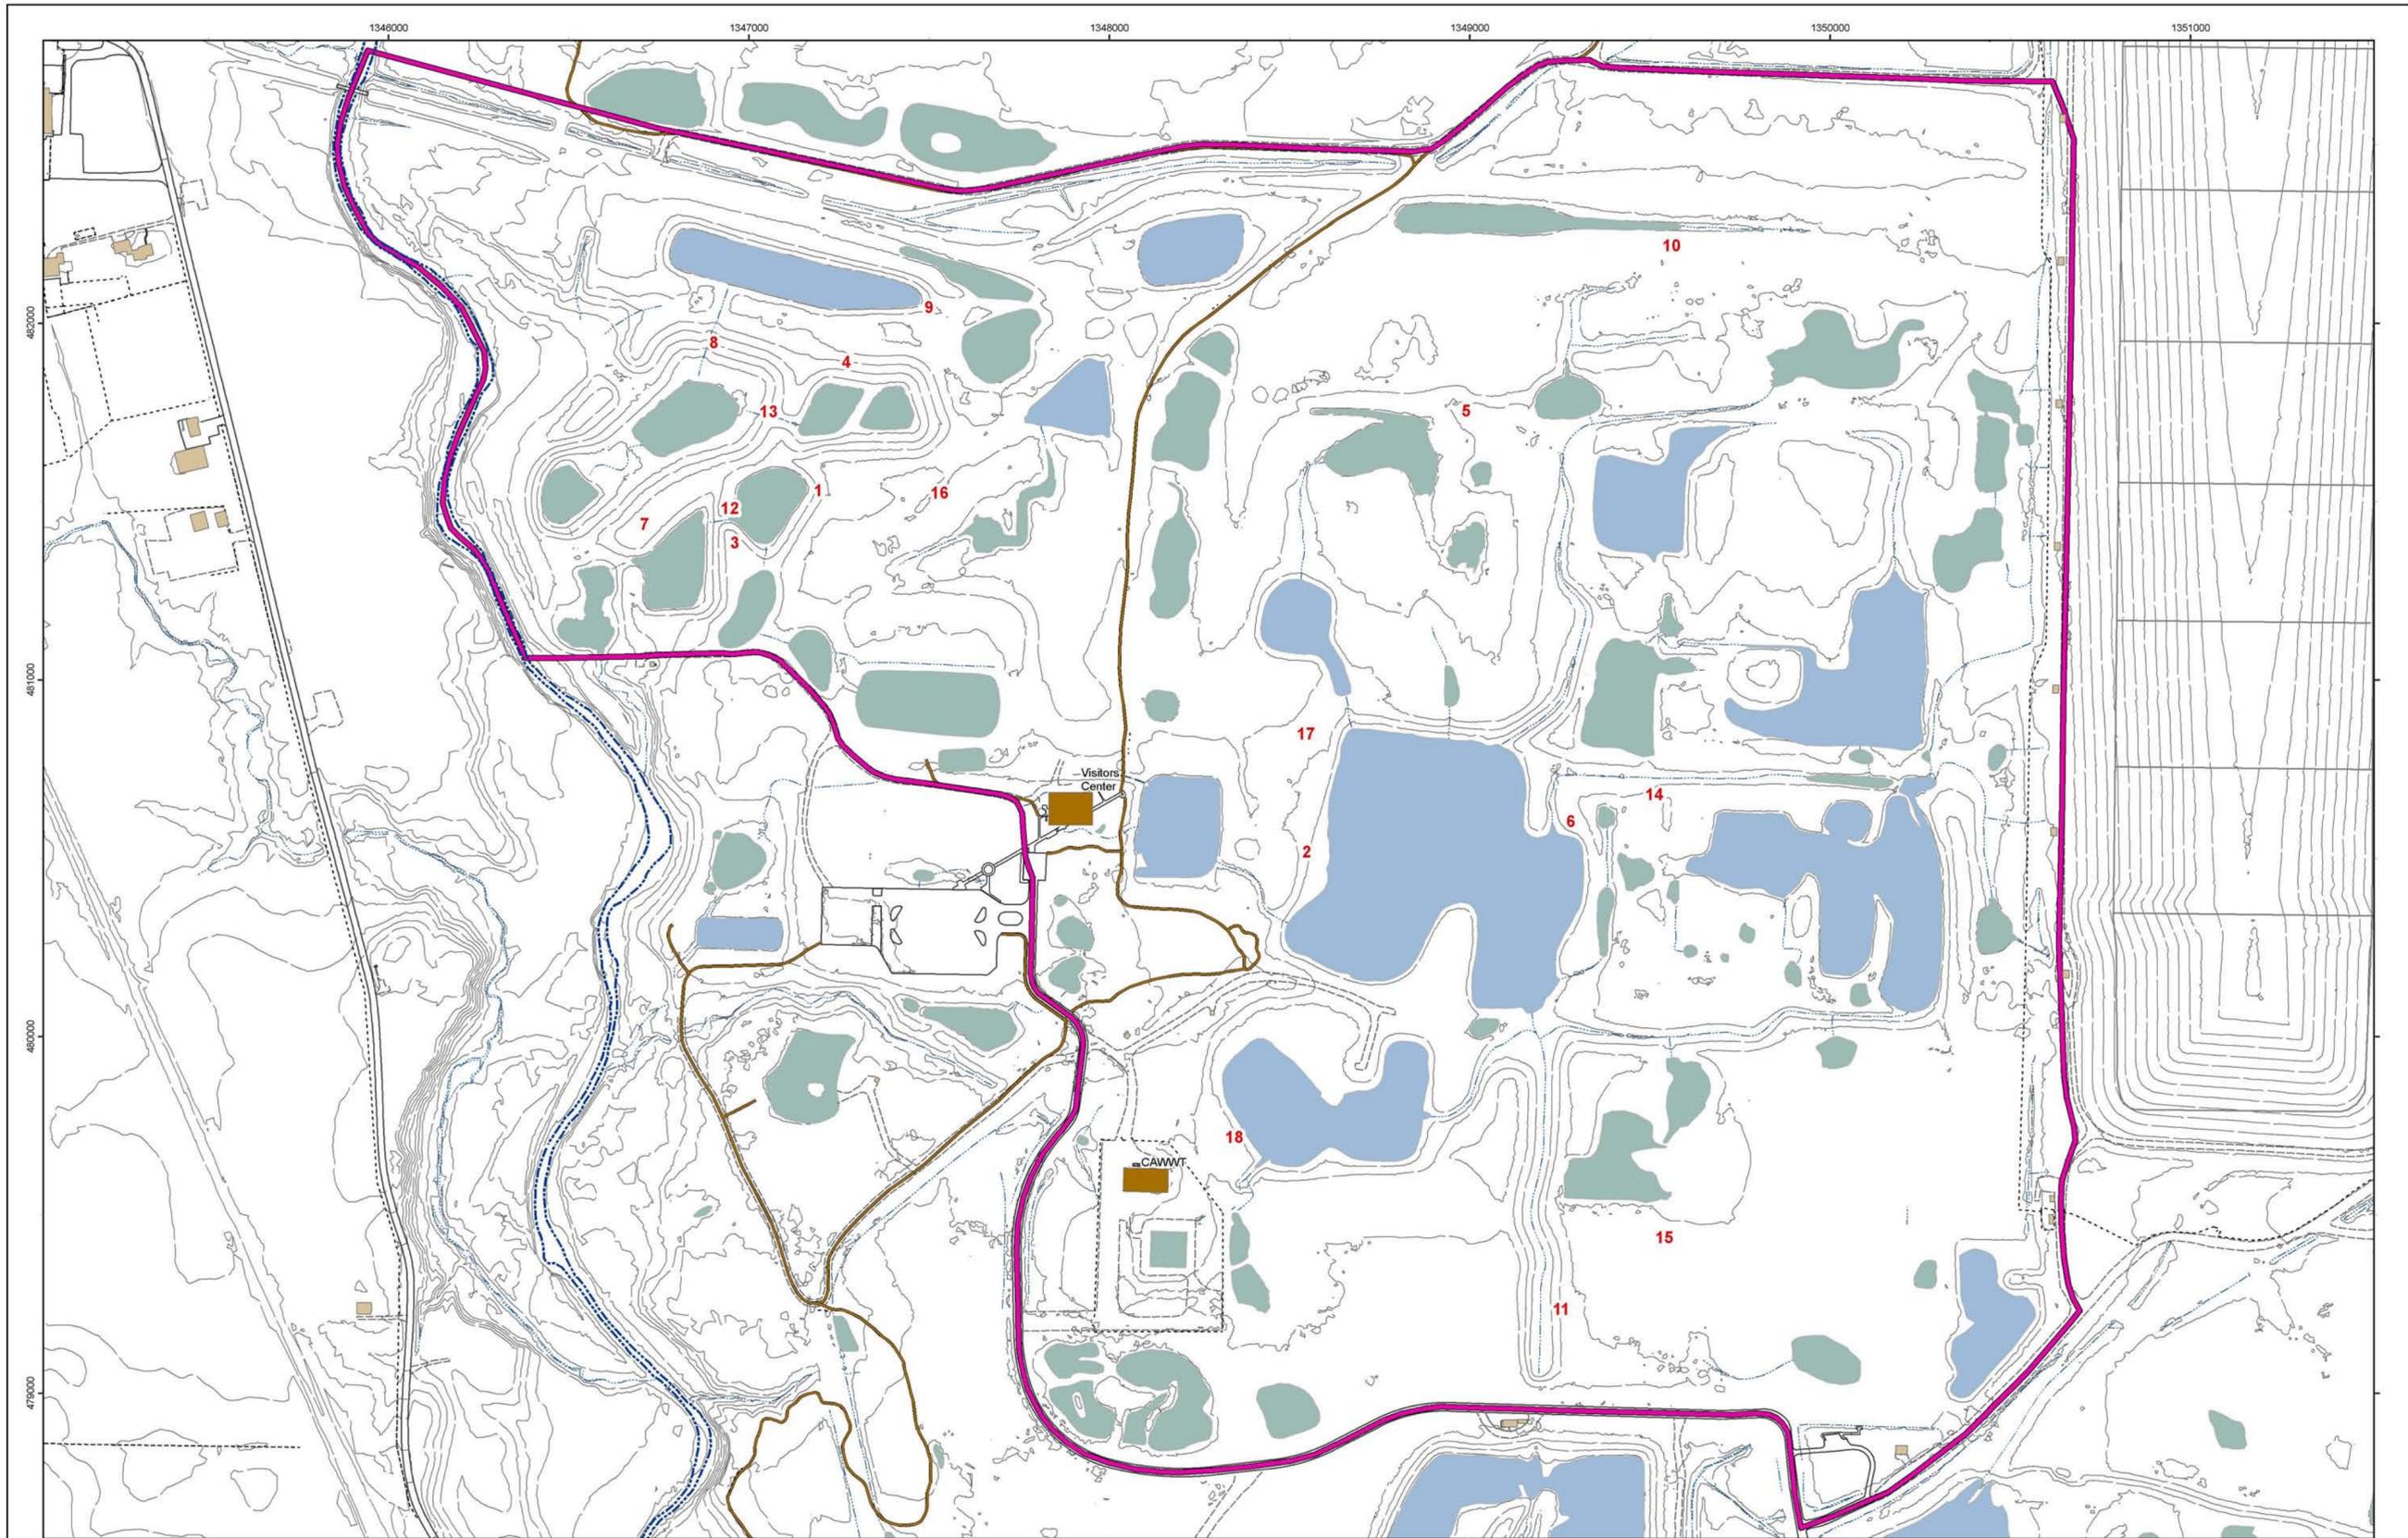
No.	Location (Use Map Whenever Possible)	GPS?	Type of Finding				Description	Photo? (File No.)	Follow Up		
			Unauthorized Use	Disturbance	Vegetation	Other			Corrected	Maintenance Req'd	Cont. Observation
1	Waste Pits	YES		X			Erosion rill	2759, 2760			X
2	West bank of Swan Pond	NO				X	Deer cages need removed or replaced	NO	X		
3	Waste Pits	NO			X		Unvegetated area	NO			X
4	Waste Pits	NO			X		Teasel patch	NO	X		
5	Former Production Area	NO			X		Teasel patches	NO	X		
6	East of Swan Pond	NO			X		Very sparse vegetation	NO			X
7	Waste Pits	NO				X	Trash	NO	X		
8	Waste Pits (south of pit 5)	YES		X			Erosion approx. 1 foot	2763, 2764			X
9	Waste Pits (east of pit 5)	YES		X			Erosion approx. 8 inches	2765, 2766			X
10	Former rail yard	NO				X	Broken culvert	NO	X		
11	East of main drainage channel	YES		X			Erosion	2767, 2768			X
12	Waste Pits	NO		X			Erosion	2756 – 2758			X
13	Waster Pits	YES		X			Erosion	2761, 2762			X

14	Former Production Area between Swan and Angel Ponds	NO			X		Sparse vegetation	NO			X
15	South of 5 Oaks	NO			X		Sparse vegetation	NO			X
16	East of Waste Pits	NO			X		Teasel	NO	X		
17	West of Swan Pond	NO			X		Teasel	NO	X
