SUBJECT: Transmittal of the December 2011 Fernald Site Inspection Forms

Fernald Preserve
Consolidated Finding Locations for North Section
of December 2011 Site Inspection

Fernald Preserve
Consolidated Finding Locations for South Section
of December 2011 Site Inspection

Fernald Preserve Field Walkdown Inspection

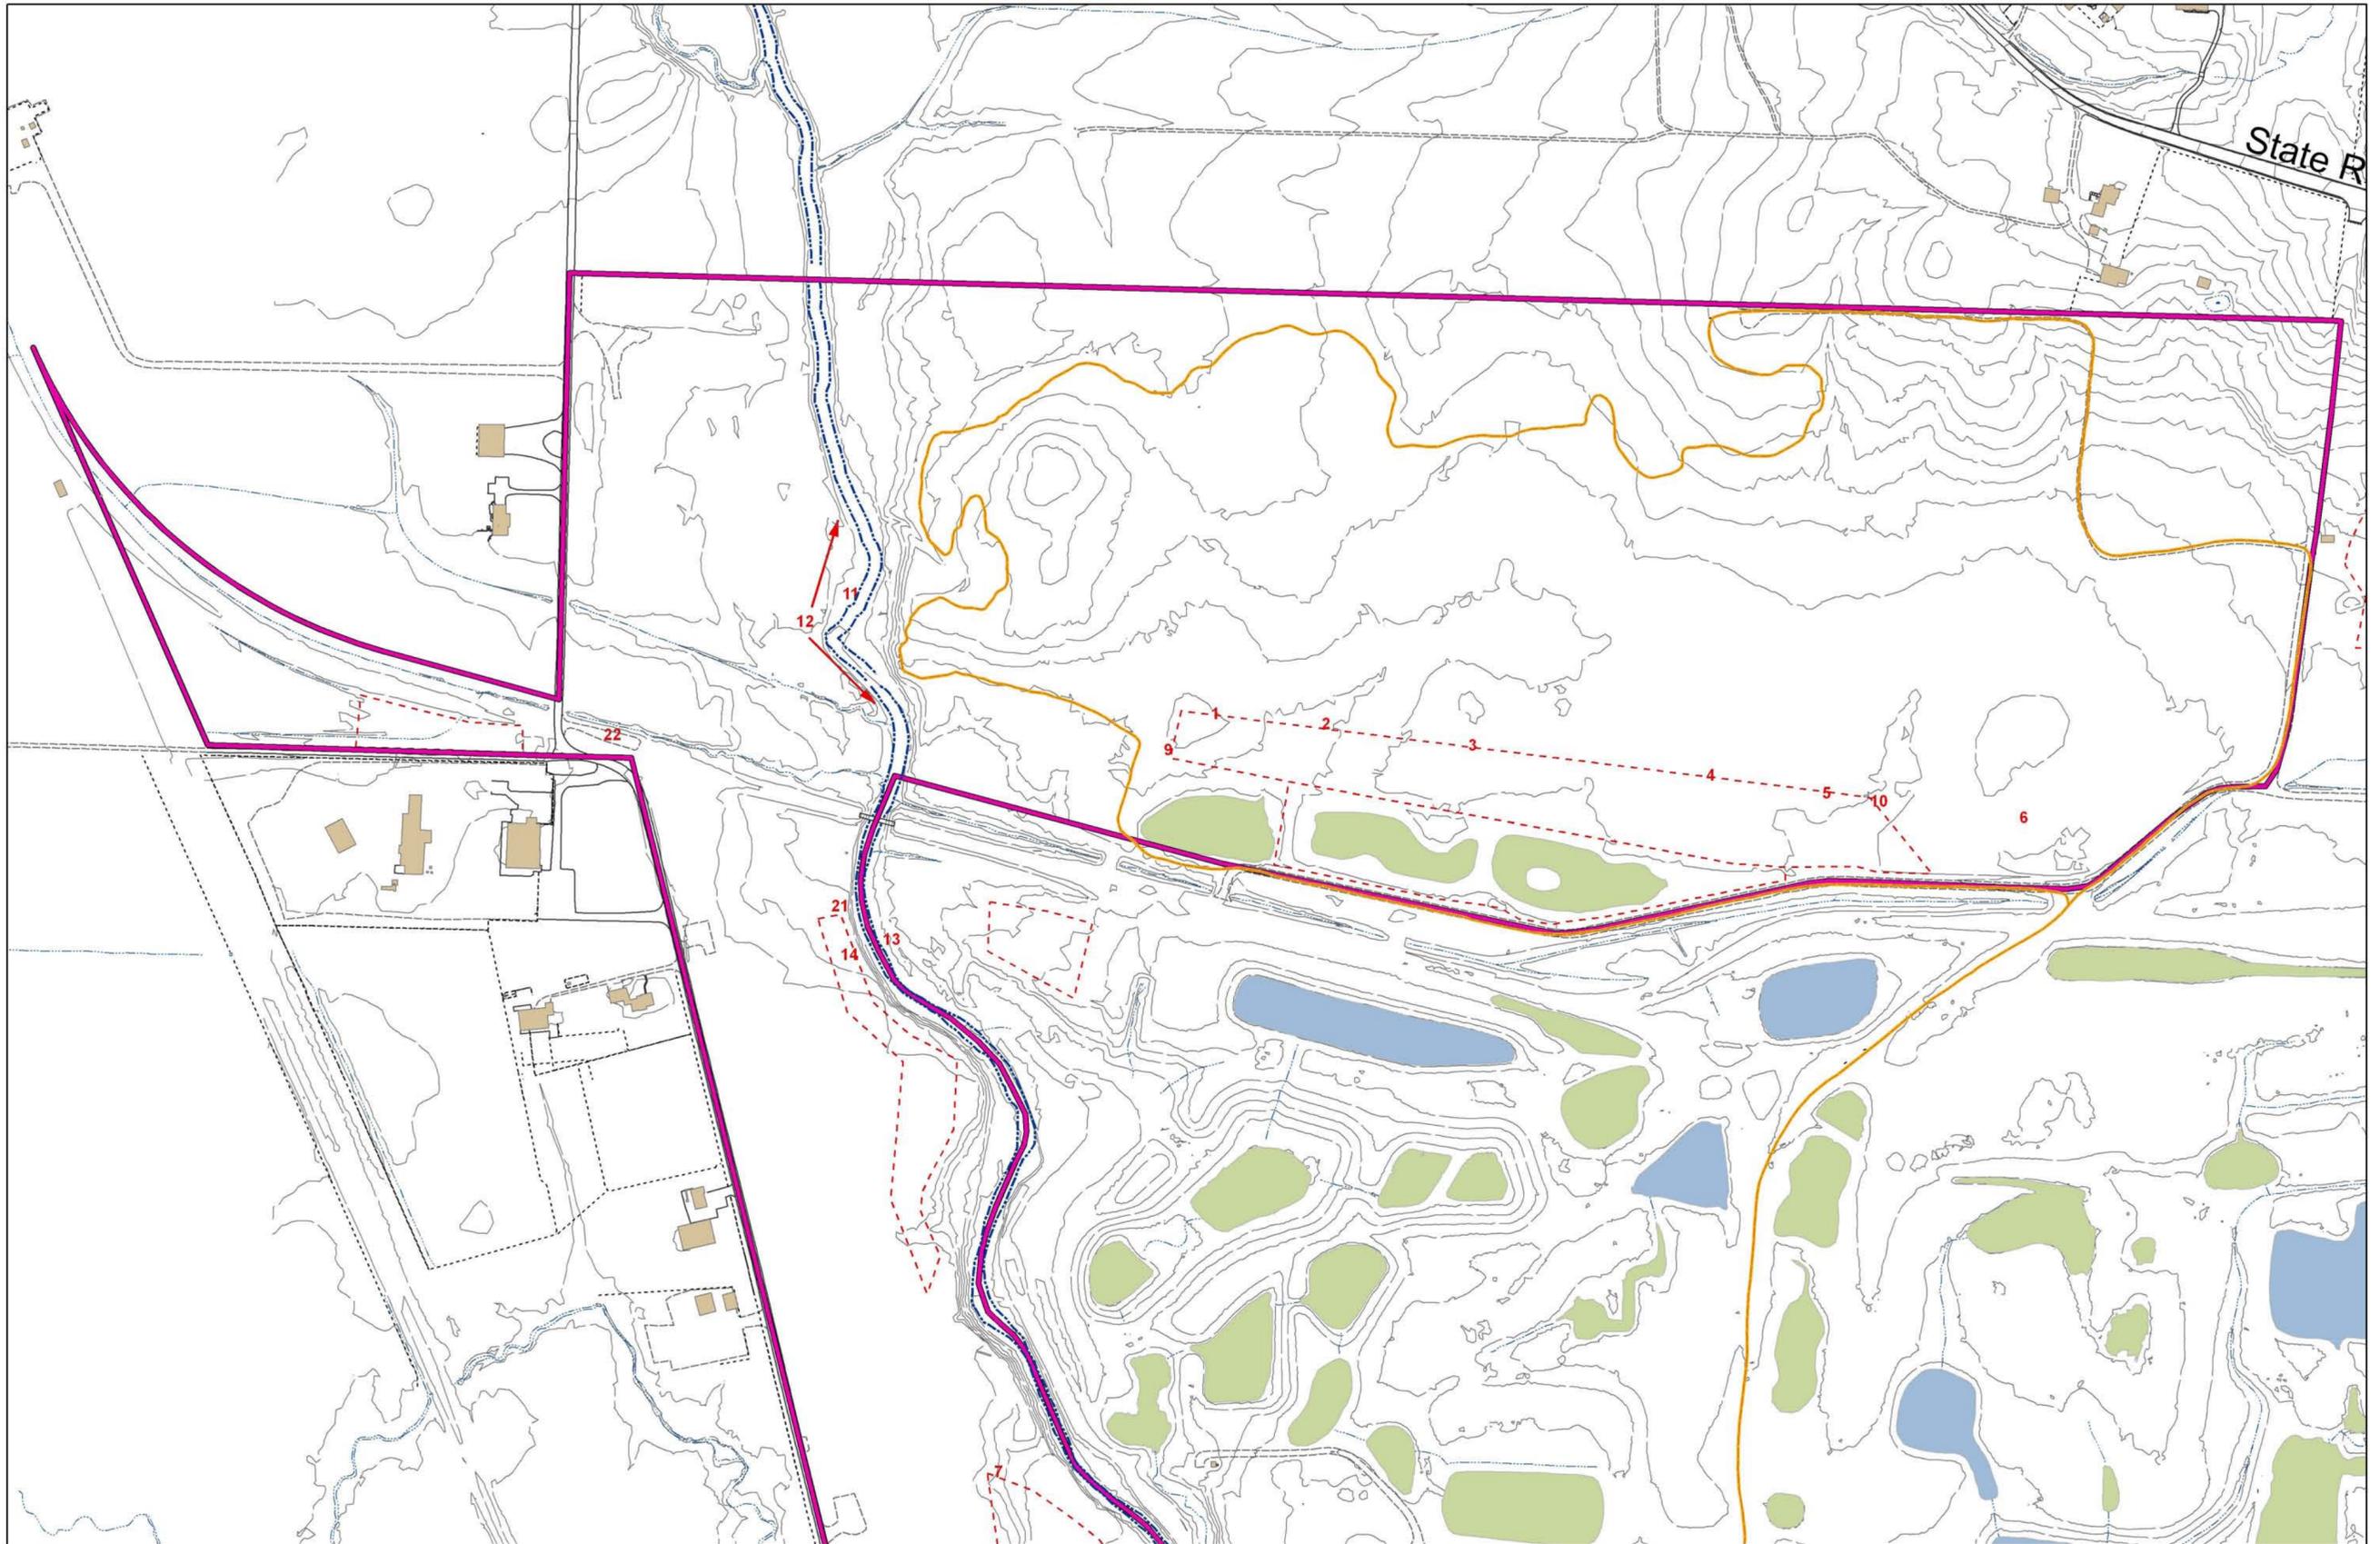
No.	Location (Use Map Whenever Possible)	GPS?	Type of Finding				Description	Photo? (File No.)	Follow Up		
			Unauthorized Use	Disturbance	Vegetation	Other			Corrected	Maintenance Req'd	Cont. Observation
1	Deer fence north of WM2 - north					X	Hole in deer fence		X		
2	Deer fence north of WM2 - north					X	Tree on deer fence		X		
3	Deer fence north of WM2 - north					X	Tree on deer fence		X		
4	Deer fence north of WM2 - north					X	Hole in fence		X		
5	Deer fence north of WM2 - north					X	Hole in fence		X		
6	SE Corner of North Woodlot					X	Debris - concrete	X			
7	A8PIII-North, south deer fence					X	Hole on north side of fence		X		
8	A8PIII-North, south deer fence					X	Hole on east side of fence		X		
9	Deer fence north of WM2 - west					X	Fence is down (tree)		X		
10	Deer fence north of WM2 - NE					X	Hole in fence		X		
11	A8PII Paddys Run west bank					X	Bottles/trash caught in fence		X		
12	A8PII Paddys Run west bank					X	Tree tubes need removed		X

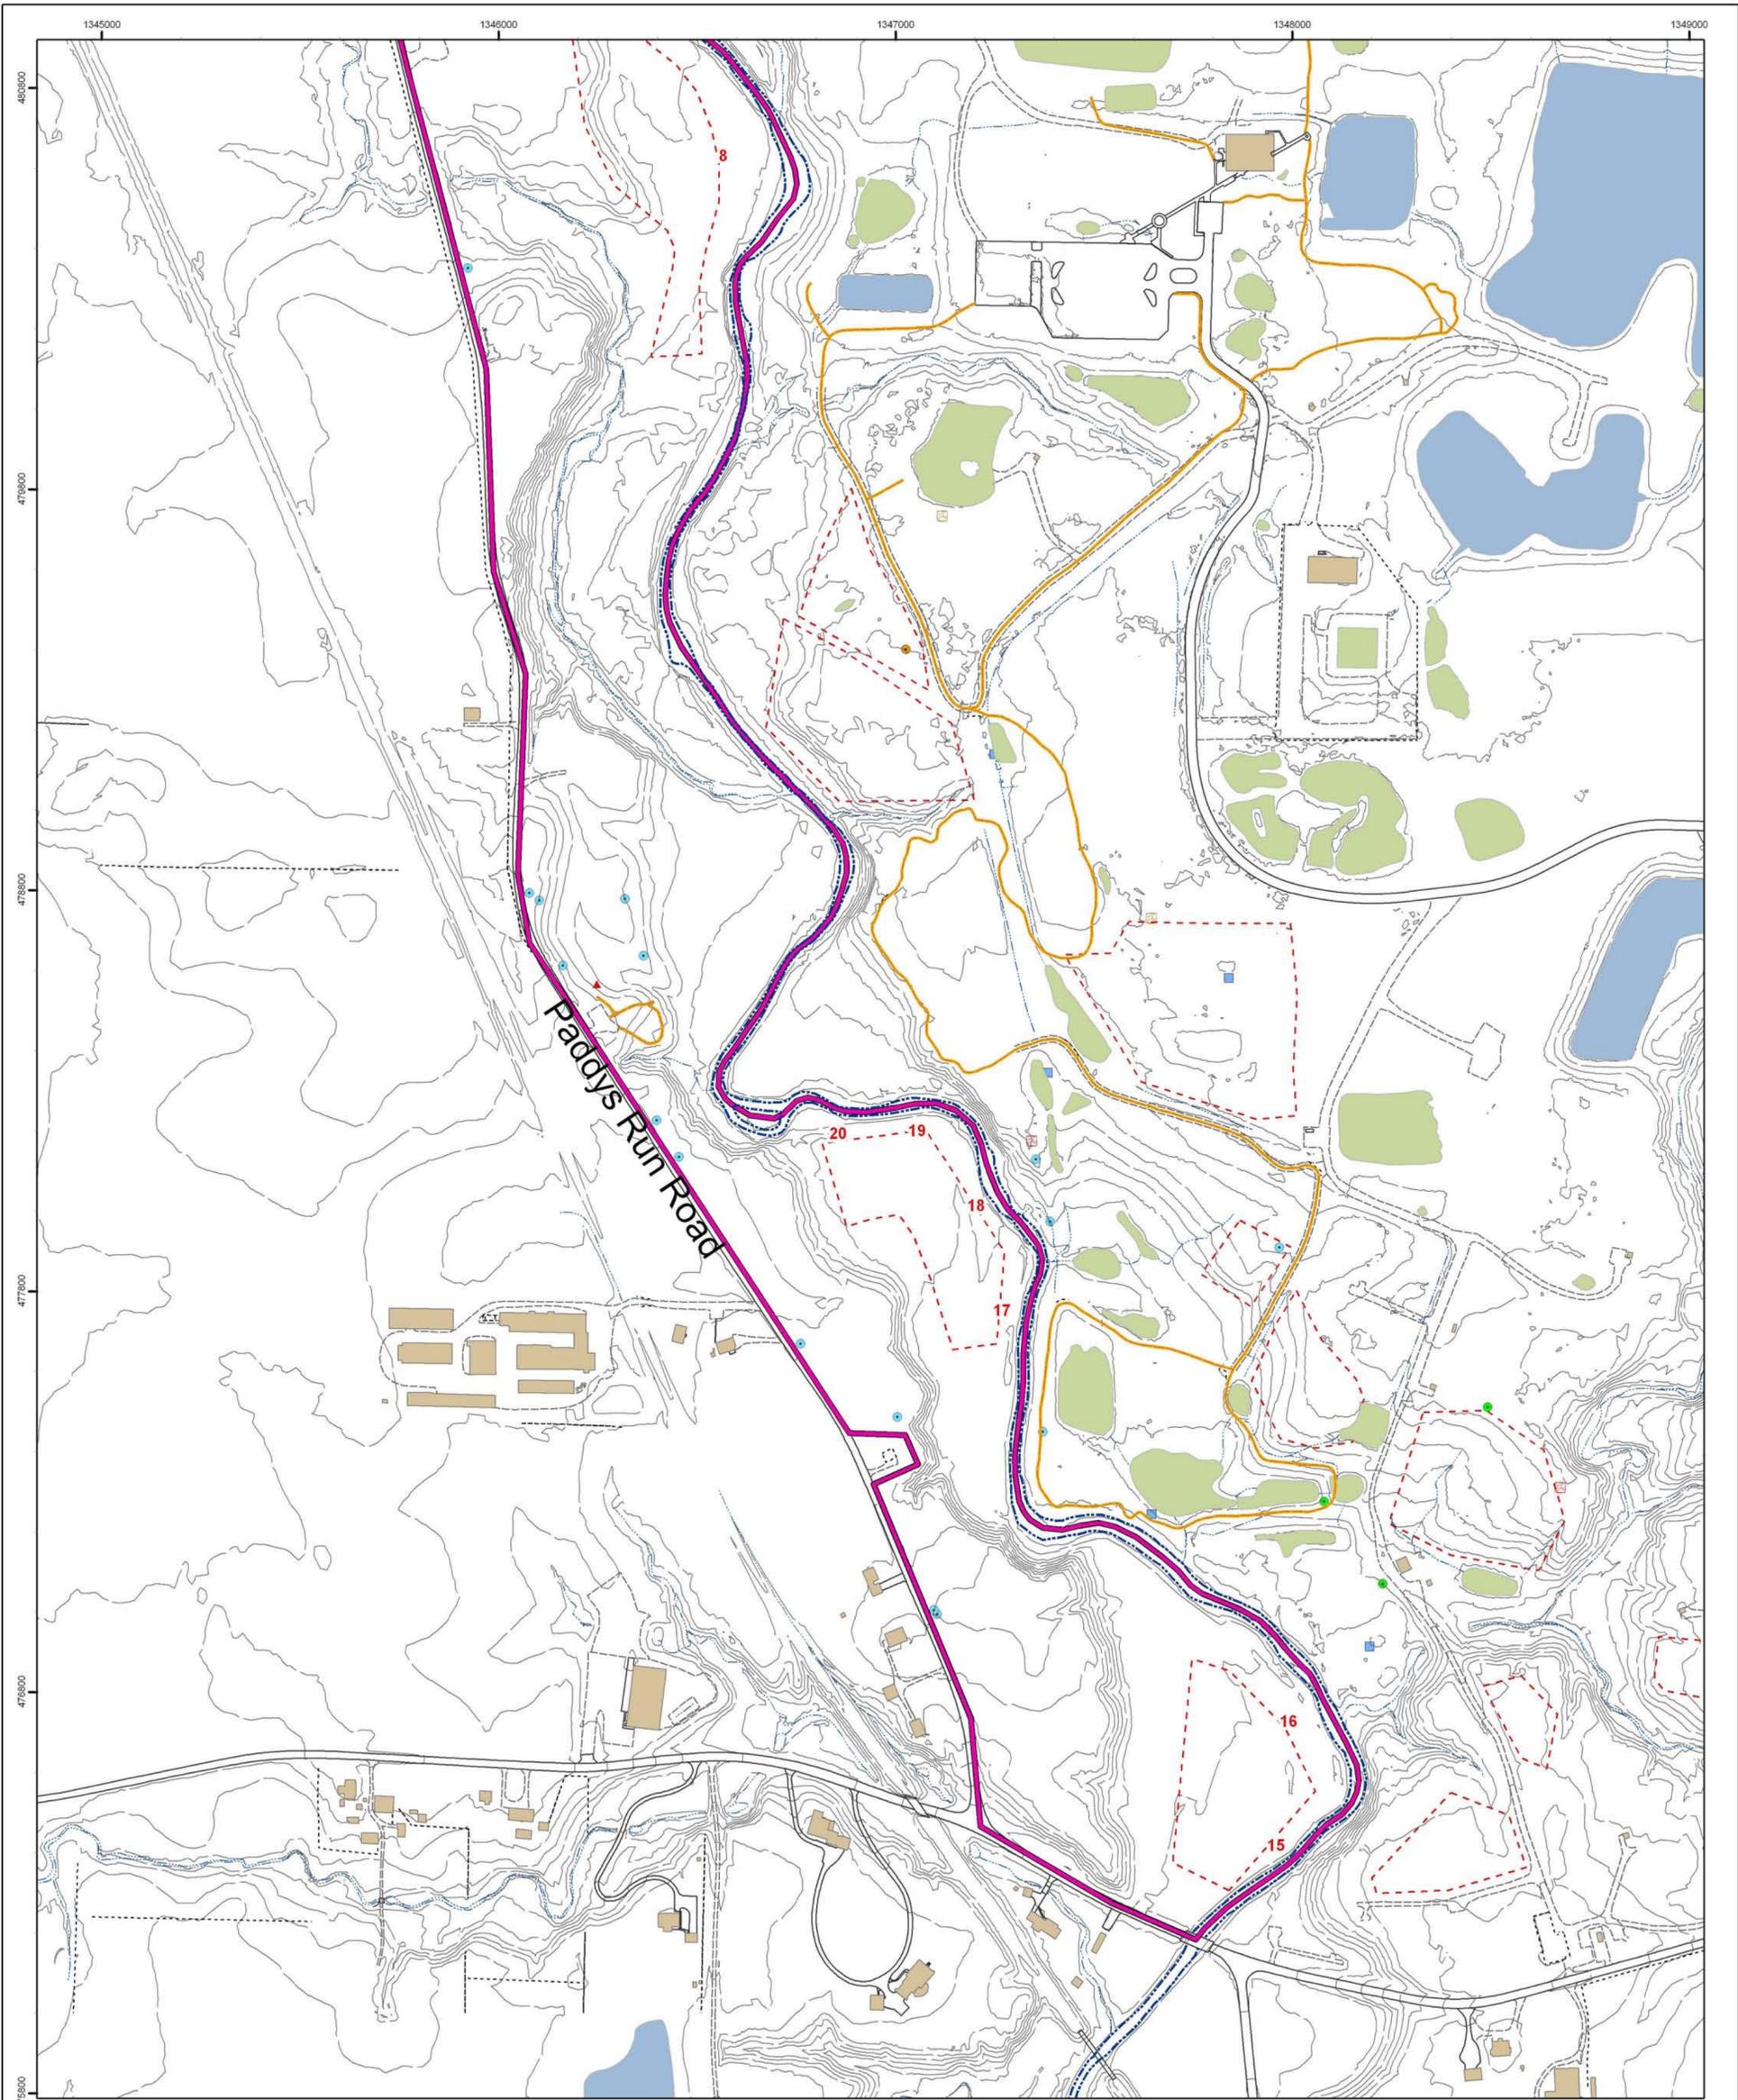
13	100 yds south of train trestle					X	Metal debris on east bank	X			
14	A8PIII-North, north deer fence					X	Fence sagging – ties broken		X		
15	Rainbow bridge deer fence - SE					X	Deer fence down		X		
16	Rainbow bridge deer fence - NE					X	Deer fence down		X		
17	Duke Energy deer fence - SE					X	Deer fence down		X		
18	Duke Energy deer fence - east					X	Deer fence down		X		
19	Duke Energy deer fence – NE					X	Tree on deer fence		X		
20	Duke Energy deer fence – north					X	Tree on deer fence		X		
21	A8PIII-North, road south of trestle					X	Tarp laying in field	X			
22	“S” bend on Paddys Run Rd.					X	4x4 barrier post is broken off at ground level, seemingly run over by a vehicle (tire tracks on either side)		X
