SUBJECT: Transmittal of the March 2012 Fernald Site Inspection Forms

Fernald Preserve Field Walkdown Inspection

Fernald Preserve
 Consolidated Finding Locations
 for March 2012 Site Inspection

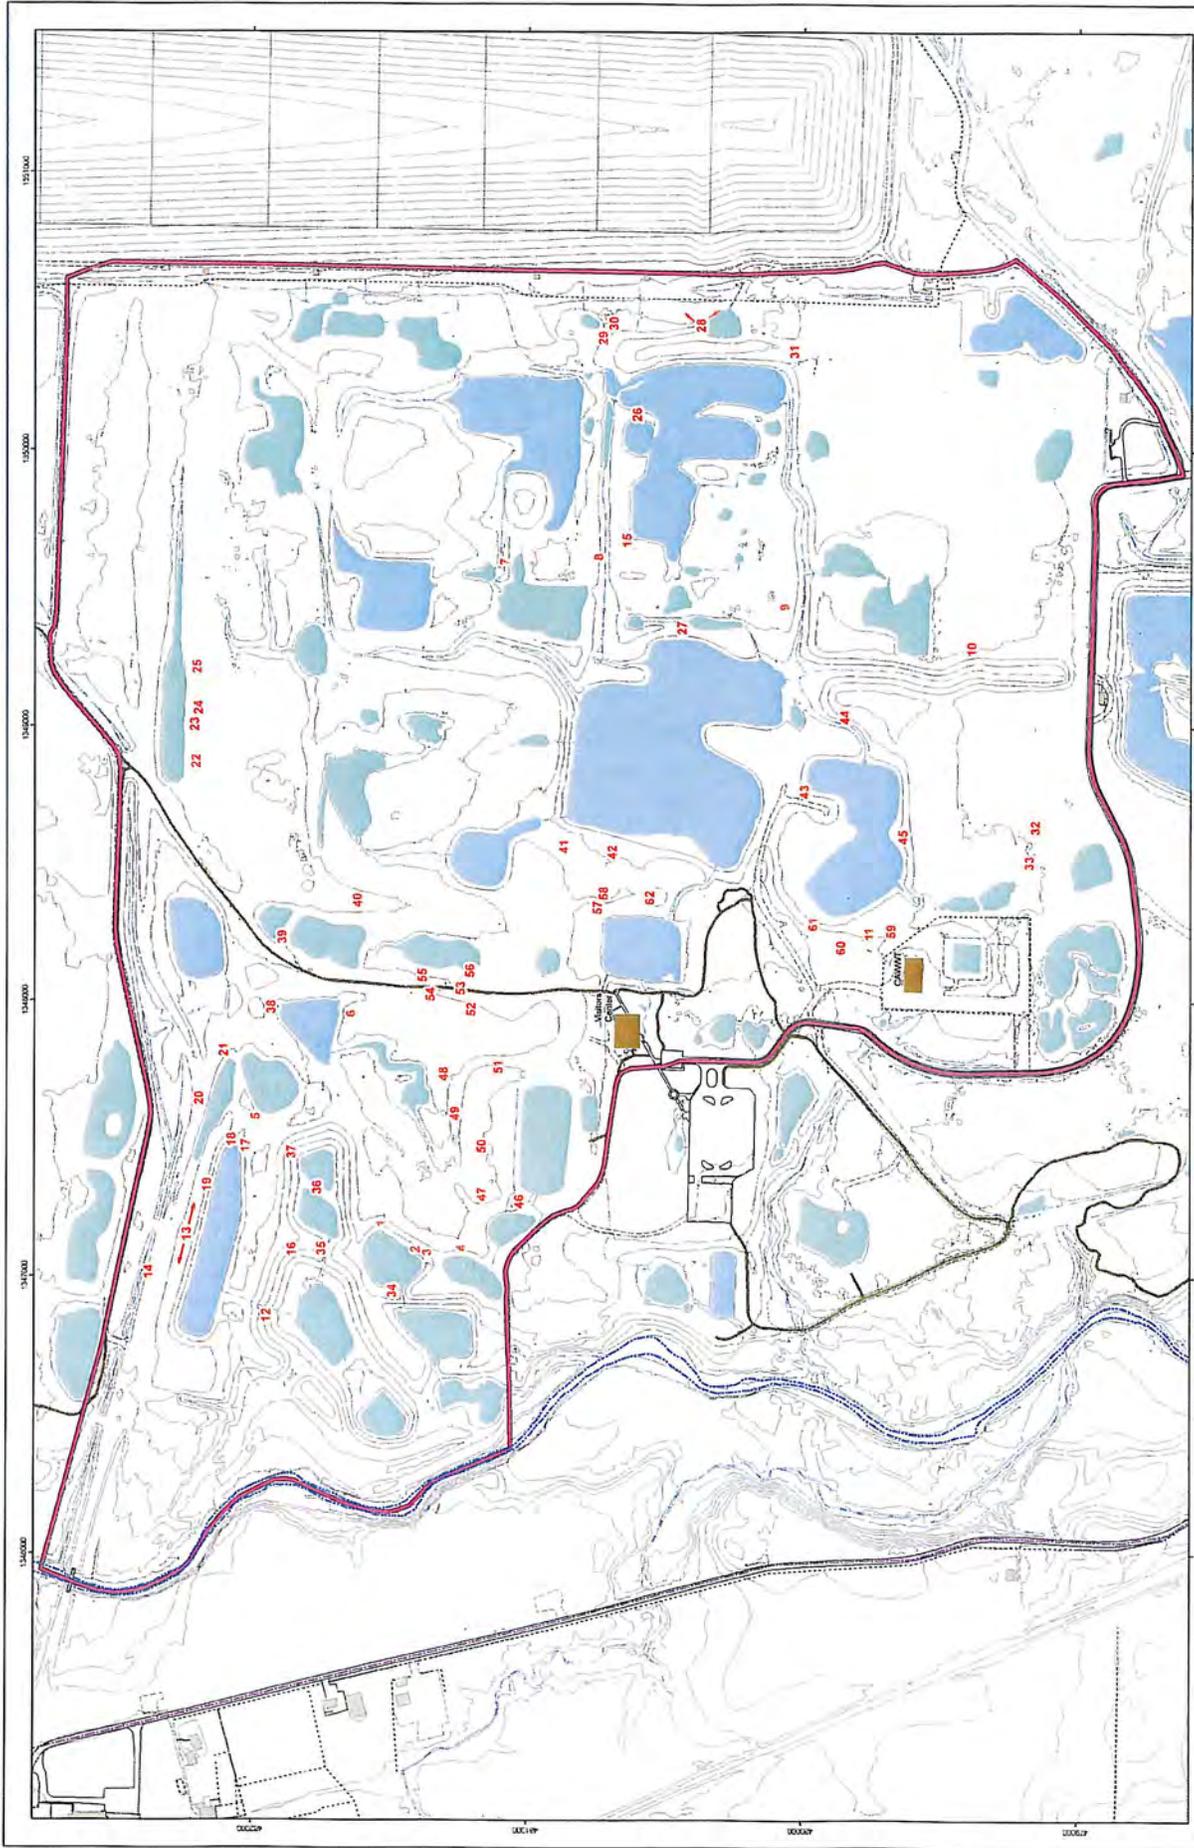
NOTE: Findings are numbered and provided on the March 2012 Field Walkdown Form.
 NOTE: Paddy's Run will be inspected as accessible - Summer/Fall.
