SUBJECT: Transmittal of the June 2013 Fernald Preserve On-Site Disposal Facility Inspection Forms

On-Site Disposal Facility Inspection Report

June 2013

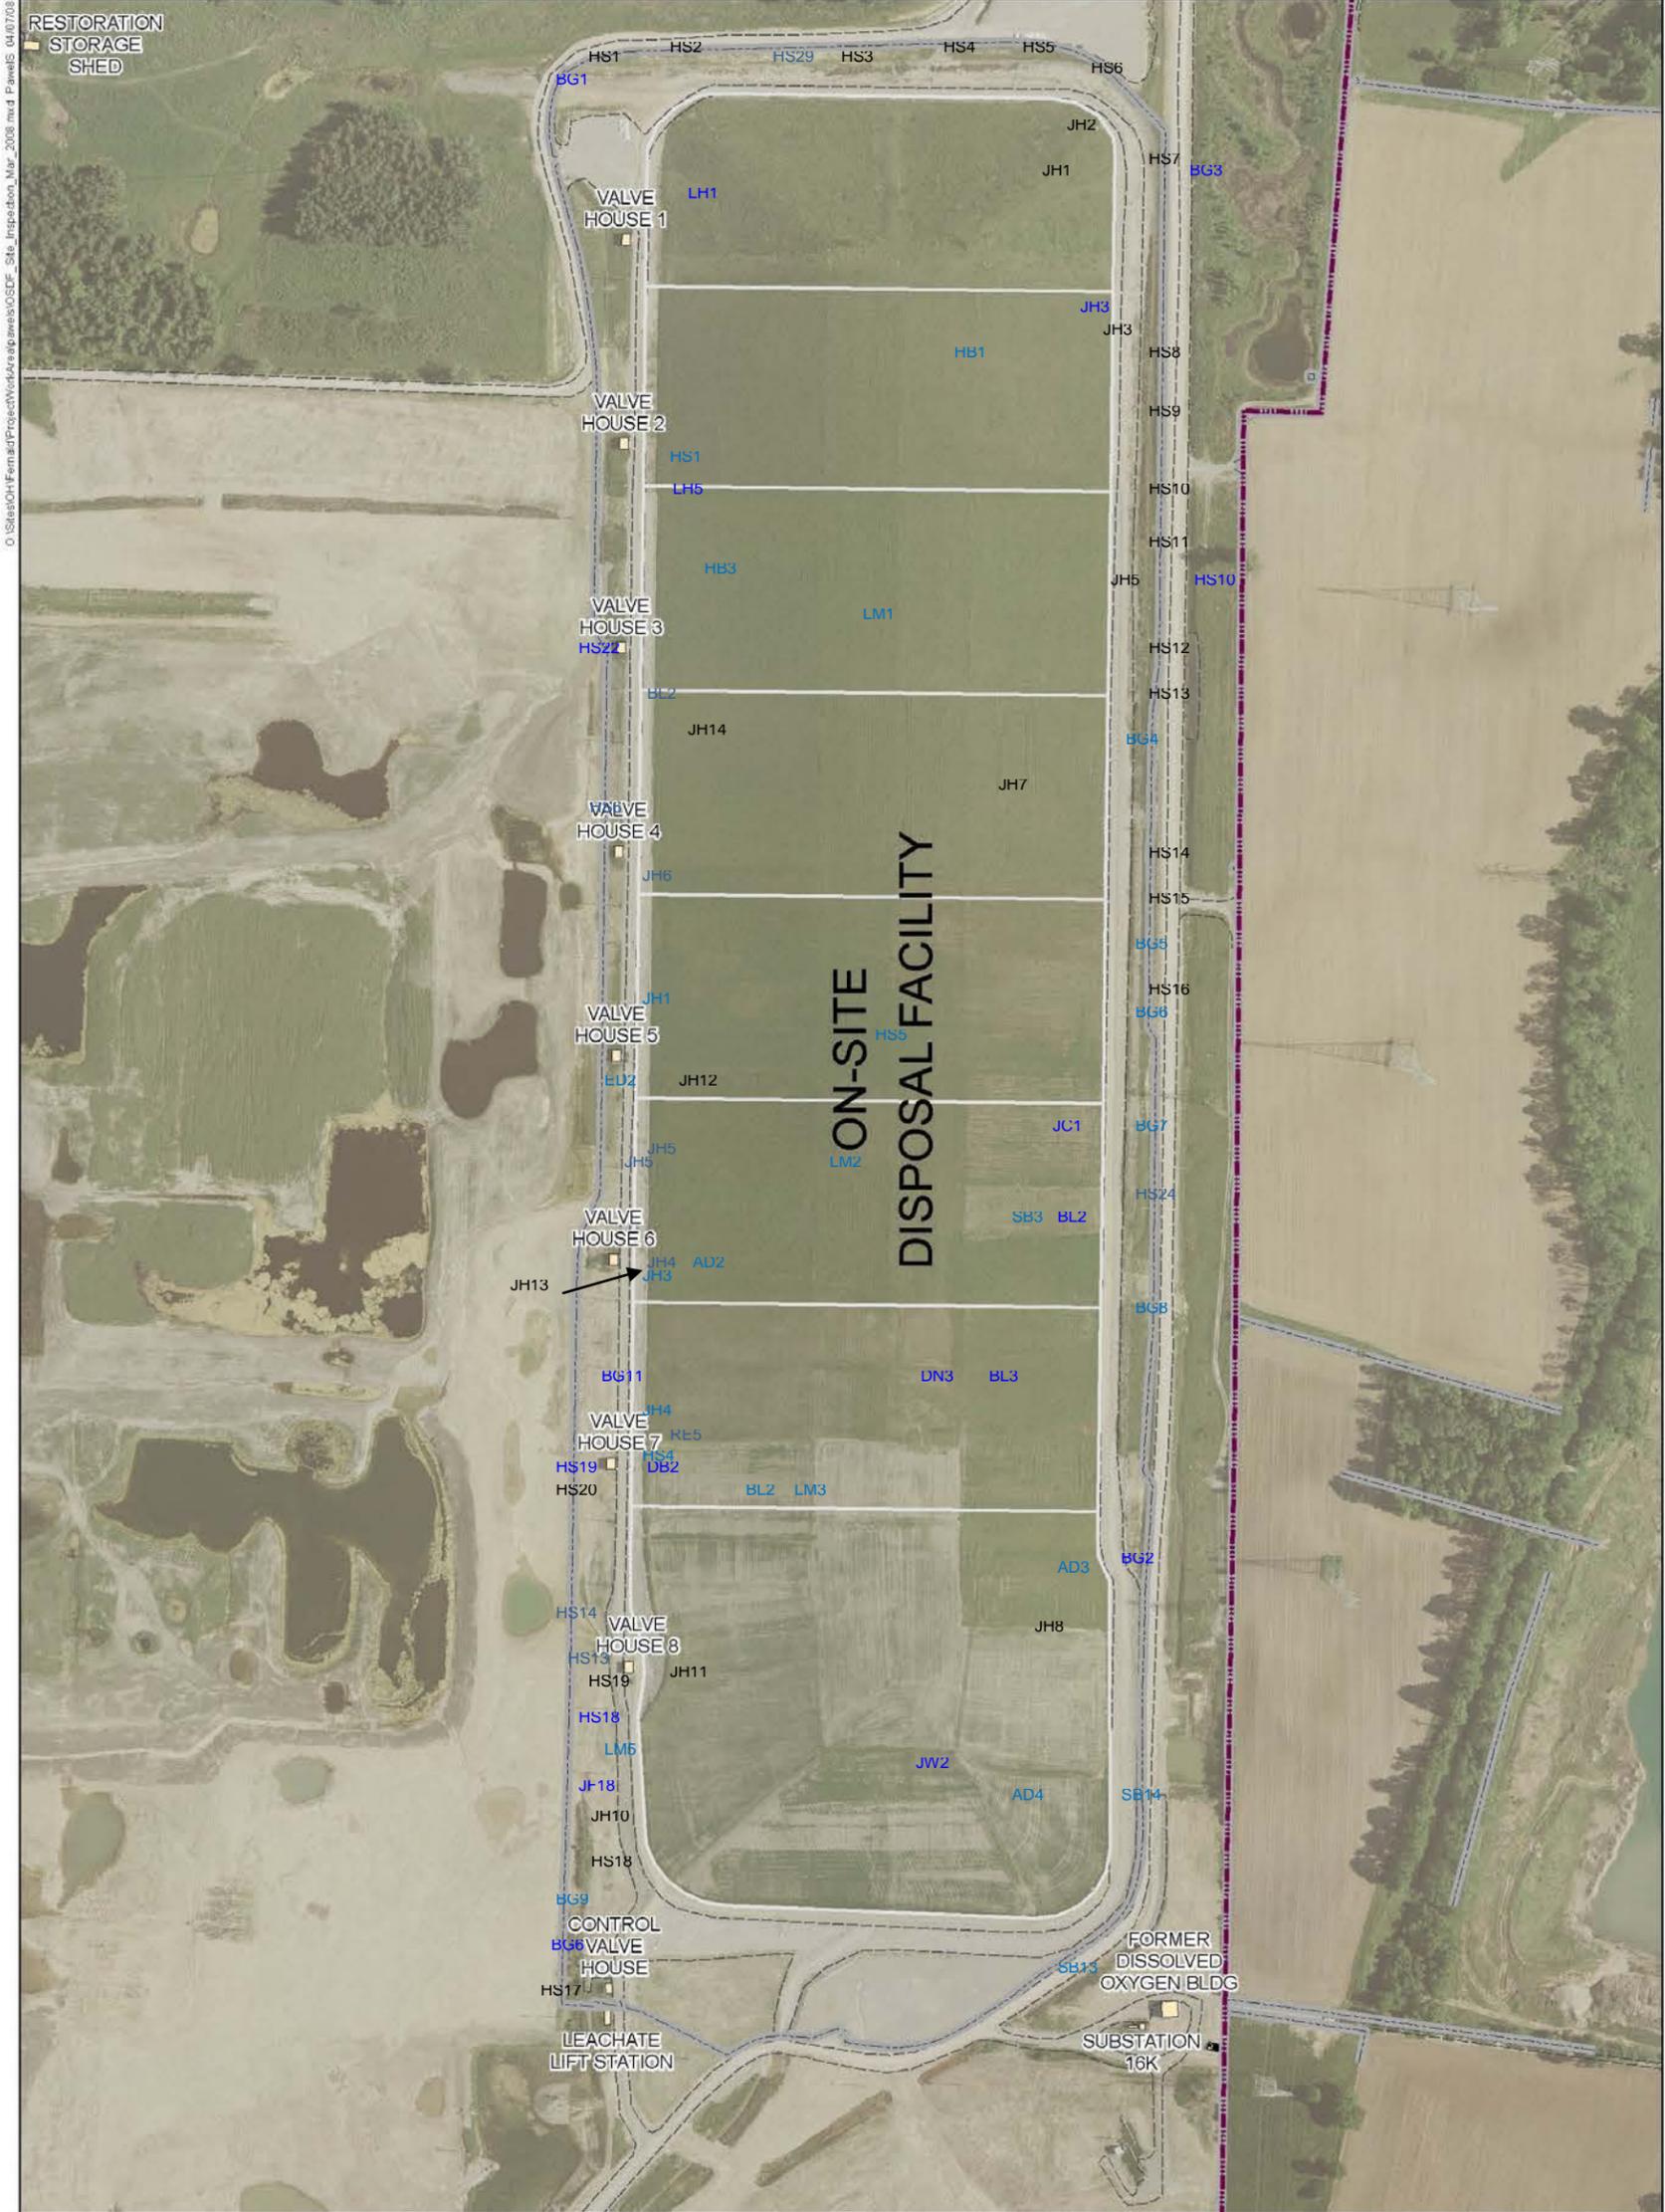
**Fernald Preserve
OSDF (On-Site Disposal Facility)
June 2013 Inspection
(Previous findings requiring follow-up or
maintenance)**

No.	Location (Use Map Whenever Possible)	GPS?	Type of Finding					Description	Photo? (File No.)	Follow Up	
			Erosion	Settlement	Vegetation	Biointrusion	Drainage			Other	Corrected
JH1	Cell 1, east 6:1				X			Crown vetch		X	
JH2	NE corner				X			Musk thistle		X	
JH3	Cell 2, drainage				X			Woody vegetation, various		X	
JH4	Cell 2, east, 6:1				X			Canada thistle and musk thistle	X		
JH5	Cell 3, drainage				X			Woody vegetation		X	
JH6	Cell 3, east 6:1				X			Crown vetch (no flag)	X		
JH7	Cell 4, east 6:1				X			Bull/musk thistle (no flag)		X	
JH8	Cell 8, east, 6:1				X			Crown vetch (no flag)		X	
JH9	SE drainage and south				X			Canada thistle (no flag)	X		
JH10	SW drainage and inner drain				X			Canada, musk, bull thistles (no flag)		X	
JH11	Cell 8, west toe				X			Crown vetch		X	
JH12	Cell 5/6, west 6:1				X			Thistle (no flag)		X	
JH13	Cell 6, west inner drain				X			Woody vegetation		X	
JH14	Cell 4, west 6:1				X			Thistle (no flag)		X

HS1	NW corner of fence				X			Honeysuckle		X	
HS2	North fence line				X			Mulberry		X	
HS3	Drainage of north fence		X					Water coming off road			X
HS4	North fence at old gate				X			Small patch both sides of fence		X	
HS5	North fence at north triangle				X			Hornbeam		X	
HS6	North fence at north triangle				X			Honeysuckle		X	
HS7	NE corner				X			Callery pear and honeysuckle		X	
HS8	Cell 2, east drain				X			Ash and willow trees		X	
HS9	Cell 2, east drain				X			Callery pear and musk thistle		X	
HS10	East Cell 2/3 boundary				X			Callery pear and musk thistle		X	
HS11	Cell 3, east drain		X					Post base exposed (previous)			X
HS12	Cell 3, east drain				X			Callery pear and honeysuckle		X	
HS13	East Cell 3-4 boundary				X			Thistle, honeysuckle, pear, mulberry		X	
HS14	Cell 4, east				X			Honeysuckle		X	
HS15	East Cell 4/5 boundary				X			Musk and bull thistle		X	
HS16	Cell 5, east drain				X			Honeysuckle and willow		X

HS17	SW corner drain				X			Woody trees and shrubs		X	
HS18	Cell 8, west outer drain				X			Bull thistle		X	
HS19	West of VH8				X			Bull thistle		X	
HS20	West of VH7				X			Bull thistle and honeysuckle		X
