SUBJECT: Transmittal of the September 2015 Fernald Quarterly Inspection Report

Fernald Preserve OSDF Walkdown Inspection Report

Fernald Preserve
 OSDF Inspection Findings
 Date: Sept 2 and 3, 2015

FERNALD PRESERVE
On-Site Disposal Facility
Inspection Report
September 2015

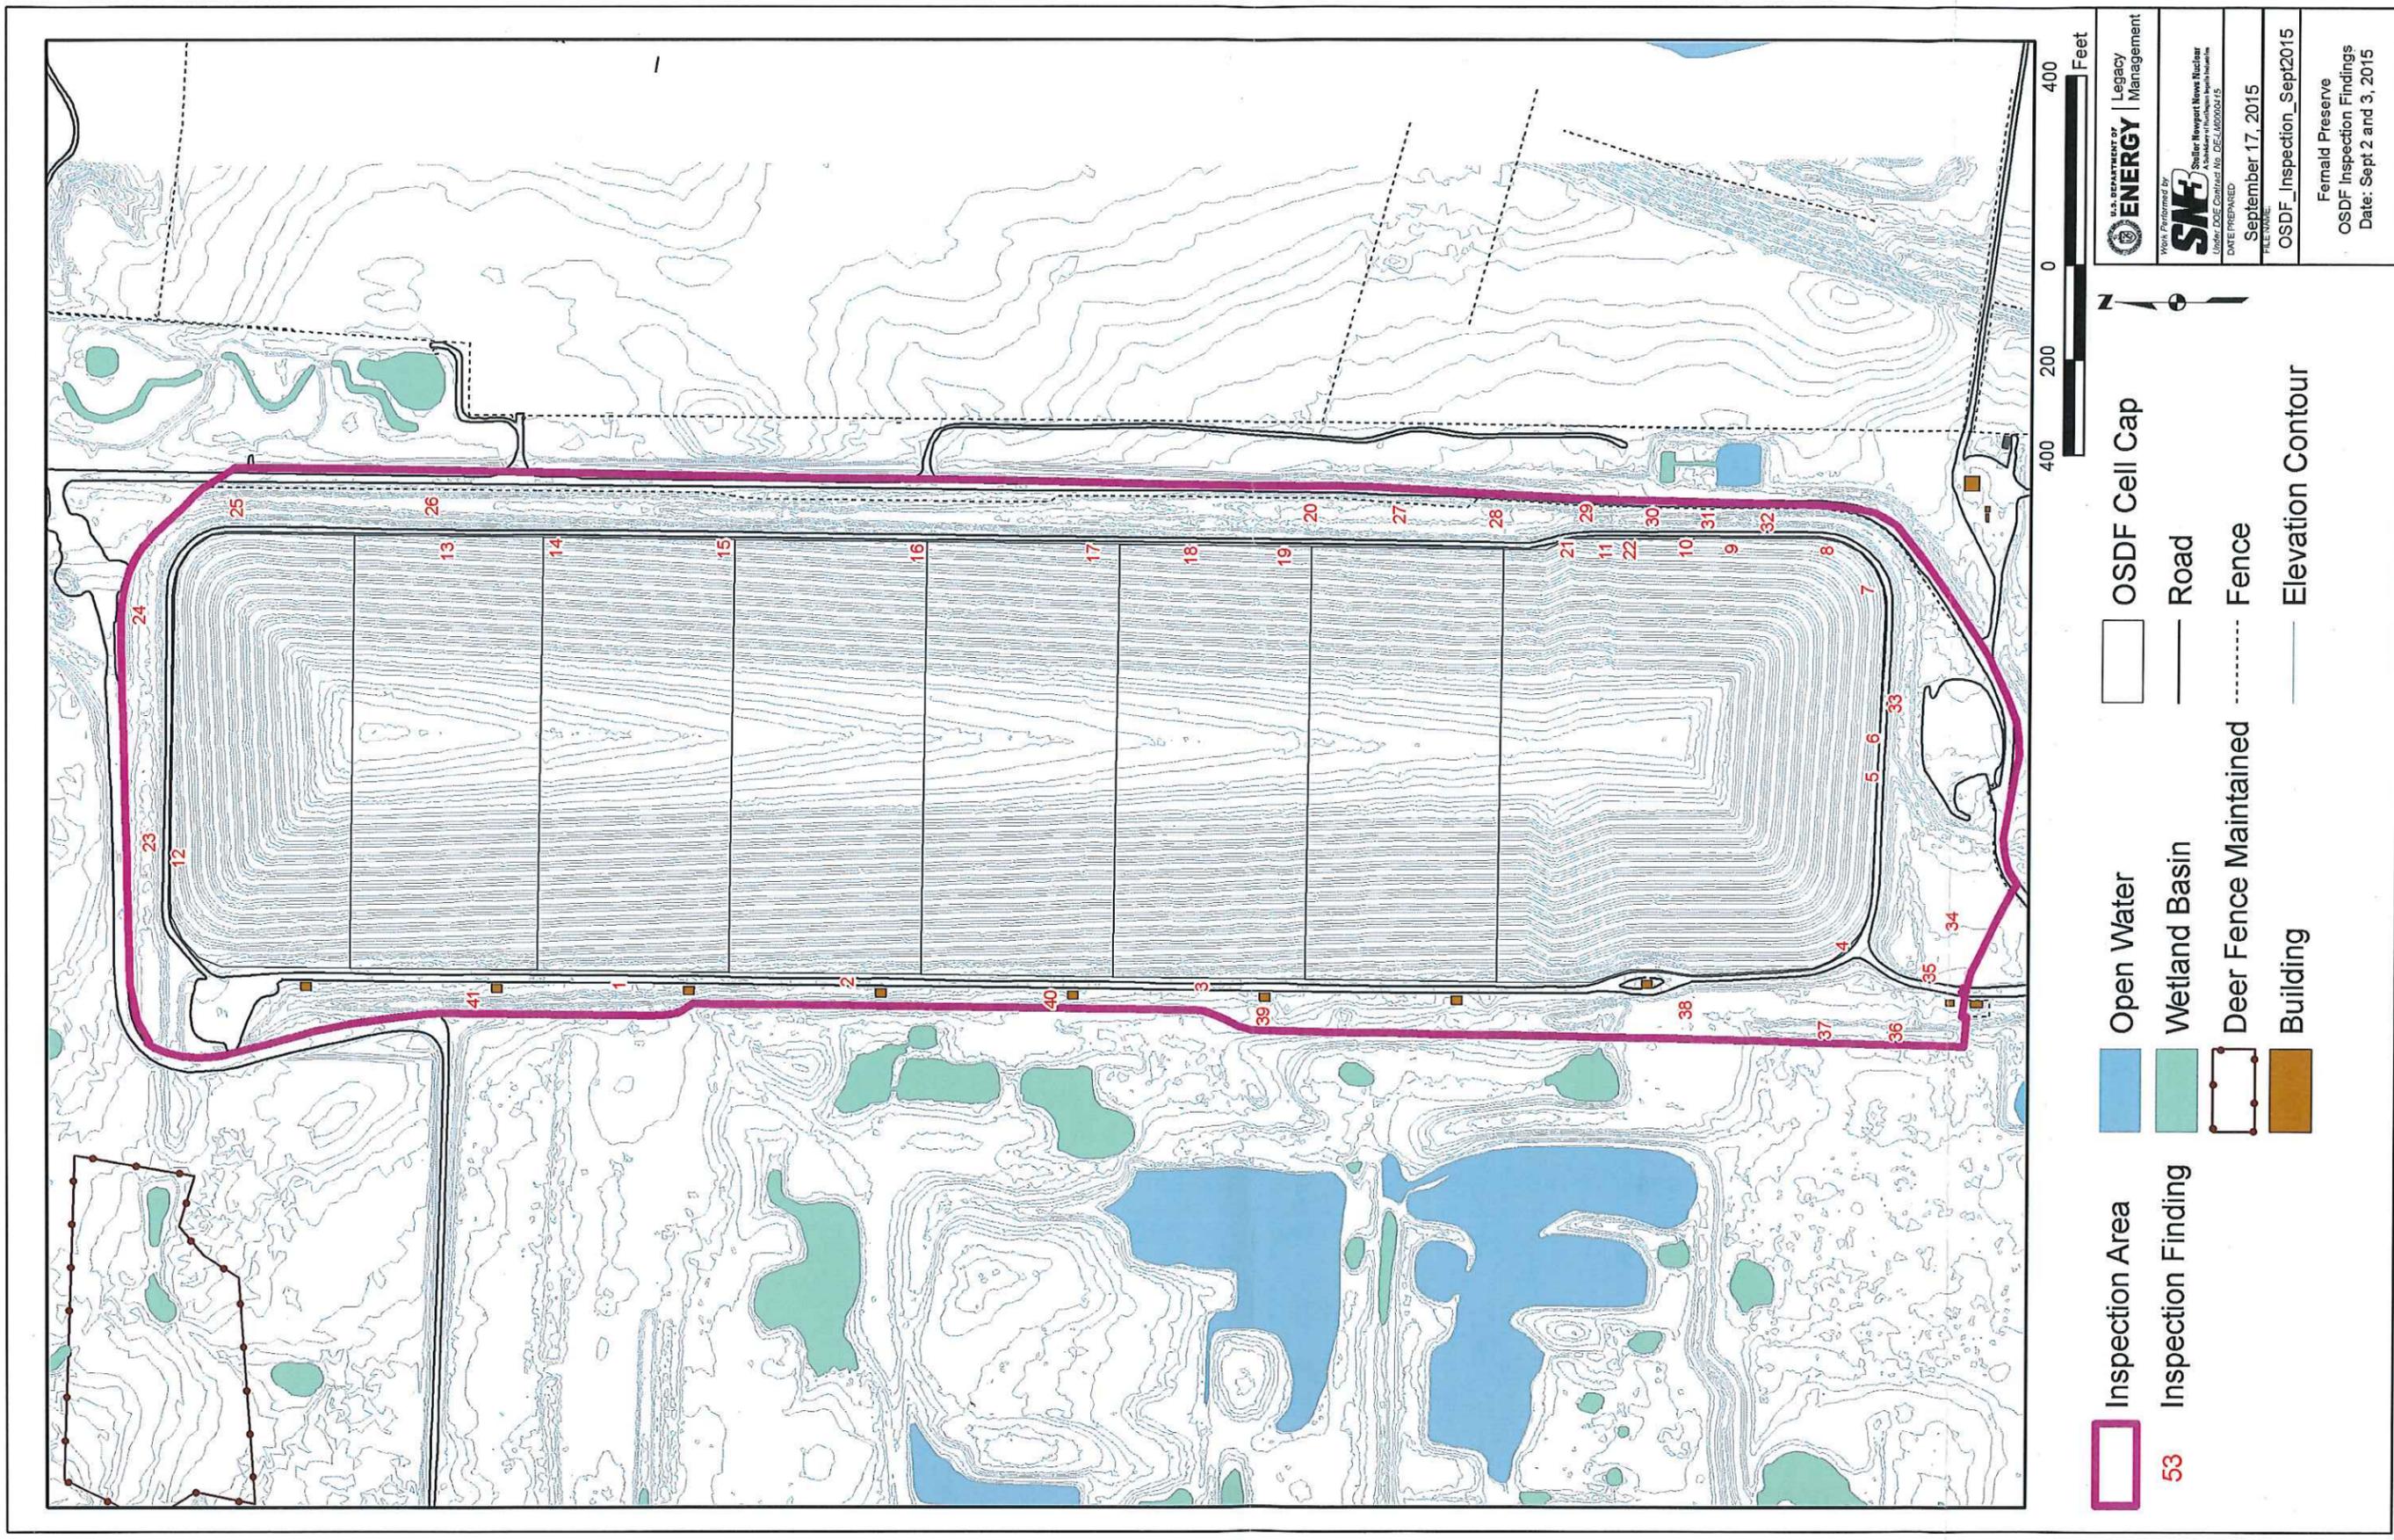
OSDF Inspection, September 2015

Map No.	Location	GPS?	Type of Finding	Description	Photo? (File No.)
1	North of VH3 along access road	No	Vegetation	Elm tree	
2	North of valve house 4 along access road	No	Vegetation	Grape vine	
3	North of VH 6 at raptor pole along access road	No	Vegetation	Grape vine, callery pear, poison ivy, hackberry	
4	Southwest corner of cell 8 toe of slope	No	Vegetation	Honeysuckle and blackcherry	
5	South toe of cell 8 near midpoint.	No	Vegetation	Honeysuckle	
6	South toe of cell 8 near midpoint	No	Vegetation	honeysuckle	
7	Southeast corner of cell 8 toe of slope	No	Vegetation	Mulberry, hackberry, honeysuckle	
8	Southeast corner of cell 8 at toe of slope	No	Vegetation	Hackberry	
9	East toe of cell 8, near midpoint	No	Vegetation	Woody vegetation	
10	East toe of Cell 8 near midpoint	No	Vegetation	poison ivy	
11	East toe of cell 8	No	Vegetation	Grape vine	
12	North toe of cell 1	No	Vegetation	woody vegetation (OST VIR)

13	East toe of cell 2 near midpoint	No	Vegetation	honeysuckle

Map No.	Location	GPS?	Type of Finding	Description	Photo? (File No.)
14	East toe of cell 3 near cell 2/3 boundary	No	Vegetation	Canada thistle	
15	East toe of cell 3 near cell 3/4 boundary	No	Vegetation	Canada thistle	
16	east toe of cell 4 near cell 4/5 boundary	No	Vegetation	dogwood and honeysuckle	
17	East toe of cell 5	No	Vegetation	Honeysuckle	
18	East toe of cell 6	No	Vegetation	Cherry tree	
19	East toe of cell 6	No	Vegetation	Honeysuckle	
20	East drain at cell 6/7 boundary	No	Vegetation	cottonwood tree	
21	East toe of cell 8	No	Vegetation	Grape vine	
22	East toe of cell 8	No	Vegetation	Honeysuckle	
23	North drainage	No	Vegetation	willow	
24	North drain	No	Vegetation	Pear tree	
25	East drain at Cell 1	No	Vegetation	woody vegetation on rip rap slope	
26	East drain at cell 2	No	Vegetation	Willow in cattails	
27	East drain at cell 7	No	Vegetation	Pear tree	
28	East drain at cell 7/8 boundary	No	Vegetation	Honeysuckle

29	East drain at cell 8	No	Vegetation	Pear tree	
30	East drain at cell 8	No	Vegetation	grape vine	
31	East drain at cell 8	No	Vegetation	Honeysuckle	
32	East perimeter fence at cell 8	No	Fencing	Hole under fence

Map No.	Location	GPS?	Type of Finding	Description	Photo? (File No.)
33	South drain	No	Vegetation	Cottonwood	
34	Field by south gate	No	Vegetation	Thistle	
35	Along south entrance road at west end of south drain	No	Vegetation	Honeysuckle	
36	West drain at southwest corner of cell 8	No	Vegetation	Varous woody vegetation	
37	West fence at cell 8	No	Vegetation	Honeysuckle growing into fence	
38	West drain at cell 8	No	Vegetation	Teasel	
39	West drain behind VH 6 at fence	No	Vegetation	Green ash	
40	West drain at cell 5	No	Vegetation	Honeysuckle and pear	
41	West drain at cell 2	No	Vegetation	Honeysuckle
