SUBJECT: Transmittal of the June 2016 Fernald Quarterly Inspection Report

Fernald Preserve
 OSDF Inspection
 June 2016

FERNALD PRESERVE

Inspection Photographs

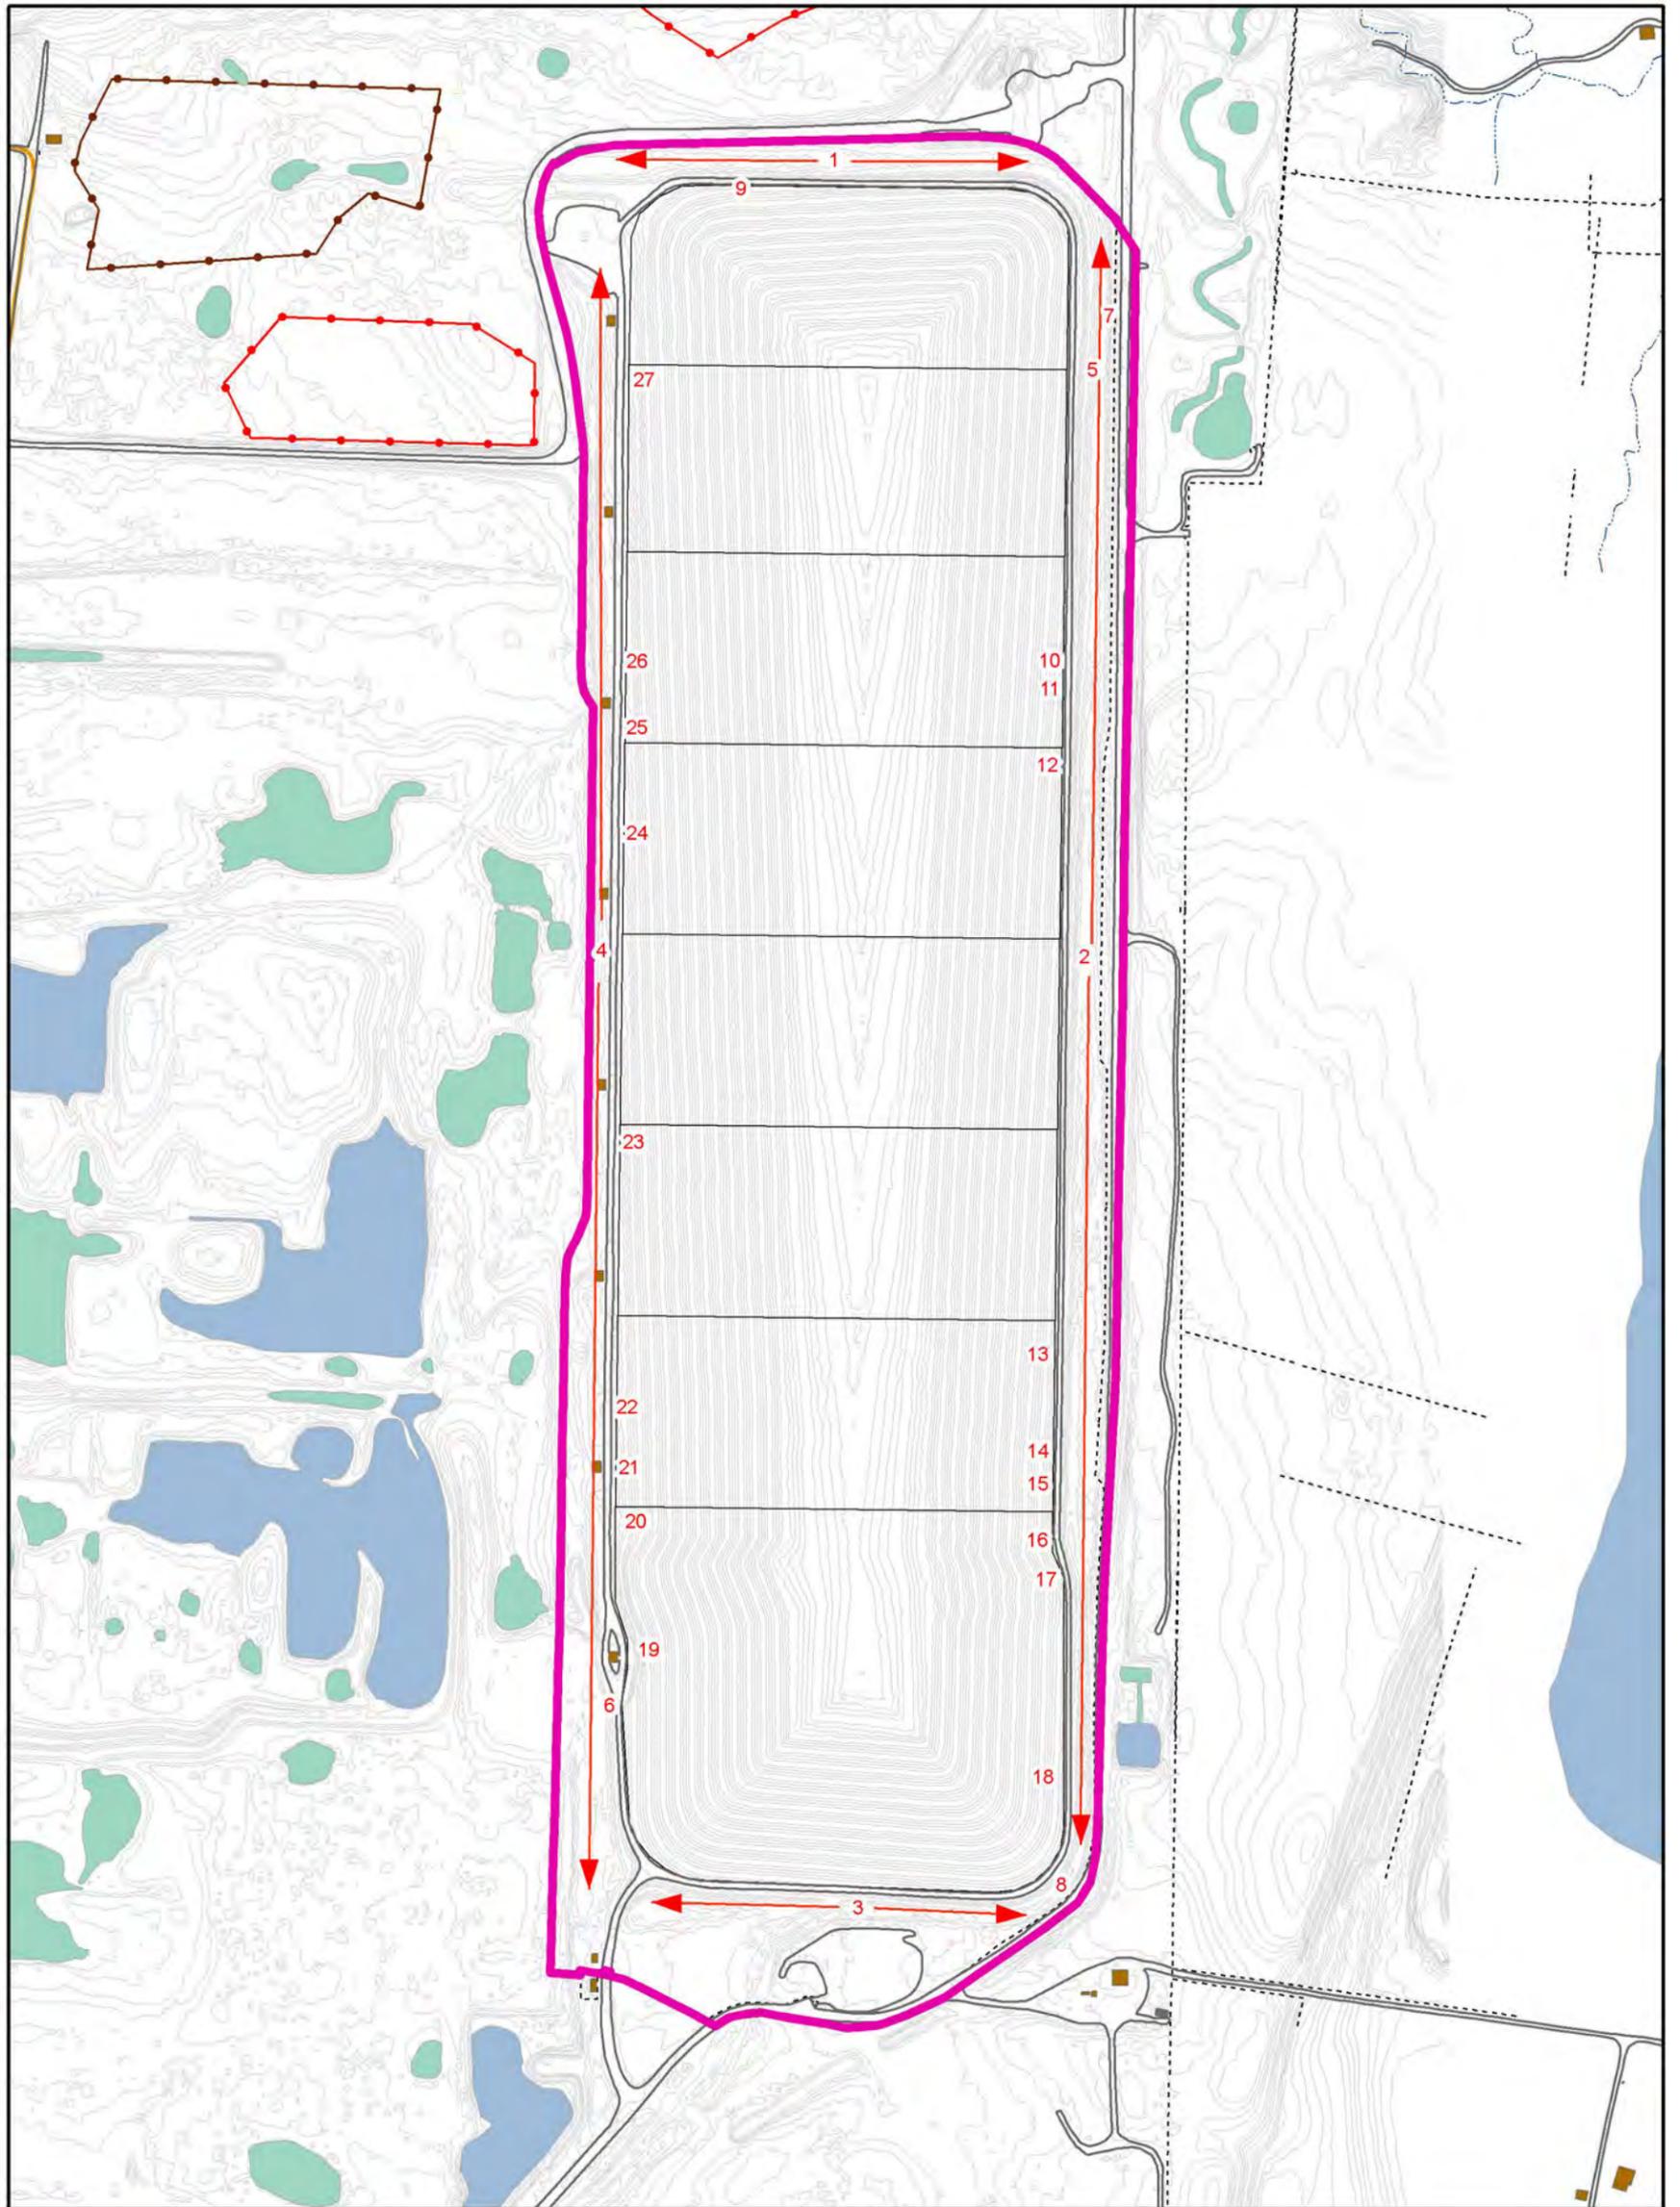
OSDF Inspection Findings - June 2016

Map No.	Location	GPS?	Type of Finding	Description	Photo? (File No.)
1	North drainage	No	Vegetation	Woody vegetation throughout the length of the north drainage	
2	East drainage	No	Vegetation	Woody vegetation throughout the length of the east drainage	
3	South drainage	No	Vegetation	Woody vegetation throughout the length of the south drainage	
4	West drainage	No	Vegetation	Woody vegetation throughout the length of the west drainage	
5	Cell 1/2 boundary, east drainage in riprap	No	Vegetation	Teasel patch growing in riprap	
6	Cell 8, on west edge of road at southwest corner	No	Vegetation	Teasel patch growing in riprap	
7	Cell 1, east fenceline	No	Biointrusion	Animal burrow under the fence	
8	Southeast corner in riprap along fenceline	No	Vegetation	Crown vetch	
9	Cell 1, north toe	No	Vegetation	Multiflora rose	
10	Cell 3, east toe	No	Vegetation	Callery pear	
11	Cell 3, east toe	No	Vegetation	Callery pear

Map No.	Location	GPS?	Type of Finding	Description	Photo? (File No.)
12	Cell 4, east toe	No	Vegetation	Callery pear	
13	Cell 7, east toe	No	Vegetation	Honeysuckle (3)	
14	Cell 7, east toe	No	Vegetation	Honeysuckle	
15	Cell 7, east toe	No	Vegetation	Honeysuckle	
16	Cell 8, east toe	No	Vegetation	Honeysuckle	
17	Cell 8, east toe	No	Vegetation	Thistle and honeysuckle	
18	Cell 8, east toe	No	Vegetation	Hackberry and honeysuckle	
19	Cell 8, west toe	No	Vegetation	Cedar tree in riprap	
20	Cell 8, in riprap near valve house	No	Vegetation	Various woody vegetation in riprap	
21	Cell 7, west toe	No	Vegetation	Various woody vegetation in riprap	
22	Cell 7, west toe	No	Vegetation	Woody vegetation	
23	Cell 6, west toe in riprap	No	Vegetation	Woody vegetation	
24	Cell 4, west toe	No	Vegetation	Woody vegetation	
25	Cell 3, west toe	No	Vegetation	Woody vegetation	
26	Cell 3, west toe	No	Vegetation	Woody vegetation	
27	Cell 1/2 boundary, west toe	No	Vegetation	Woody vegetation

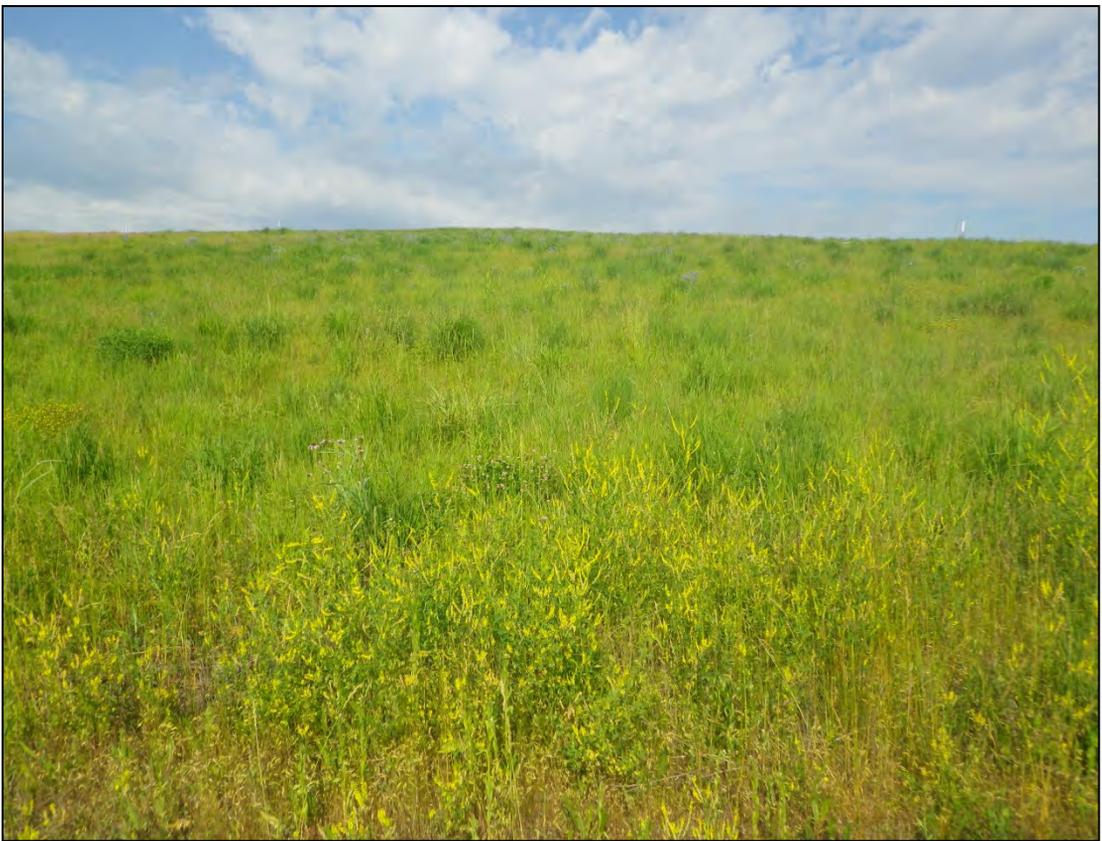
IMGP5404

East Face Cell 1

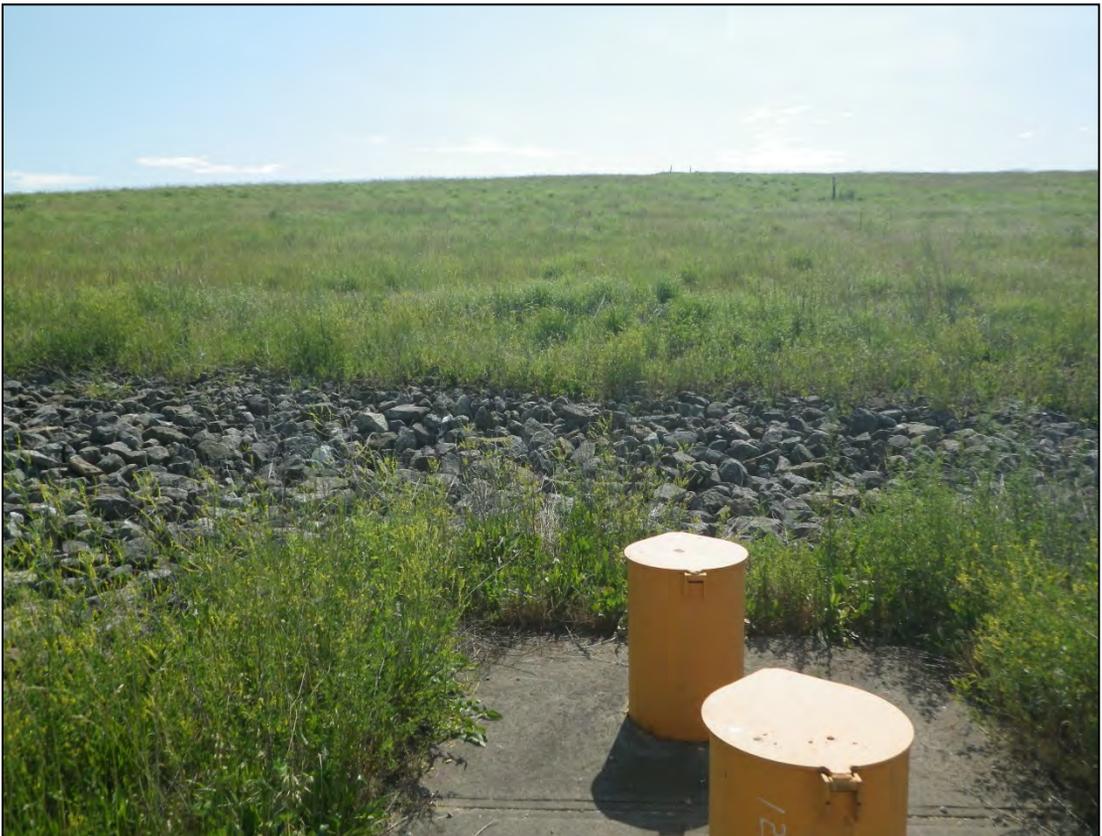
IMGP5429

West Face Cell 1

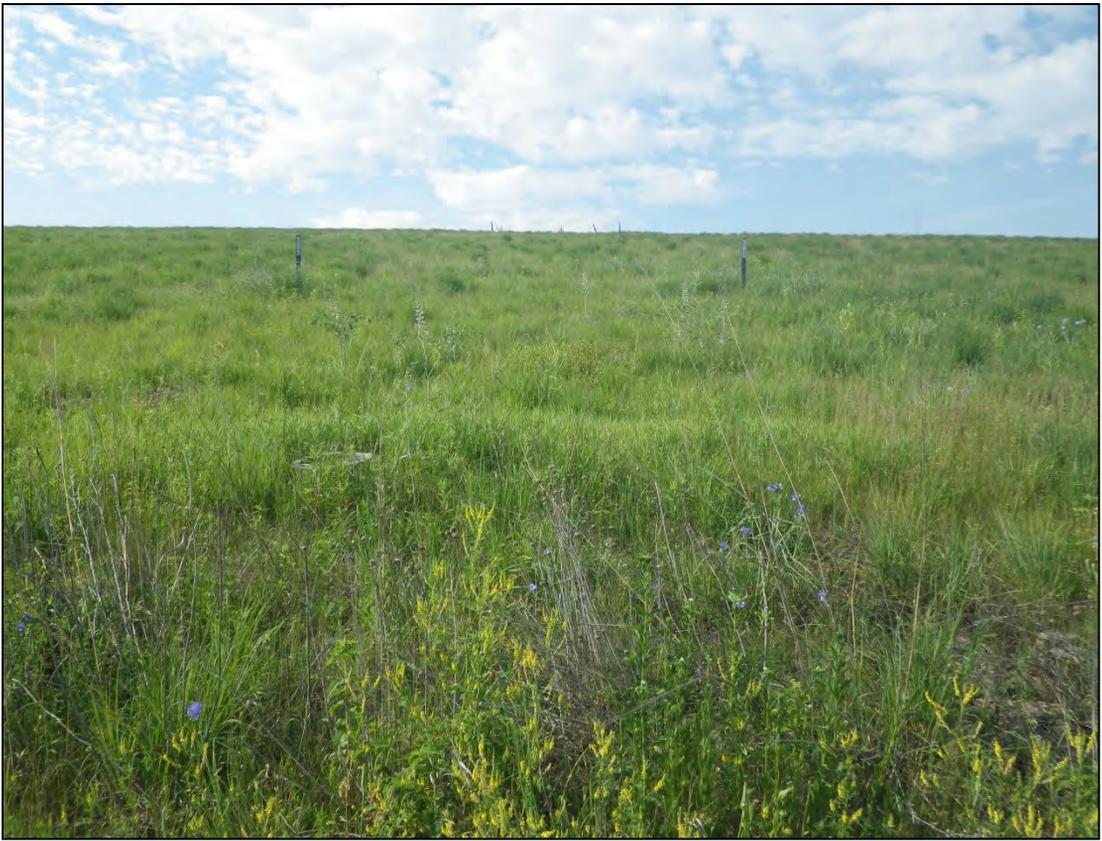
IMGP5402

North Face Cell 1

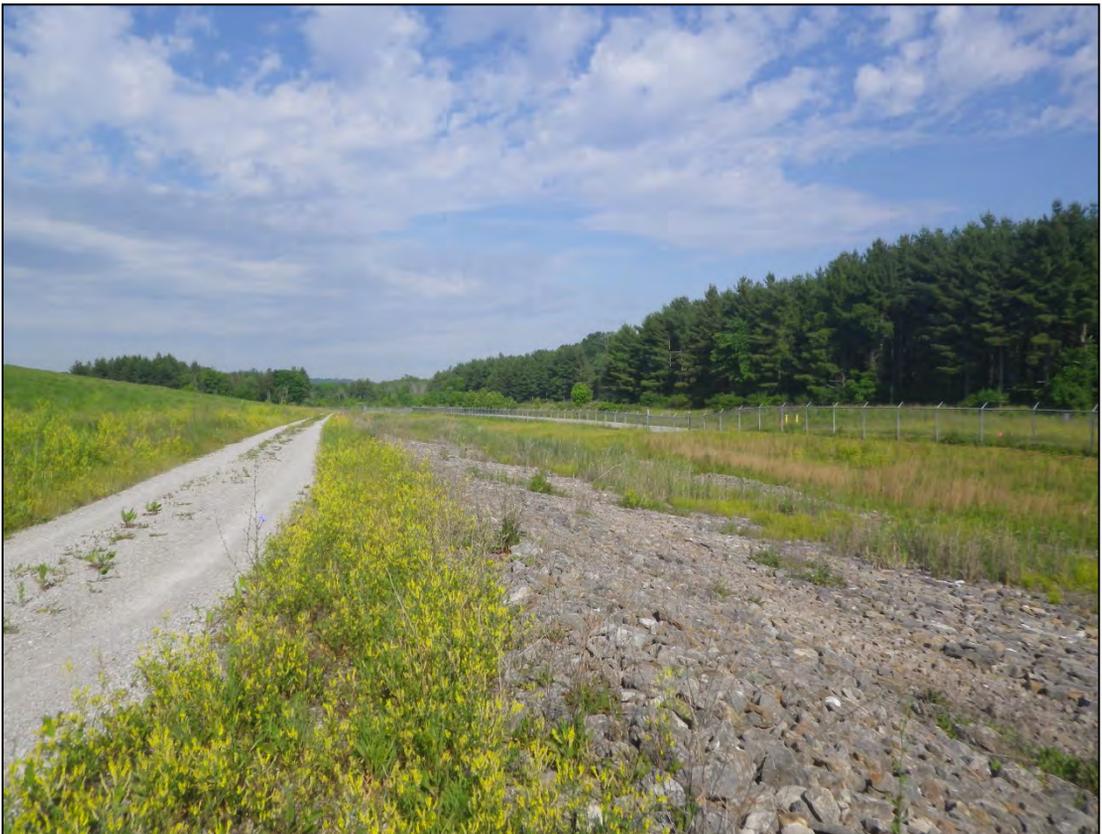
IMGP5403

North Drainage (looking west)

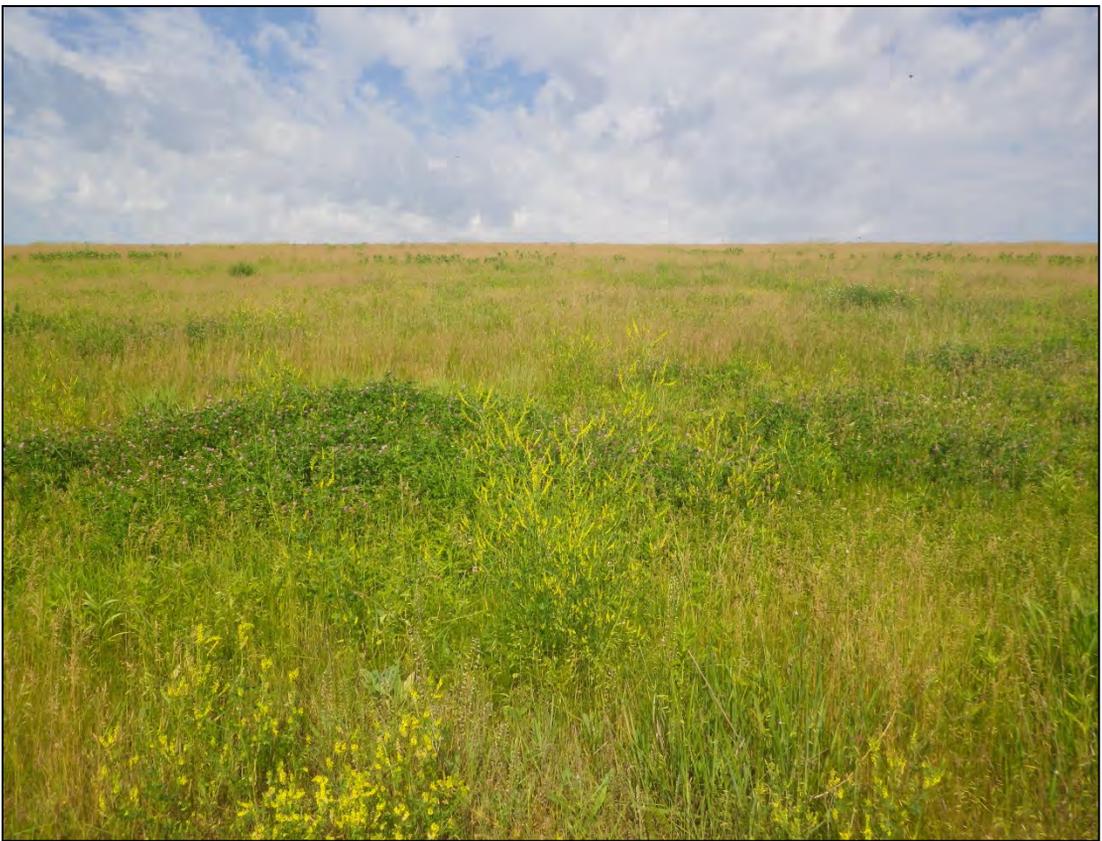
IMGP5406

East Face Cell 2

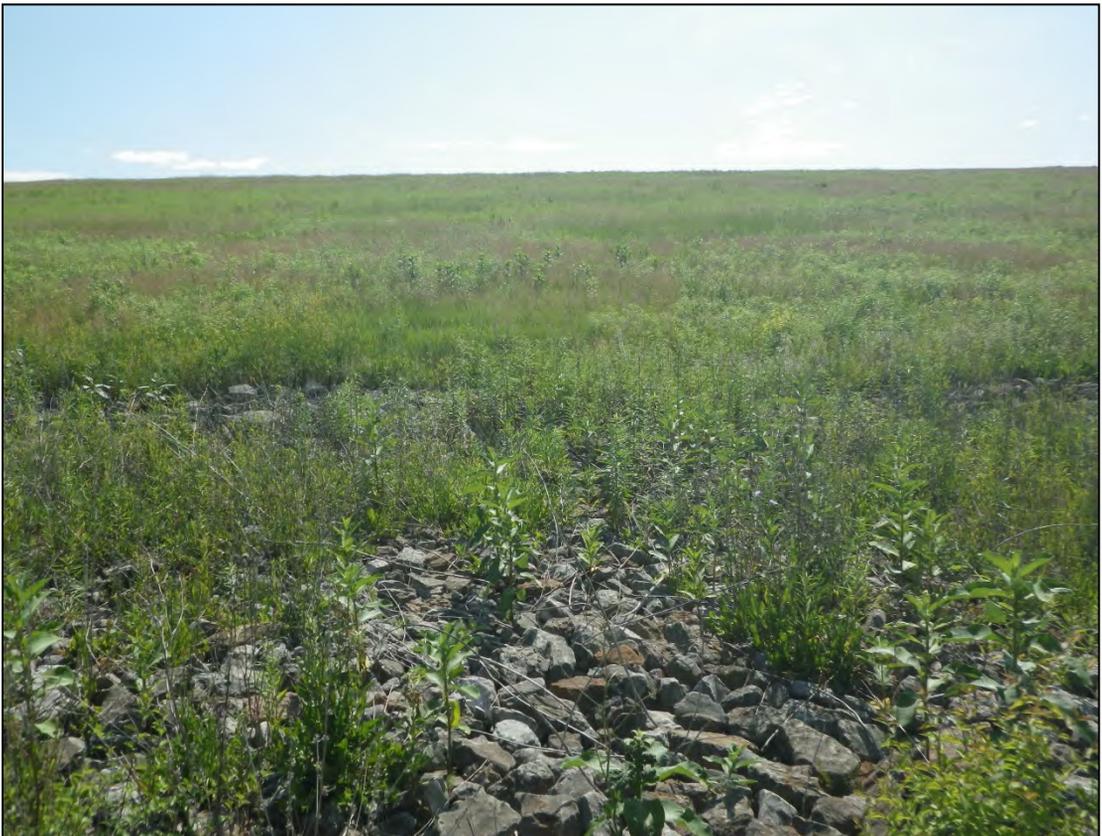
IMGP5428

West Face Cell 2

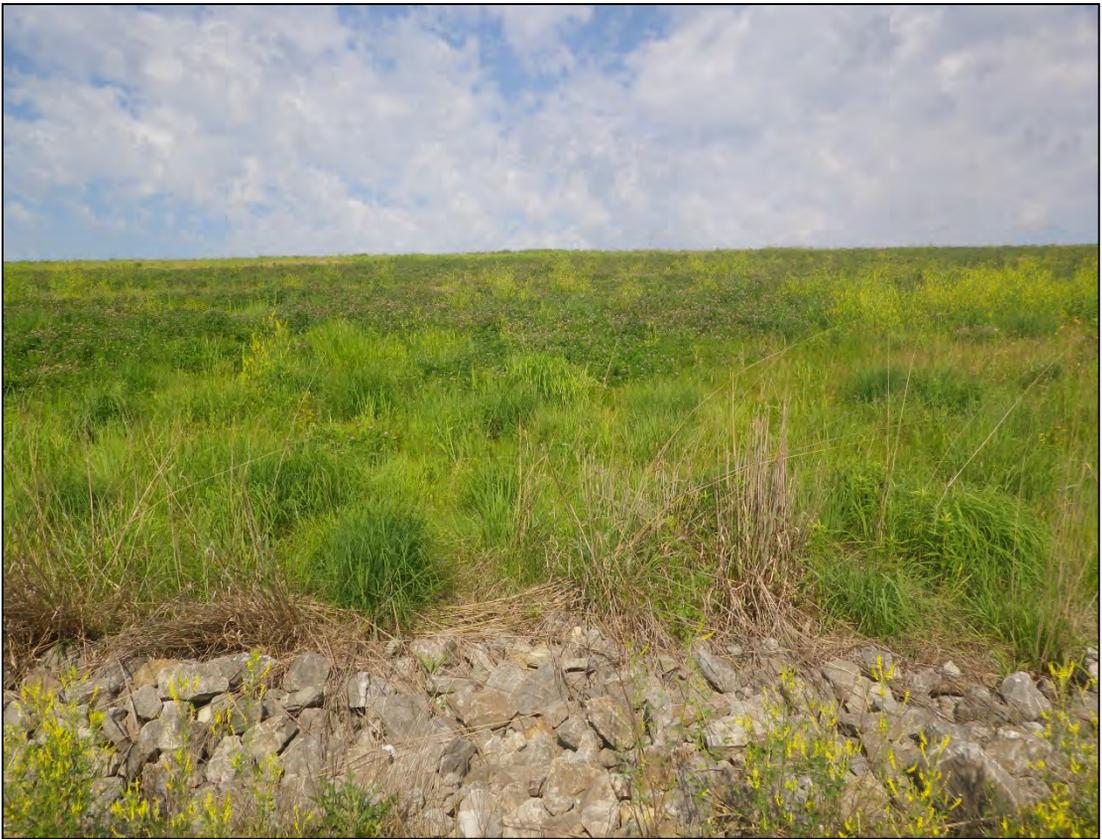
IMGP5407

East Face Cell 3

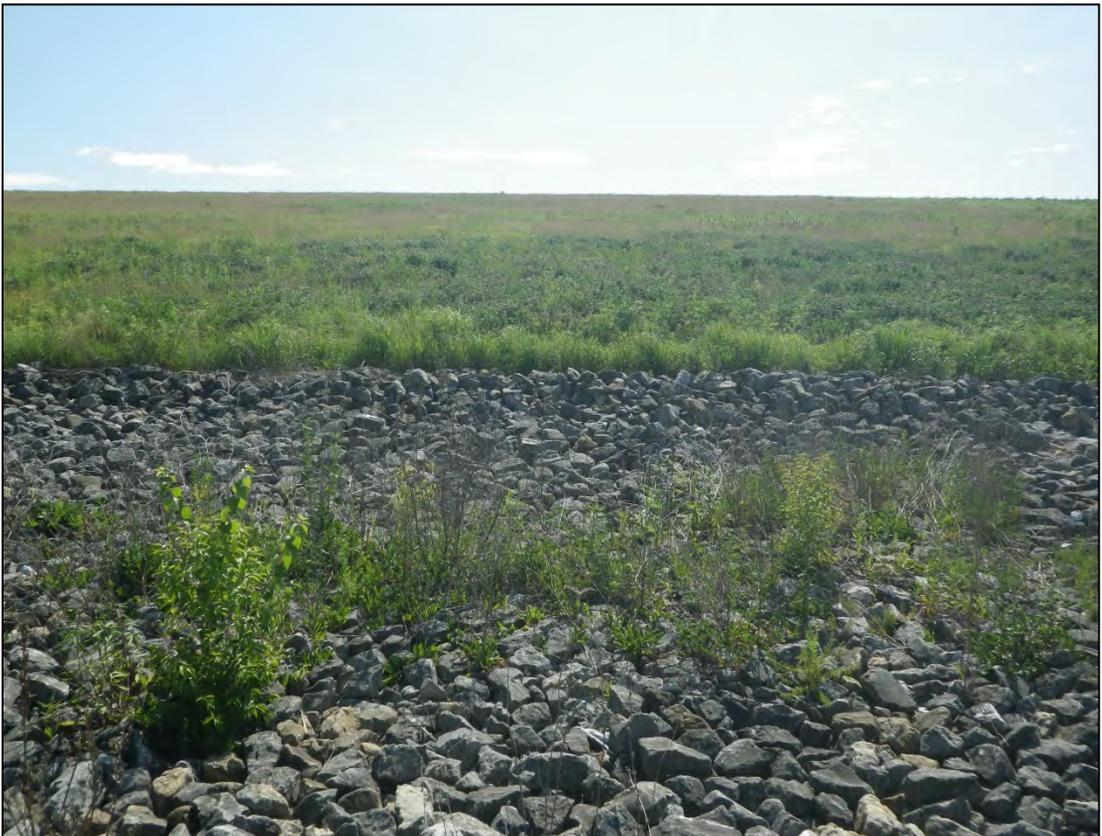
IMGP5427

West Face Cell 3

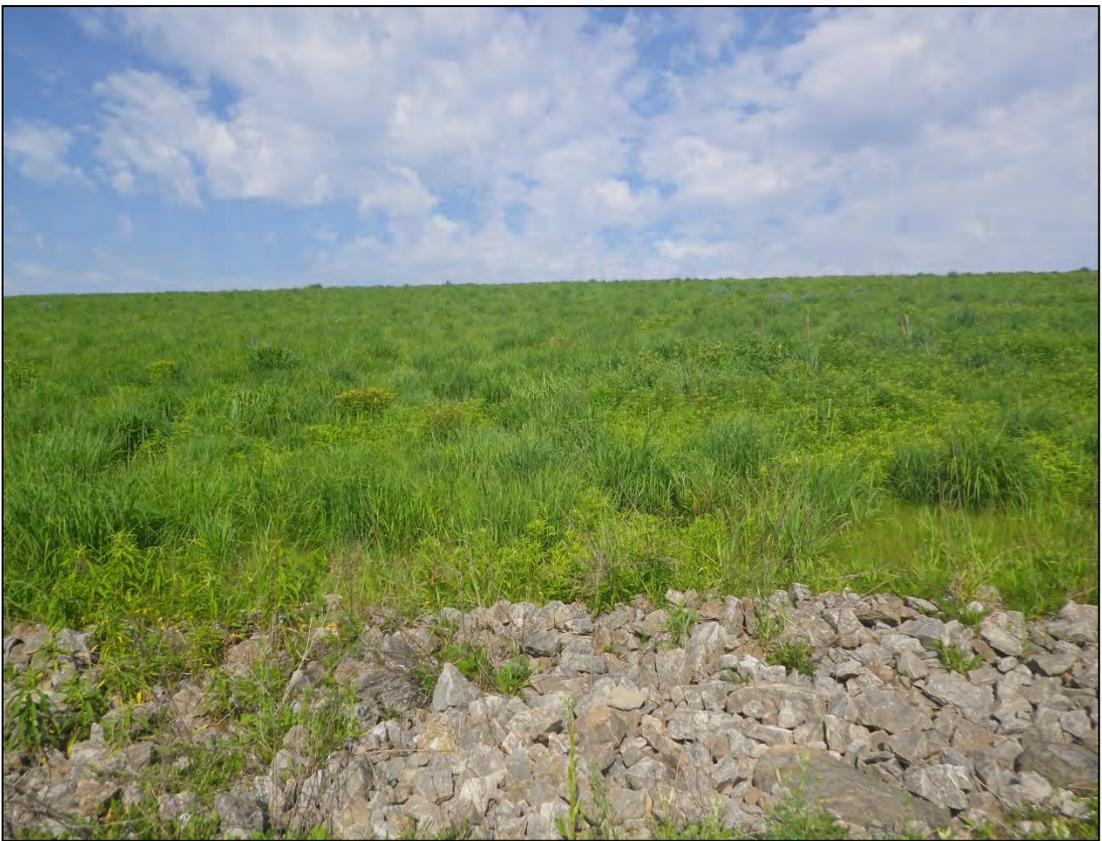
IMGP5408

East Face Cell 4

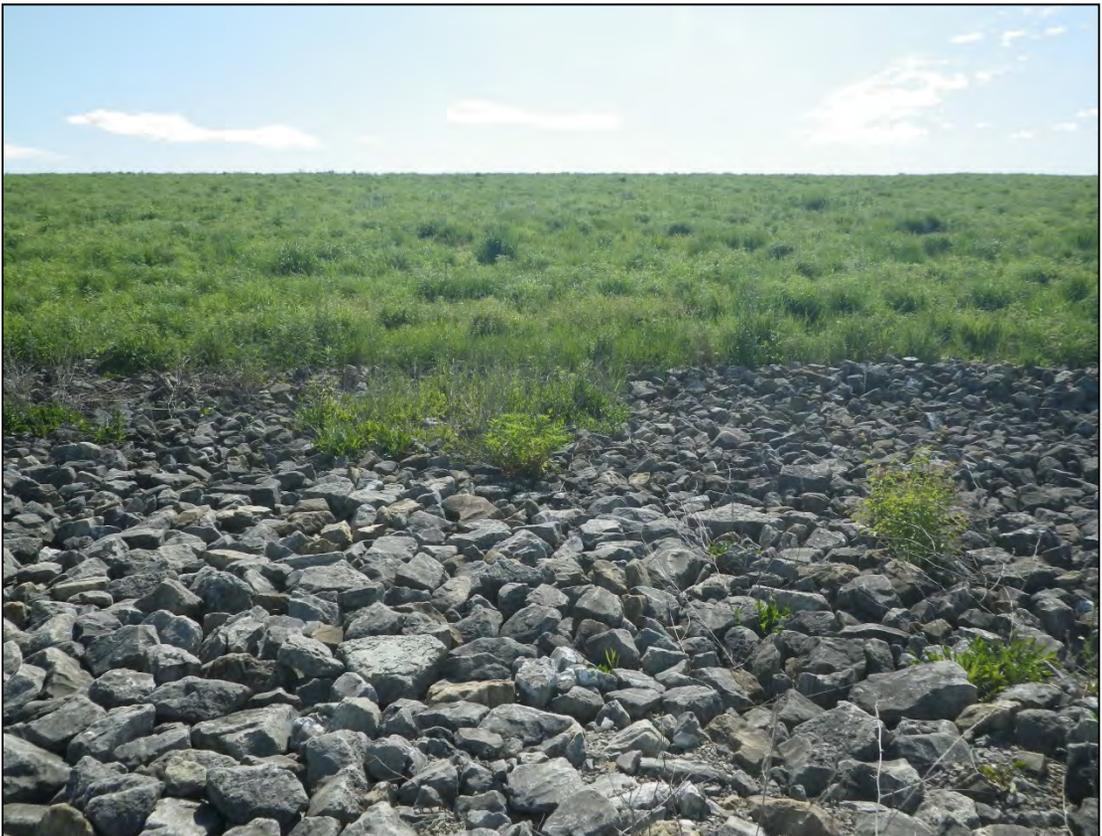
IMGP5425

West Face Cell 4

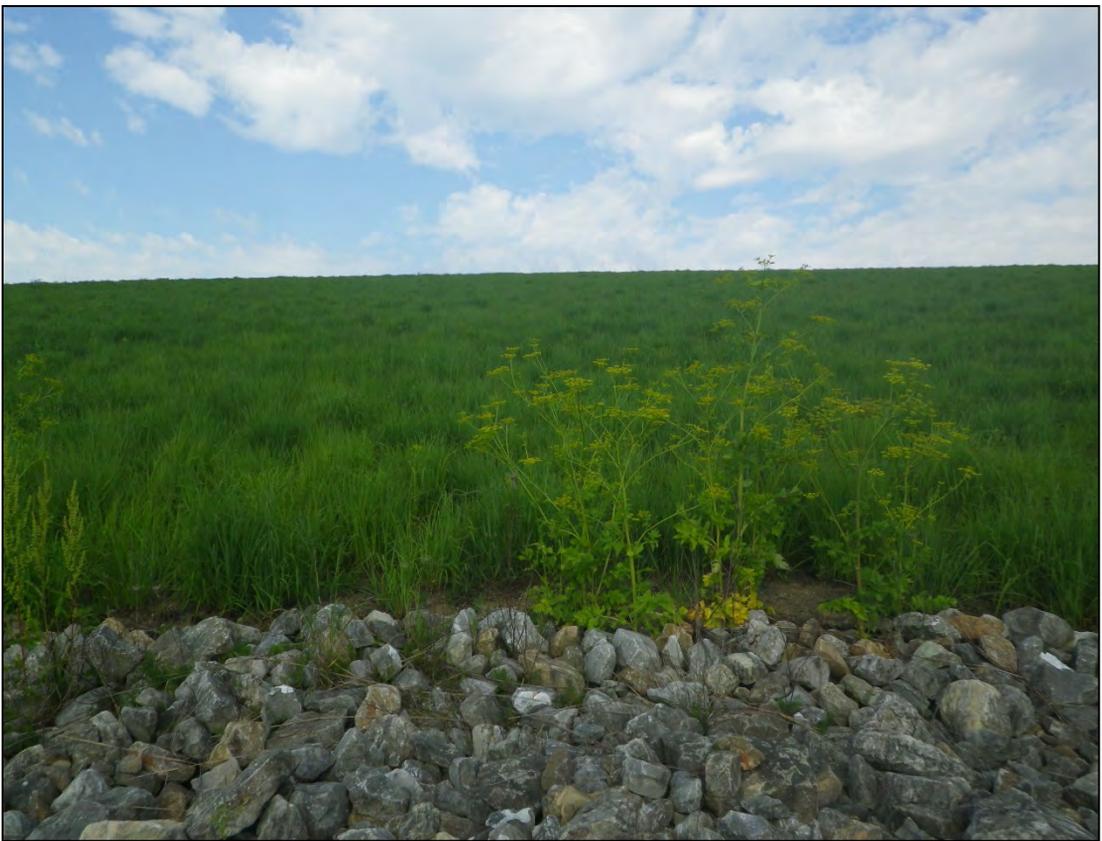
IMGP5410

East Face Cell 5

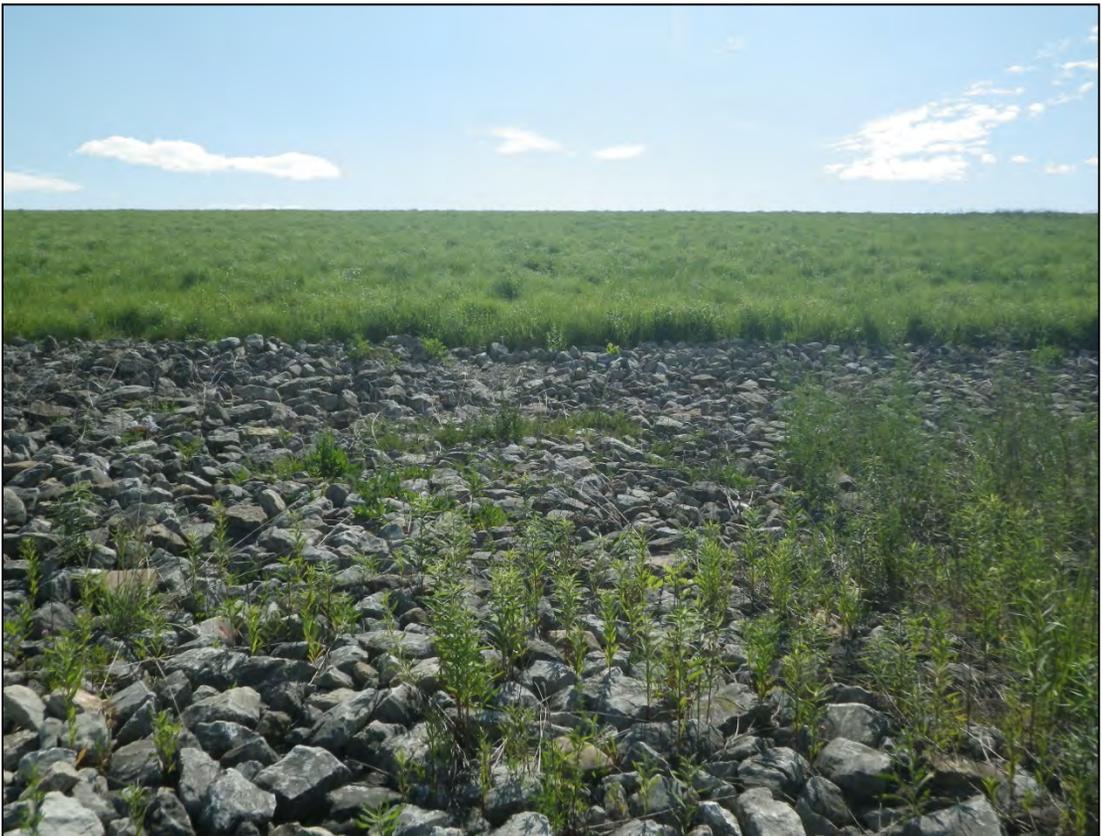
IMGP5424

West Face Cell 5

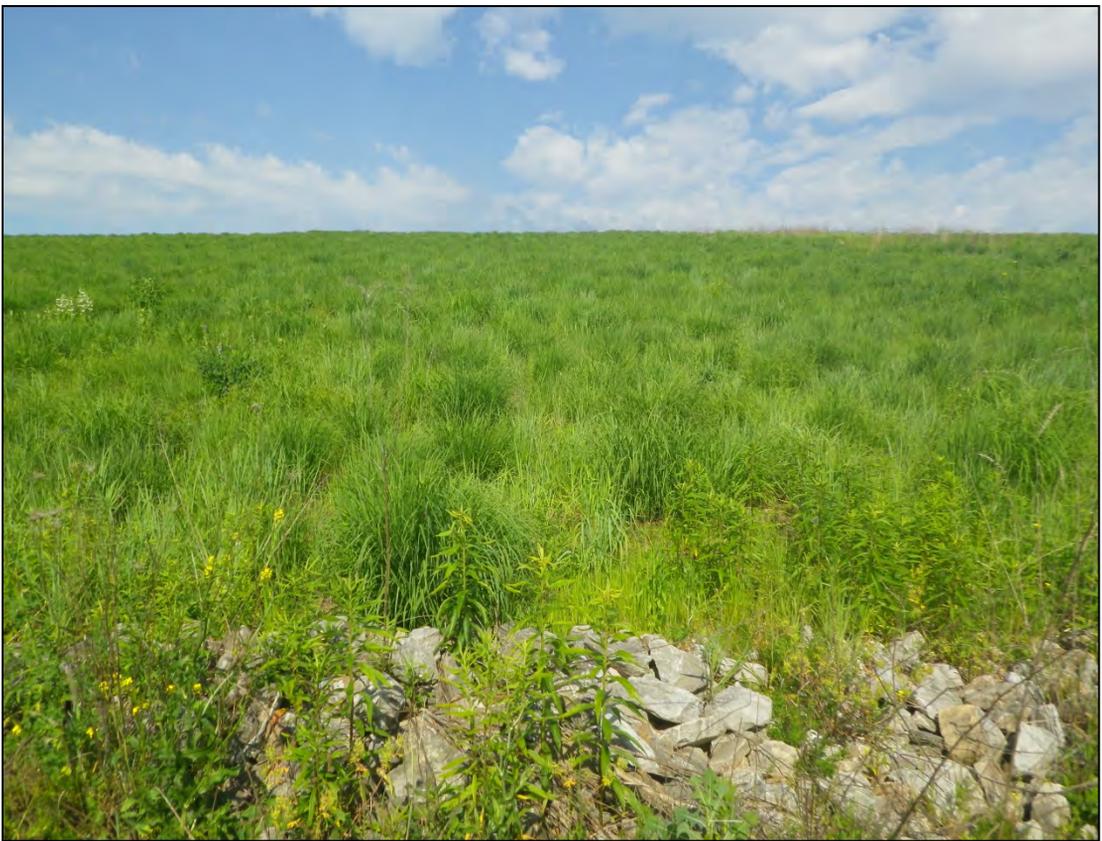
IMGP5411

East Face Cell 6

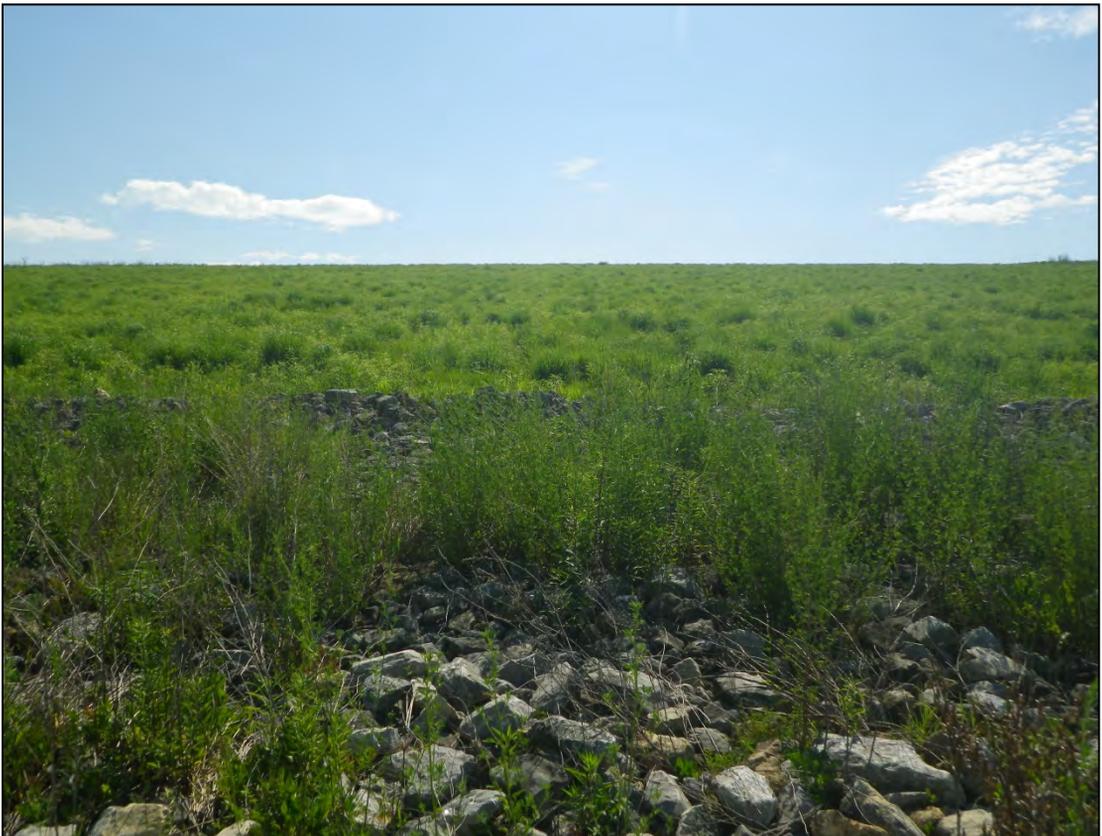
IMGP5423

West Face Cell 6

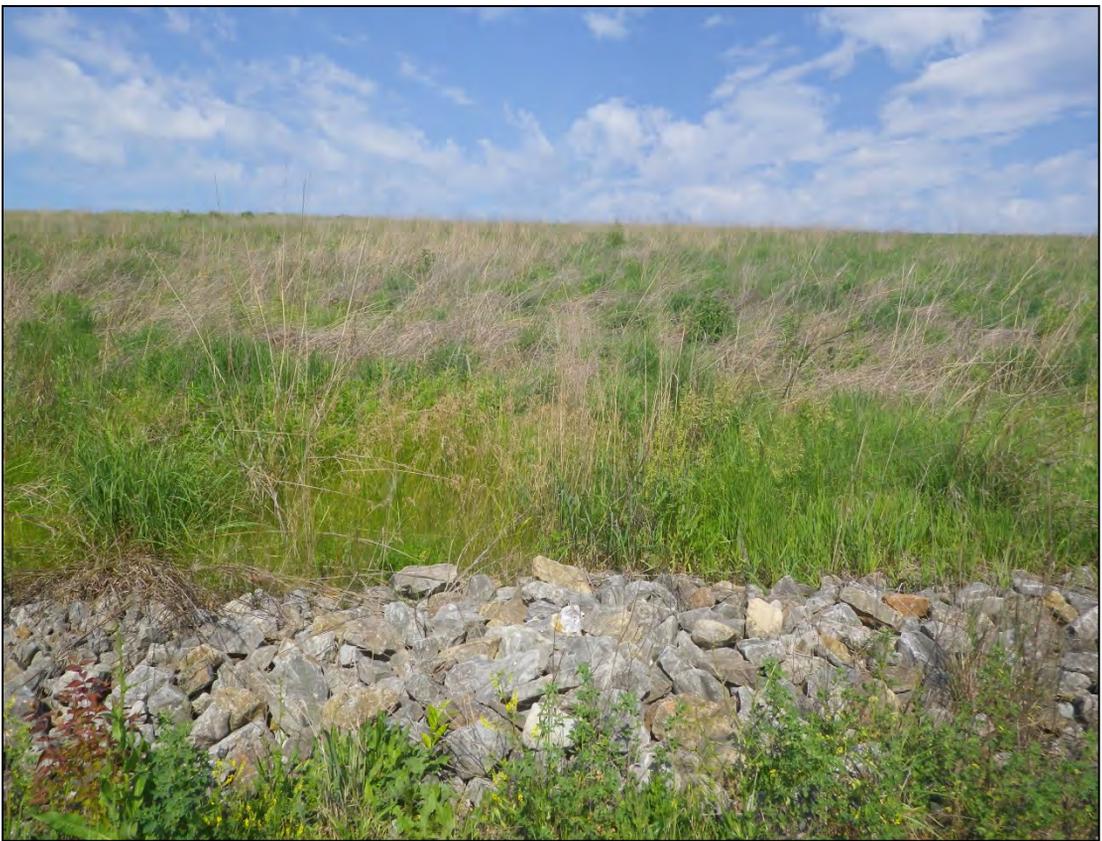
IMGP5412

East Face Cell 7

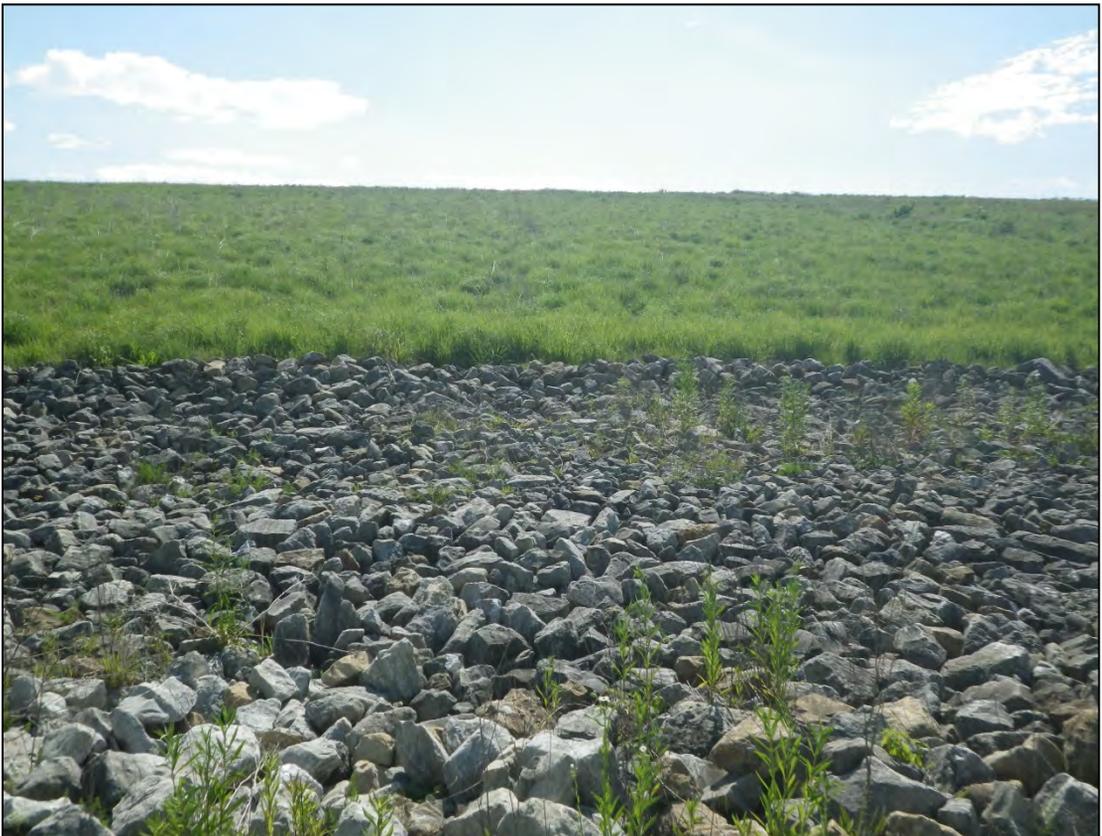
IMGP5421

West Face Cell 7

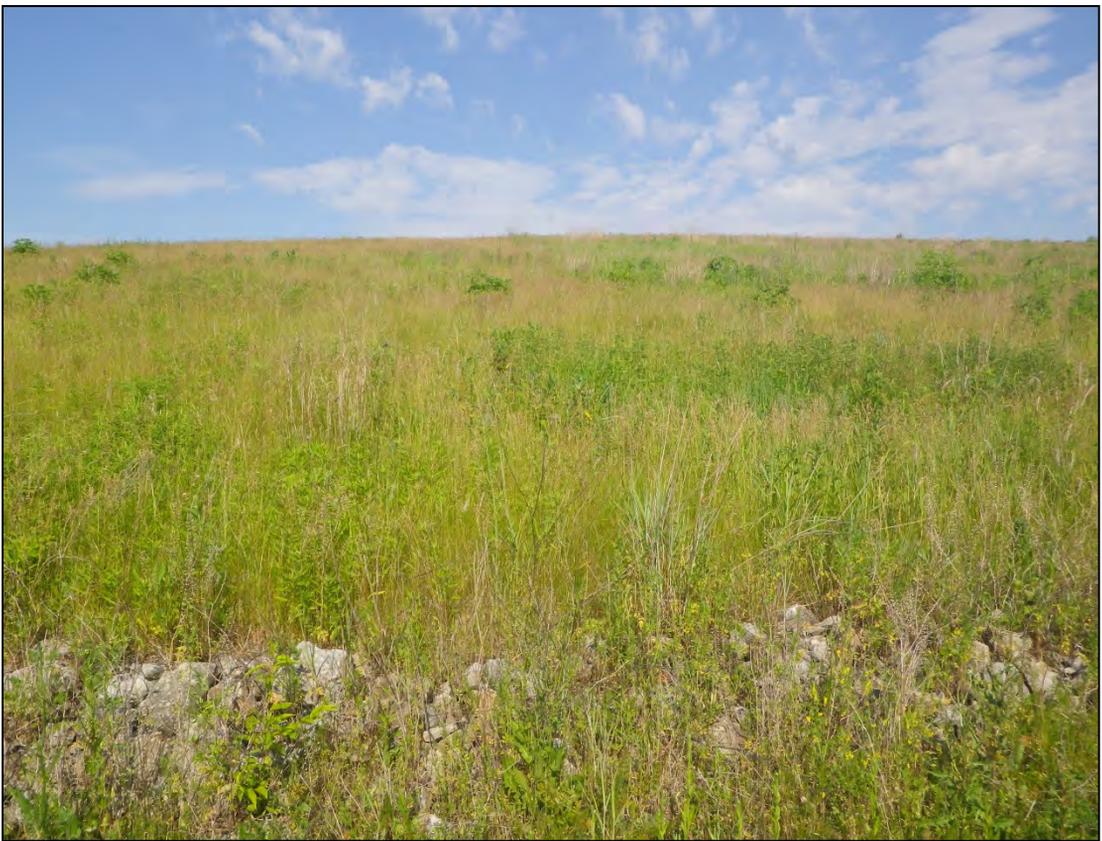
IMGP5414

East Face Cell 8

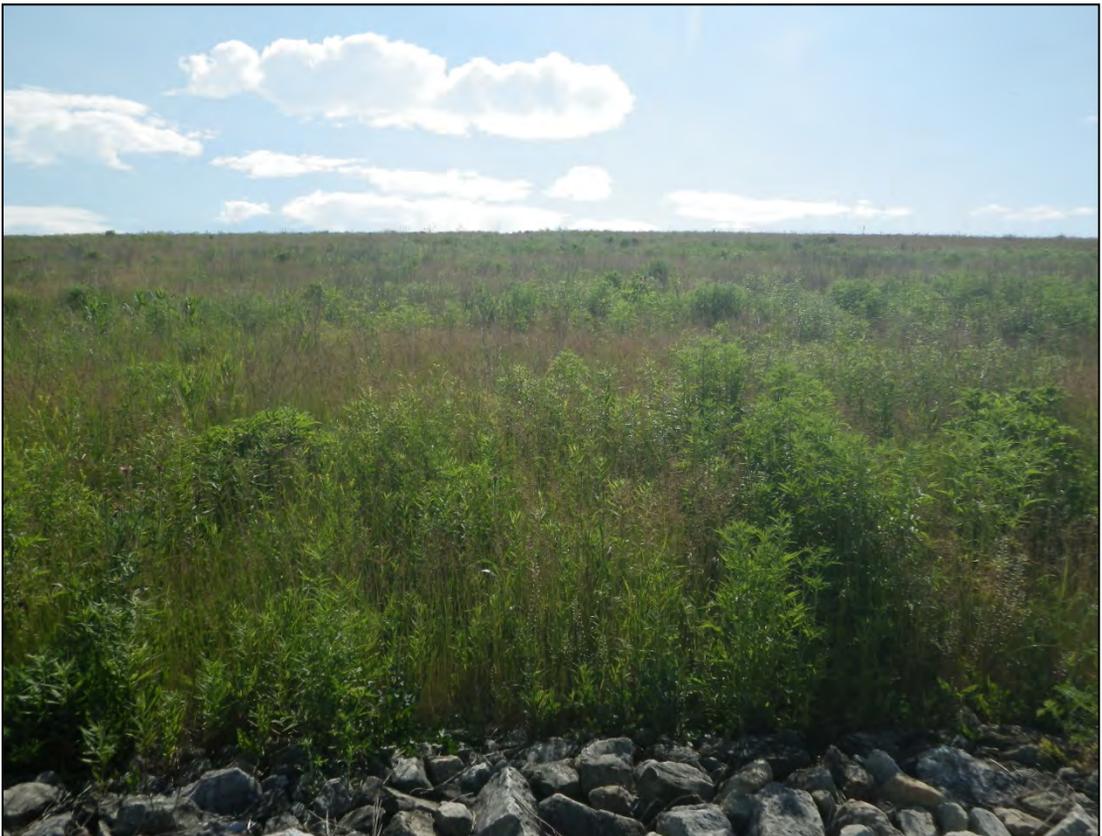
IMGP5417

West Face Cell 8

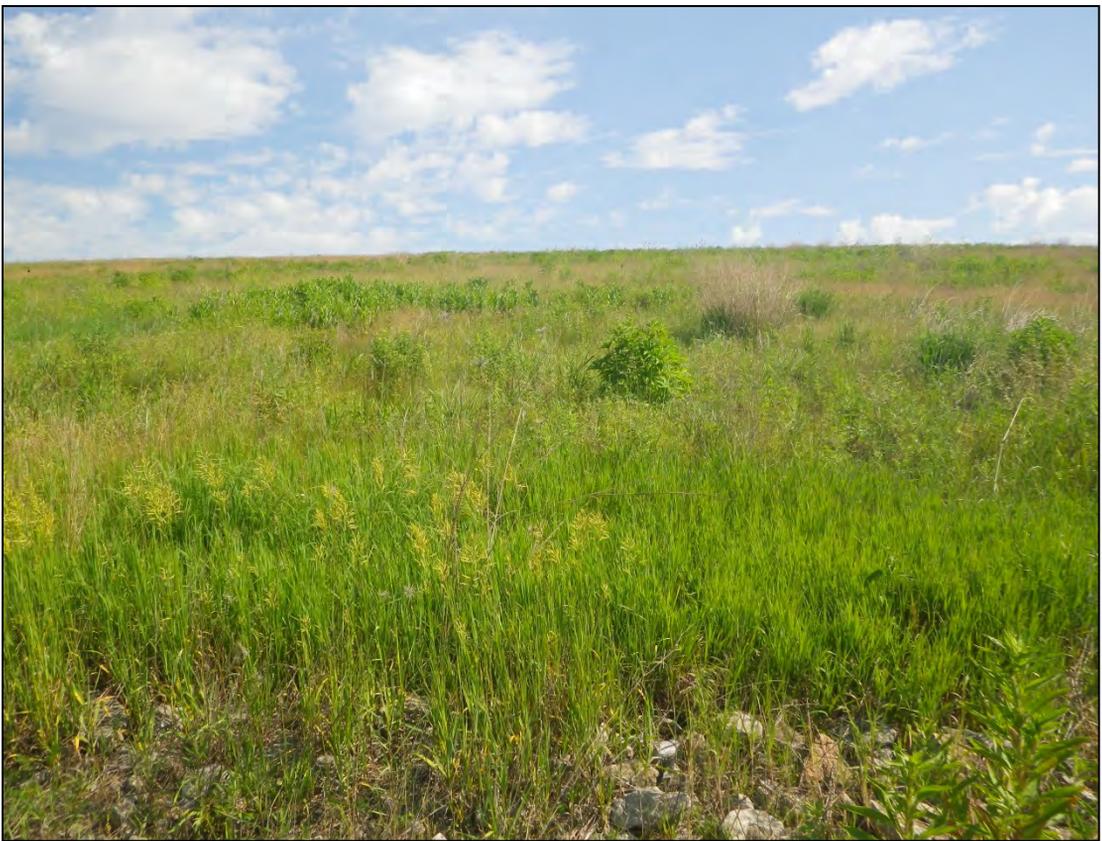
IMGP5416

South Face Cell 8

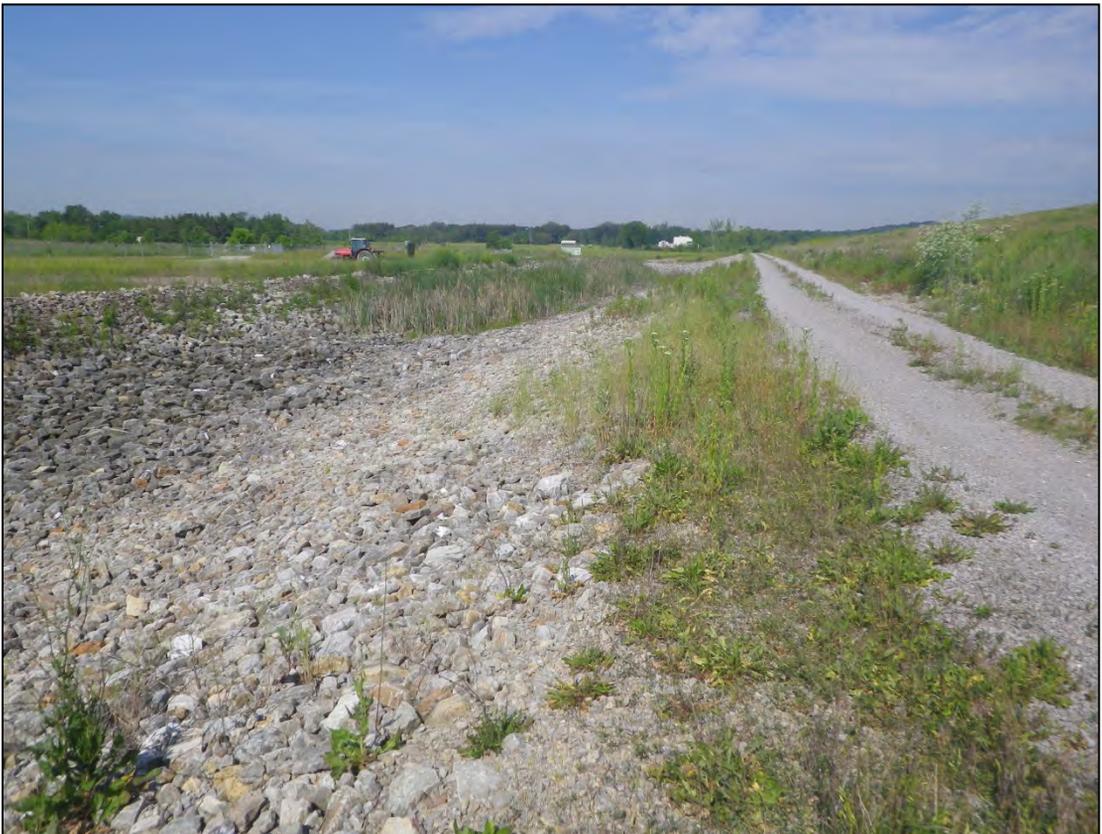
IMGP5415

South Drainage (looking west)
