SUBJECT: Transmittal of the June 2016 Fernald Quarterly Inspection Report

Fernald Preserve
 OSDF Inspection
 June 2016

FERNALD PRESERVE

Inspection Photographs

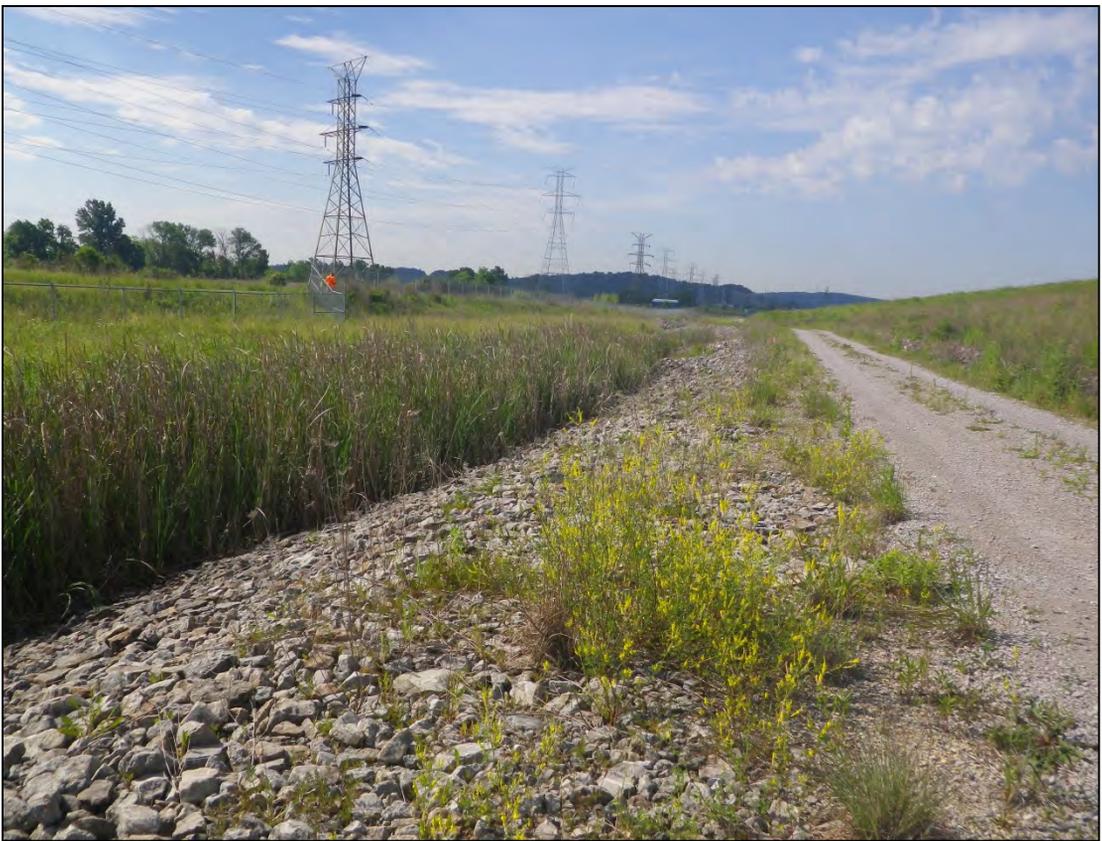
IMGP5413

East Drainage Cell 7 (looking south)

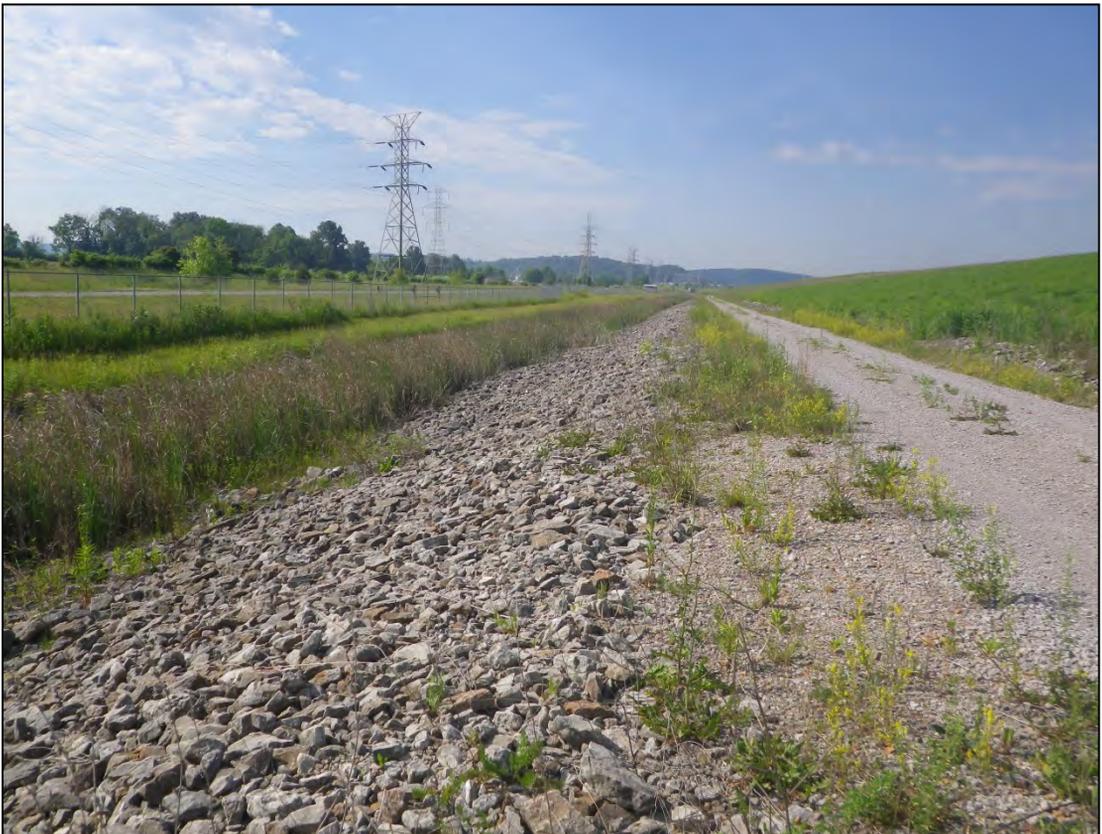
IMGP5409

East Drainage Cell 4 (looking south)

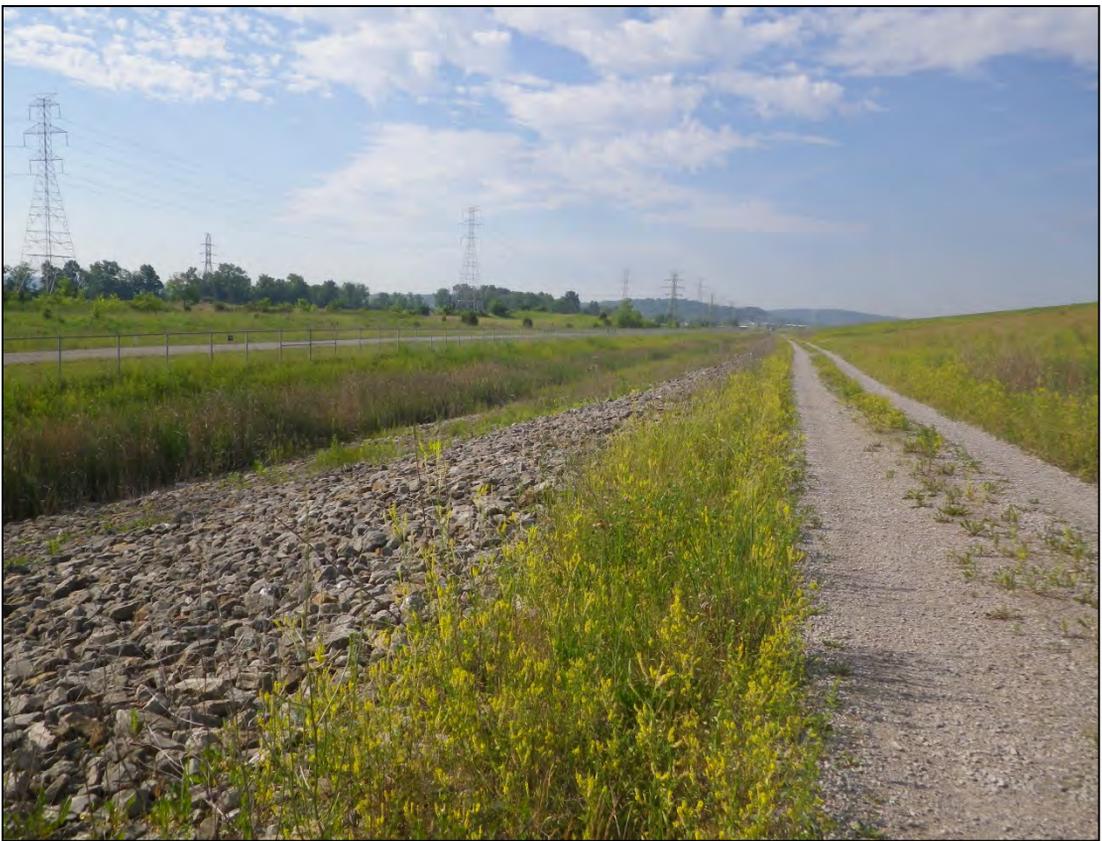
IMGP5405

East Drainage Cell 1 (looking south)

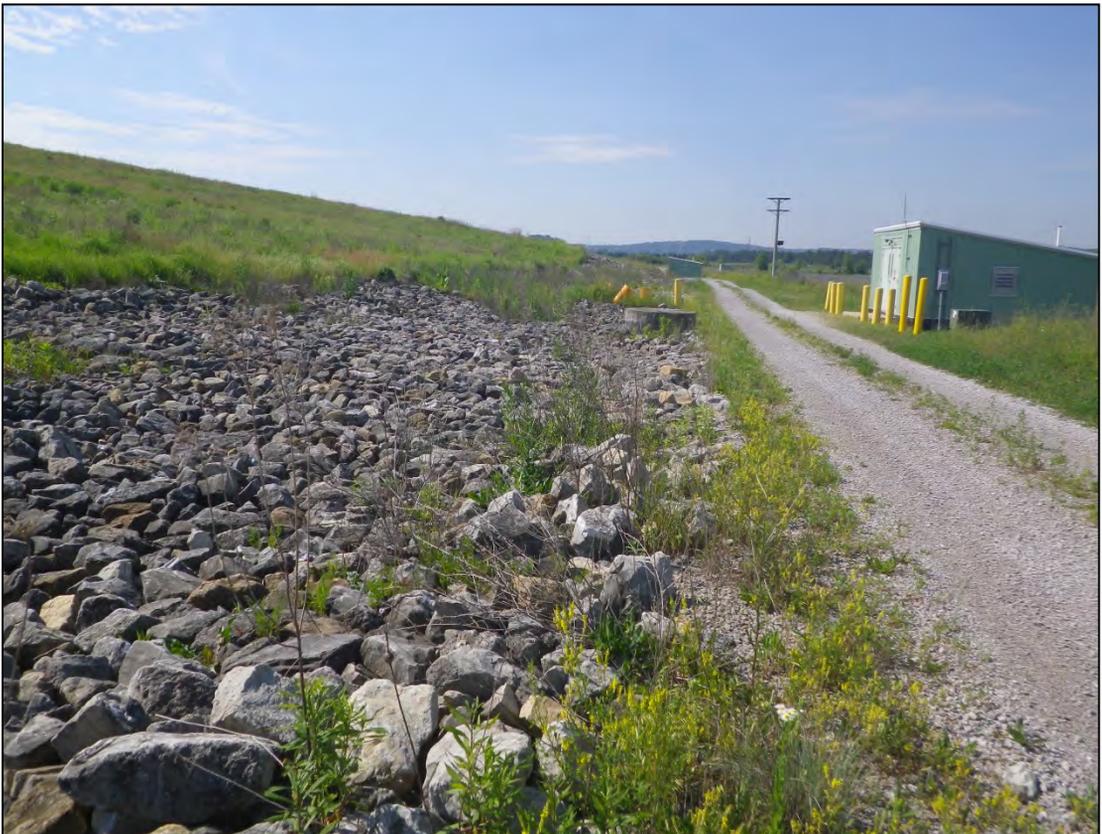
IMGP5422

West Inner Drainage Cell 7 (looking south)

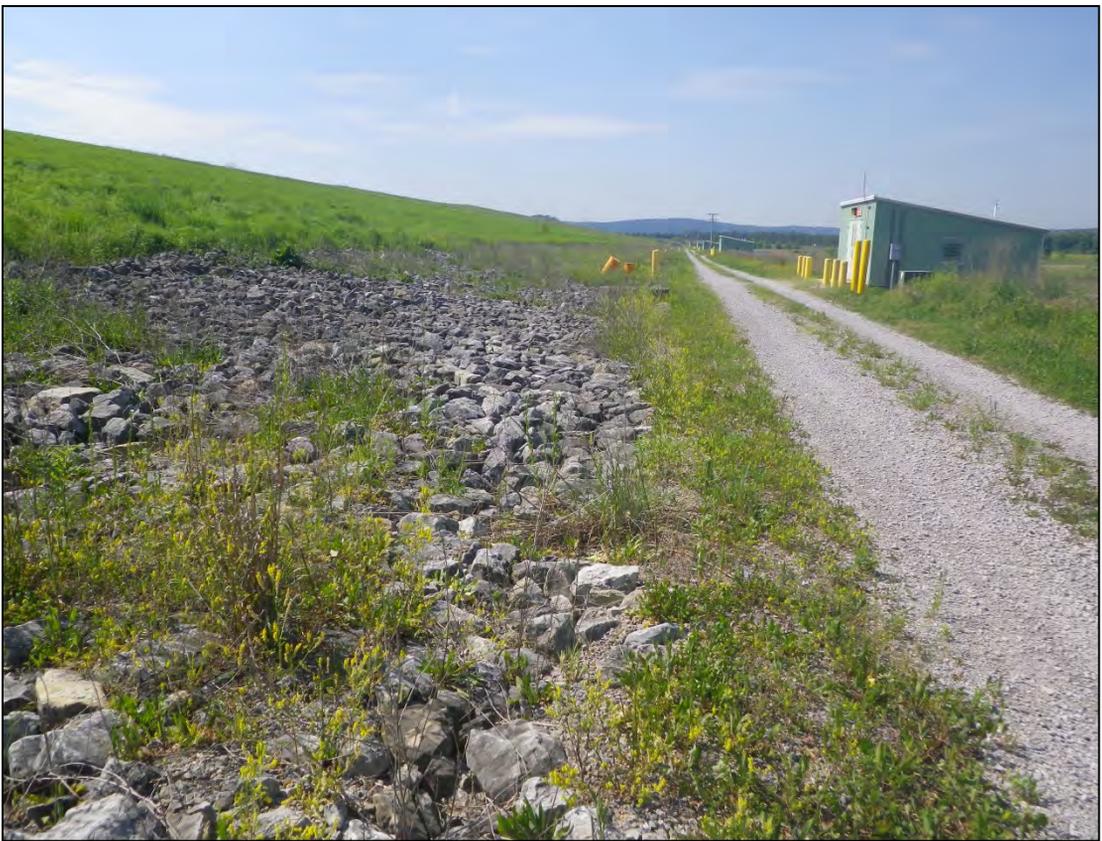
IMGP5426

West Inner Drainage Cell 4 (looking south)

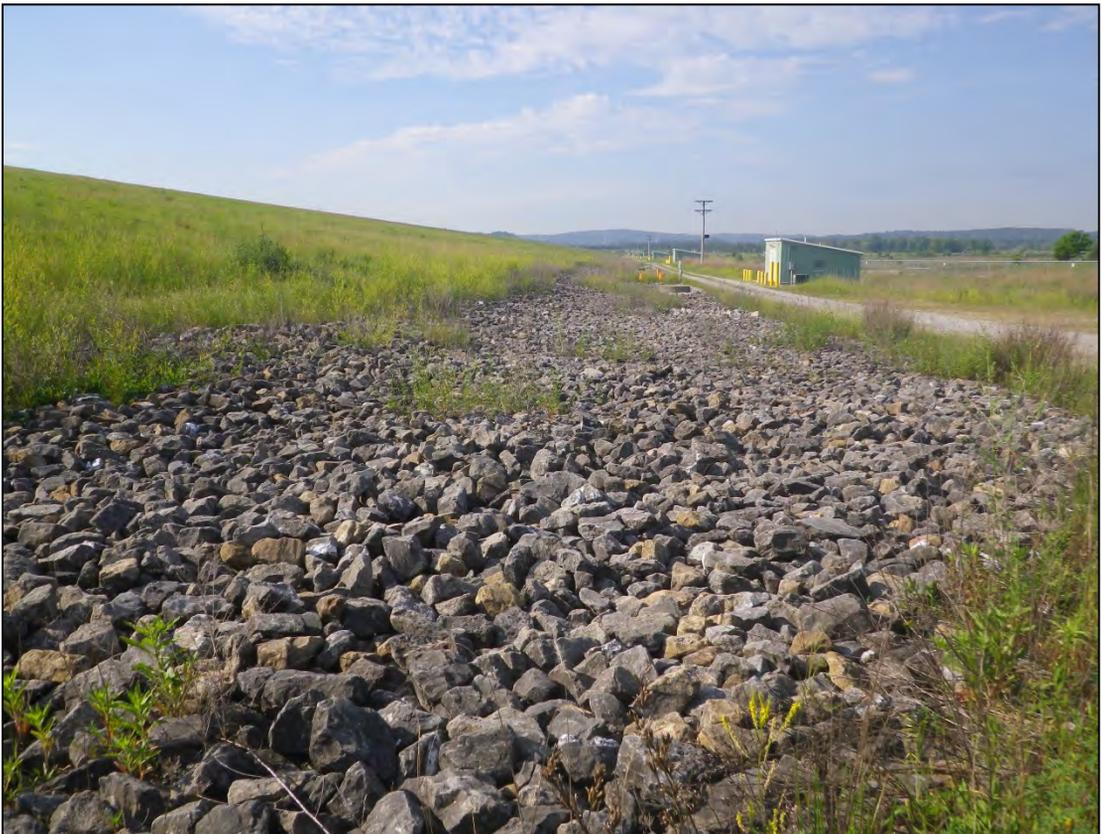
IMGP5401

West Inner Drainage Cell 1 (looking south)

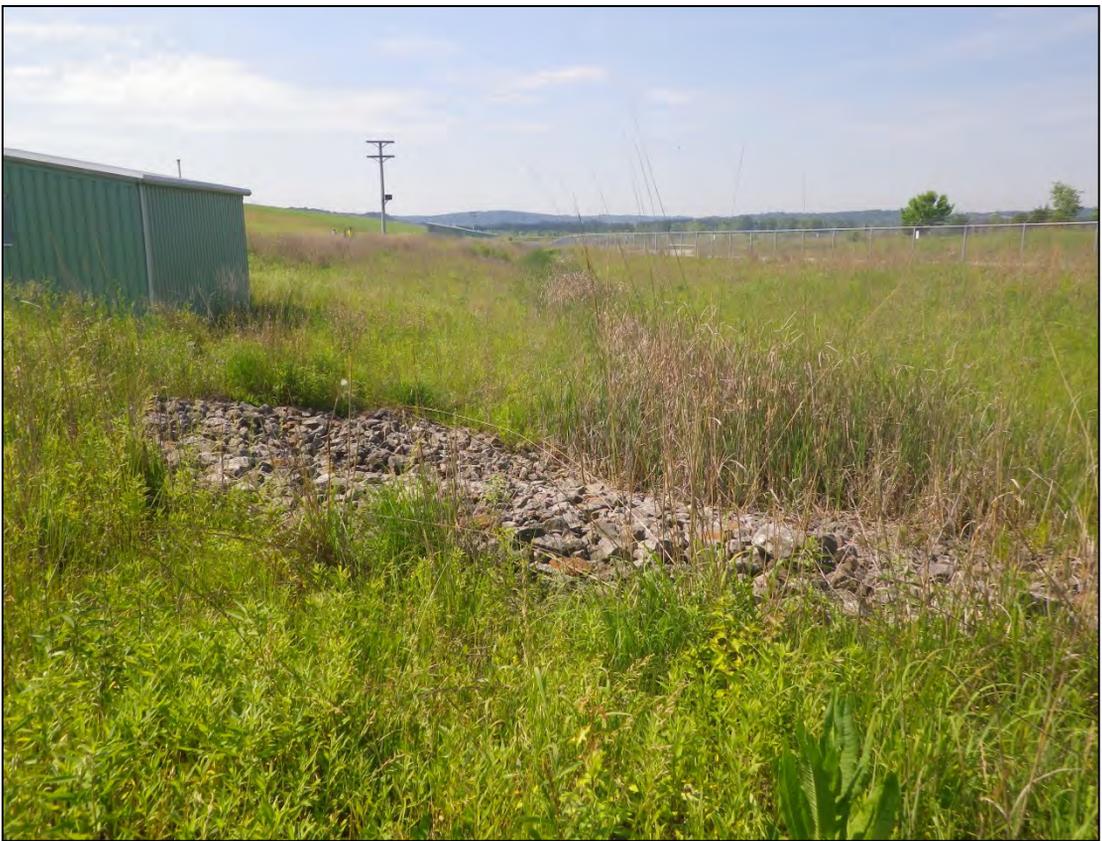
IMGP5430

West Outer Drainage Cell 1 (looking south)

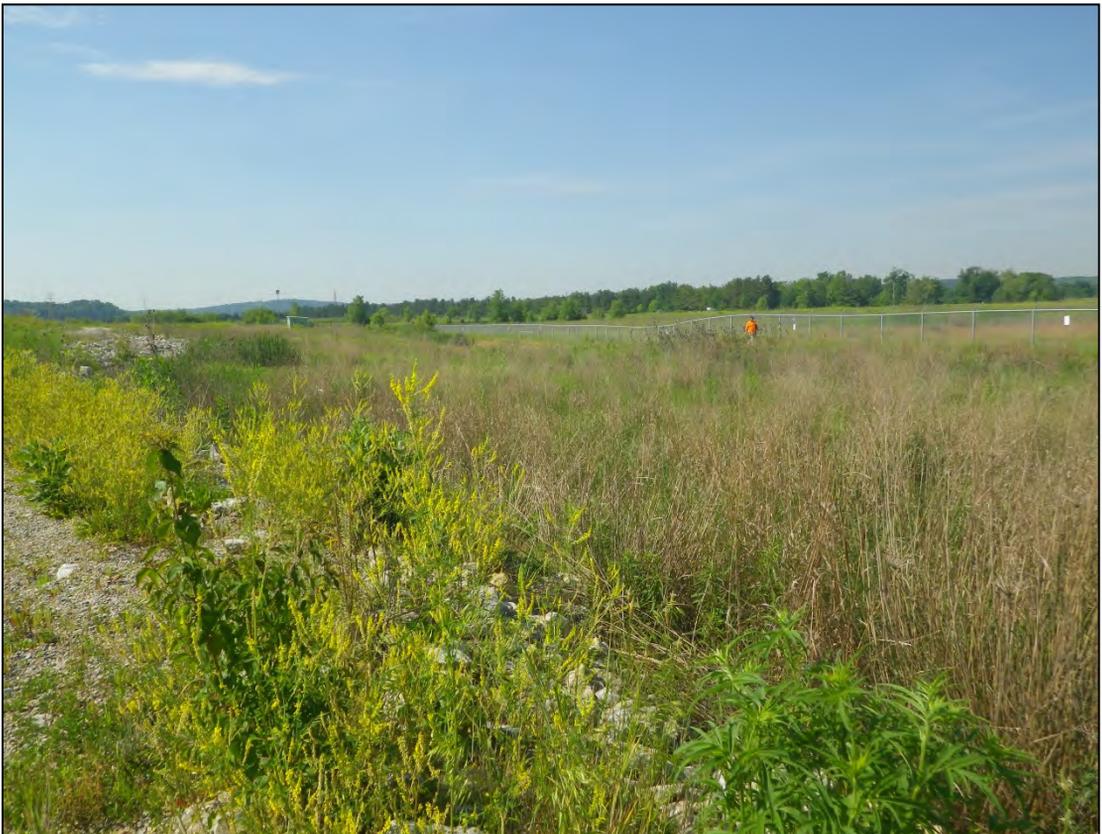
IMGP5420

West Outer Drainage Cell 8 (looking south)

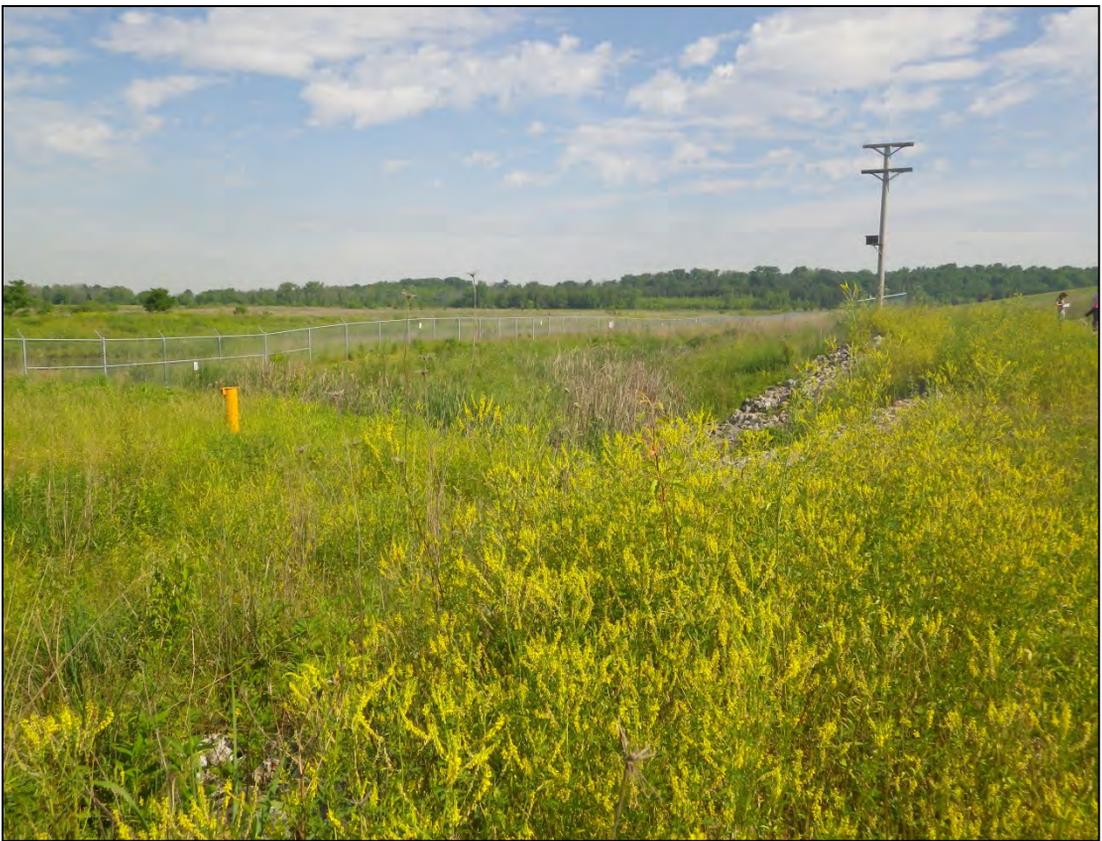
IMGP419

West Outer Drainage Cell 8 (looking north)
