SUBJECT: Transmittal of the September 2016 Fernald Quarterly Inspection Report

This letter is the September 2016 quarterly inspection report for the Fernald Preserve at the Fernald, Ohio, Site. Inspections are conducted as directed by the *Comprehensive Legacy Management and Institutional Controls Plan (LMICP) (LMS/FER/S03496)*. This letter also fulfills the reporting requirements specified in the Environmental Covenant, which is Appendix D of the *Consent Decree Resolving Ohio's Natural Resource Damage Claim Against DOE*. The inspections confirm that the activity and use limitations for the Fernald Preserve remain in place and are being complied with.

Fernald Preserve OSDF Walkdown Inspection Report

FERNALD PRESERVE

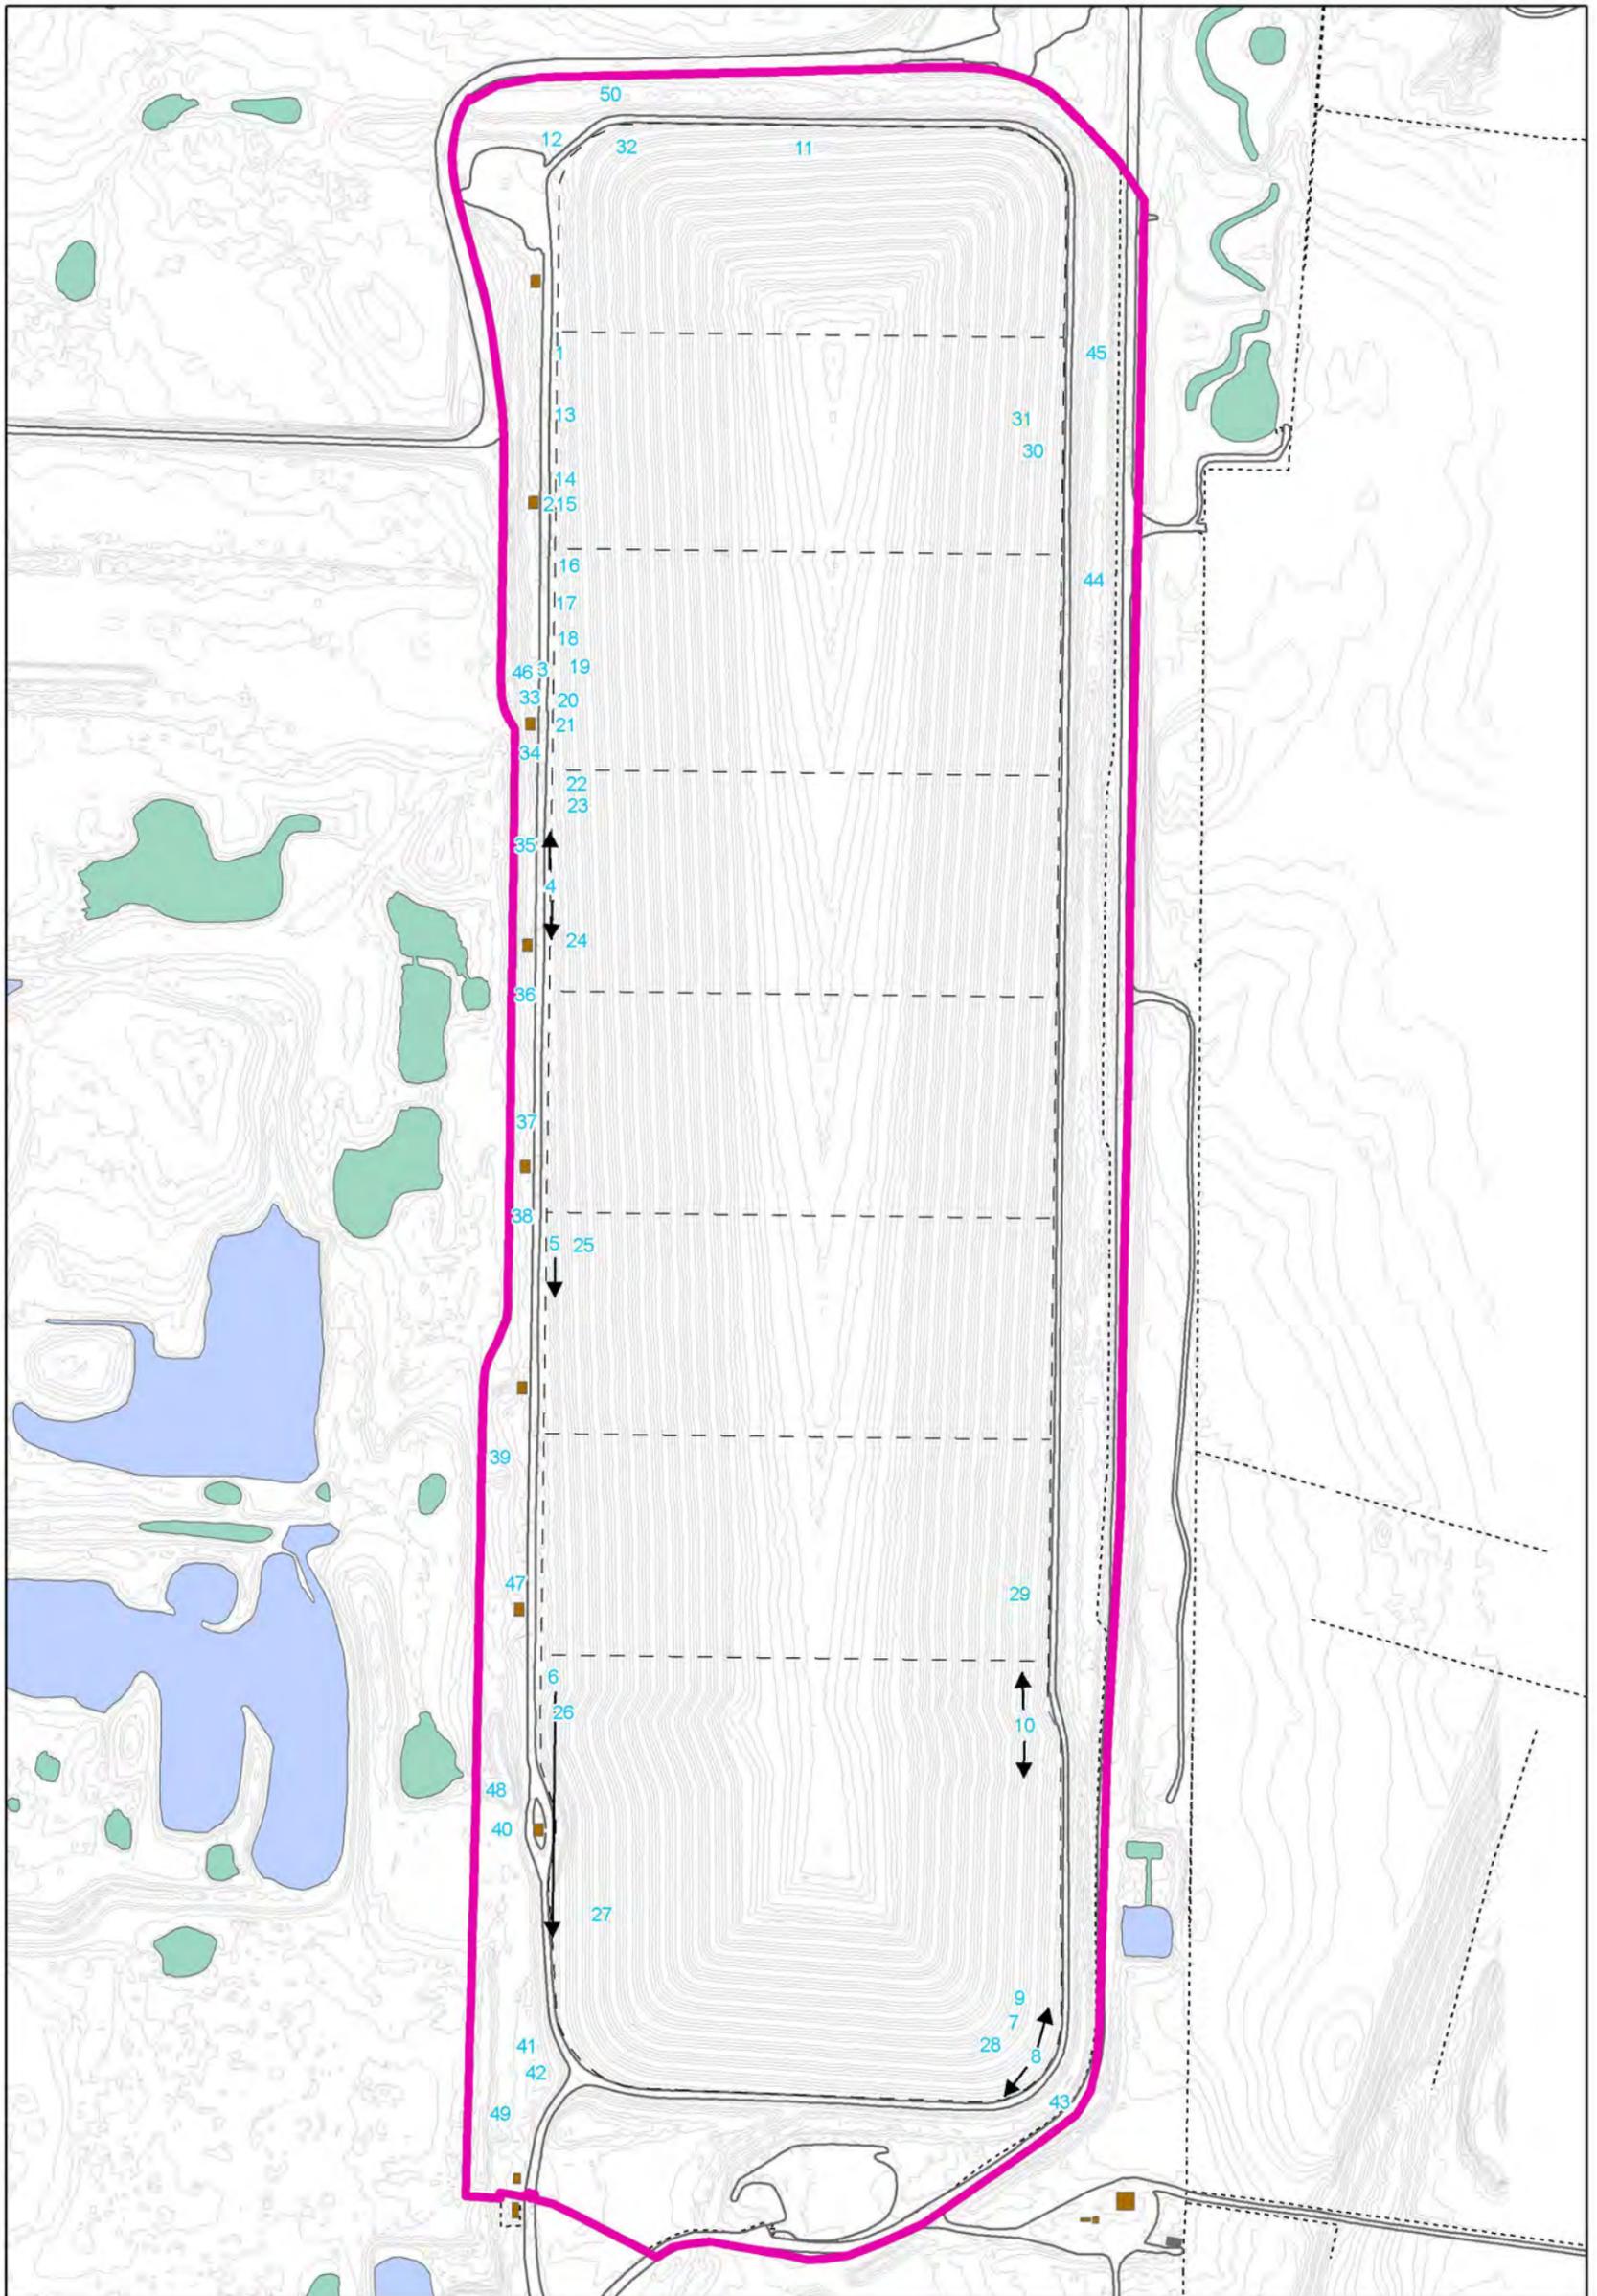
September 2016 OSDF Inspection

Map No.	Location	GPS?	Type of Finding	Description	Photo? (File No.)
1	Cell 2, west inner drainage	No	Vegetation	Honeysuckle	
2	Cell 2, west inner drainage at horizontal till well	No	Vegetation	Pear tree	
3	Cell 3, west inner drainage between valve houses	No	Vegetation	Pear and other woodies	
4	Cell 4, west inner drainage	No	Vegetation	Cattails in drainage	
5	Cell 6, west inner drainage	No	Vegetation	Woody vegetation	
6	Cell 8, west inner drainage	No	Vegetation	Woody vegetation throughout drainage	
7	Cell 8, southeast slope of cap, several locations	No	Vegetation	Honeysuckle and pear	
8	Cell 8, southeast corner at toe of slope	No	Vegetation	Honeysuckle and pear	
9	Cell 8, southeast corner on slope to top	No	Vegetation	Several honeysuckle	
10	Cell 8, east toe of slope	No	Vegetation	Many honeysuckle and pear	
11	Cell 1, north toe at reasearch well	No	Signage	Survey marker, used to indicate location of well, is down

12	Cell 1, northwest corner, along ridge, north of parking lot	No	Vegetation	Honeysuckle

Map No.	Location	GPS?	Type of Finding	Description	Photo? (File No.)
13	Cell 2, west toe, midpoint	No	Vegetation	Honeysuckle	
14	Cell 2, west toe	No	Vegetation	Honeysuckle	
15	Cell 2, west toe across from VH2	No	Vegetation	Honeysuckle	
16	Cell 3, west toe, north end	No	Vegetation	Woody vegetation	
17	Cell 3, west toe	No	Other	Sandy dirt pile	
18	Cell 3, west toe	No	Vegetation	Woody vegetation	
19	Cell 3, west toe	No	Vegetation	Callery pear	
20	Cell 3, west toe	No	Vegetation	Ash tree	
21	Cell 3, west toe	No	Vegetation	Several callery pear	
22	Cell 4, west toe, north end	No	Vegetation	Callery pear and honeysuckle	
23	Cell 4, west toe, north end	No	Vegetation	Cherry tree	
24	Cell 4, west toe, near VH about 5 feet up slope	No	Vegetation	Callery pear	
25	Cell 6, west toe, north end	No	Vegetation	Honeysuckle	
26	Cell 8, west toe	No	Biointrusion	Groundhog hole	
27	Cell 8, west slope about 30 feet upslope from the toe	No	Vegetation	Mulberry

28	Cell 8, southeast corner toe	No	Vegetation	Honeysuckle	
29	Cell 7, east toe	No	Vegetation	Honeysuckle	
30	Cell 2, east toe, near midpoint	No	Vegetation	Honeysuckle

Map No.	Location	GPS?	Type of Finding	Description	Photo? (File No.)
31	Cell 2, east toe, 15 feet up slope	No	Vegetation	Callery pear	
32	Cell 1, northwest corner toe	No	Vegetation	Rose bush	
33	Cell 3, west drainage, north side of VH3	No	Vegetation	Woody vegetation	
34	Cell 3, west drainage, south end	No	Vegetation	Woody vegetation	
35	Cell 4, west drainage, near raptor pole	No	Vegetation	Various woody vegetation	
36	Cell 5, west drainage, north end	No	Vegetation	Woody vegetation	
37	Cell 5, west drainage, midpoint	No	Vegetation	Various woody vegetation	
38	Cell 6, west drainage, north end	No	Vegetation	Woody vegetation	
39	Cell 7, west drainage, north end	No	Vegetation	Woody vegetation	
40	Cell 8, west drainage, behind VH8	No	Vegetation	Woody vegetation	
41	Cell 8, west drainage at riprap edge, south of VH8	No	Vegetation	Cottonwood	
42	Cell 8, west drainage, southwest corner	No	Vegetation	Mulberry	
43	Cell 8, southeast corner drainage	No	Vegetation	Woody vegetation and thistle

44	Cell 3, east drainage	No	Vegetation	Multiple woody vegetation in drainage near cattails	
45	Cell 2, east drainage, north end	No	Vegetation	Willows in cattails	
46	Cell 3, west drainage, north of VH3	No	Vegetation	Johnson grass	
47	Cell 7, west drainage at fenceline	No	Vegetation	Woody vegetation	
48	Cell 8, west drainage	No	Vegetation	Woody vegetation

Map No.	Location	GPS?	Type of Finding	Description	Photo? (File No.)
49	Cell 8, west drainage, southwest corner	No	Fencing	Hole under fencing	
50	Cell 1, north drainage	No	Vegetation	Phragmites

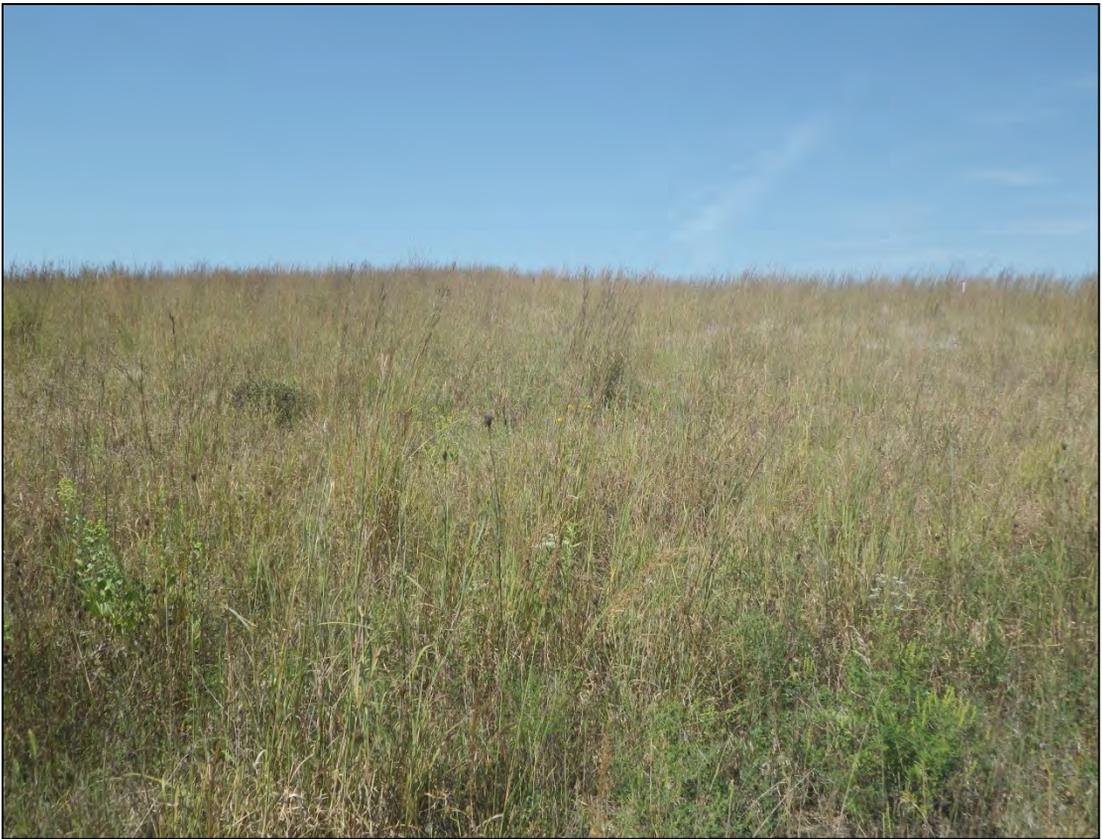
IMGP5825

East Face Cell 1

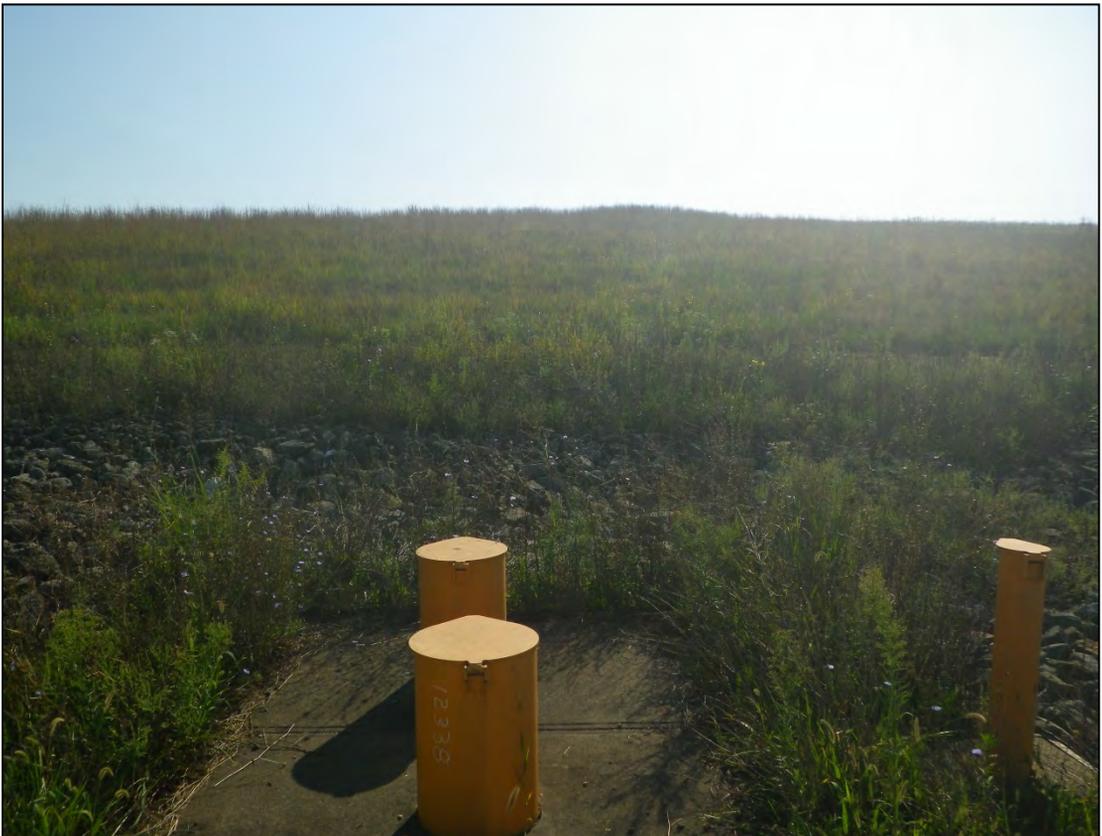
IMGP5802

West Face Cell 1

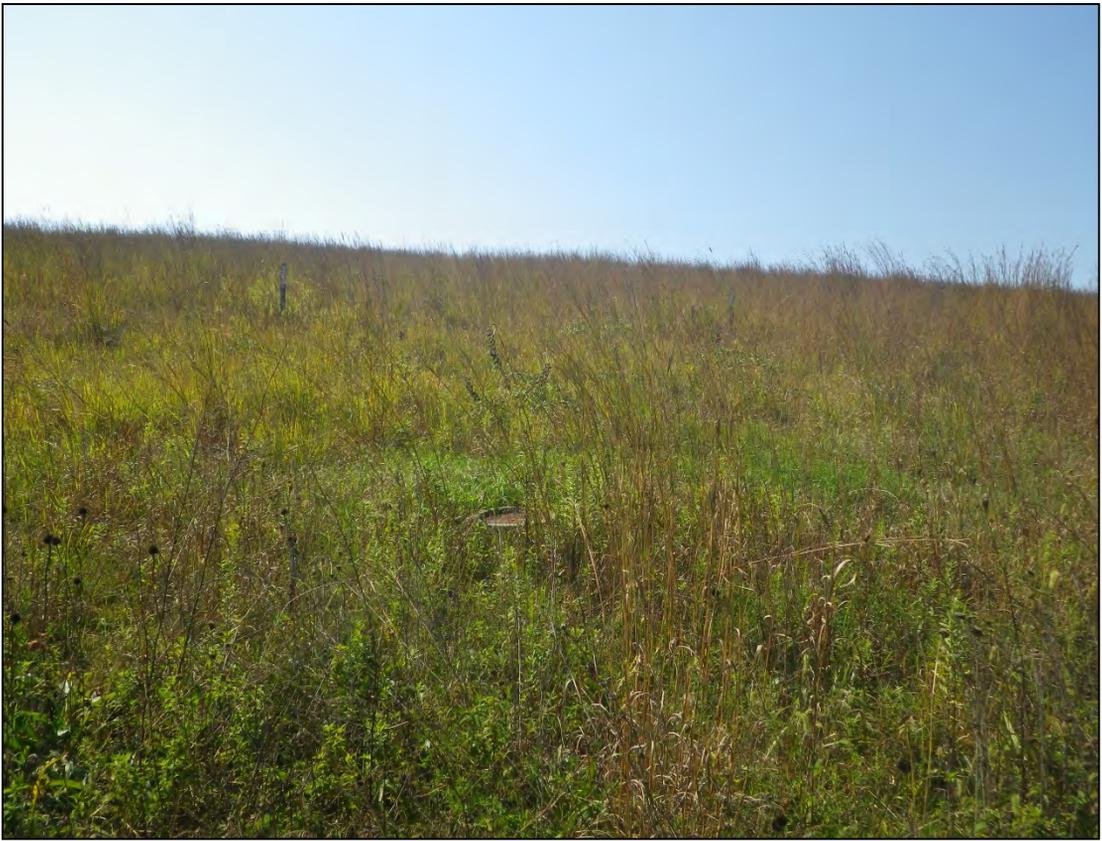
IMGP5828

North Face Cell 1

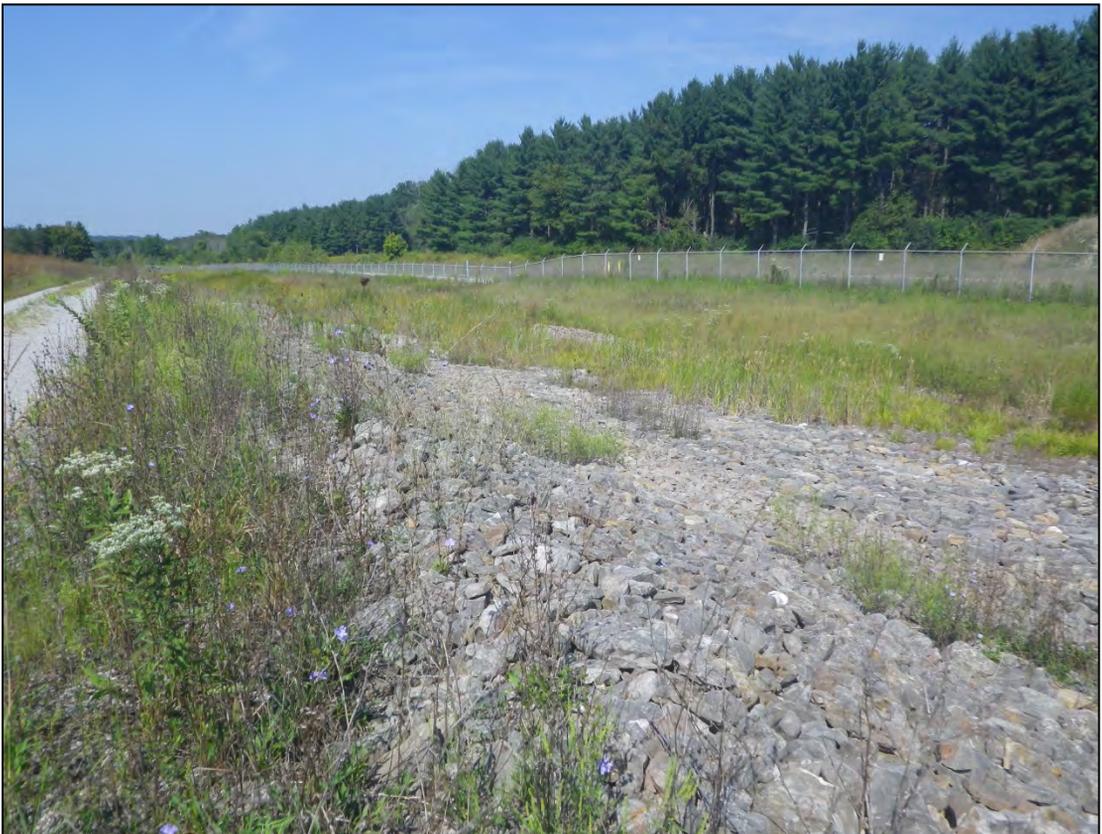
IMGP5827

North Drainage (looking west)

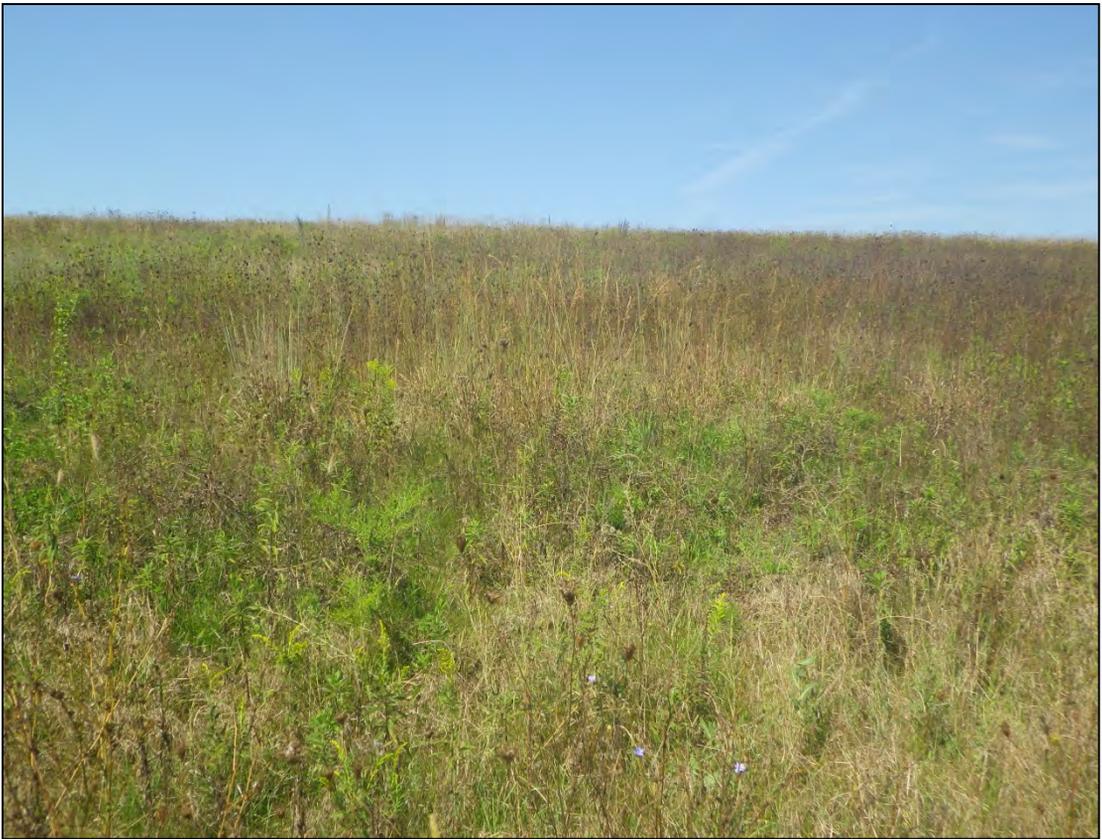
IMGP5824

East Face Cell 2

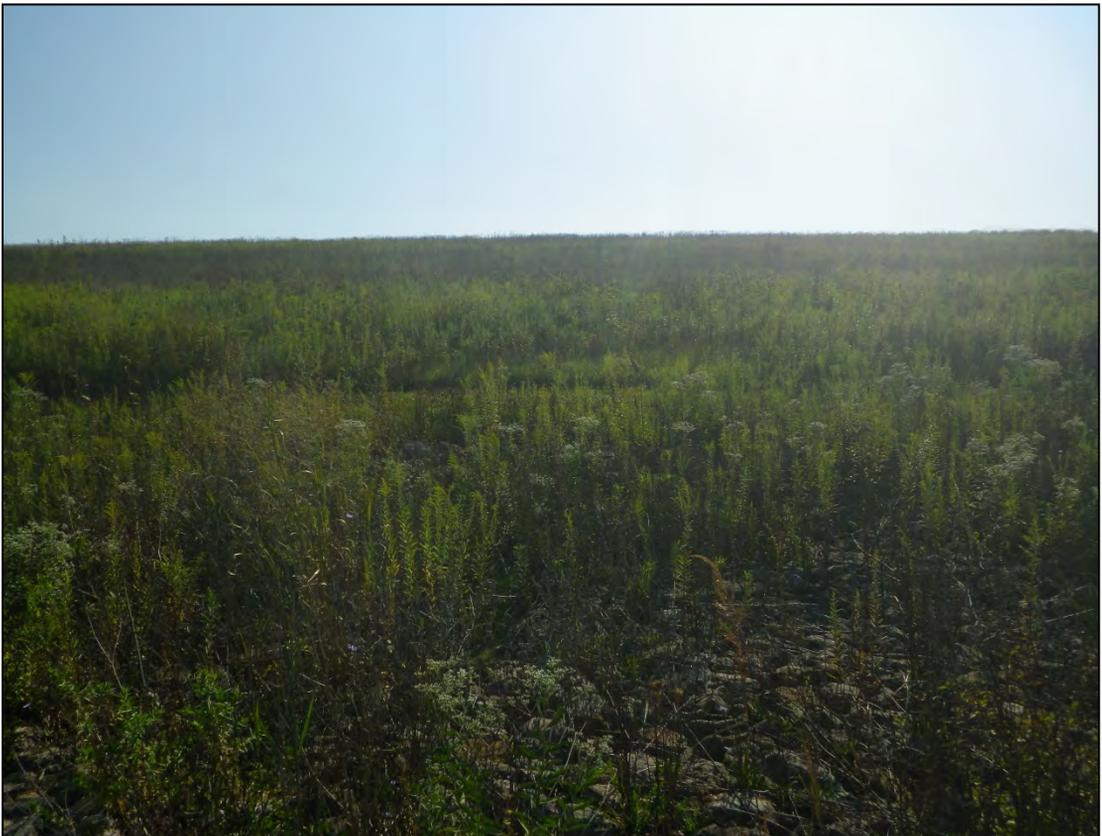
IMGP5803

West Face Cell 2

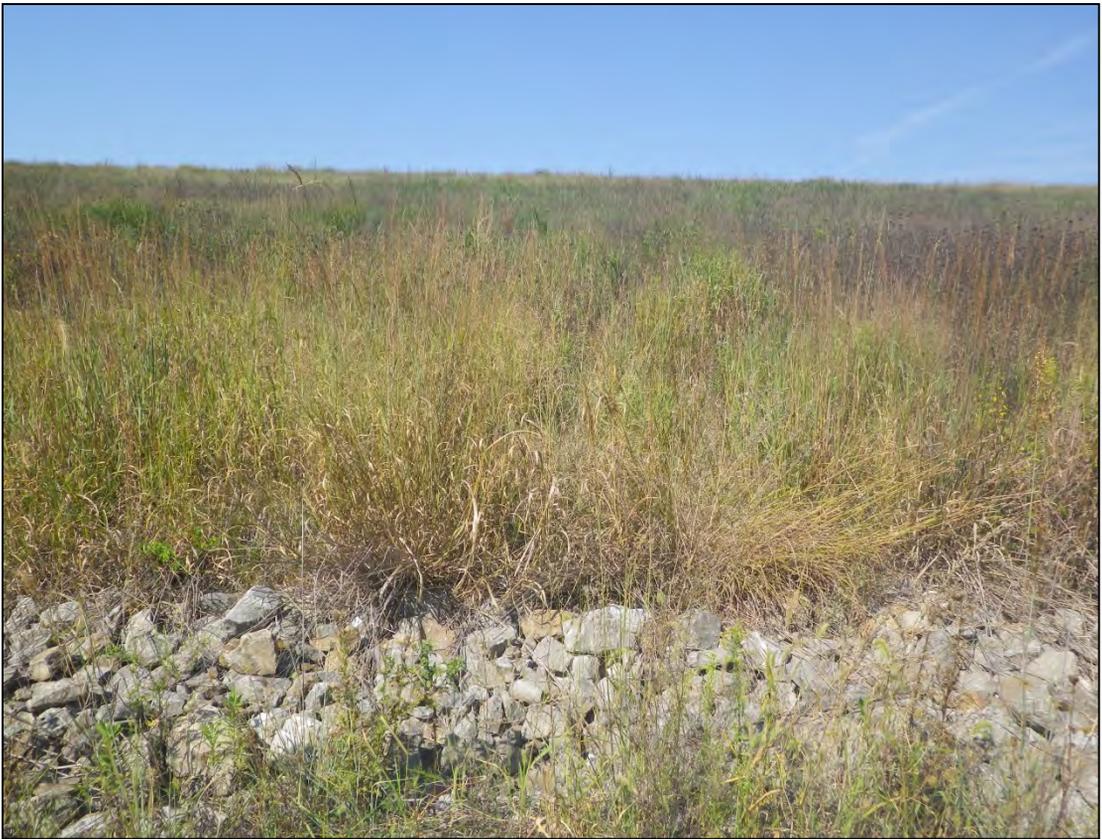
IMGP5823

East Face Cell 3

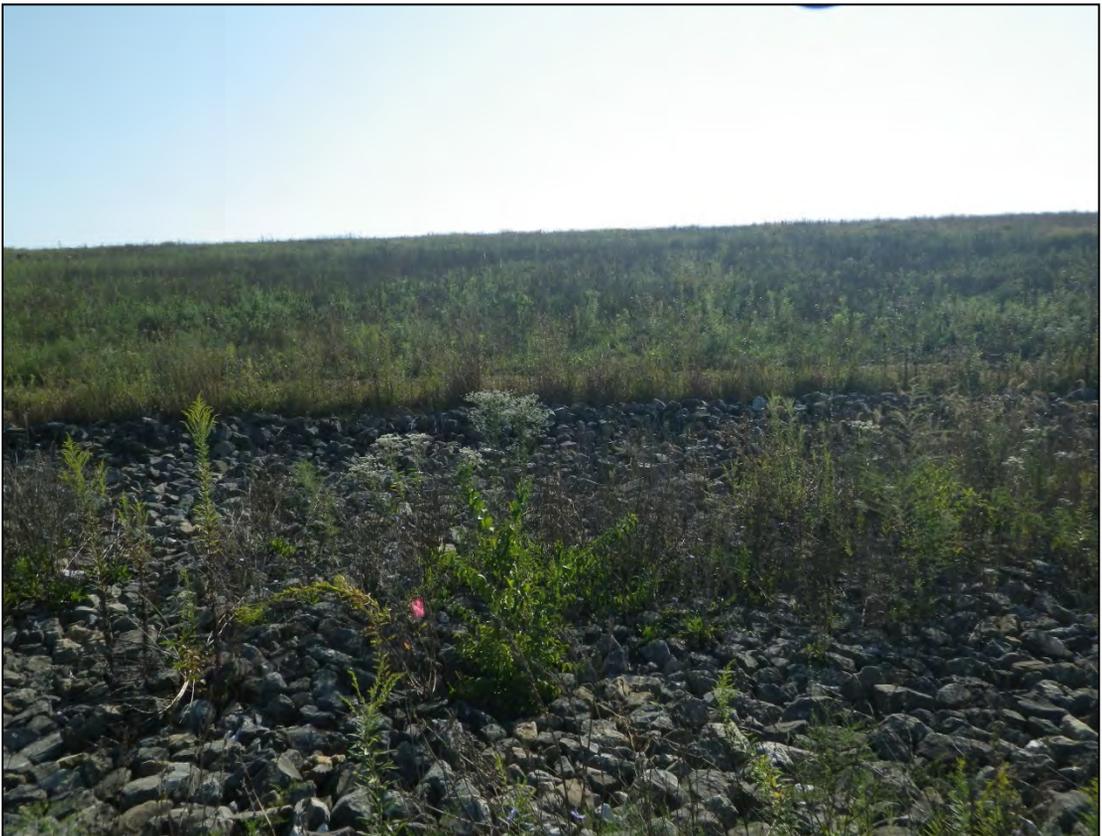
IMGP5804

West Face Cell 3

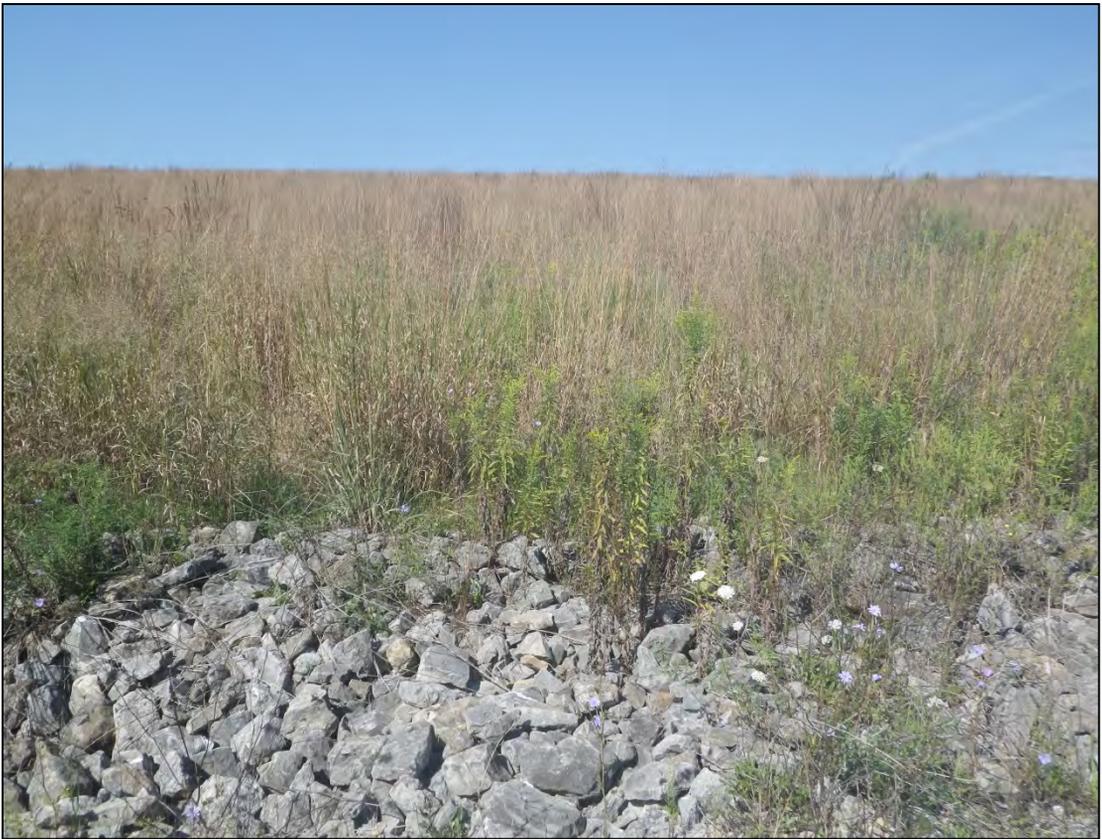
IMGP5821

East Face Cell 4

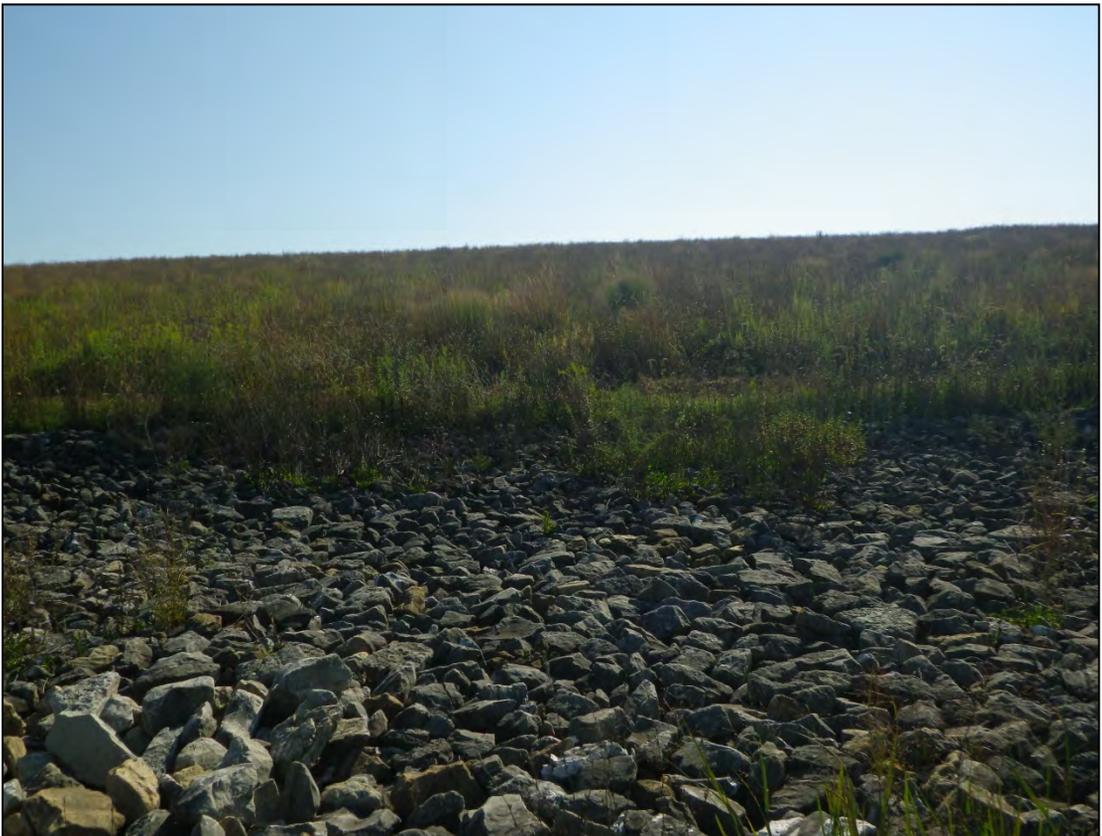
IMGP5805

West Face Cell 4

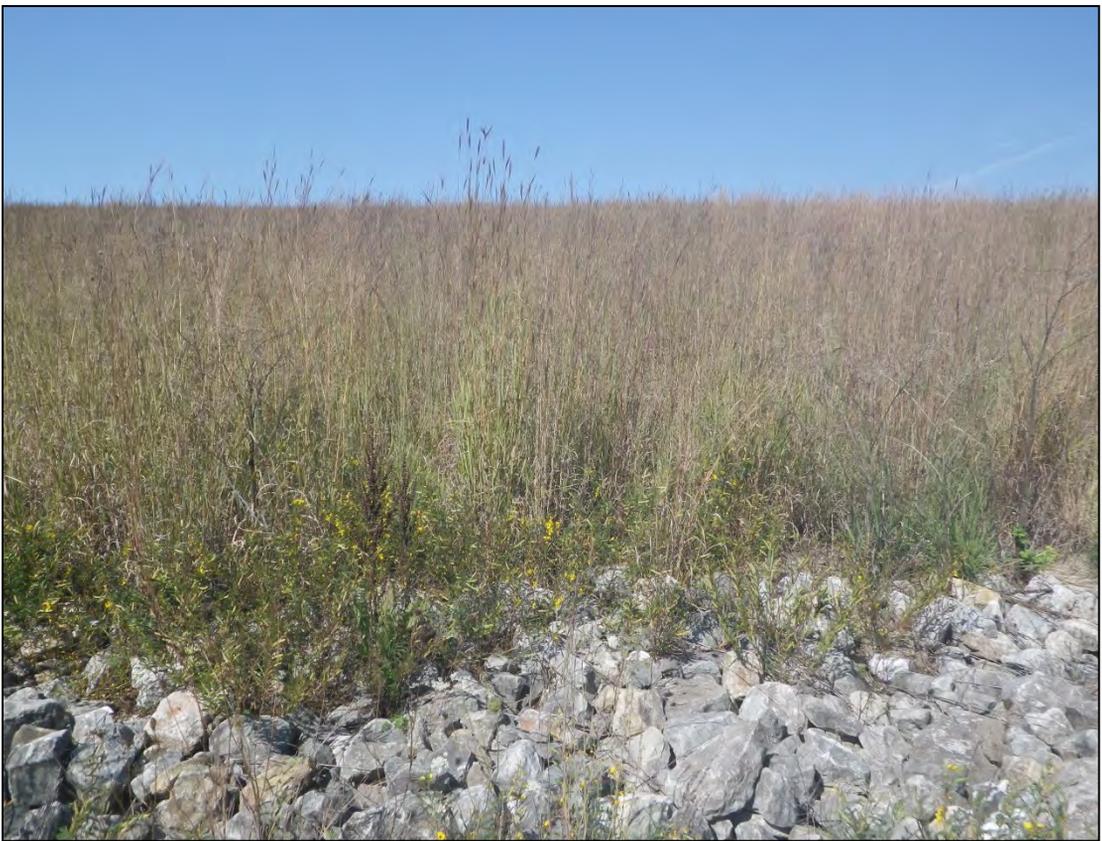
IMGP5820

East Face Cell 5

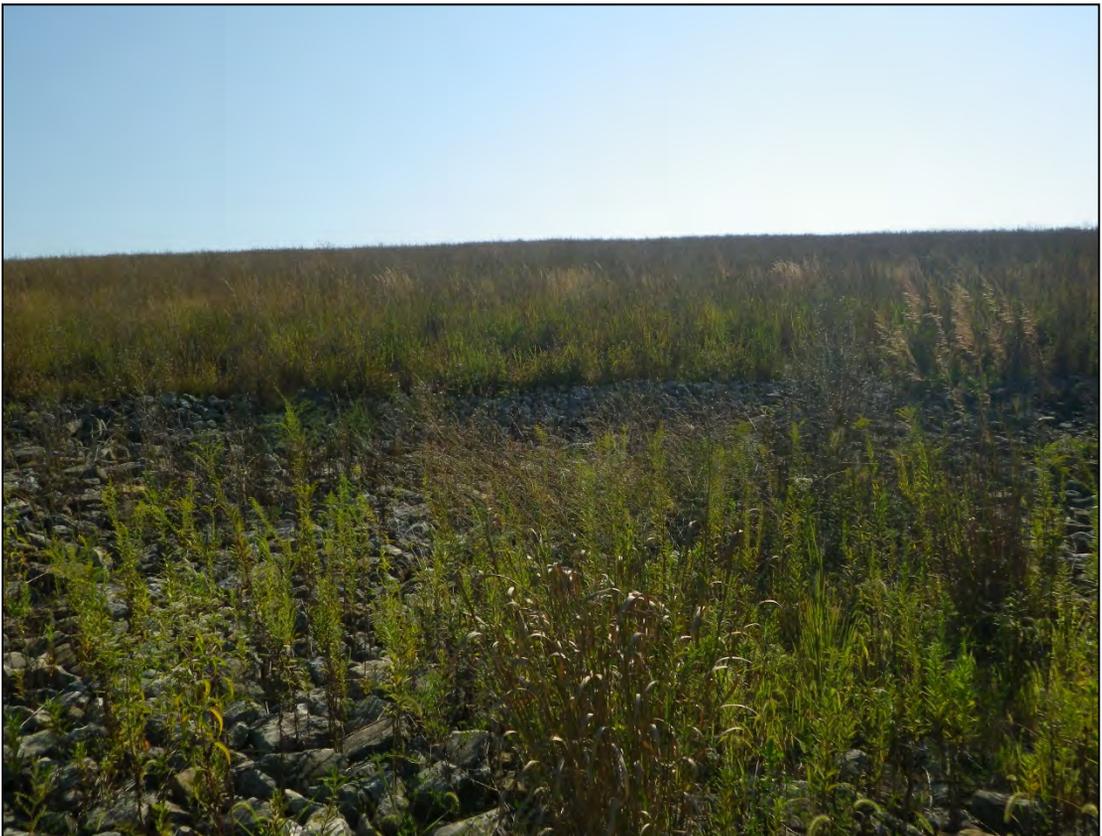
IMGP5807

West Face Cell 5

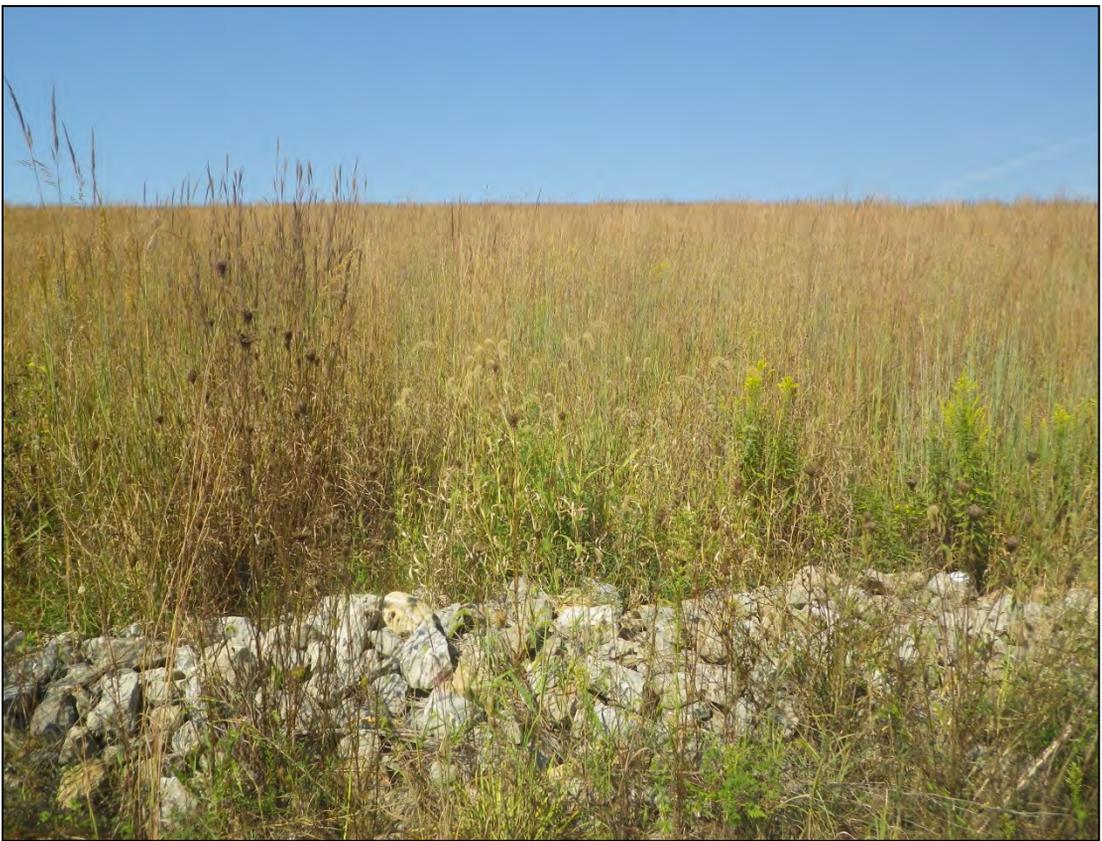
IMGP5819

East Face Cell 6

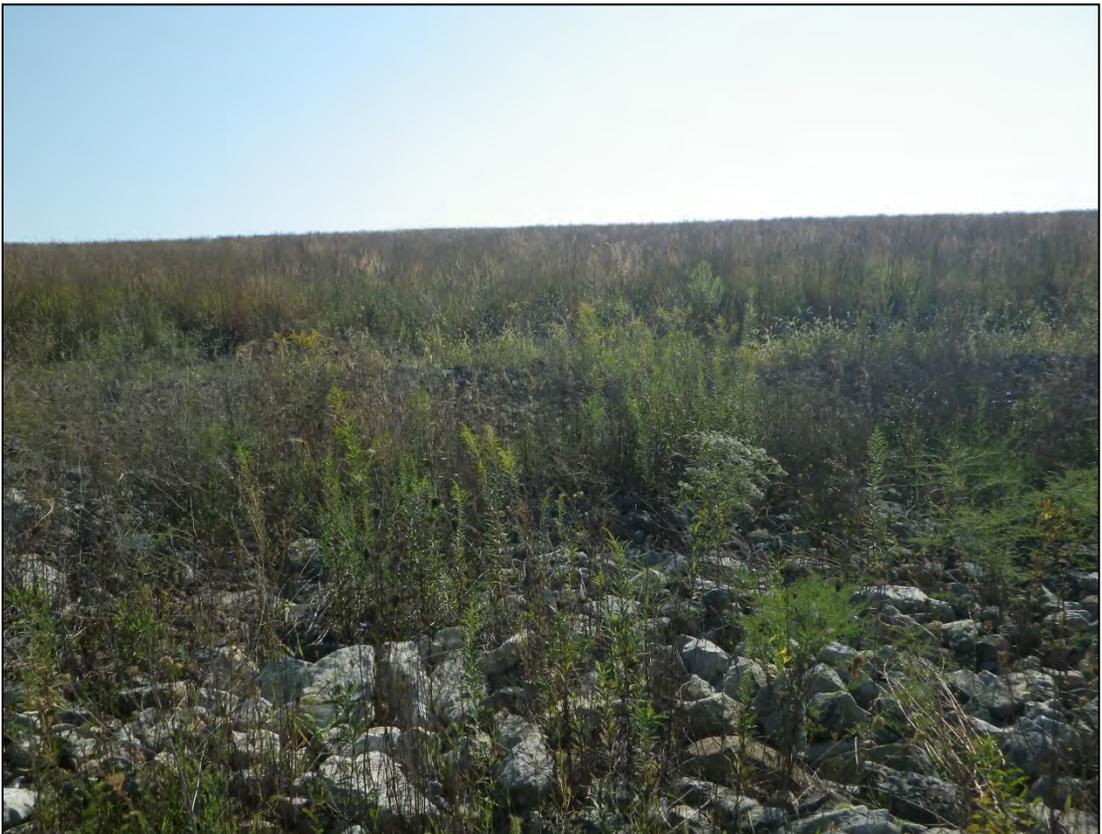
IMGP5808

West Face Cell 6

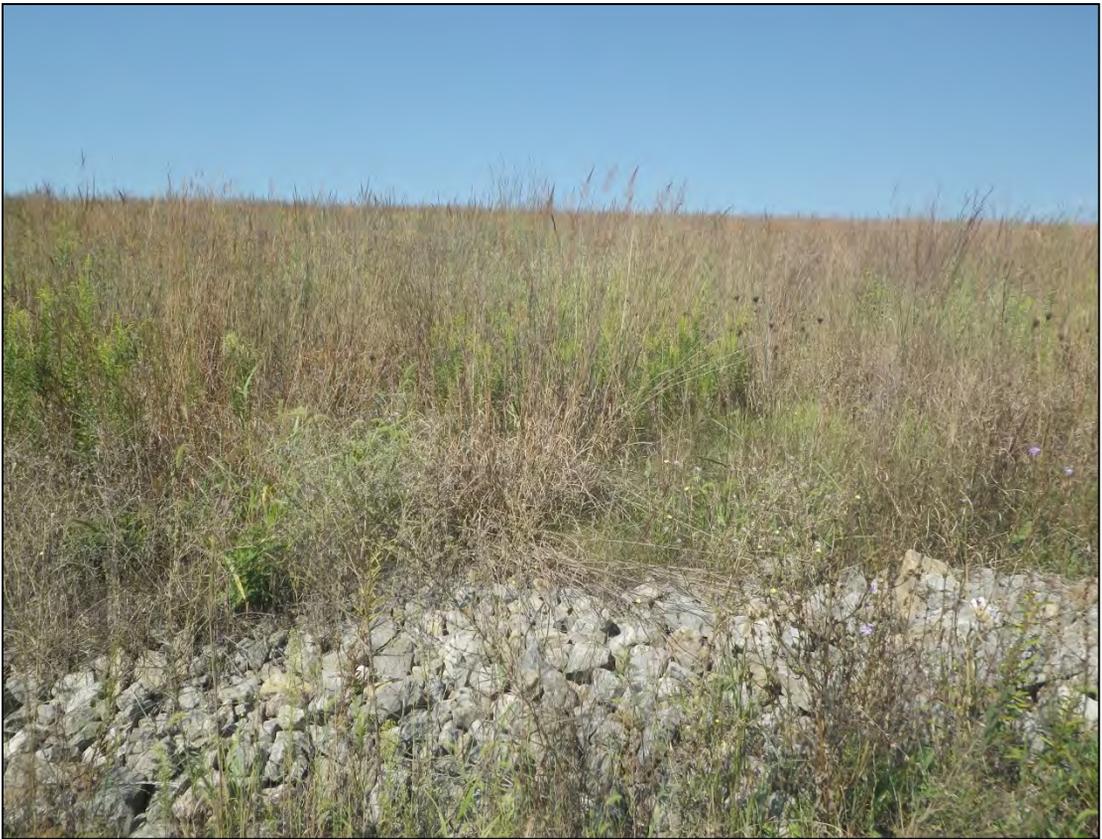
IMGP5817

East Face Cell 7

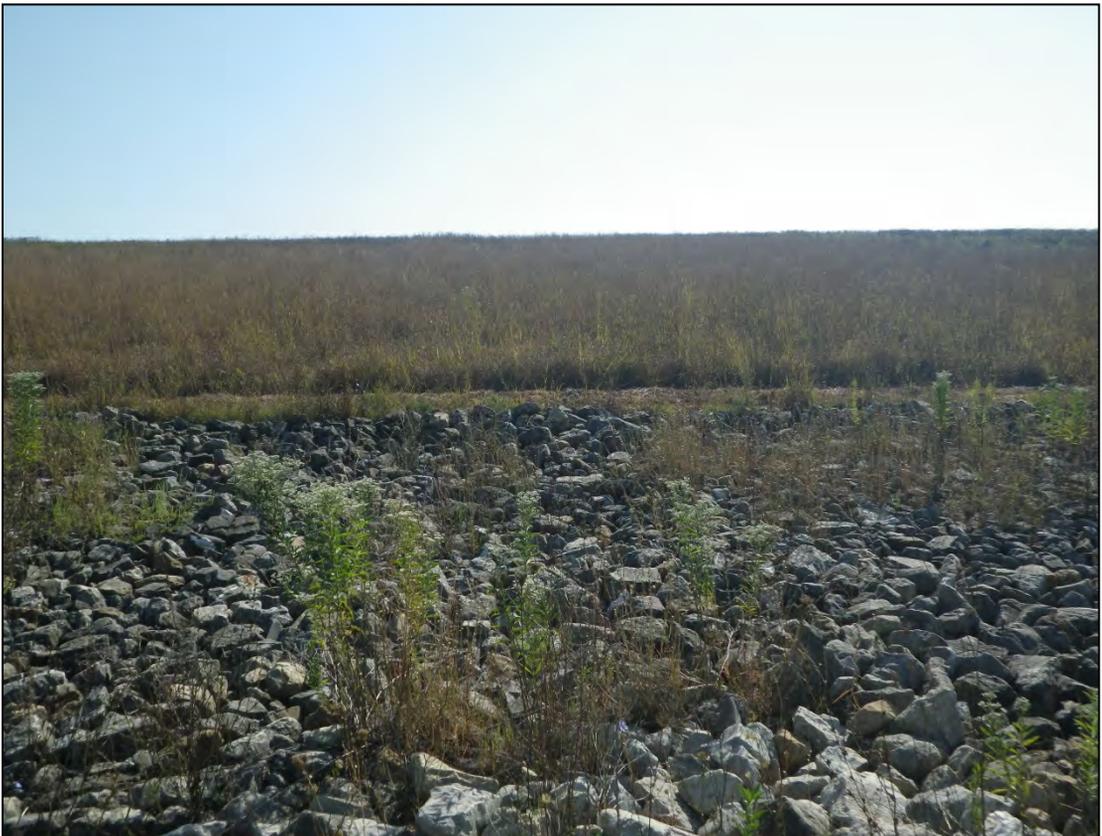
IMGP5809

West Face Cell 7

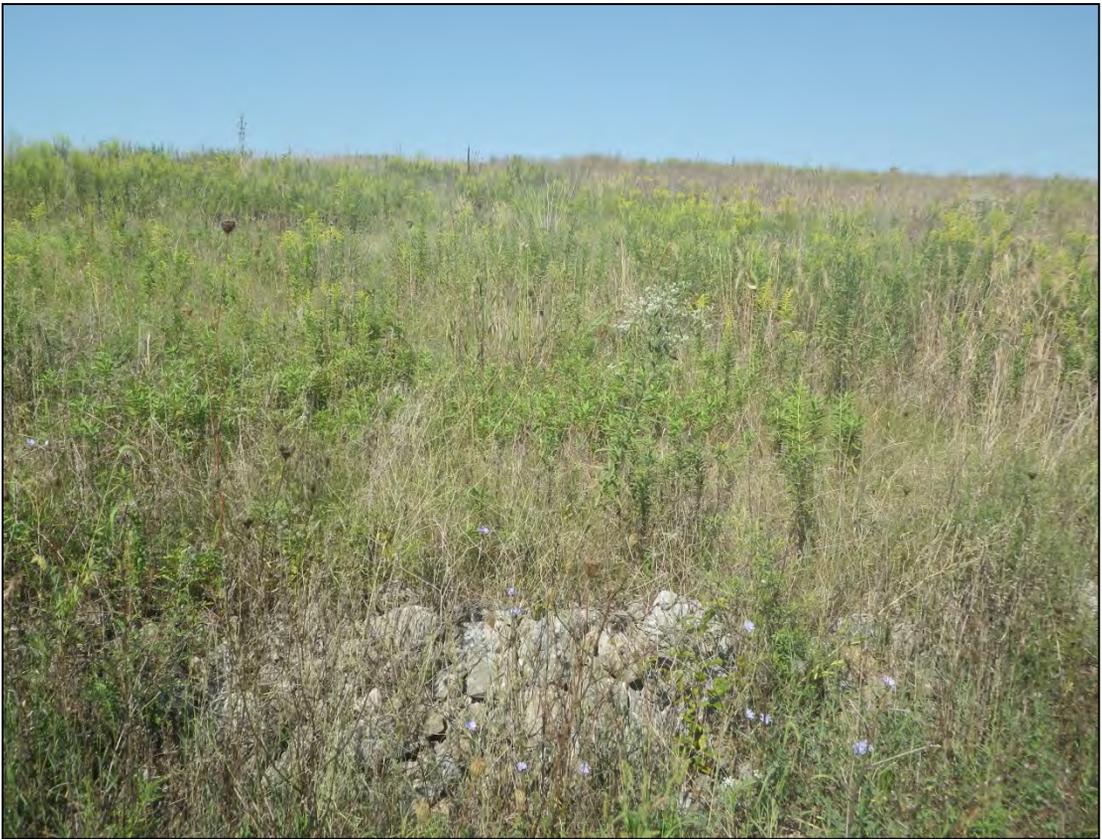
IMGP5816

East Face Cell 8

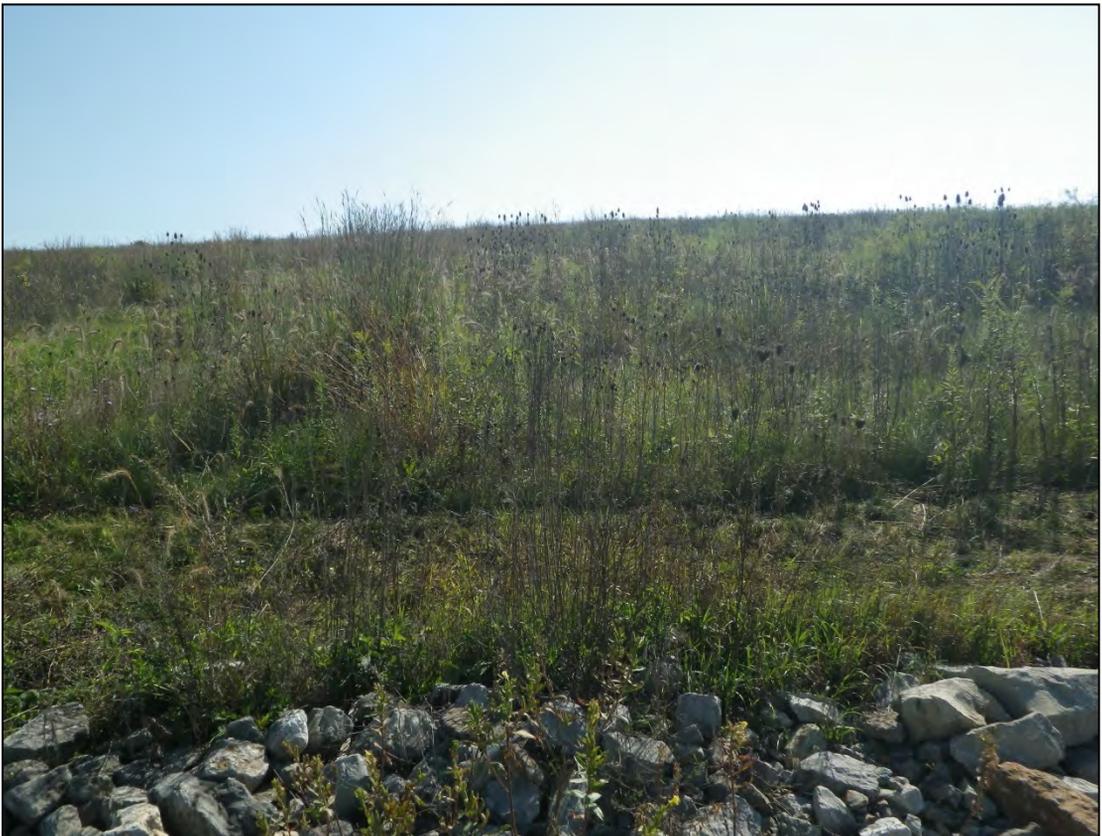
IMGP5813

West Face Cell 8

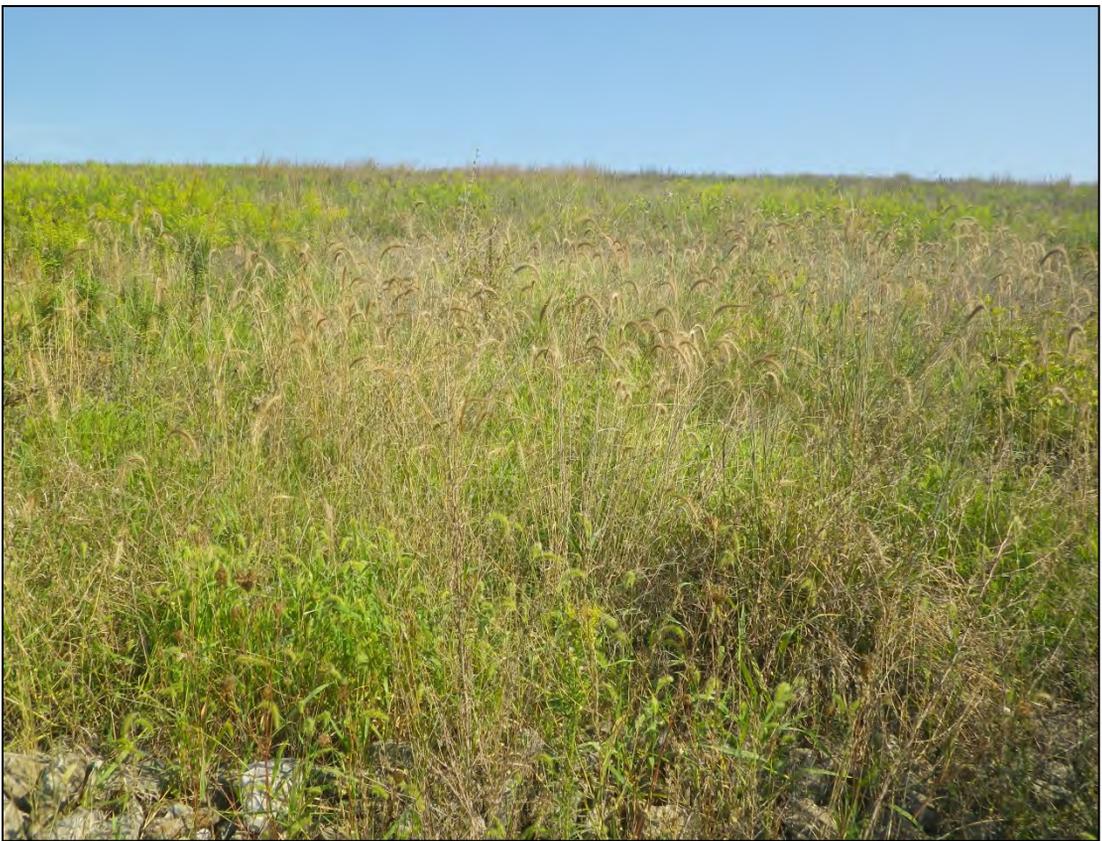
IMGP5814

South Face Cell 8
