SUBJECT: Transmittal of the September 2016 Fernald Quarterly Inspection Report

This letter is the September 2016 quarterly inspection report for the Fernald Preserve at the Fernald, Ohio, Site. Inspections are conducted as directed by the *Comprehensive Legacy Management and Institutional Controls Plan (LMICP) (LMS/FER/S03496)*. This letter also fulfills the reporting requirements specified in the Environmental Covenant, which is Appendix D of the *Consent Decree Resolving Ohio's Natural Resource Damage Claim Against DOE*. The inspections confirm that the activity and use limitations for the Fernald Preserve remain in place and are being complied with.

Fernald Preserve OSDF Walkdown Inspection Report

FERNALD PRESERVE

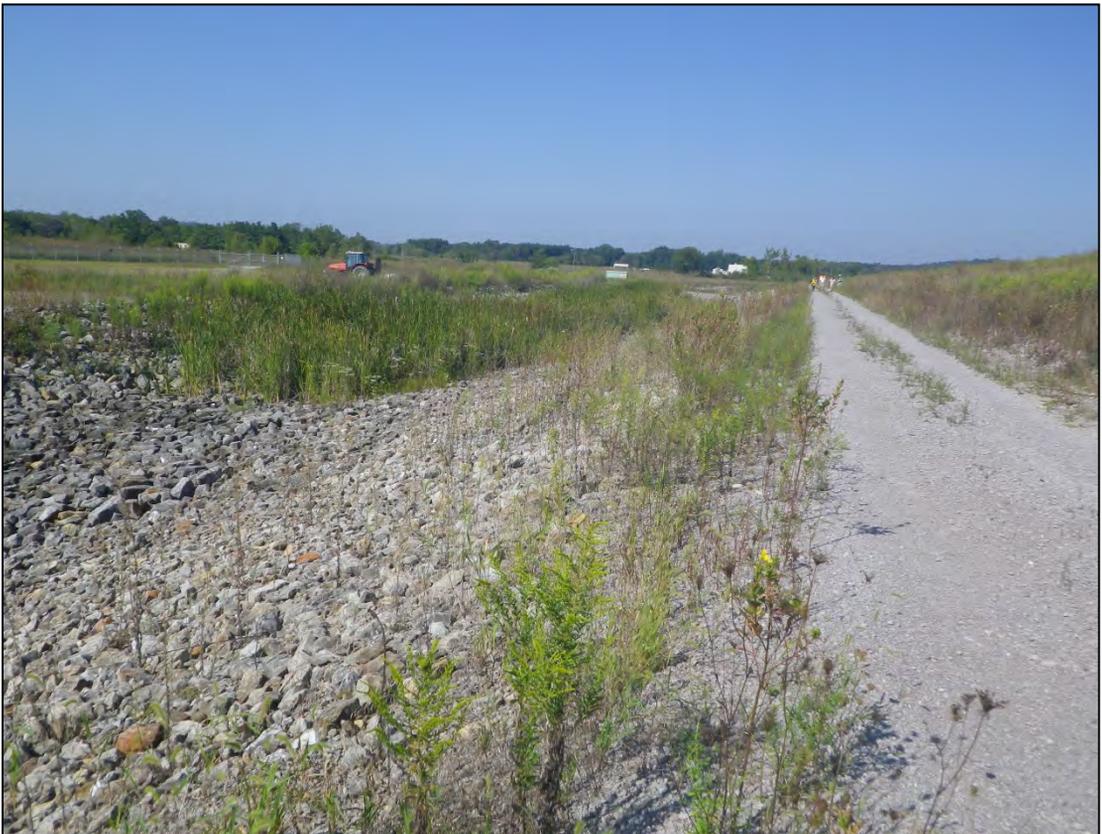
IMGP5815

South Drainage (looking west)

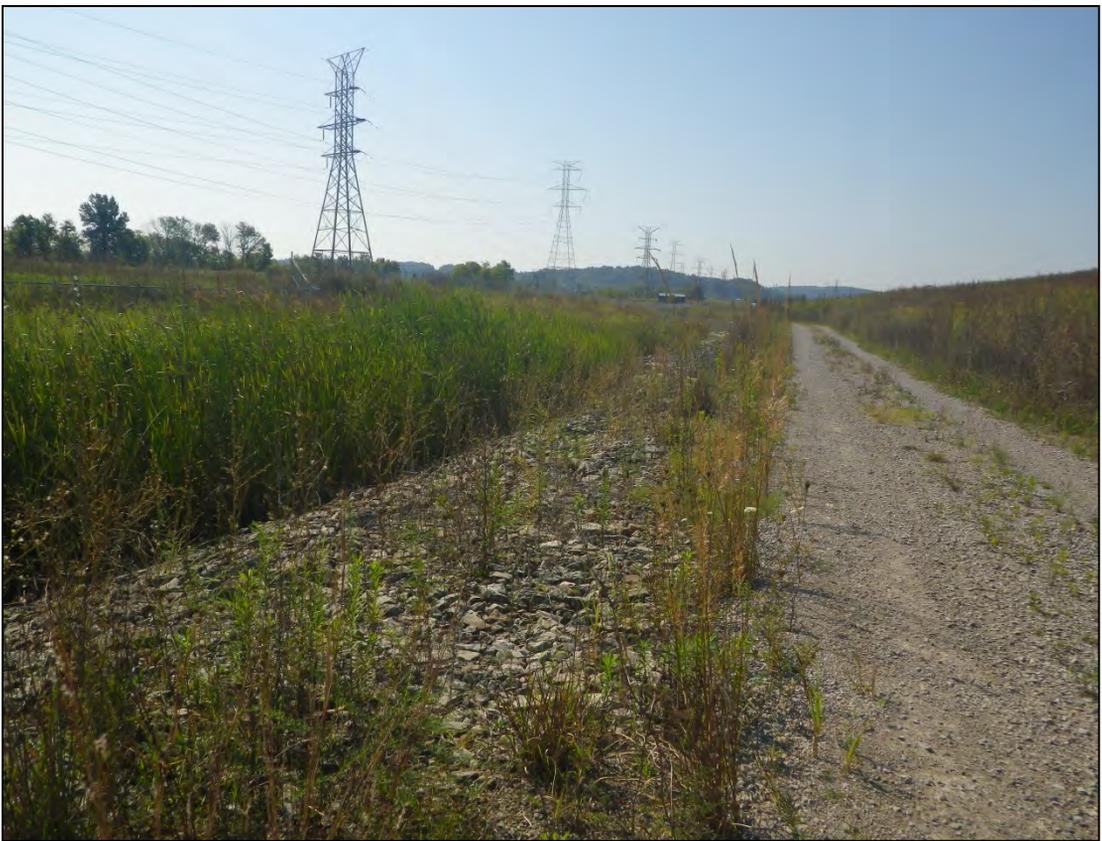
IMGP5818

East Drainage Cell 7 (looking south)

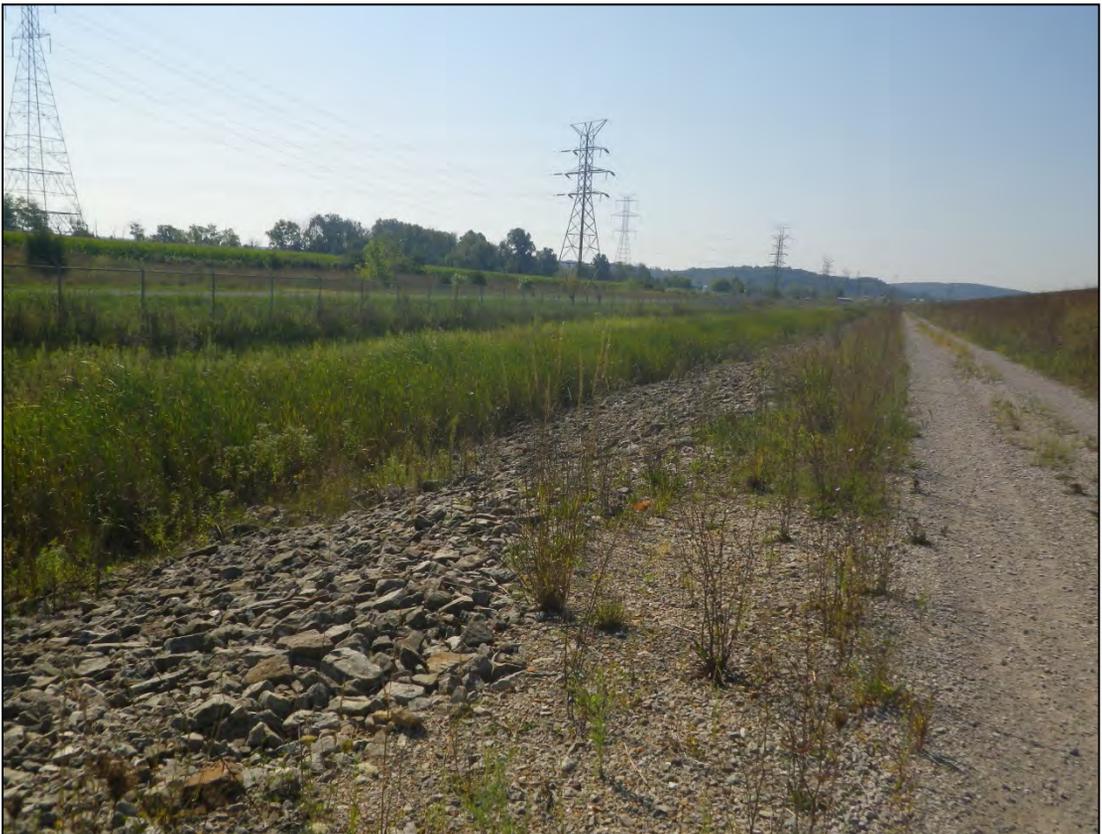
IMGP5822

East Drainage Cell 4 (looking south)

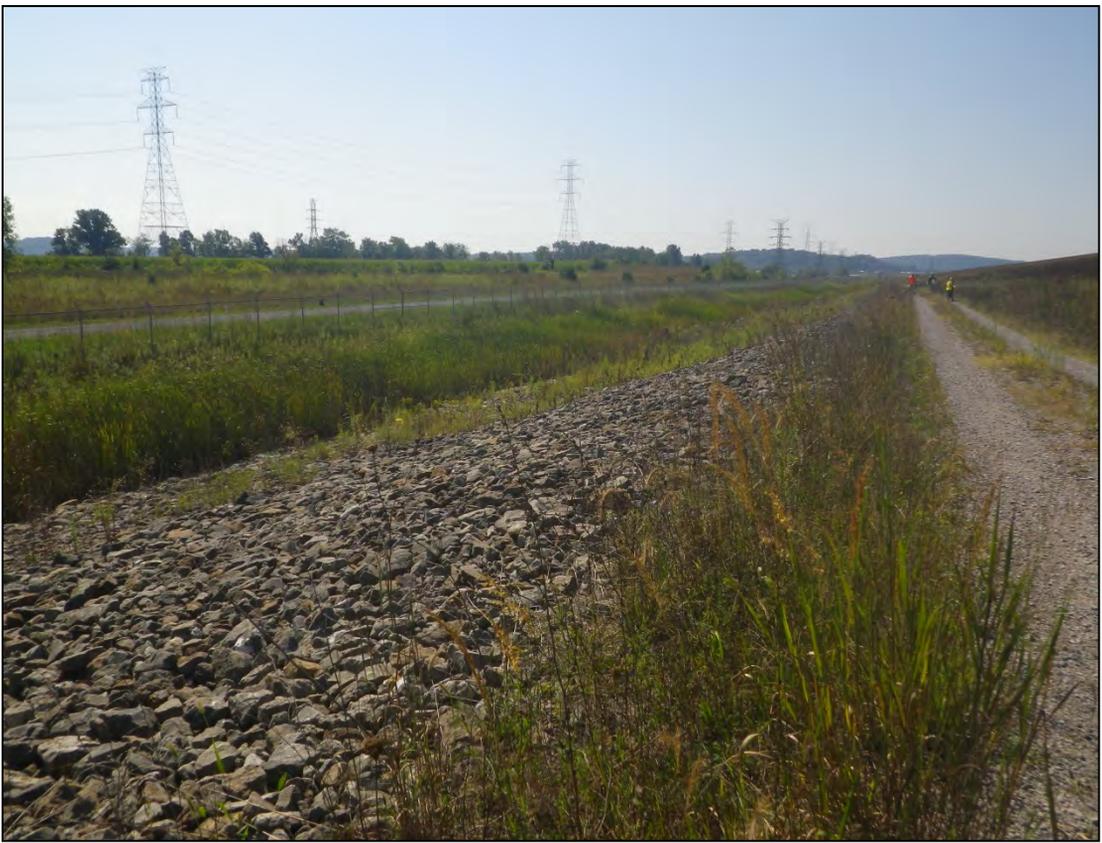
IMGP5826

East Drainage Cell 1 (looking south)

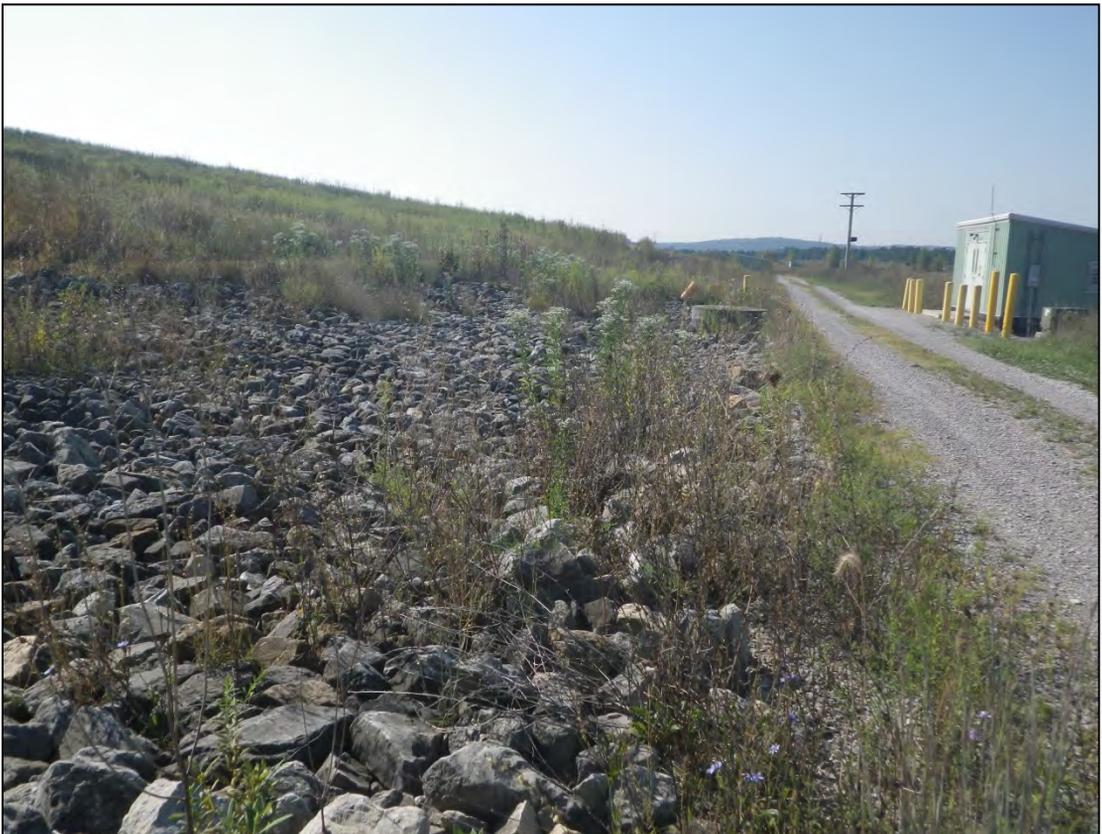
IMGP5810

West Inner Drainage Cell 7 (looking south)

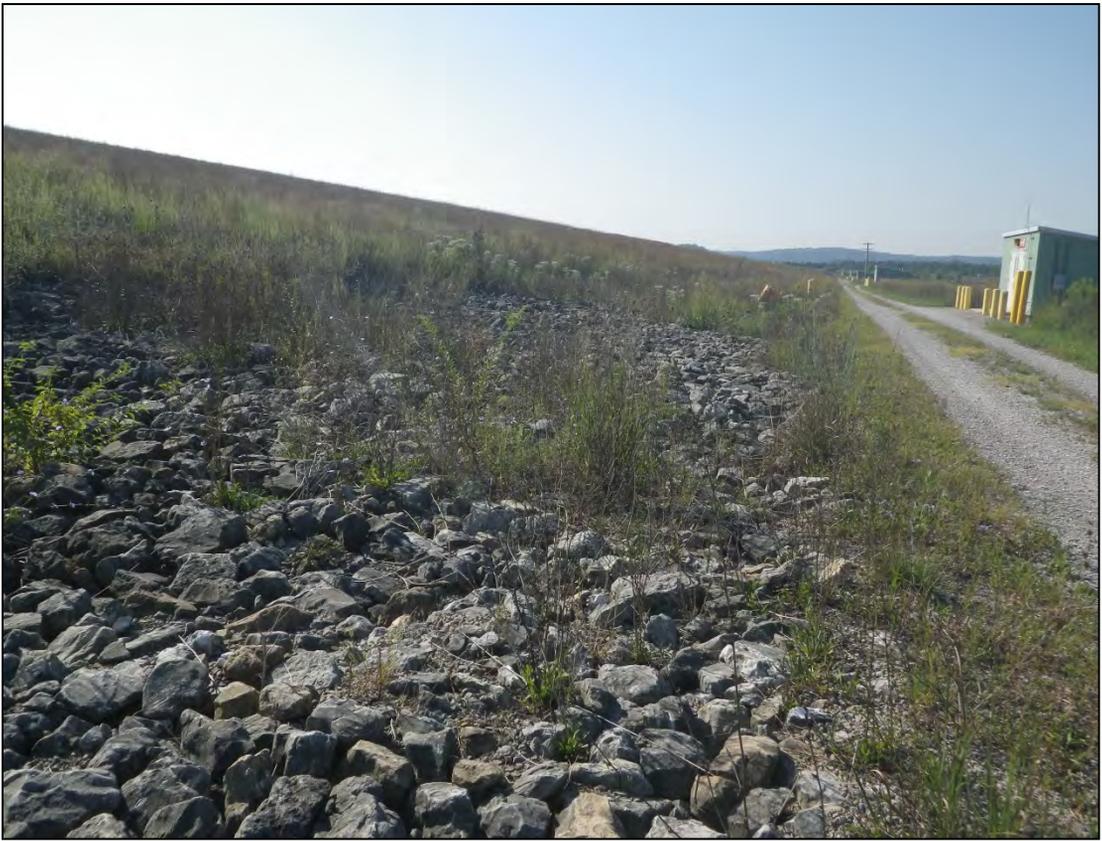
IMGP5806

West Inner Drainage Cell 4 (looking south)

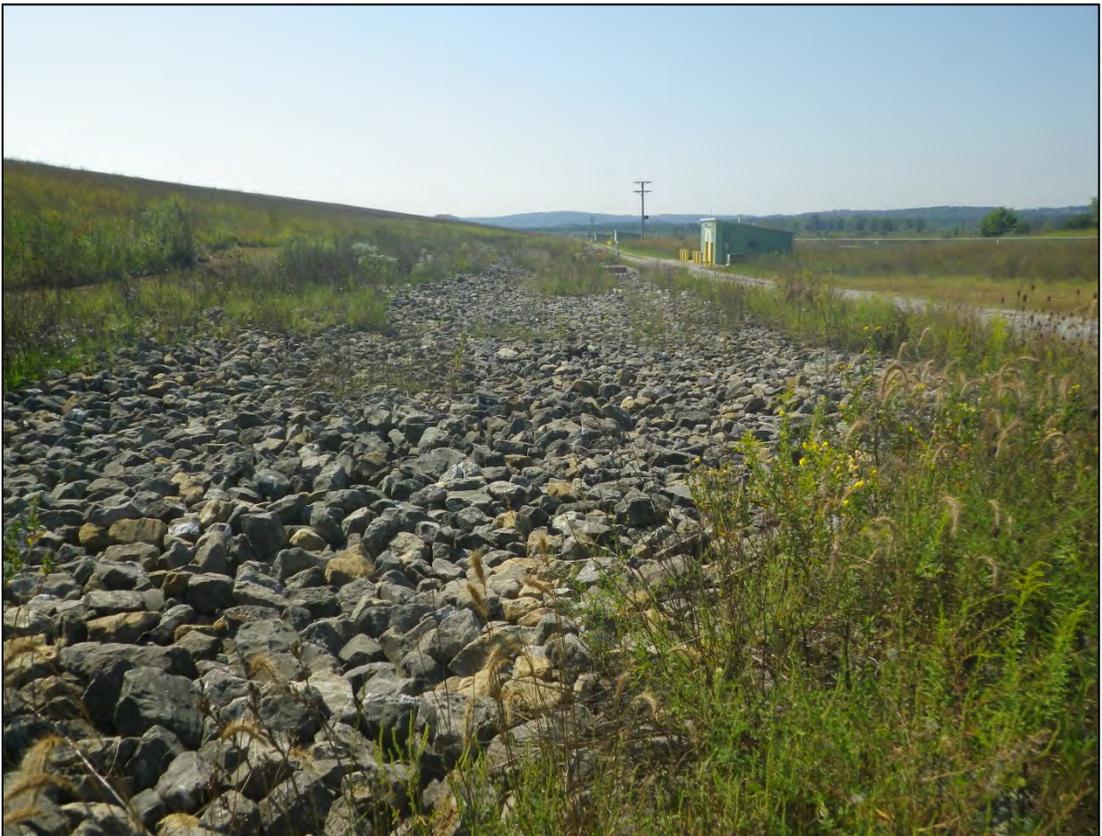
IMGP5829

West Inner Drainage Cell 1 (looking south)

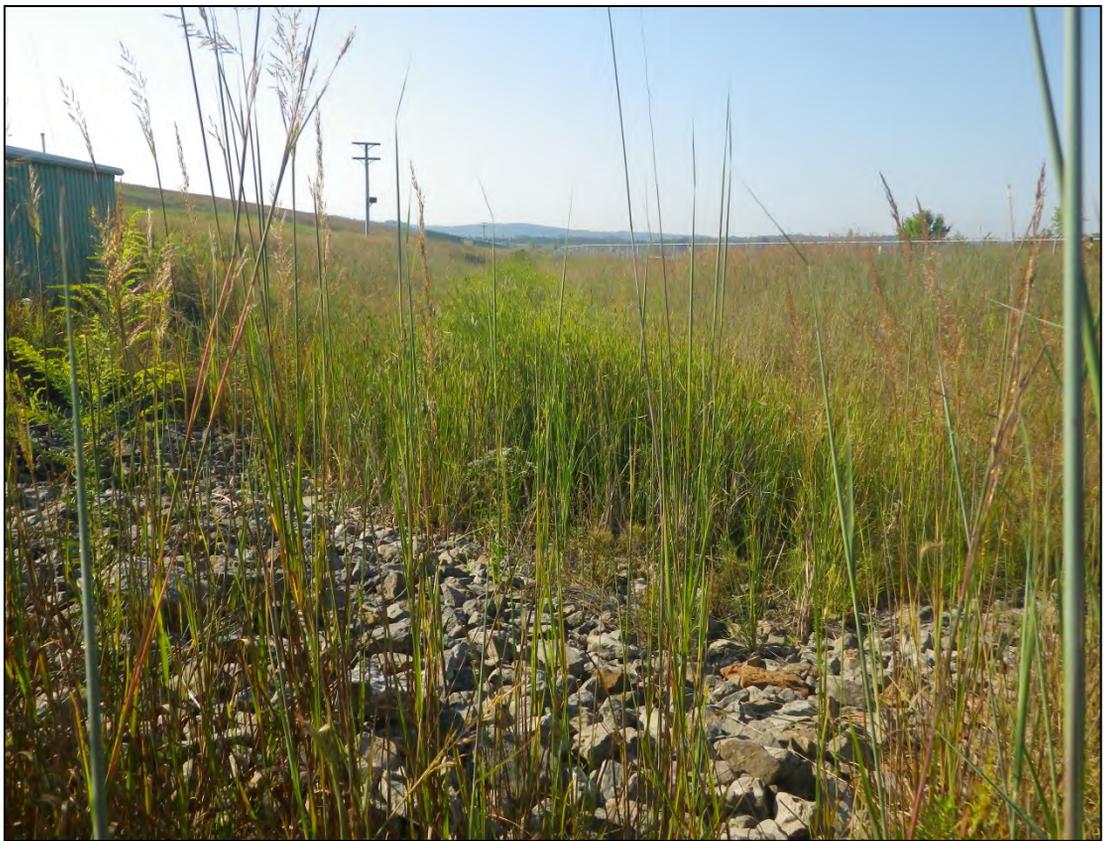
IMGP5801

West Outer Drainage Cell 1 (looking south)

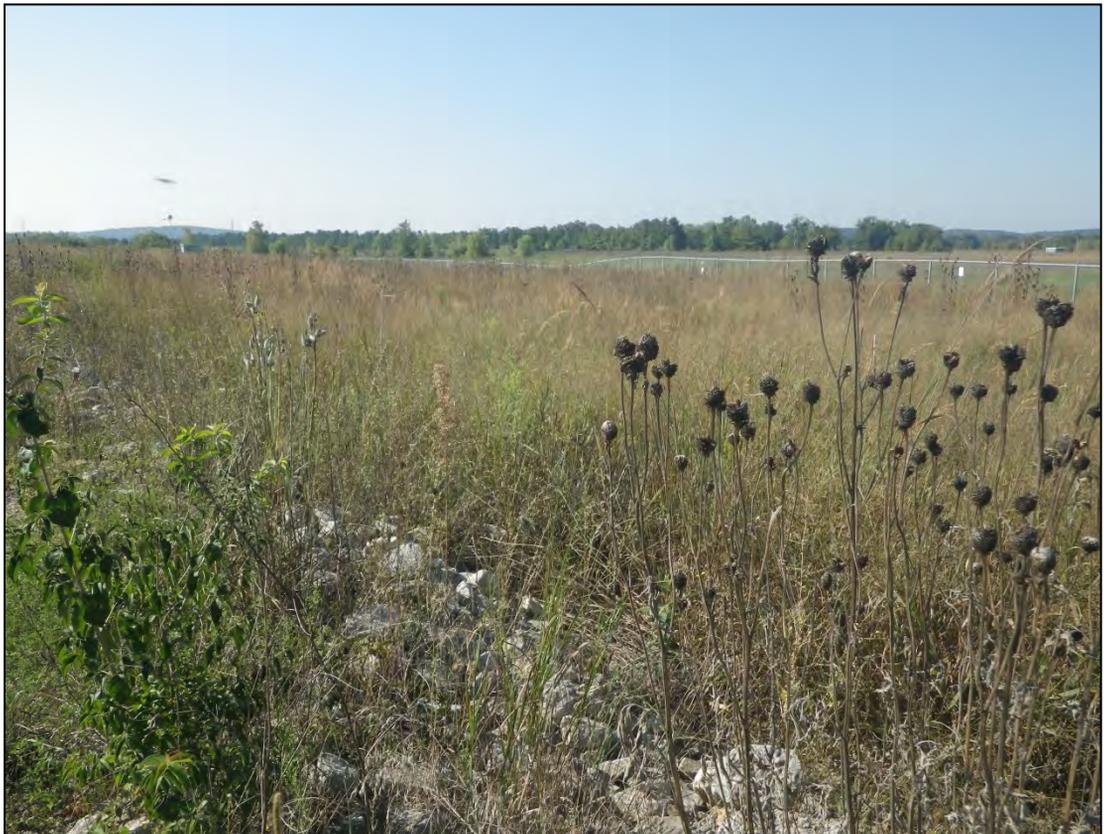
IMGP5812

West Outer Drainage Cell 8 (looking south)

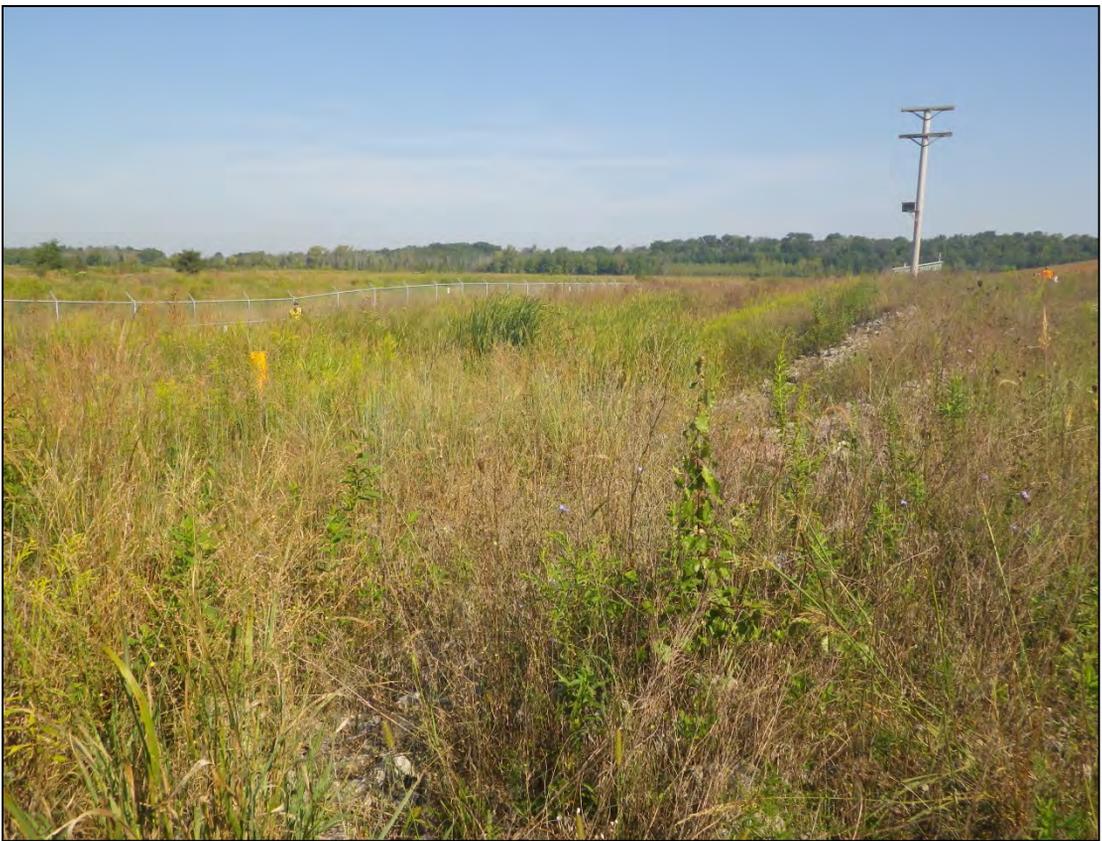
IMGP5811

West Outer Drainage Cell 8 (looking north)
