SUBJECT: Transmittal of the June 2012 Fernald Preserve On-Site Disposal Facility Inspection Forms

On-Site Disposal Facility Inspection Report

June 2012

Fernald Preserve OSDF Walkdown Inspection

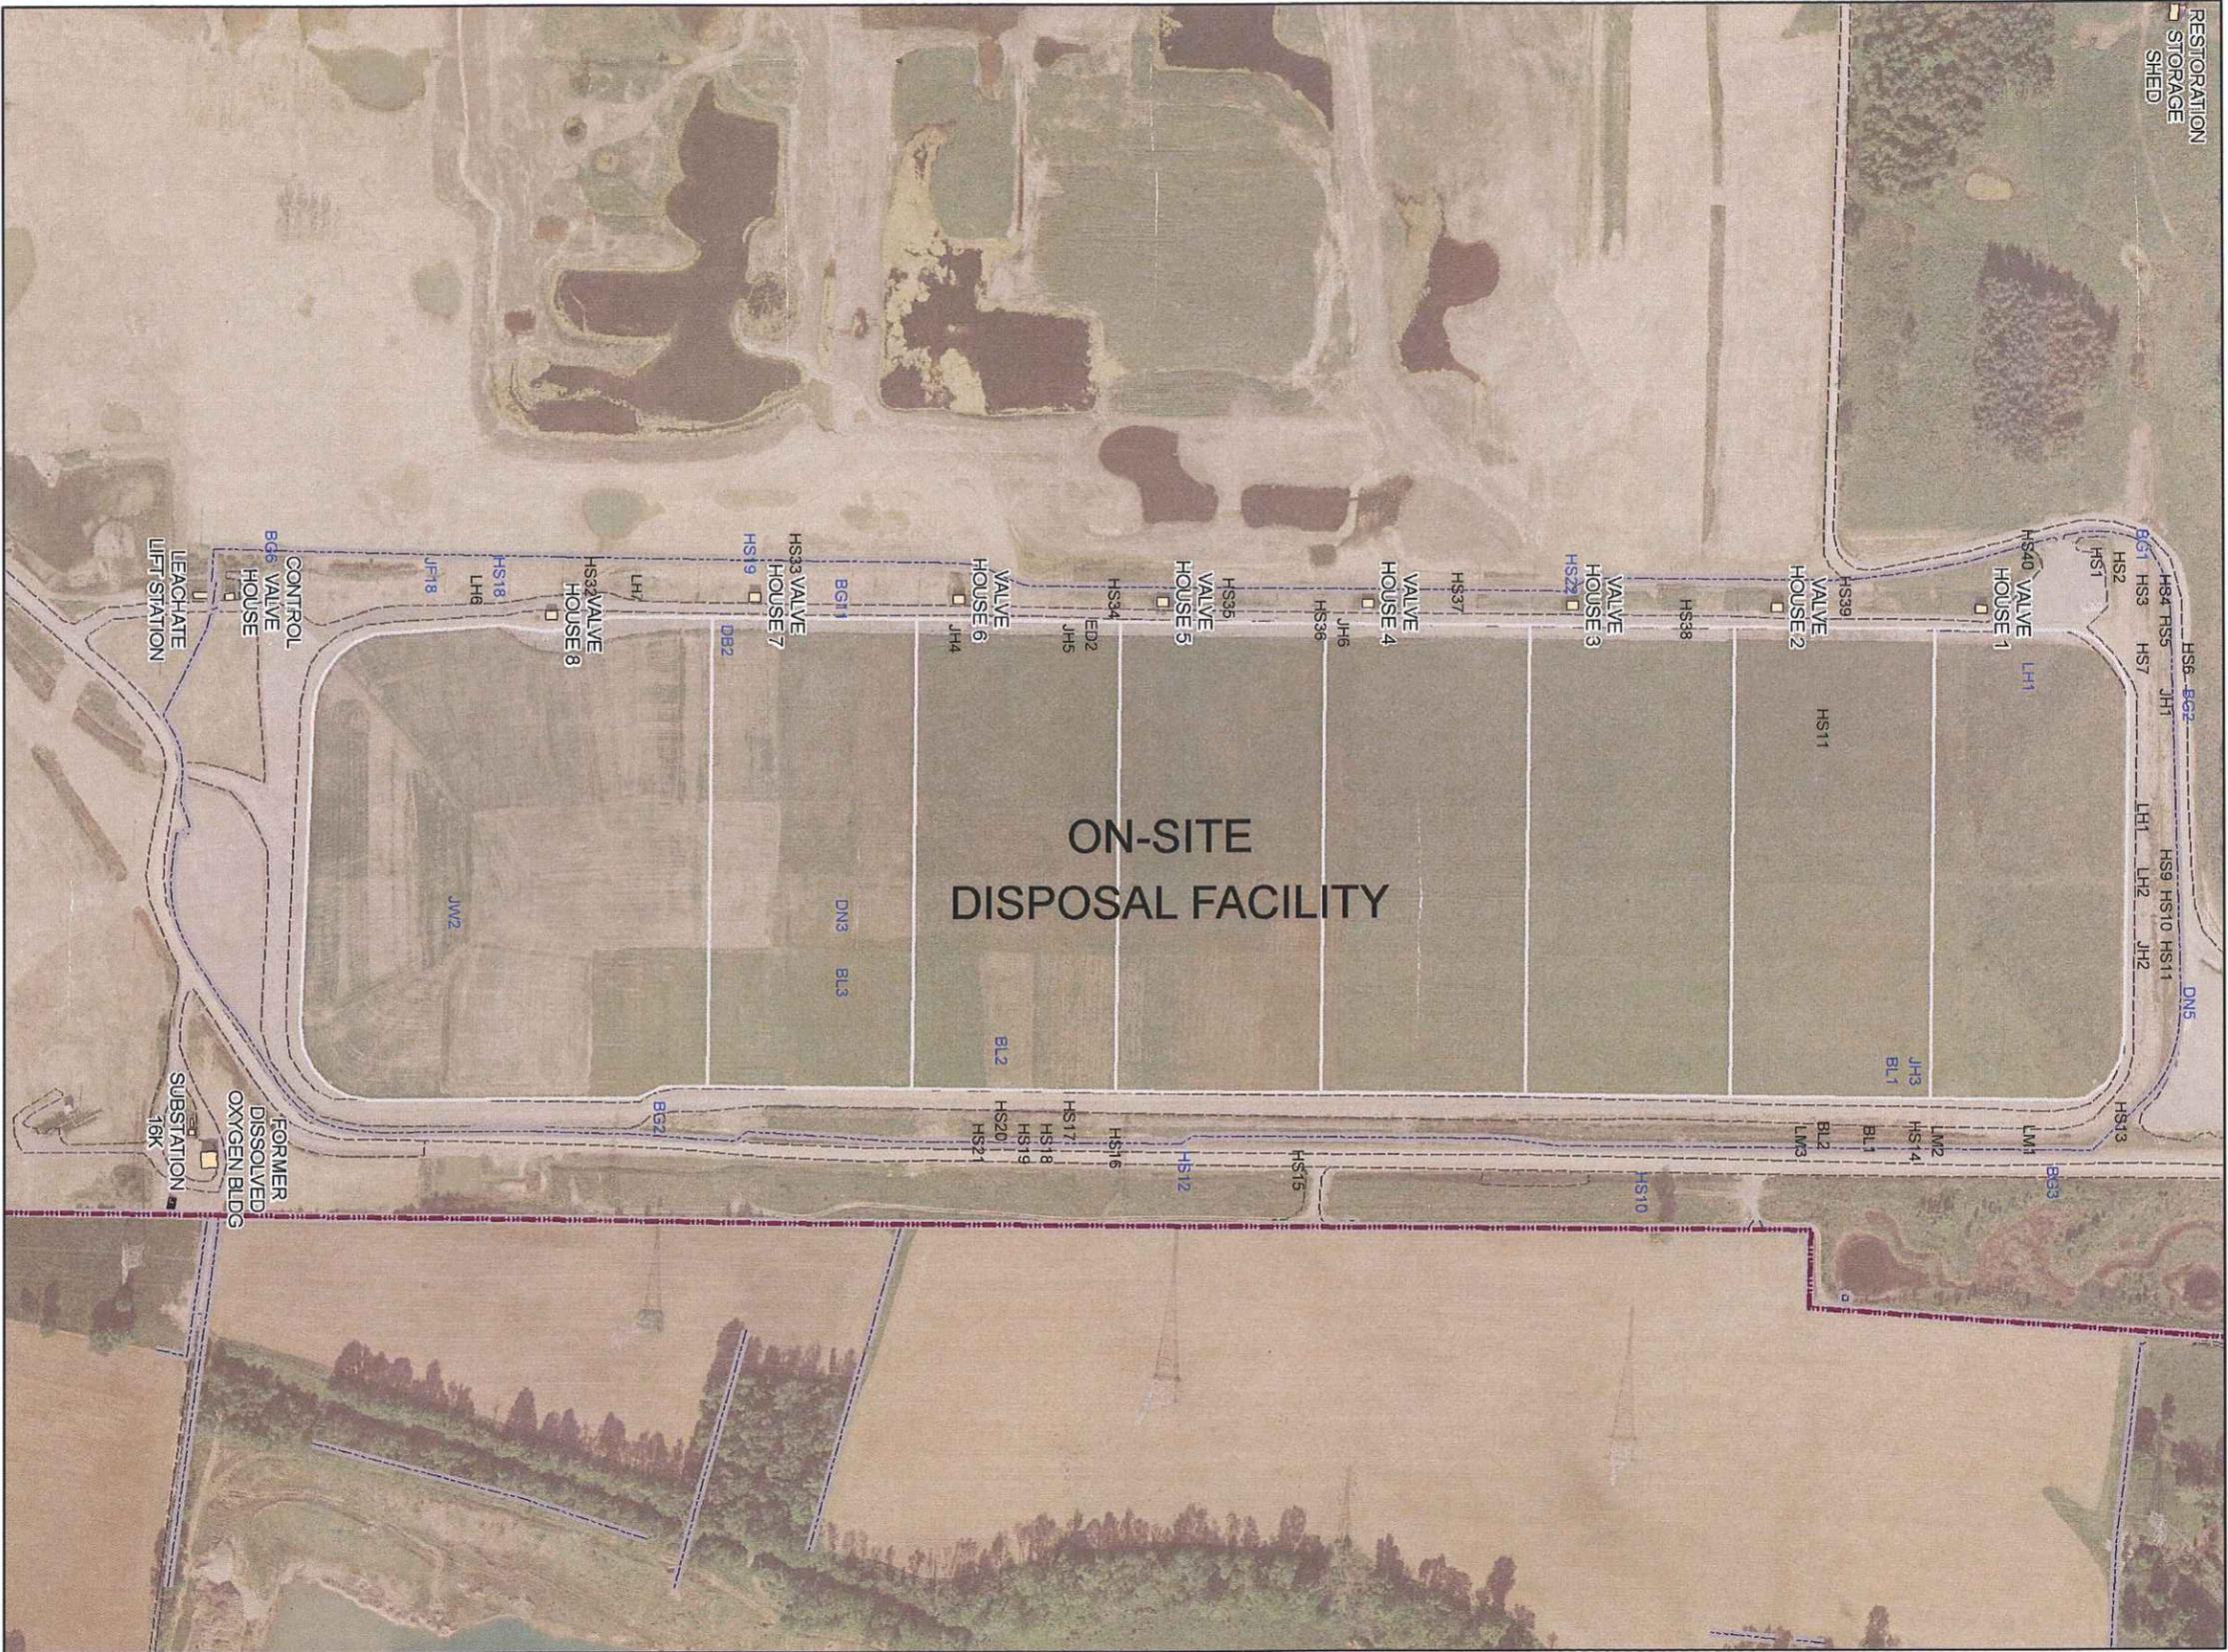
**Fernald Preserve
OSDF (On-Site Disposal Facility)**

June 2012 Inspection Findings
Previous Findings Requiring
Maintenance or Follow-up
