SUBJECT: Transmittal of the September 2012 Fernald Site Inspection Forms

Fernald Preserve Field Walkdown Inspection

Date September 5, 2012 Inspector SM Stoller, Ohio EPA

U.S. DEPARTMENT OF ENERGY HAMILTON, OHIO	Work Performed by S.M. Stoller Corporation <small>Under DOE Contract No. DE-AM01-07LM00060</small>
Fernald Preserve Consolidated Finding Locations for North Section of September 2012 Site Inspection	
DATE PREPARED:	FILENAME:
September 7, 2012	inspection_areas_3rdqtr_2012_north_loc

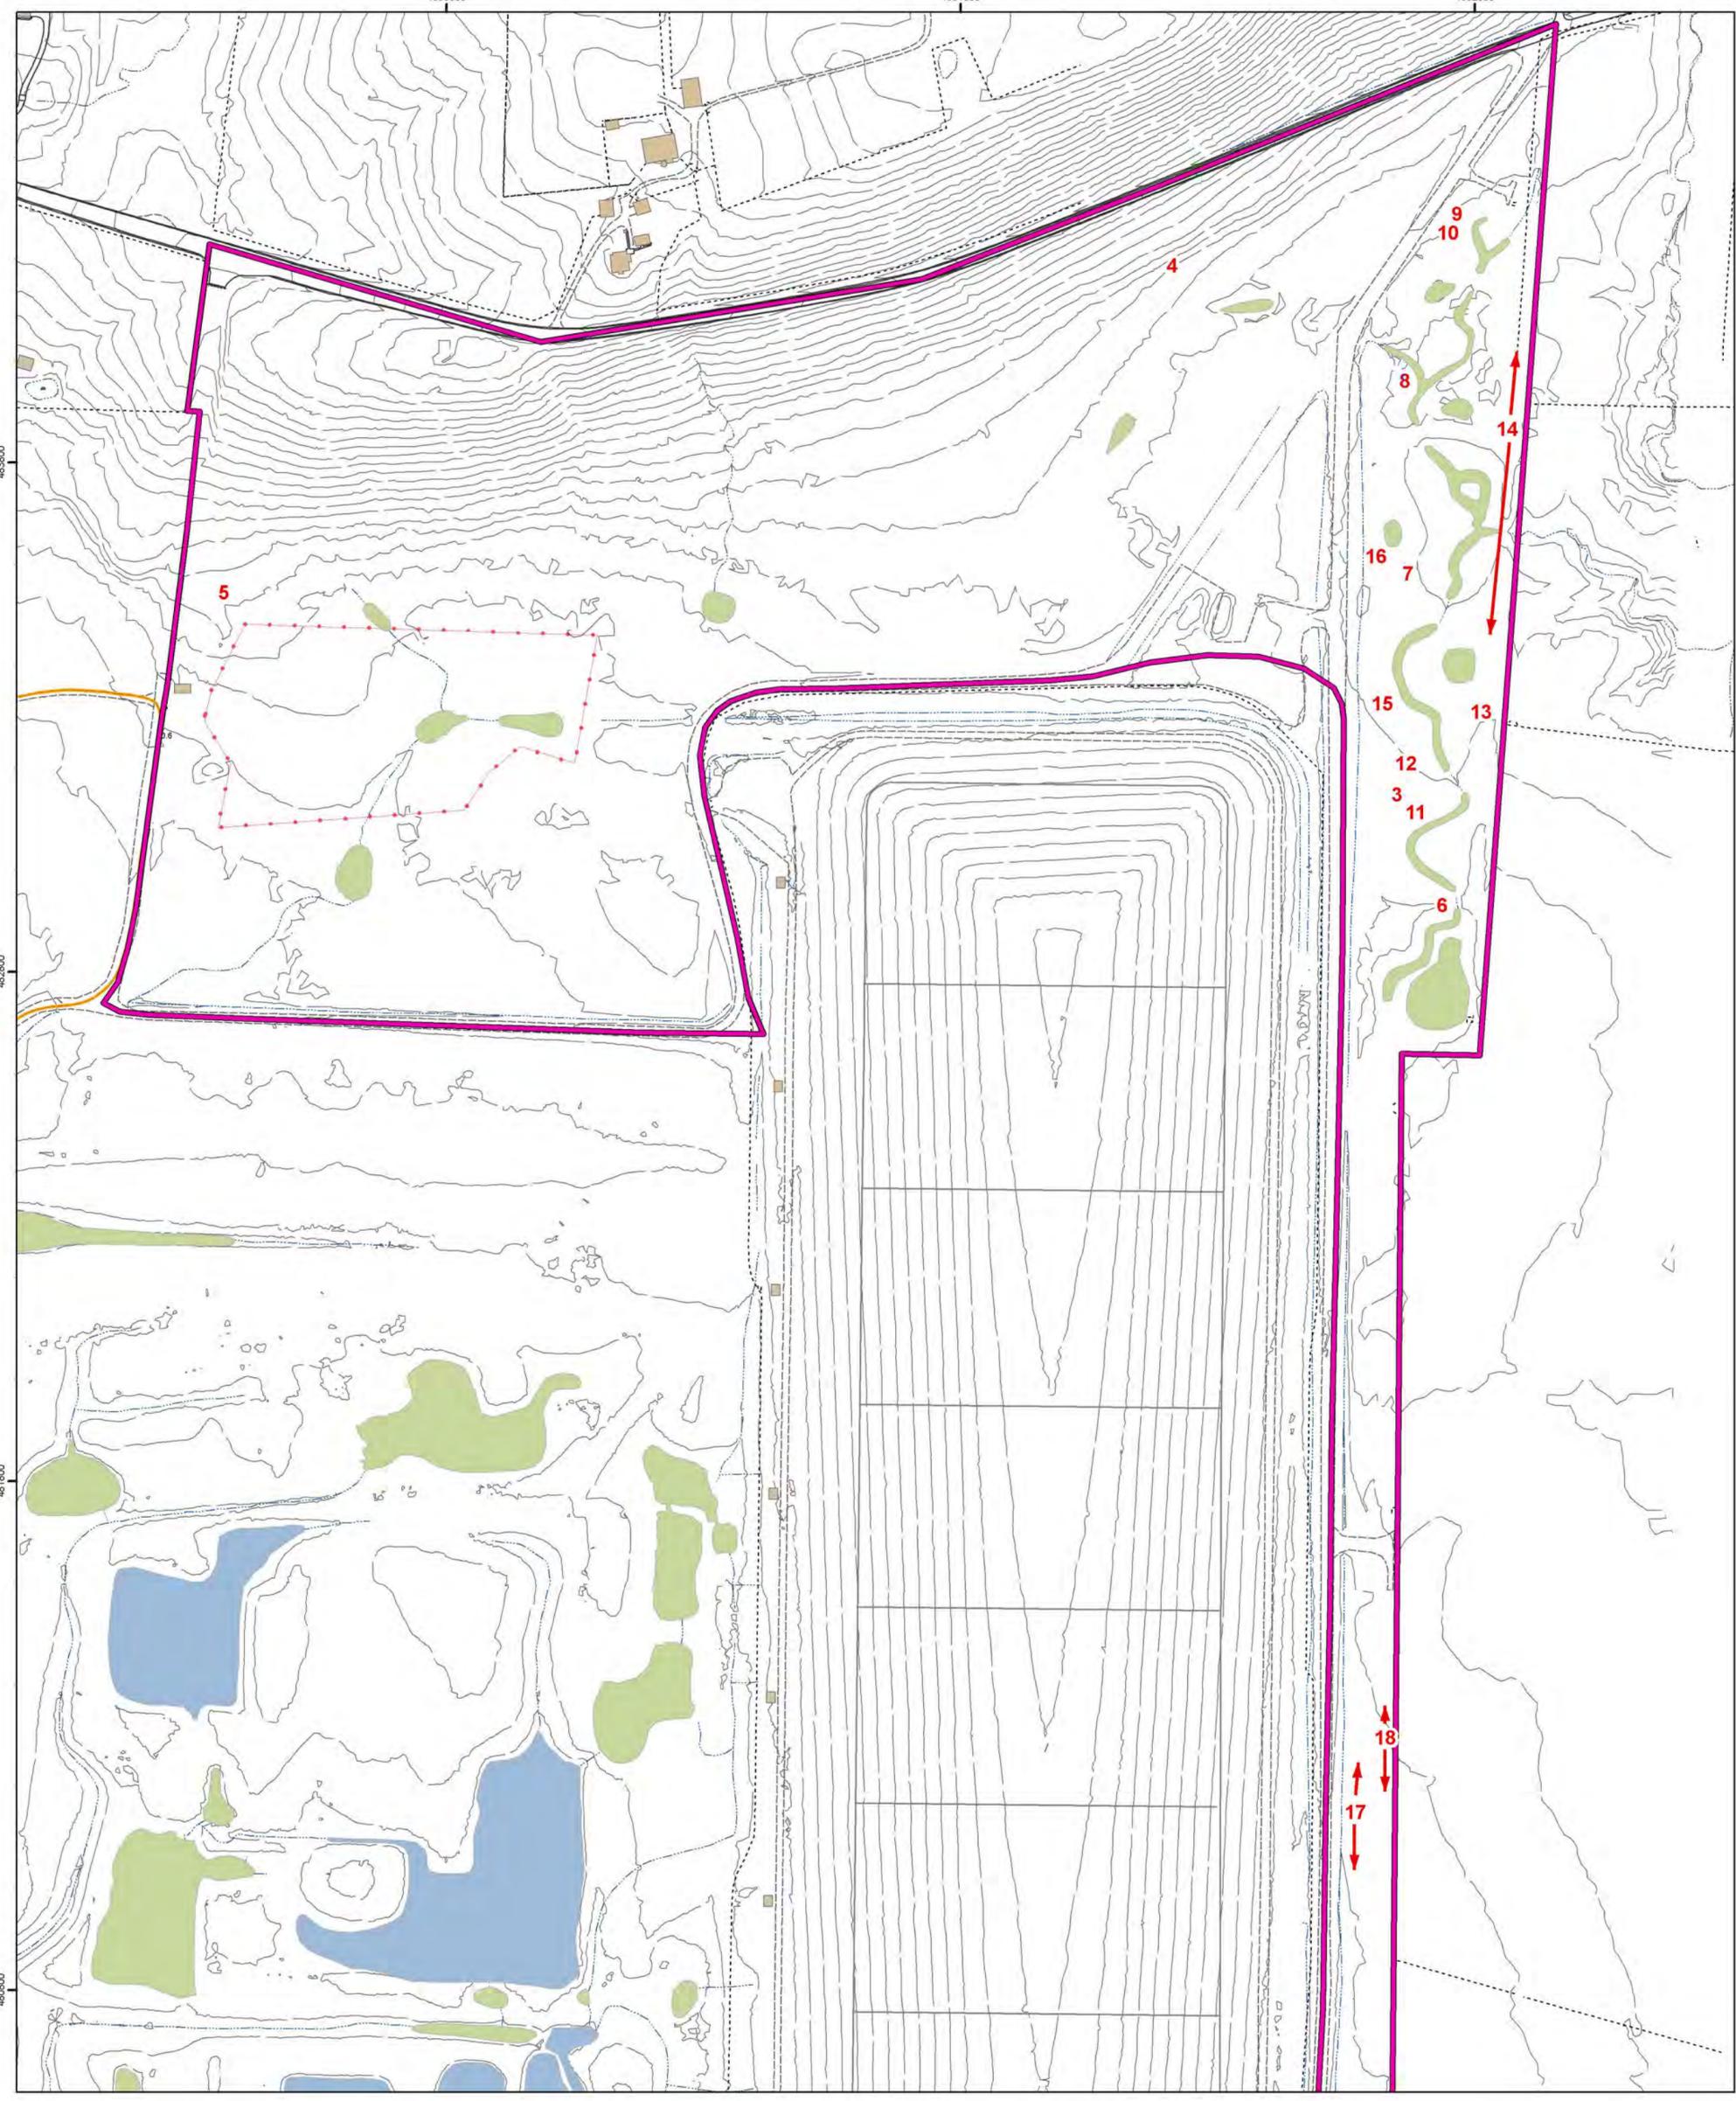
No.	Location (Use Map Whenever Possible)	GPS?	Type of Finding				Description	Photo? (File No.)	Follow Up		
			Unauthorized Use	Disturbance	Vegetation	Other			Corrected	Maintenance Req'd	Cont. Observation
1	East perimeter	NO			X		Callery pear		X		
2	East field	NO			X		Callery pear		X		
3	WM1, Basin 3	NO				X	Rubber pipe and charred log		X		
4	North Pines	NO			X		Teasel on hillside	X			
5	North of Restoration shed	NO				X	Gravel/asphalt patch		X		
6	WM1, W4 and 3	NO			X		Honeysuckle/pear		X		
7	WM1, W5 and 1	NO			X		Honeysuckle		X		
8	WM1, W6	NO			X		Canada thistle and teasel	X			
9	WM1, W7	NO			X		Honeysuckle		X		
10	WM1, W7	NO				X	T-post in hole		X		
11	WM1, W3	NO			X		Bare spot		X		
12	WM1, W3 and 2	NO			X		Bare spot		X		
13	WM1, W2 – fenceline	NO				X	A bat house coming down		X		
14	WM1, fenceline	NO			X		Large honeysuckle		X		
15	WM1	NO			X		Multiflora rose		X		
16	WM1	NO				X	Soil erosion		X		
17	East perimeter	NO			X		Field of poison ivy	X

18	East fence	NO			X		Poison ivy on fence	X			
19	Lodge Pond basin north bank	NO			X		Thistle		X		
20	Lodge Pond trail inside loop	NO			X		Thistle		X
