PC-000456/0

# GENERAL ATOMICS HOT CELL CHARACTERIZATION REPORT

**GA HOT CELL D&D PROJECT**  
**CONTRACT NO. DE-AC03-95SF20798**  
**PROJECT NO. 7340**

**DECEMBER 1995**

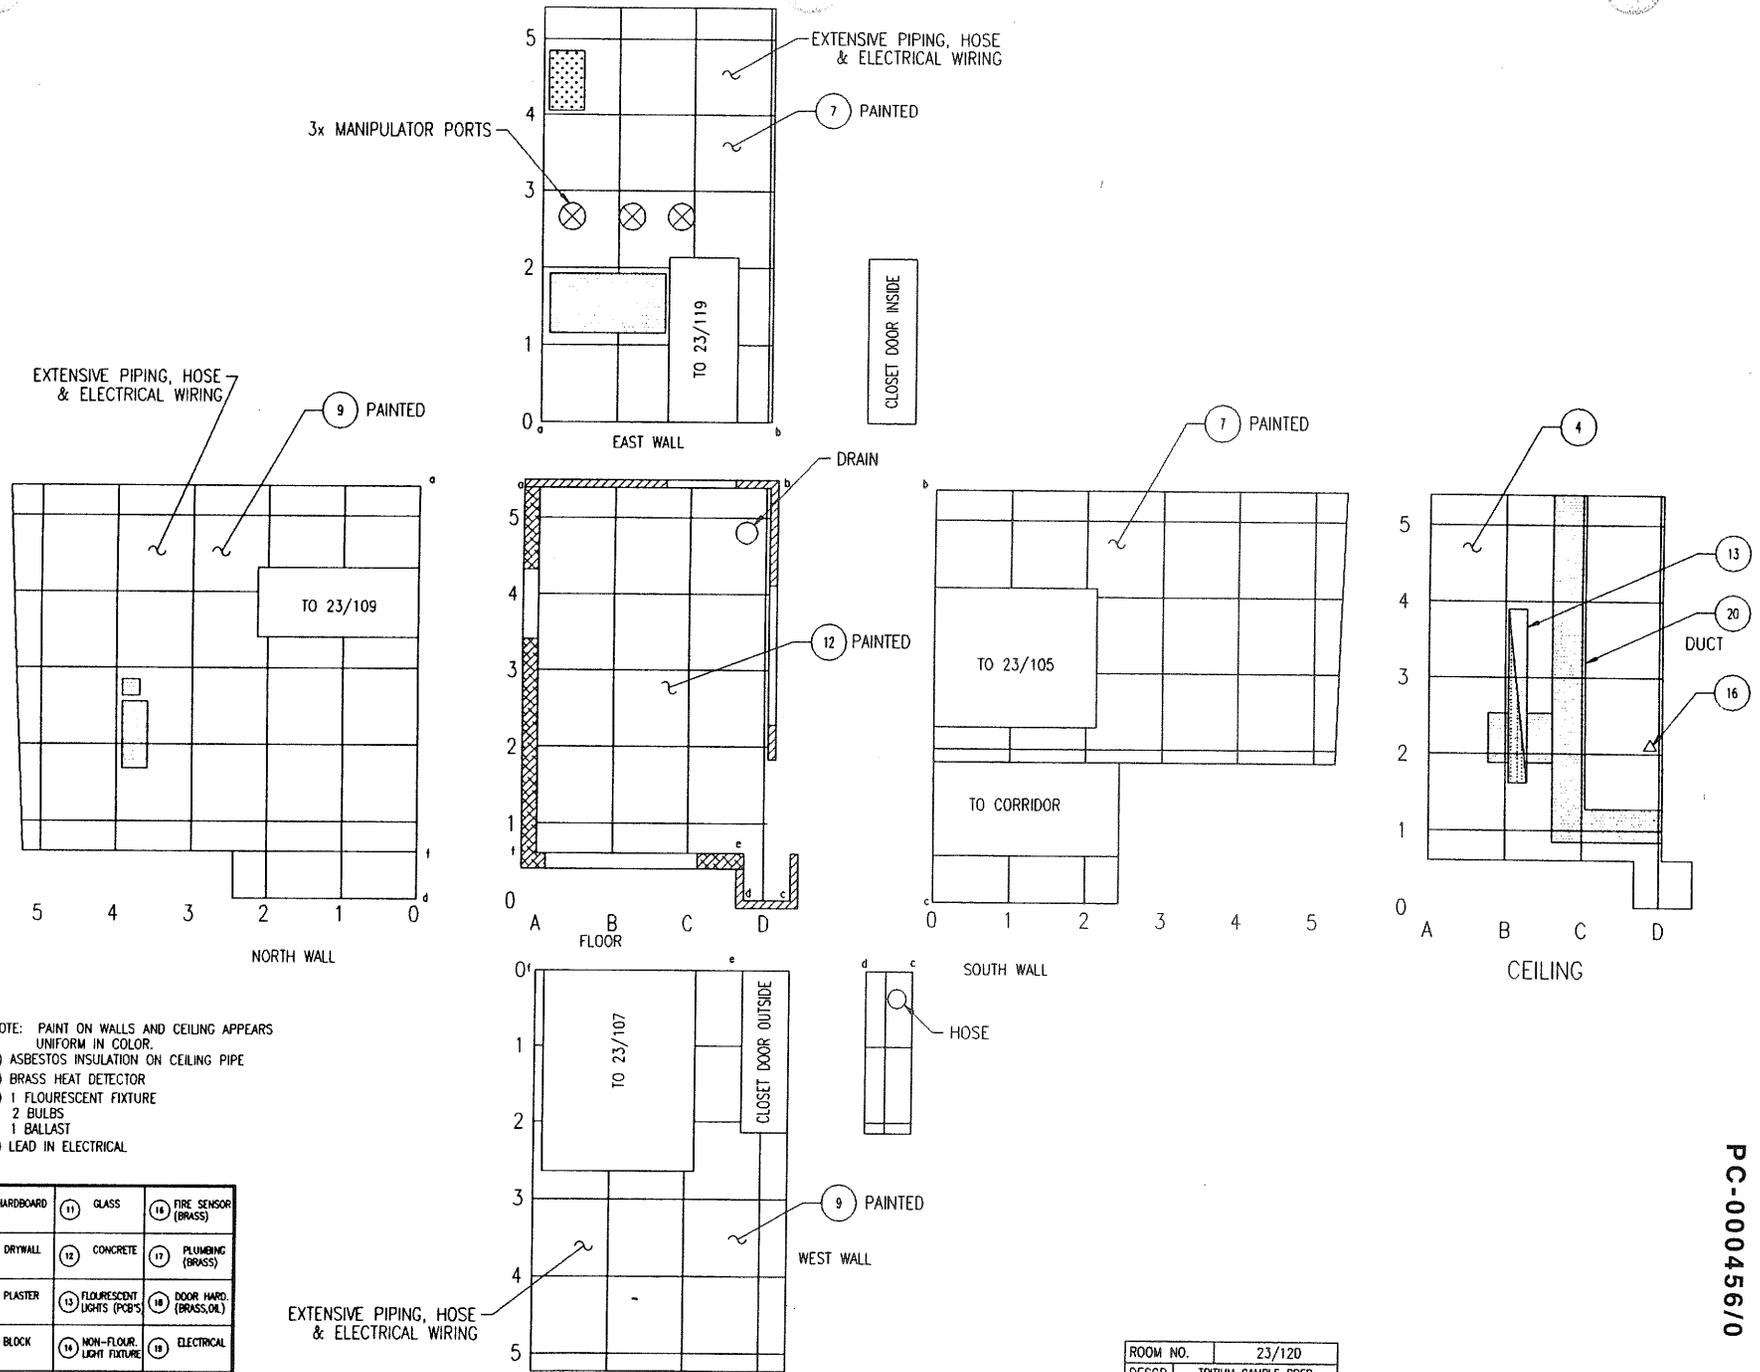
Fig. 4-25—Room 120, ESTES Sample Preparation

NOTE: PAINT ON WALLS AND CEILING APPEARS UNIFORM IN COLOR.  
 1) ASBESTOS INSULATION ON CEILING PIPE  
 2) BRASS HEAT DETECTOR  
 3) 1 FLOURESCENT FIXTURE  
    2 BULBS  
    1 BALLAST  
 4) LEAD IN ELECTRICAL
