Annual Inspection of the Grand Junction, Colorado, Site

1.1 Inspection Summary

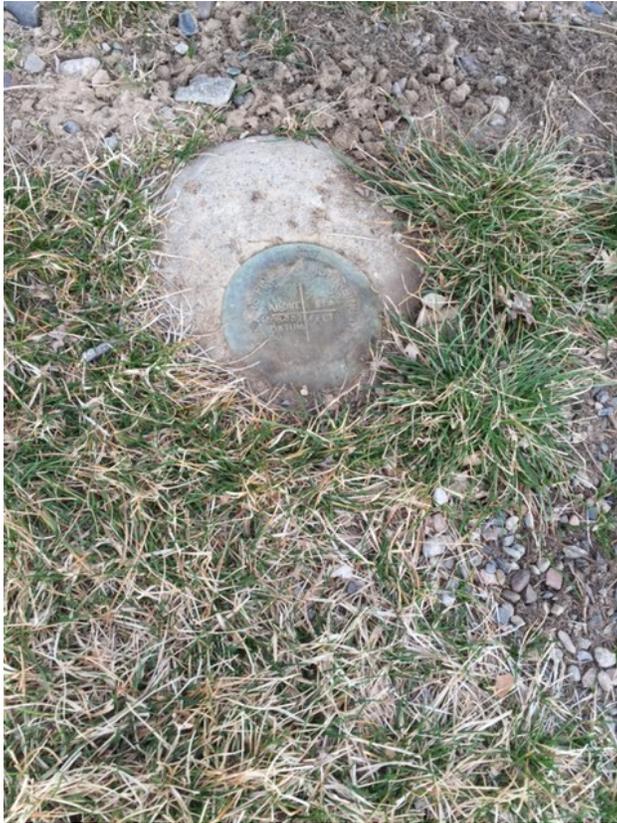
A U.S. Coast and Geodetic Survey monument near the former north gate to the site establishes elevation control for the site. This monument was in good condition (PL-1).

GJO 3/2016. PL-1. U.S. Coast and Geodetic Survey Monument.

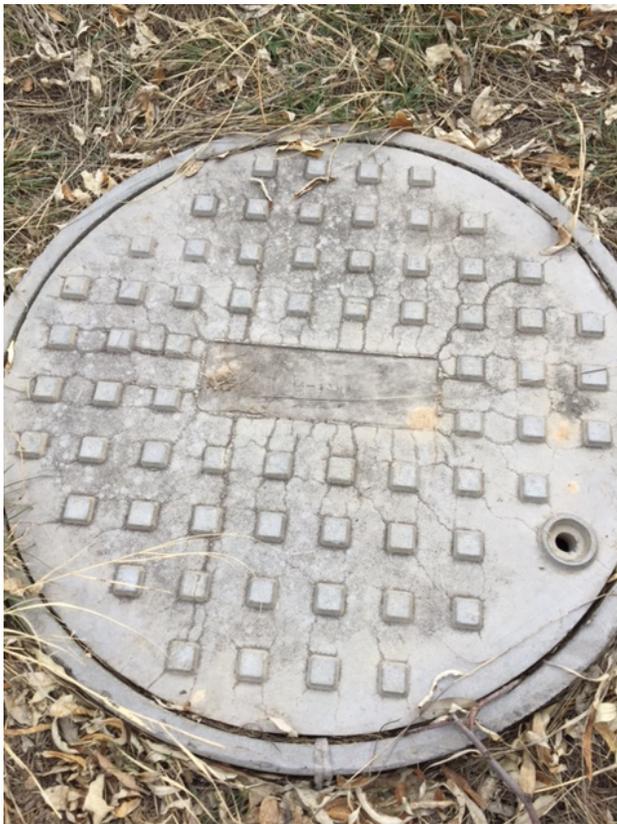
DOE owns eight monitoring wells on the property to monitor the progress of natural flushing of contaminants from the alluvial aquifer. Wells 10-19N, 11-1S, 14-13NA (PL-2), GJ01-02 (PL-3), and GJ84-04 are flush mounted and protected with standard monitoring well metal caps or manhole covers; well GJ84-04 is also protected by steel bollards. Wells 6-2N, 8-4S, and GJ01-01 have above-ground steel well casing protectors; steel bollards are in place as further protection for wells 6-2N and 8-4S. Monitoring well 11-1S well label was re-stamped following the inspection for improved readability. The visible portions of all wells were in good condition.

GJO 3/2016. PL-2. Monitoring well 14-13NA.

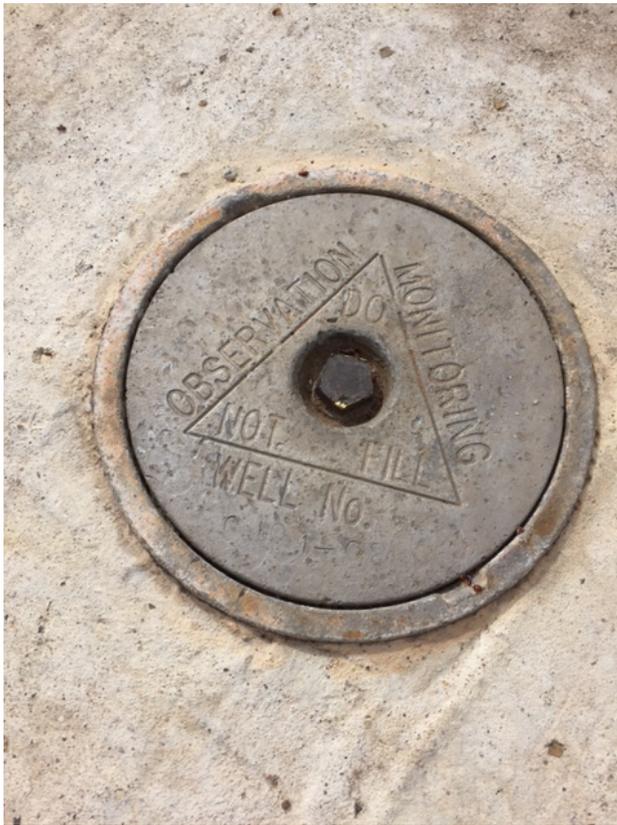
GJO 3/2016. PL-3. Monitoring well GJ01-02.

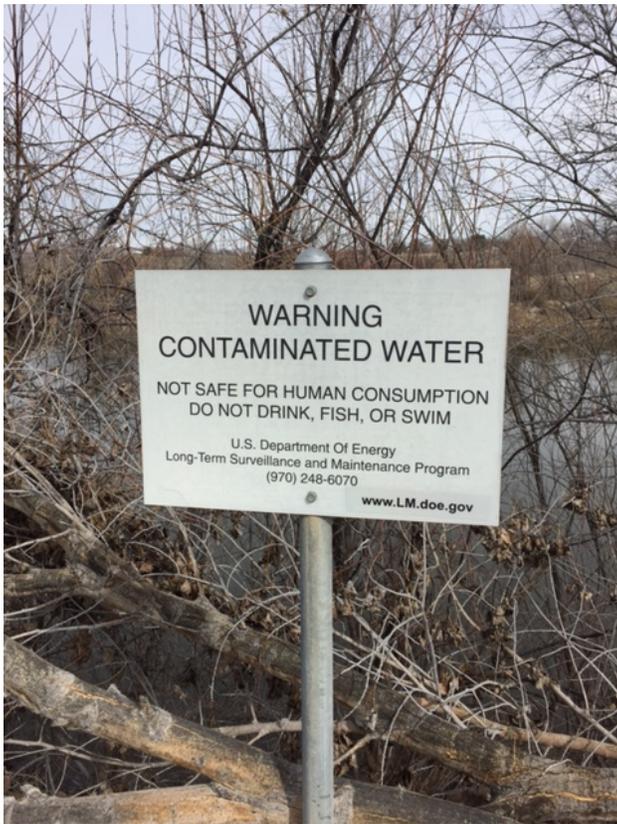
Fifteen warning signs installed on galvanized steel posts are positioned around the surface water areas so the warning will be visible to a person approaching from any direction of reasonable access. All signs were undamaged and legible (PL-4 and PL-5).

GJO 3/2016. PL-4. South Pond warning sign S3.

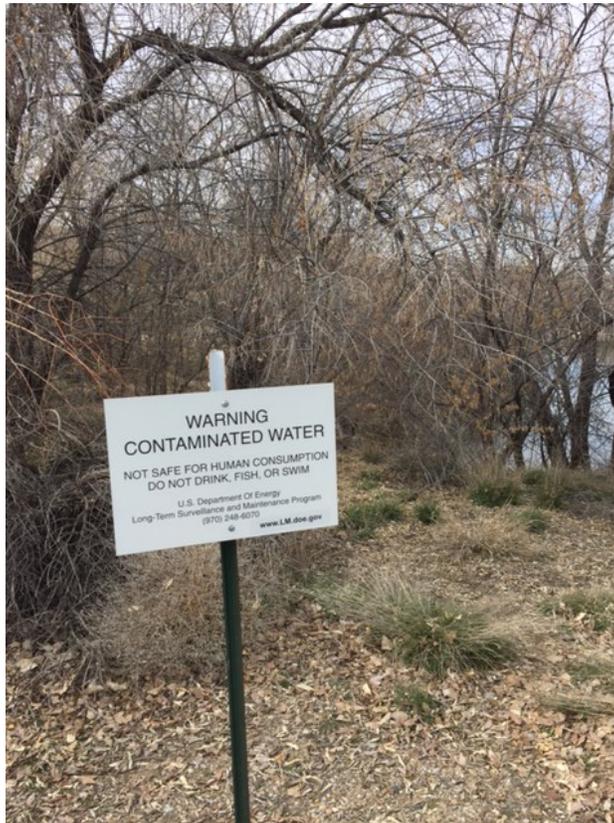
GJO 3/2016. PL-5. South Pond warning sign S1.

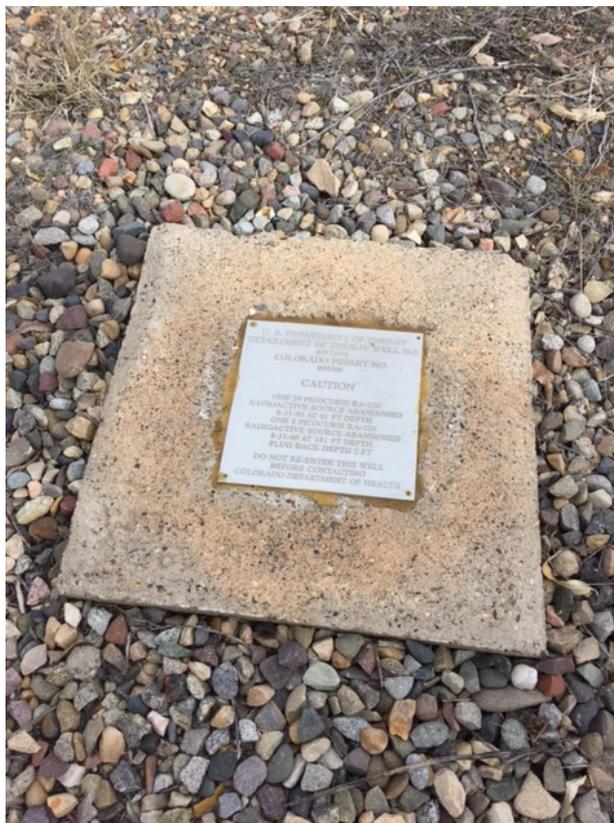
The borehole was decommissioned in place in 2000. DOE perforated the casing above and below each strip of foil and pressure-grouted the annulus with Portland cement to seal the foil in place. The borehole was filled with grout, and a metal plaque was mounted in concrete at ground level over the well. The metal plaque with the borehole information and warning engraved into the metal was in good condition (PL-6).

GJO 3/2016. PL-6. Plaque at decommissioned borehole containing radium foil.
