2011 Annual Inspection Report for the Grand Junction, Colorado, Site

Summary

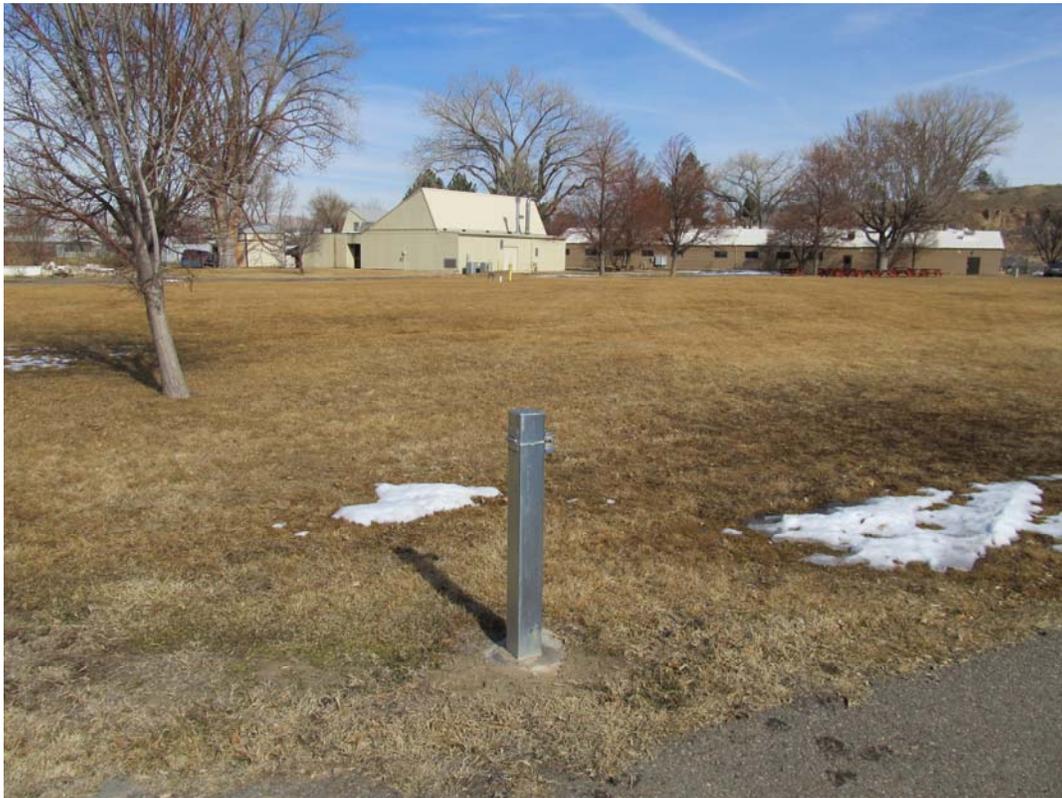
Monitoring Wells—DOE owns eight monitoring wells on the property to monitor the progress of natural flushing of contaminants from the alluvial aquifer. Currently, seven of the wells are sampled annually. Several of the wells are flush mounted and protected with standard monitoring well metal caps or manhole covers. A new above-ground metal well protector was installed at well GJ01-01 since the last inspection (PL-1). Visible portions of all wells were in good condition. The lock on well 6-2N appeared closed but pulled open when tested; the lock was subsequently lubricated to ensure that it would latch properly.

GJO 2/2011. PL-1. New well protector at monitoring well GJ01-01.

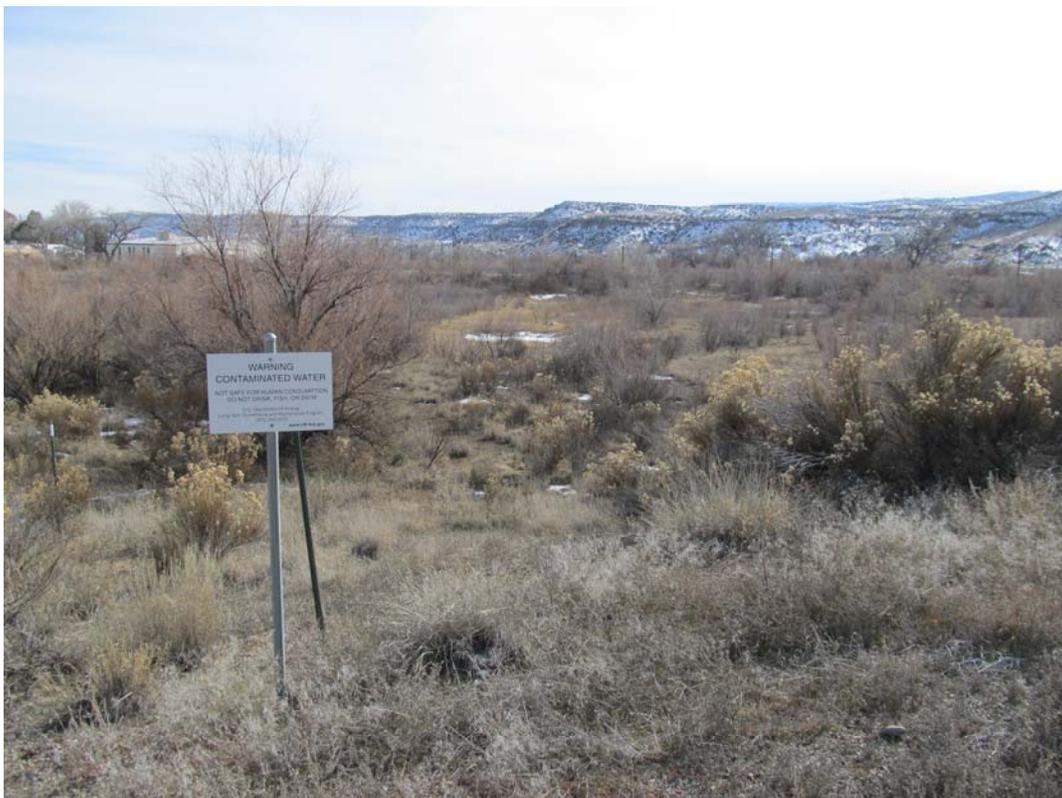
Warning Signs—Fifteen warning signs installed on galvanized steel posts are positioned around the surface water areas so the warning will be visible to a person approaching from any direction of reasonable access. All signs were undamaged and legible (PL-2).

GJO 2/2011. PL-2. Warning sign S14 and the north wetlands area.

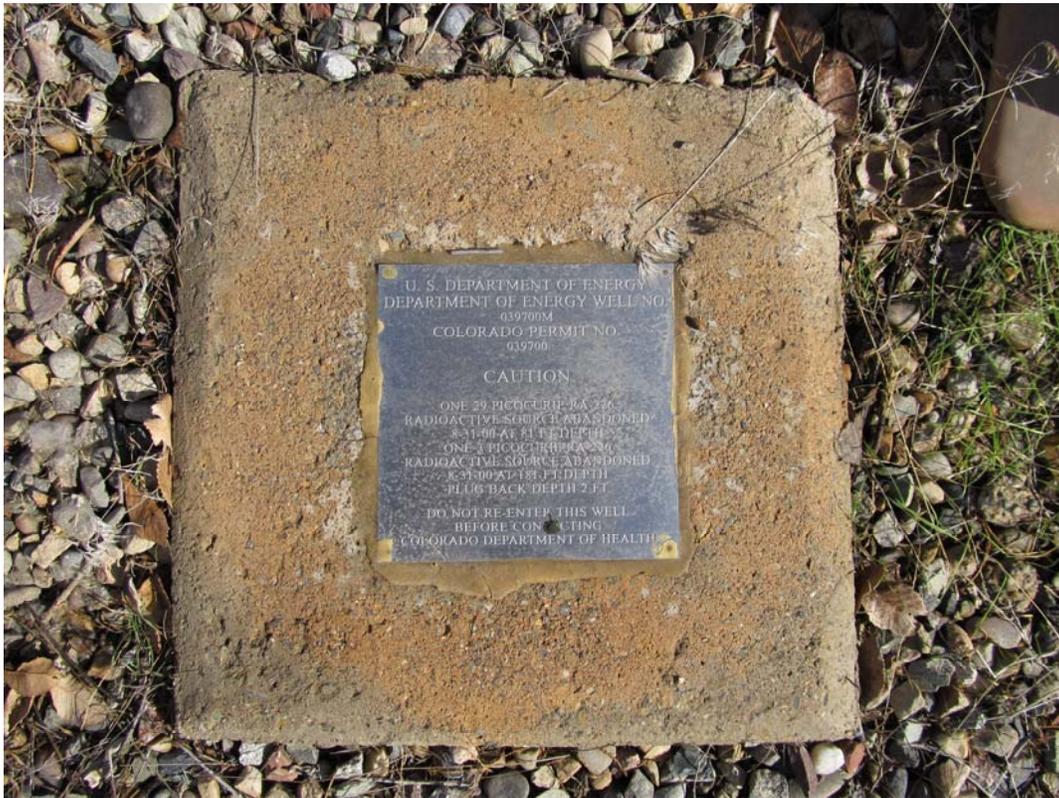
The borehole was decommissioned in place in 2000. DOE perforated the casing above and below each strip of foil and pressure-grouted the annulus with Portland cement to seal the foil in place. The borehole was filled with grout, and a metal plaque was mounted in concrete at ground level over the well. The metal plaque with the borehole information and warning engraved into the metal was in excellent condition (PL-3).

GJO 2/2011. PL-3. Plaque at the decommissioned borehole containing radium foil.

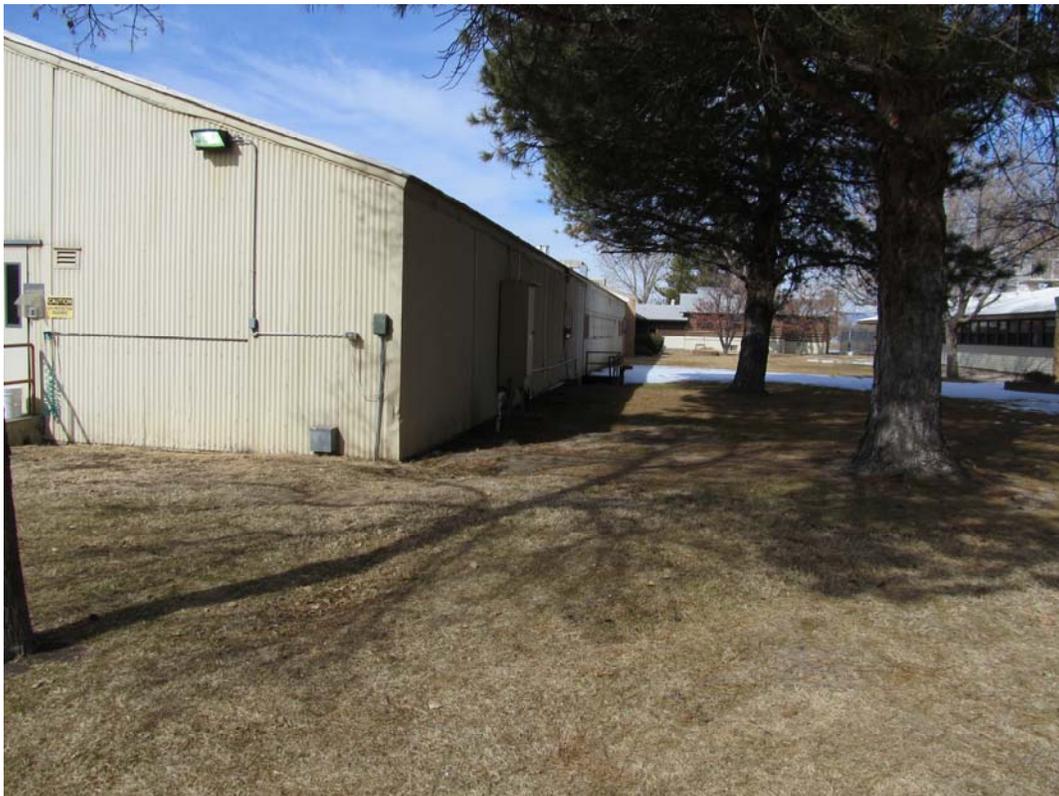
The interior floor area of Building 12A was inspected. There was no visual evidence of floor penetrations in the affected area since the last inspection. Exterior areas adjacent to the contaminated media under the building were not disturbed (PL-4 and PL-5). A new access ramp was added to the south end of Building 12A since the last inspection (PL-6); excavation of soils adjacent to the building was not required for construction of the ramp. The current site owner controls maintenance activities in the exterior areas near the contaminated soil, and DOE contractor personnel observe these exterior areas during normal working activities.

GJO 2/2011. PL-4. East side of Building 12A.

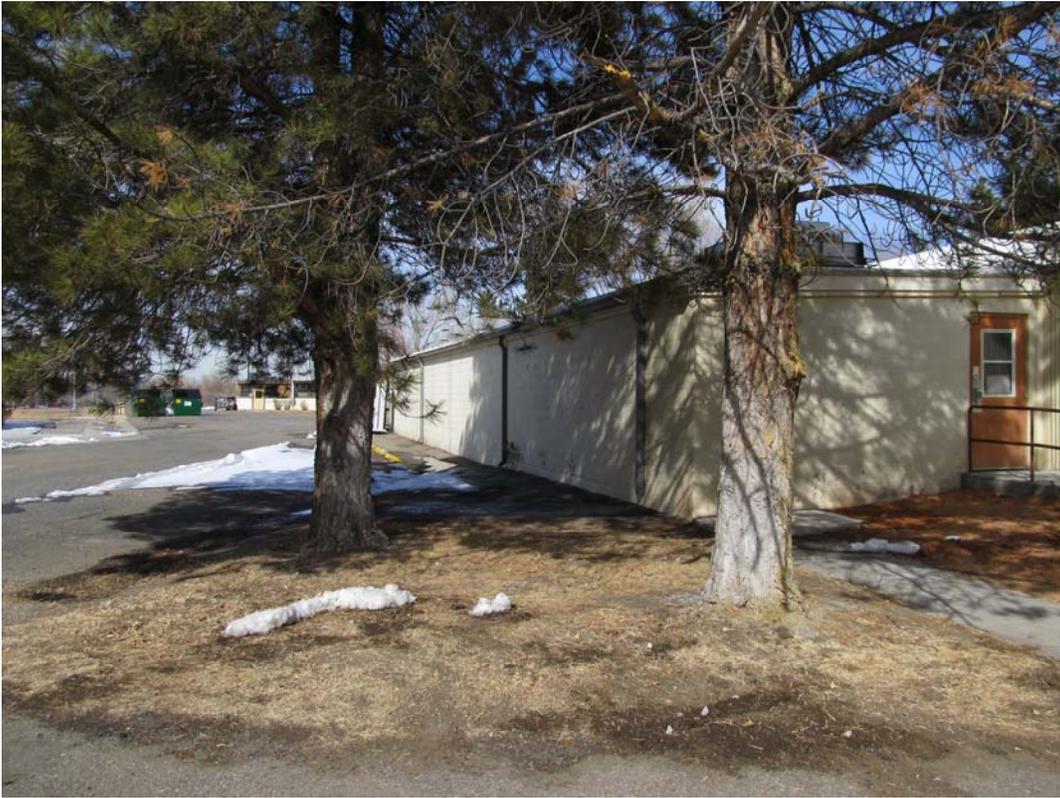
GJO 2/2011. PL-5. West side of Building 12A.

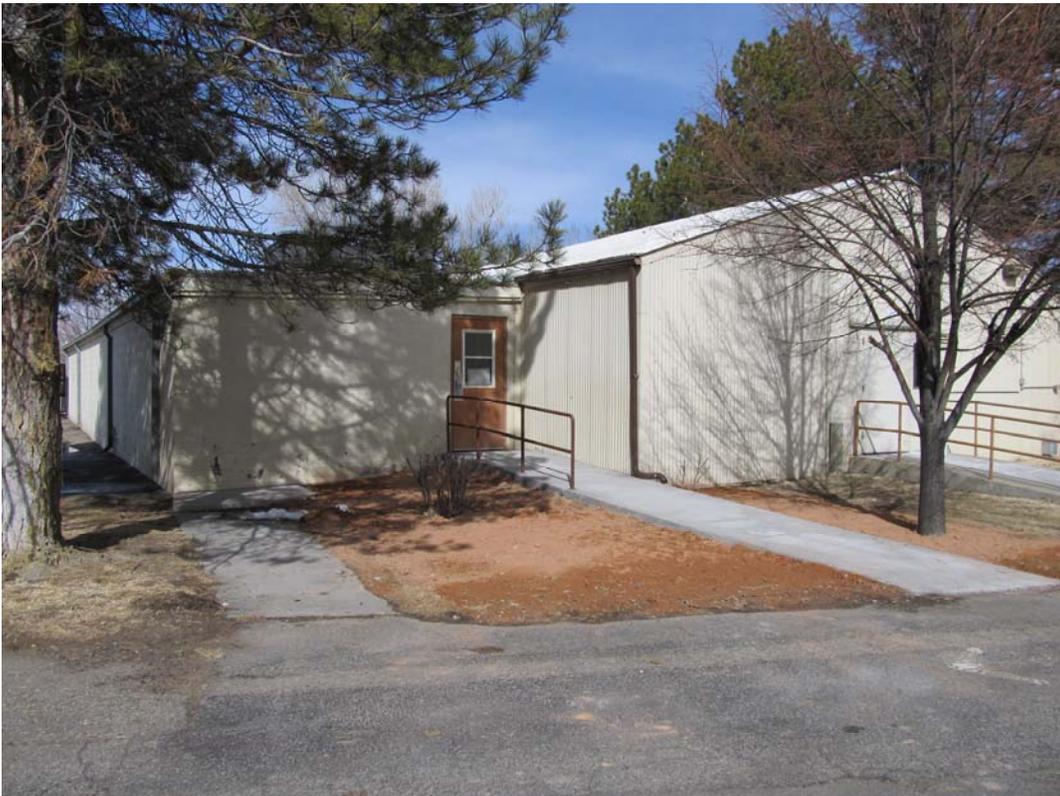
GJO 2/2011. PL-6. New access ramp at the south end of Building 12A.

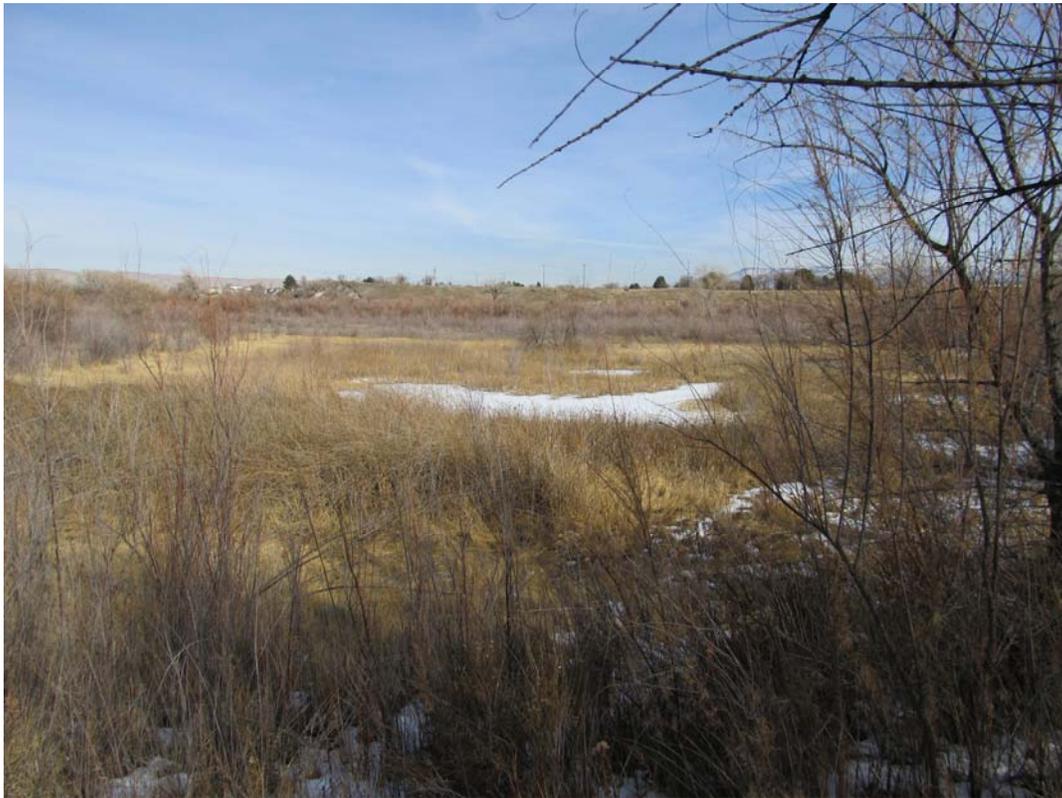
GJO 2/2011. PL-7. Wetlands area north of South Pond.
