## 8.0 Gunnison, Colorado, Disposal Site

### 8.1 Compliance Summary

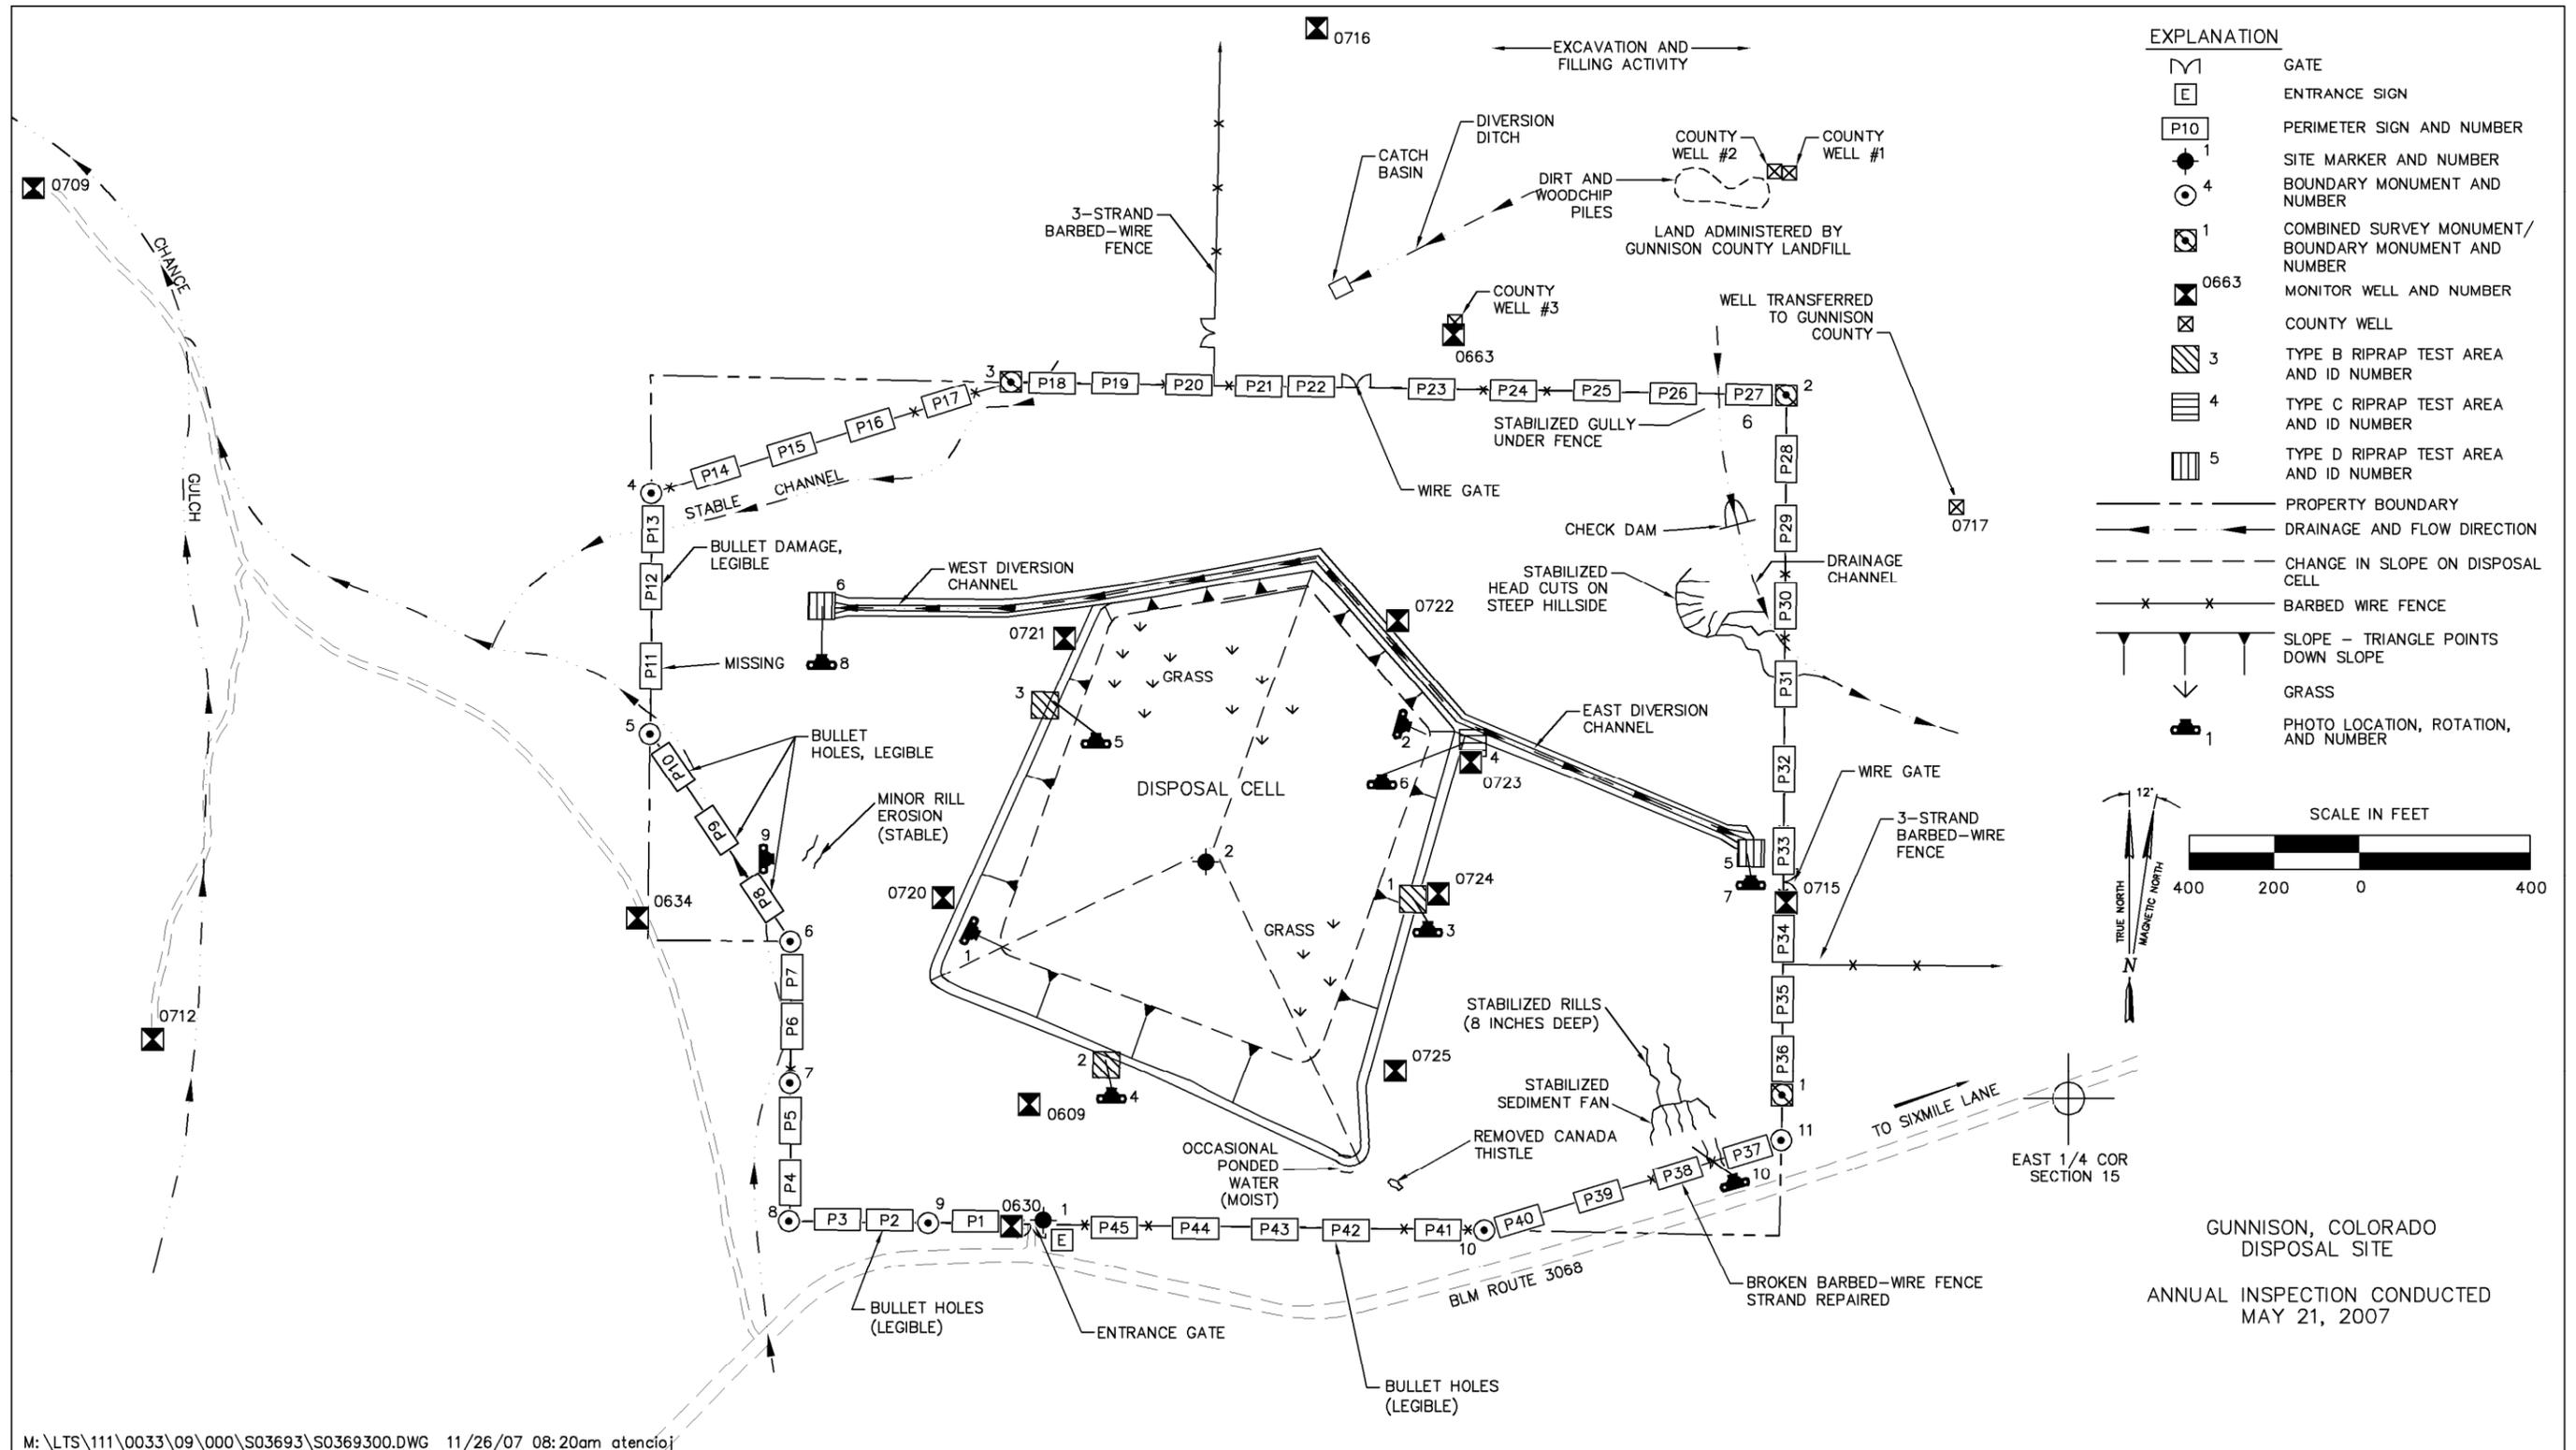
Figure 8-1. 2007 Annual Compliance Drawing for the Gunnison, Colorado, Disposal Site

The site, located southeast of Gunnison, Colorado, was inspected on May 21, 2007. Results of the inspection are described below. Features and photograph locations (PLs) mentioned in this report are shown on Figure 8-1. Numbers in the left margin of this report refer to items summarized in the Executive Summary table.

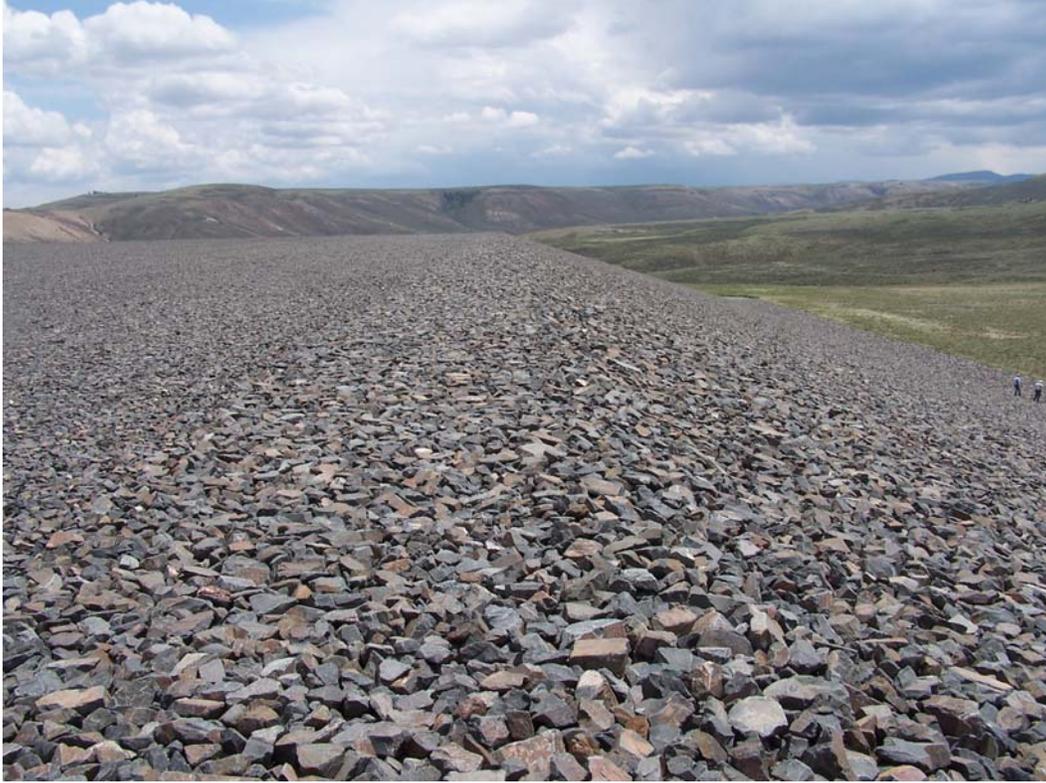
**Side Slopes, Apron, and Diversion Ditches**—The riprap-covered side slopes, apron, and diversion ditches were in excellent condition (PL-1 and PL-2). No evidence of slumping, settling, or significant encroachment of vegetation was observed.

*GUN 5/2007. PL-1. View along the disposal cell top and south side slope.*

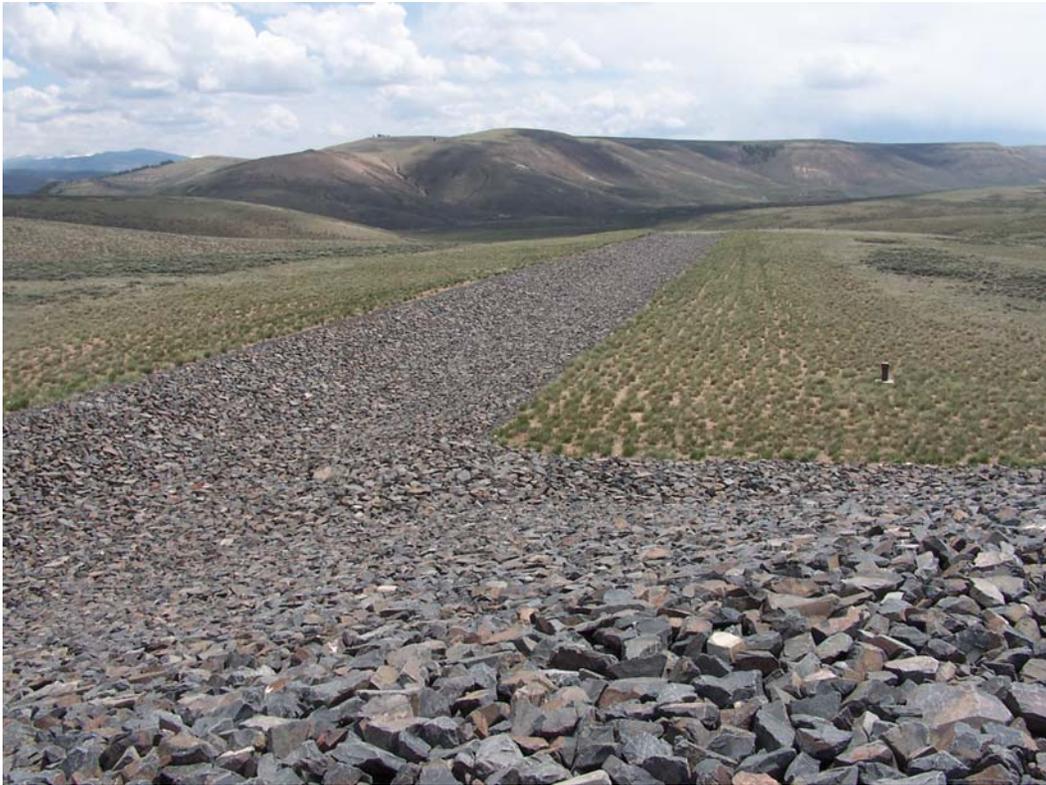
*GUN 5/2007. PL-2. East drainage channel.*

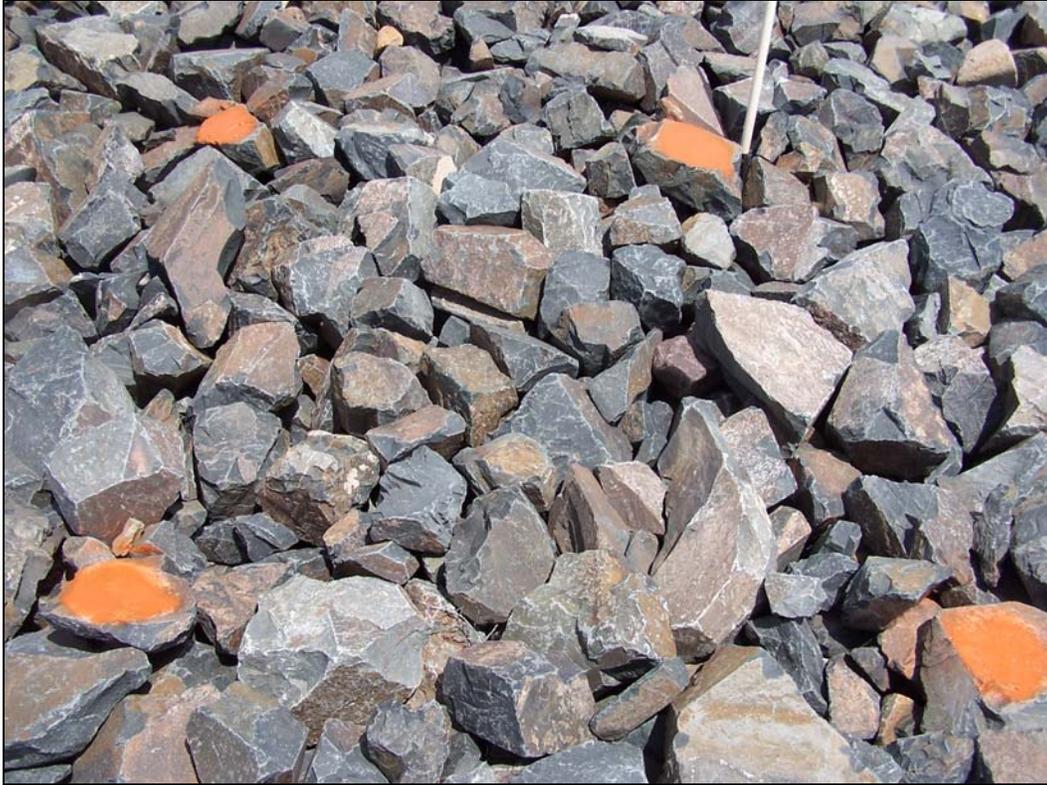
8A The condition of the riprap in six monitoring plots was inspected. Each monitoring plot, approximately 1 square meter in area, is in a “critical flow path” location in the apron and diversion channels. The corners of each monitoring plot, marked with orange paint, were re-sprayed during the inspection. In accordance with the LTSP, annual photographs were taken of these monitoring plots through 2002 and compared. After 2002, the monitoring plots are required to be photographed every 5 years until 2017. The monitoring plots were photographed in 2007 (PL-3 through PL-8) and compared with previous photographs. The rock is in excellent condition; no degradation of the rock quality was evident. The next photo documentation event will be in 2012.

*GUN 5/2007. PL-3. Riprap Test Area No. 1 (Type B riprap) on the cell's east apron.*

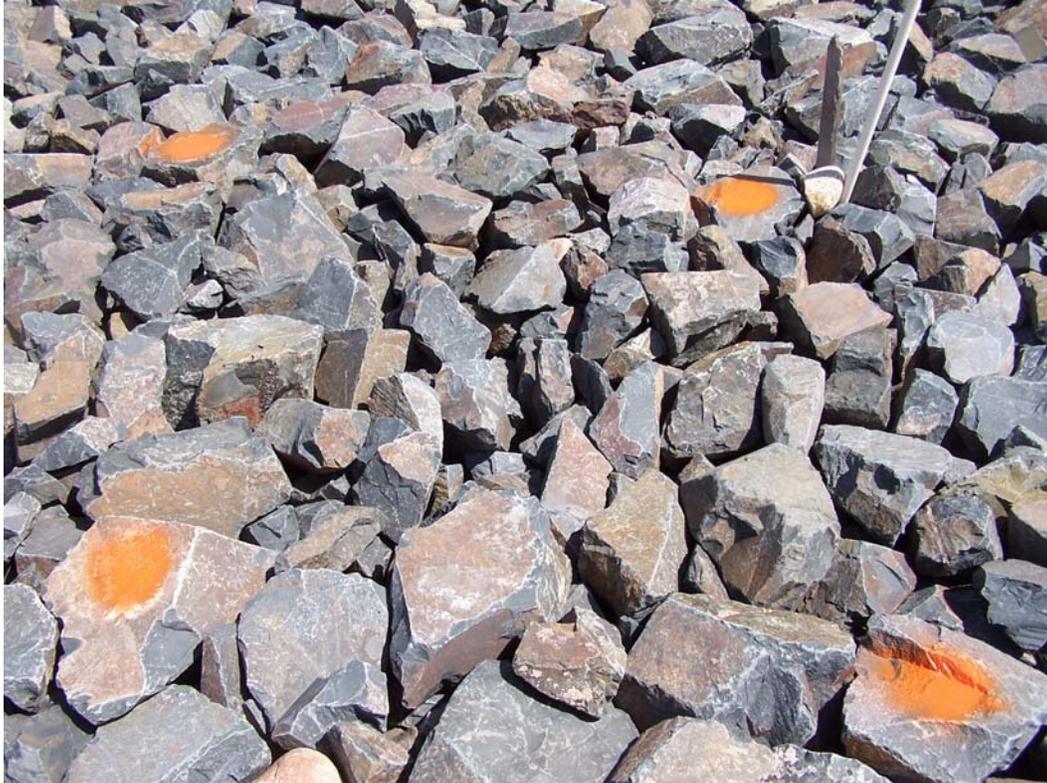
*GUN 5/2007. PL-4. Riprap Test Area No. 2 (Type B riprap) on the cell's south apron.*

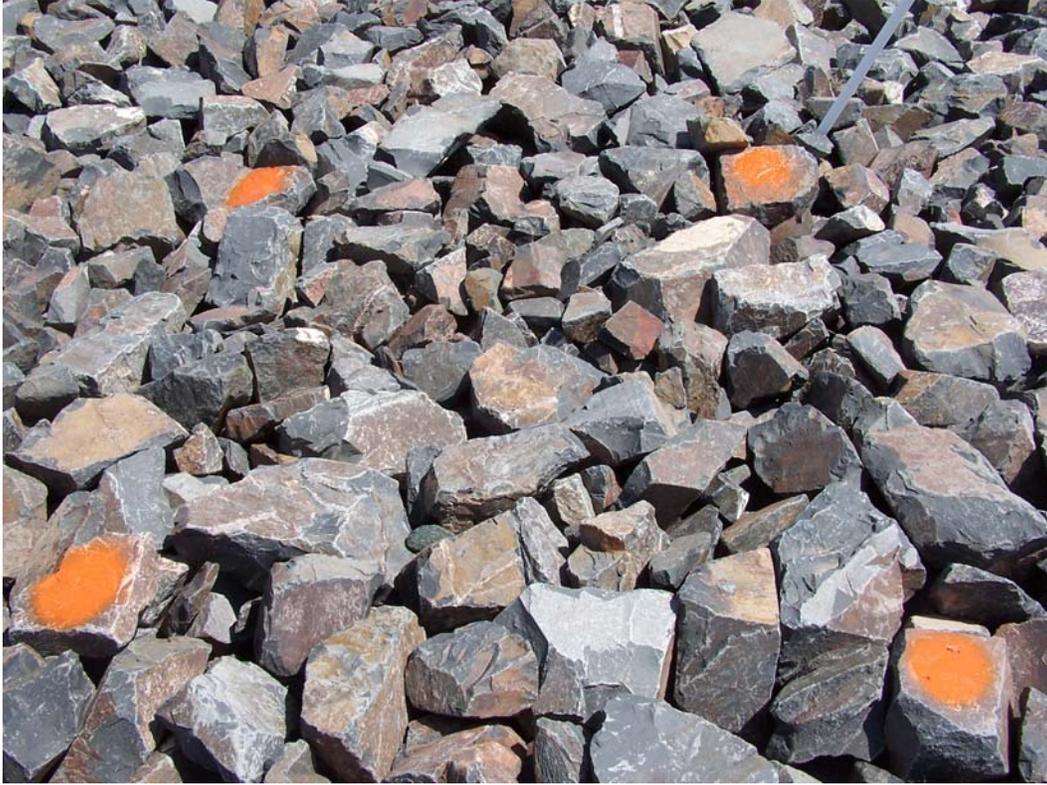
*GUN 5/2007. PL-5. Riprap Test Area No. 3 (Type B riprap) on the cell's west apron.*

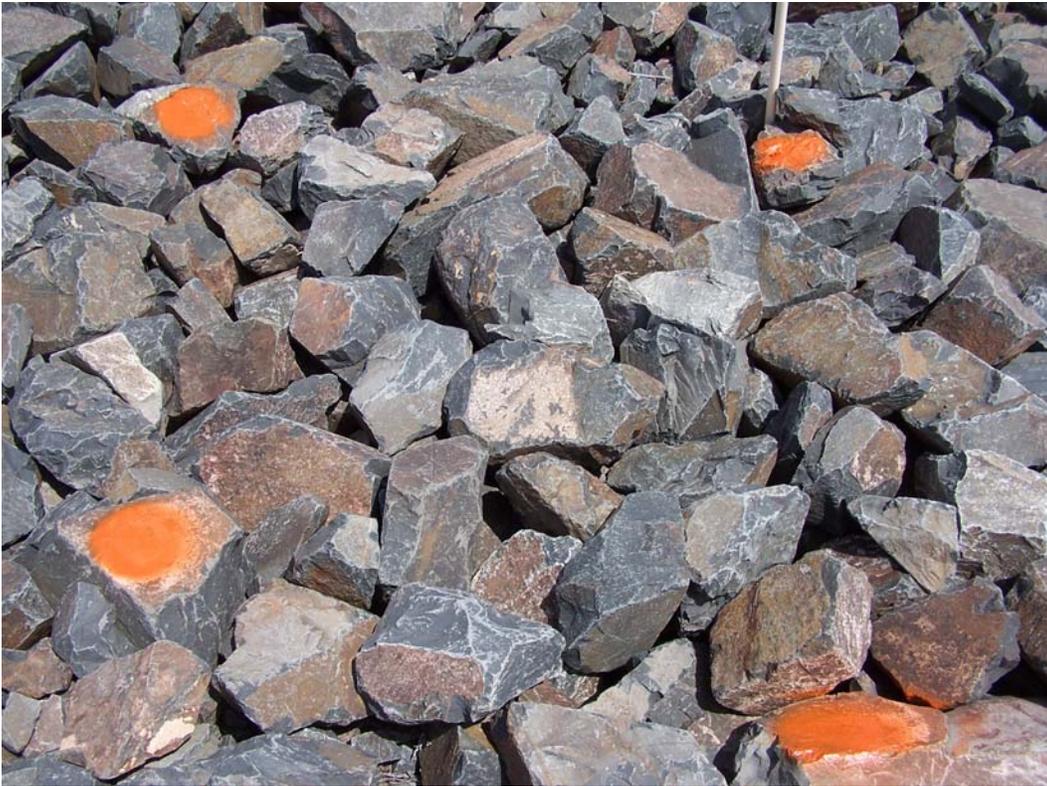
*GUN 5/2007. PL-6. Riprap Test Area No. 4 (Type C riprap) in the east diversion channel.*

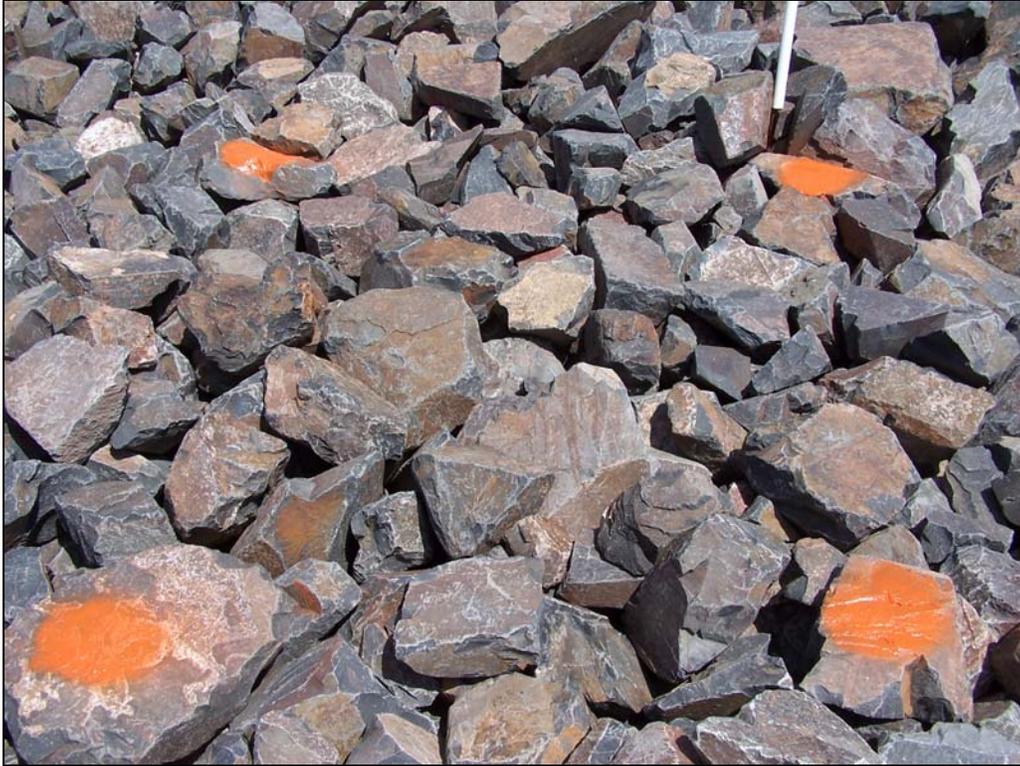
*GUN 5/2007. PL-7. Riprap Test Area No. 5 (Type D riprap) at the east diversion channel outlet.*

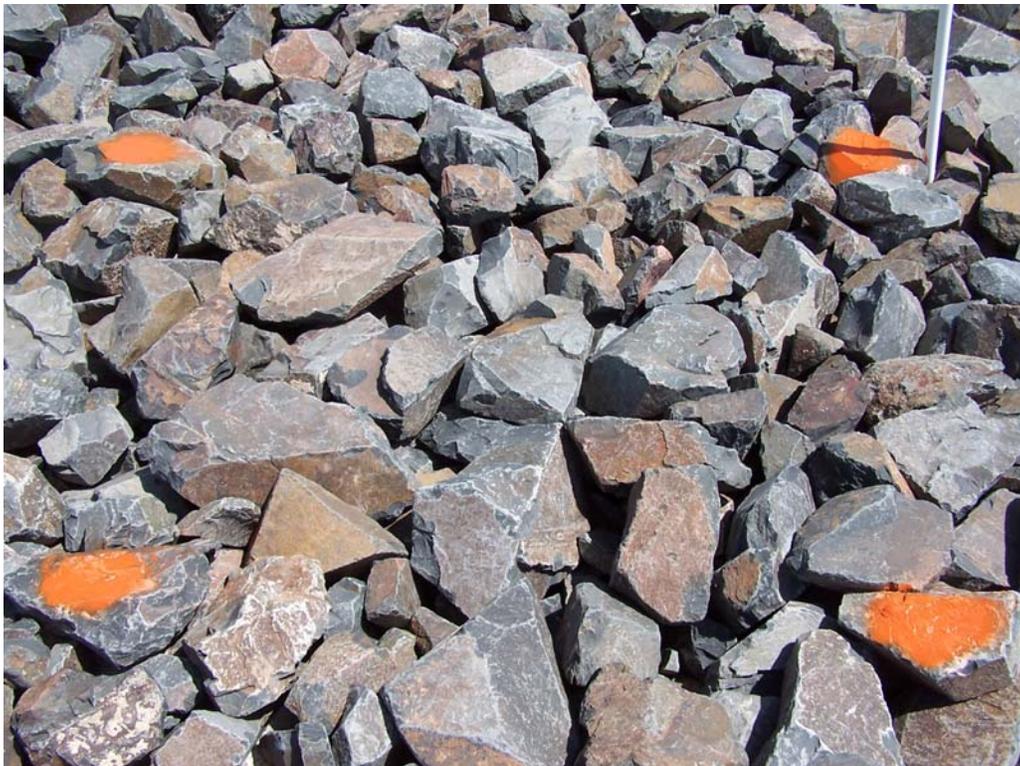
*GUN 5/2007. PL-8. Riprap Test Area No. 6 (Type D riprap) at the west diversion channel outlet.*

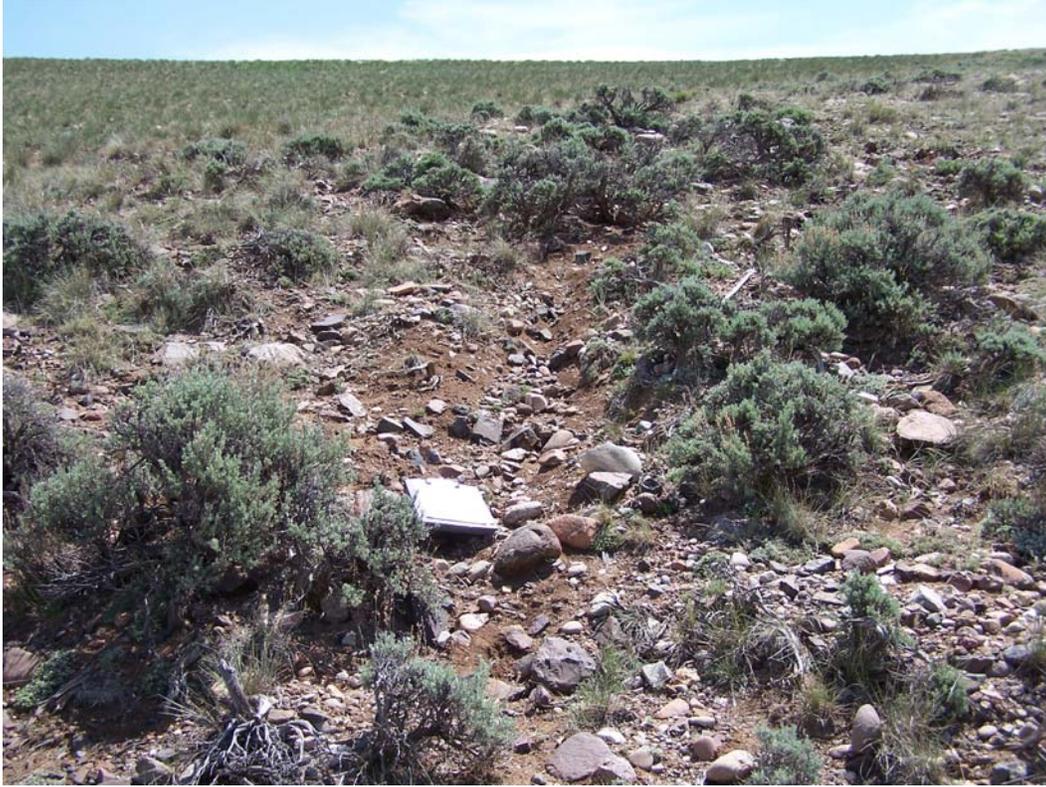
Several locations in areas of steep topography had been susceptible to erosion in the past. A significant rainfall event since the last inspection caused minor rill erosion at two locations near the perimeter of the site, but the areas appear to be stable at this time with new vegetation beginning to establish in the rills (PL-9 and PL-10). All other areas of erosion previously observed also appeared to be stable. All locations will continue to be monitored for signs of renewed erosion and any other indications of slope instability.

*GUN 5/2007. PL-9. Recent erosion near the western edge of the site.*

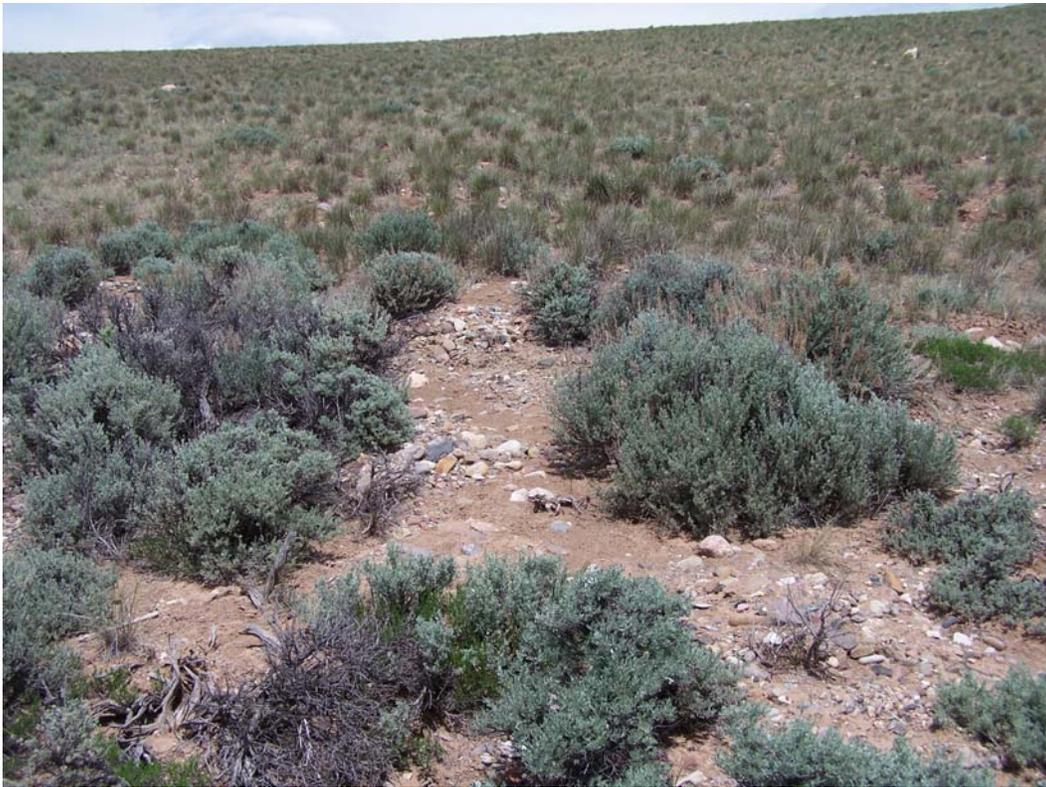
*GUN 5/2007. PL-10. Recent erosion in the southeast corner of the site.*
