## 8.0 Gunnison, Colorado, Disposal Site

### 8.1 Compliance Summary

Figure 8-1. 2013 Annual Inspection Drawing for the Gunnison Disposal Site

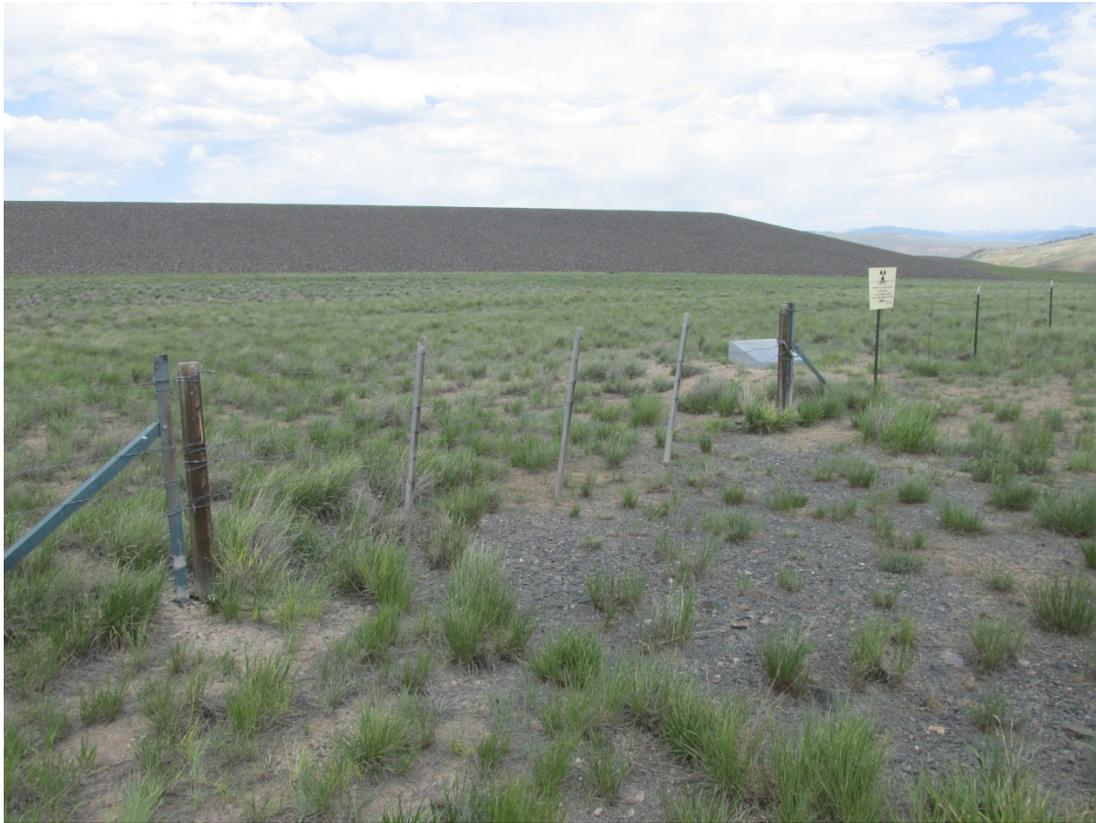
The entrance gate is a simple barbed-wire gate in the stock fence that surrounds the site. The entrance gate, located along the south portion of the perimeter fence, was secured by a padlock and chain to the adjoining post and was in good condition (PL-1).

*GUD 6/2013. PL-1. Site entrance gate.*

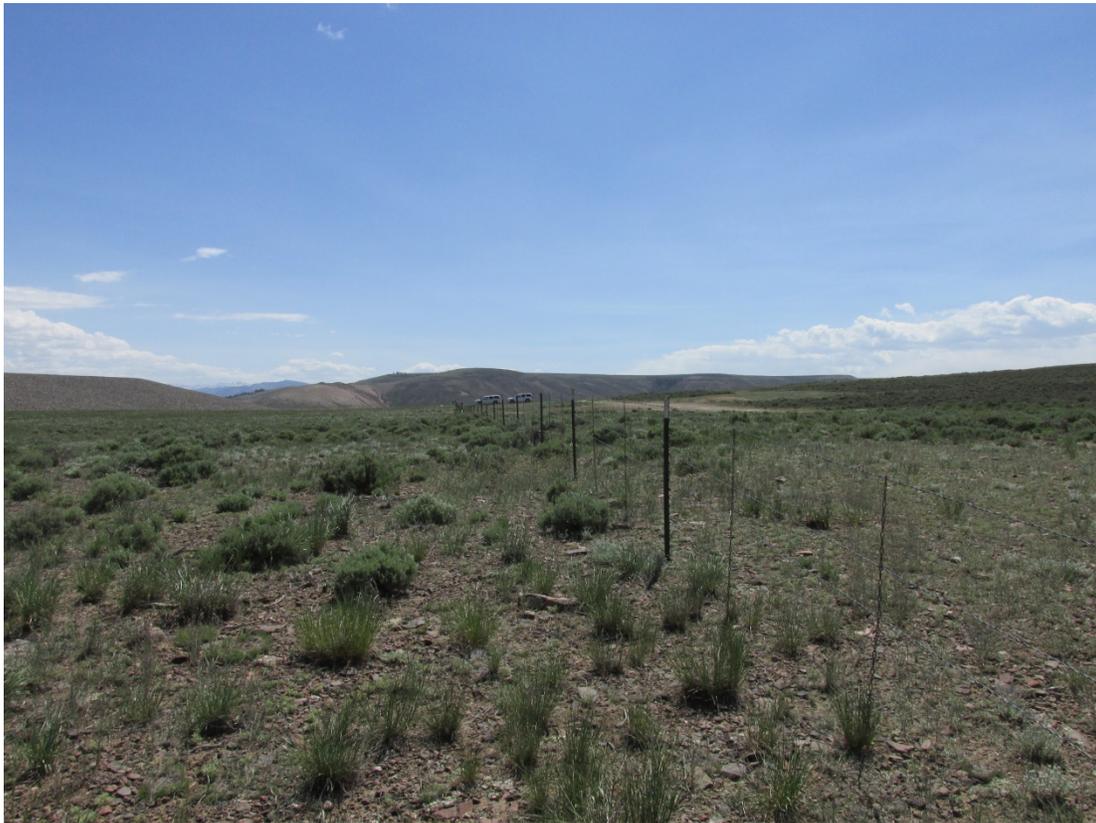
A three-strand, barbed-wire fence delineates the site; most of it is set along the property boundary. The fence was in good condition (PL-2). Two locked barbed-wire gates—one on the north fence line and the other on the east fence line—provide monitoring-well access. The gates were locked and in good condition.

*GUD 6/2013. PL-2. Site perimeter fence looking east from boundary monument BM-8.*

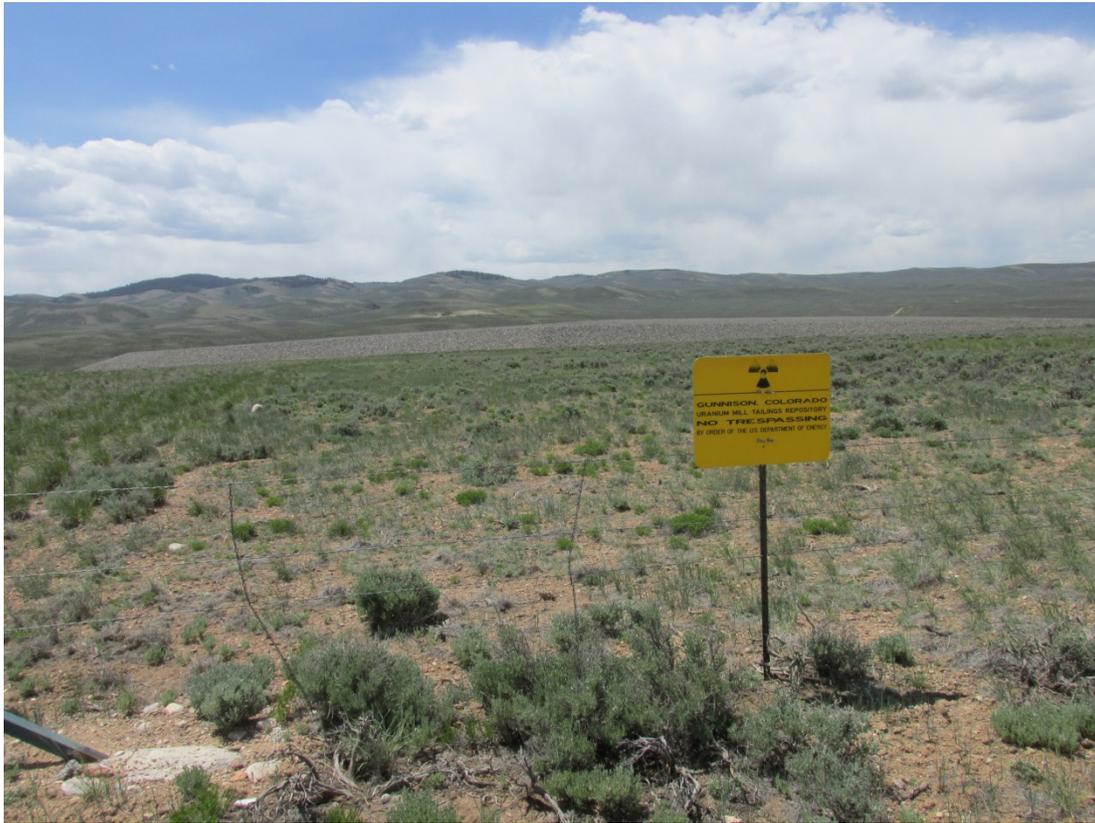
Forty-five perimeter signs are bolted to the perimeter fence posts. Several perimeter signs have bullet holes but were legible. The other signs were in good condition (P-3).

GUD 6/2013. PL-3. Perimeter sign P22 and the disposal cell.

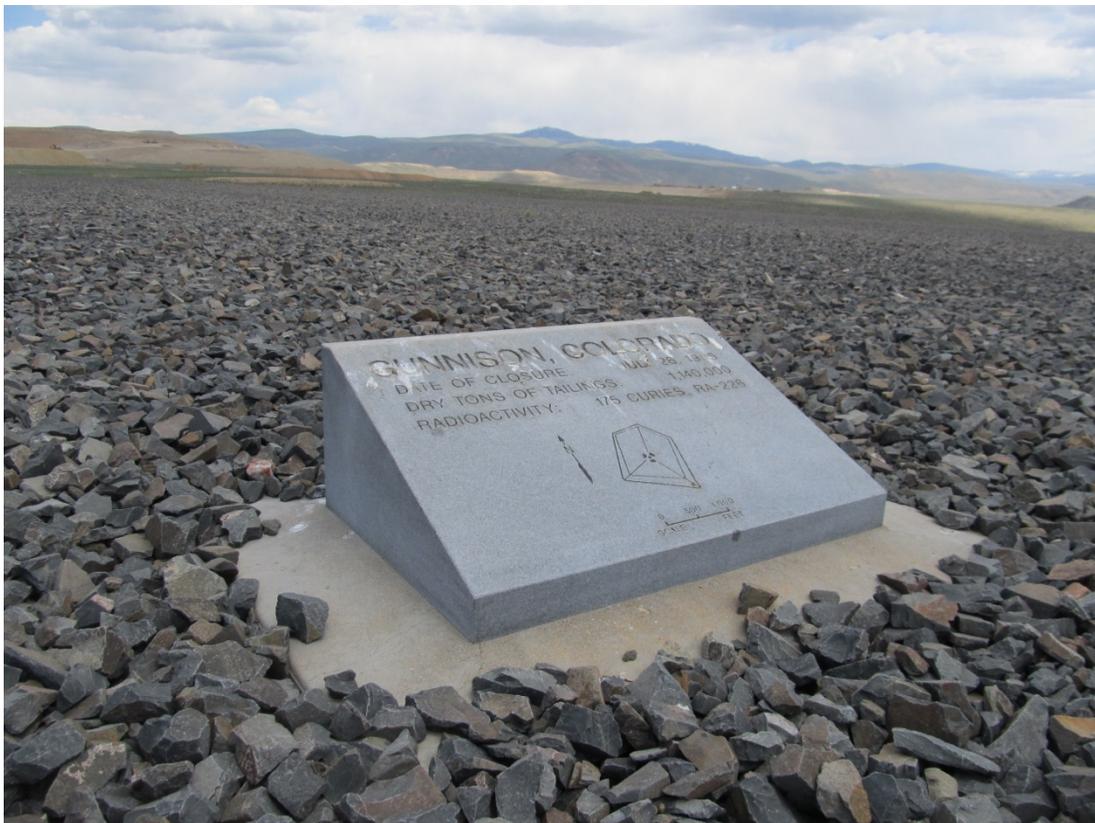
The site has two granite site markers. Site markers SMK-1 (just inside the entrance gate) and SMK-2 (on top of the disposal cell; PL-4) were in excellent condition.

GUD 6/2013. PL-4. Site marker SMK-2 on top of the disposal cell.

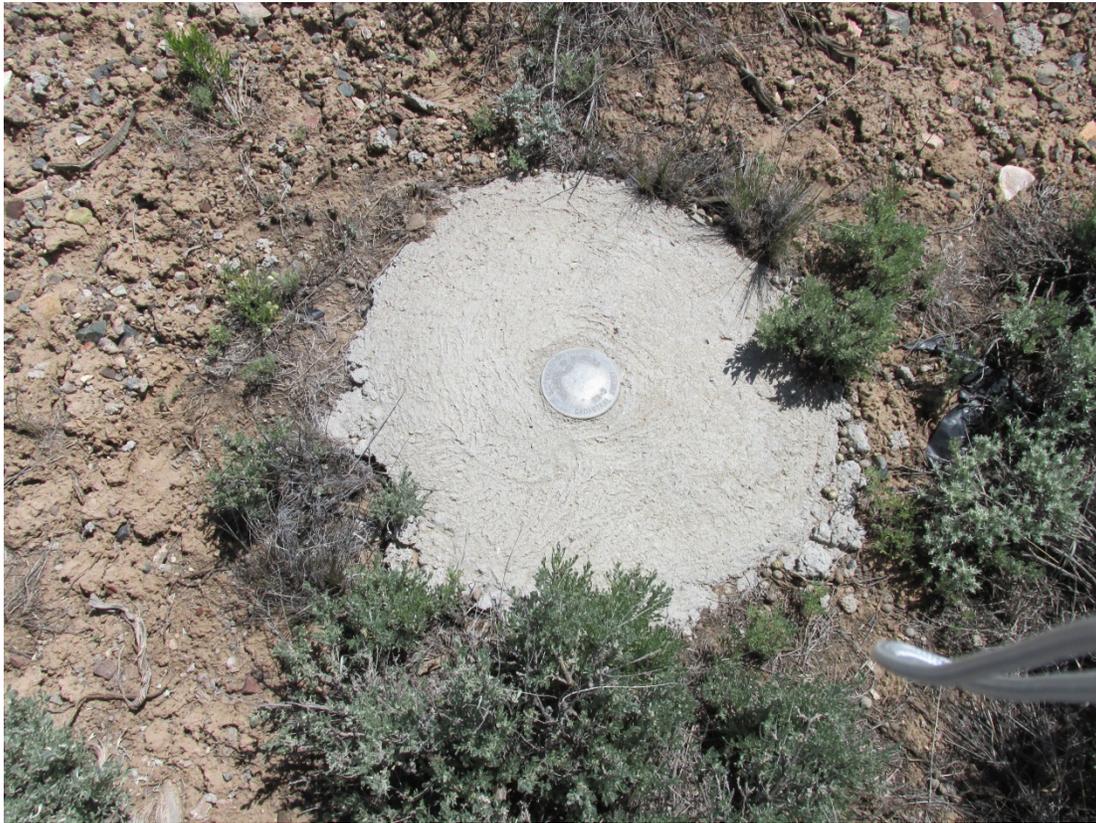
The three combined survey/boundary monuments (SM-1/BM-1, SM-2/BM-2, and SM-3/BM-3) and eight additional boundary monuments (BM-4 through BM-11) were in excellent condition (PL-5).

*GUD 6/2013. PL-5. Boundary monument BM-5.*

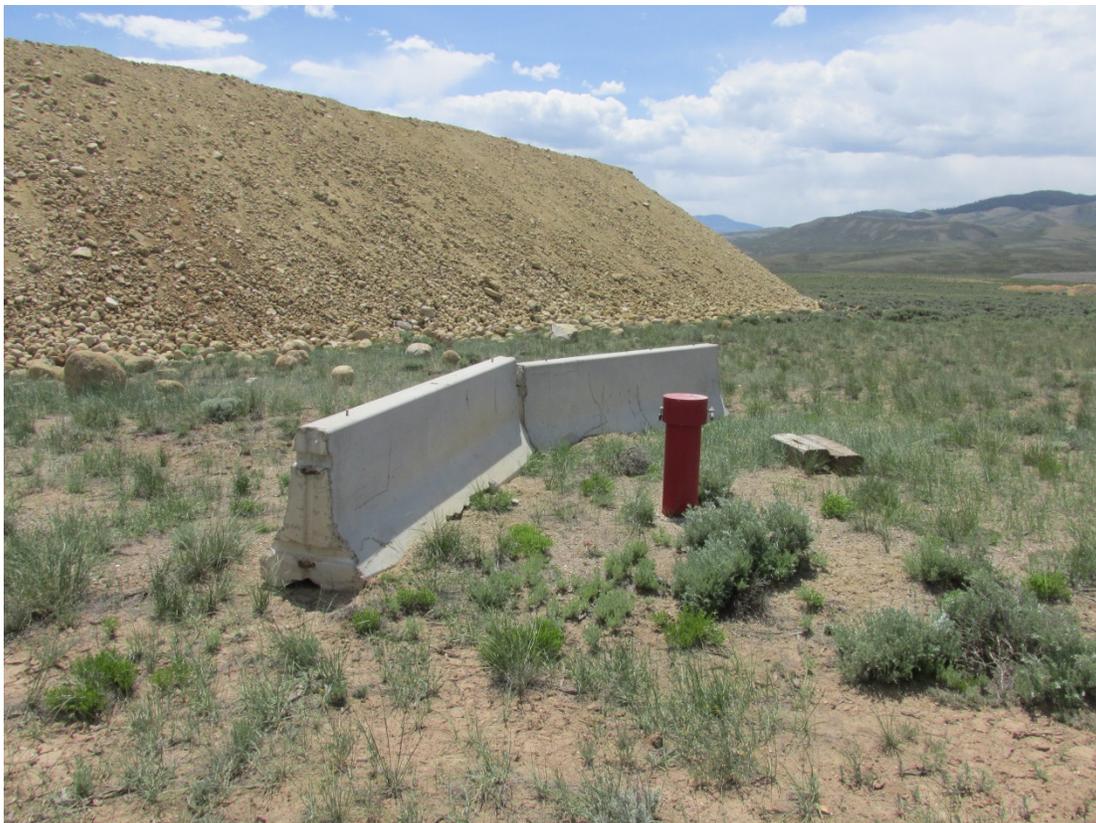
Sixteen wells constitute the groundwater monitoring network for the site. The wells were secure and in excellent condition. The Gunnison County landfill has placed a new overburden spoil pile near monitoring well 0716, which is located on landfill property. The landfill operators have placed concrete barriers to protect the well (PL-6).

*GUD 6/2013. PL-6. Monitoring well 0716 protected by concrete barriers.*

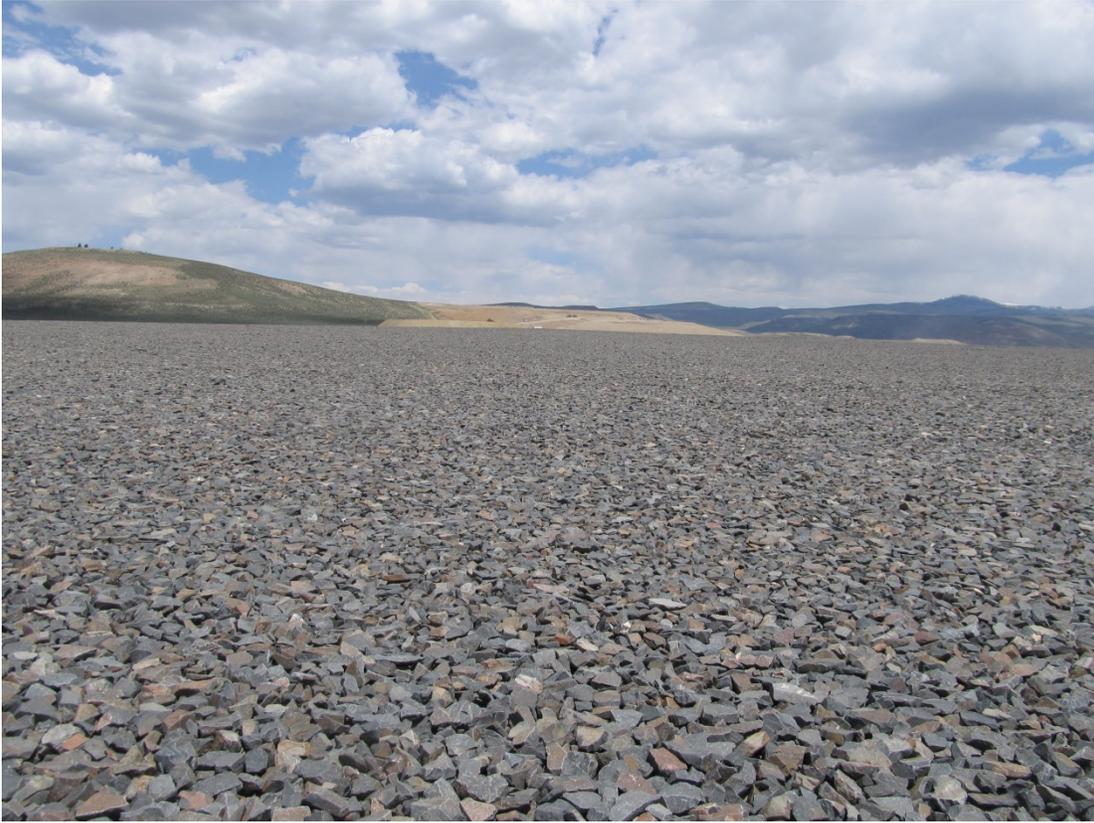
The rock-covered top of the disposal cell was in excellent condition (PL-7). There was no evidence of erosion, settling, slumping, or rock degradation. Several isolated patches of grass are randomly distributed over the disposal cell cover; however, these shallow-rooted plants are not a cause for concern.

*GUD 6/2013. PL-7. Top of the disposal cell and the Gunnison County landfill in the background.*

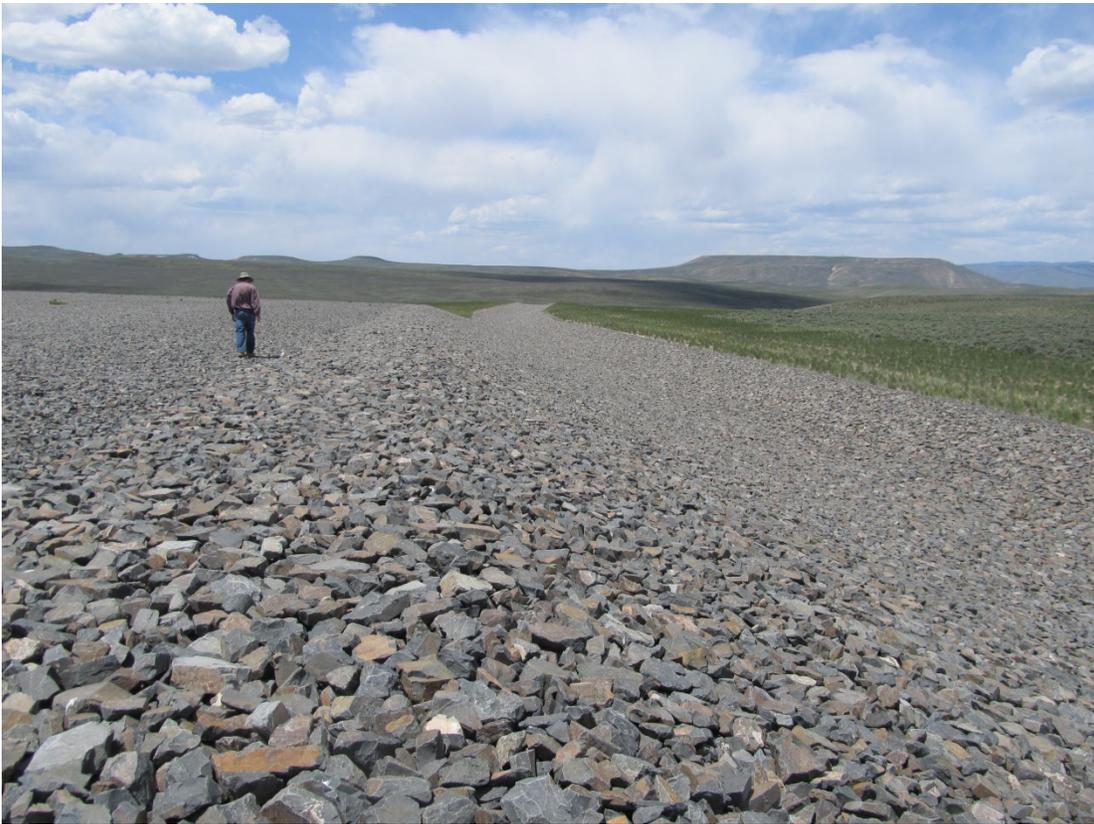
The riprap-covered side slopes, apron, and diversion channels were in good condition (PL-8 and PL-9). No evidence of slumping, settling, rock degradation, or encroachment of vegetation was observed.

*GUD 6/2013. PL-8. Northwest side of the disposal cell and the west diversion channel.*

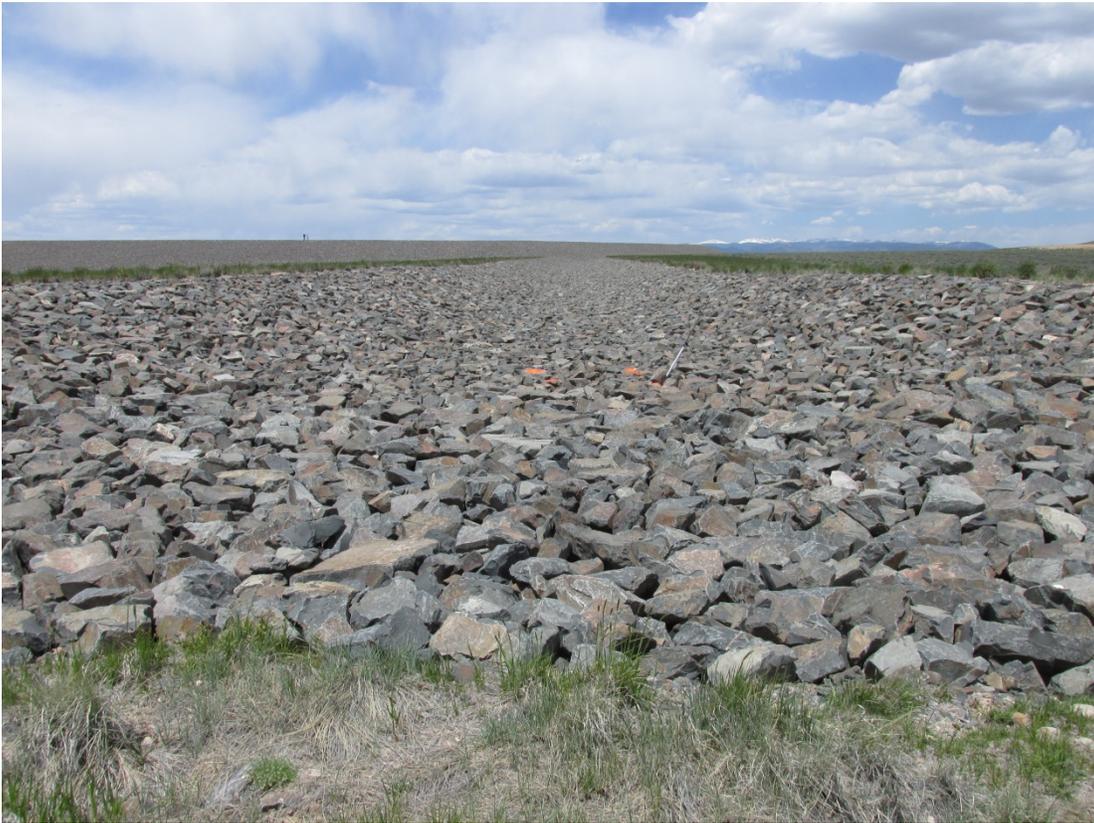
*GUD 6/2013. PL-9. View upgradient of the east diversion channel.*

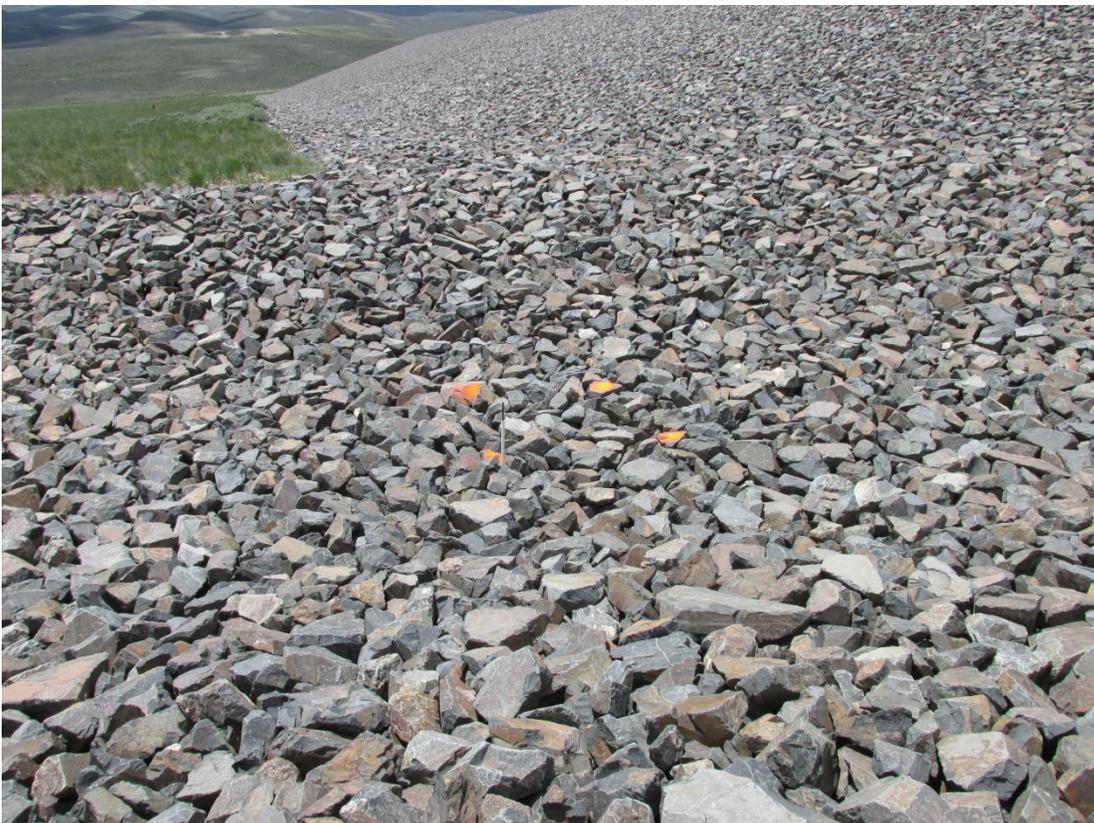
The condition of the riprap in six monitoring test areas was visually inspected. The test areas, each approximately 1 square meter in area, are in critical flow path locations in the apron and diversion channels (PL-10). The corners of each monitoring plot are marked with orange paint. The riprap in all of the test areas was in excellent condition. When the rocks were compared to the photos taken of them in 2012, there was no evidence that individual rocks had split or otherwise been degraded. As outlined in the LTSP, annual photographing and comparing of these test areas was performed through 2002; after that, the LTSP requires the test areas to be photographed every 5 years through 2017. The next and final set of photos will be taken in 2017.

*GUD 6/2013. PL-10. Riprap test area No. 4 in the east diversion channel.*

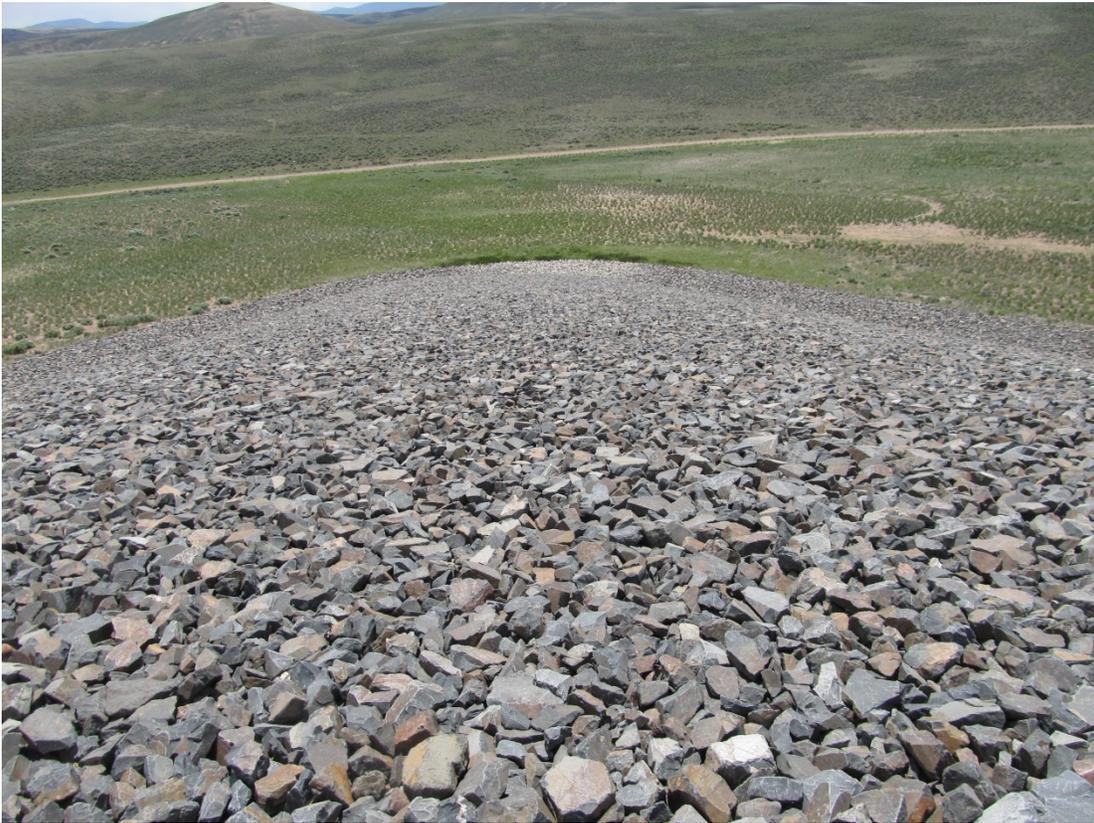
Precipitation runoff from the cell occasionally ponds in a low-lying area along the southeast corner of the cell. The riparian-type vegetation that has become established there indicates that the area retains moisture much of the time. Water collection in this area does not pose a problem because the cell is designed to drain to the southeast, and any water that ponds there is below the elevation of the encapsulated tailings material. This location was dry at the time of the inspection (PL-11).

*GUD 6/2013. PL-11. Southeast corner of the disposal cell (no runoff water accumulation).*

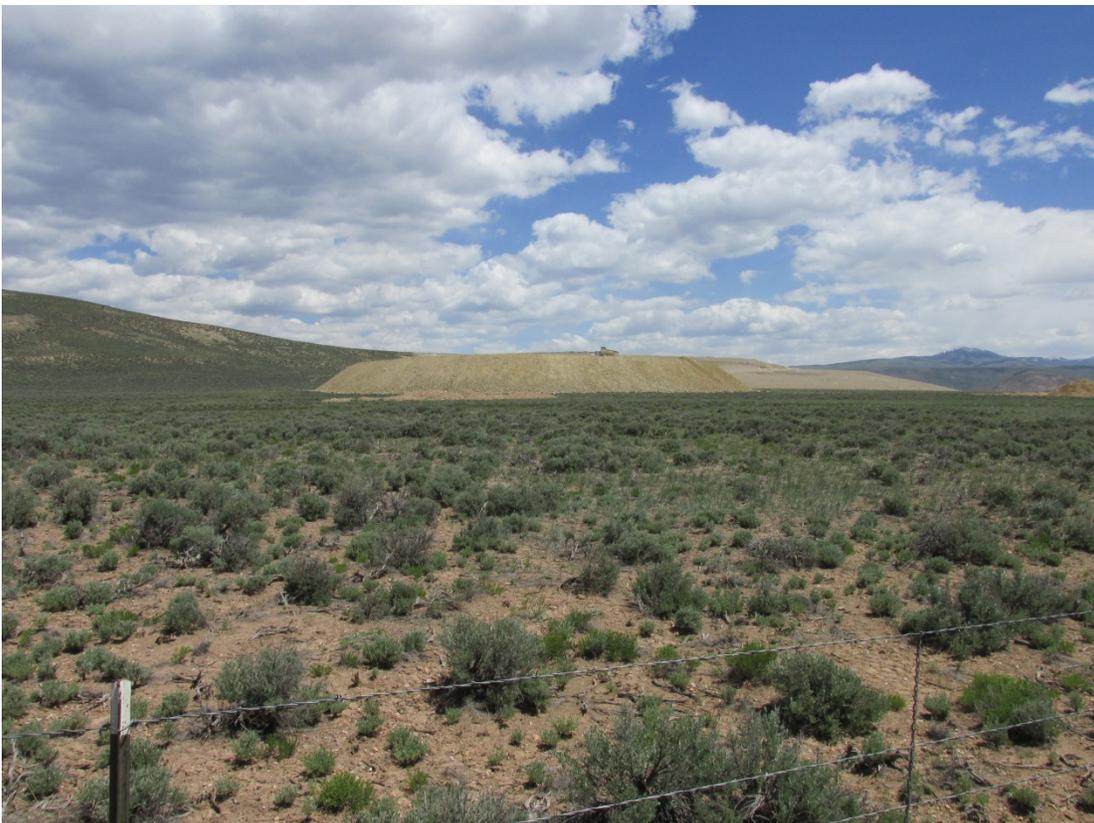
Gunnison County owns the land that adjoins the site boundary to the north and east, and uses the land for a municipal landfill. Landfill operations have encroached to within approximately 400 feet of the northeast corner of the DOE property boundary. A new overburden spoil pile has been placed near monitoring well 0716 (PL-12). Although landfill activities do not appear to threaten the site, future inspections will continue to monitor the level of activity occurring near the DOE property boundaries and site surveillance features (e.g., fences, monitoring wells).

*GUD 6/2013. PL-12. New spoil pile at the Gunnison County landfill.*
