8.0 Gunnison, Colorado, Disposal Site

8.1 Compliance Summary

The Gunnison, Colorado, Uranium Mill Tailings Radiation Control Act (UMTRCA) Title I Disposal Site was inspected on June 7, 2011. The disposal cell and all associated surface water diversion and drainage structures were in excellent condition and functioning as designed. Six riprap test areas on the cell apron and diversion ditches were visually inspected; no apparent rock degradation was noted when compared to previous photos. A broken fence strand was repaired. No other maintenance needs or cause for a follow-up or contingency inspection was identified.

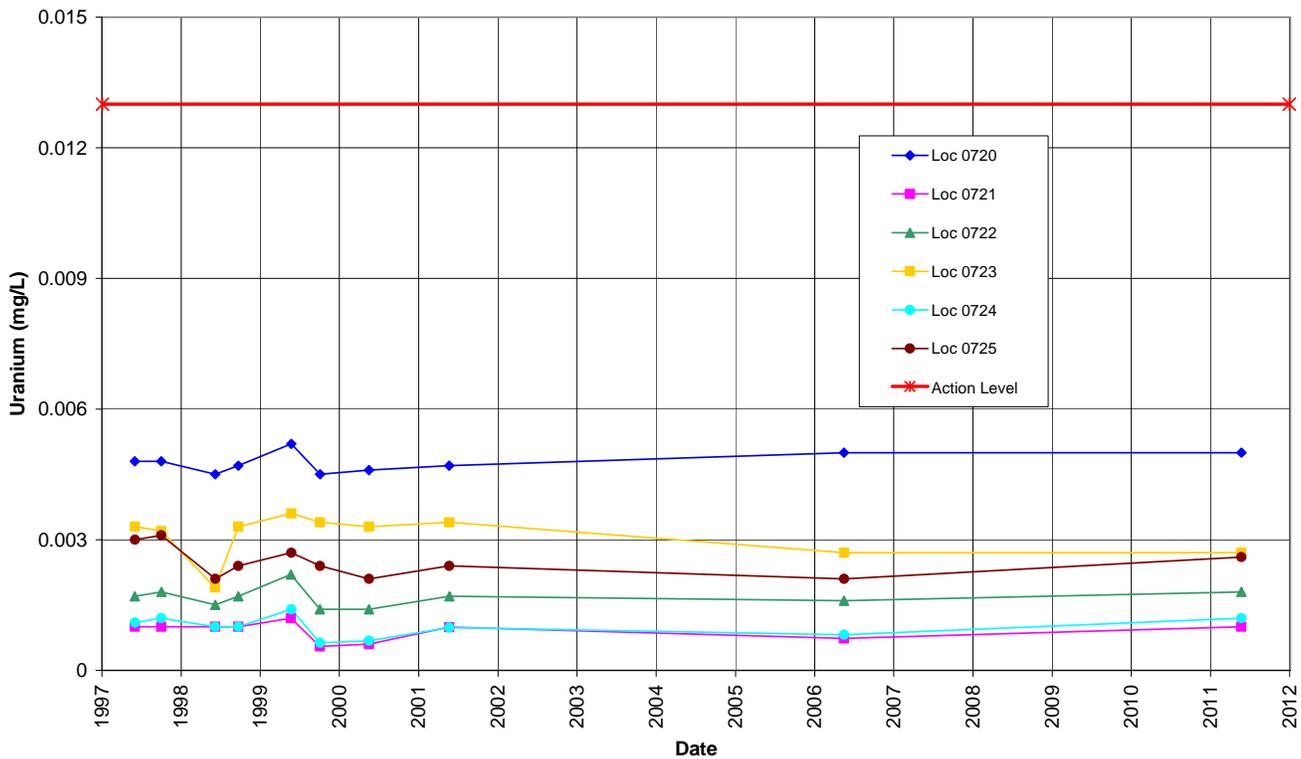
Figure 8–2. Time-Concentration Plots of Uranium in Groundwater at the Gunnison, Colorado, Disposal Site

0.0038 mg/L and 0.0022 mg/L, respectively. The concentrations of uranium in samples collected from POC wells ranged between 0.001 mg/L and 0.005 mg/L, which is consistent with historical results, as shown in the time-versus-concentration graph (Figure 8–2). Uranium results from the POC wells were an order of magnitude below the action level of 0.013 mg/L.

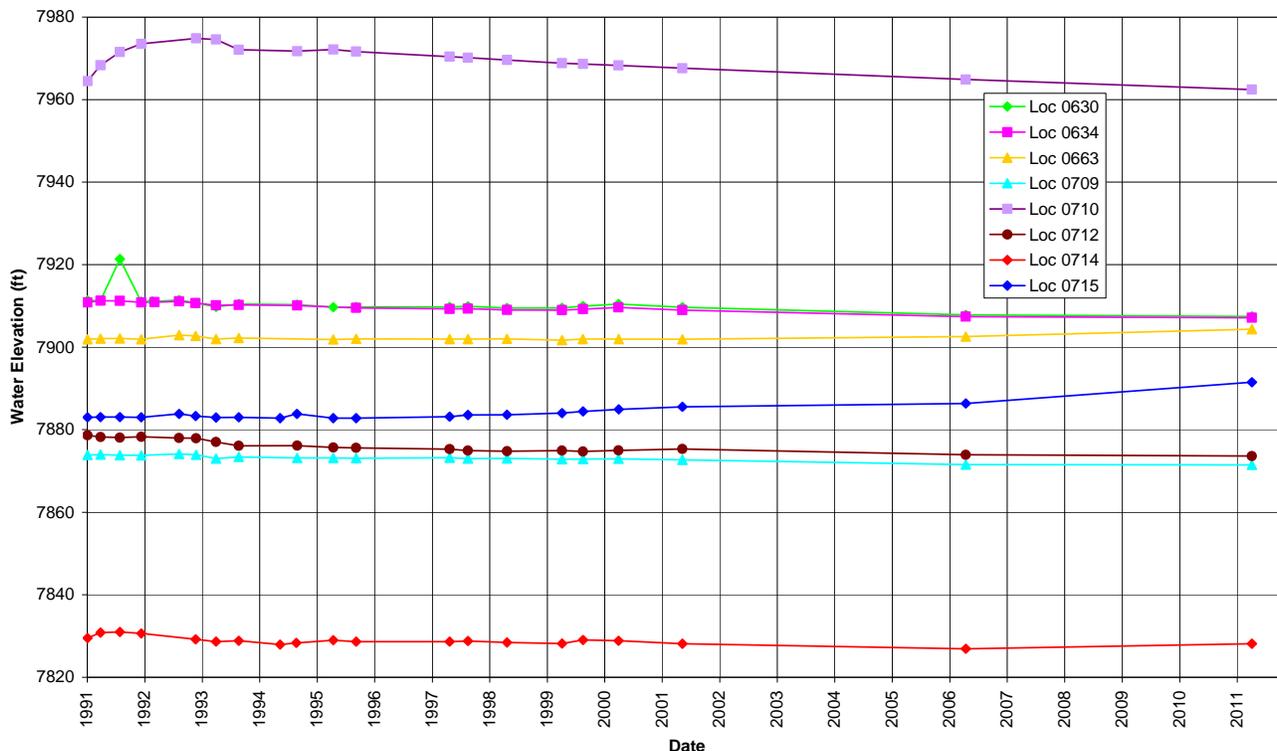
Figure 8-3. Water-Level Measurements at Active Monitoring Wells at the Gunnison, Colorado, Disposal Site

Groundwater-Level Monitoring—Water levels from the entire monitoring network were measured in May 2011. Data from water-level measurements show only minor fluctuations in groundwater elevations since completion of the disposal cell in 1995; hydrographs from selected wells across the site illustrate this consistency in water levels (Figure 8–3). Water-level measurements indicate essentially steady-state groundwater conditions at the site.

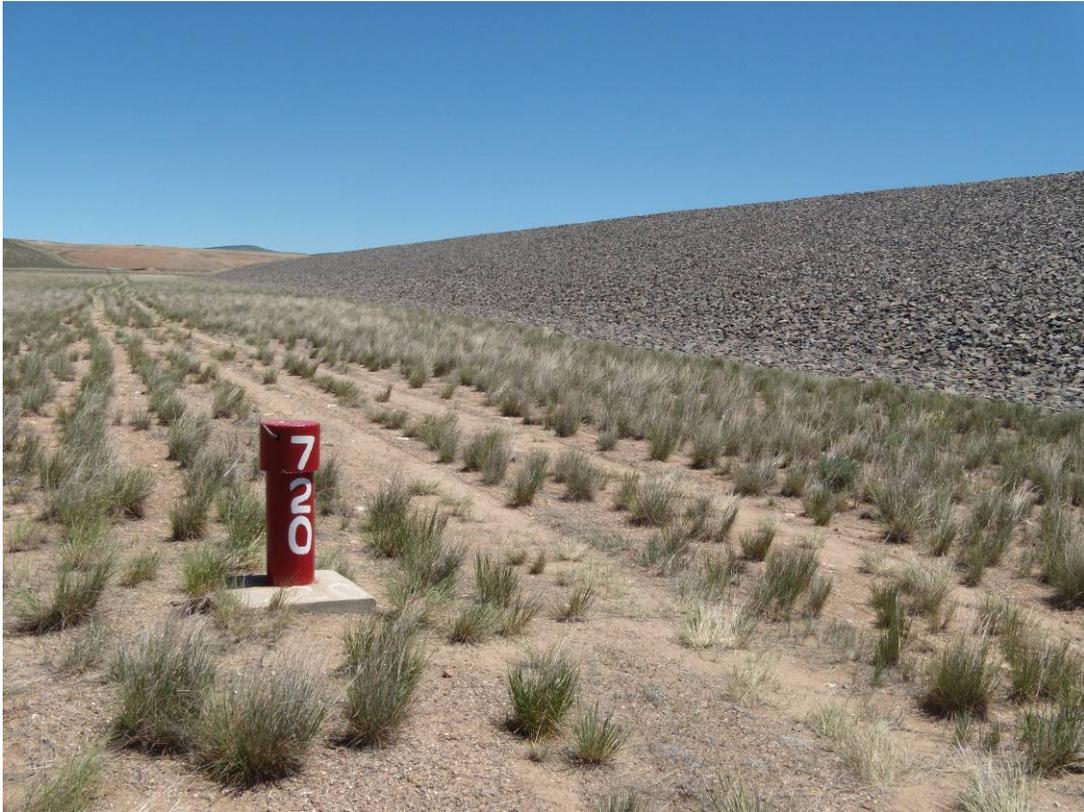
Monitoring Wells—Sixteen wells constitute the groundwater monitoring network at the site. Six of the wells are for monitoring cell performance, two are for monitoring background groundwater quality, and eight are for water-level measurements. The wells were secure and in excellent condition (PL-1).

GUN 6/2011. PL-1. Monitoring well 0720.

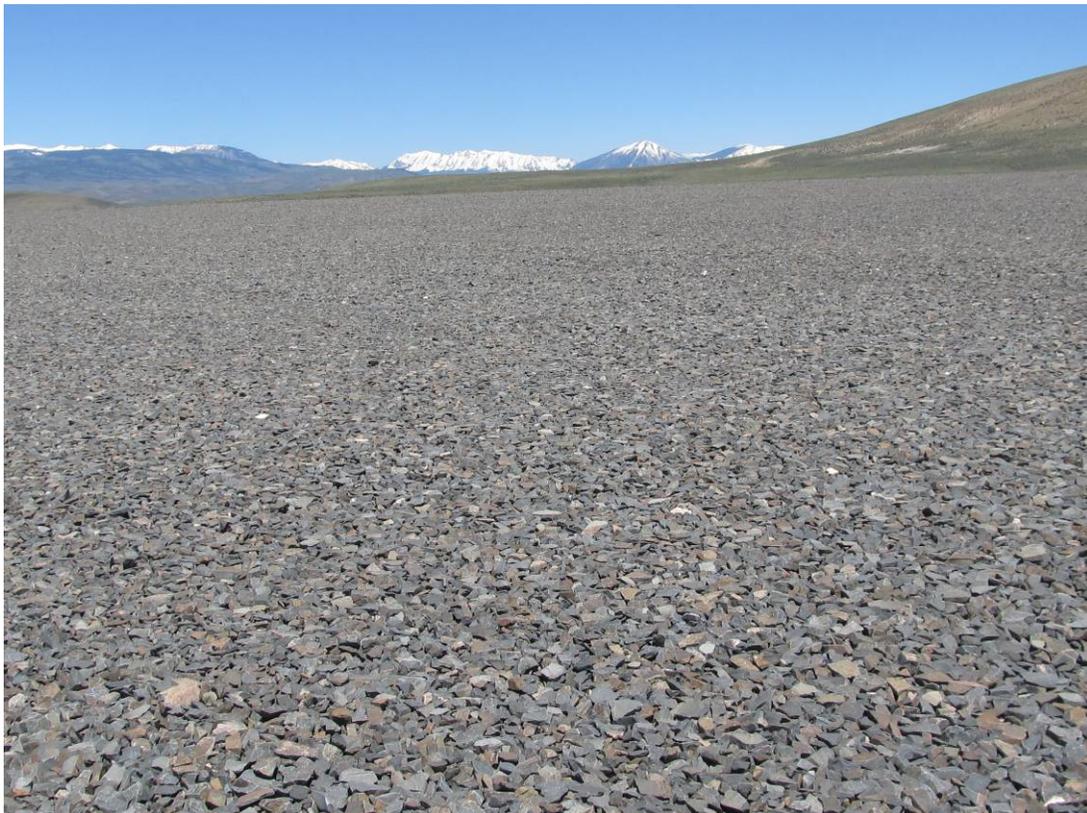
Top of the Disposal Cell—The top of the disposal cell was in excellent condition (PL–2). There was no evidence of erosion, settling, slumping, or rock degradation. Several isolated patches of grass are randomly distributed over the disposal cell cover; however, these shallow-rooted plants are not a cause for concern.

GUN 6/2011. PL-2. West portion of the disposal cell top.

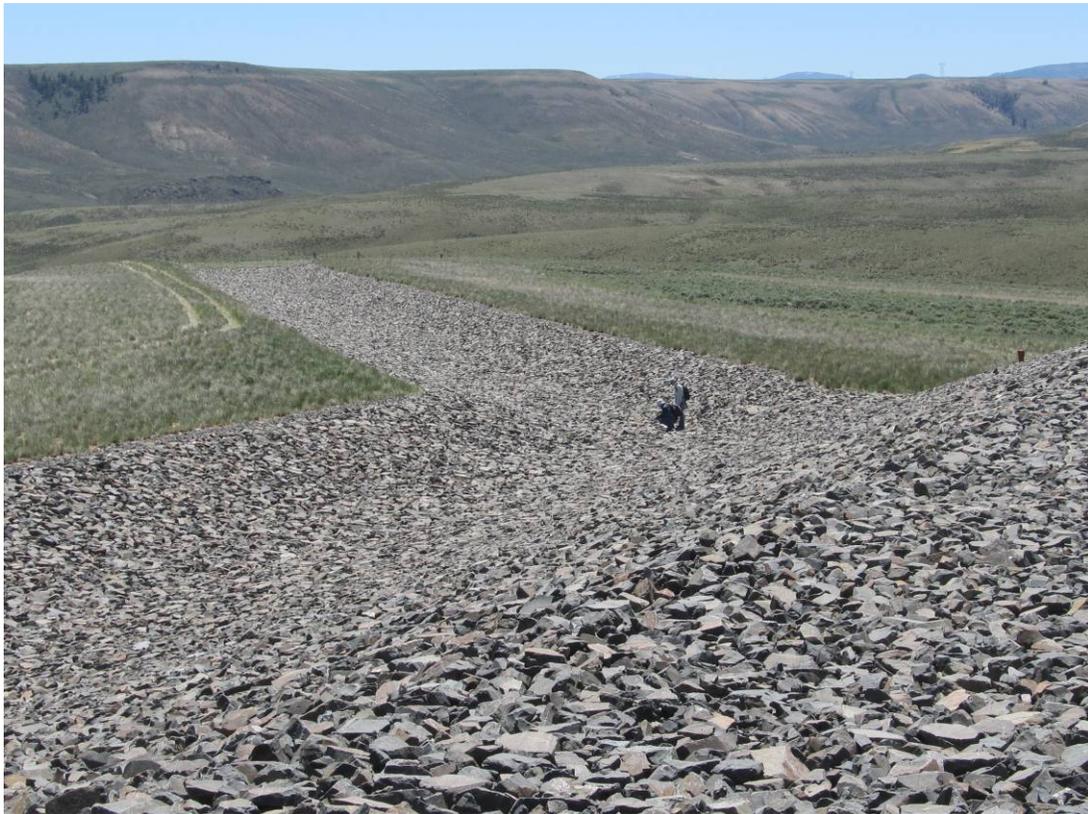
Side Slopes, Apron, and Diversion Ditches—The riprap-covered side slopes, apron, and diversion ditches were in good condition (PL–3). No evidence of slumping, settling, rock degradation, or encroachment of vegetation was observed.

GUN 6/2011. PL-3. East diversion channel.

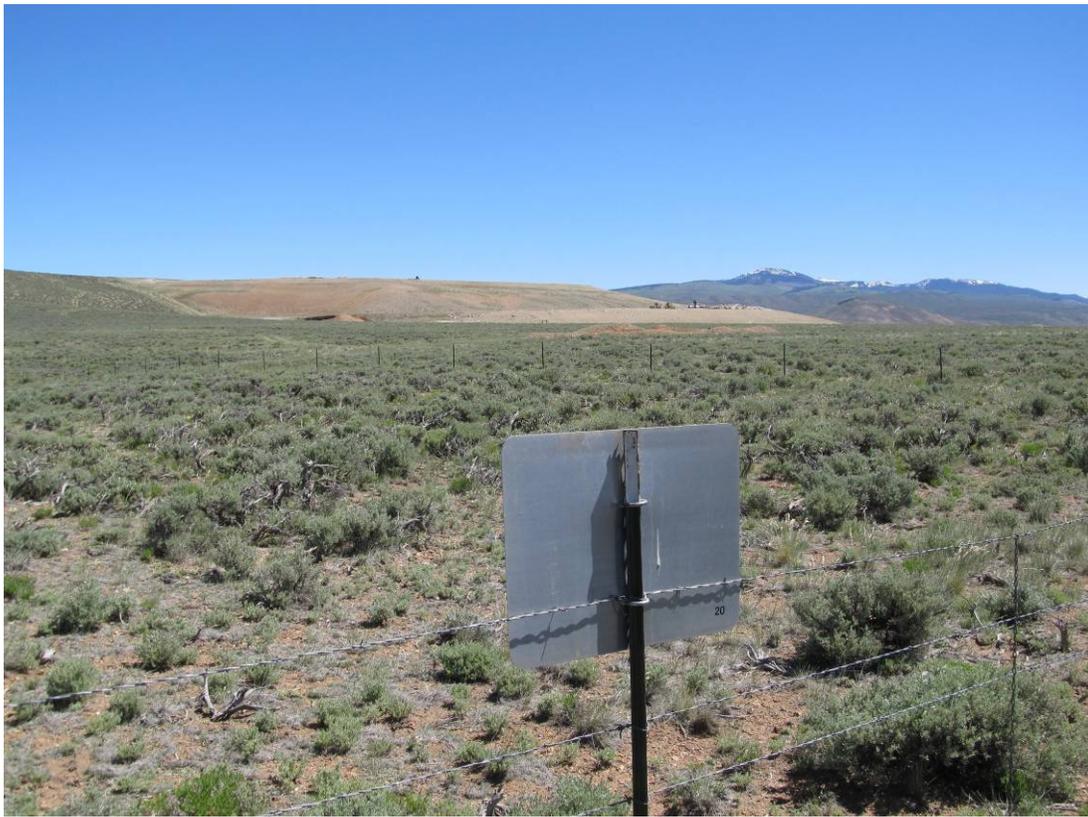
Landfill operations have encroached to within approximately 400 feet of the northeast corner of the DOE property boundary (PL–4). A diversion ditch and catchment basin were constructed on landfill property north of the site. These features were constructed to control runoff and sediment transport onto landfill property. Although landfill activities do not appear to threaten the site, future inspections will continue to monitor the level of activity occurring near the DOE property boundaries and site-surveillance features (e.g., fences, monitoring wells).

GUN 6/2011. PL-4. County landfill activities northeast of the site.
