10.0 Lowman, Idaho, Disposal Site

10.1 Compliance Summary

The Lowman, Idaho, Uranium Mill Tailings Radiation Control Act (UMTRCA) Title I Disposal Site was inspected on May 18, 2015. The disposal cell was in excellent condition. Minor maintenance to address erosion in the interceptor benches on State of Idaho property was identified. No additional maintenance needs or cause for a follow-up or contingency inspection was identified.

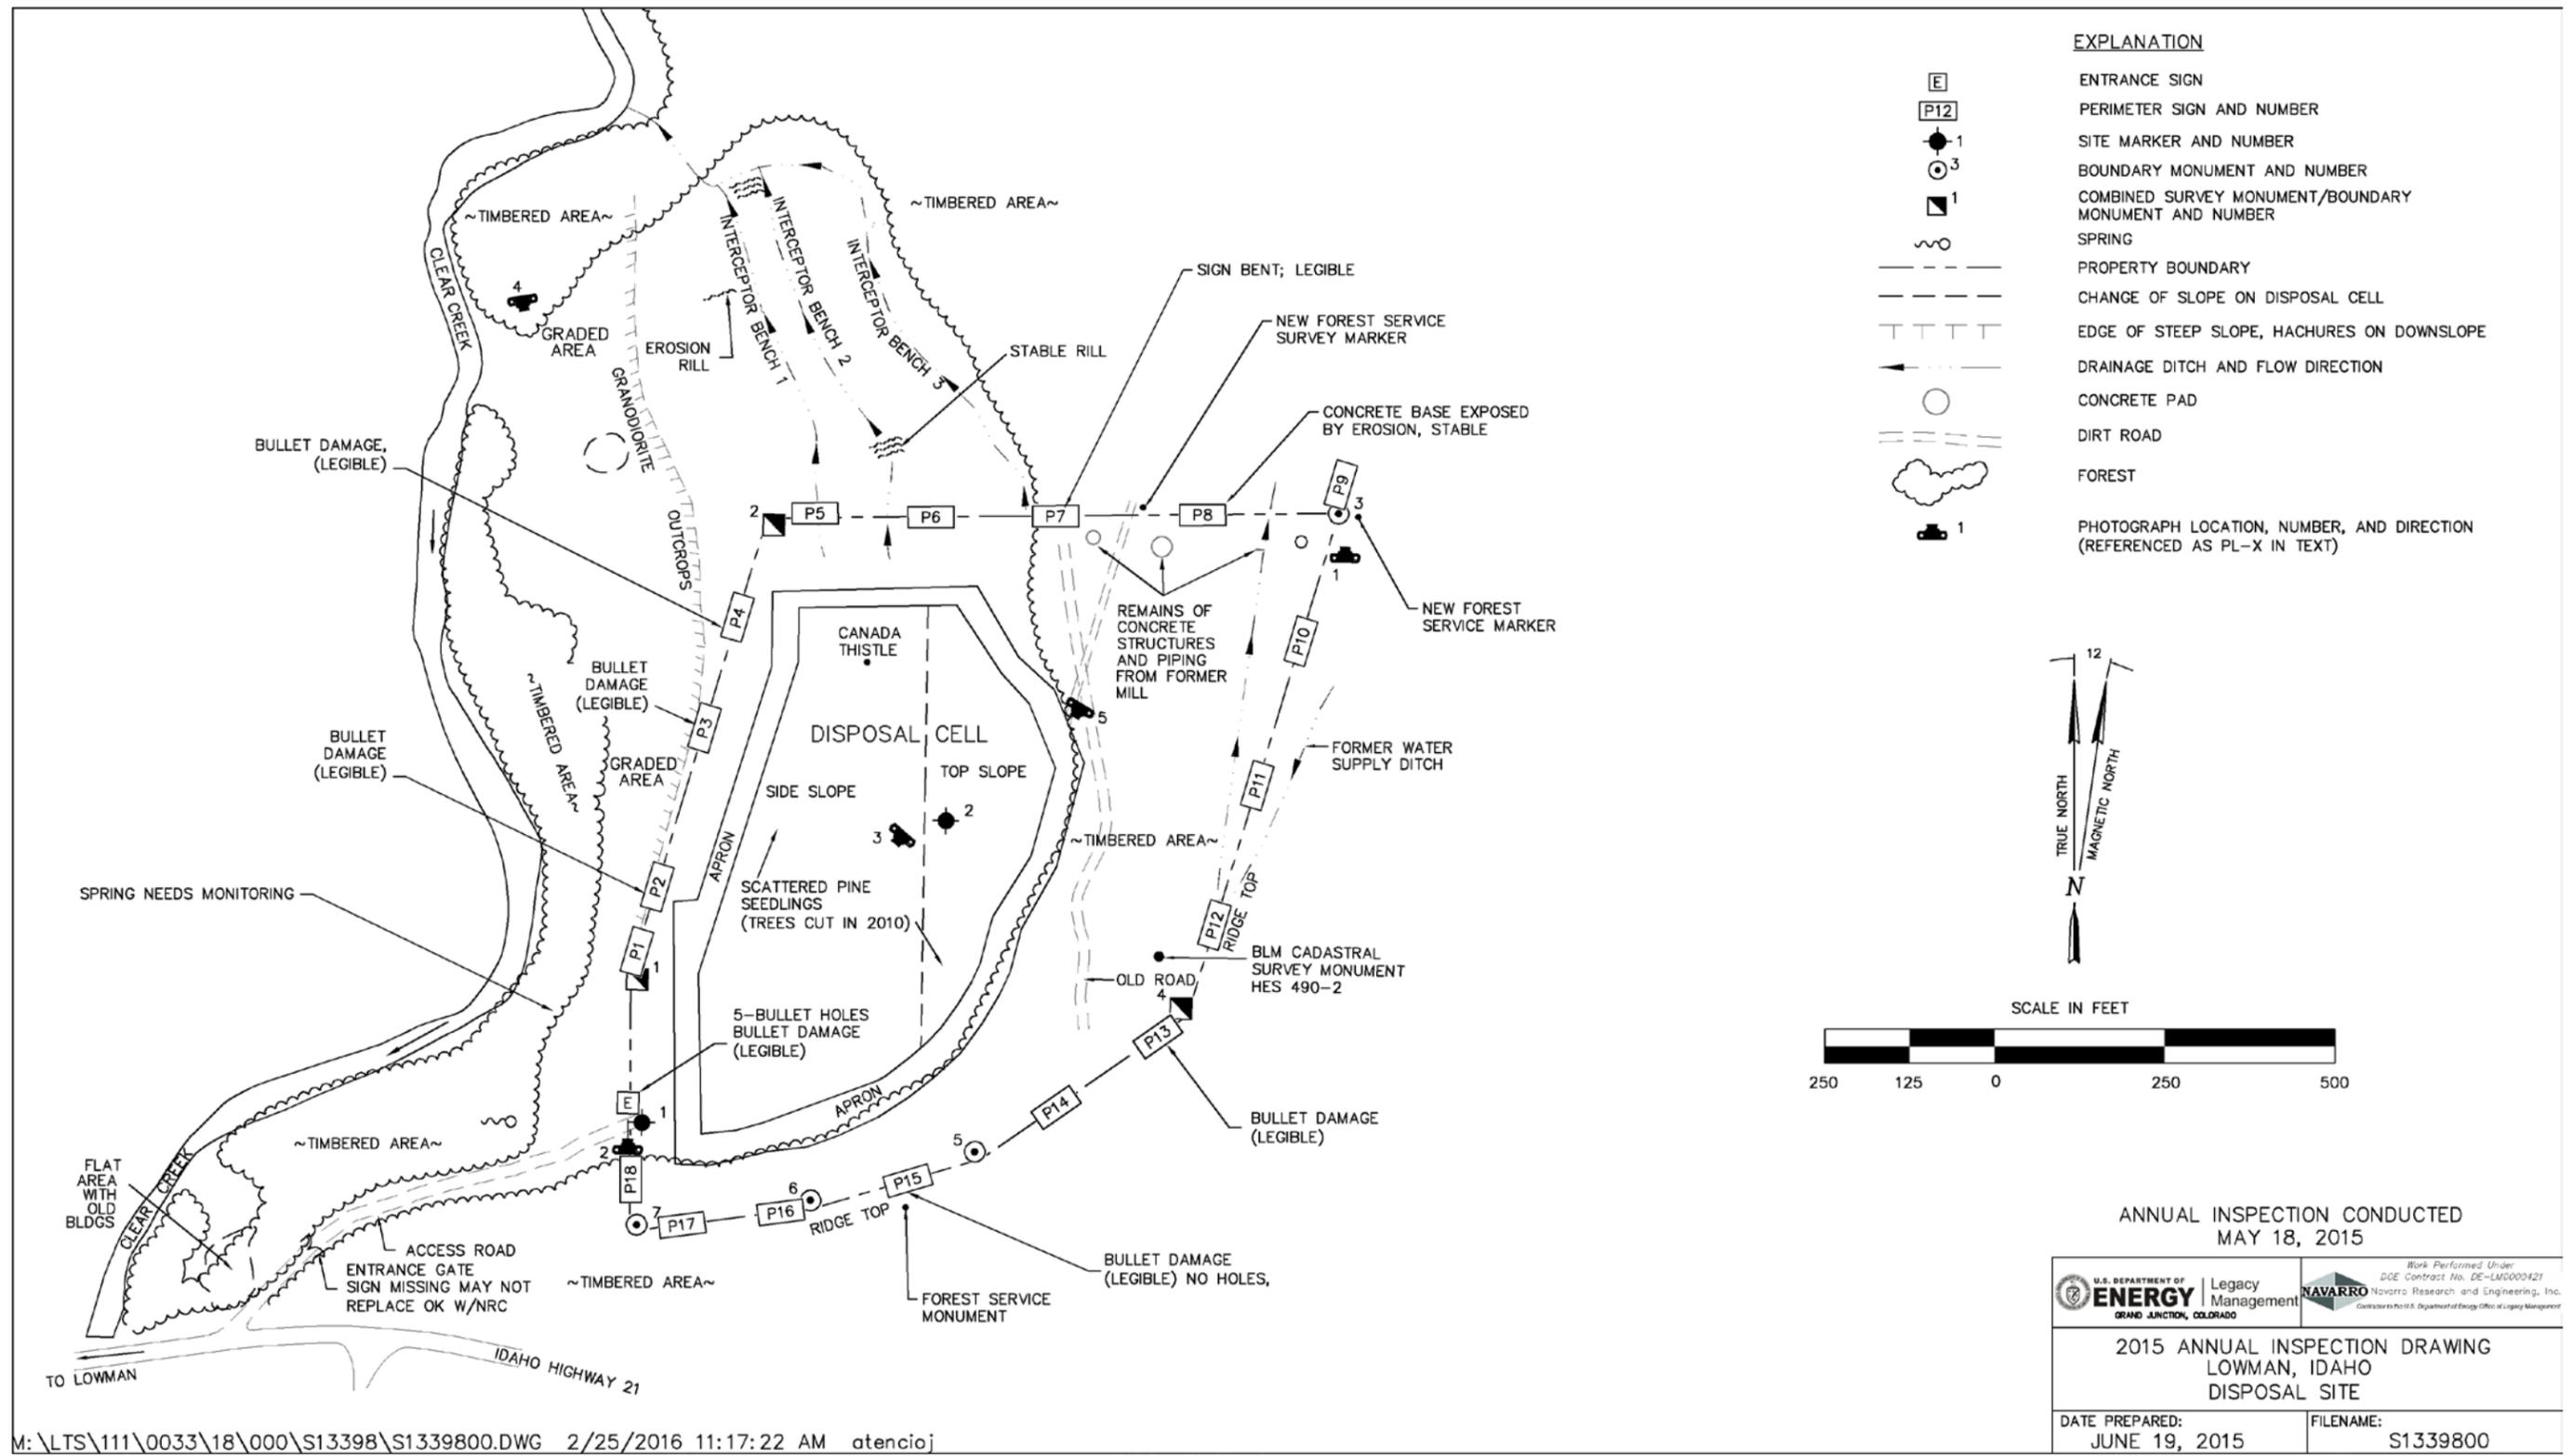
Figure 10-1. 2015 Annual Inspection Drawing for the Lowman Disposal Site

Figure 10-1 shows the locations of site surveillance features. Inspection results and recommended maintenance activities associated with site surveillance features are included in the following subsections. Photographs to support specific observations are identified in the text and in Figure 10-1 by photograph location (PL) numbers.

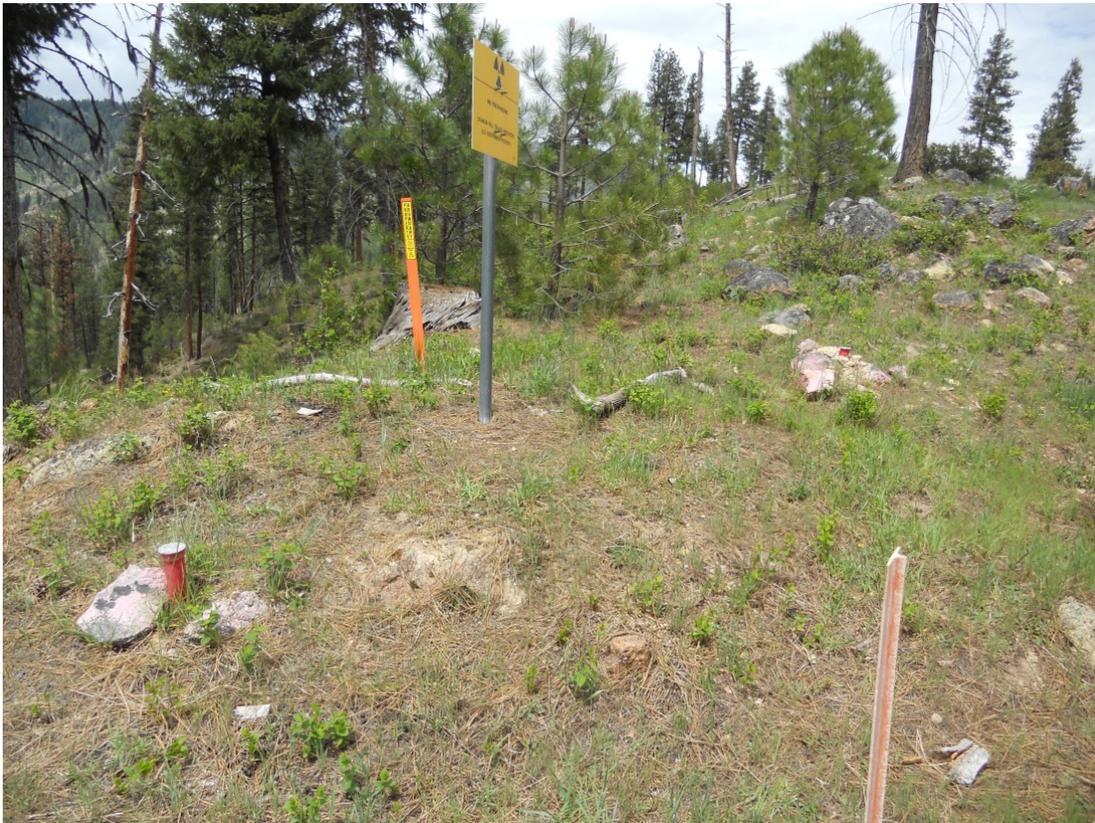
Eighteen perimeter signs (PL-1) are located along the site boundary. Several signs (P2, P3, P4, P13, and P15, and the entrance sign) have bullet damage but remain legible and do not need to be replaced at this time.

LOW 5/2015. PL-1. Perimeter sign P-9 with DOE boundary monument 3 and Forest Service monument in red.

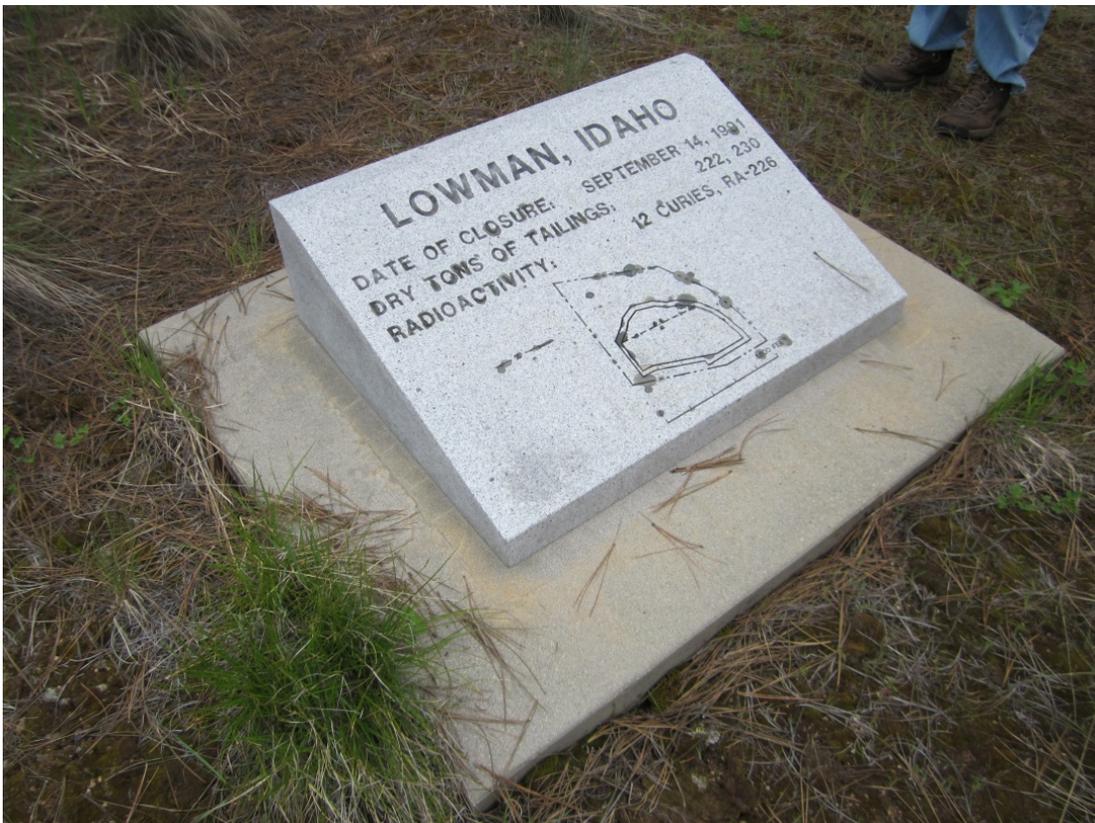
Two site markers are present at the site. The first, SMK-1 (PL-2), is just inside the site’s southwest boundary. The second, SMK-2, is on top of the disposal cell. Both markers are in excellent condition.

LOW 5/2015. PL-2. Site marker 1 (lichen growing on granite causes what looks like bullet marks).

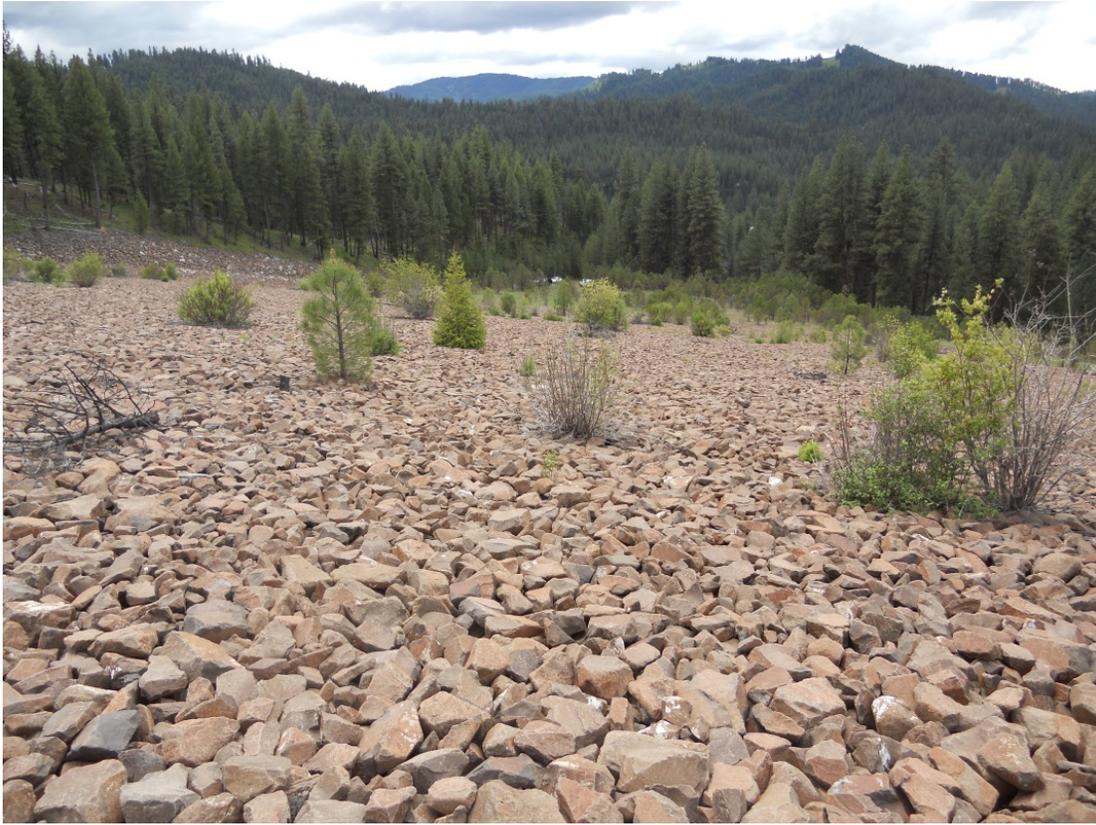
The disposal cell was completed in 1991. Basalt riprap armors the top and west-facing side slopes of the disposal cell. An apron of larger riprap surrounds the disposal cell on all sides. The riprap was in excellent condition (PL-3, PL-4). No evidence of instability, such as subsidence, slumping, or cracking, was observed on the cell surfaces.

LOW 5/2015. PL-3. Disposal cell surface near site marker 2.

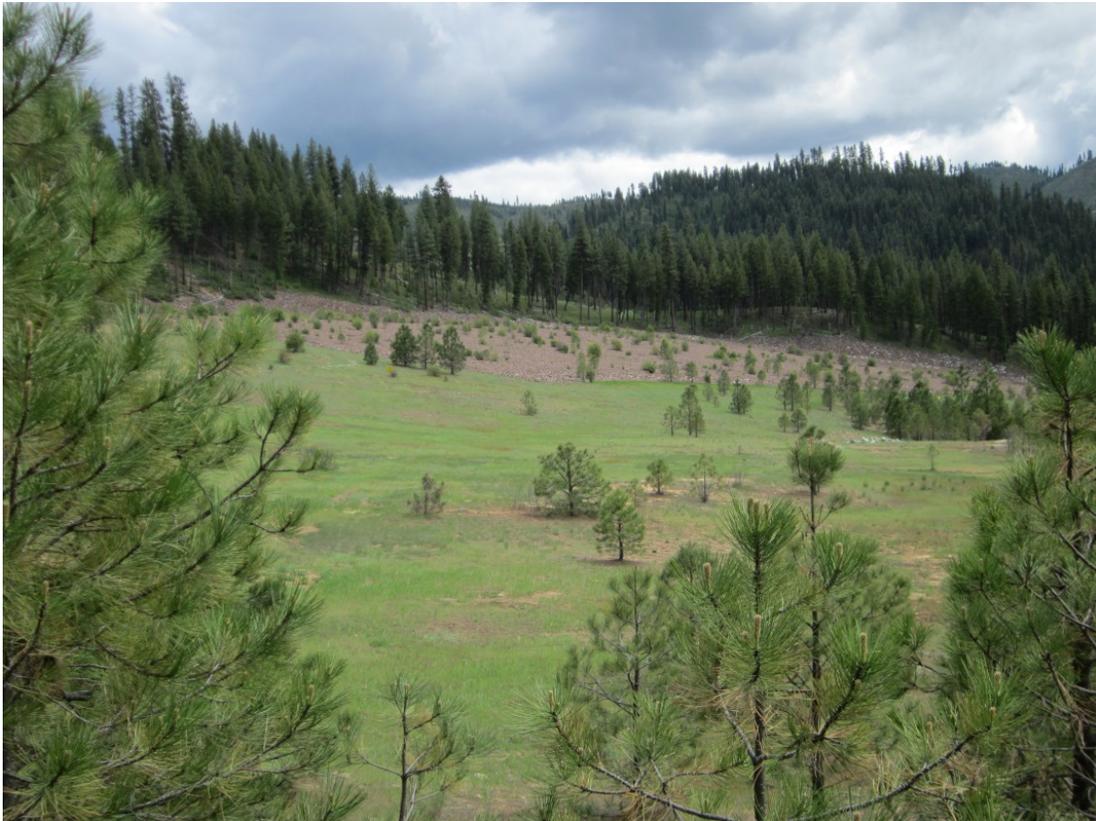
LOW 5/2015. PL-4. Disposal cell from the northwest.

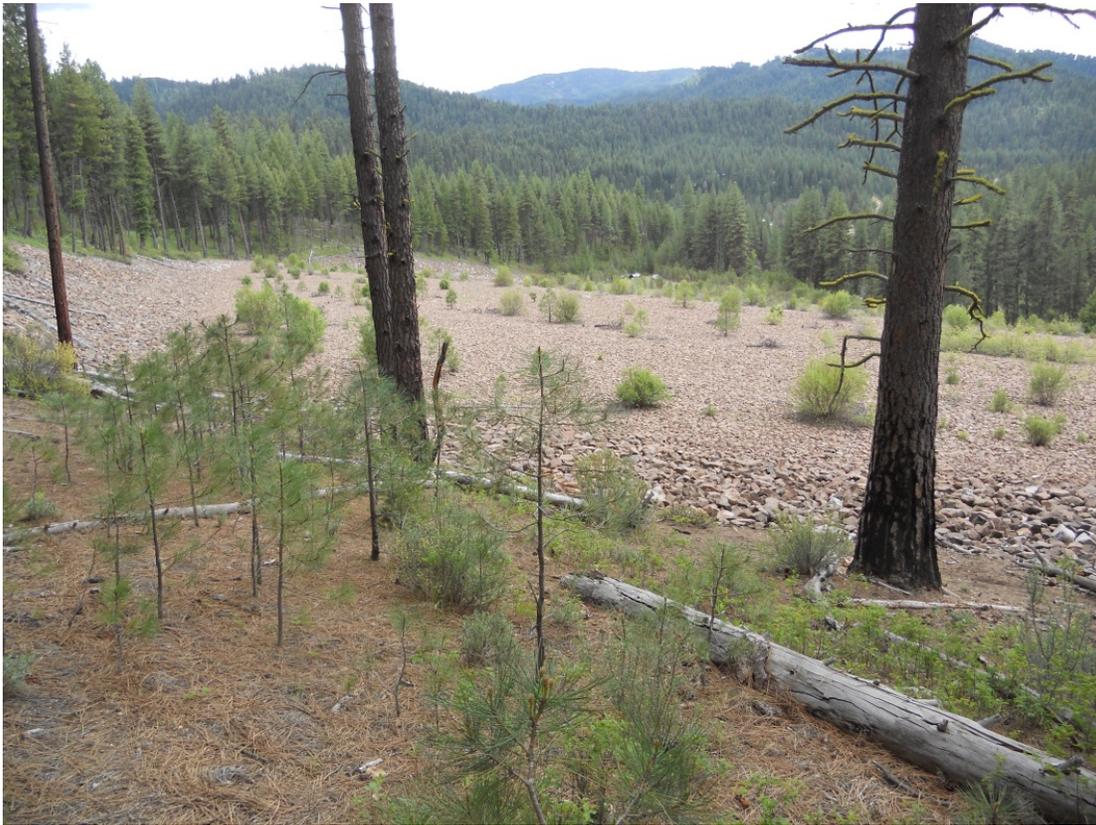
Vegetation encroachment continues on the top and side slopes of the disposal cell. Encroachment is a natural process operating at this location and will be allowed to continue in accordance with the LTSP. However, high velocity winds periodically blow down mature trees in the region. Therefore, at the request of the Idaho Department of Environmental Quality, trees large enough to damage the disposal cell cover and uproot cell materials if knocked down by wind storms are routinely removed. Site ecologists believe that any trees would need to be at least 20 years old to present a hazard, but tree growth will continue to be monitored annually. Trees were cut down in 2010, and no large trees are currently growing on the cover (PL-5).

LOW 5/2015. PL-5. Disposal cell from the northeast.
