11.0 Maybell, Colorado, Disposal Site

11.1 Compliance Summary

Figure 11-1. 2015 Annual Inspection Drawing for the Maybell Disposal Site

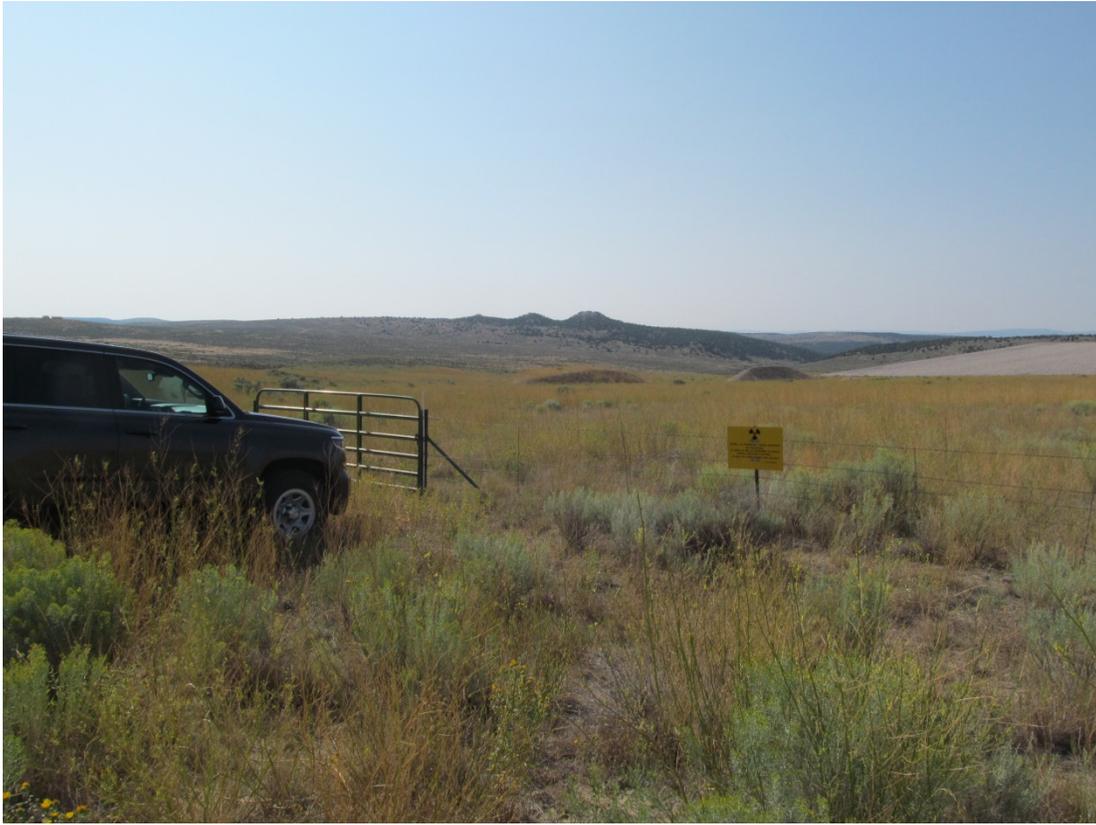
The entrance sign is located near the entrance gate and is mounted on a t-post in the fence line. It had a couple of bullet holes but remains legible (PL-1).

MAY 8/2015. PL-1. Site entrance gate and sign; east corner of disposal cell in background.

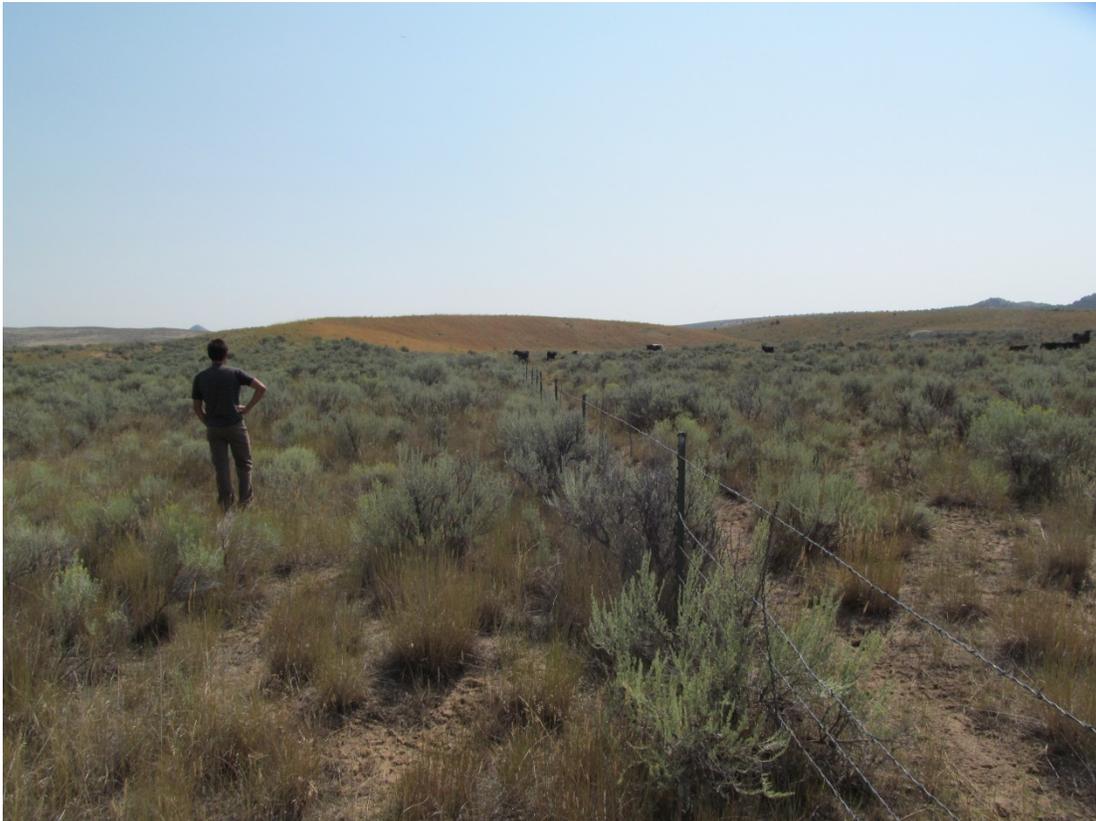
MAY 8/2015. PL-2. View east from southwest corner of site showing cattle grazing outside the perimeter fence.

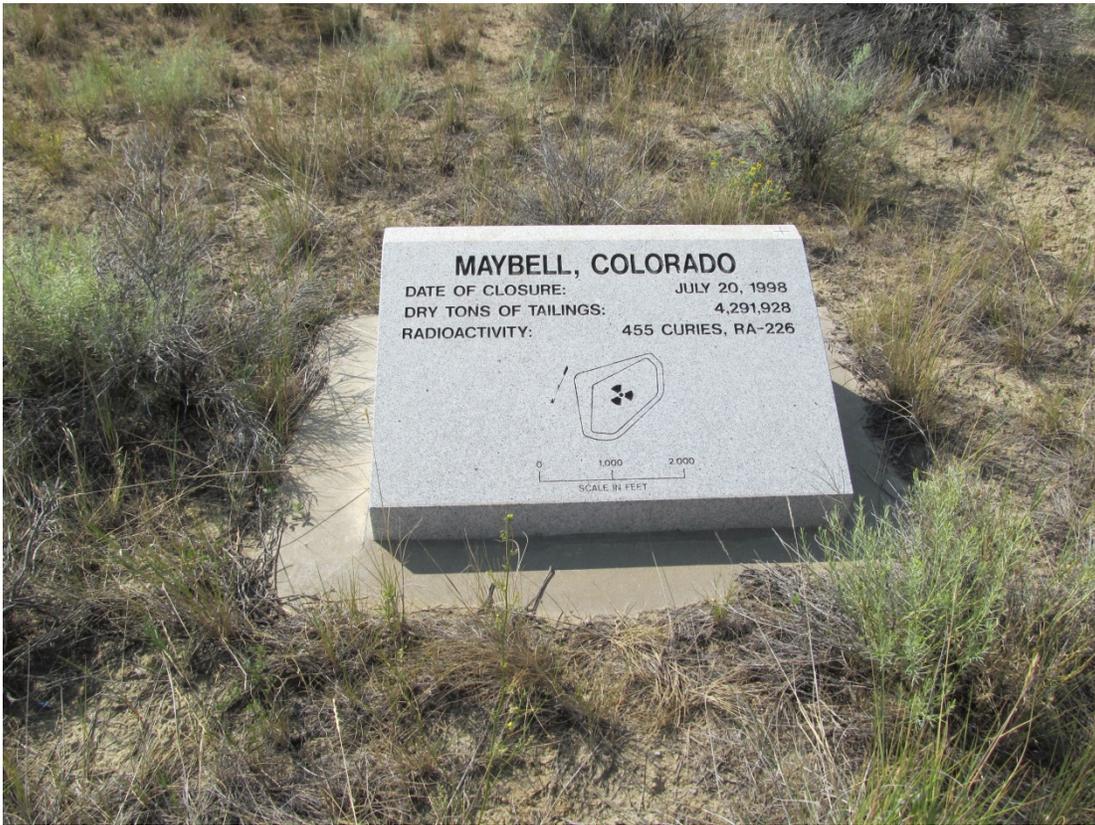
Two standard granite site markers are at the site. Site marker SMK-1 is located near the entrance gate (PL-3), and site marker SMK-2 is located on top of the disposal cell (PL-4). Both site markers were in good condition.

MAY 8/2015. PL-3. Site marker SMK-1.

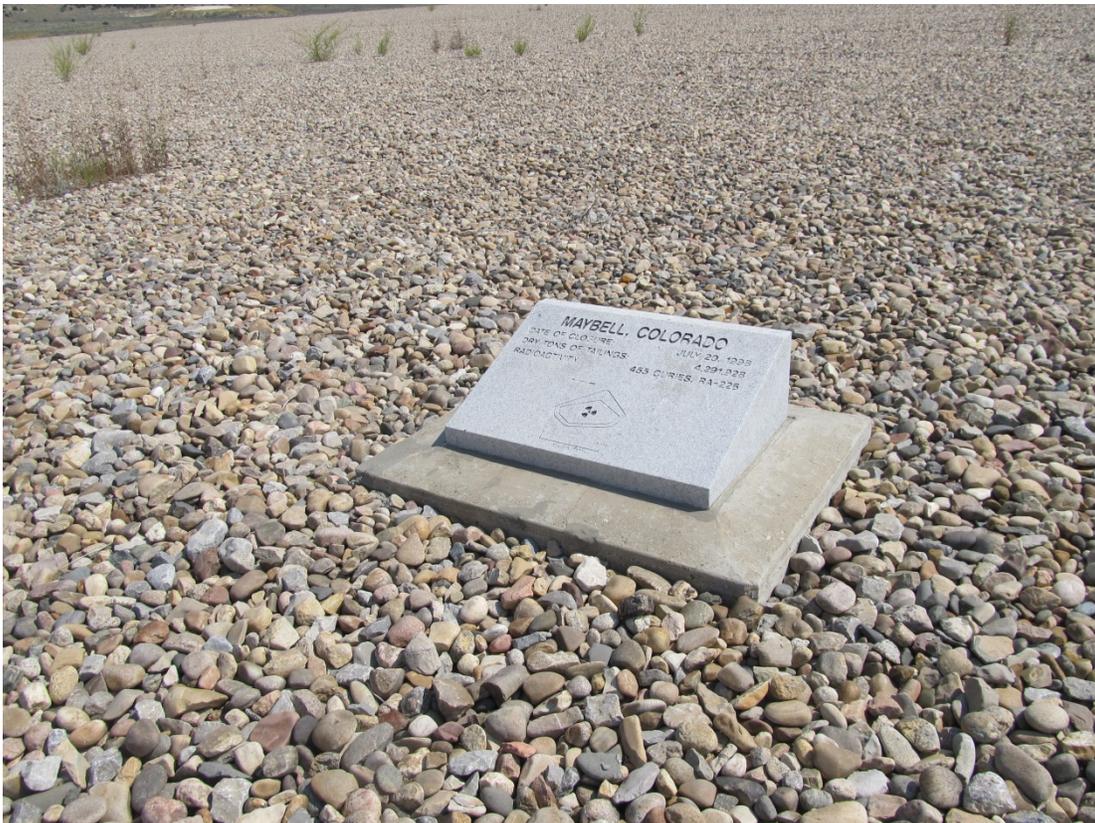
MAY 8/2015. PL-4. Site marker SMK-2.

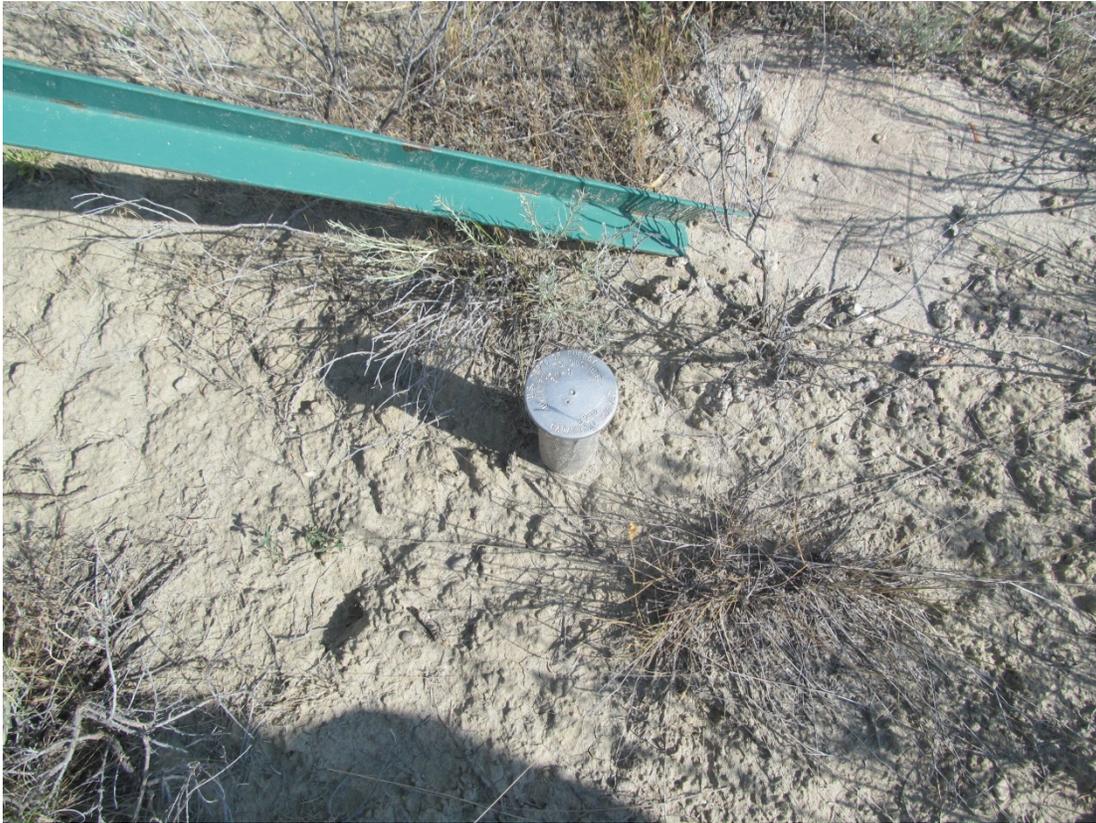
Originally, four boundary monuments had been installed along the property boundary. These four monuments, however, did not adequately represent the site property boundary. Therefore, additional monuments were installed in September 2002. A 2008 real property assessment noted that the 2002 land survey did not match the legal description included in the BLM permanent withdrawal for the site. BLM confirmed that the perimeter fence along the north and northwest sides of the site corresponds to the actual site boundary and that nine of the new boundary monuments outside the fence in that area were located outside the property boundary. BLM recommended in 2014 that DOE leave those nine monuments in place undisturbed to avoid the cost of removing them. BLM and DOE documented the issue and recommendation in their records. Figure 11-1 shows the correct boundary monuments and property corners. All boundary monuments observed during the inspection were in good condition (PL-5).

MAY 8/2015. PL-5. Boundary monument BM-1.

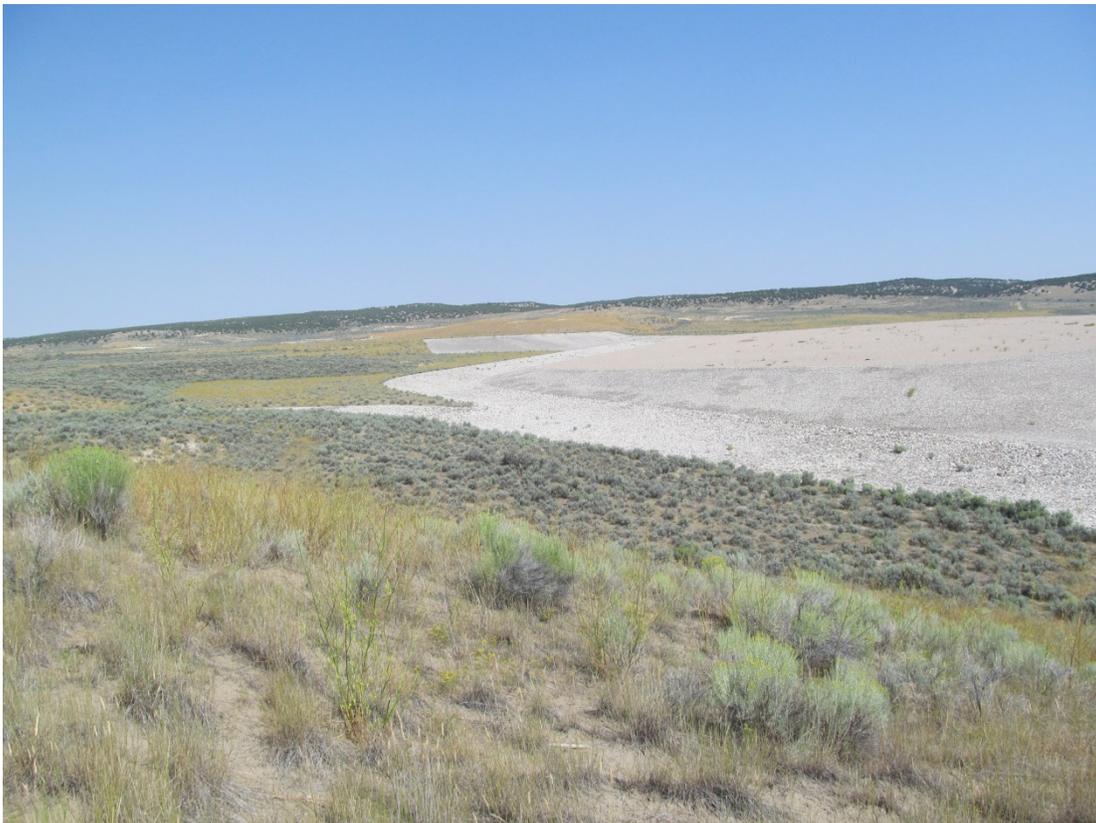
The disposal cell covers approximately 66 acres of the approximately 250-acre disposal site property (PL-6 and PL-7). The side slopes of the disposal cell are at a 20 percent grade to create a stable slope, and the top of the disposal cell has a 3 percent grade to promote drainage toward the west. The disposal cell showed no evidence of settlement, slumping, erosion, or rock degradation (PL-8 and PL-9). Scattered shallow-rooted plants continue to establish on the disposal cell top and side slopes; these plants do not affect the integrity of the disposal cell. Deep-rooted plants and noxious weeds are controlled as required by the LTSP.

MAY 8/2015. PL-6. Southwestern portion of disposal cell.

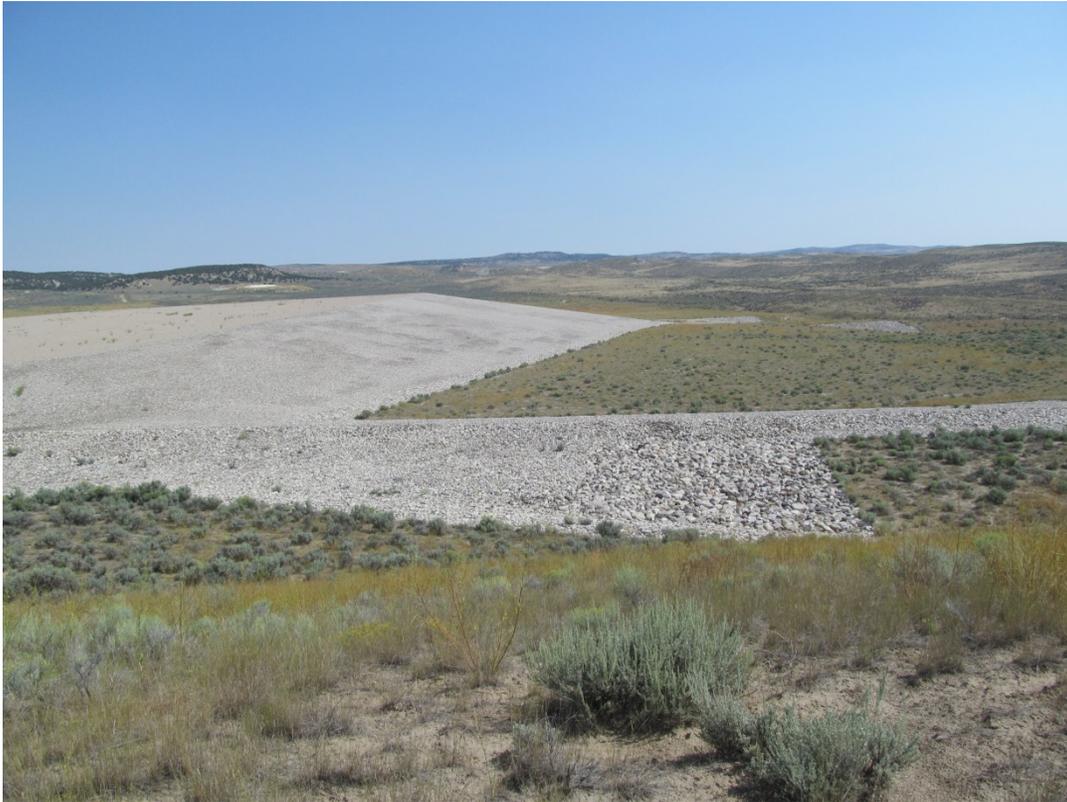
MAY 8/2015. PL-7. Southeastern portion of disposal cell.

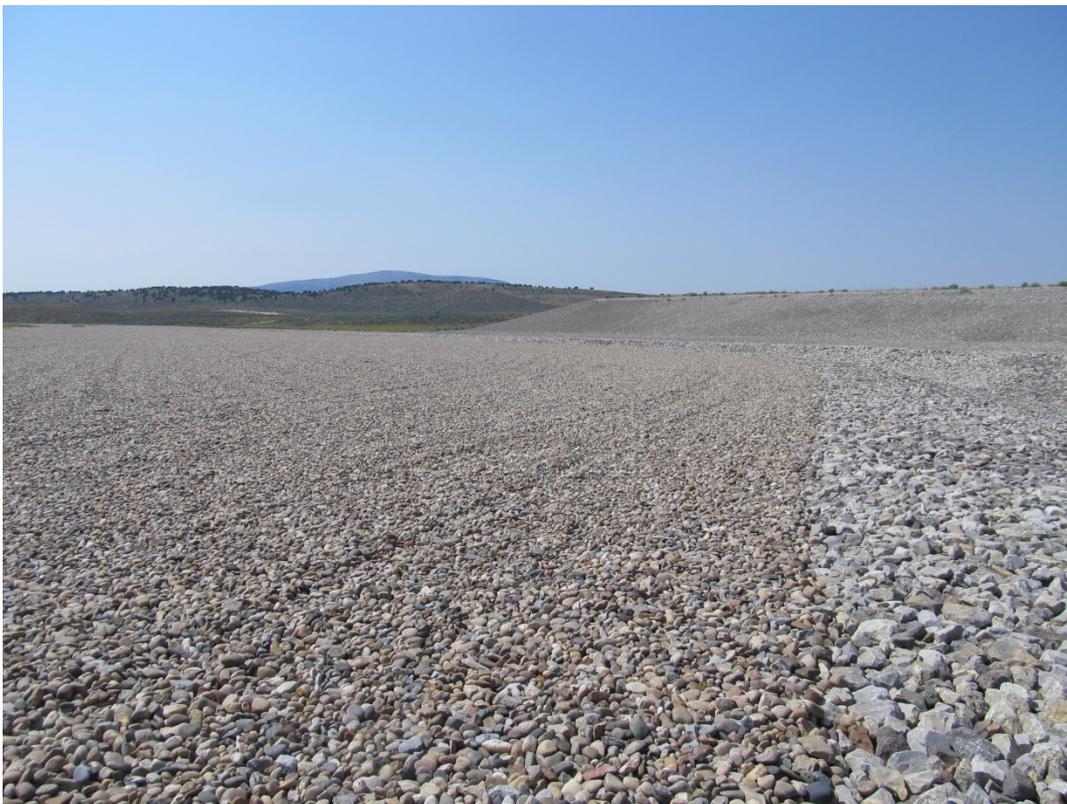
MAY 8/2015. PL-8. Northwest corner of disposal cell, view to south southwest; riprap-covered slope west of cell in background.

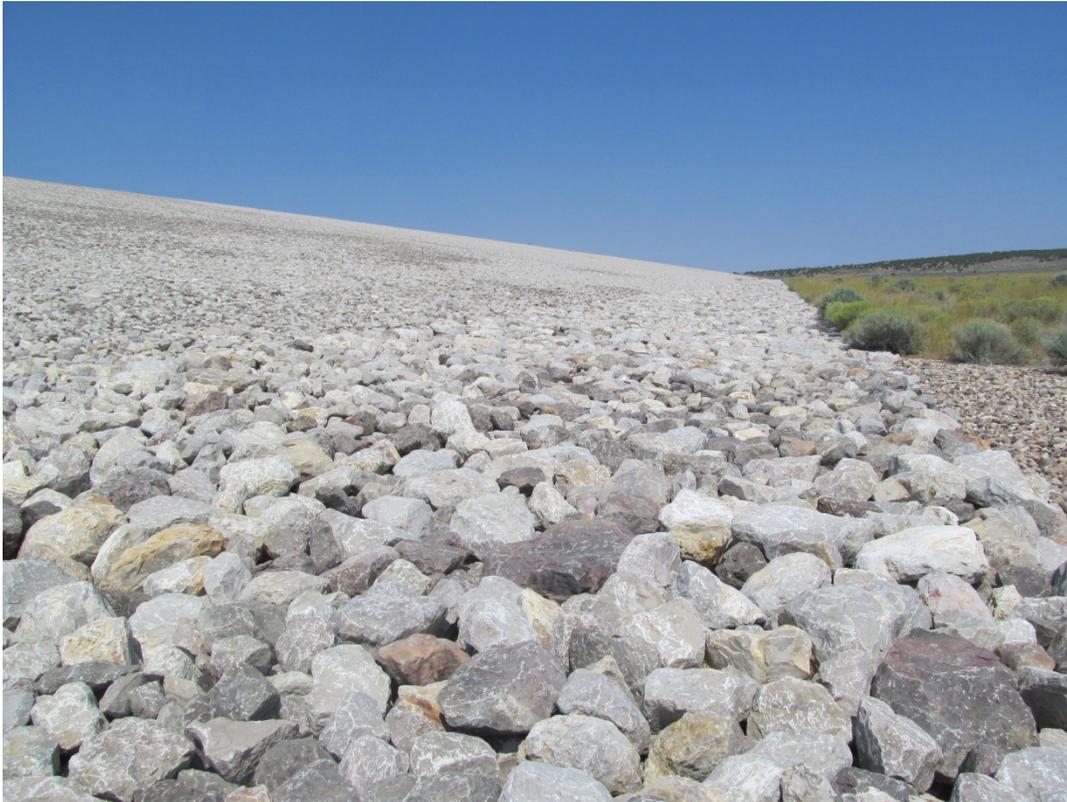
MAY 8/2015. PL-9. East-northeast side slope of disposal cell.

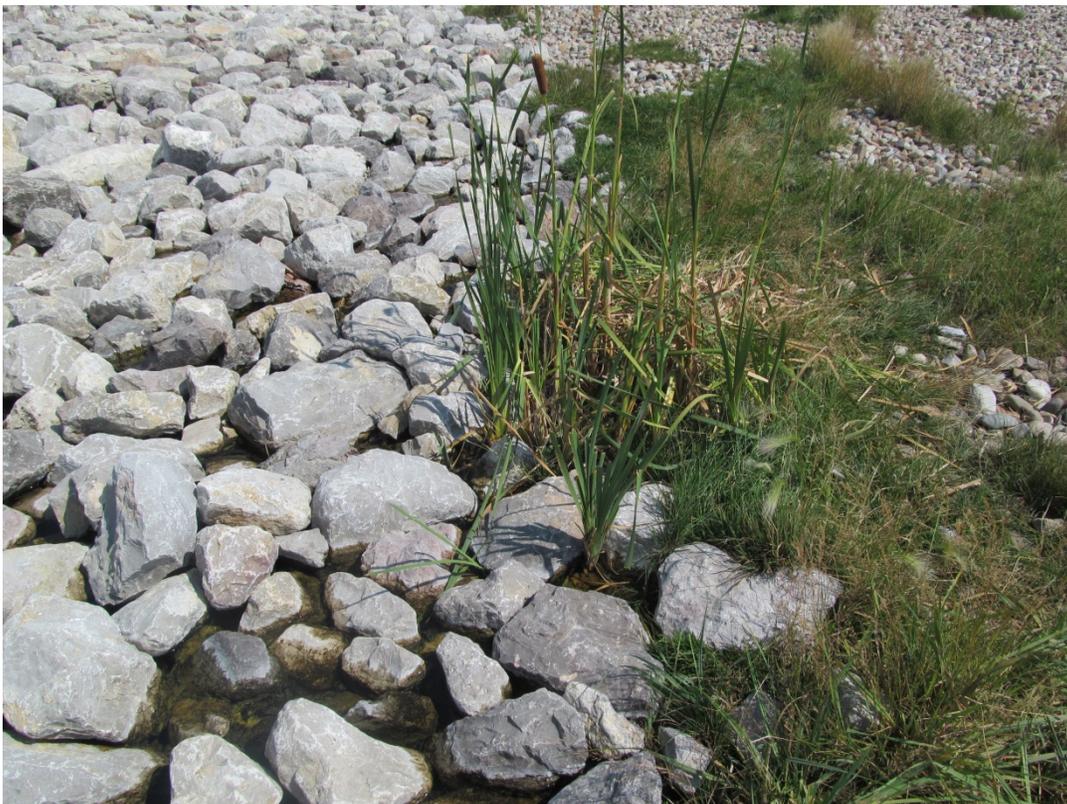
observed at the toe of the disposal cell in these areas. Cattails continue to be observed growing at the toe of the east corner of the disposal cell, indicating the presence of moisture. Surface runoff from the cell discharges at this location; standing water has been observed in this area during past inspections and was present at the time of this inspection (PL-10). A 2003 laboratory analysis of evaporite minerals from this location confirmed that no constituents attributable to the cell contents were present.

MAY 8/2015. PL-10. Cattails growing at base of southeast side slope of disposal cell where surface water runoff accumulates.

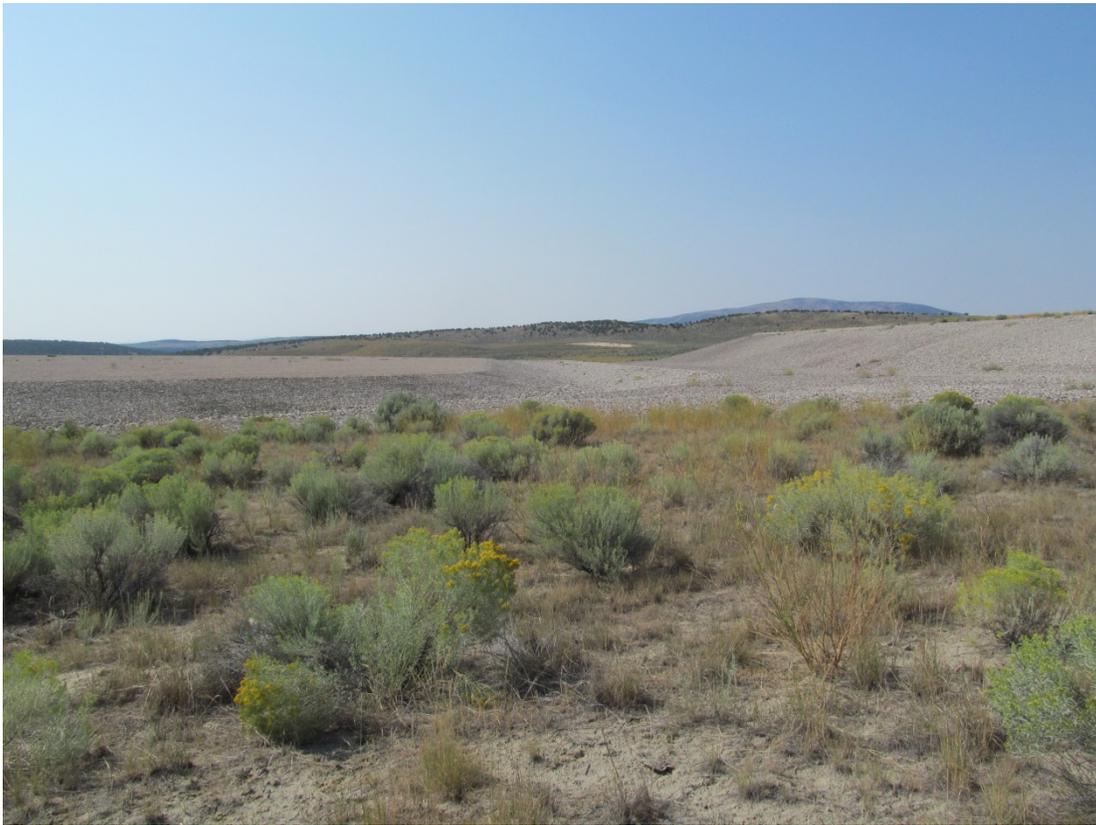
MAY 8/2015. PL-11. Diversion Channel No. 1 separating disposal cell and riprap covered slope west of cell.

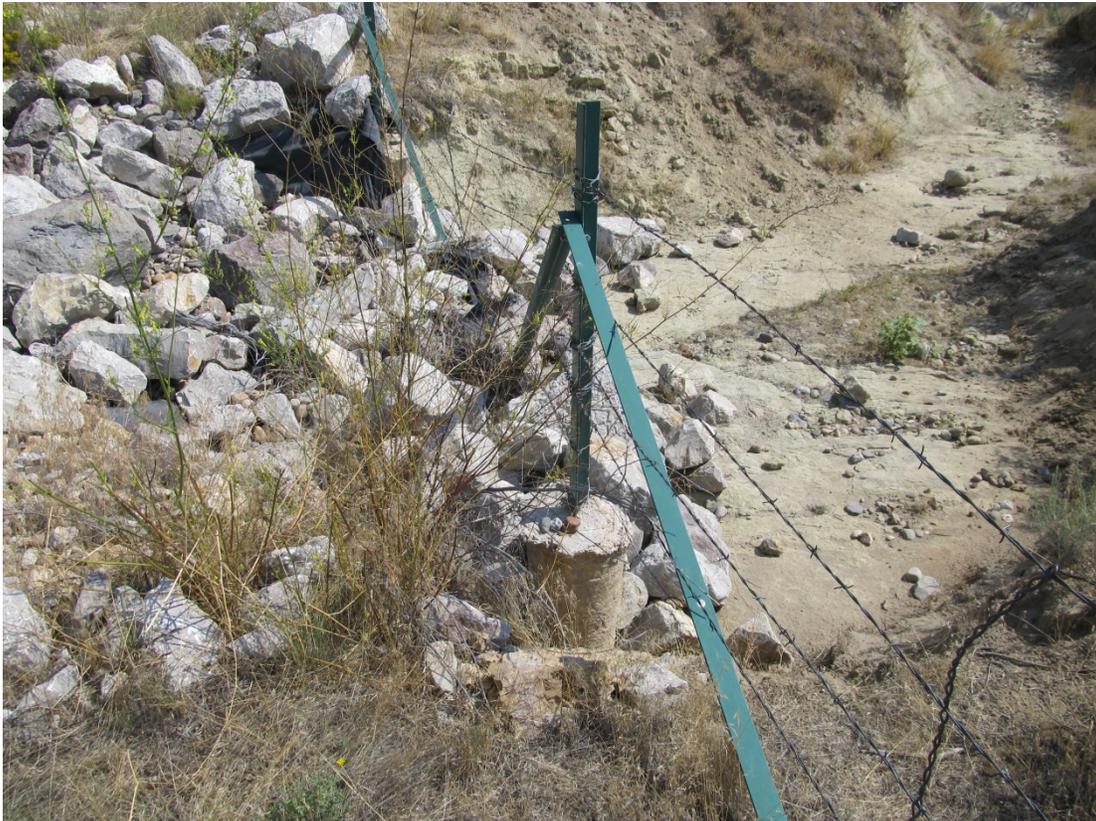
MAY 8/2015. PL-12. Erosion occurring at the outlet to Diversion Channel No. 1.

- 11A Noxious weeds and deep-rooted plants on the disposal cell were sprayed with herbicide during two separate vegetation management visits in 2015. Maintenance of the perimeter fence will be performed when warranted (i.e., repair of broken strands and bent posts, removal of sand directly

north of the Johnson Pit, and erosion damage at the outlet of Diversion Channel No. 1); the fence remains functional. No other maintenance needs were identified.

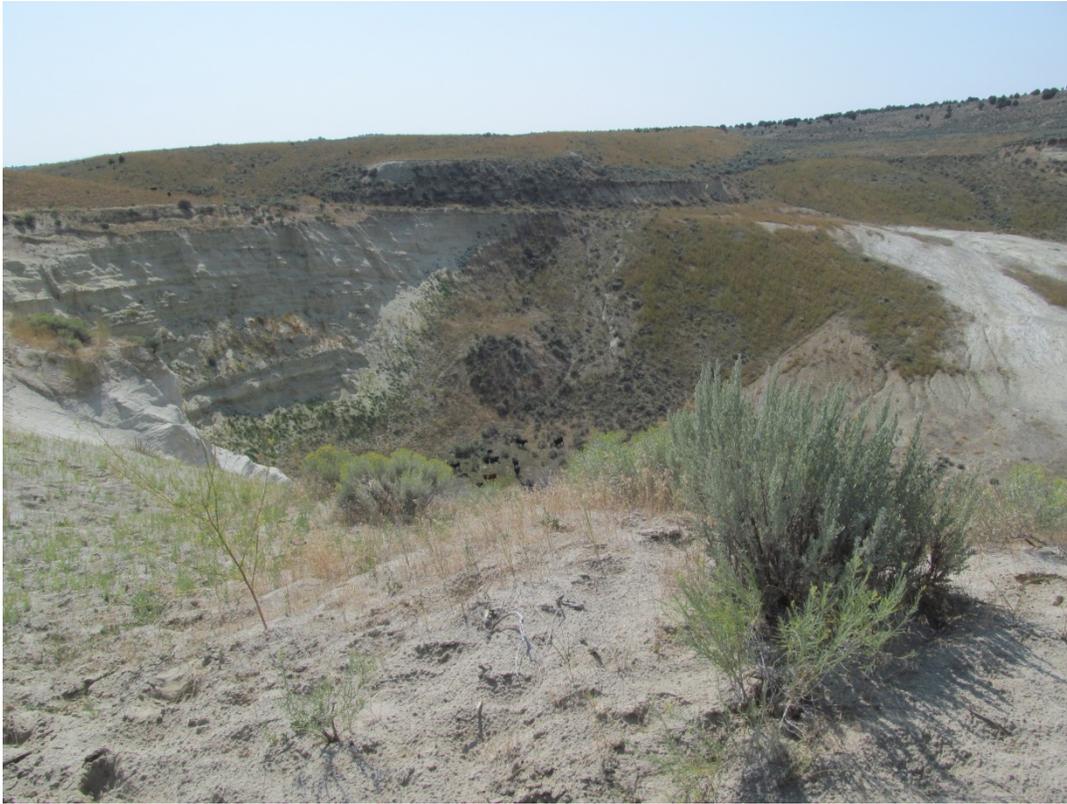
Directly south of the site is a former open-pit uranium mine referred to as the Johnson Pit (PL-13). Over time, slumping of the pit wall resulted in the pit encroaching several feet onto what is now DOE property. This encroachment presents no threat to the integrity of the disposal cell and occurred prior to reclamation and transfer of the site to DOE for long-term surveillance and maintenance. This encroachment is visually monitored annually and periodically documented with photographs to determine if any further slumping of the pit wall is occurring and to verify the integrity of the perimeter fence. There was no evidence of any additional encroachment of the pit onto the site at the time of the inspection. However, windblown sand continues to accumulate along the northern crest of the pit wall along the fence line (PL-14); maintenance will be performed before the fence is no longer functional.

MAY 8/2015. PL-13. Northeast portion of Johnson Pit.

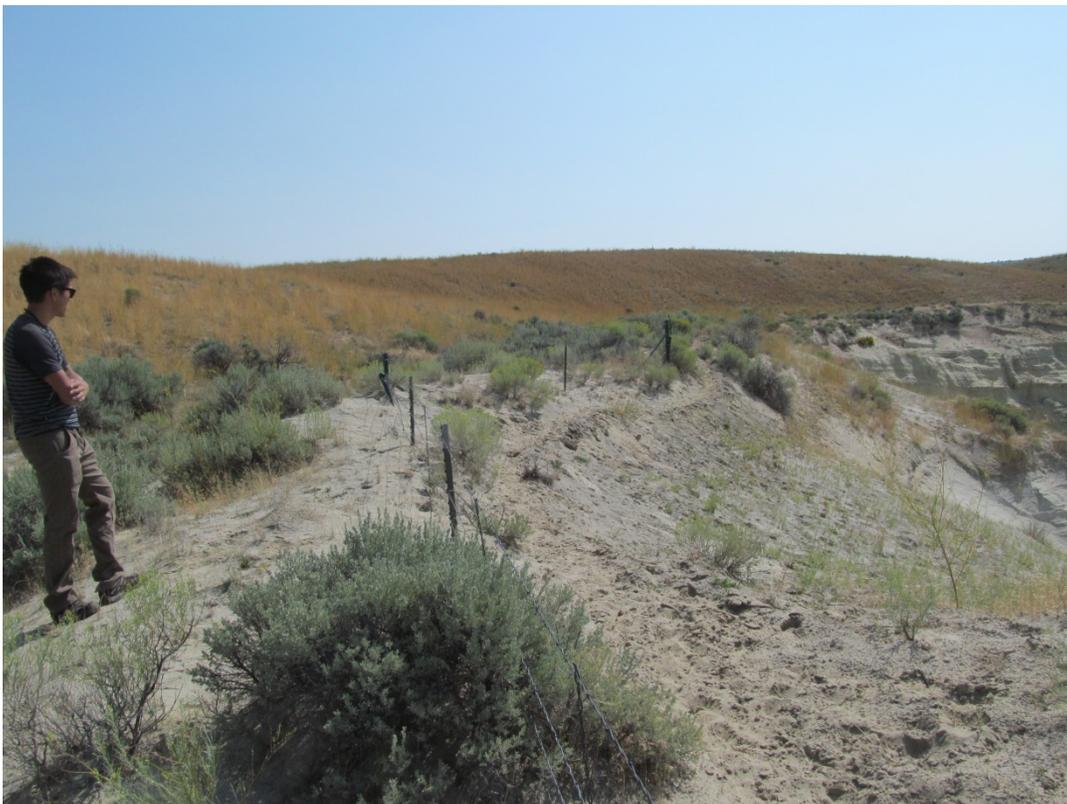
MAY 8/2015. PL-14. Sand accumulation covering perimeter fence along southern property boundary directly north of Johnson Pit.
