4.0 Maybell West, Colorado, Disposal Site

Figure 4-1. 2015 Annual Inspection Drawing for the Maybell West, Colorado, Disposal Site

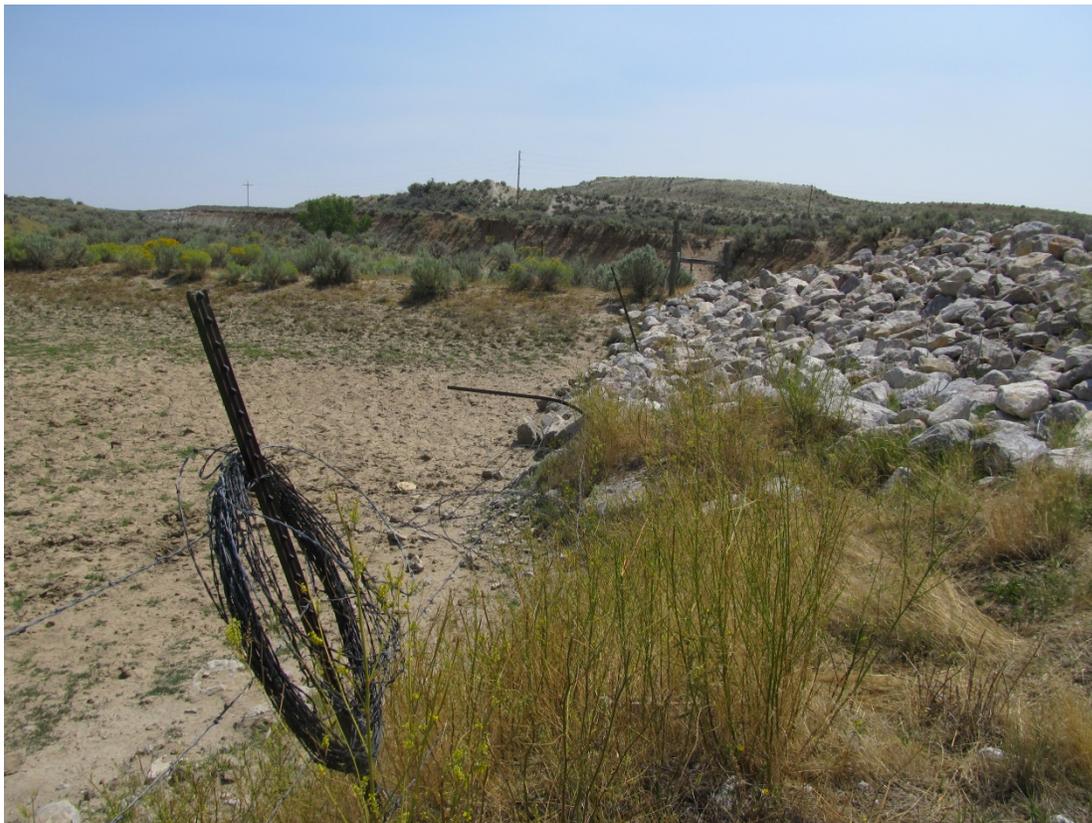
A standard four-strand barbed-wire stock fence surrounds the disposal cell, the ancillary cell, the drainage structures, and much of the site. The fence facilitates land management by DOE, because the site is located in wintering grounds frequented by big game animals (primarily pronghorn, deer, and elk) and is also surrounded by open range land used for grazing by cattle. With the exception of a damaged fence post (PL-1) and erosion occurring along a short portion of the fence line (PL-2), the fence was in good condition. Those fence repairs will be made when more significant repairs are needed; the fence remained functional.

| Photo Location Number | Azimuth | Photograph Description |
|---|---|--|
| PL-1 | 140 | Fence damage near Diversion Channel No. 1 outlet channel. |

MAW 8/2015. PL-1. Fence damage near Diversion Channel No. 1 outlet channel.

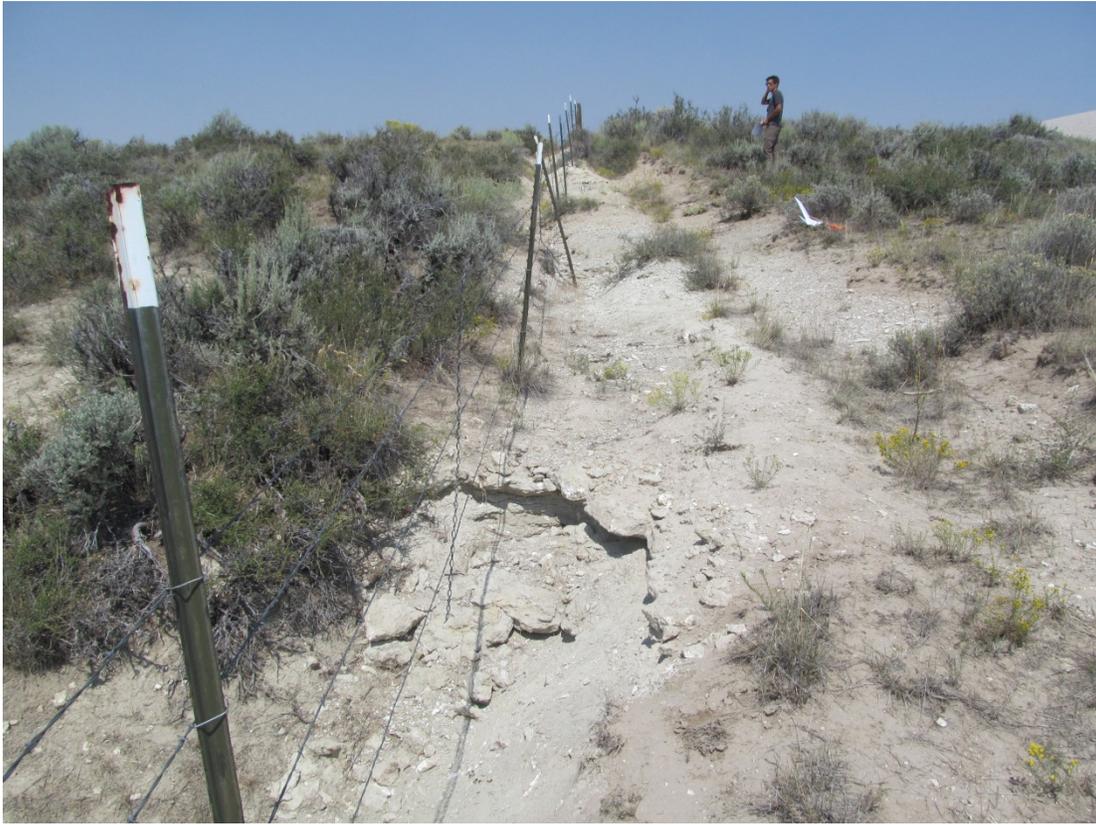
| Photo Location Number | Azimuth | Photograph Description |
|---|---|--|
| PL-2 | 360 | Erosion along perimeter fence. |

MAW 8/2015. PL-2. Erosion along perimeter fence.

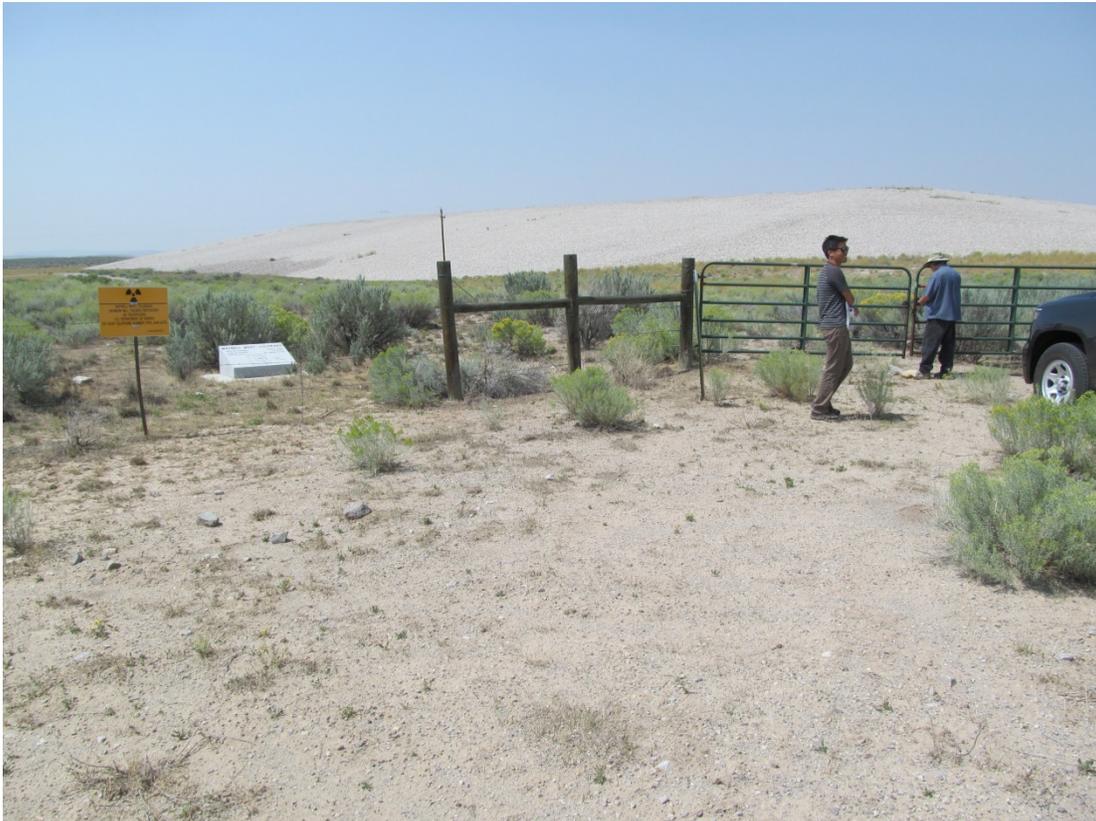
The entrance gate, a standard tubular metal stock gate, is located near the southeast corner of the site (PL-3). The gate was locked and in good condition. There are no other gates at the site.

The entrance sign is mounted on a perimeter fence metal t-post directly south of the entrance gate (PL-3). The entrance sign was in good condition.

MAW 8/2015. PL-3. Site entrance gate and sign; site marker in background.

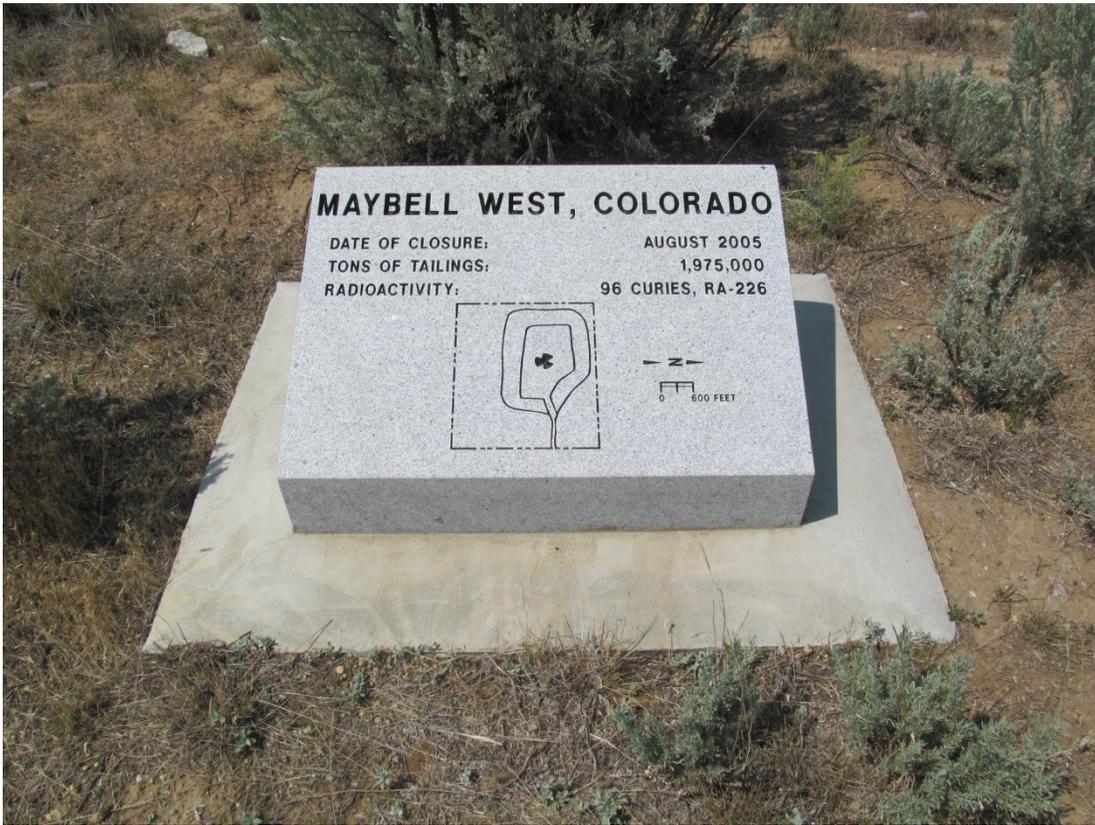
One granite site marker is located on the site near the entrance gate (PL-4). The site marker was in good condition.

MAW 8/2015. PL-4. Site marker.

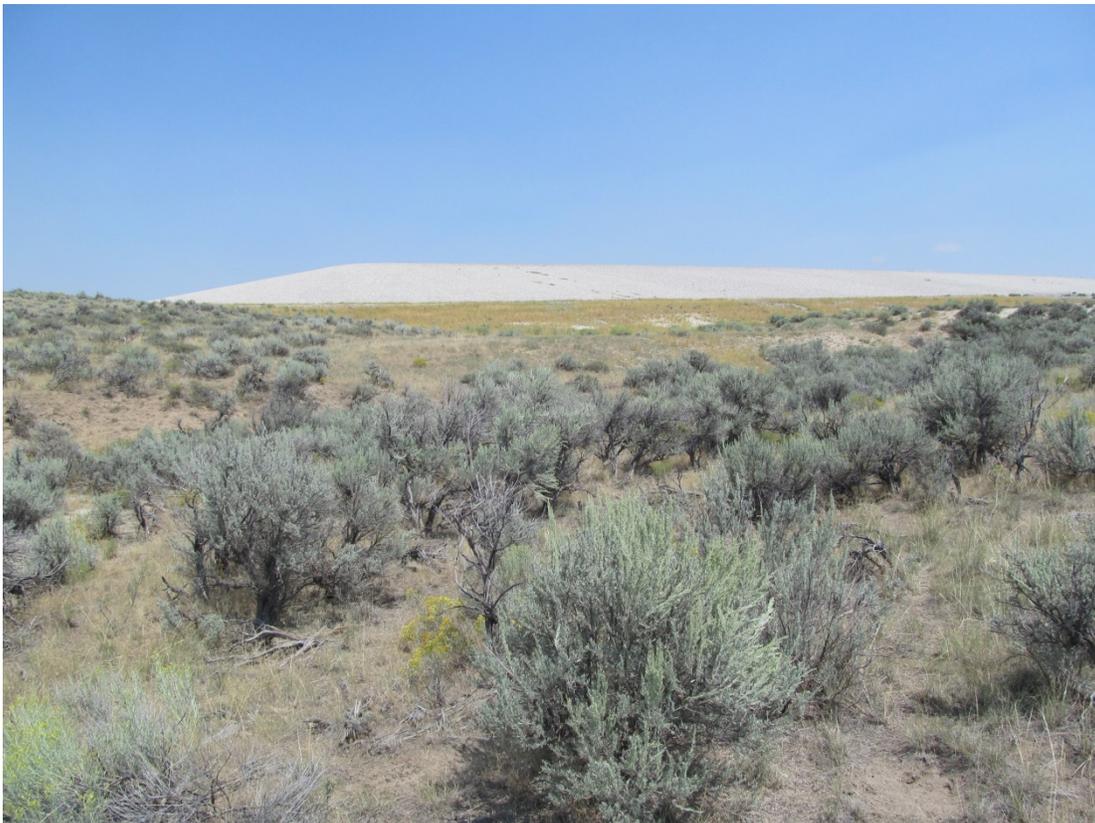
The rock-covered disposal cell, a reclaimed former heap leach area that occupies about 60 acres of the site, was in good condition (PL-5). It rises to a maximum height of approximately 75 feet above the surrounding landscape.

MAW 8/2015. PL-5. Southwestern portion of the site; disposal cell in background.

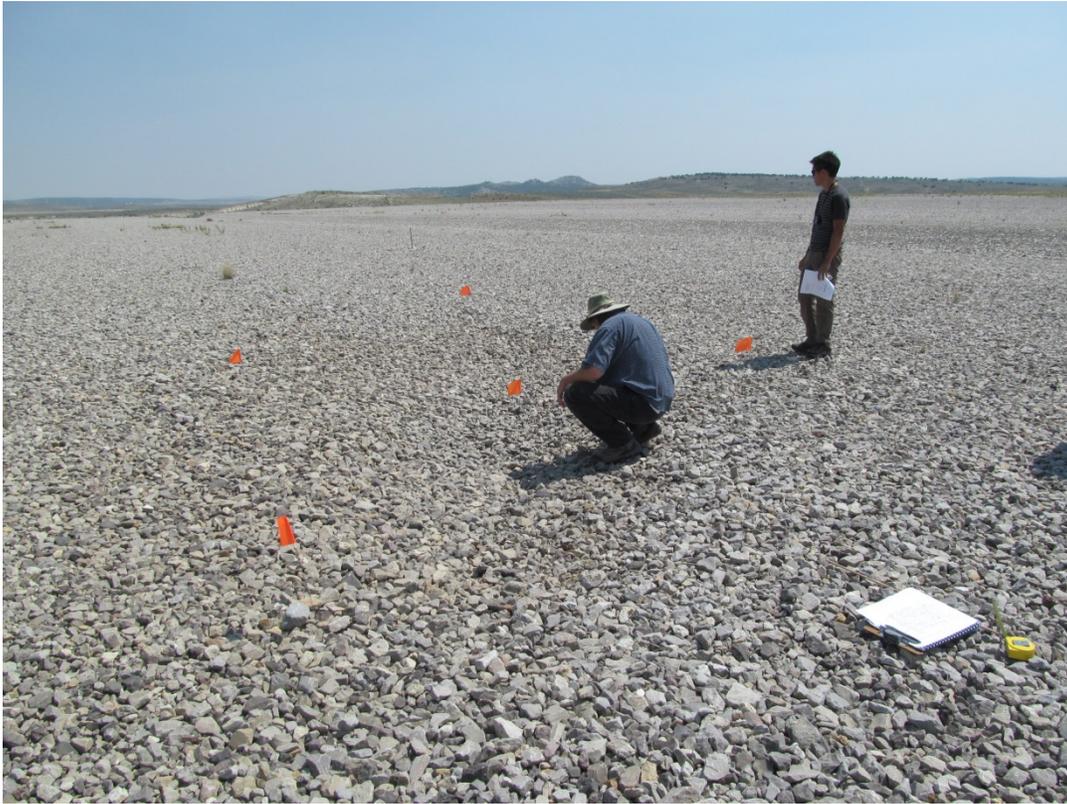
No evidence of slumping, erosion, or rock degradation was observed. However, a small shallow depression is present just north of Diversion Channel No. 1 (PL-6). This depression, approximately 25 feet long, 15 feet wide, and 1 foot deep in the center, appears to be the result of settlement of the underlying materials since completion of the cell. The depression remained approximately the same size as noted during the last annual inspection. Measurements of the depression will continue to be performed during annual inspections to determine if additional settlement is occurring. The depression currently does not prevent positive drainage of the cover or threaten the integrity or performance of the disposal cell.

MAW 8/2015. PL-6. Depression on disposal cell top.

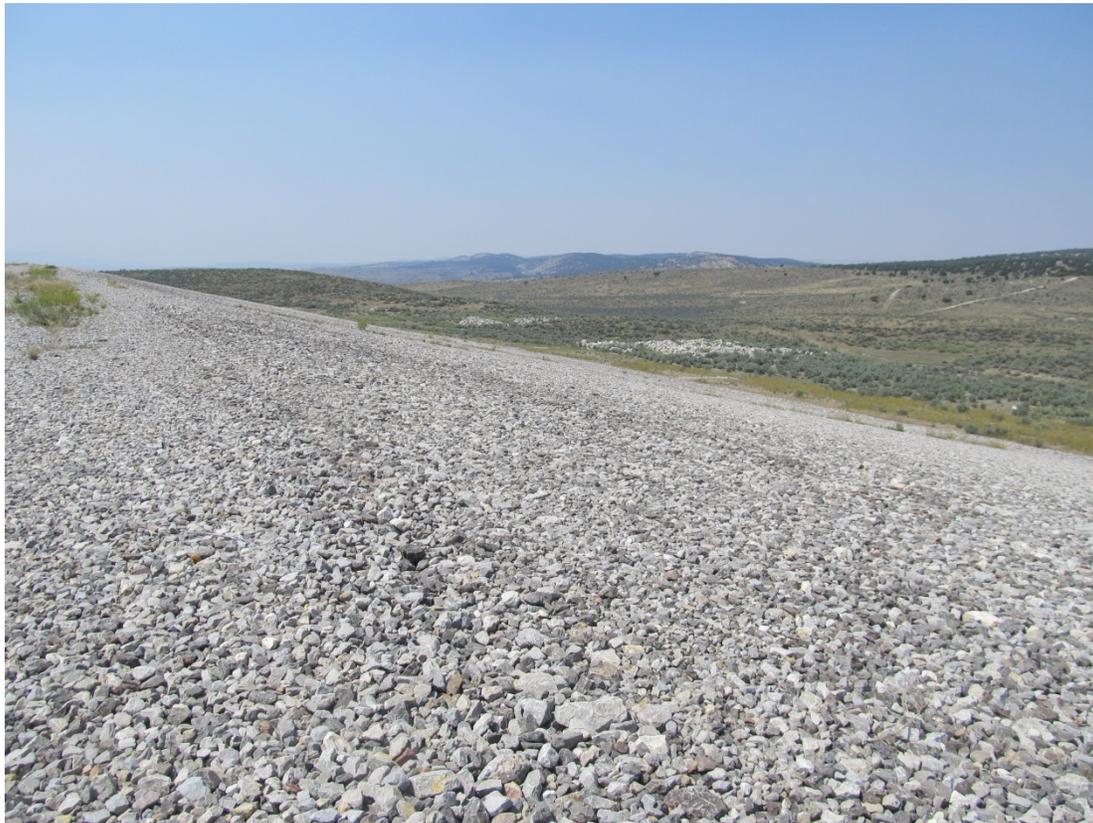
The disposal cell was designed to control surface-water runoff resulting from a probable maximum flood event. The side slopes of the disposal cell, constructed with a 20-percent slope grade and covered with a 1-foot-thick layer of riprap, were in good condition (PL-7). Surface-water runoff from the side slopes is conveyed by an apron at the toe of the slope to five riprap-armored toe drains at low points in the apron. The apron and toe drains are constructed channels with a minimum depth of 2 feet and filled with riprap that has a minimum 12-inch-diameter rock size. Minor erosion has occurred adjacent to a toe drain along the north side of the disposal cell, but that has not impacted the performance of the toe drain.

MAW 8/2015. PL-7. Northeast side slope of the disposal cell.

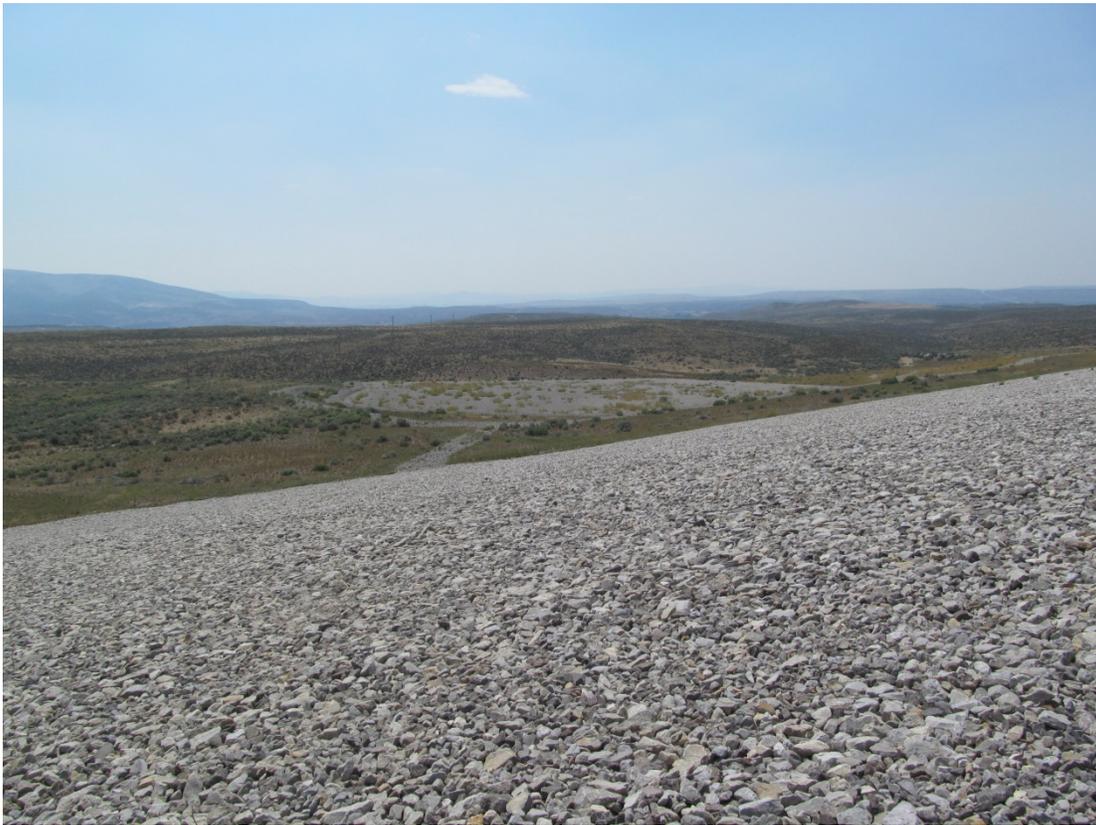
The ancillary cell, which was in good condition (PL-8), was constructed to contain waste materials associated with the reclaimed evaporation pond area. A heap drainage storage pond that was constructed below grade and adjacent to the heap leach repository was used as the footprint for this cell. At the close of reclamation activities for the main disposal cell, the synthetic pond liner material, evaporation pond material, and other contaminated debris remaining on the site were compacted in the ancillary cell. The ancillary cell slopes gently toward the southwest. A rock berm wraps around the eastern and northern sides of the ancillary cell to provide protection from surface-water runoff.

MAW 8/2015. PL-8. South side slope of the disposal cell; ancillary cell in the background.

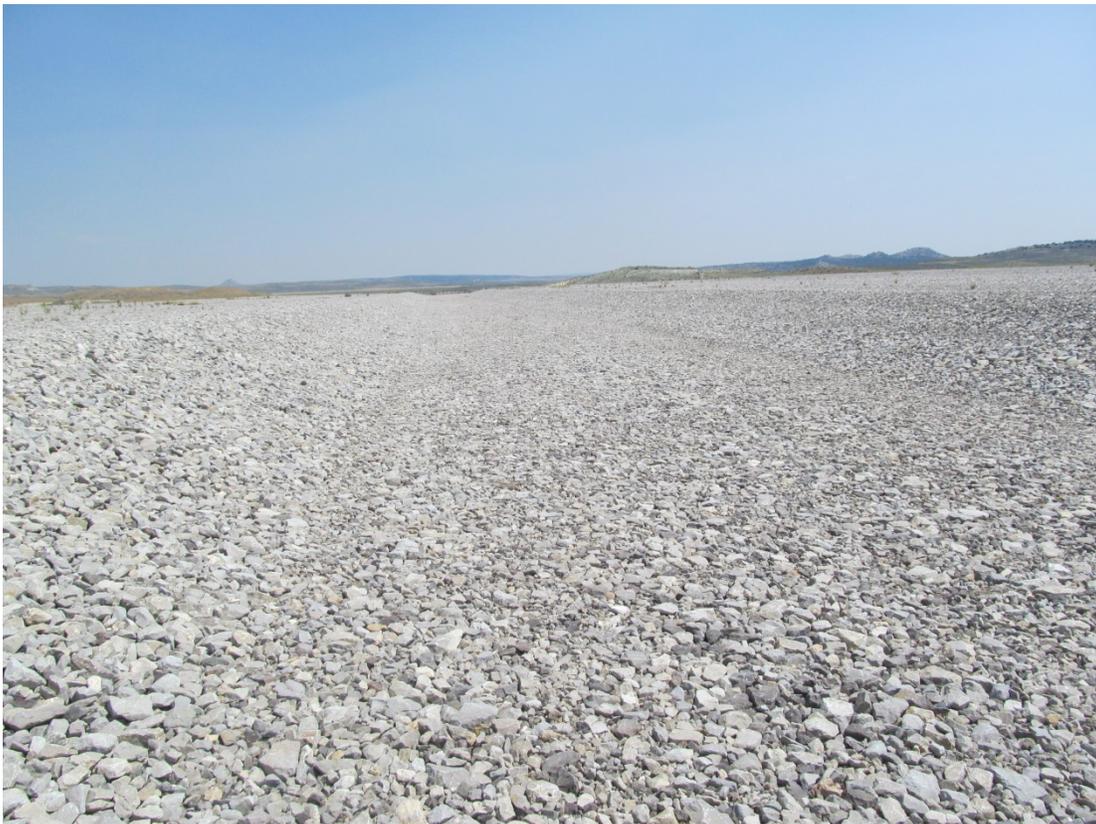
The top slope of the cell was designed to drain surface-water runoff to the center and into riprap-armored Diversion Channel No. 1 (PL-9), which is graded toward and then down the east side slope of the cell (PL-10). Surface-water runoff ultimately discharges into Rob Pit east of the site. An erosion protection structure, referred to as the launch rock erosion protection basin, was constructed at the outfall of Diversion Channel No. 1 to protect the disposal cell from head-cutting that may occur from the deep channel that runs into Rob Pit. Diversion Channel No. 2 runs along the south side of the ancillary cell to convey surface-water runoff away from the cell (PL-11). The diversion channels and outlet channel of the launch rock erosion protection basin were in good condition (PL-12).

MAW 8/2015. PL-9. Diversion Channel No. 1; view downslope.

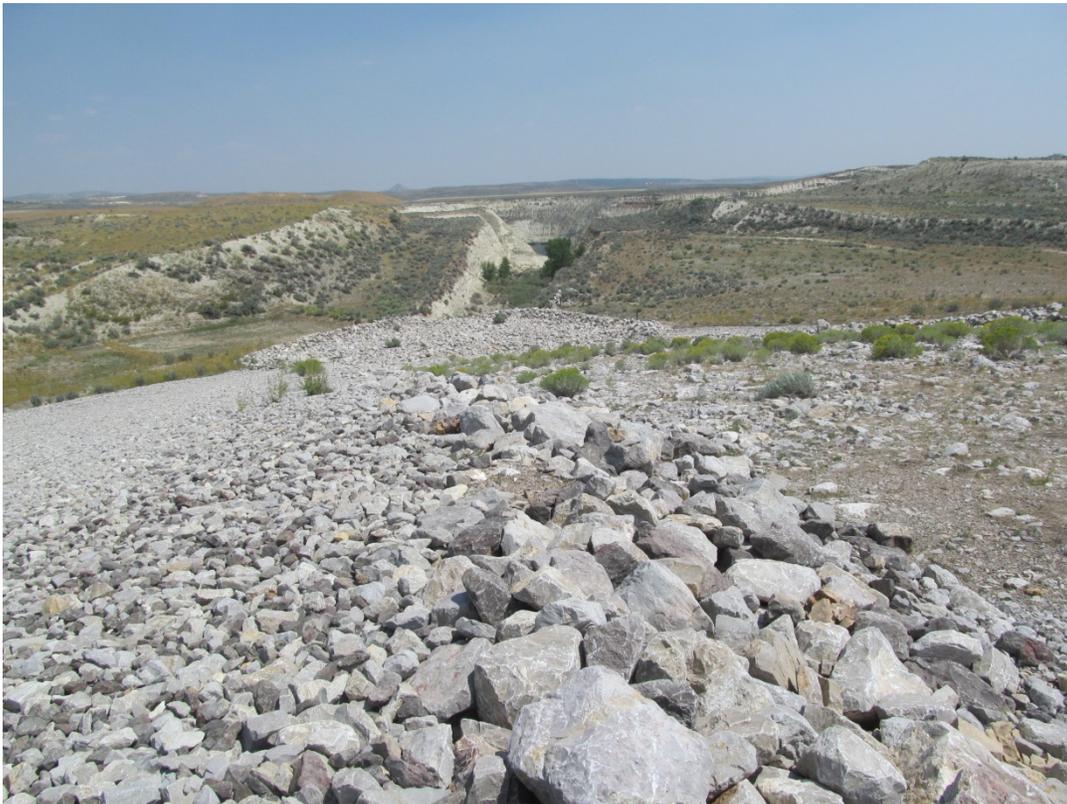
MAW 8/2015. PL-10. Diversion Channel No. 1 outlet into the launch rock erosion protection basin on the east side slope of the disposal cell; Rob Pit in background.

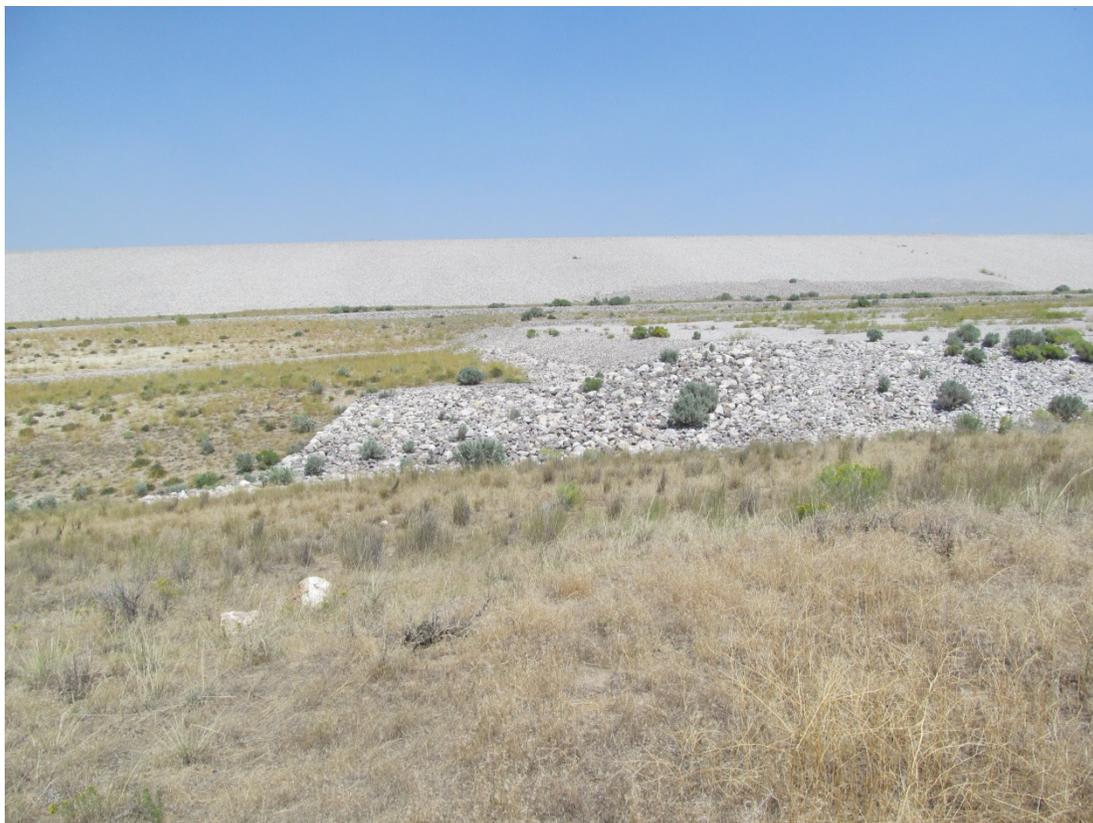
MAW 8/2015. PL-11. Diversion Channel No. 2 outlet and ancillary cell; main disposal cell in background.

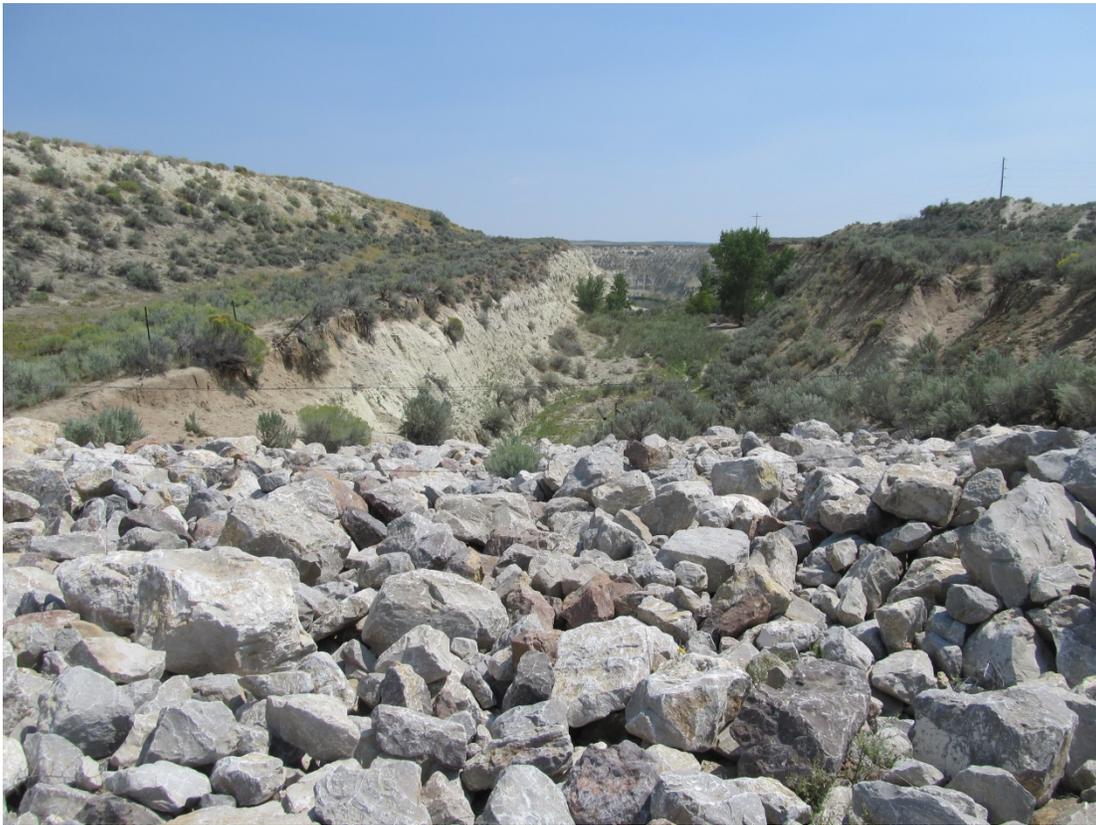
MAW 8/2015. PL-12. Diversion Channel No. 1 outlet channel; Rob Pit in background.

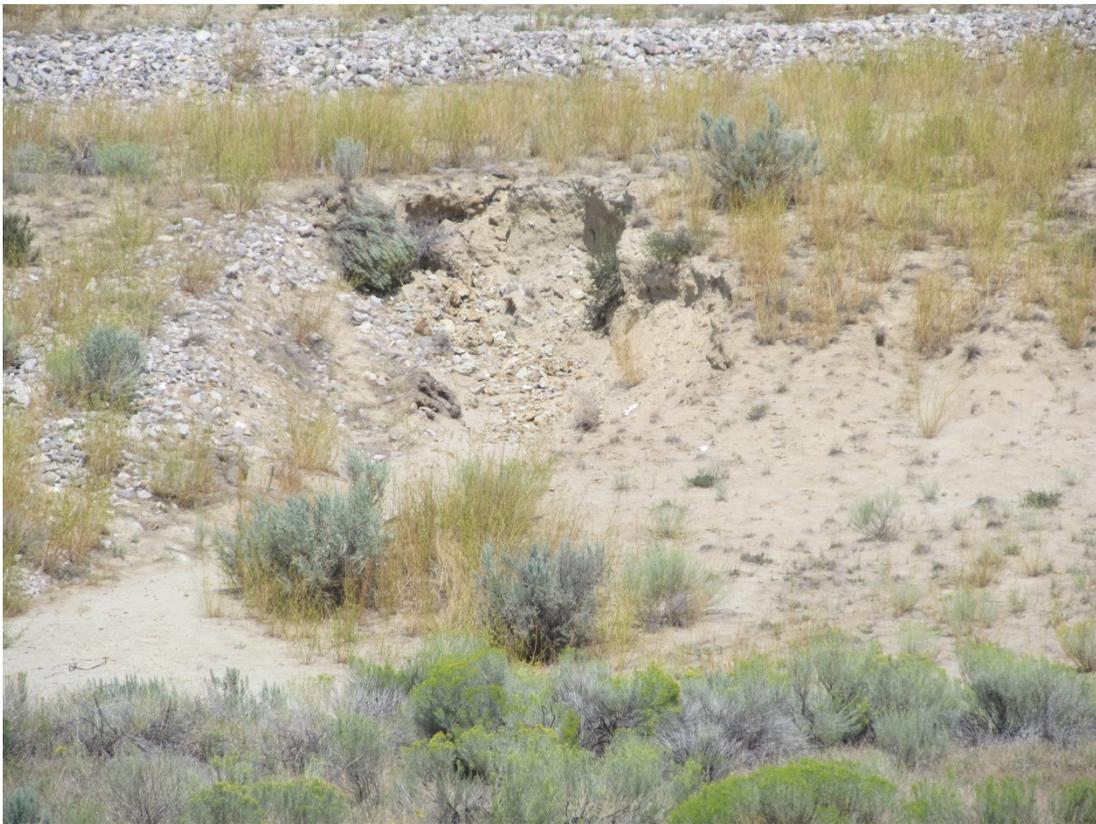
The rock berm that runs along the northern edge of the ancillary cell continues west across the slope south of the main disposal cell to provide protection against erosion. Several gullies and rills have developed along this slope but do not threaten the integrity of the disposal cell (PL-13). They will continue to be monitored and repaired as needed. This erosion is expected to stabilize

over time as site vegetation improves. The rock berm appears to be effective at controlling head-cutting from these gullies and providing protection to the disposal cell.

MAW 8/2015. PL-13. Gully on slope south of disposal cell.
