2003 Annual Inspection of the Monticello Mill Tailings (USDOE) and Monticello Radioactively Contaminated Properties Sites

Summary

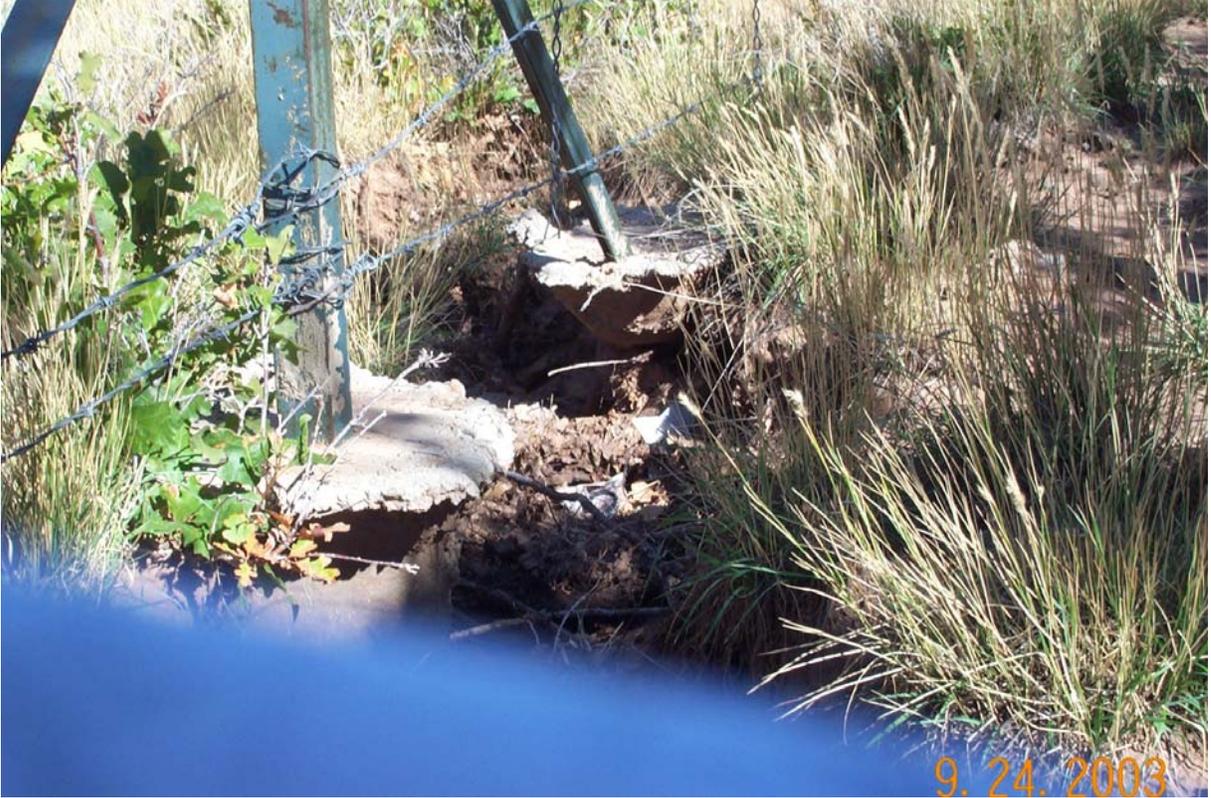
MNT 9/2003. PL-1. Fence post along Highway 191.

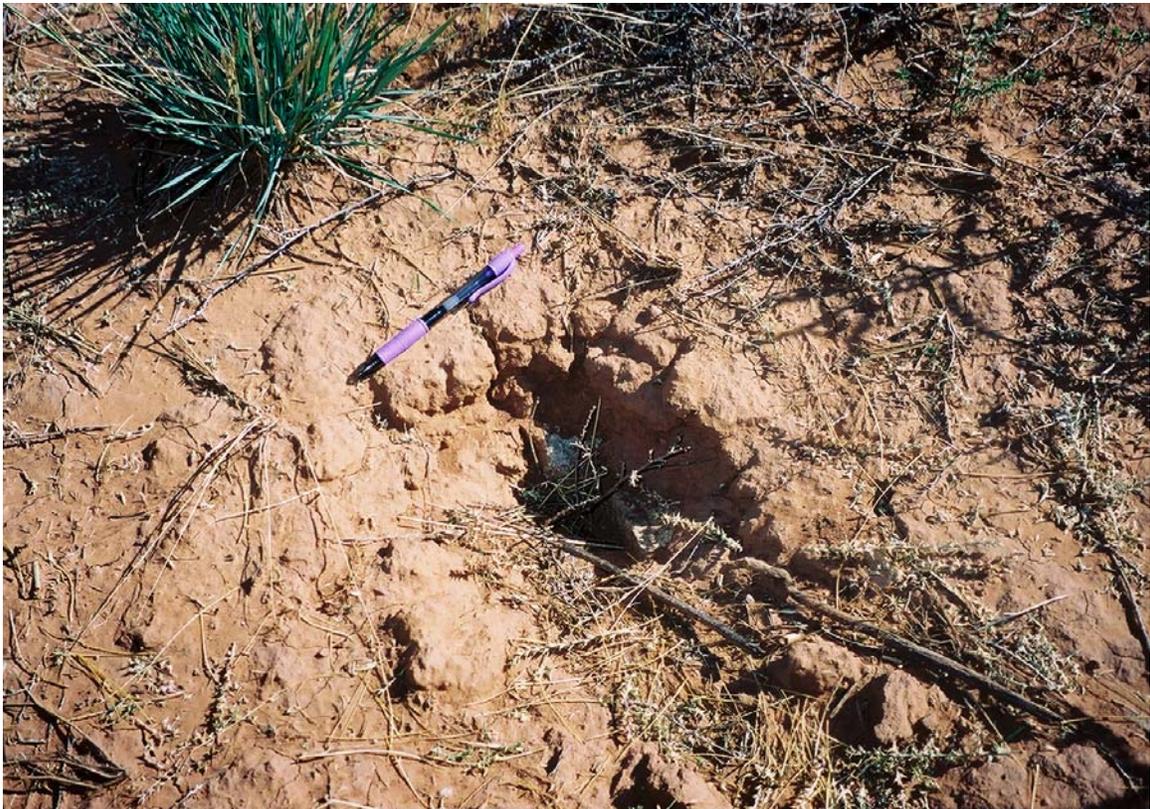
Overall, the top of the disposal cell is in good condition. Settling, slumping, and significant erosion were not observed. As in 2002, small erosion rills were observed adjacent to the gravel road on the north side of the repository (between Zones A1 and B). The rills were formed as a result of storm water running off the compacted surface of the road. Erosion rills also were noted on the south side of the repository just above the south drainage channel. No maintenance action is required; however, inspectors should monitor these features. In Zone B, where 6 inches of soil was placed directly over riprap during cell construction, inspectors noted small holes in the surface where animals had burrowed or soil had “washed” through the underlying rock (PL-4). These features also do not present a problem but should be monitored.

MNT 9/2003. PL-4. Typical hole/burrow in Zone B.

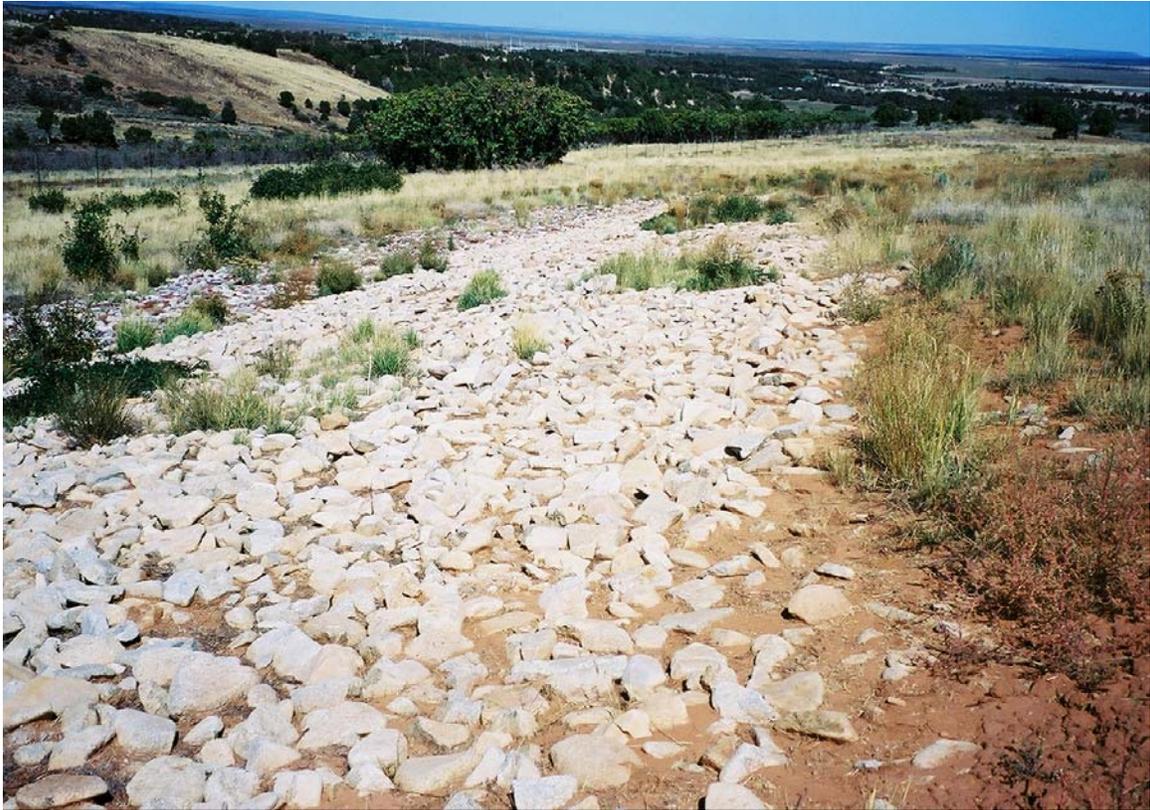
The five-to-one and ten-to-one side slopes of the repository are covered with rock armor. The side slopes are in excellent condition. No evidence of rock movement or degradation, settling, slumping, or erosion was observed. In areas adjacent to Zones A1 and A2, topsoil has eroded into the riprap interstices (PL-5). Inspectors also noted that herbaceous and woody plants are encroaching into riprap-covered areas (PL-5 and PL-6). Neither of these natural processes is a concern.

MNT 9/2003. PL-5. Silt deposition in riprap area (NW portion of cover); note vegetation encroachment.

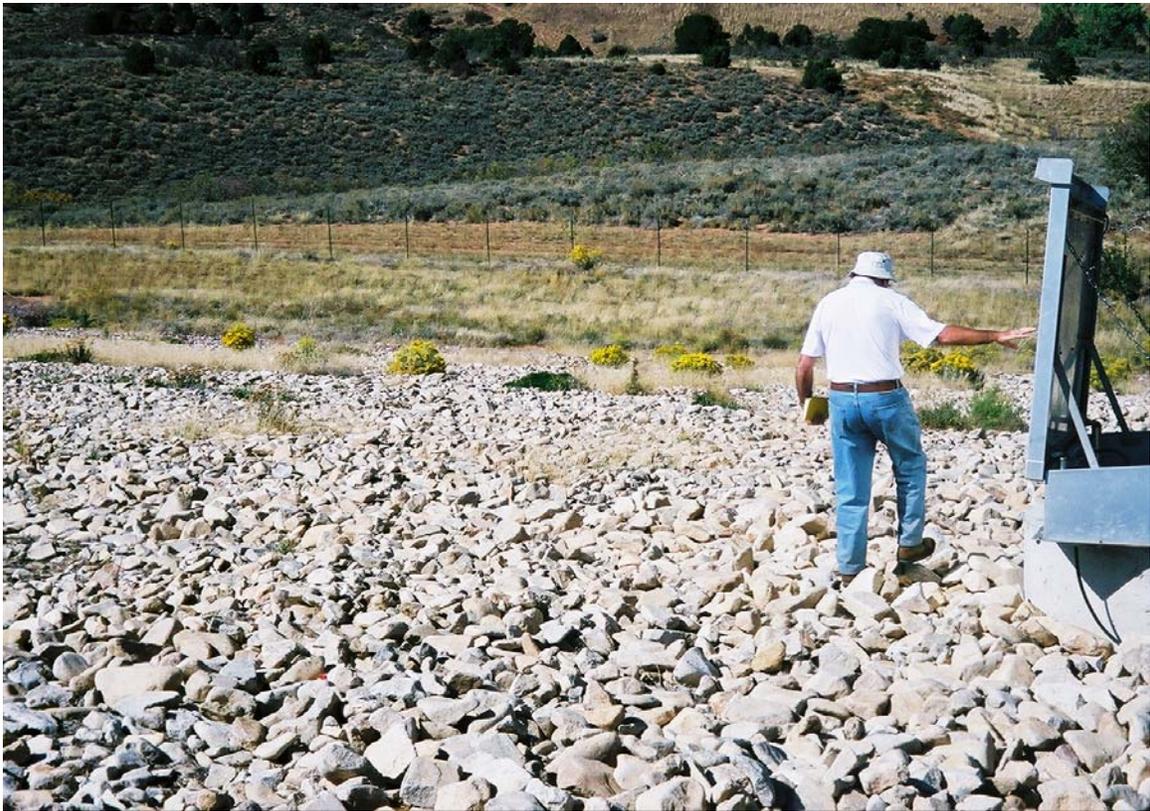
MNT 9/2003. PL-6. Vegetation encroachment near Manhole 2.

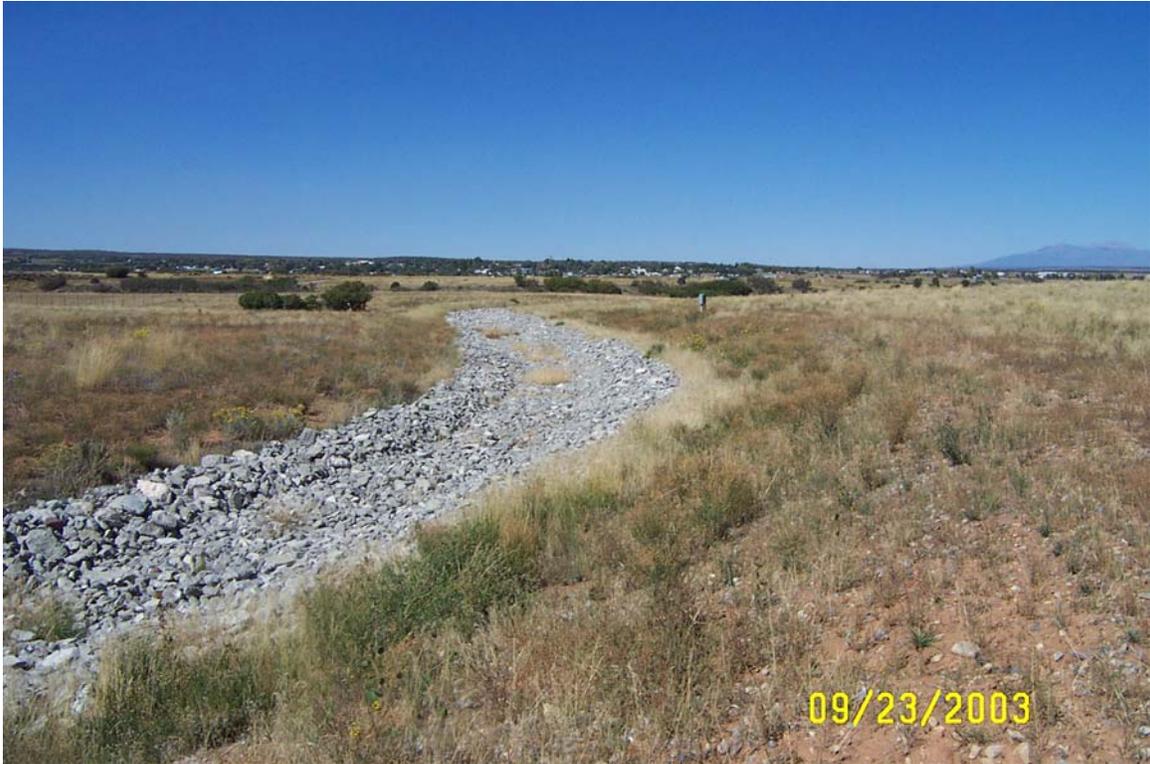
observed growing in the upper portion of the west drainage channel, but it does not affect the function of the channel (PL-7). At the 2003 annual inspection, the rock channels were in excellent condition.

MNT 9/2003. PL-7. West Drainage Channel.

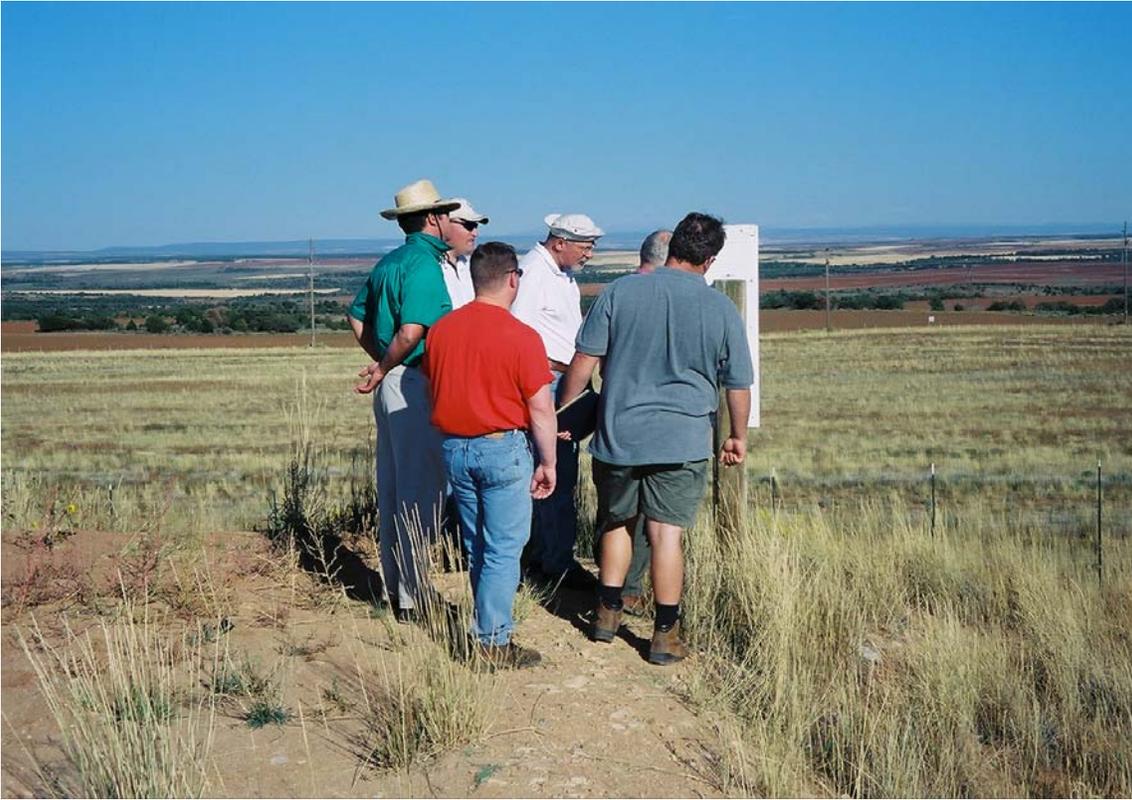
Four lifesaving stations are positioned around the pond. These stations contain buoys, life jackets, and ropes. The stations were in generally good condition. The polypropylene rope attached to the buoy in the middle cabinet on the north side of the pond showed evidence of solar degradation and should be replaced (PL-8). The latch and/or hinges on the door of the safety cabinet in the southeast corner of Pond 4 were not functioning properly and should be repaired. This condition made it difficult to open the door to access emergency equipment (PL-9). The LTS&M representatives will replace the buoy rope and repair the cabinet door.

MNT 9/2003. PL-9. DOE, EPA, UDEQ, and NETL representatives struggling with malfunctioning life-saving equipment door.

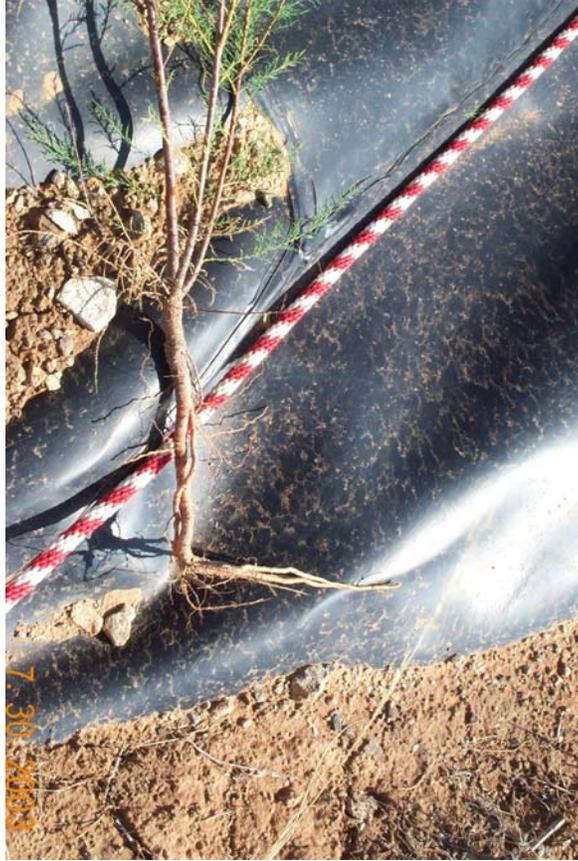
During the 2002 annual inspection, tamarisk was growing in sediment in the bottom of the lined pond. The tamarisk plants have been cut, the stalks have been sprayed with herbicide, and the plants have been left within the contaminated area to biodegrade (PL-10). Earlier in the year, the LTS&M representatives dug up one of the larger plants and determined that the roots are not damaging the liner; the roots grow parallel to the liner upon reaching it (PL-11).

MNT 9/2003. PL-11. Tamarisk removed from Pond 4. Note change of direction of root growth upon encountering liner.

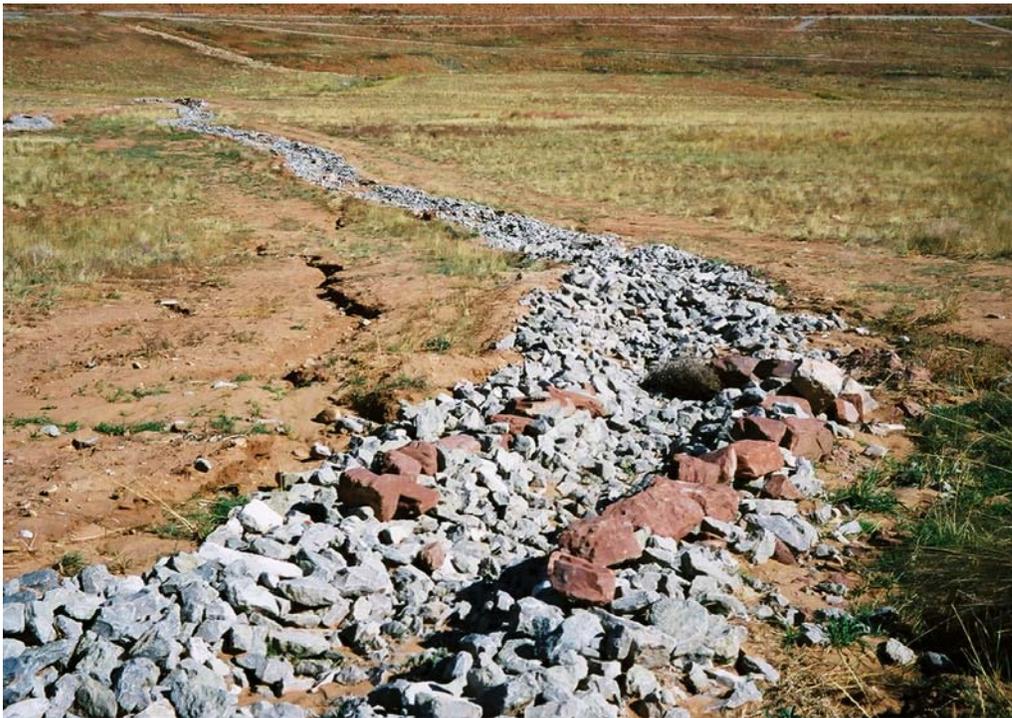
MNT 9/2003. PL-12. Draining channel between topsoil borrow area and millsite. Note gully next to riprap.

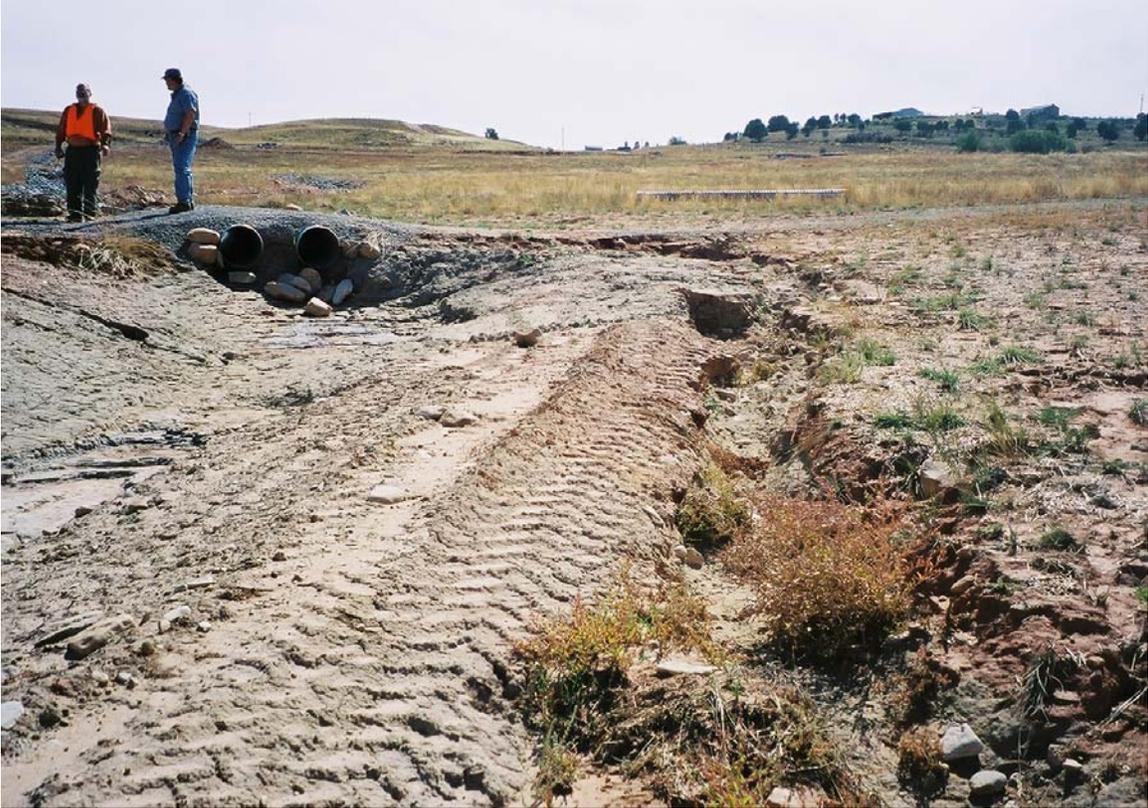
MNT 9/2003. PL-13. Culverts beneath walking path. Note eroded area adjacent to ditch.

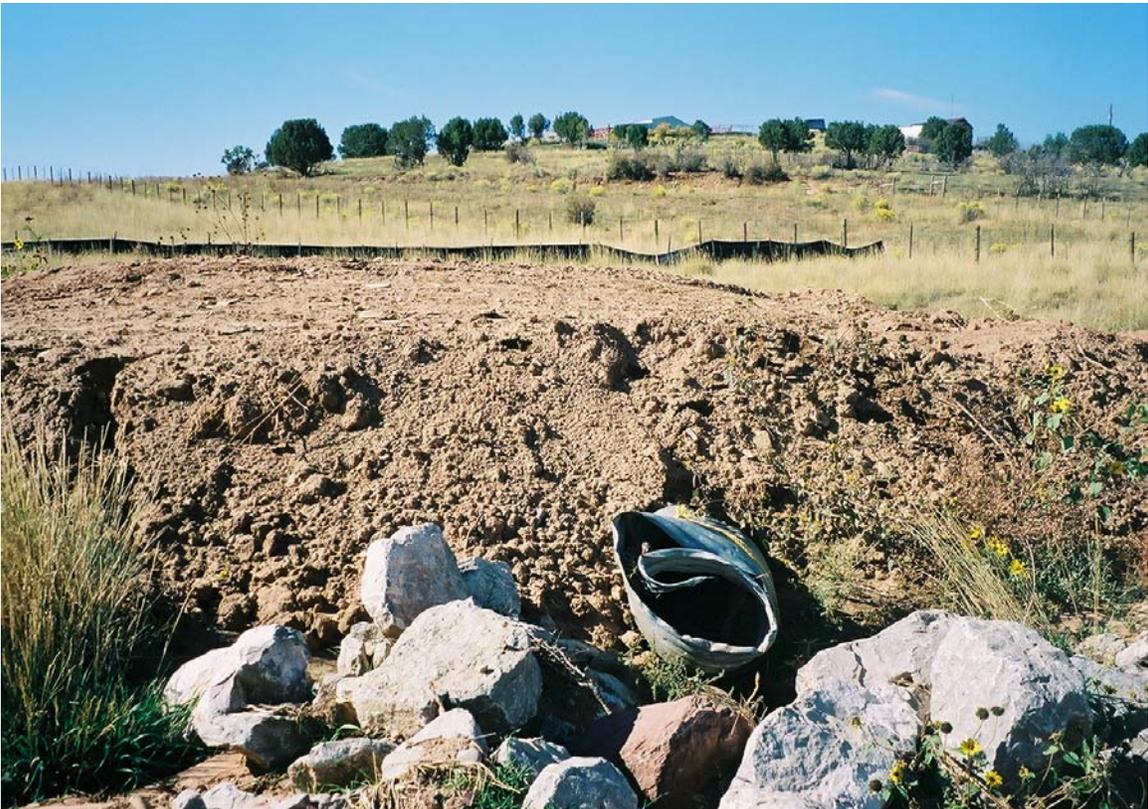
- DOE had recently cleaned out the retention pond on MP-00391. Representatives from EPA/UDEQ noted that material on the dam face needed to be compacted. Additionally, the downstream side of the culvert placed in the dam was bent and needs to be straightened or cut off, as the contorted opening was routing water away from the rocked channel (PL-14).

MNT 9/2003. PL-14. Downstream side of culvert in MP-00391 retention pond.

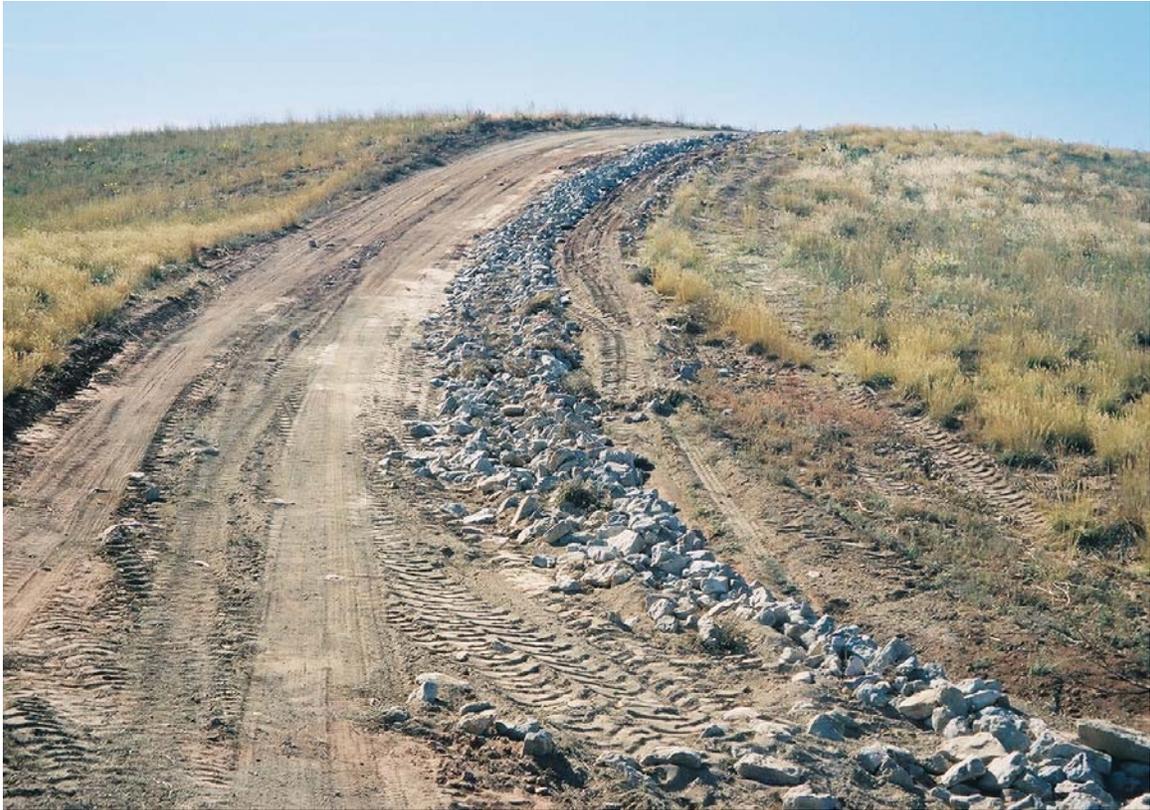
- In an effort to prevent gullying of the road leading to the MP-00391 retention pond, DOE had recently bladed a small drainage ditch along the road and placed riprap in it for stability (PL-15). Inspectors noted that the newly placed riprap fills the ditch and will likely redirect runoff to the road surface rather than into the ditch. A more defined ditch needs to be constructed.

MNT 9/2003. PL-15. Road leading to MP-00391.

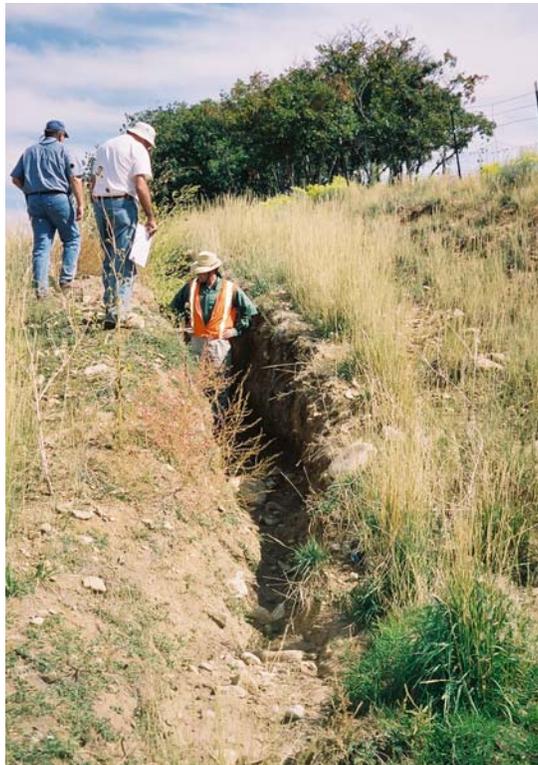
MNT 9/2003. PL-16. Erosion within Christensen's ditch just above confluence with Montezuma Creek.

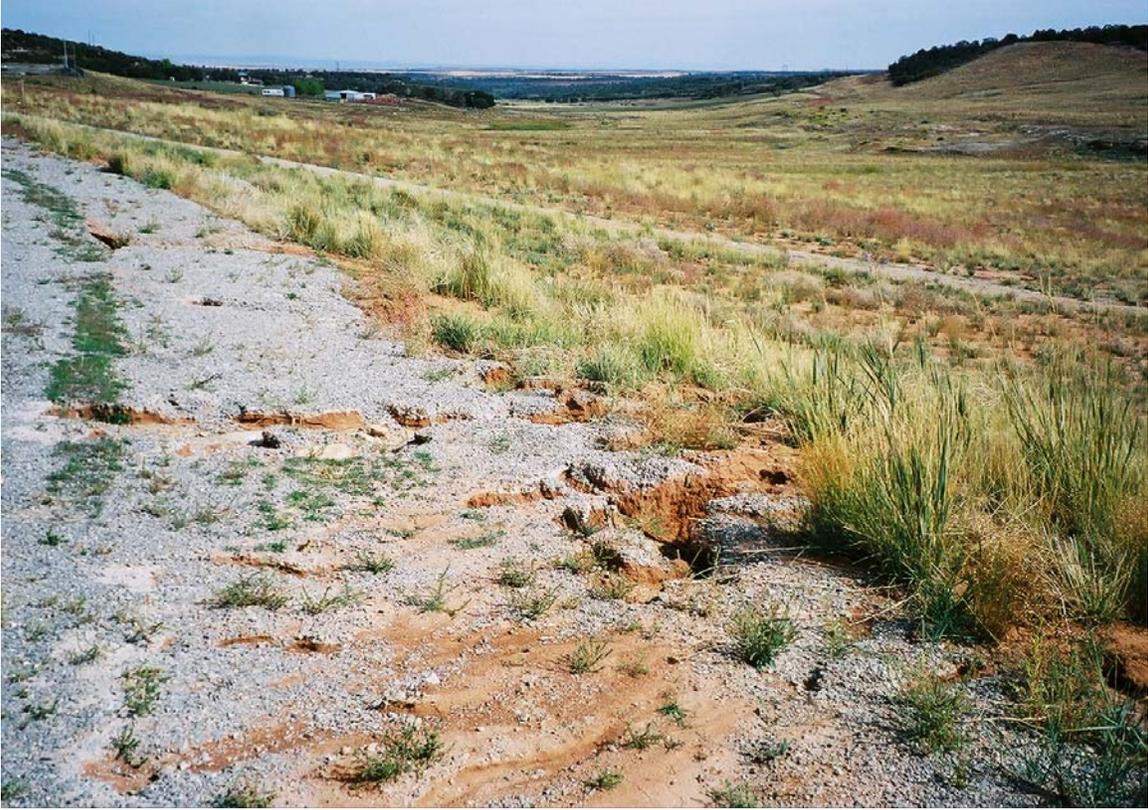
MNT 9/2003. PL-17. Runoff from upland areas has eroded walking path.

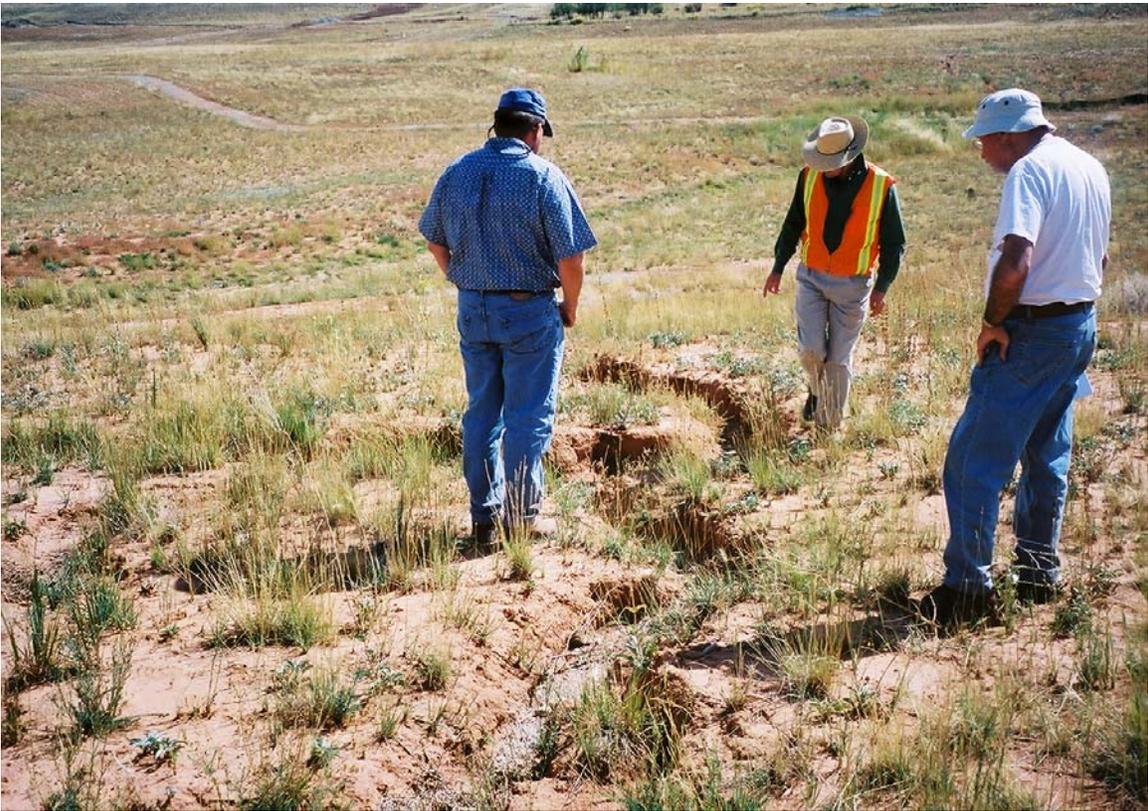
- Immediately west of the millsite access road turn-around, a silt fence has caused runoff waters to form gullies in the upland side slope (PL-18).
- Large gullies have formed on the side slope below Goodknight Spring, and sediment has been deposited in the Seep Pond wetland (PL-19). The sediment is negatively affecting the wetland area by raising the surface elevation and lowering the water table (relative to the soil surface). As of July 29, 2003, approximately 1,500 square feet of wetland was present in the Seep Pond. This area may not be considered wetland by July 2004, when the next wetland monitoring is scheduled. Although the loss of this wetland would not significantly affect the total wetland acreage on the millsite, when combined with other potential wetland area losses, it may become significant in the long term.

MNT 9/2003. PL-18. Gully in upland area of millsite.

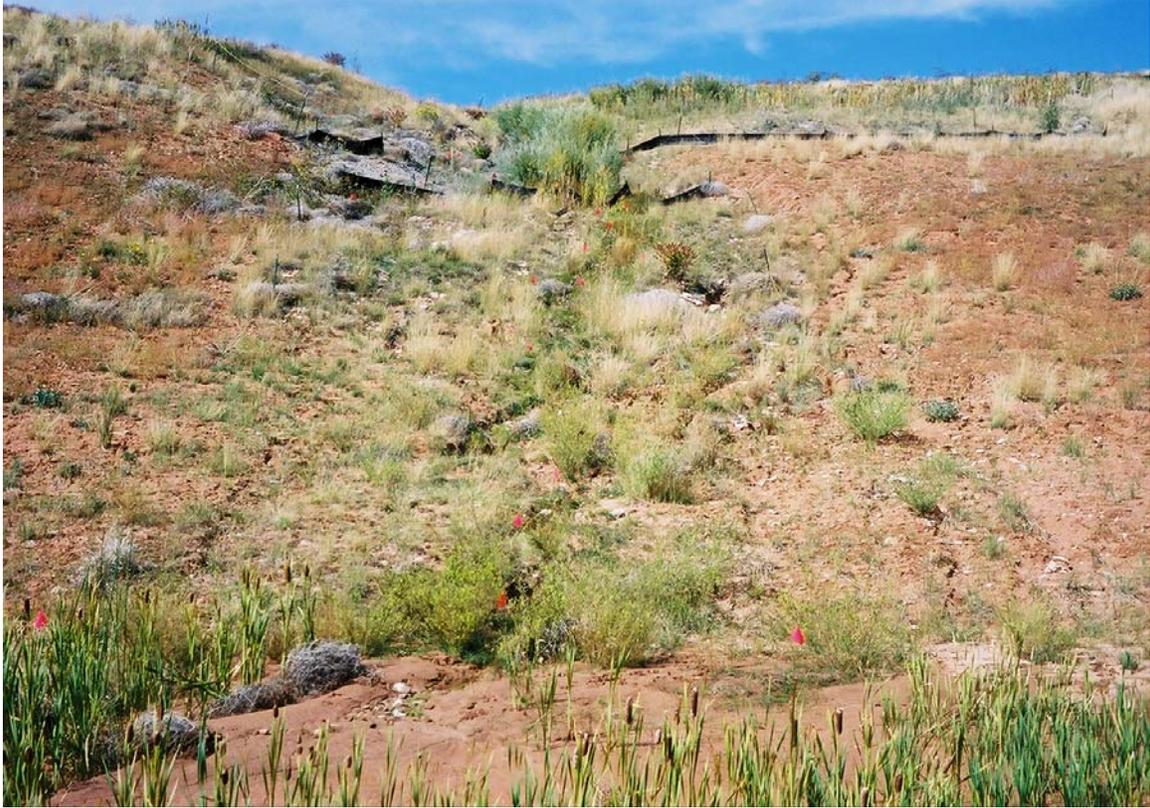
MNT 9/2003. PL-19. Gullies below Goodknight Spring. Note sediment deposition in Seep Pond (foreground).

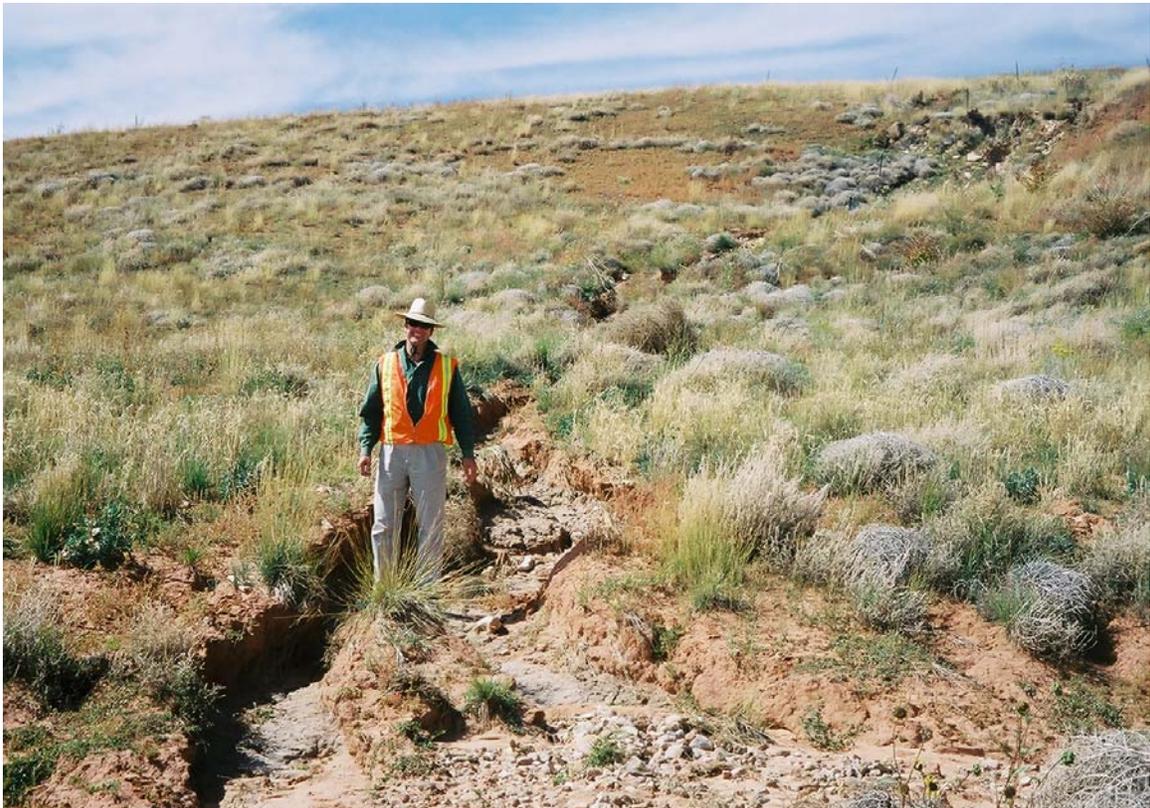
- A large gully has formed on the side slope below Highway Seep (PL-20), and sediment has been deposited in Backwater Wetland #1. The sediment has already negatively affected the wetland area by raising the surface elevation and lowering the water table (relative to the soil surface); the area of sediment deposition does not meet the criteria for wetland. Further deposition needs to be prevented in this area to avoid affecting the remaining wetland area. Removal of the current sediment deposit is not recommended at this time because of its relatively small and insignificant size (i.e., restoring this area to wetland would not significantly affect the total wetland acreage on the millsite).

MNT 9/2003. PL-20. Gully below Highway Seep.

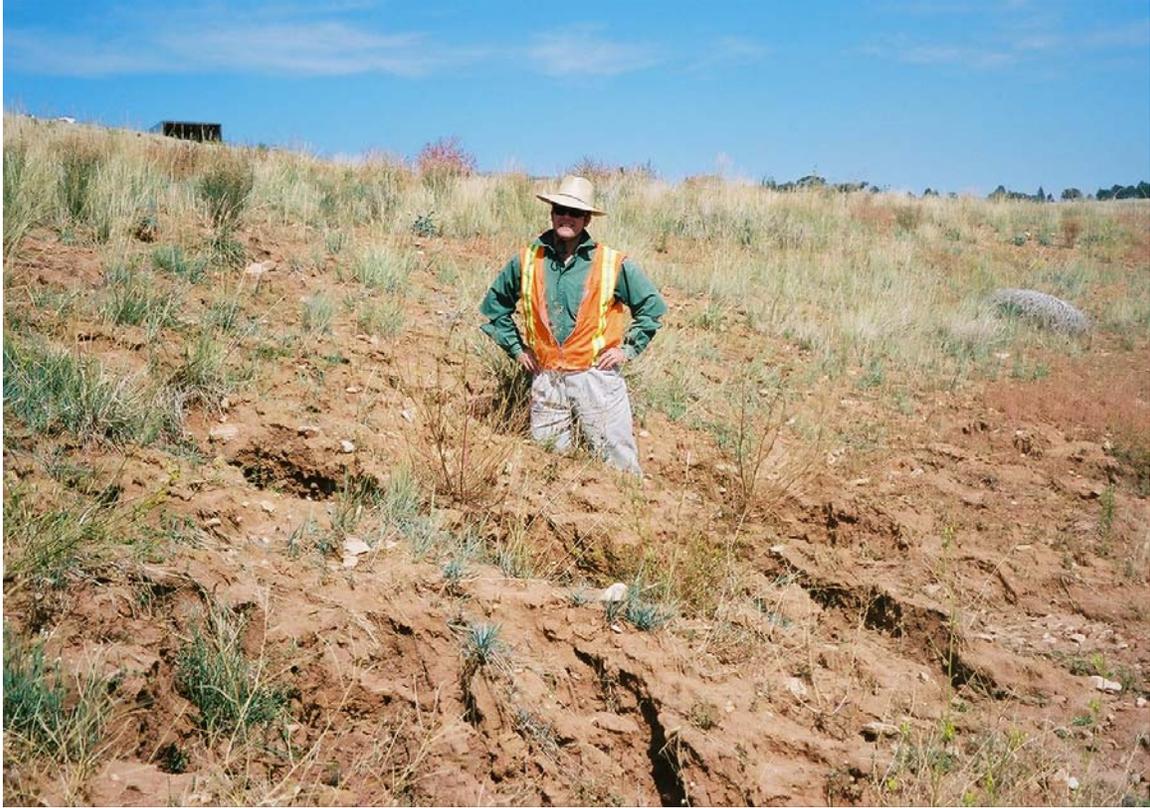
MNT 9/2003. PL-21. Gully on north side of Backwater Wetland #1.

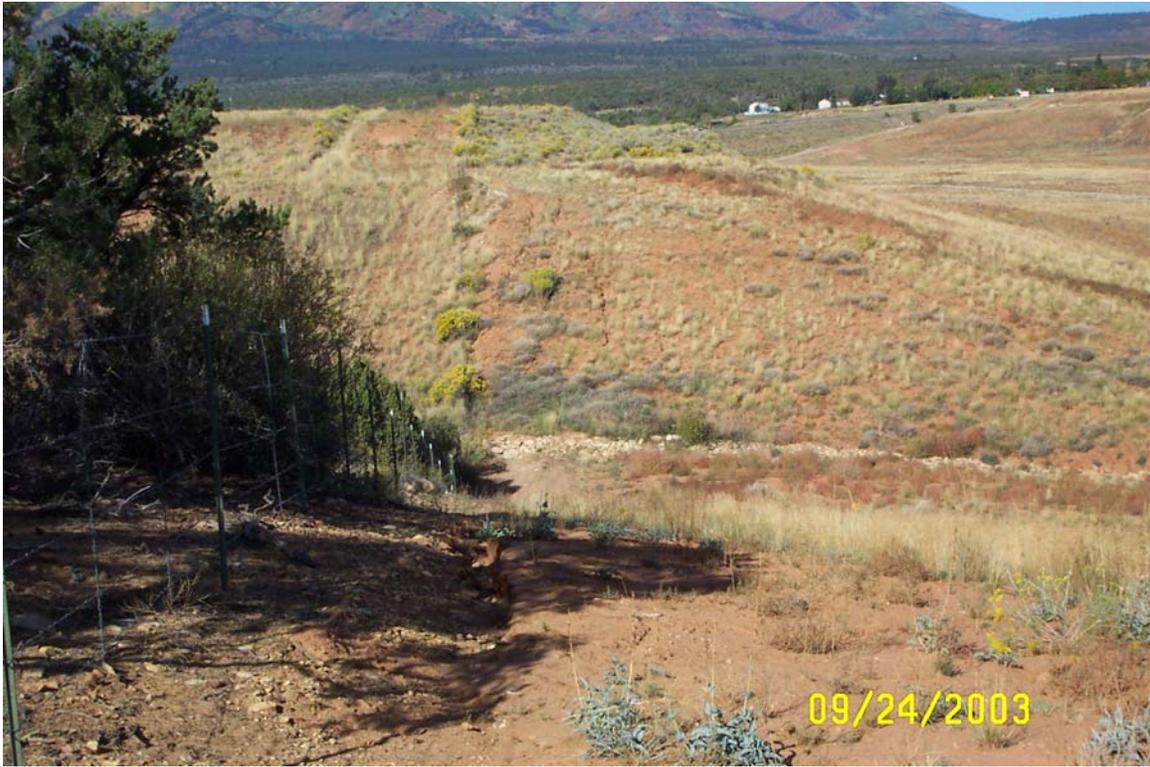
- The city did not finish the construction work required to direct Deer Draw flows into the rock-lined drainage ditch. The ditch along the north side of the fence needs to be armored with rocks (PL-23). The culvert where Deer Draw crosses under the supplemental standards fence needs to be removed, and the drainage that collects water needs to be lined with rock. The rock drainage channel has been damaged by recent storms; the rock needs to be distributed evenly over the length of the channel to prevent hydraulic jumps from occurring. The bottom seventy feet of the rock channel is filled with silt, which should be removed.

MNT 9/2003. PL-23. Deer Draw at supplemental standards boundary.

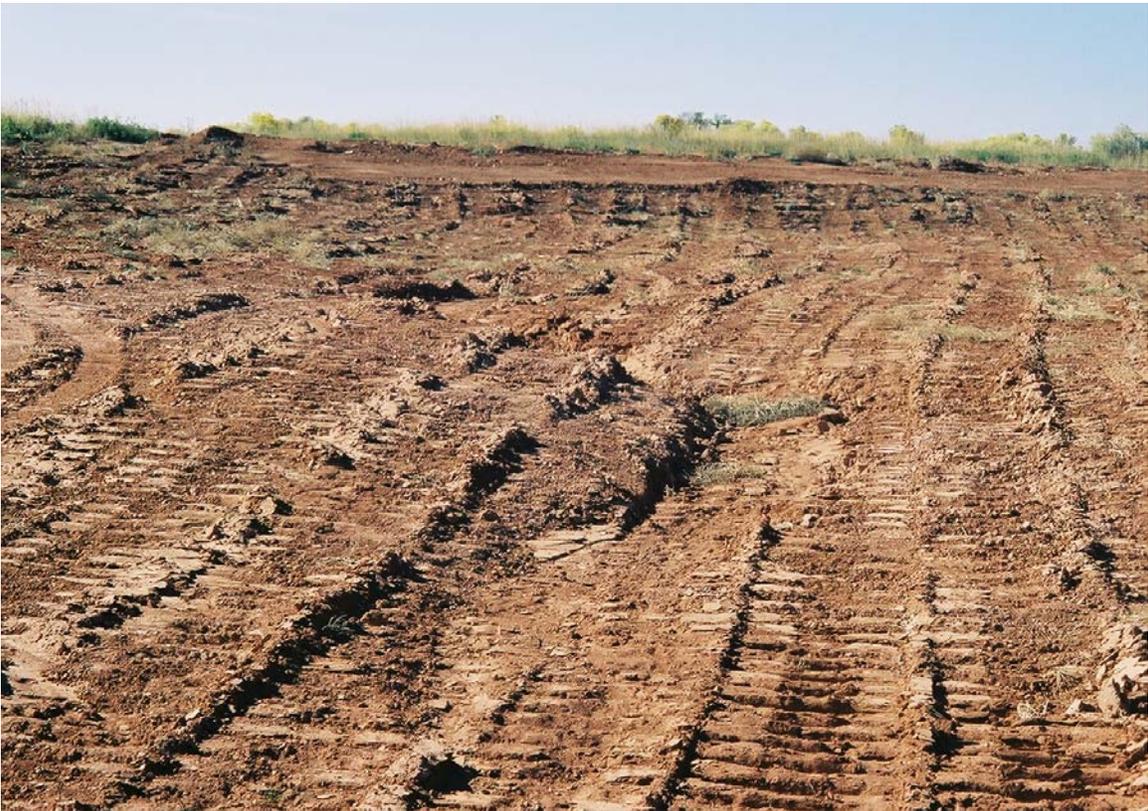
MNT 9/2003. PL-26. Borrow area showing gully formation.

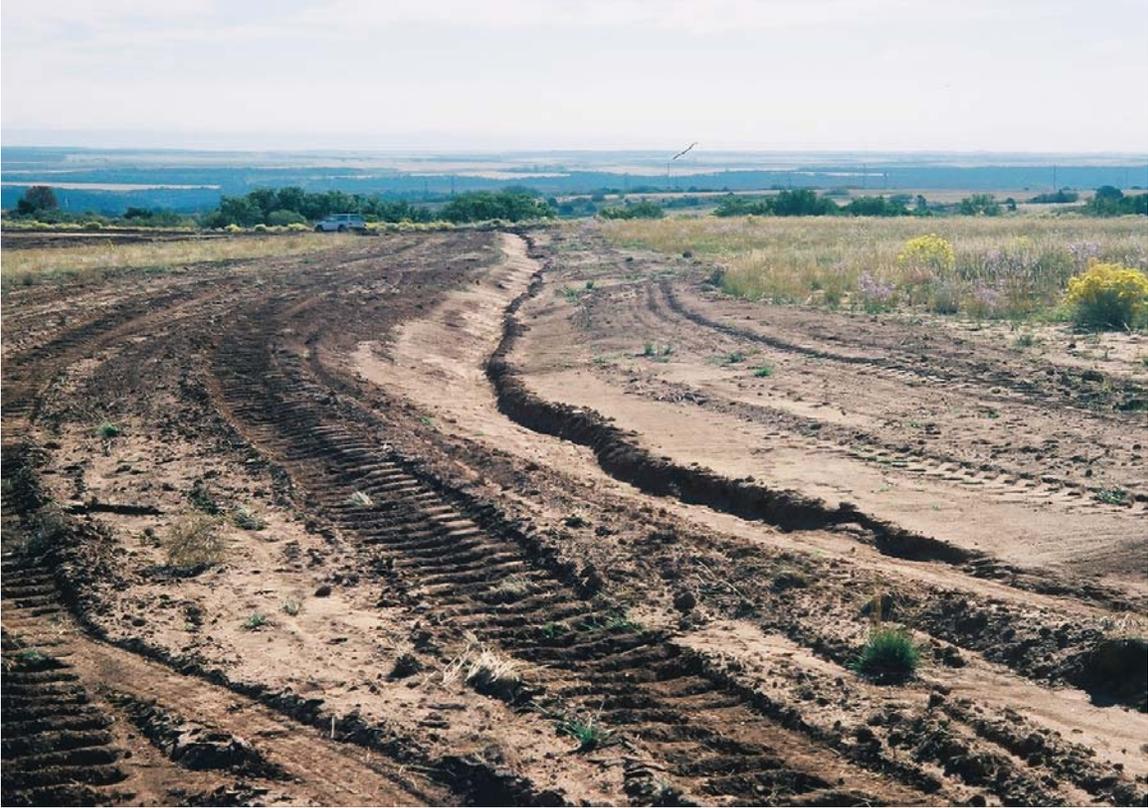
MNT 9/2003. PL-27. Borrow area showing ditch needing riprap.

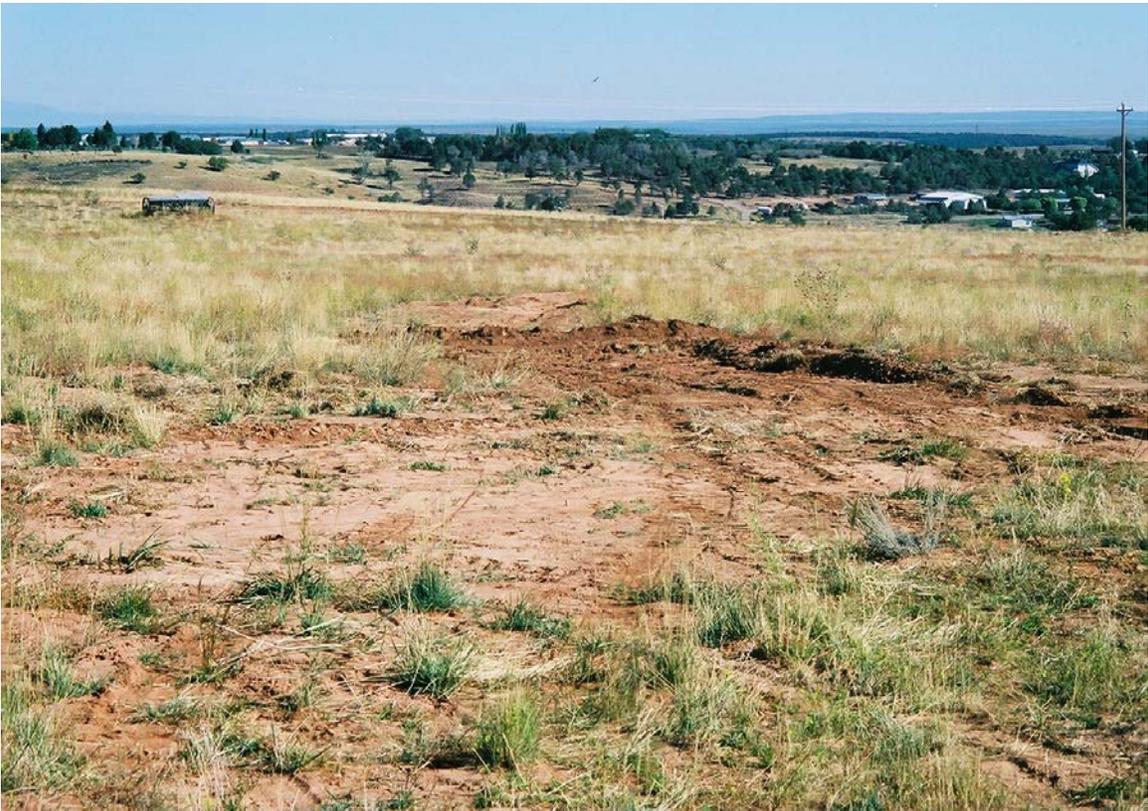
MNT 9/2003. PL-28. Borrow area showing check dam in need of compaction.

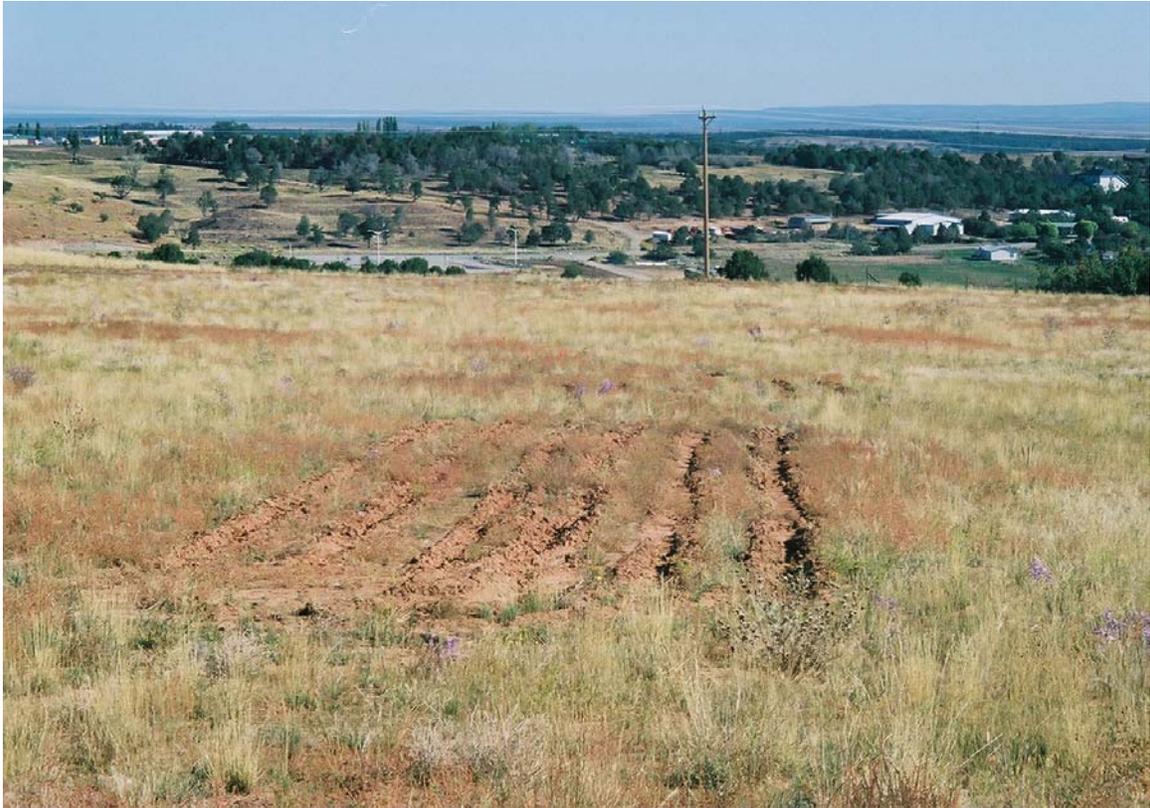
- Although most of the repaired areas on the topsoil borrow site had been ripped by a D-4 dozer on the contour, one small area had been ripped in a down slope direction (PL-29) and seeded. It was recommended that this area be re-ripped on the contour.

MNT 9/2003. PL-29. Borrow area showing area needing to be ripped on contour.

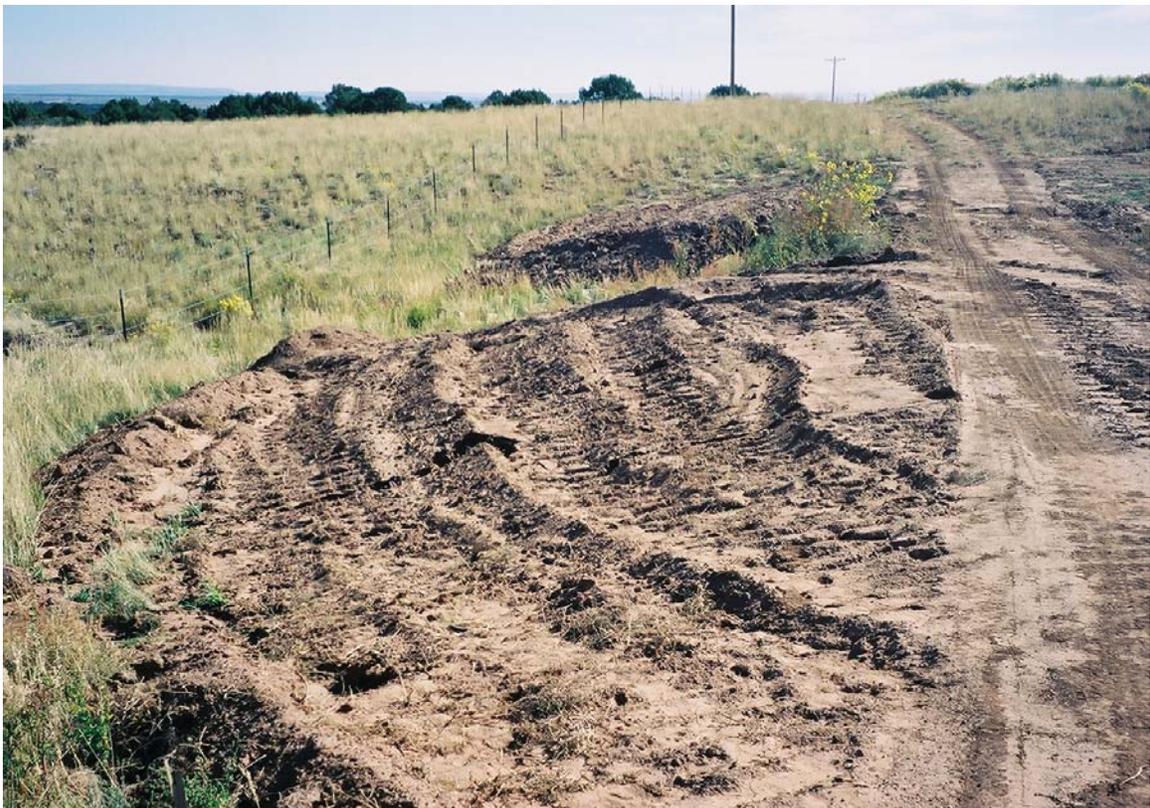
- Sediments within the Deer Draw retention pond (at the north end of the topsoil borrow site) had recently been removed and placed on the downside of the dam face (PL-30). It was recommended that these sediments be regraded and compacted and that runoff waters be diverted to avoid the dam face.

MNT 9/2003. PL-30. Borrow area showing Deer Draw retention pond dam.
