2003 Annual Inspection of the Monticello Mill Tailings (USDOE) and Monticello Radioactively Contaminated Properties Sites

Summary

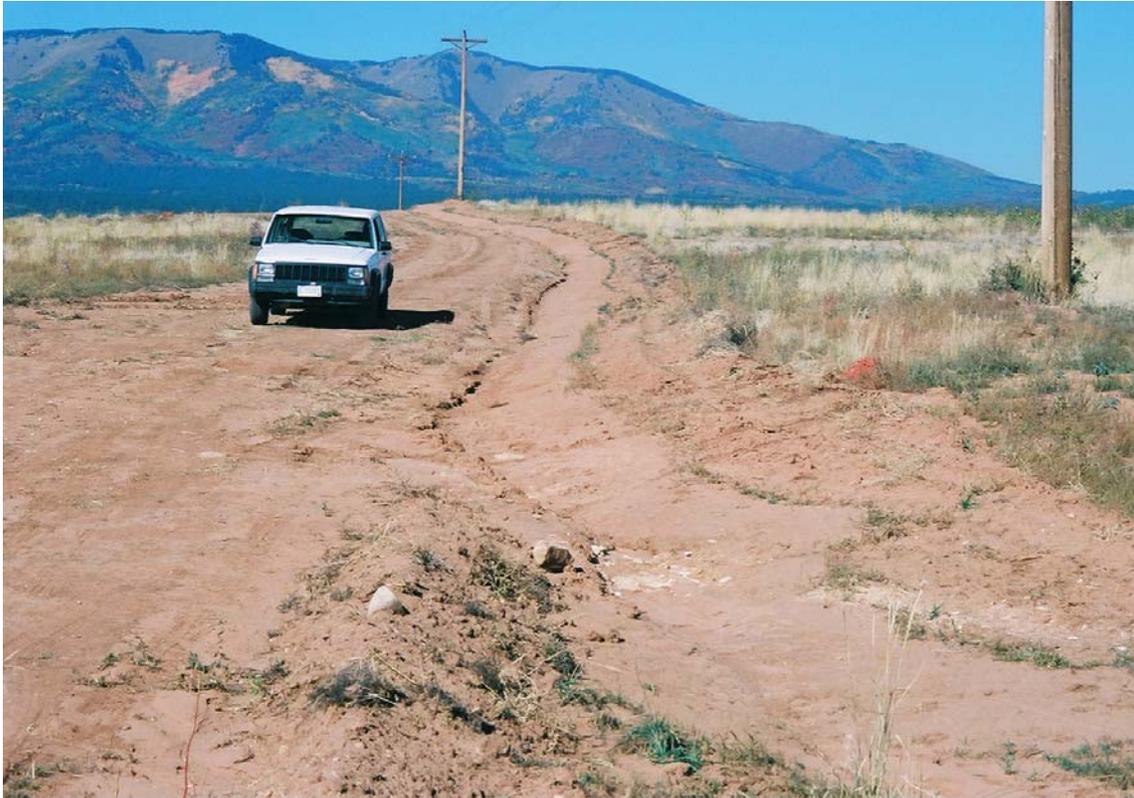
- A ditch adjacent to the road leading to the Deer Draw retention pond had recently been bladed (PL-31). Inspectors recommended that this road and/or ditch be water barred to divert runoff into the retention pond (rather than to the gulch below the retention pond).

MNT 9/2003. PL-31. Borrow area showing road near Deer Draw retention pond.

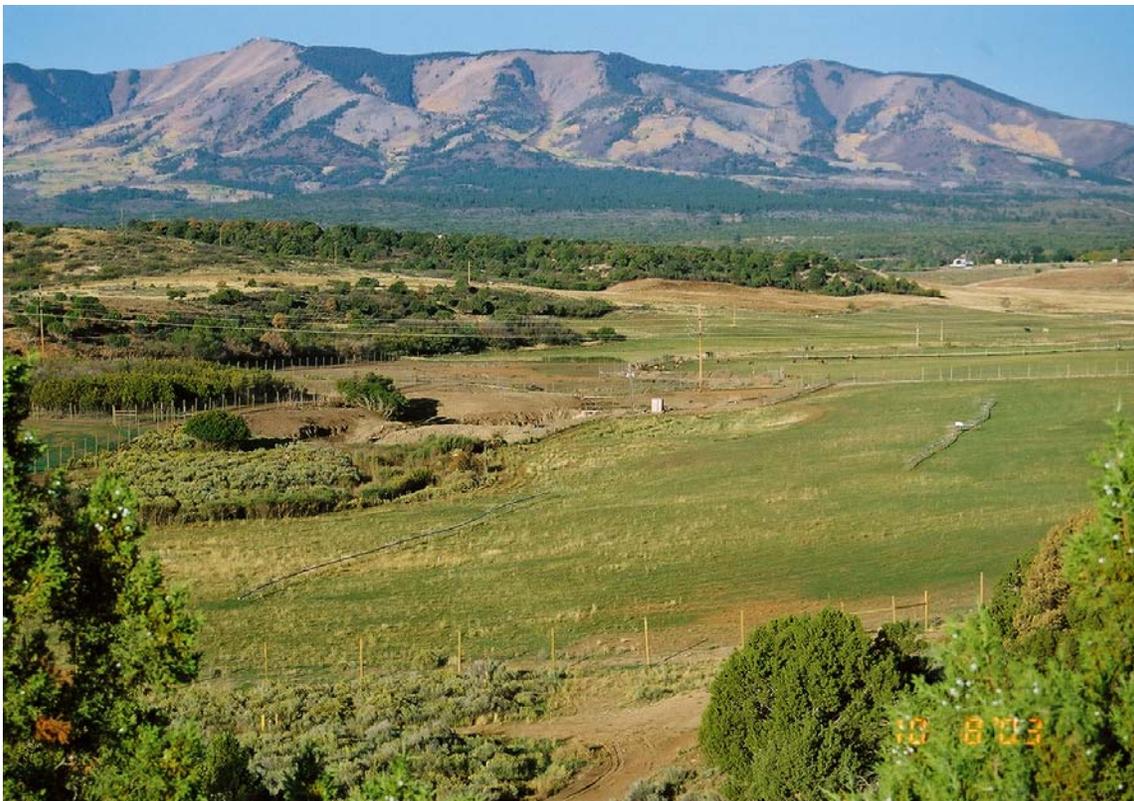
MNT 9/2003. PL-32. Elk ranch below former millsite. Note denuded vegetation, breached dam, and new fence in foreground.
